Environmental Study Report

Wycroft Road Improvements from Bronte Road to Kerr Street

Appendix H: Structures and Culverts

Subject Town of Oakville - Wyecroft EA - Visual Inspection of Structures

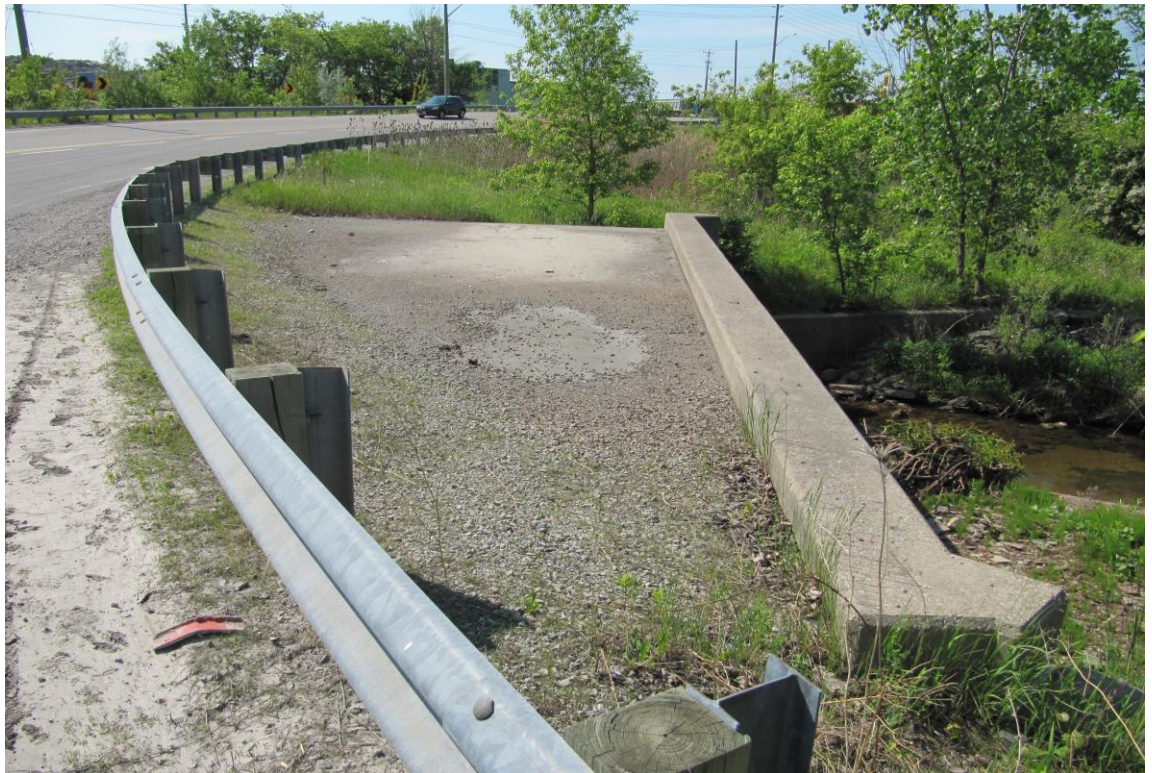
Condition of Existing Guide Rail System

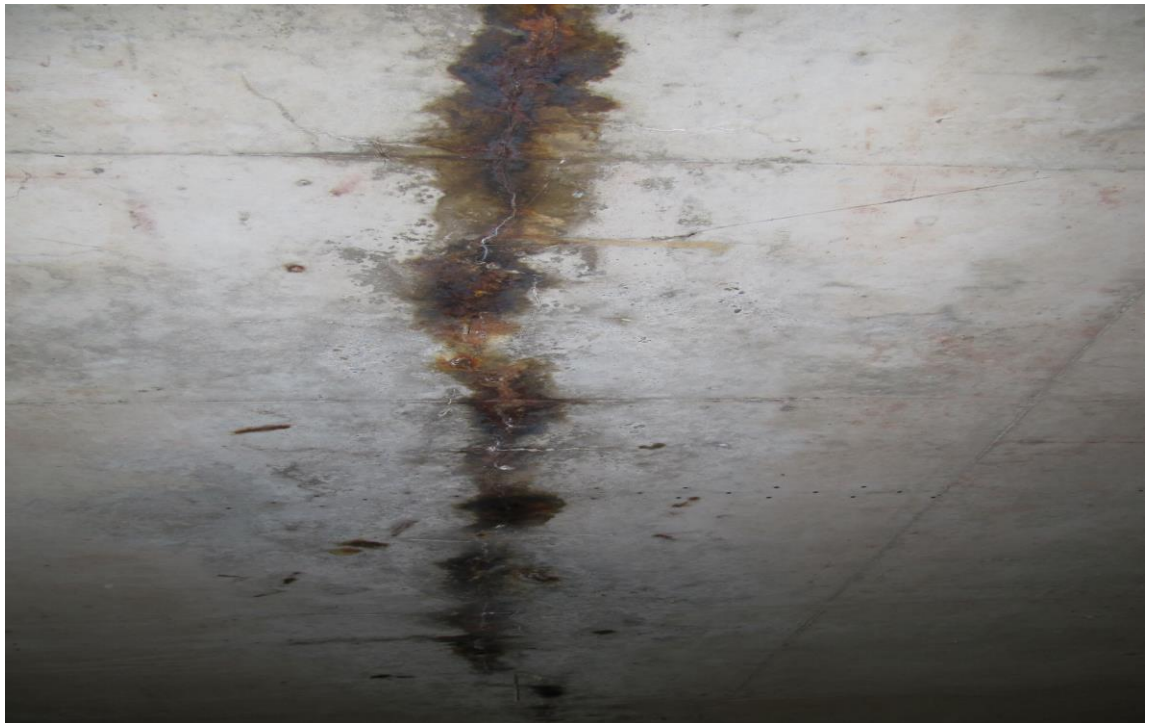
- The bituminous surfacing exhibits transverse and random longitudinal cracks.
- Deck soffit exhibits transverse stained cracks on both south and north cells.
- The reinforcement chairs were visible from the deck soffit.
- It was observed that top slab exhibits water drainage problems.

Transverse Crack in the North Cell (Typical)

The existing structure requires minor rehabilitation works including patch repairs to improve the durability of the structure and prevent further concrete deterioration.

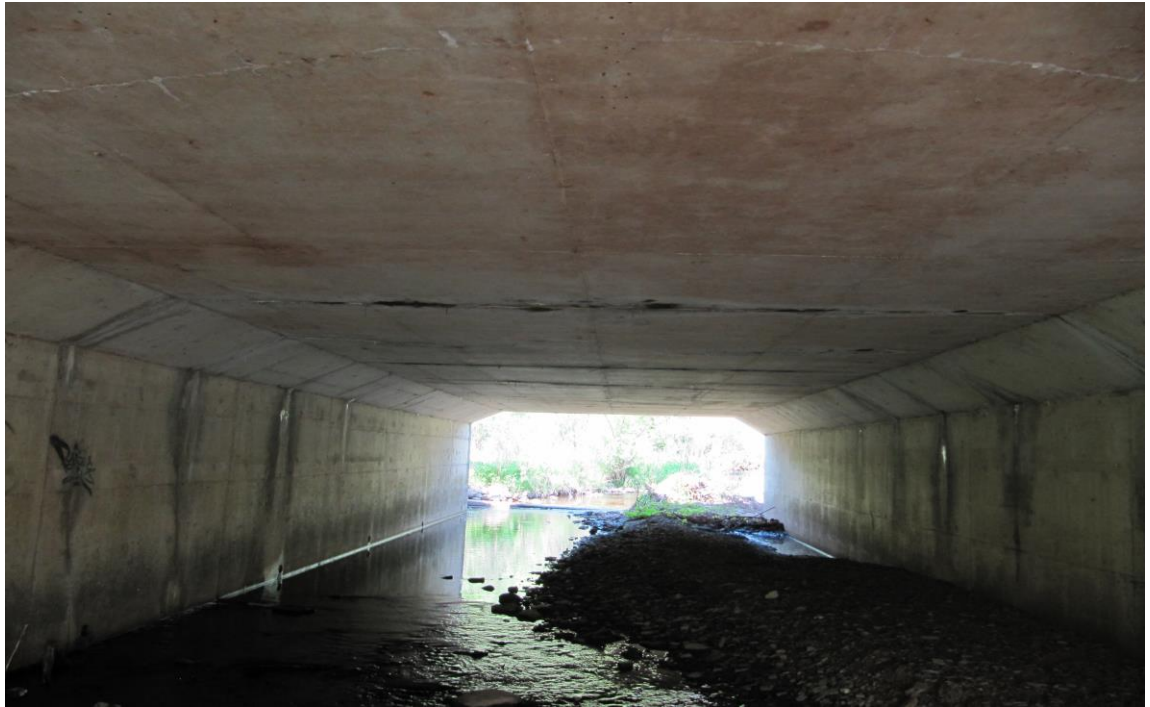
Sediment Buildup in the South Cell Looking West

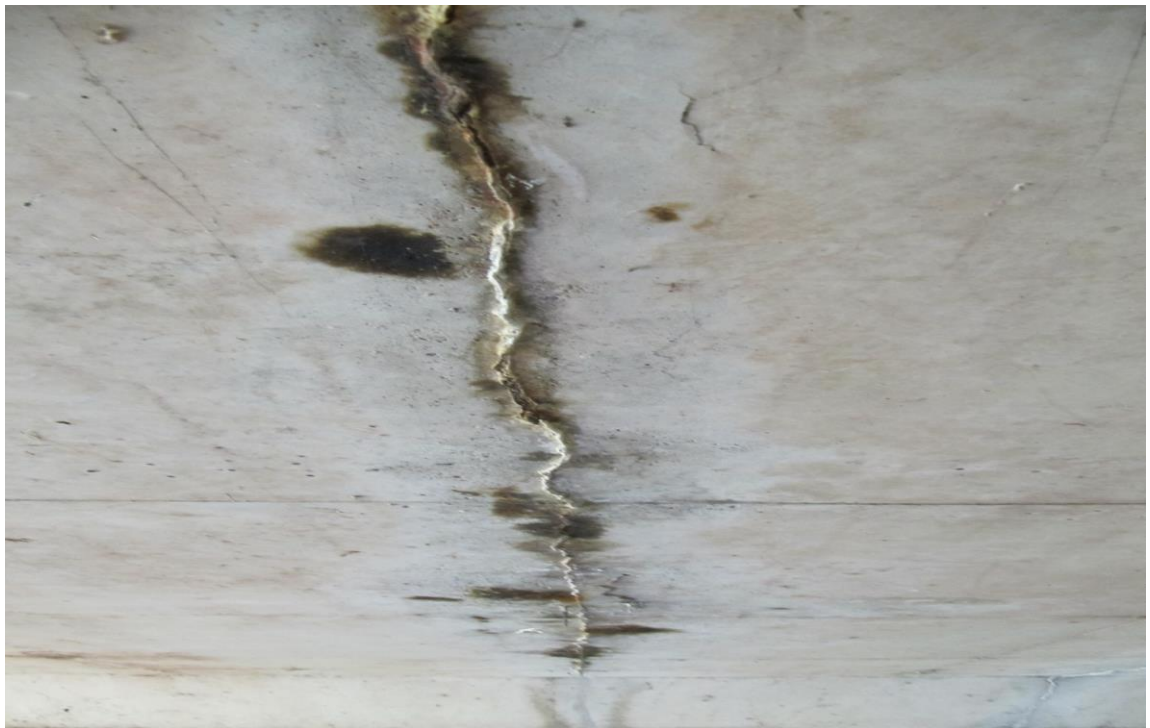
Transverse Crack in the South Cell (Typical)

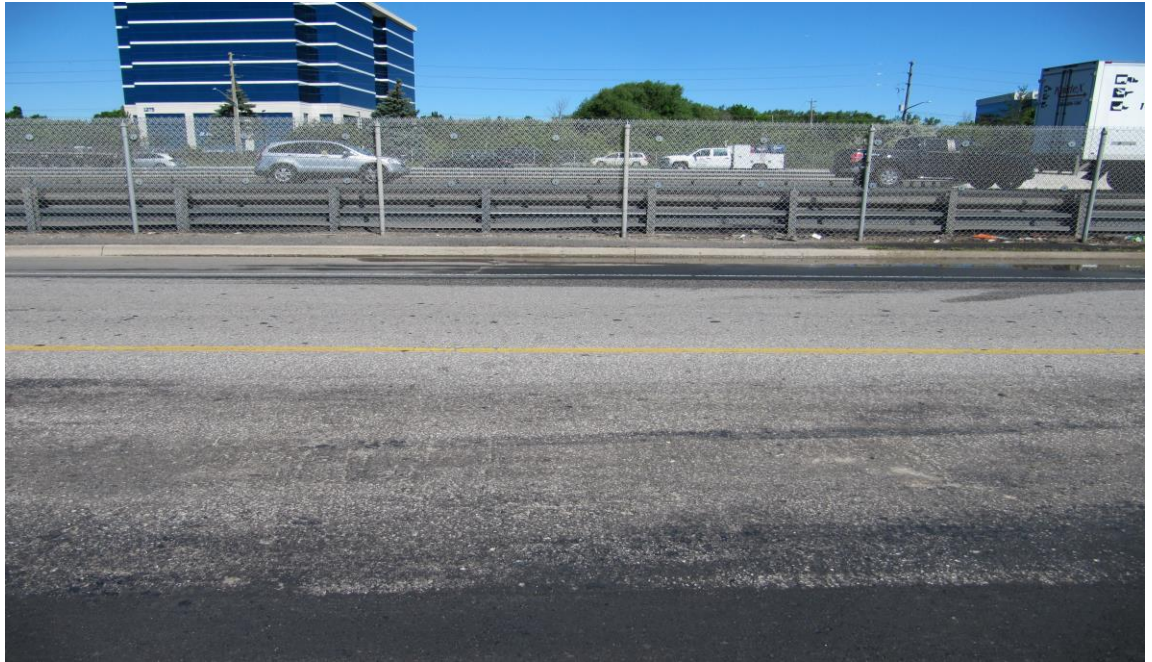
Existing Condition of Wearing Surface

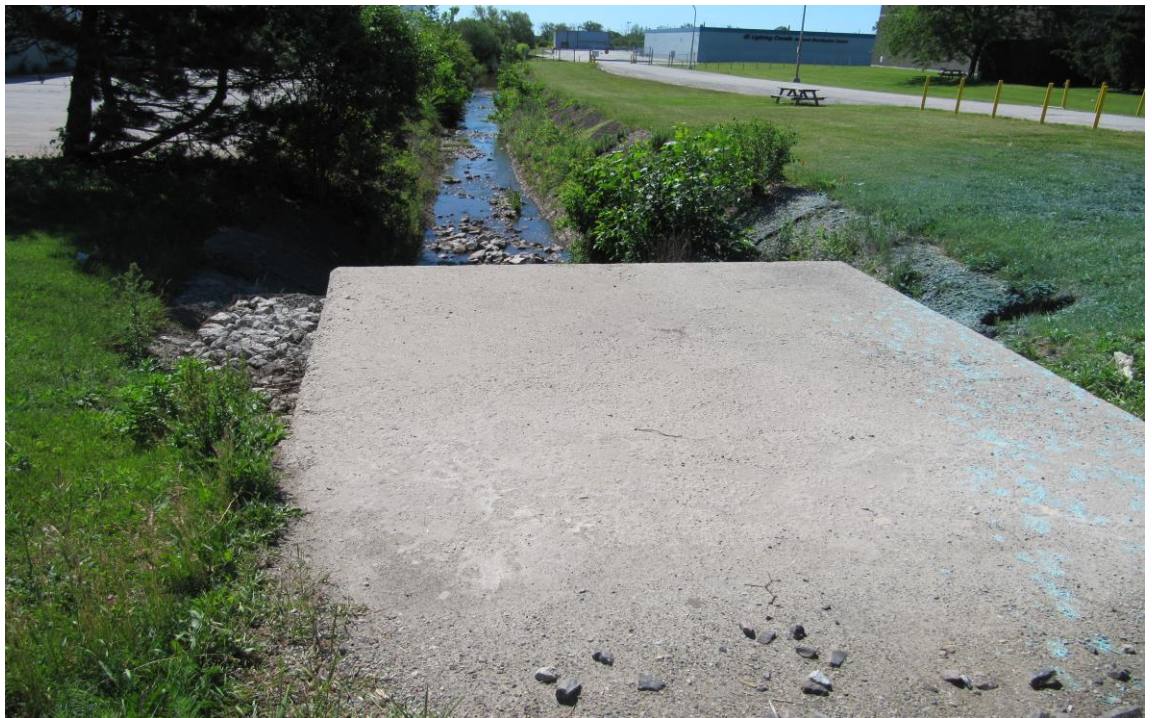
Existing Surface Condition of the Top Slab

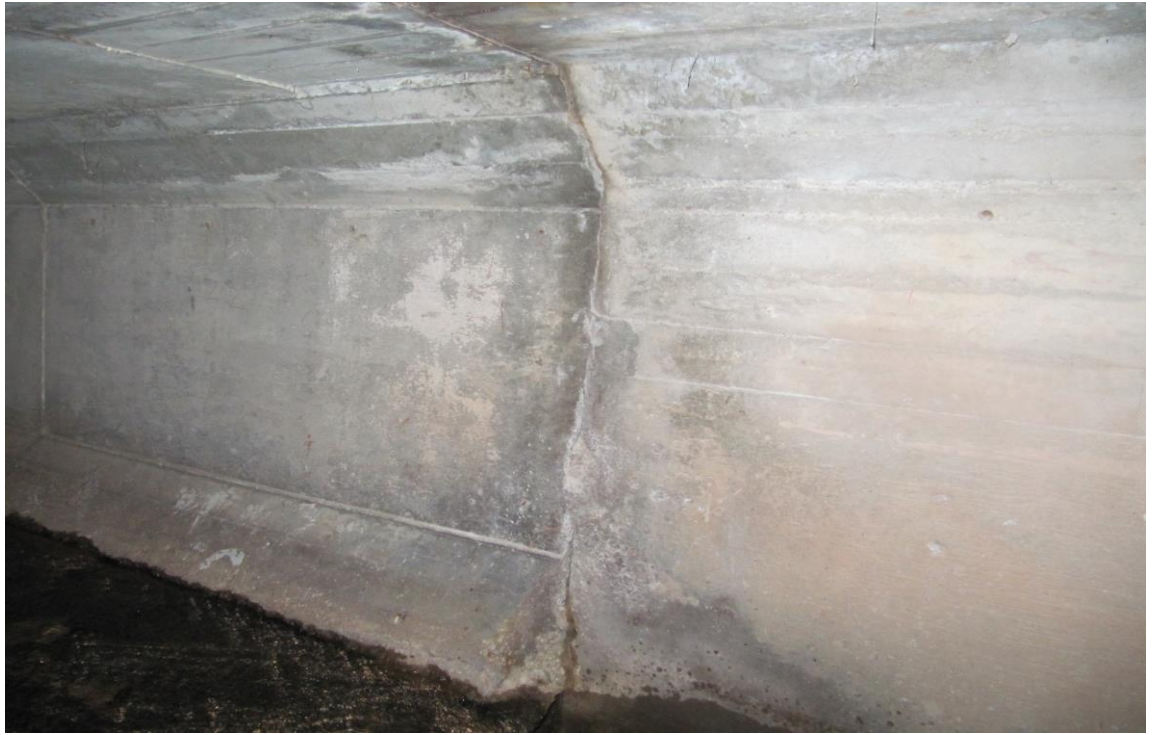
- The bottom slab exhibits severe concrete disintegration at the drop-off location where centre (original) section connect with the south extension section of the culvert.
- Scouring of streambed and erosion of adjacent embankment slopes was noted at the culvert outlet
- New concrete patch repairs were completed for centre and the south extension sections of culvert.

Concrete Disintegration at the Drop-off Location

The existing structure requires rehabilitation works including concrete repairs and embankment restoration.

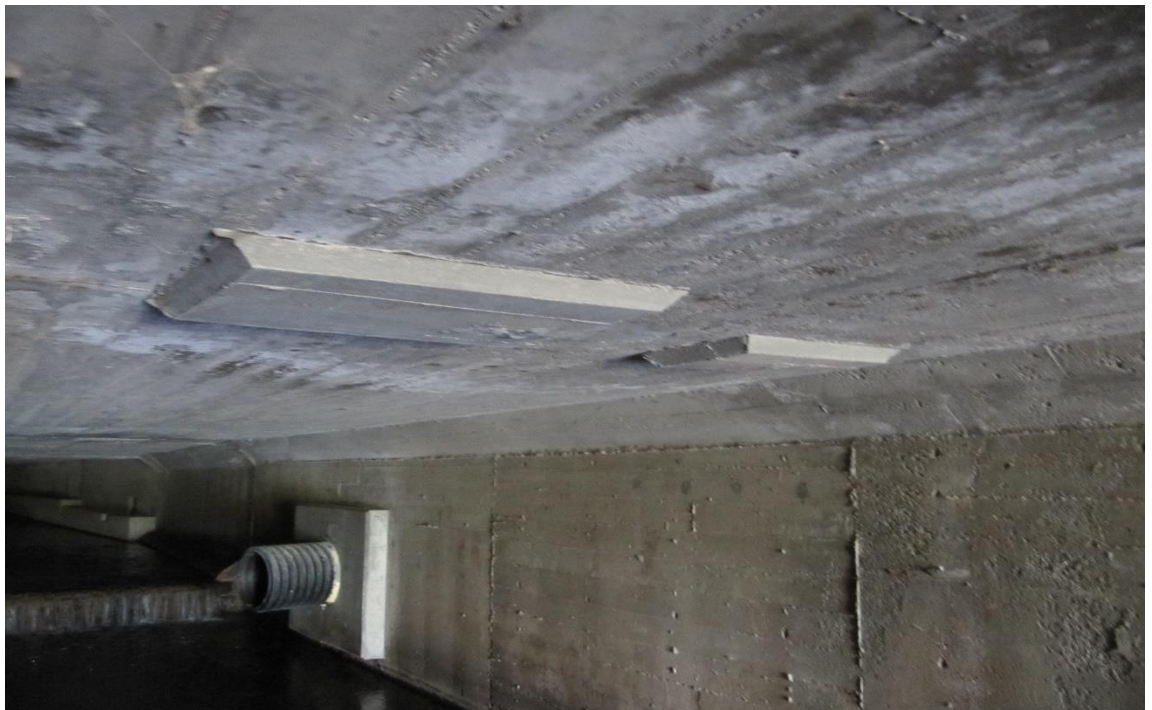
Patched Concrete Repairs for the South Extension Section of the Culvert

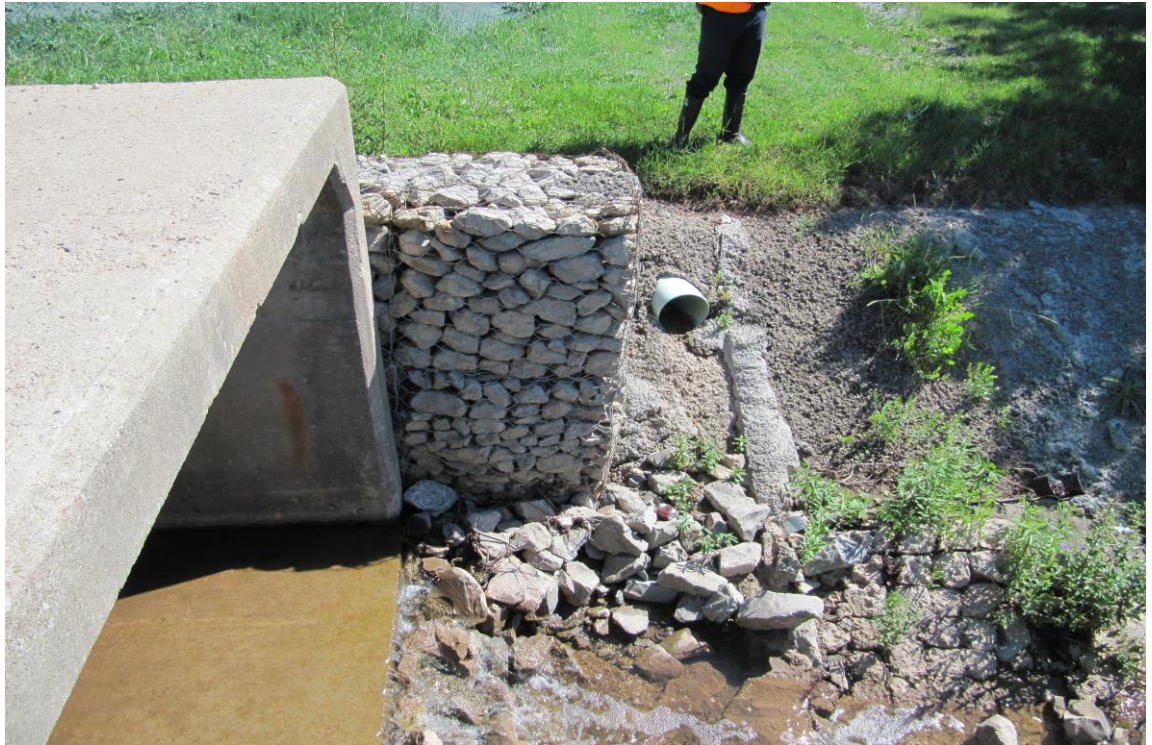
Condition of Gabion Basket

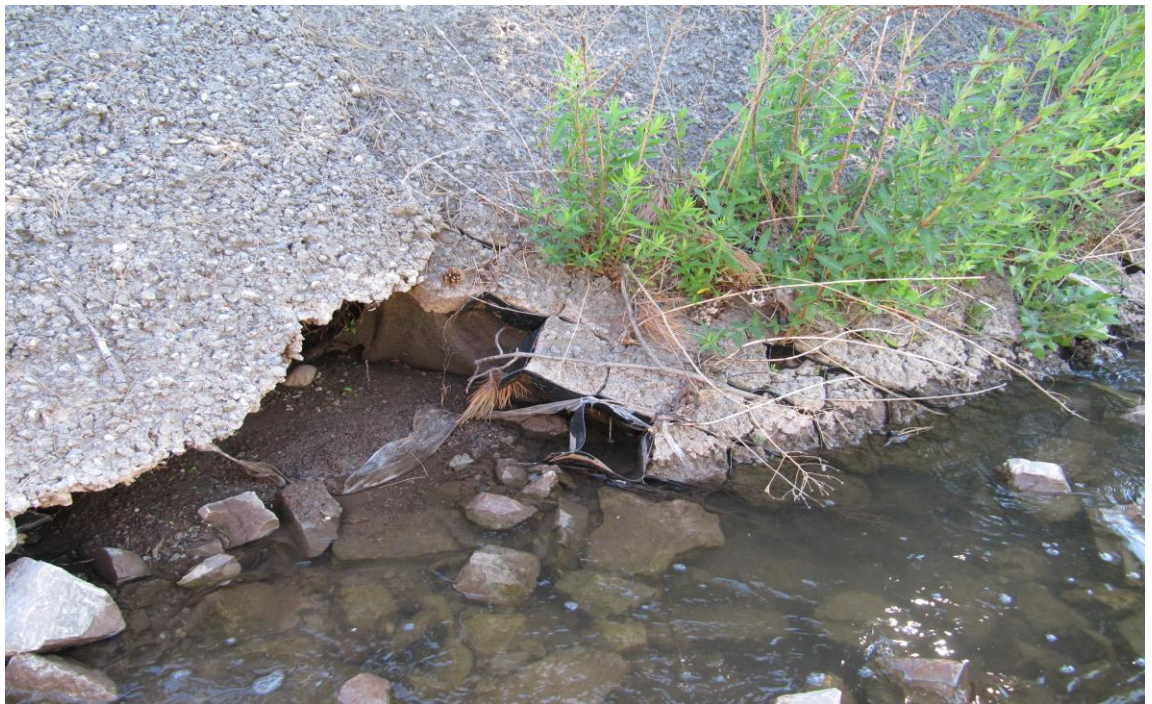
Scour of Streambed – Note Exposed Geogrid near Outlet

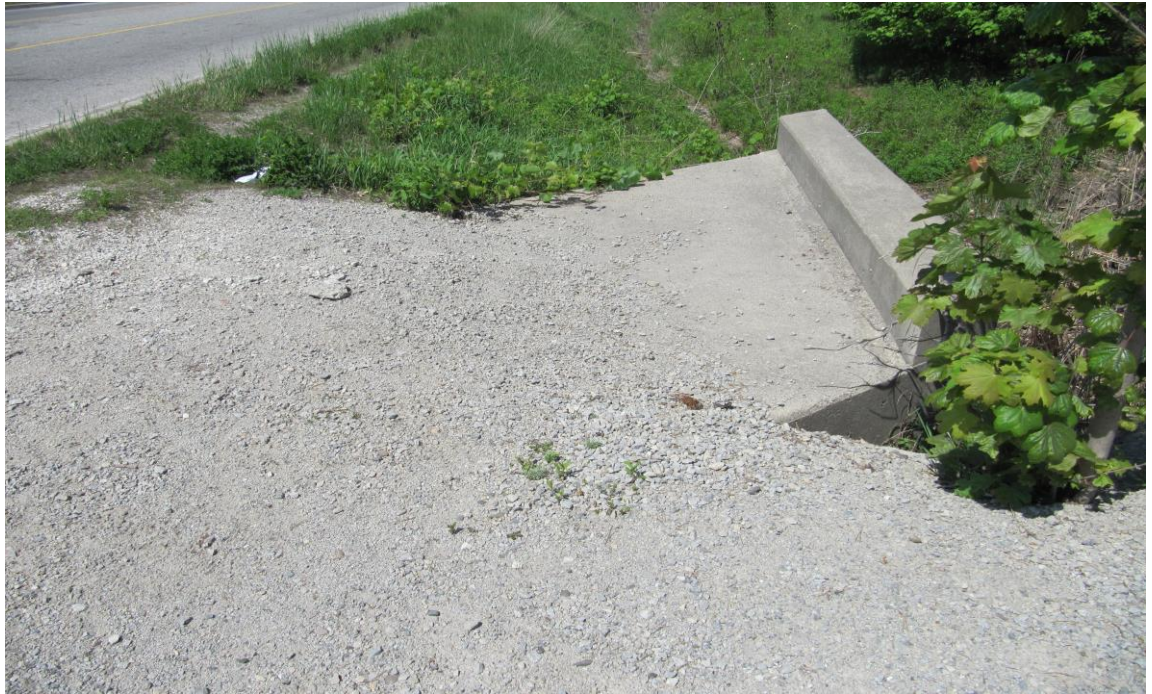
Existing Surface Condition of the Top Slab

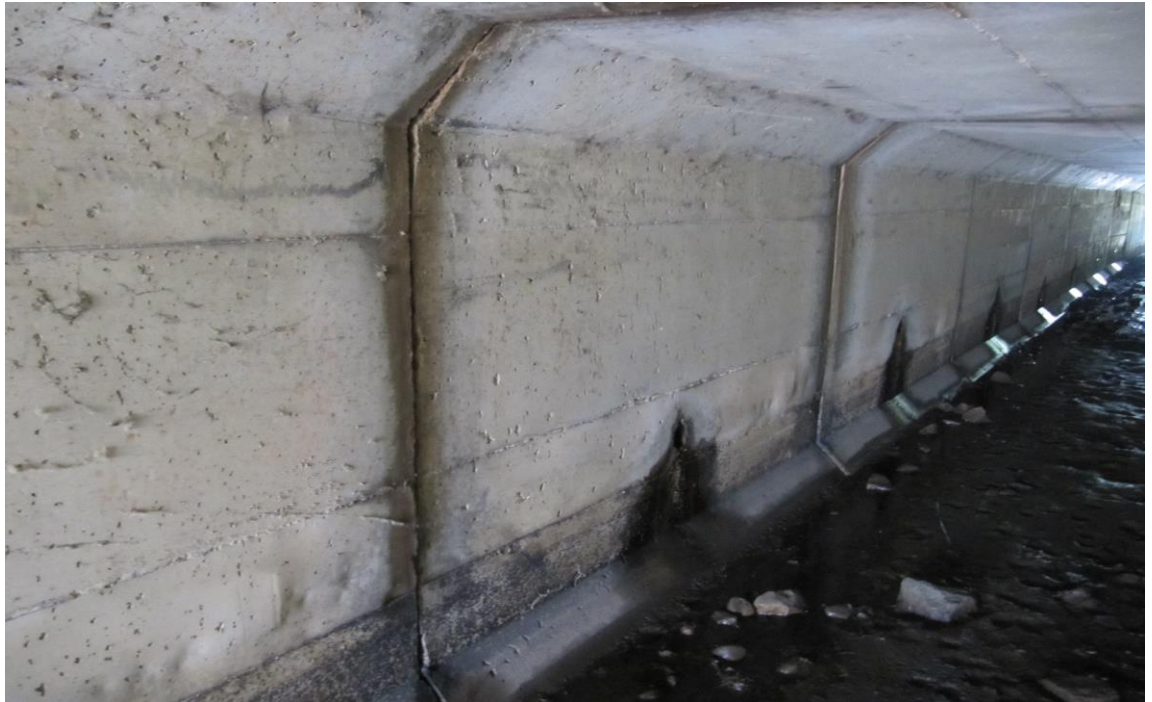
- The bituminous surfacing exhibits longitudinal and random transverse cracks.
- The culvert exhibits delaminated and spalled concrete areas.
- The deck soffit exhibits transverse separation of the concrete causing joint leaking problems.
- Sediment buildup at the outlet is approximately 0.3m thick.

Transverse Separation of the Concrete Segments

The structure is in fair condition but it requires rehabilitation works including concrete and joint repairs.

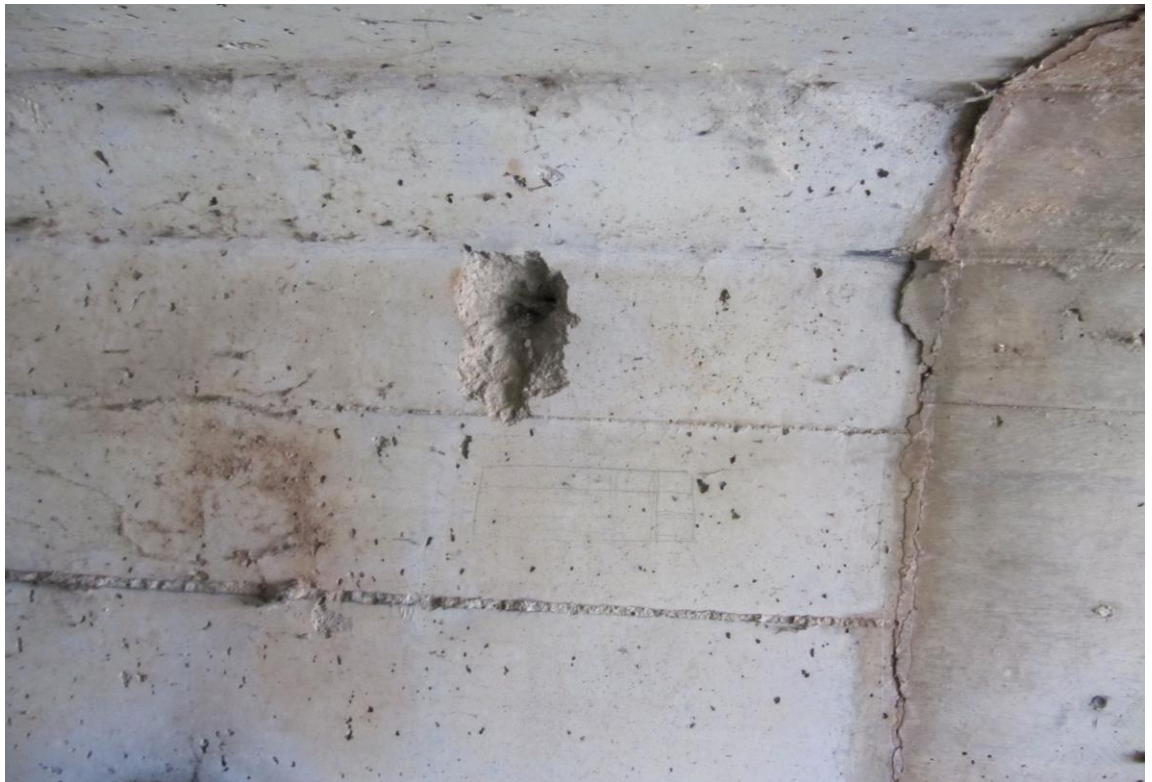
Spalled Concrete

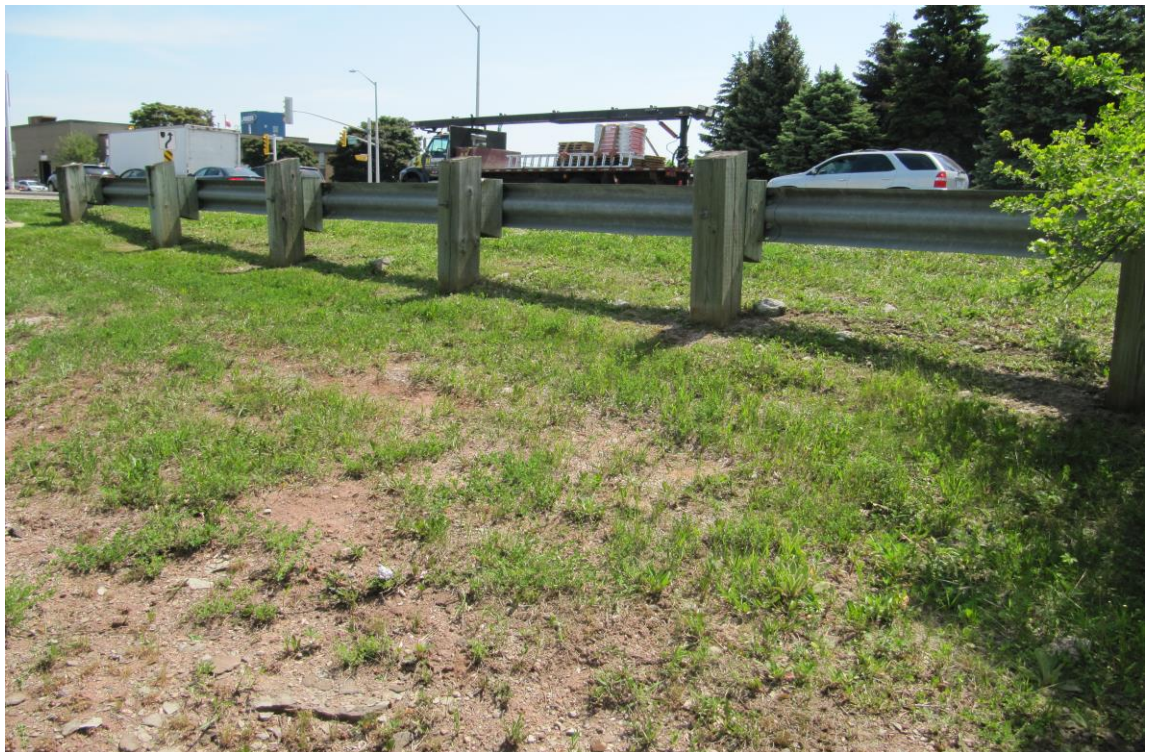
Condition of Existing Guide Rail System

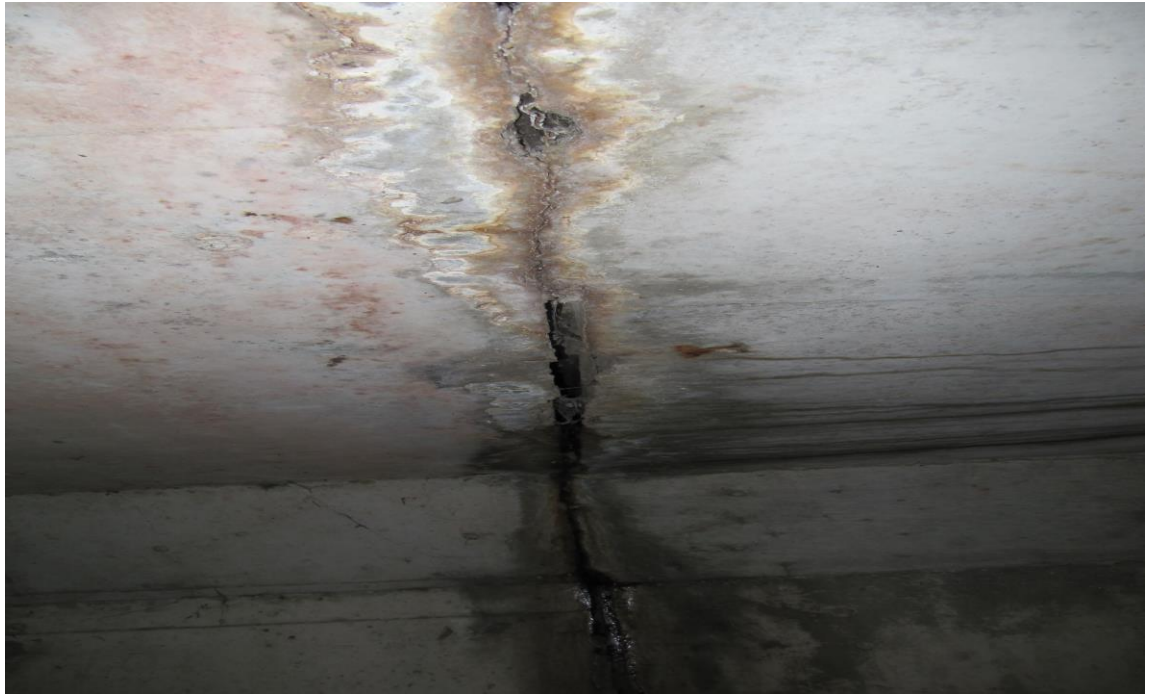
- The bituminous surfacing exhibits random longitudinal and transverse cracks.
- The culvert exhibits spalled and delaminated areas of concrete.
- Deck soffit exhibits transverse spalling and joint separation causing leaking problems at approximately the same transverse location for both cells.

Concrete Spalling and Delamination

The existing structure requires rehabilitation works including concrete and joint repairs.

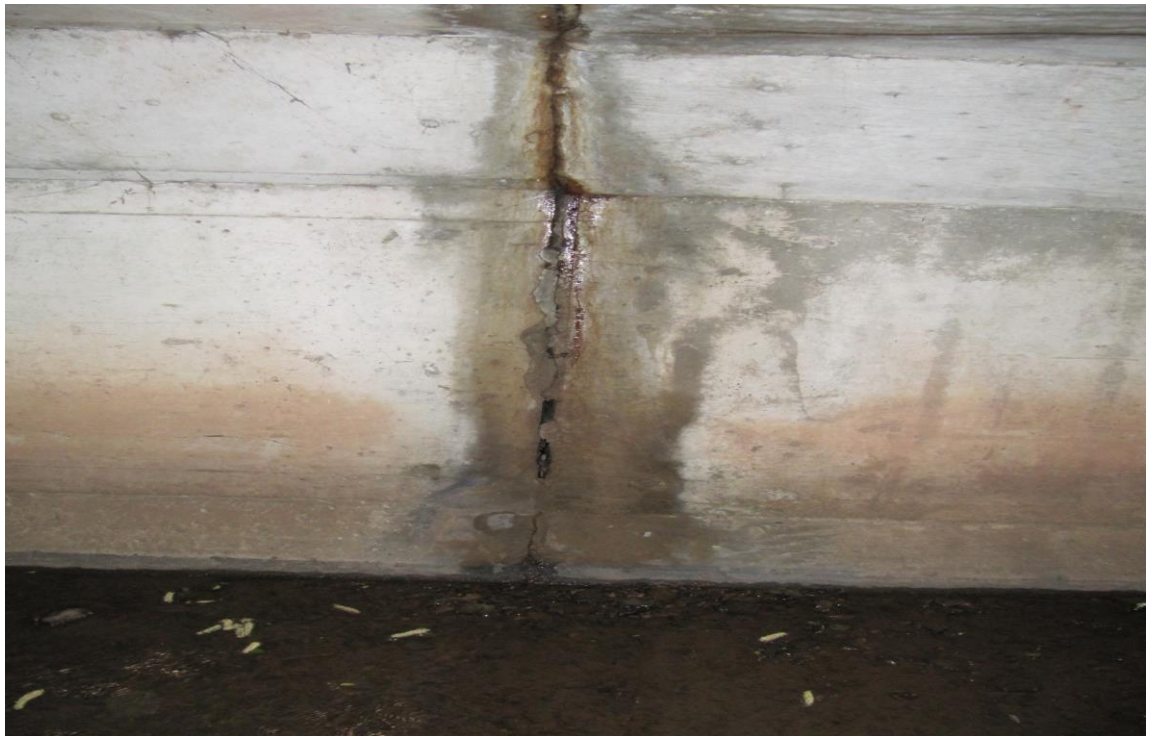
Joint Separation

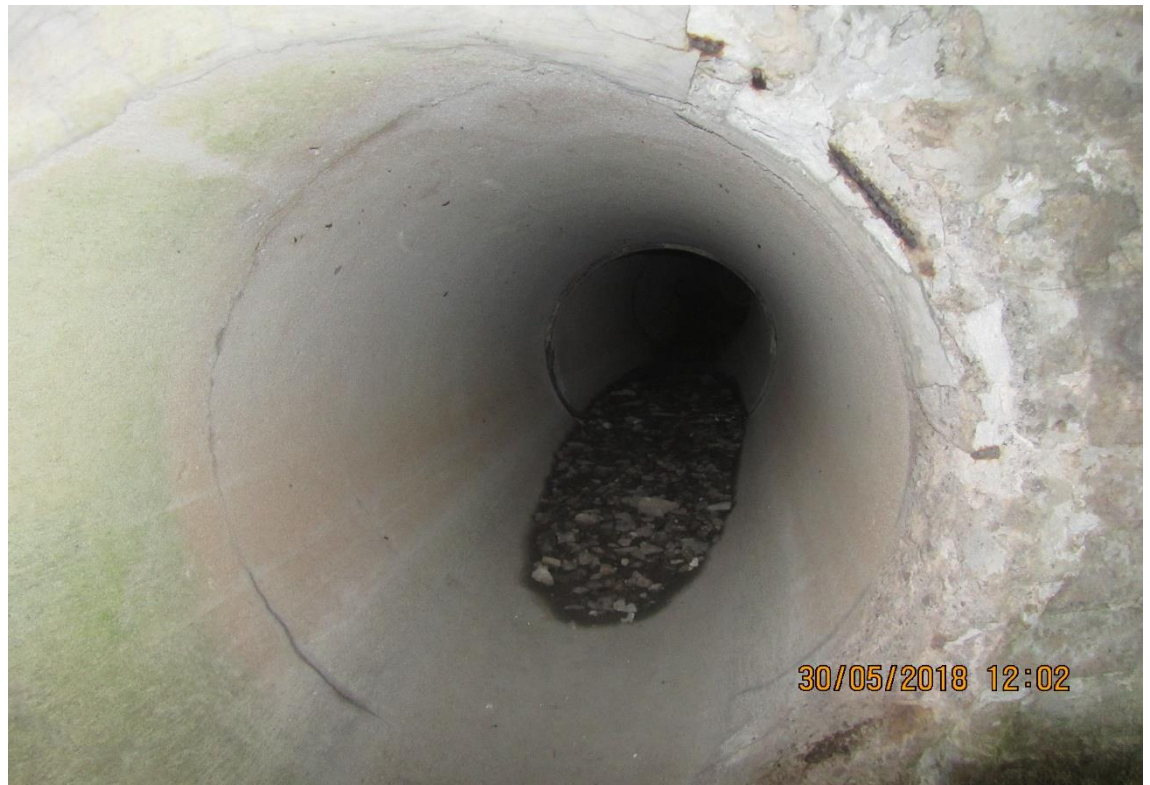
Condition of Existing Stormwater Sewer

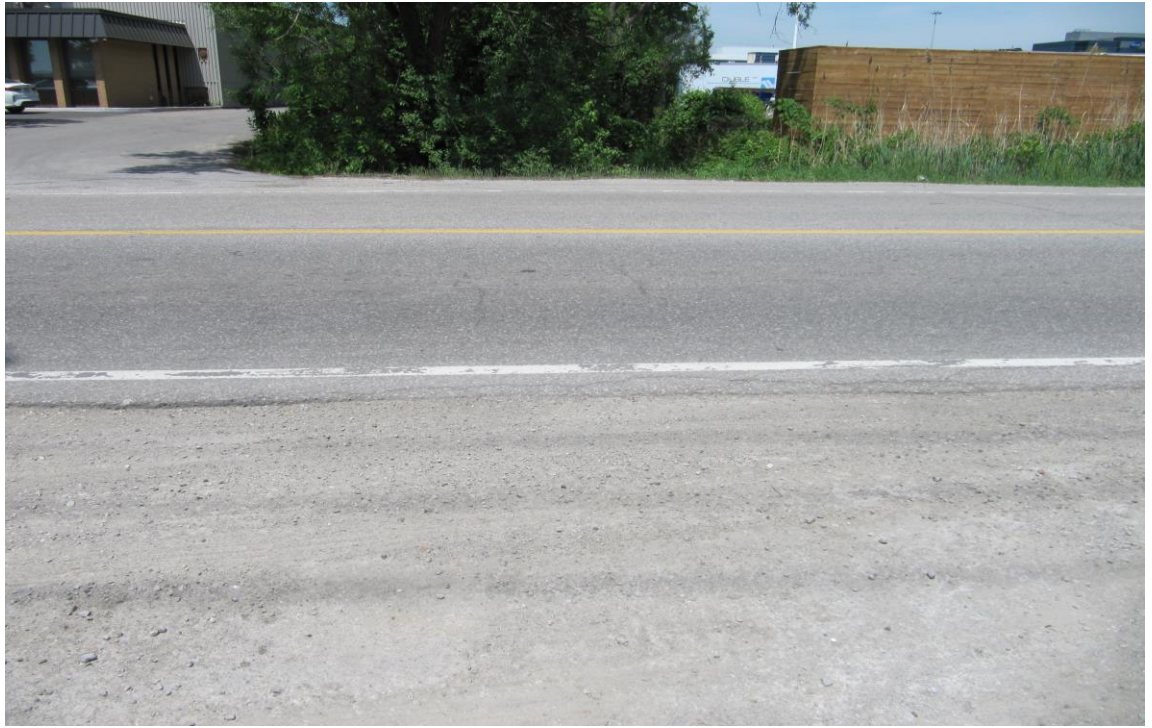
Existing Condition of Wearing Surface

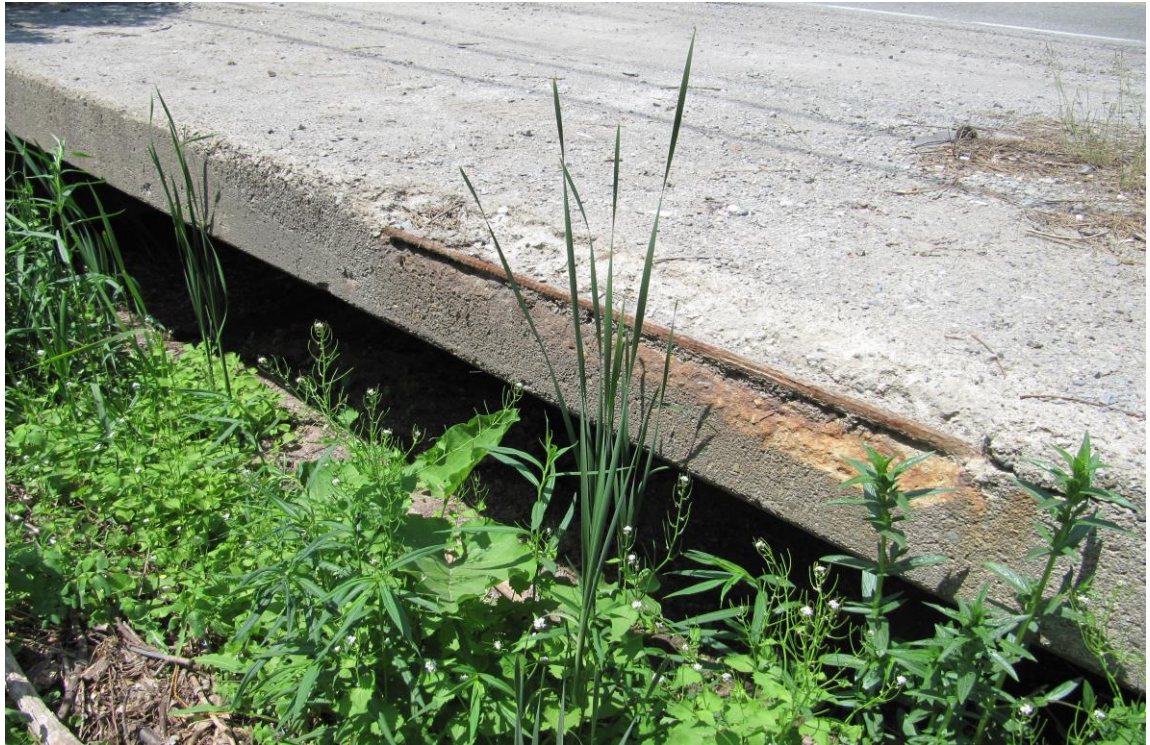
- The bituminous surfacing exhibits transverse cracks.
- The first metre of the culvert at the outlet is in poor condition with extensive delamination, areas of spalled concrete, exposed corroded reinforcing steel and honeycombing.
- Heavy sediment buildup on the west side of the bridge.
- The embankment slopes adjacent the culvert inlet and outlet are steep.
- The existing roadside safety treatment does not comply with the Ontario Roadside Design Guide.

Spalled Concrete with Exposed Rebar at Outlet

The existing structure is in poor condition and should be replaced. This is considering the anticipated unexpected construction delays due to extensive full depth removals and significant cost over runs, the age of the structure, and the significant sediment buildup within the barrel.

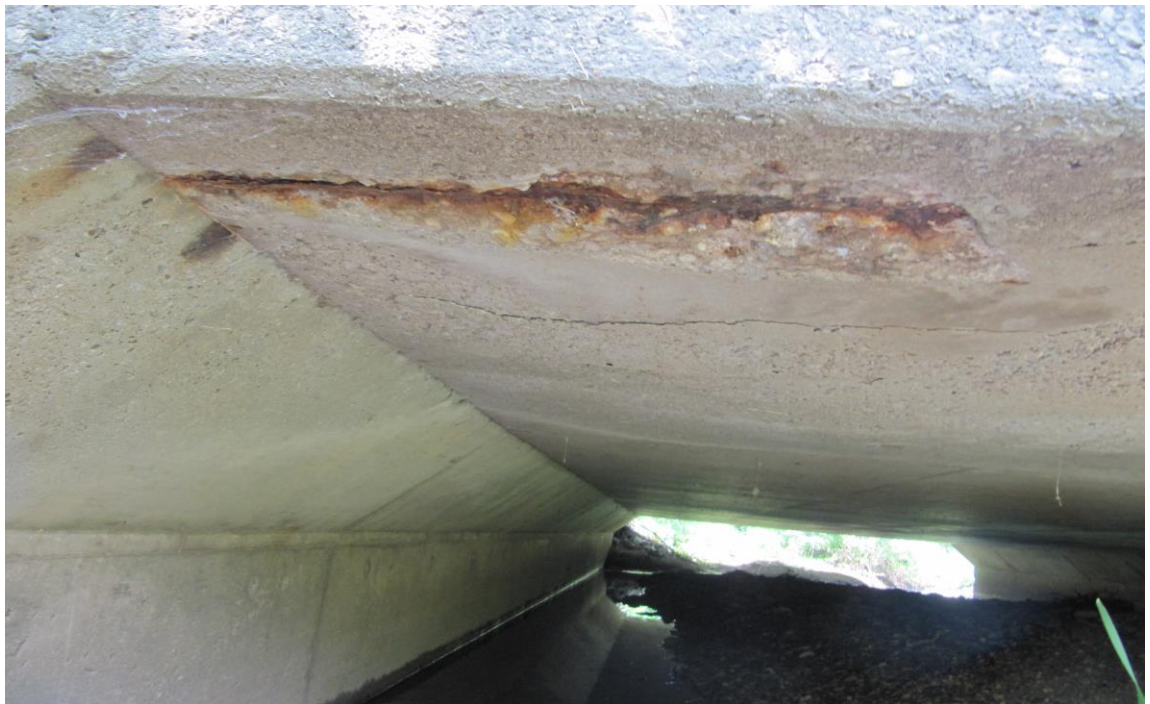
Spalled Concrete with Exposed Rebar of Soffit near Outlet

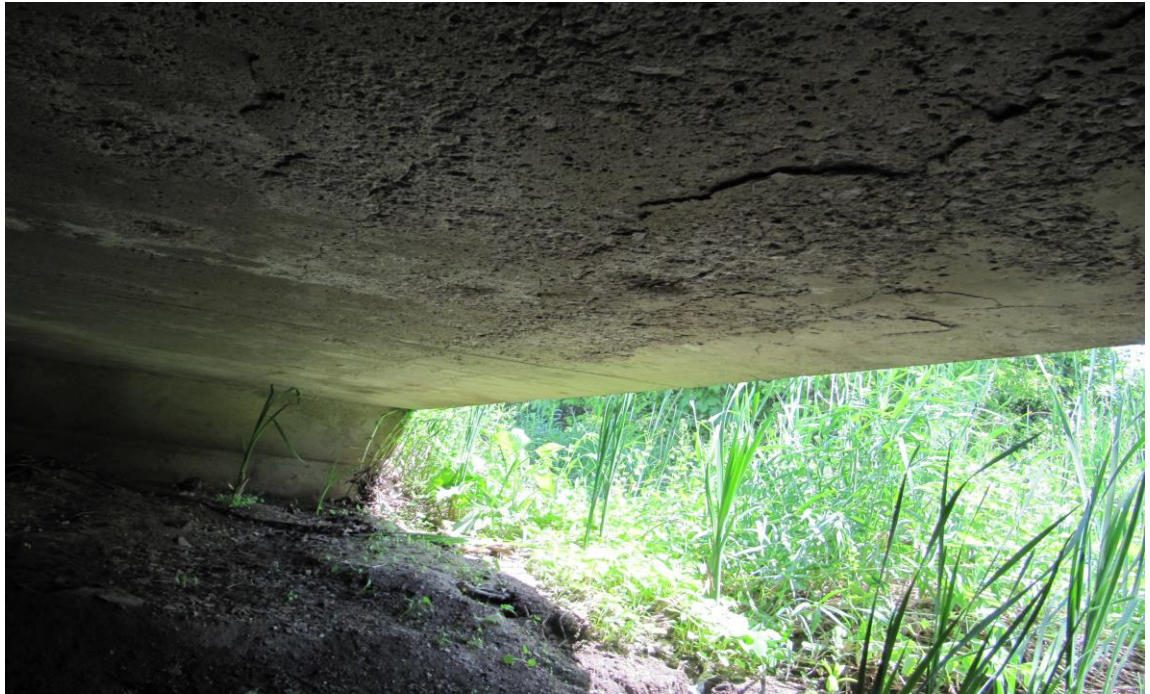
Concrete Honeycombing near Outlet

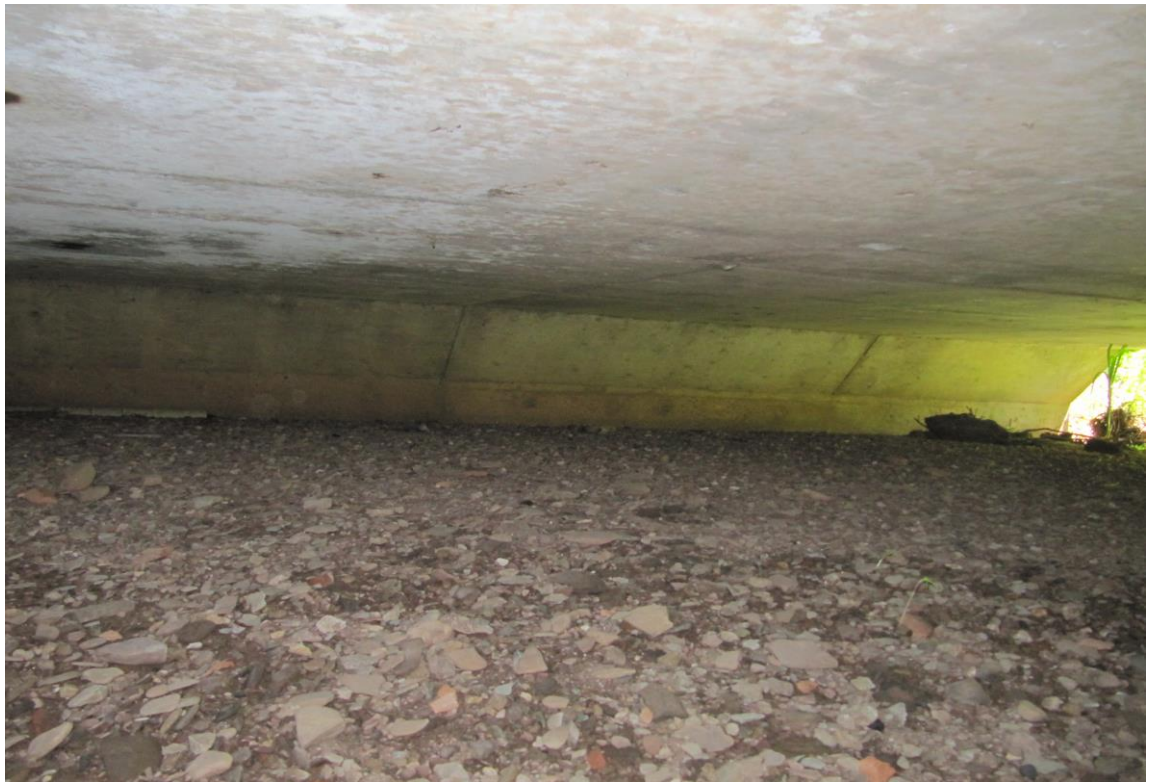
Heavy Sediment Buildup inside the Structure
