### **Aquatic and Bat Habitat Surveys for McCraney Creek (2018)**

**Ref:** Amec Foster Wheeler TPB166047

**Date:** January 24, 2018

**Re:** **Aquatic and Bat Habitat Surveys for Proposed Channel Realignment of McCraney Creek North of Lakeshore Road to Rebecca Street.**

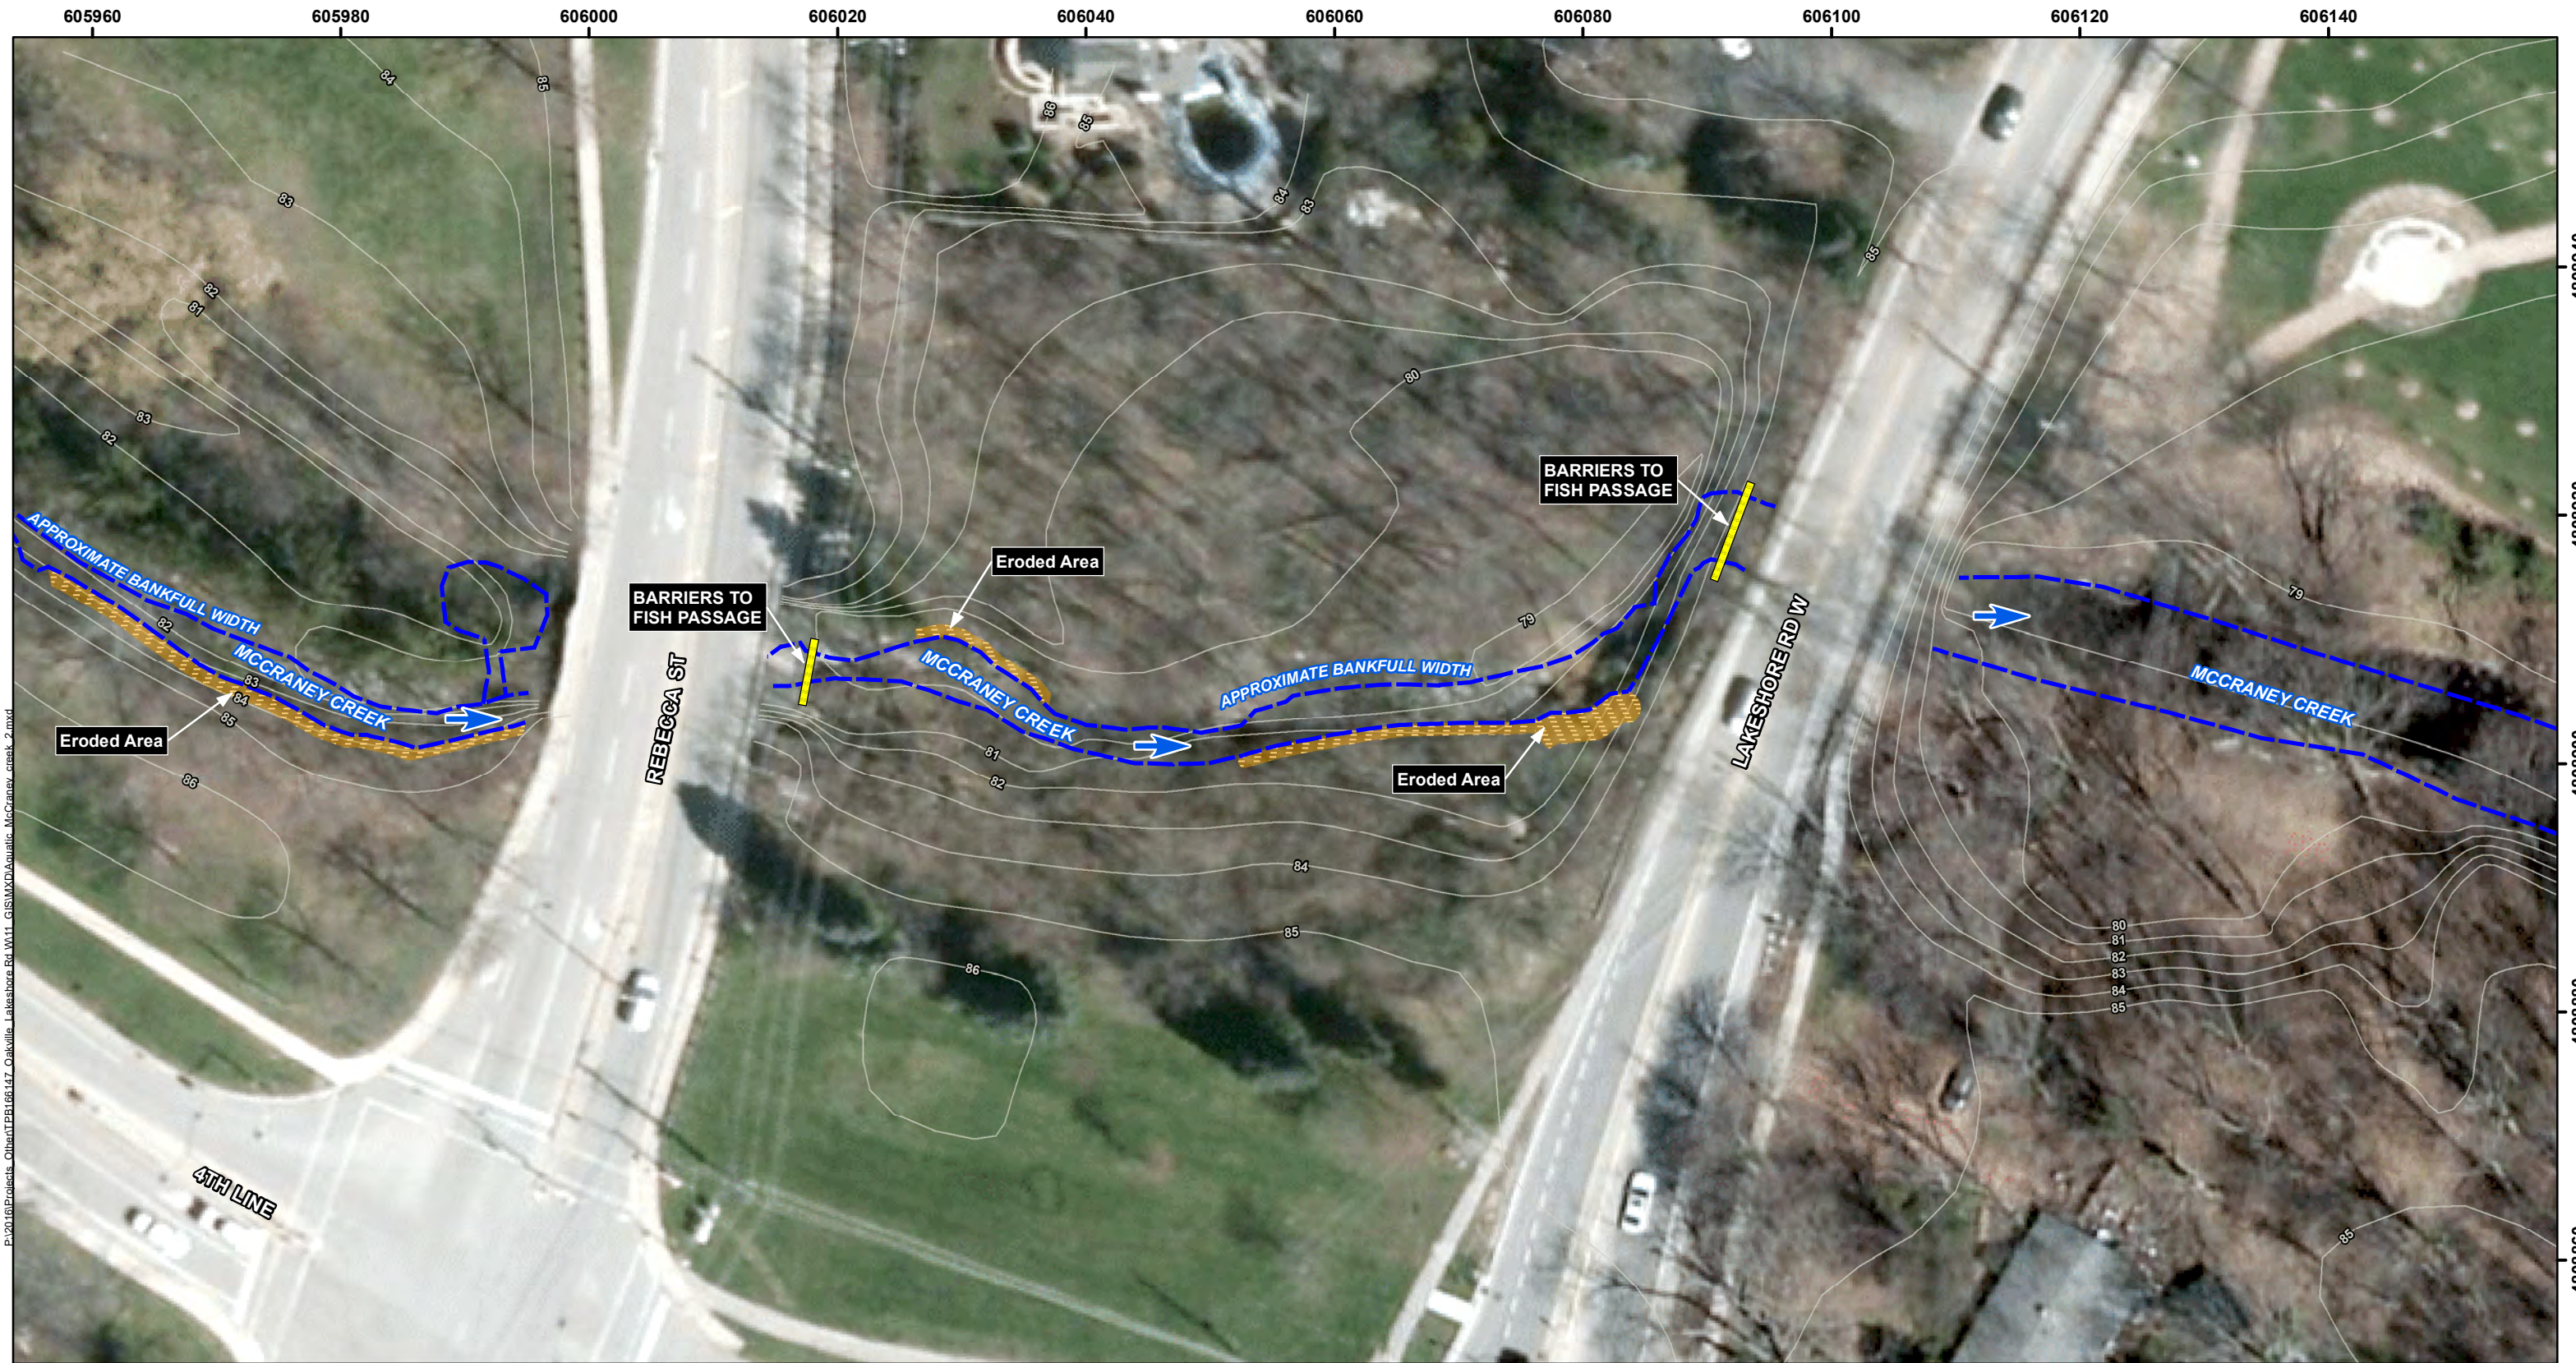
**Aquatic Areas and Erosion Areas**

A depiction of the key features and habitat mapping for the site are provided in (Attachment 1; Figure 2). Upstream of Lakeshore Road West, McCraney Creek maintains a relatively uniform wetted width of approximately 6 m as it meanders through the woodlot. Flows are slow and is mainly comprised of flats with a few small sets of riffles where rocky substrate is present in shallower areas.

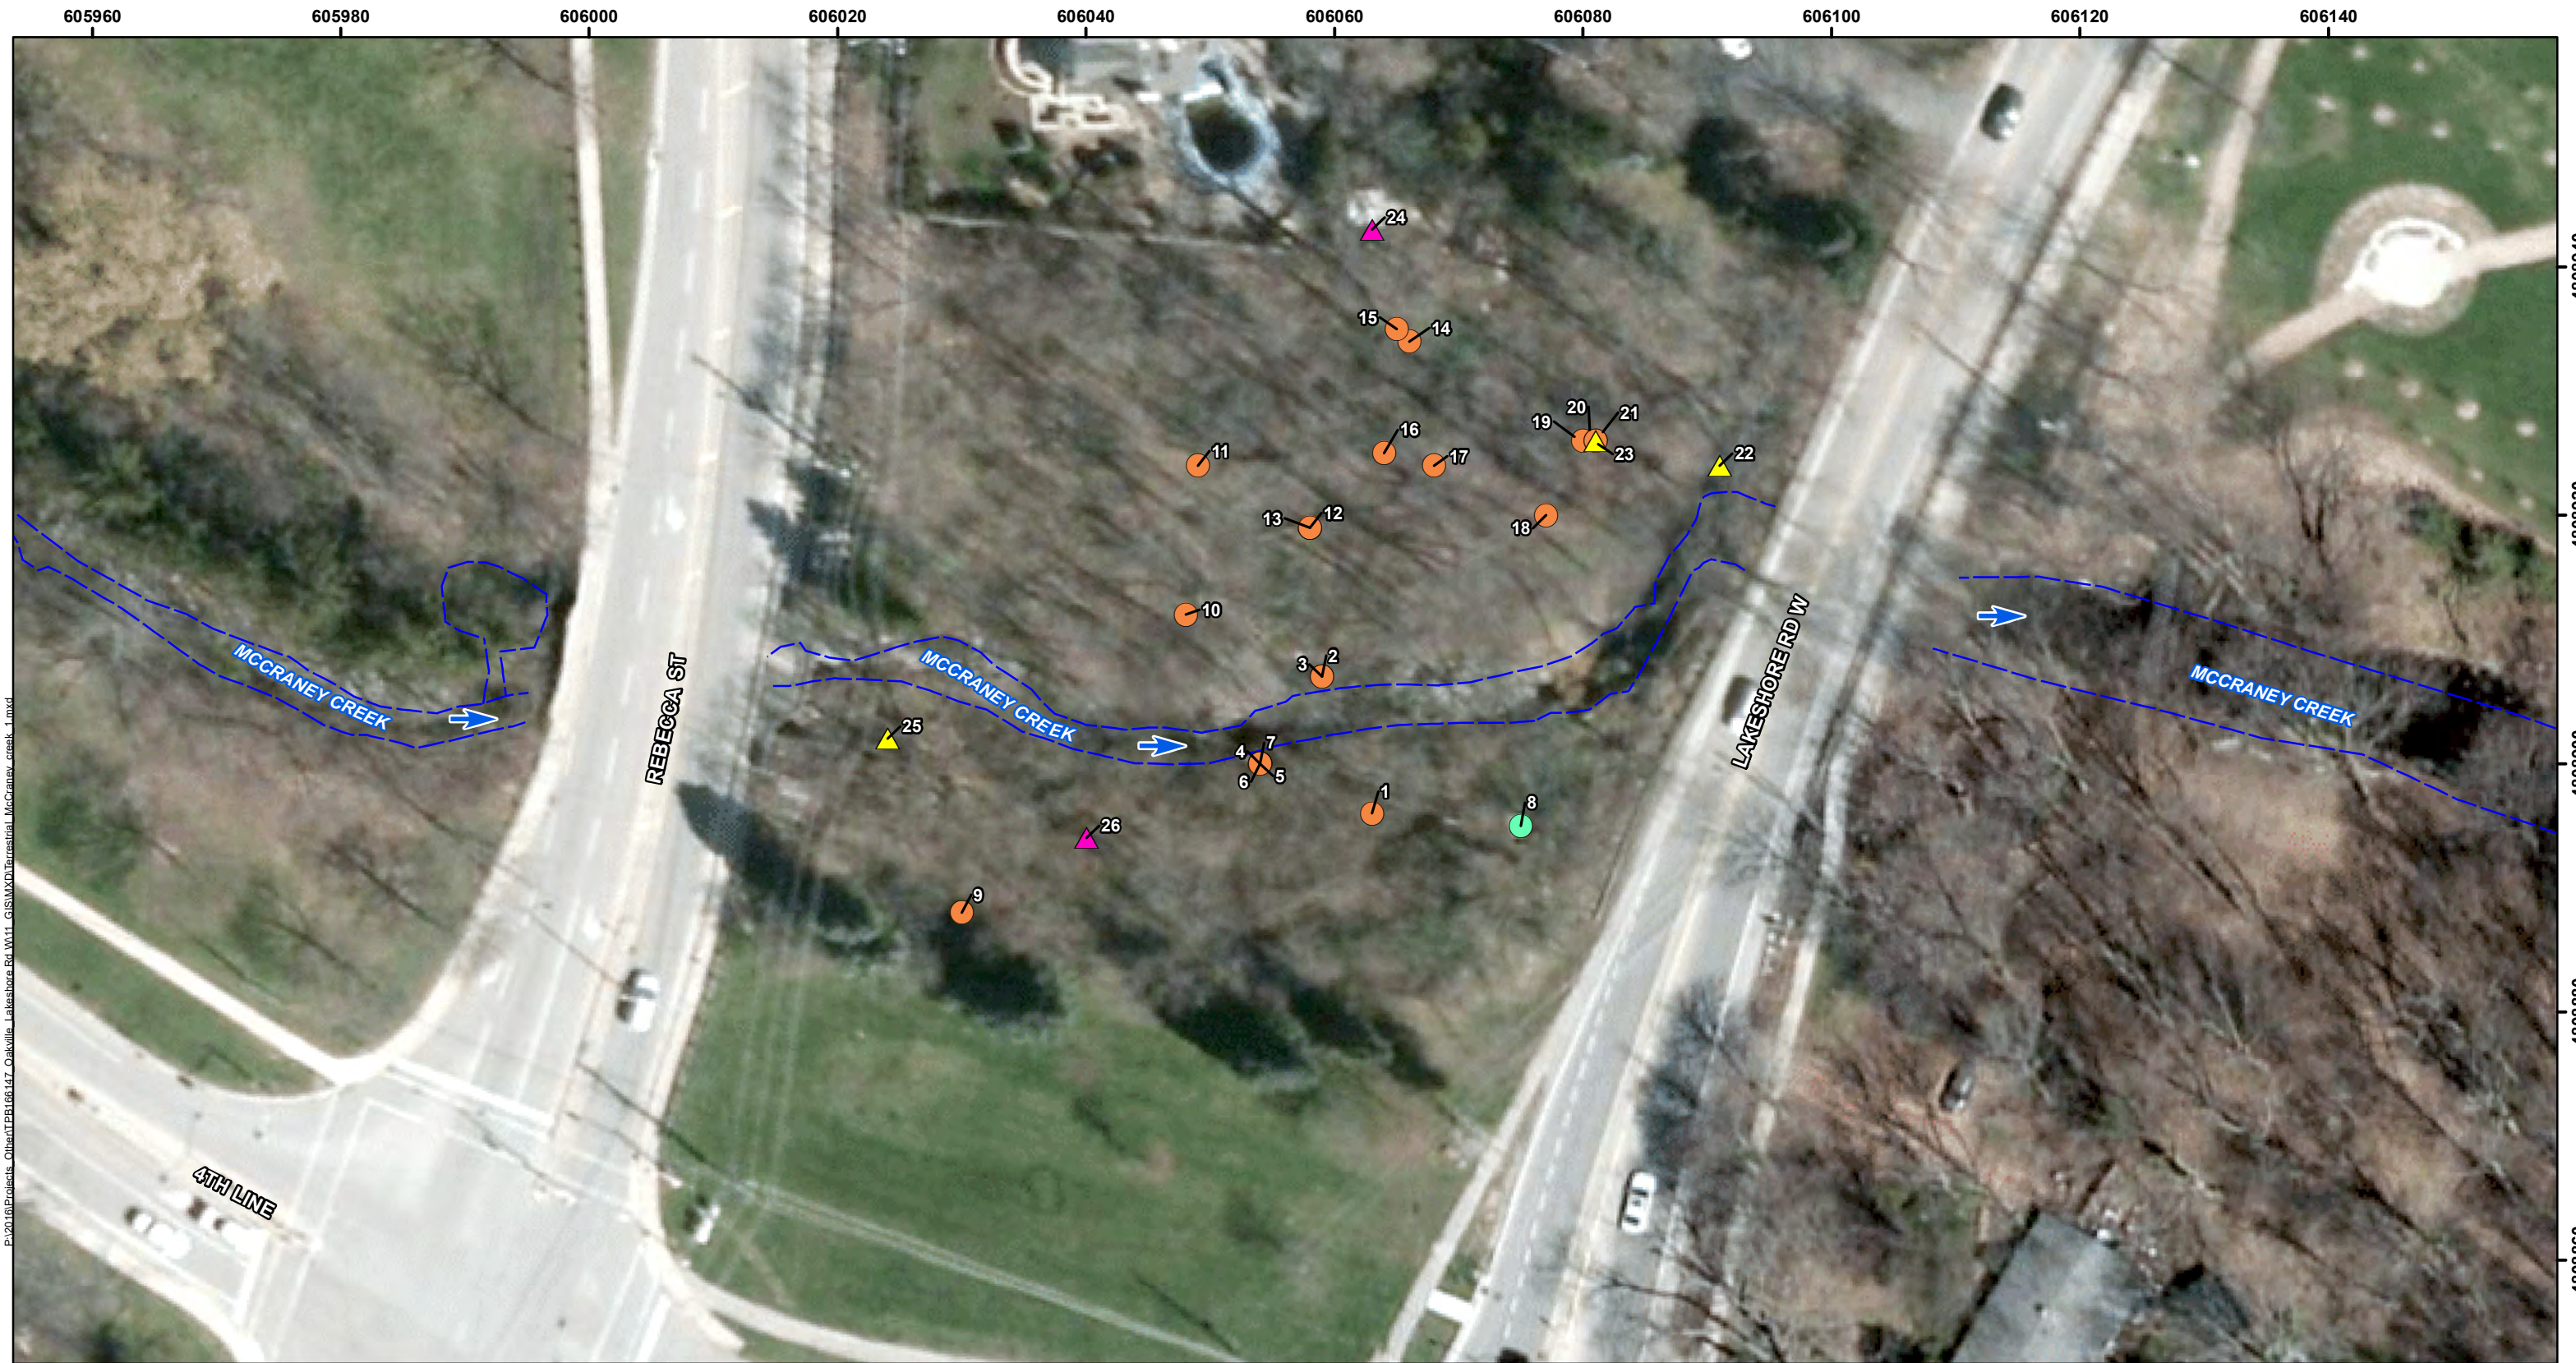
**Bat Habitat Features**

Four trees with potentially suitable maternity roost sites for Little Brown and Northern Myotis were recorded within the study area, as well as one additional tree in a backyard immediately adjacent to the study area. Cavities noted included: two knotholes in willow species; two woodpecker cavities in a willow and a dead tree of unknown species; and a natural cavity in a rotting dead tree. The rotting dead tree also had loose bark which may provide roosting habitat. The data for potentially suitable roosting trees is summarised in Table 1 and mapped locations provided in Figure 3 (Attachment 1).

Potentially suitable trees for Tri-colored Bat found included fourteen Norway Maple (*Acer platanoides*) and one Manitoba Maple (*Acer negundo*). No dead leaf clusters were observed on any of these trees. This data is summarised in Table 2 and mapped in Figure 3 (Attachment 1).

- Selection of native species for vegetation restoration including selection of native trees able to outcompete invasive trees and shrubs present such as Norway Maple. Recommended trees may include Black Maple (*Acer nigrum*) and Red Maple (*Acer rubrum*);
- Provide forest management to monitor the site to encourage the growth of native tree species and maintain existing large trees, as well as potentially controlling invasive species such as Norway Maple and Multiflora Rose;
- Install bat roosting boxes to provide additional roosting habitat for SAR bats.

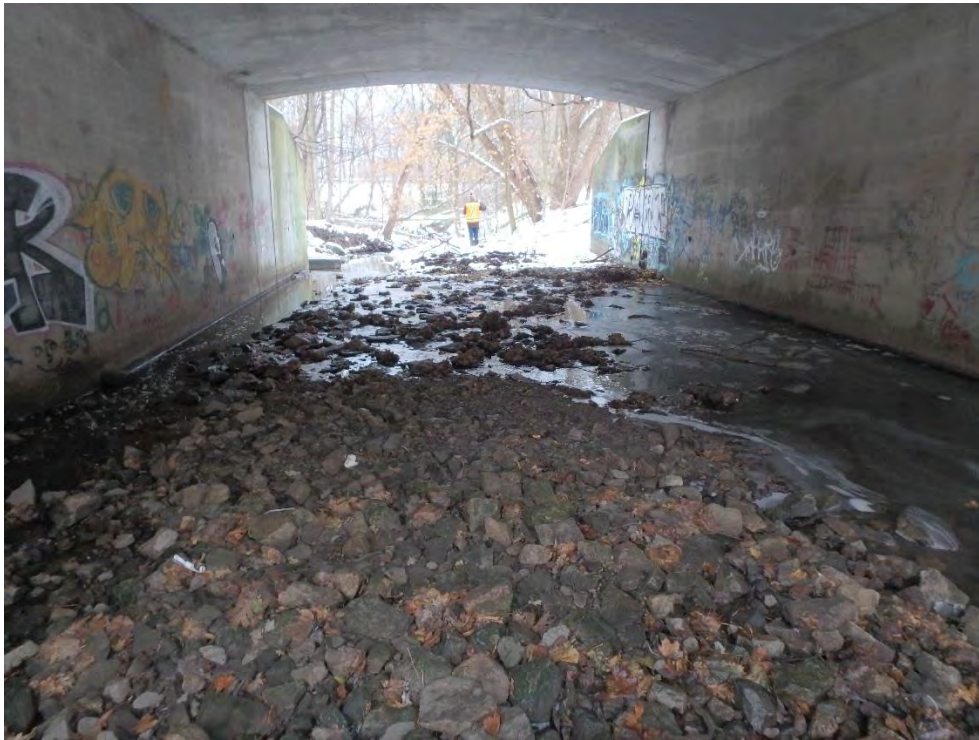
Immediately downstream of Rebecca Street, there is a vertical drop where the poured concrete slab foundation of the crossing meets the natural stream substrate. Flows at the outlet of the crossing structure are concentrated on the easternmost side of the crossing where they flow over this structure, as a large accumulation of woody debris and leaves blocks the majority of the channel at the westernmost side of the crossing outlet. The vertical drop from the poured cement slab to the natural stream substrate is approximately 0.5 m high on the west and 0.8 m high on the east. This area of concentrated flow exhibits a higher velocity than the surrounding watercourse and laminar flow is present. As such, this feature is a barrier to the upstream movement of small-bodied fish. The effects of this barrier would be exacerbated during periods of high flow.

**Photo 1:** *Within Rebecca Street ROW facing downstream. Note large area of debris at west downstream end of crossing forcing flows to move over cement ledge on east.*

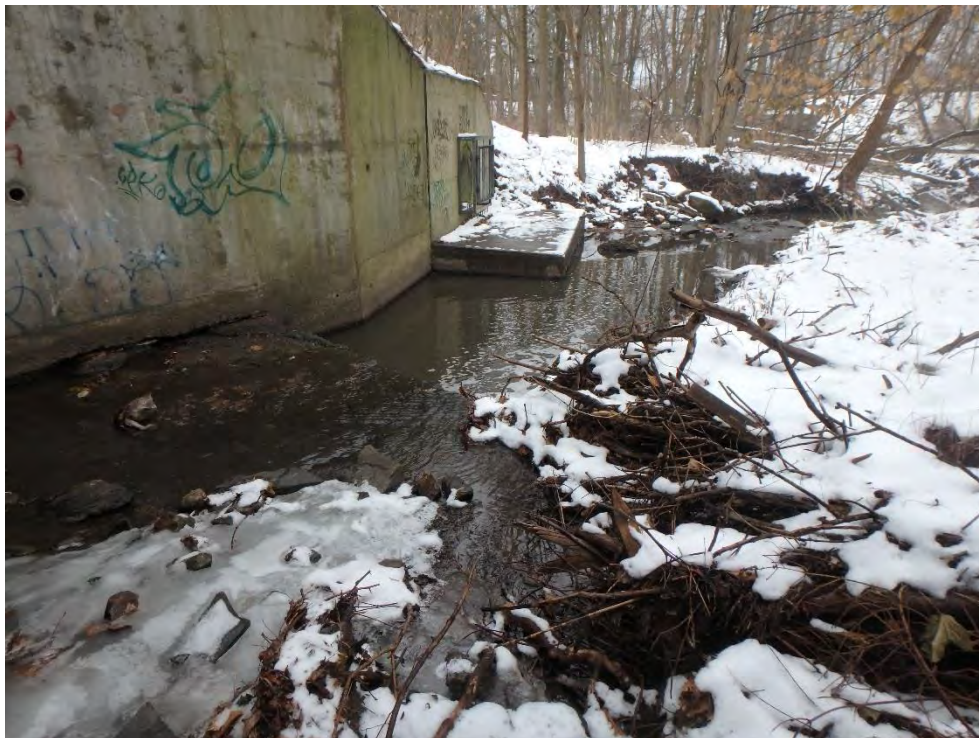
**Photo 2:** *Cement slab present at downstream end of Rebecca Street crossing is a barrier to small-bodied fish.*

- Select a new replacement structure that will improve fish passage:
  - Consider flow velocities and select the structure, grading, etc. that will ensure the crossing structure is passable by fish species known to inhabit the watercourse which include smaller-bodied species which may move through the watercourse seasonally based on stream temperatures and are capable of low/moderate swim speeds (i.e. Longnose Dace 0.65 meters per second (m/sec) and White Sucker 0.45-0.60 m/sec). Rainbow Trout, a sensitive cool/coldwater species has also been found within the watercourse and is likely migrating through the study area to reach upstream breeding grounds. This species can move up to 5.70 m/sec (Peake, S.J, 2008).

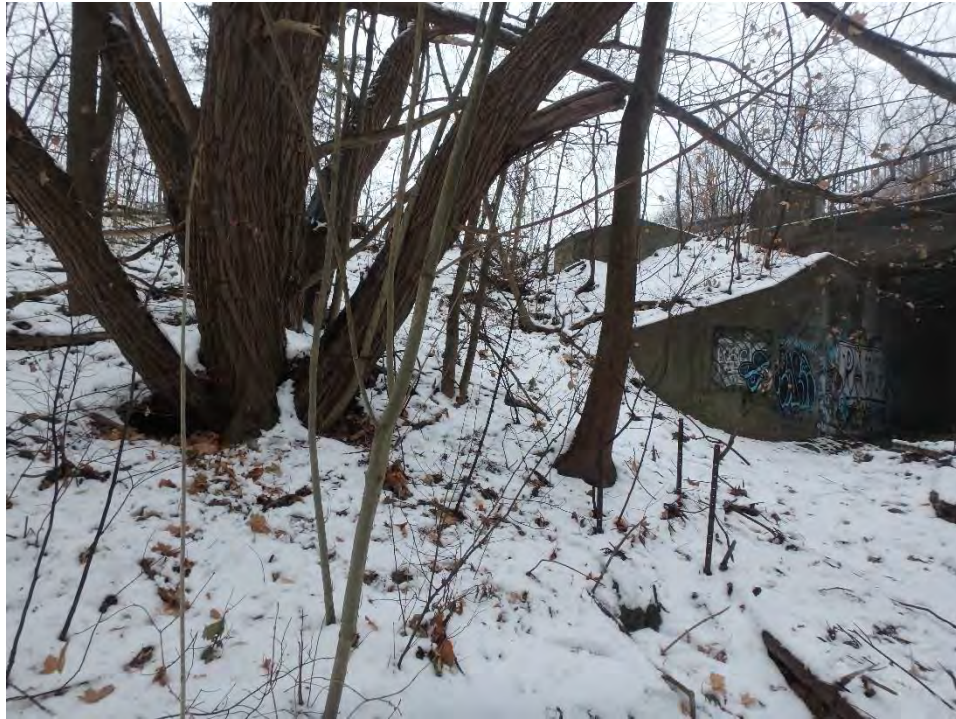
**Photo 3:** *Photo of stable west bank at Rebecca Street.*

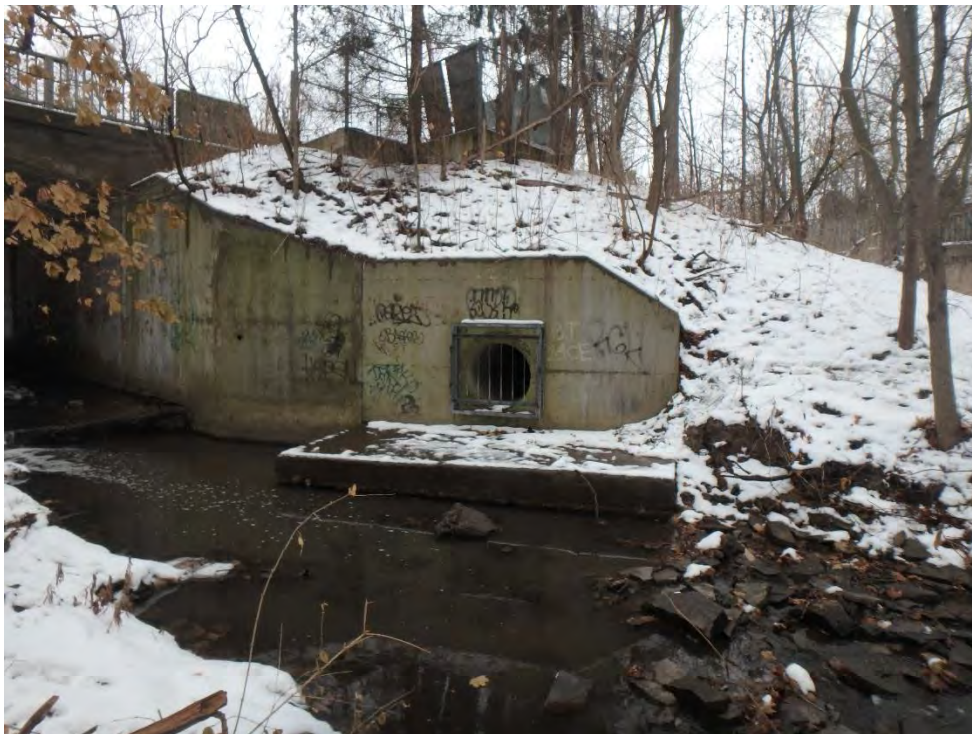
**Photo 4:** *Photo of stable east bank at Rebecca Street.*

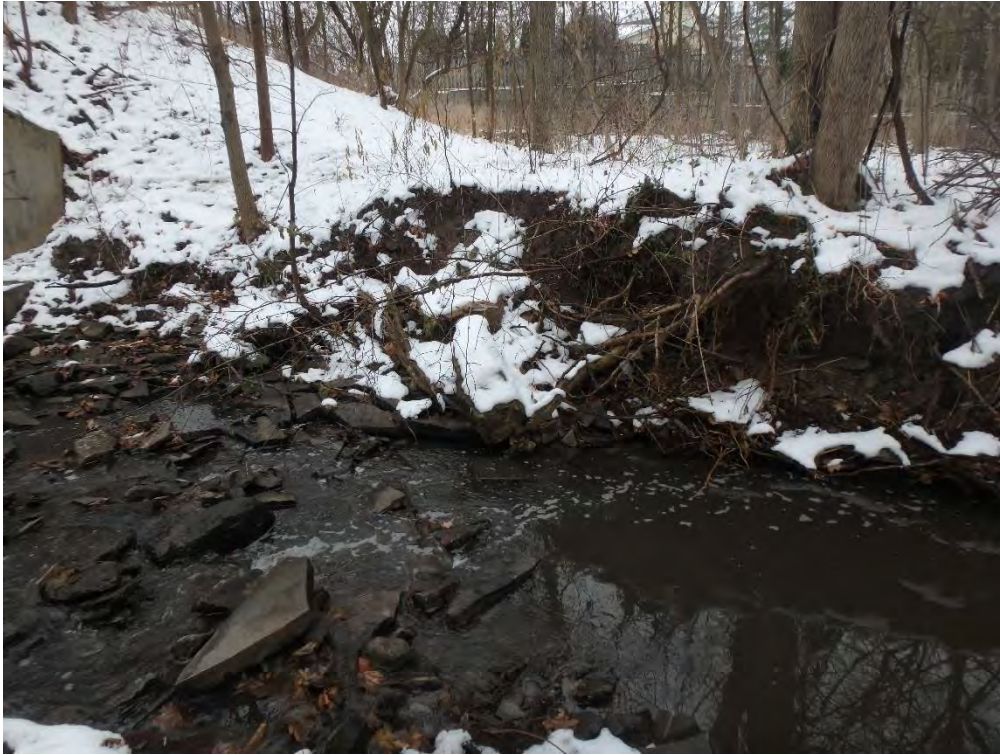
Immediately downstream of this area past the southwest headwall of the Rebecca Street crossing, erosion is evident along the east bank of the watercourse, spanning a length of approximately 10.3 m. Unstable soil and exposed roots are evident up to a height of approximately 1 m. The west bank was stable in this area. No further erosion was observed on the easternmost bank approaching the Lakeshore Road ROW.

**Photo 5:** Erosion evident at east bank immediately downstream of Rebecca Street retaining wall. Area spans approximately 10.3 m in length. Height of erosion averages at 1 meter.

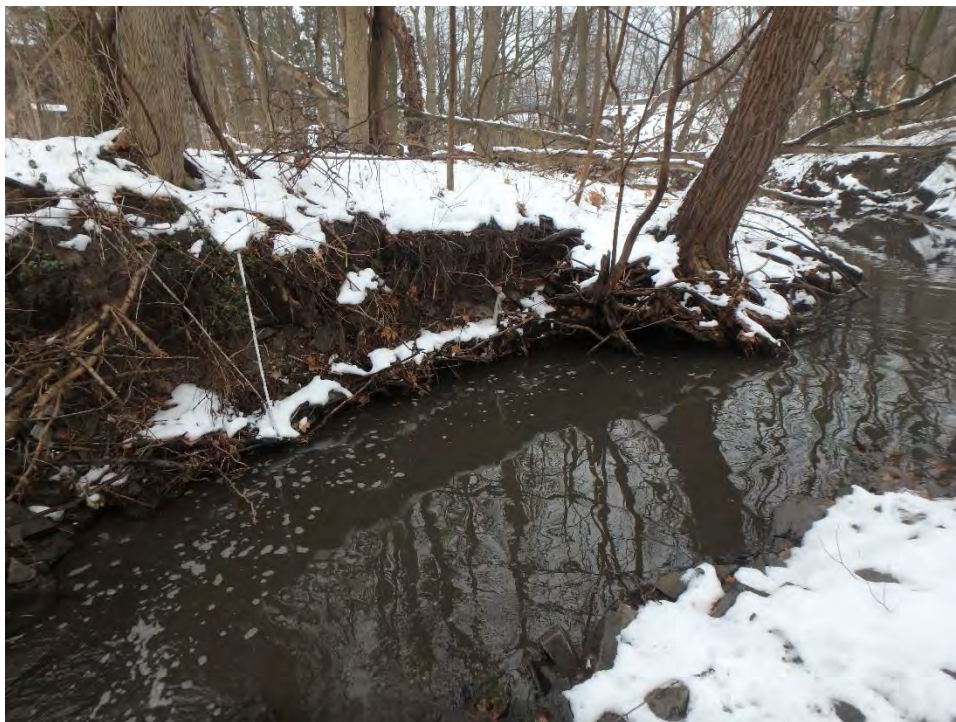
**Photo 6:** Erosion evident at east bank immediately downstream of Rebecca Street retaining wall.

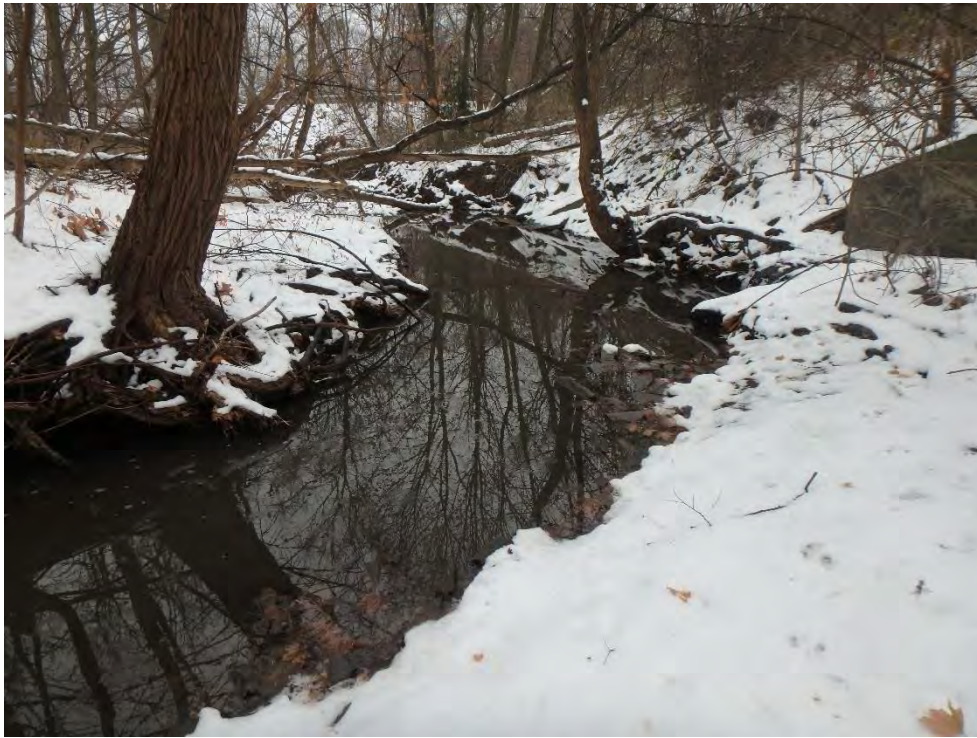
**Photo 7:** *Downstream banks stabilize before erosion area present on west bank.*

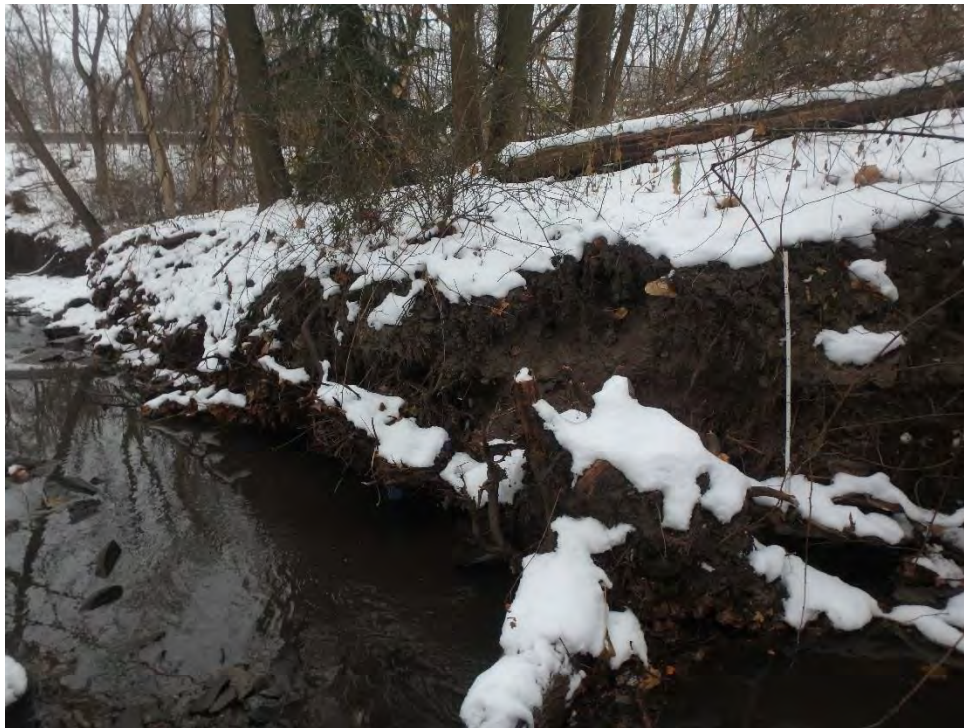
Downstream of this area, erosion became evident on the west bank of the watercourse, with exposed soils and bare roots evident spanning along approximately 31.5 m of channel. The unstable banks were approximately 1m high. As the watercourse approaches the tight bend at Lakeshore Road, the erosion becomes more severe with the greatest amounts of erosion found at the crest of the turn where McCraney Creek transitions its flow from a southerly direction to an easterly direction as it reaches the Lakeshore Road ROW. The bank height, through this area reaches a maximum height of approximately 2.5 m.

**Photo 8:** *Erosion evident on west bank for approximately 31.5 meters prior to reaching retaining wall for Lakeshore Road.*

- Incorporate natural channel design for the channel realignment to improve bank stability, and create flow morphology diversity;
- Following the completion of the construction activities, vegetate margins under the structure where light penetration is sufficient for growth;

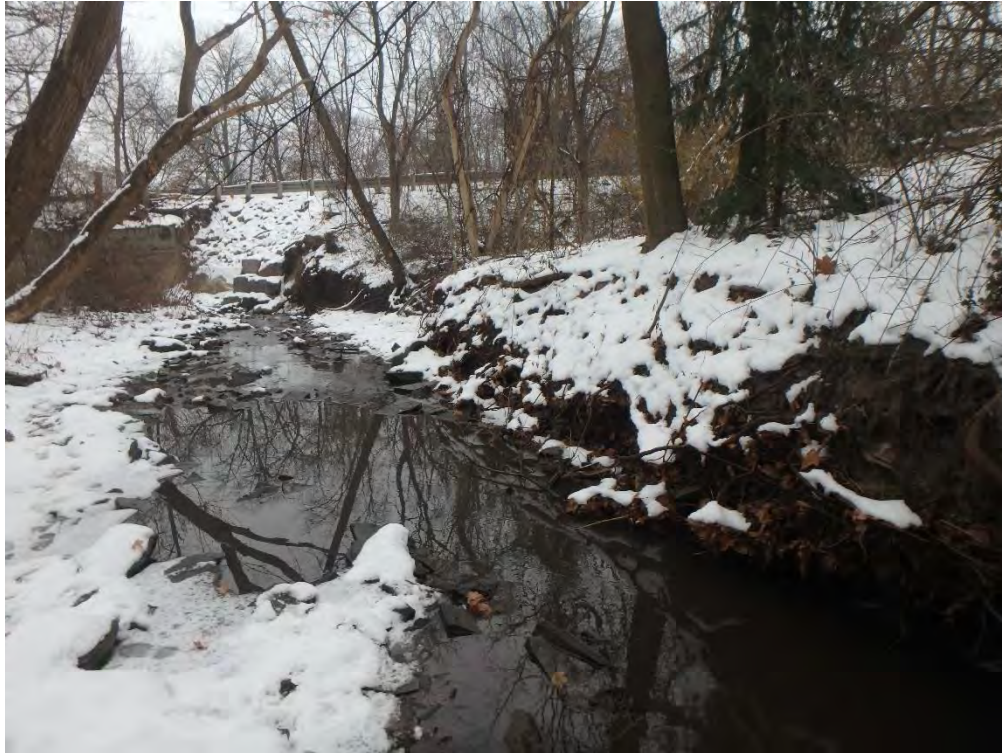
**Photo 9:** *Erosion evident at west bank on approach to Lakeshore Road ROW.*

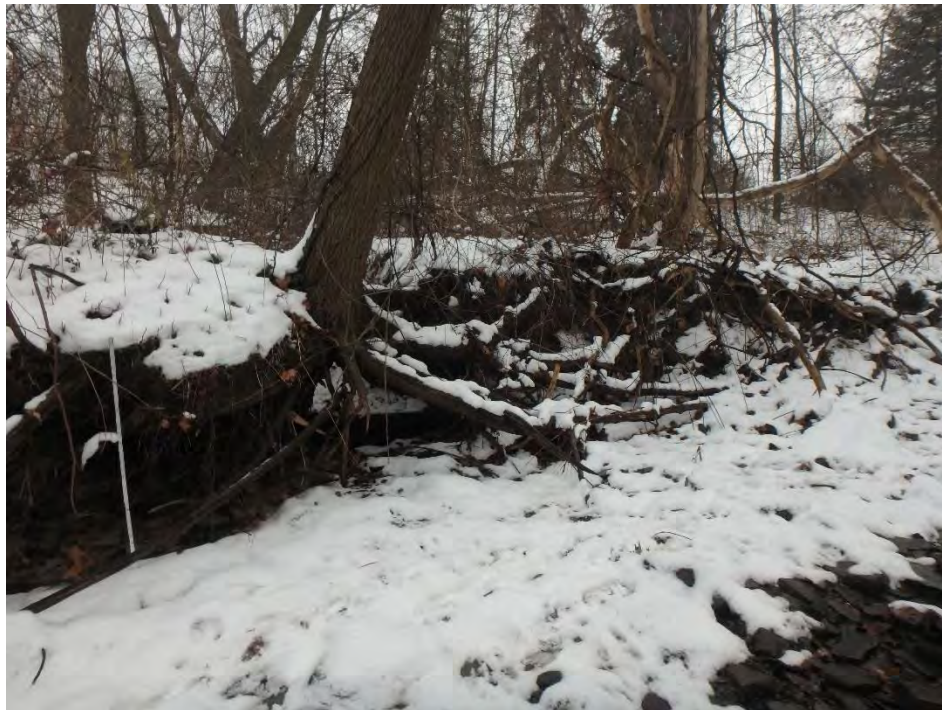
**Photo 10:** *Close up or exposed roots present on west bank.*

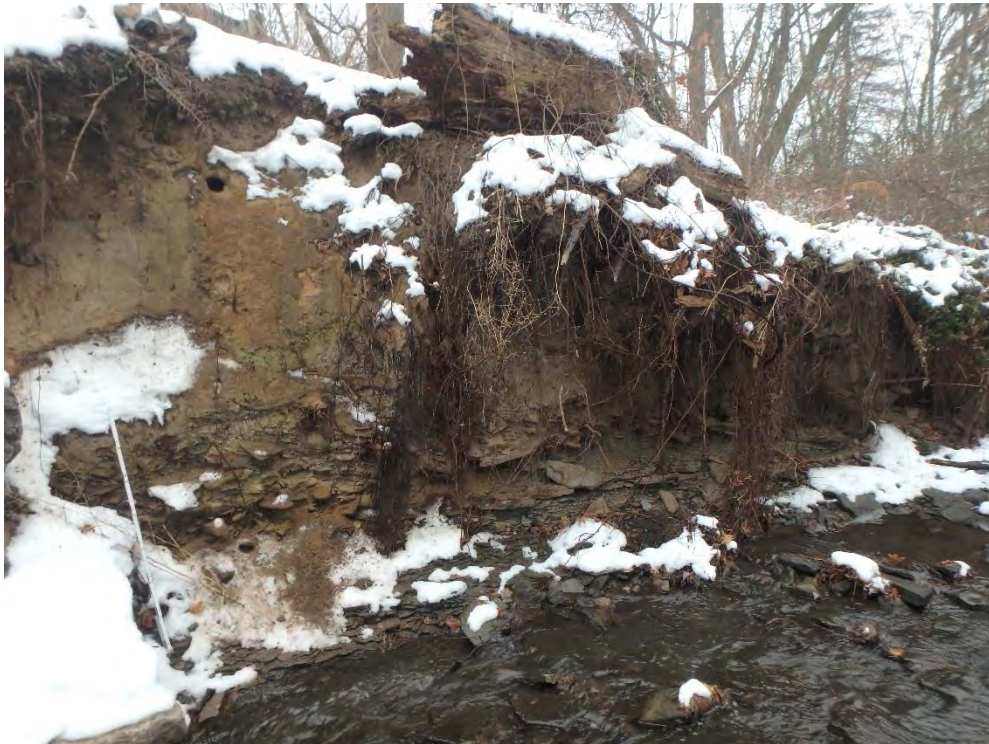
**Photo 11:** Bank nearest the retaining wall structure experiencing significant erosion. Erosion of bank reaches approximately 2.5 meters in height at its highest point.

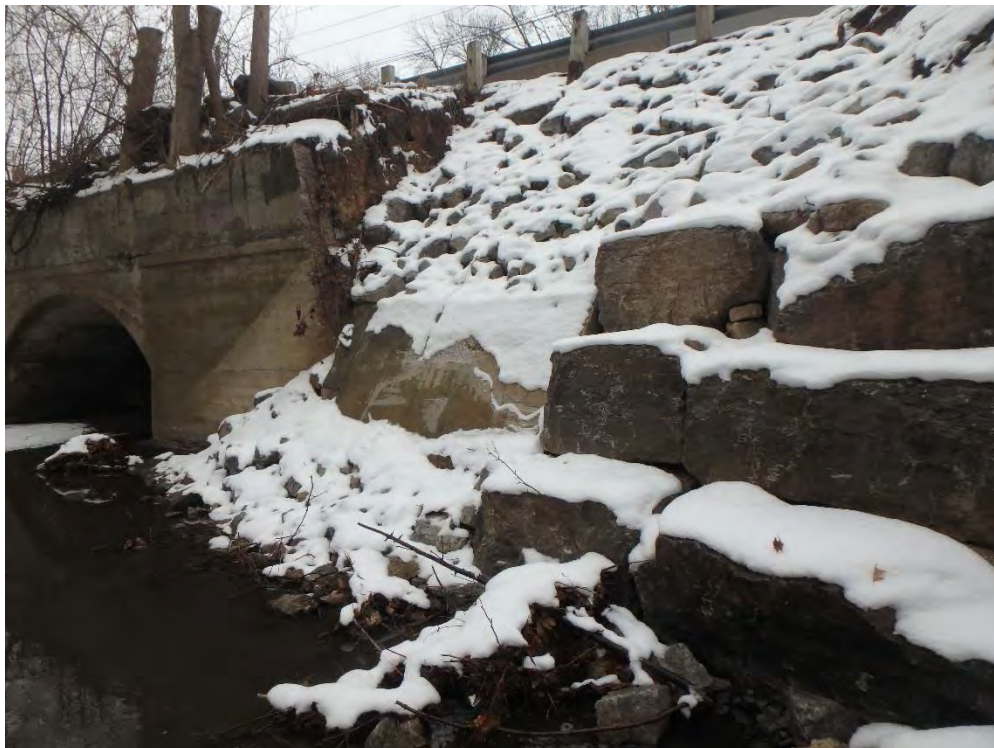
**Photo 12:** Emergency works were completed in the summer of 2017 to repair the severely eroded bank present directly west of the Lakeshore Road crossing.

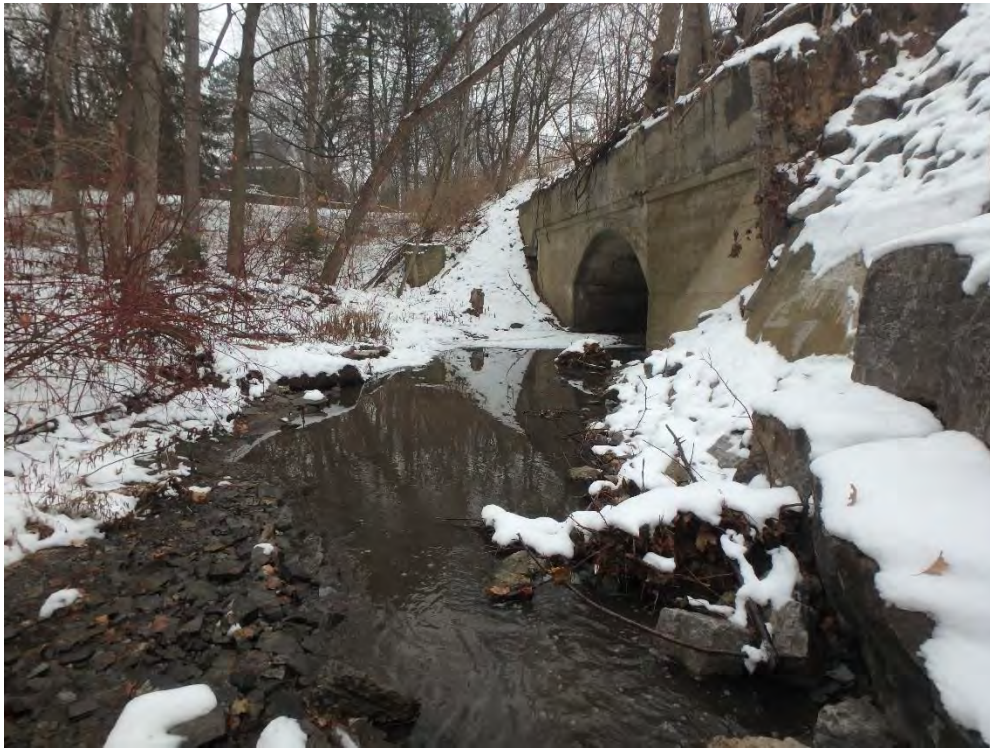
**Photo 13:** *Upstream end of Lakeshore Road crossing. Note some erosion is also evident at northeast bank, where exposed sandy soils are present.*

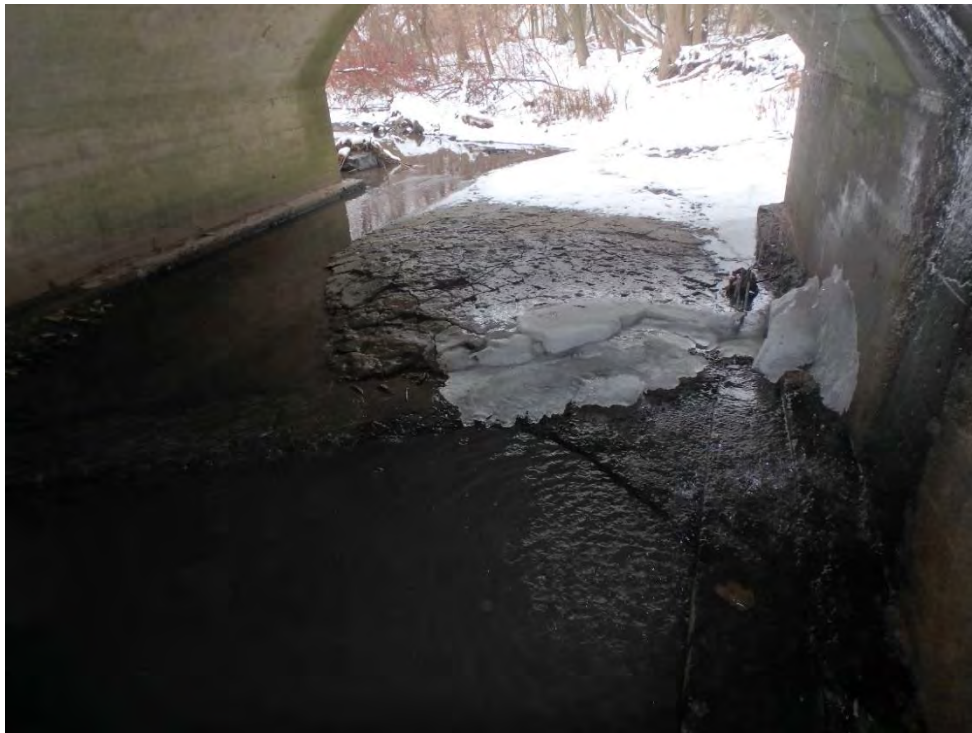
At the inlet of the Lakeshore Road crossing, an area of exposed limestone is evident. At the downstream end of the limestone, a poured concrete pad is evident. This was potentially installed for the protection of a conduit or other underground infrastructure. A step/face of concrete is present at the edge of the concrete pad, where the pad stops and meets with the natural channel bed downstream. Laminar flow was evident flowing over the limestone bedrock and concrete pad during surveys previously conducted in June, 2017. During a revisit of the site in September 2017 as well as the December 18th, 2017 surveys, flows were significantly reduced, exposing much of the limestone and resulting in shallow laminar flow. As such, it is believed that this area may pose

a barrier to fish movement. Removal of this feature represents a potential enhancement opportunity.

**Photo 14:** *Standing within Lakeshore Road ROW facing upstream. Note large area of limestone present to right (east) of structure inlet. Cement slab located at left may pose a potential barrier to smaller-bodied fish during periods of high flow.*

- Naturalize the substrate within the ROW. Consider modifying the limestone bedrock and poured concrete slab substrate at the upstream end of the ROW to improve fish passage within the ROW by creating a low flow channel.
