# Wycroft Road Improvements from Bronte Road to Kerr Street

## Appendix C: Fluvial Geomorphology

# Wycroft Road Improvements Municipal Class Environmental Assessment

## Fluvial Geomorphological Assessments Fourteen Mile Creek and Tributary, Taplow Creek and Glen Oaks Creek

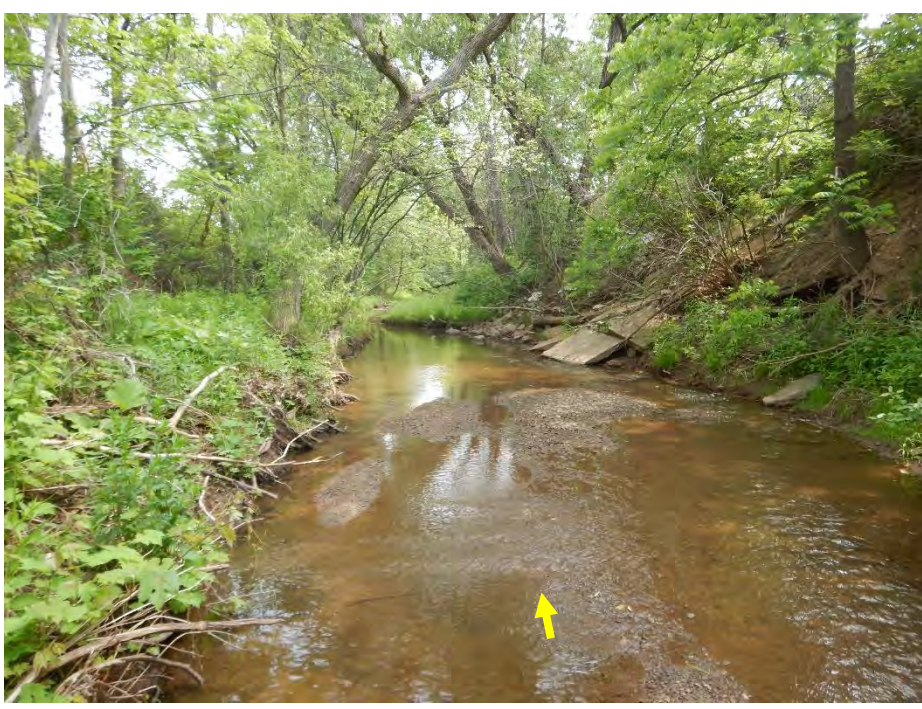
Photo 1  
Reach 14MC-1: South of Queen Elizabeth Way (QEW) to 250 m downstream of South Service Road

Fourteen Mile Creek had a well established riparian buffer consisting of mature deciduous trees. Some debris (concrete blocks) were observed upstream of the Fourth Line crossing. Yellow arrow indicates flow direction

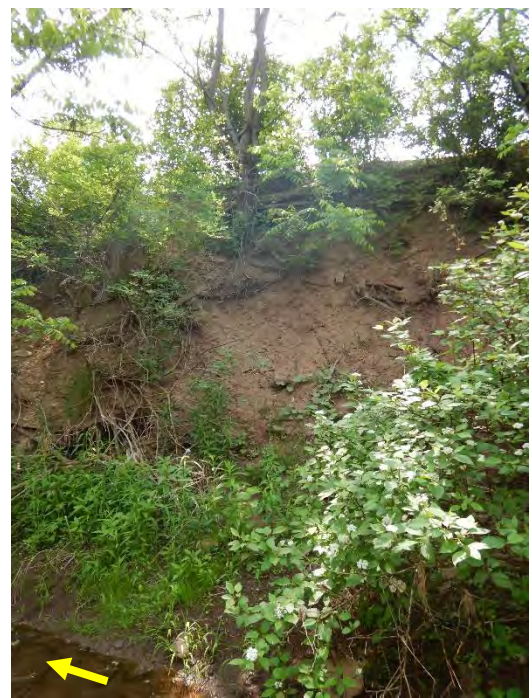
Photo 2  
Reach 14MC-1: South of QEW to 250 m downstream of South Service Road

Several valley wall contacts were observed within the assessed portion of Fourteen Mile Creek, on both sides of the channel.

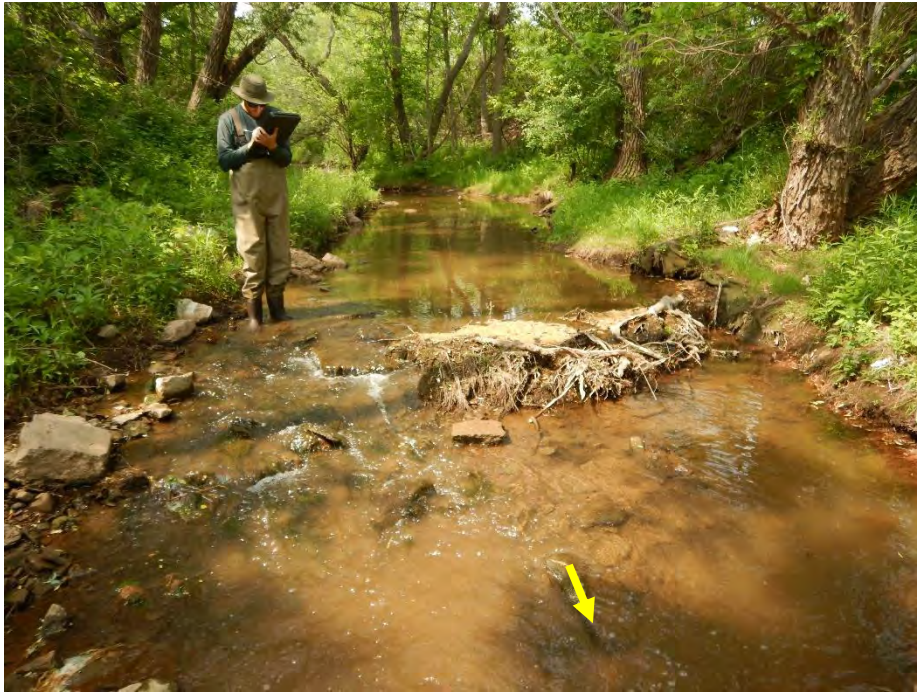
Photo 3  
Reach 14MC-1: South of QEW to 250 m downstream of South Service Road

The RGA results for Reach 14MC-1 indicated the reach was in transition (score of 0.28), with evidence of degradation and widening. Reach 14MCT-1 was assessed to be in regime (score of 0.12). Reach 14MC-1 was assessed to be in good condition according to the RSAT (score of 30), with channel stability as the limiting feature. The Fourteen Mile Creek tributary was also assessed to be in good condition (score of 27) with water quality as the limiting feature. RGAs and RSATs were not completed for Taplow Creek and Glen Oaks Creek as Taplow Creek consisted of a hardened channel and Glen Oaks Creek was channelized.

The channel bed was composed of bedrock throughout the reach, with surficial platy cobbles and gravels. Two small knickpoints were also observed, evidence of channel degradation.

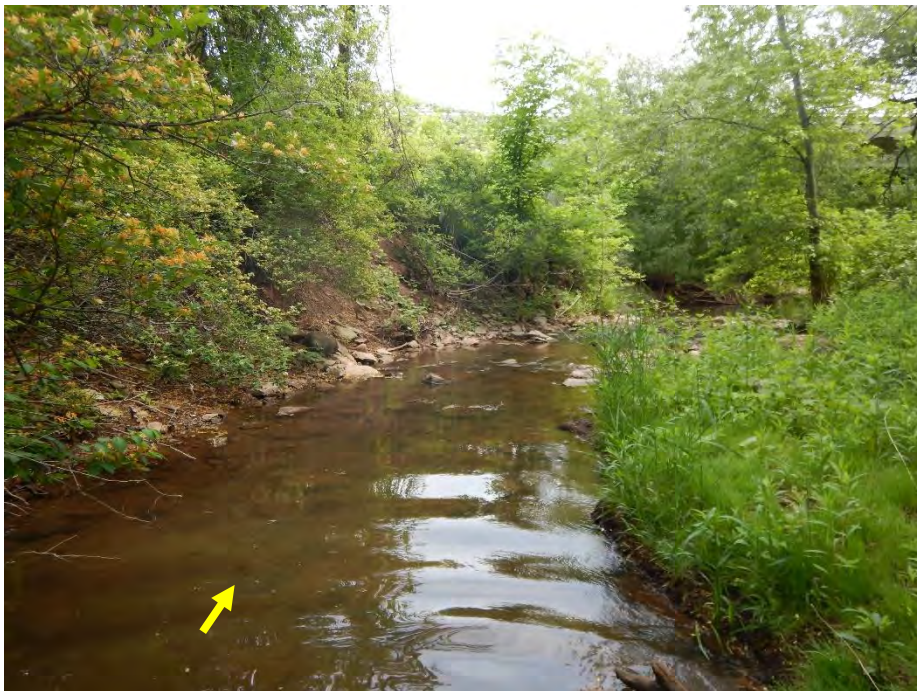
Photo 4  
Reach 14MC-1: South of QEW to 250 m downstream of South Service Road

The channel exhibited compound meanders within the valley, few point bars and low to moderate amounts of bank erosion on the outside of the bends.

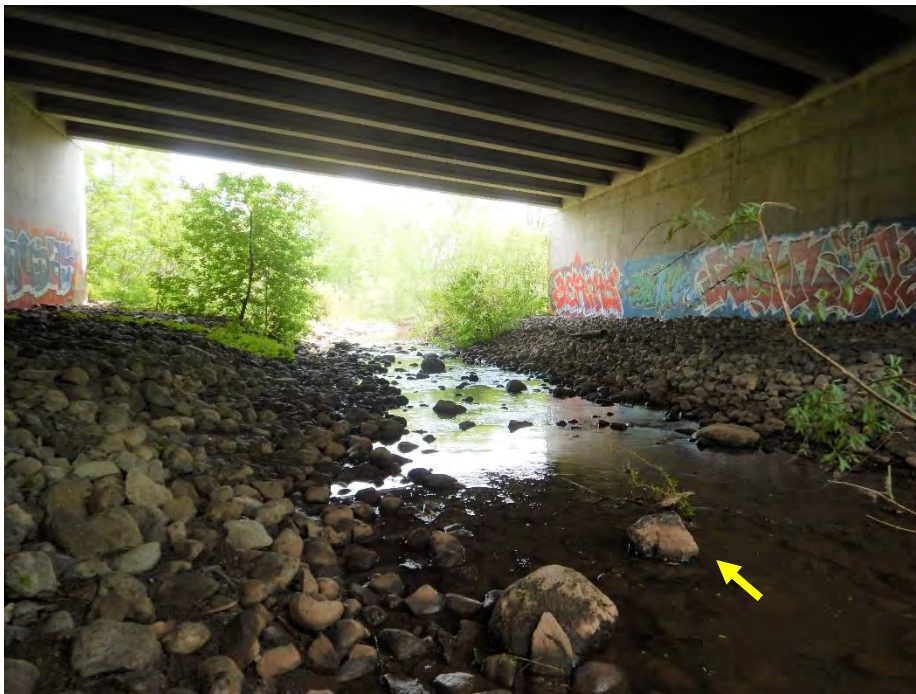
Photo 5  
Reach 14MC-1: South of OEW to 250 m downstream of South Service Road

The Third Line crossing was a bridge, with the channel and banks composed of large cobble-sized riverstone.

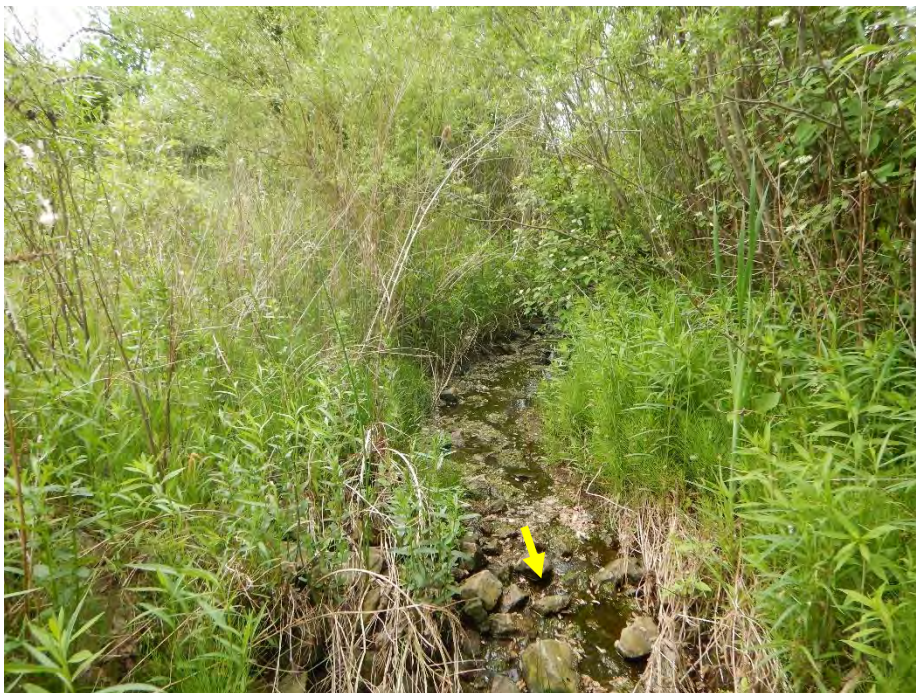
Photo 6  
Reach 14MC-1: South of OEW to 250 m downstream of South Service Road

A small channel conveyed flows from a headwall located east of Third Line and discharged into Fourteen Mile Creek approximately 30 m from the South Service Road crossing. The channel was lined with cobbles and had significant algal growth.

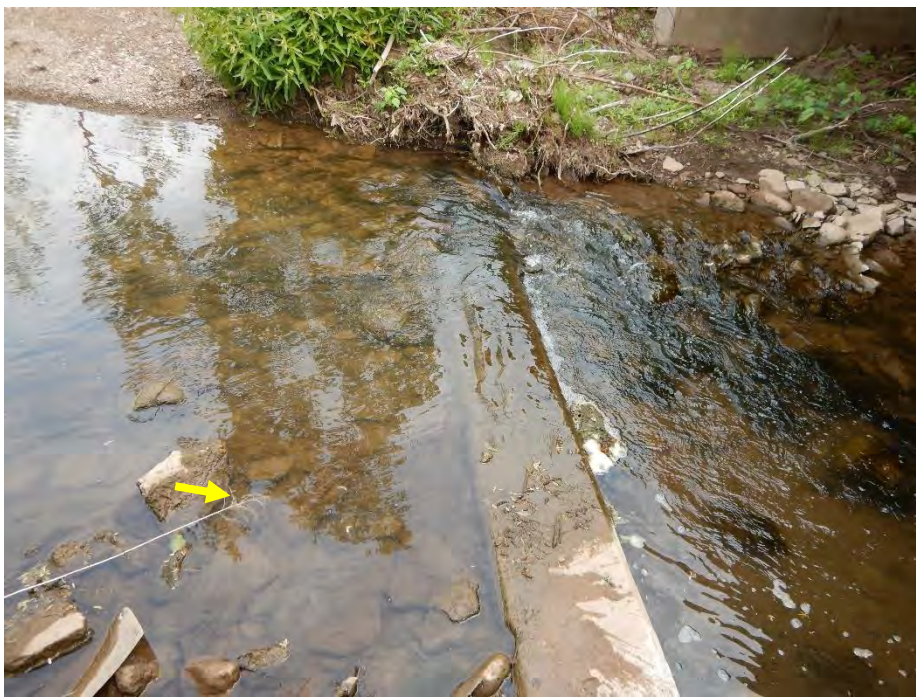
Photo 7  
Reach 14MC-1: South of OEW to 250 m downstream of South Service Road

A concrete weir spanned the channel immediately upstream of the South Service Road crossing.

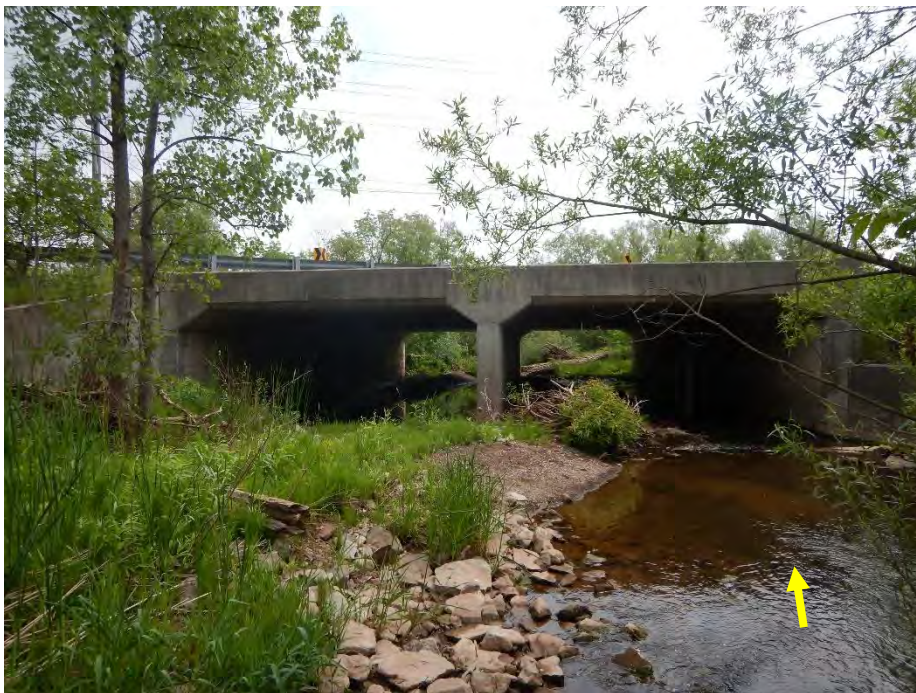
Photo 8  
Reach 14MC-1: South of OEW to 250 m downstream of Wycroft Road

The South Service Road crossing was a twin box culvert, with the channel aligned with the southern culvert. The northern culvert was partially blocked by a well-vegetated bar.

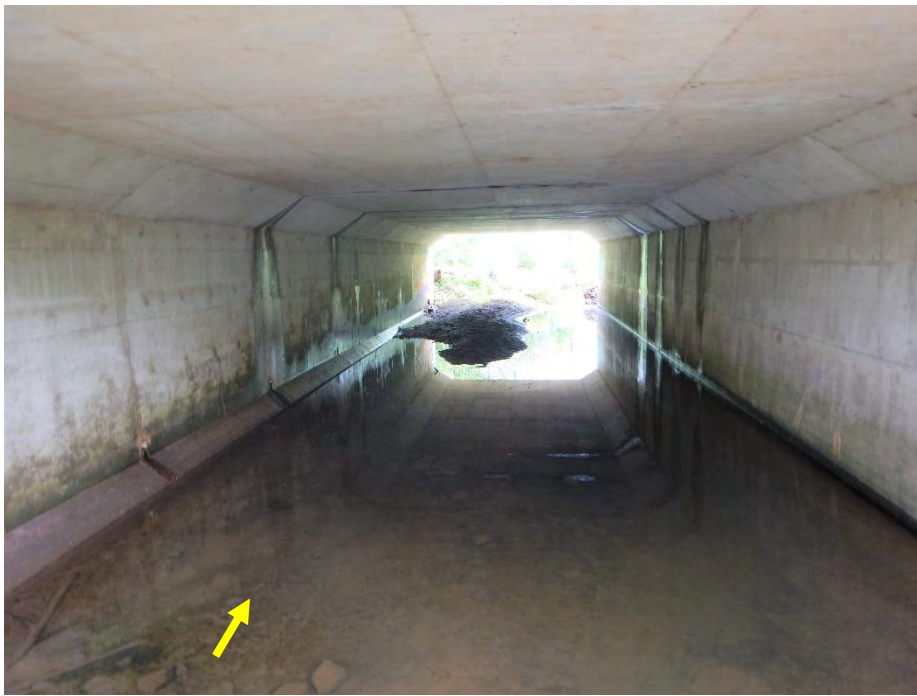
Photo 9  
Reach 14MC-1: South of QEW to 250 m downstream of Wynecroft Road

The northern culvert contained standing water.

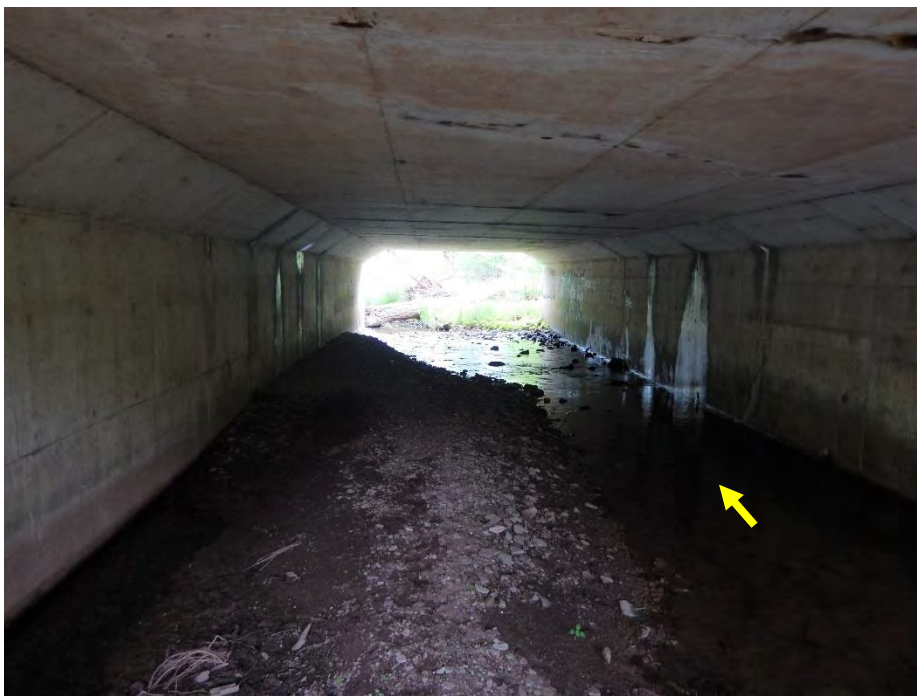
Photo 10  
Reach 14MC-1: South of QEW to 250 m downstream of Wynecroft Road

A bar formed along the north side of the southern box culvert.

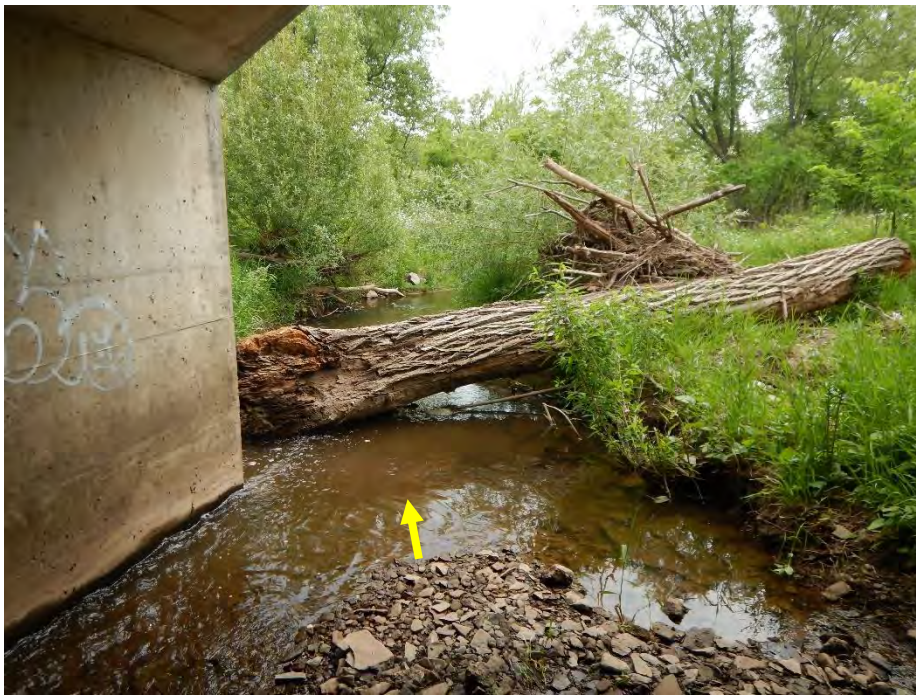
Photo 11  
Reach 14MC-1: South of QEW to 250 m downstream of Wynecroft Road

The channel was naturally constricted at the downstream end of the southern box culvert. A fallen tree transverse to the channel further impeded flows.

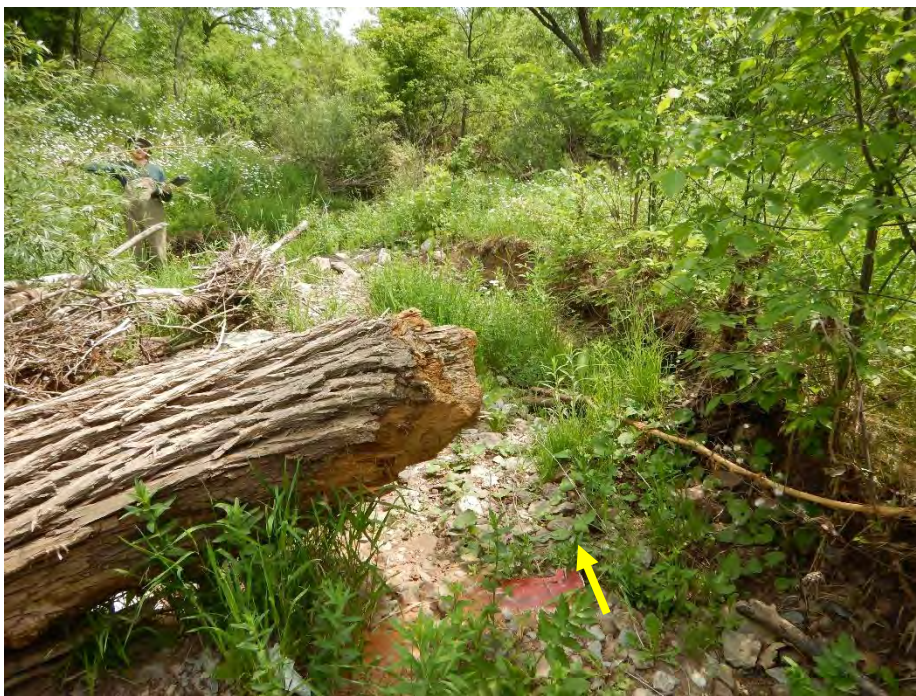
Photo 12  
Reach 14MC-1: South of QEW to 250 m downstream of Wynecroft Road

Due to the channel constriction beyond the downstream end of the southern culvert, high flows have evidently overtopped the bank and eroded the south valley wall.

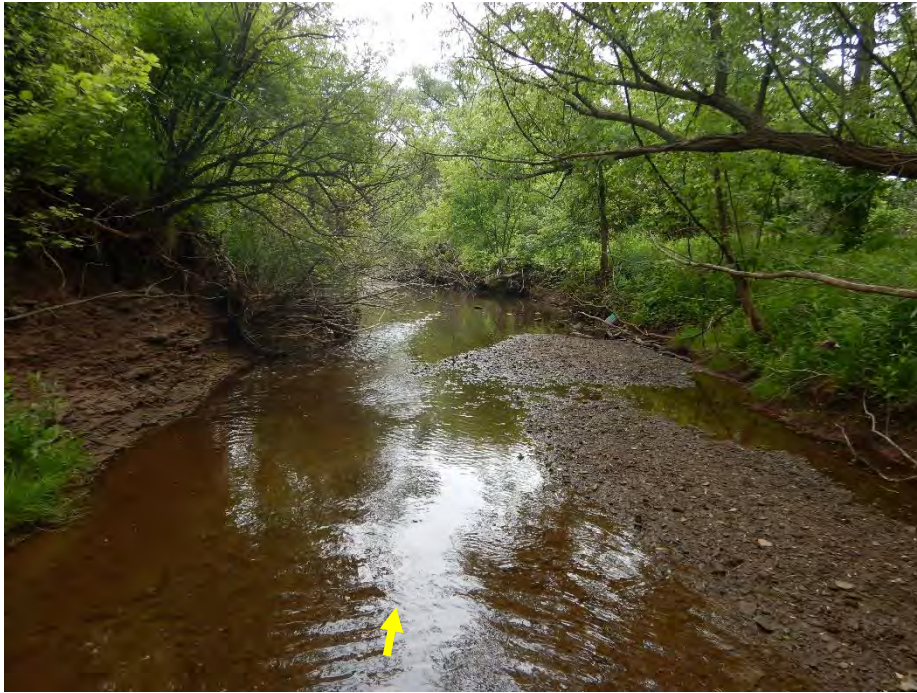
Photo 13  
Reach 14MC-1: South of QEW to 250 m downstream of South Service Road

Channel conditions downstream of the South Service Road crossing were consistent with observations upstream, including valley wall contacts. In this instance, the channel laterally eroded Queenston Shale along the north side of the channel.

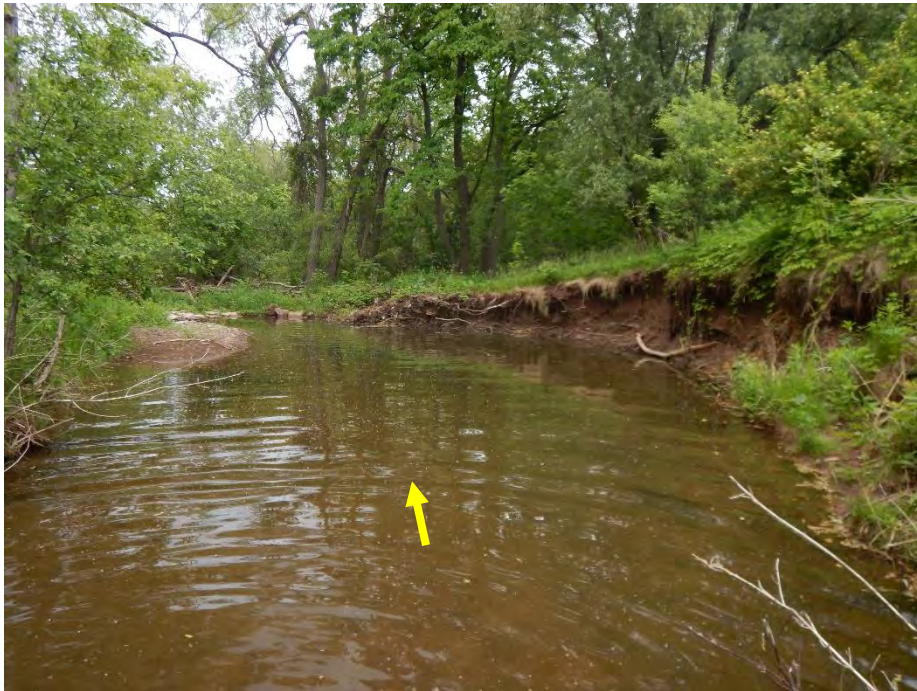
Photo 14  
Reach 14MC-1: South of QEW to 250 m downstream of South Service Road

At the first meander bend downstream of the South Service Road crossing, the outside bank was eroded and a point bar formed on the inside of the bend.

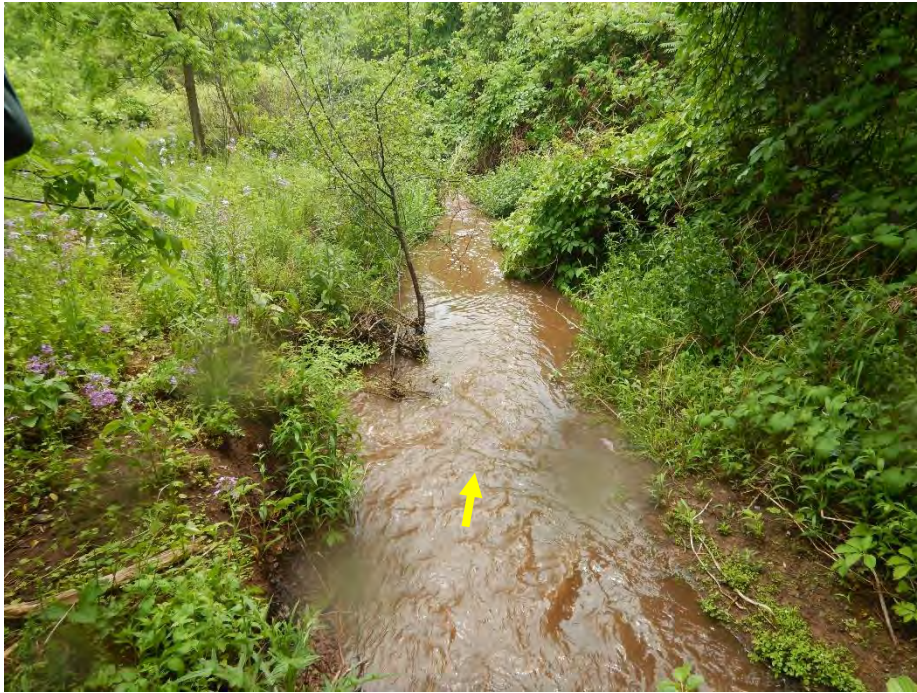
Photo 15  
Reach 14MCT-1: North of QEW

Upstream of the QEW, the channel had an irregularly meandering planform and conveyed flows through a corridor populated by deciduous trees and herbaceous plants.

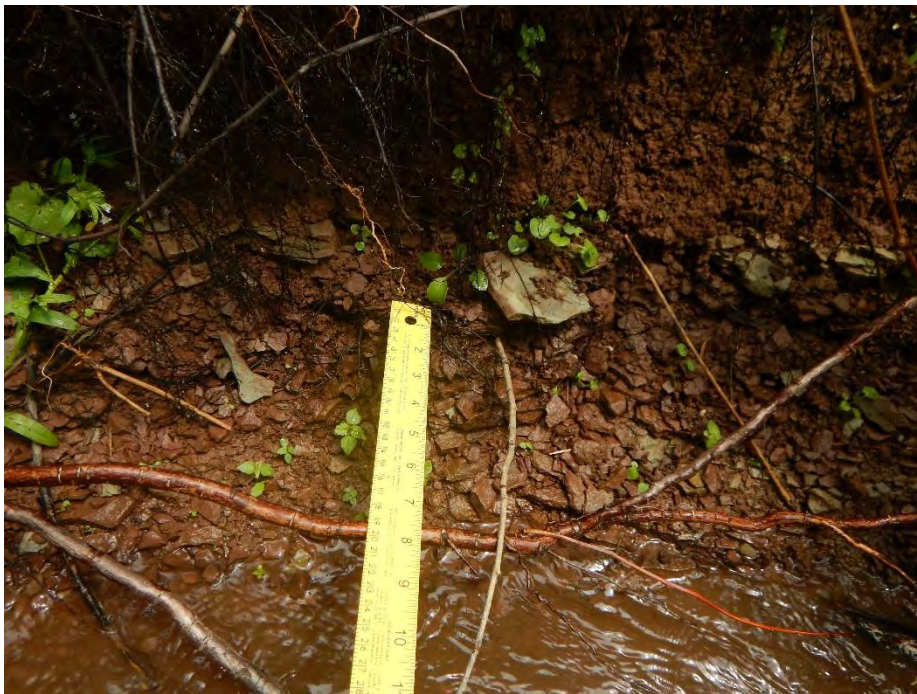
Photo 16  
Reach 14MCT-1: North of QEW

The channel showed evidence of degradation, including the presence of a suspended armour layer consisting of Queenston Shale within the banks, and parent material on the channel bed.

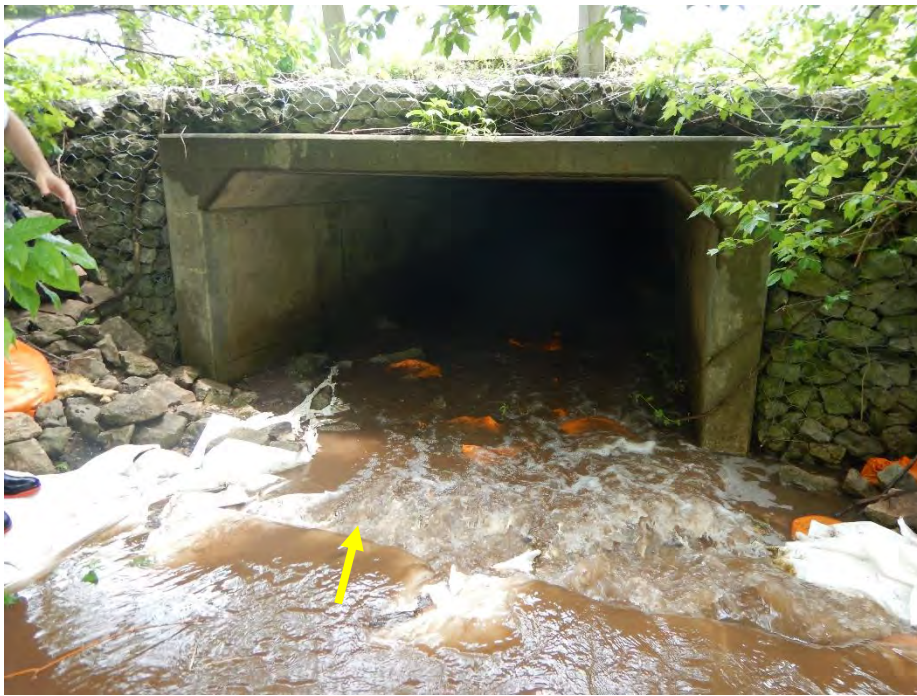
Photo 17  
Reach 14MCT-1: North of QEW

A 100-m long box culvert (Crossing C3), with a 3 m span and 1.5 m rise, conveyed flows across the QEW and South Service Road to Reach 14MCT-2. Notably, at the upstream end of the culvert, sandbags were found spanning the channel. The placement of these sandbags suggest that they may have been used to control creek flows during construction activities and subsequently forgotten. Within the box culvert, there were two drops that were about 0.3 m high, which likely inhibits fish passage. A third drop was observed at the culvert outlet; this drop did not appear to be a result of downstream channel degradation.

Immediately upstream of the ~100 m long culvert conveying flows across the QEW and the South Service Road, sand bags spanned the channel creating a weir.

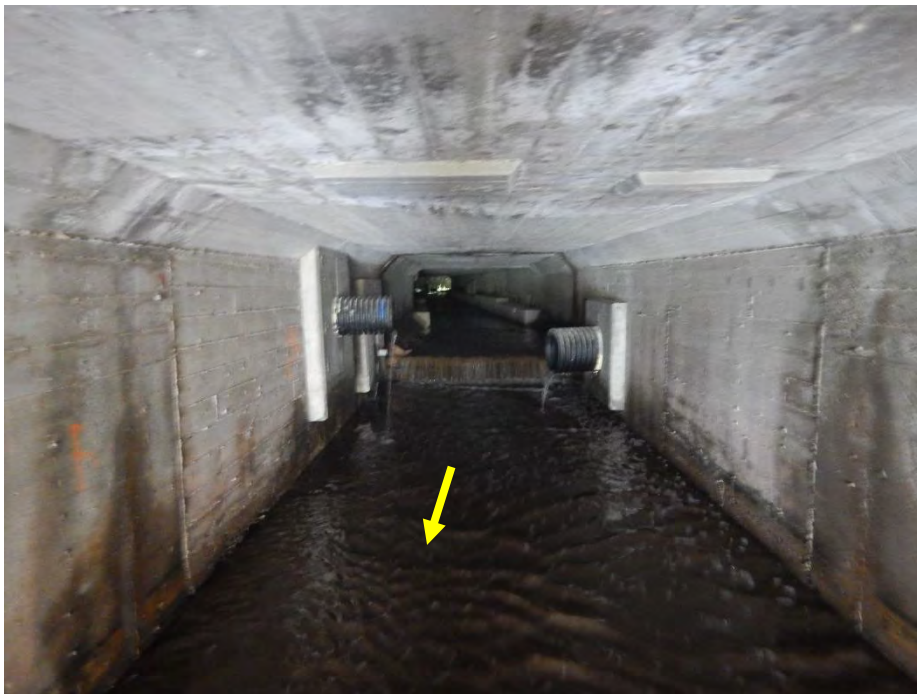
Photo 18  
Reach 14MCT-1: North of QEW

Within the culvert, two drops each approximately 0.3 m high were observed. These may prevent upstream fish migration.

Crossing C3 at the tributary of Fourteen Mile Creek is proposed to be extended on the south side of the road. The perched condition of Crossing C3 outlet could be addressed as part of the culvert extension and/or receiving channel restoration. Further discussion with the regulatory agencies is recommended as this tributary is currently considered to be a contributing Redside Dace reach, a designation that may change. Moreover, there are two additional drops within the culvert that may impede fish passage.

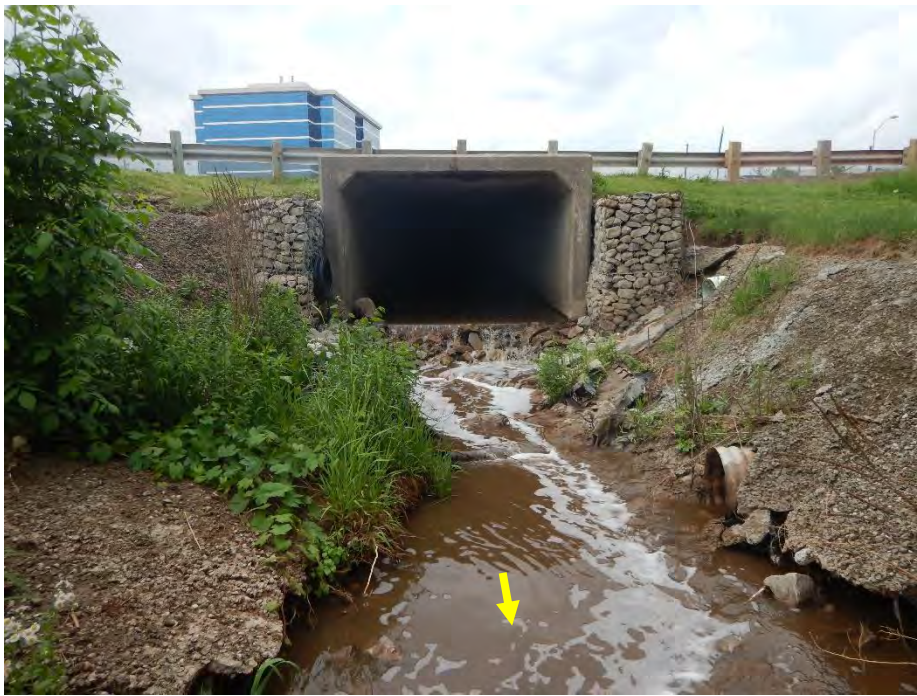
Photo 19  
Reach 14MCT-2: OEW to GE Distribution Centre

Another drop was present at the culvert outlet at South Service Road. The channel banks were composed of concrete, but eroded along the toe in the vicinity of the culvert outlet.

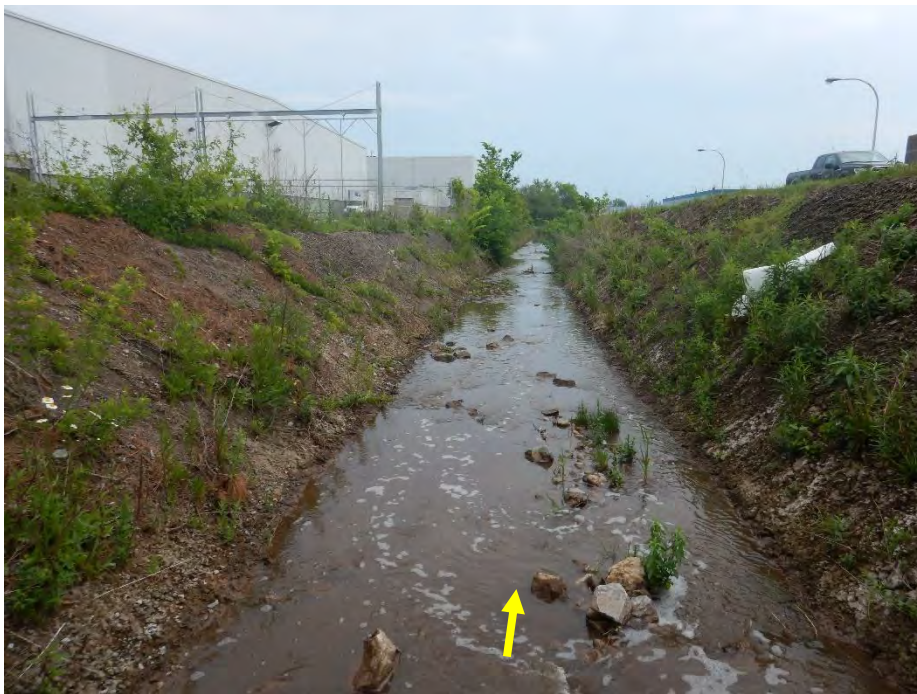
Photo 20  
Reach 14MCT-2: OEW to GE Distribution Centre

Downstream of South Service Road the channel was straight and concrete-lined with no morphological variability.

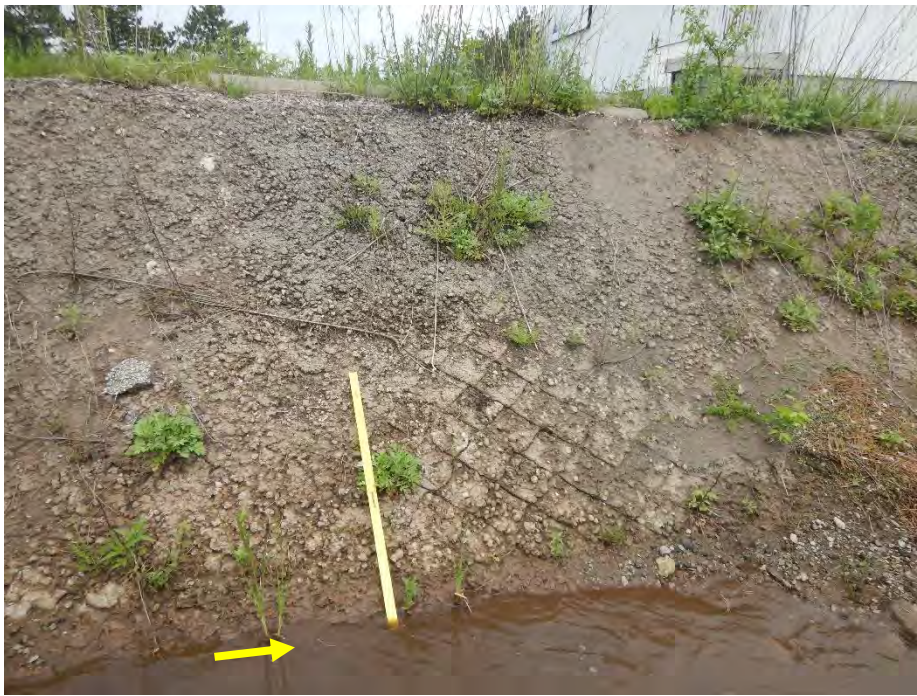
Photo 21  
Reach 14MCT-2: OEW to GE Distribution Centre

Channel banks were generally 2 m high and had a 1.5:1 slope, with some erosion from abrasion exposing the supporting wire within the concrete.

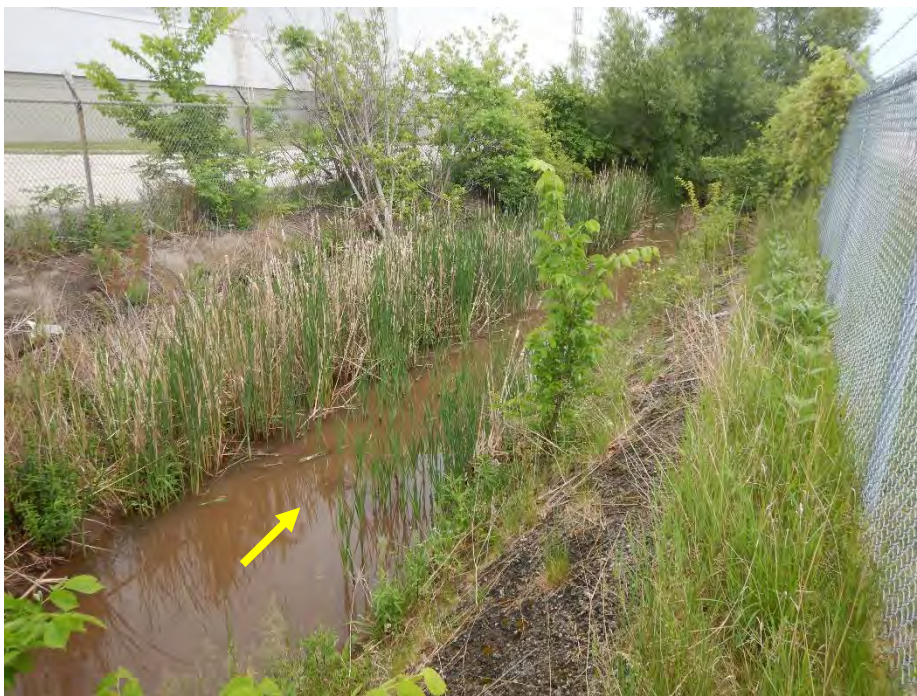
Photo 22  
Reach 14MCT-2: OEW to GE Distribution Centre

At the downstream extent of the assessed portion of the reach, cattail and reed canary grass were established along the channel margins.

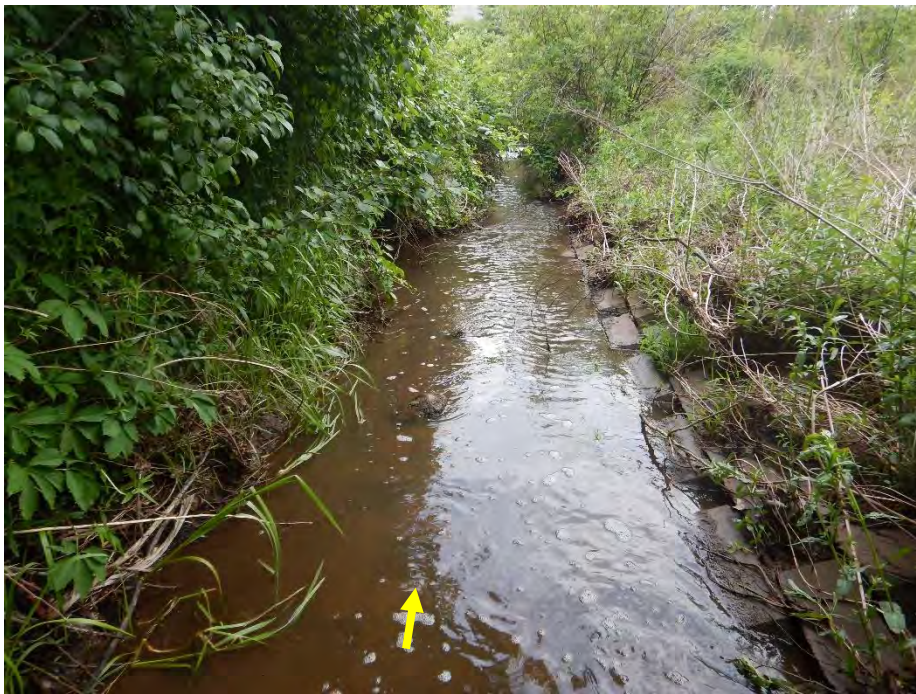
Photo 23  
Reach TC-1: 125 m North and South of South Service Road

At the upstream end of the assessed portion of Taplow Creek, riparian vegetation included juvenile deciduous trees and herbaceous plants.

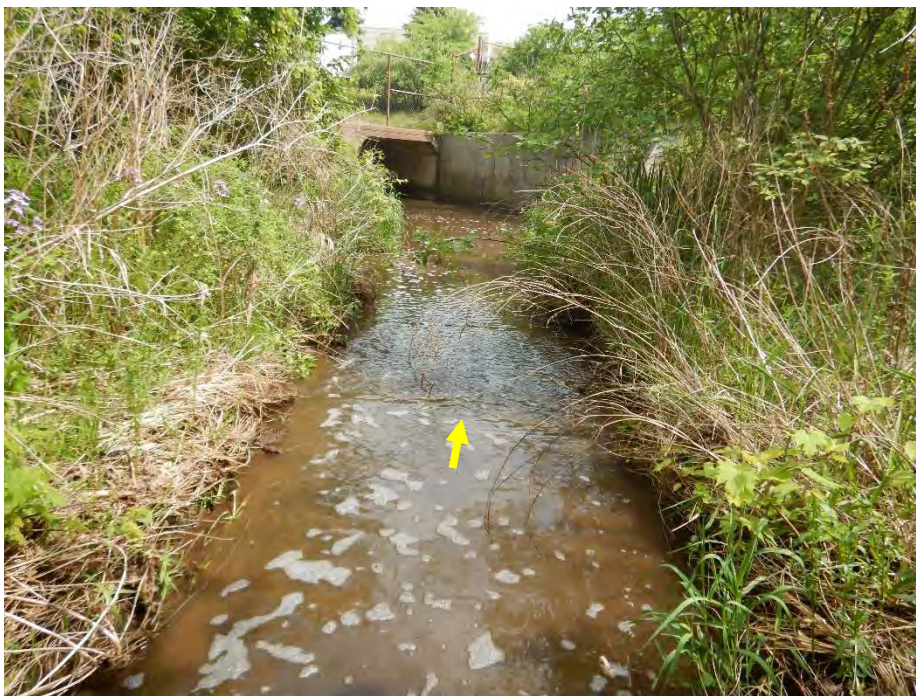
Photo 24  
Reach TC-1: 125 m North and South of South Service Road

The channel bed and banks were lined with articulated concrete blocks throughout the extent assessed. No erosion was noted to channel bed or banks.

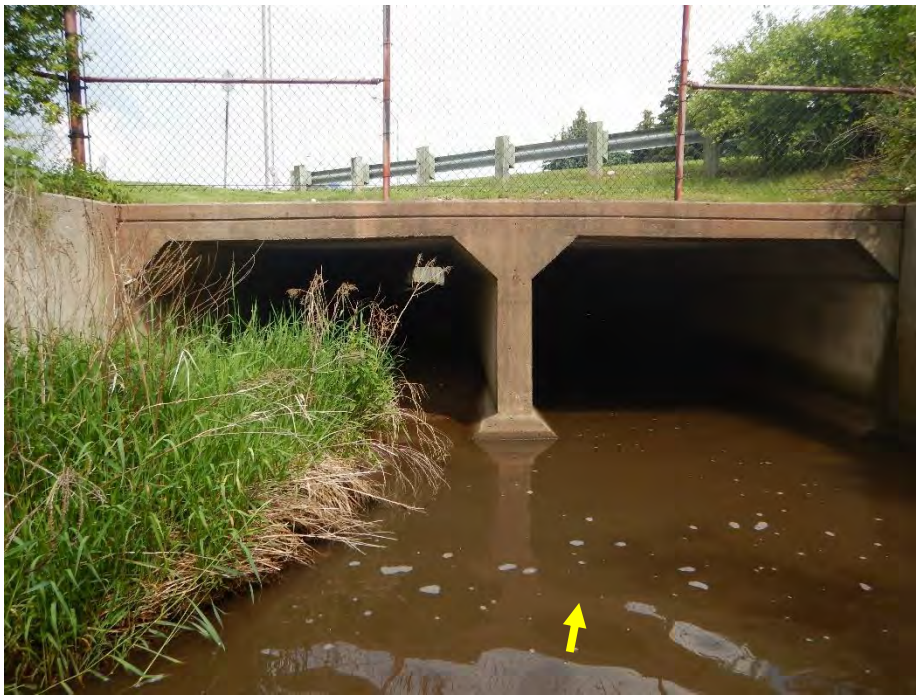
Photo 25  
Reach TC-1: 125 m North and South of South Service Road

The South Service Road crossing was a twin box culvert. While both culverts conveyed flow, the eastern culvert was partially blocked by a well-vegetated bar. Two-metre-high concrete retaining walls directed flow into the culvert.

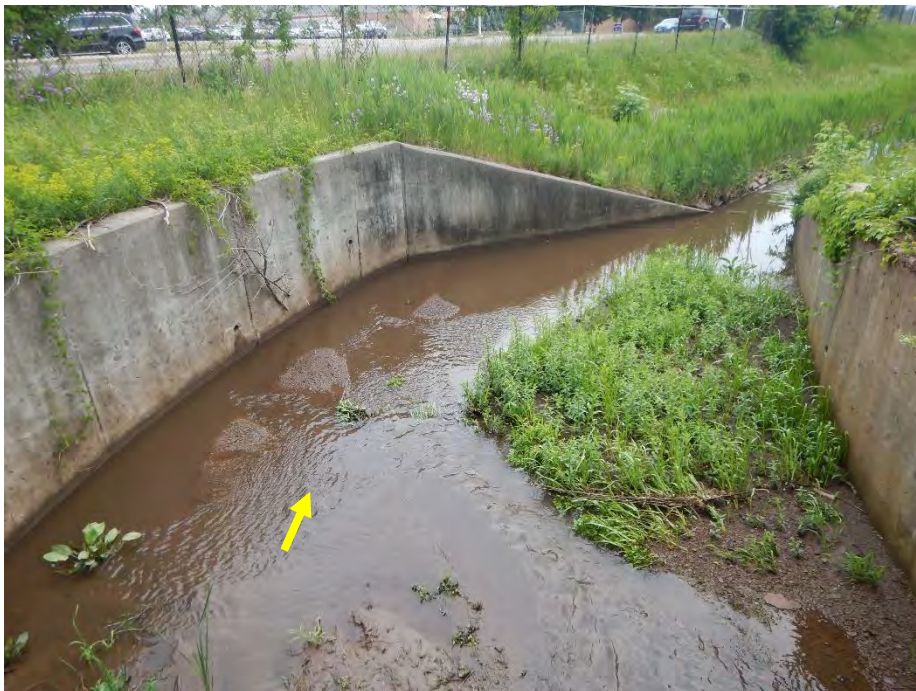
Photo 26  
Reach TC-1: 125 m North and South of South Service Road

At the outlet of the South Service Road culvert was a vegetated bar.

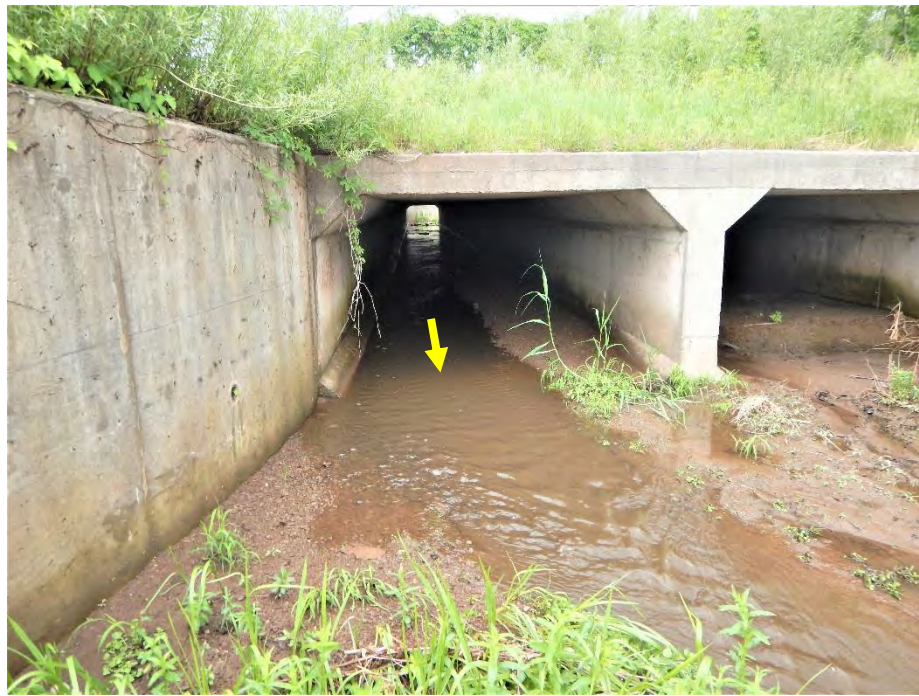
Photo 27  
Reach TC-1: 125 m North and South of South Service Road

Within the western culvert, low-flow travelled along the west side of the culvert, and sediment was deposited along the east side.

With respect to Crossing C6, there is an opportunity to improve conditions for fish, should this be desired. Currently, both barrels of the twin box culvert have sediment accumulation, but the east barrel has less with a low-flow channel travelling along one side. Culvert capacity may need to be restored by removing sediment, but a low-flow channel could still be installed through the east barrel for fish passage during baseflow conditions if the existing culvert is sufficiently embedded to allow for a certain depth of substrate that would be stable and not slide on the concrete slab (to be assessed at the detailed design stage). It should be noted, however, that substrate, or a functionally equivalent measure, would need to be placed in the west barrel to direct low flows through the east barrel, and this could affect culvert capacity to an extent that results in an unacceptable increase in upstream flooding potential. If the existing culvert is not embedded, the installation of baffles or other means of reducing low-flow velocities can be explored, but again its feasibility must be evaluated with consideration to culvert hydraulics/capacity, upstream flooding and the assessed importance of improving fish passage and habitat.

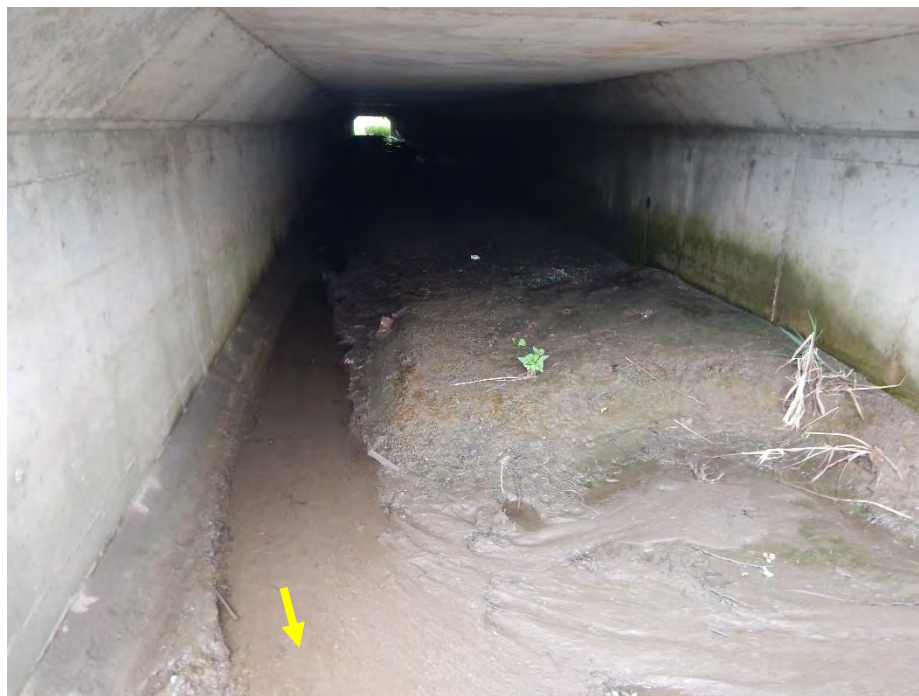
Photo 28  
Reach TC-1: 125 m North and South of South Service Road

Sediment has accumulated within the eastern culvert, with a narrow and shallow channel along the west side of the culvert.

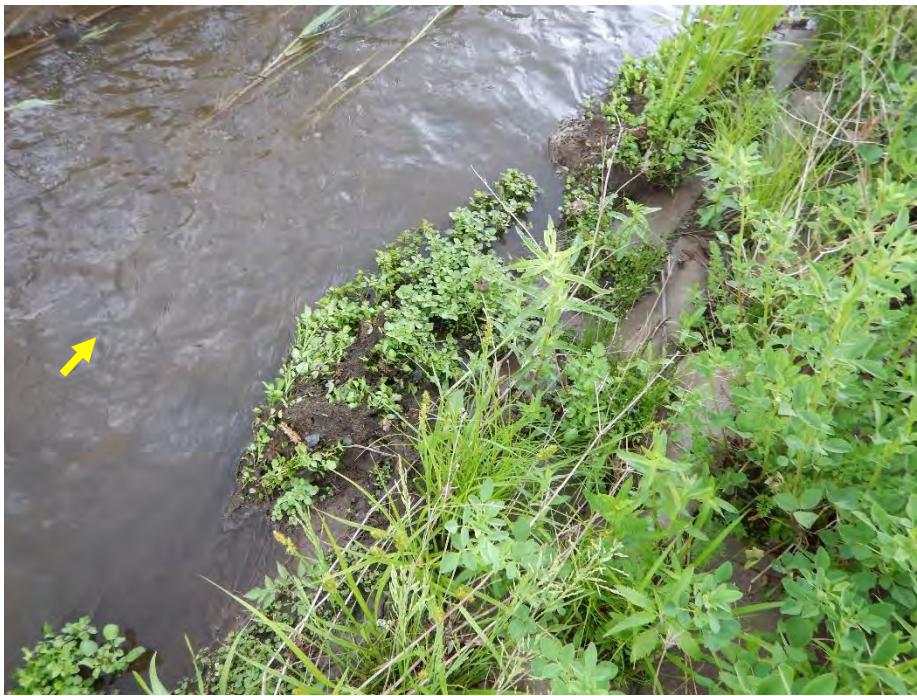
Photo 29  
Reach TC-1: 125 m North and South of South Service Road

Water cress, an indicator of groundwater upwelling, was observed downstream of the South Service Road crossing.

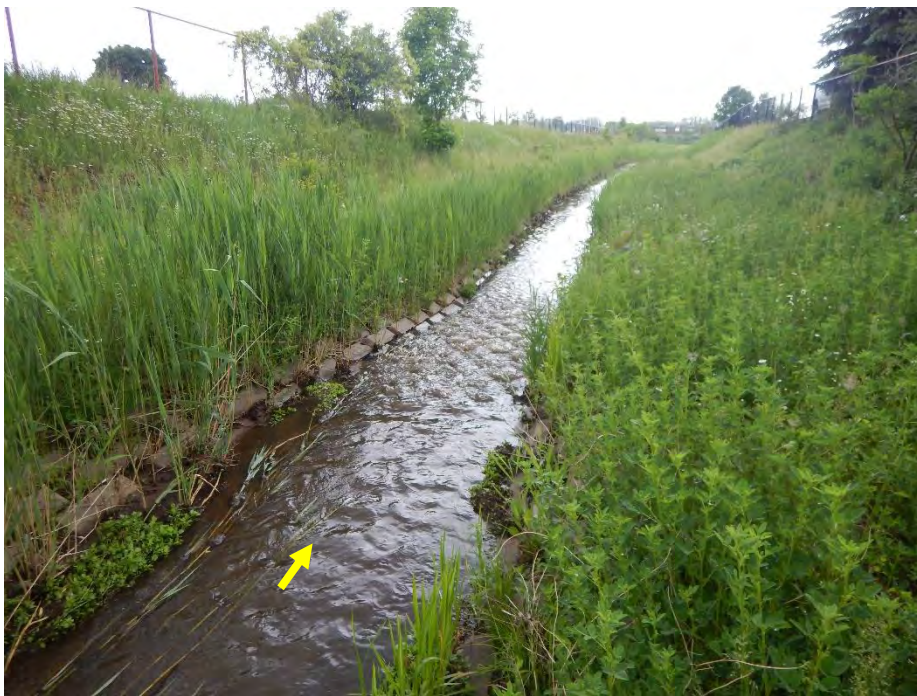
Photo 30  
Reach TC-1: 125 m North and South of South Service Road

Taplow Creek downstream of South Service Road had a riparian buffer that lacked woody vegetation. The channel bed and banks were composed of articulated concrete blocks, consistent with upstream conditions.

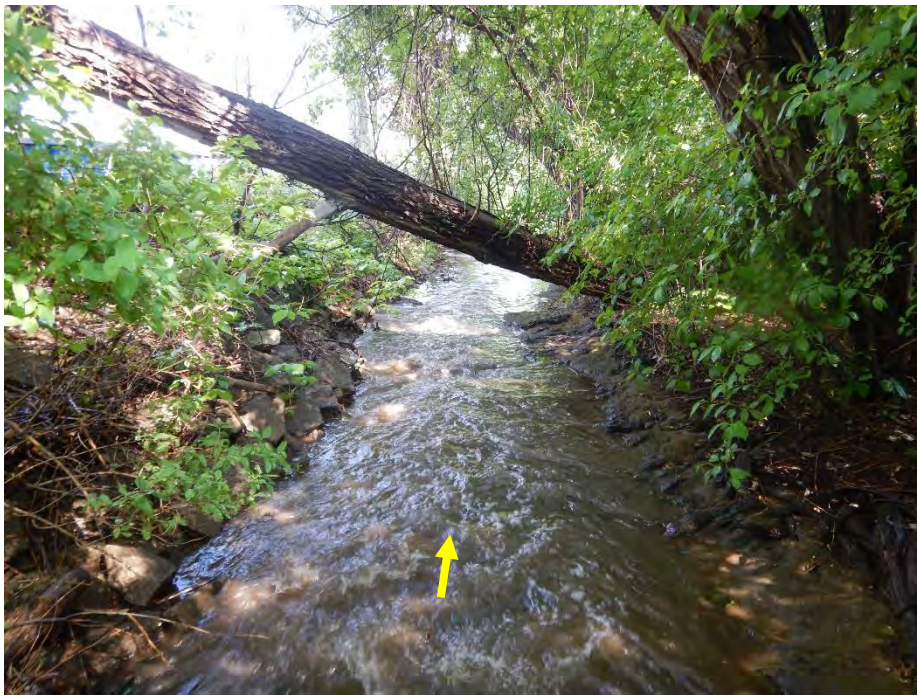
Photo 31  
Reach GO-1: 125 m north and south of Wyecroft Road

Glen Oaks Creek conveyed flows within a narrow corridor in which sparse mature deciduous trees provided some cover.

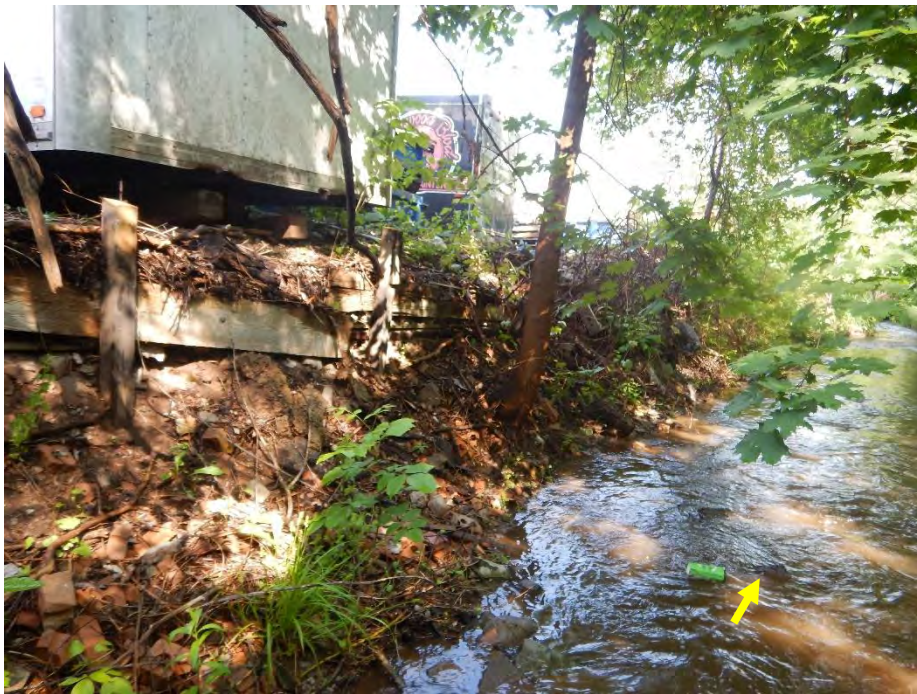
Photo 32  
Reach GO-1: 125 m north and south of Wyecroft Road

In several locations the corridor lacked a riparian buffer, and debris from the adjacent industrial properties had been deposited into the creek.
