# Wycroft Road Improvements from Bronte Road to Kerr Street

## Appendix C: Fluvial Geomorphology

# Wycroft Road Improvements Municipal Class Environmental Assessment

## Fluvial Geomorphological Assessments Fourteen Mile Creek and Tributary, Taplow Creek and Glen Oaks Creek

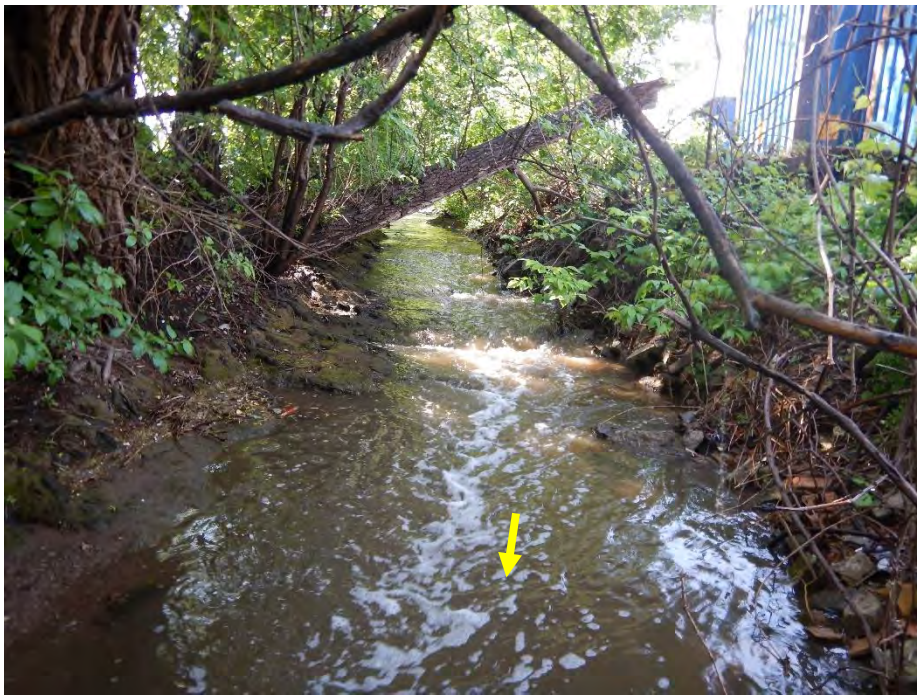
Photo 33  
Reach GO-1: 125 m north and south of Wyecroft Road

The channel bed was comprised of bedrock throughout the reach, with one knickpoint upstream of Wyecroft Road. Channel banks were generally composed of a silt and clay mixture with willow rootlets providing stability to the channel banks.

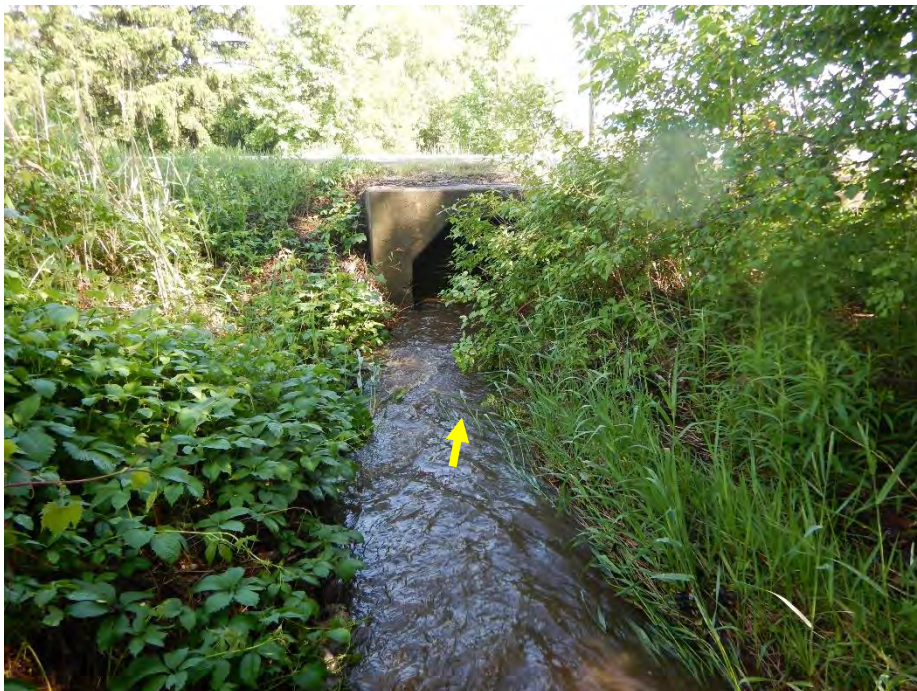
Photo 34  
Reach GO-1: 125 m north and south of Wyecroft Road

The Wyecroft Road crossing was a 6 m wide box culvert which was partly misaligned with the existing channel.

The replacement of Crossing C7 at Glen Oaks Creek with a longer open-bottom structure offers an opportunity to reinstate a low-flow channel across the road and improve fish habitat and passage. Similar to Crossing C1, natural channel design principles could be employed to develop a channel through the culvert. The replacement culvert will be longer than existing and therefore will require channel works. The channel beyond the proposed ends of the culvert can be restored so that it better aligns with the culvert. Bioengineered banks are recommended for the restored channel to provide aquatic habitat benefits and enhance stability.

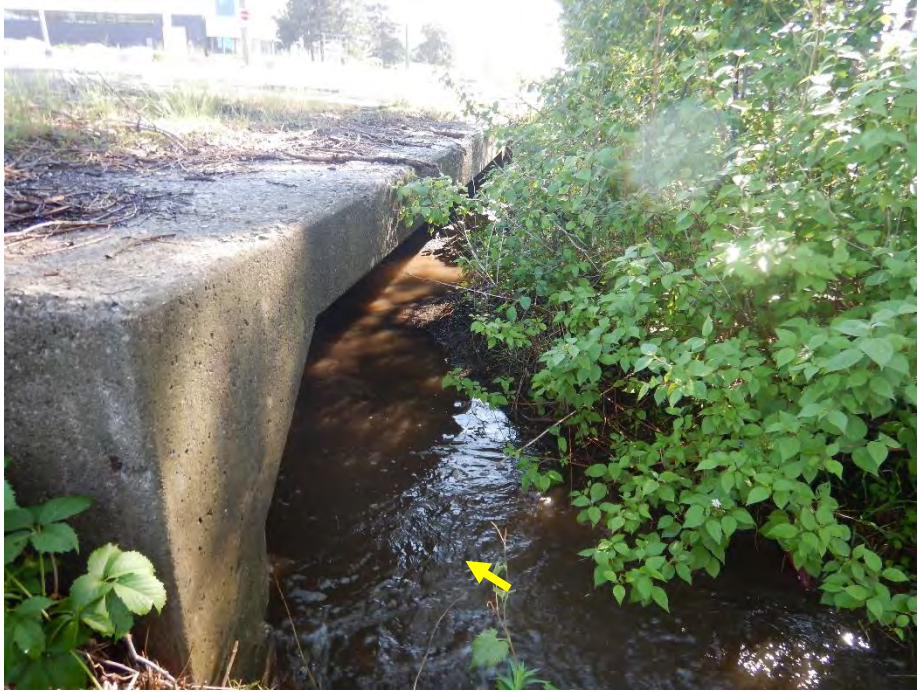
Photo 35  
Reach GO-1: 125 m north and south of Wyecroft Road

A well-vegetated bar blocked approximately three-quarters of the Wyecroft Road culvert inlet.

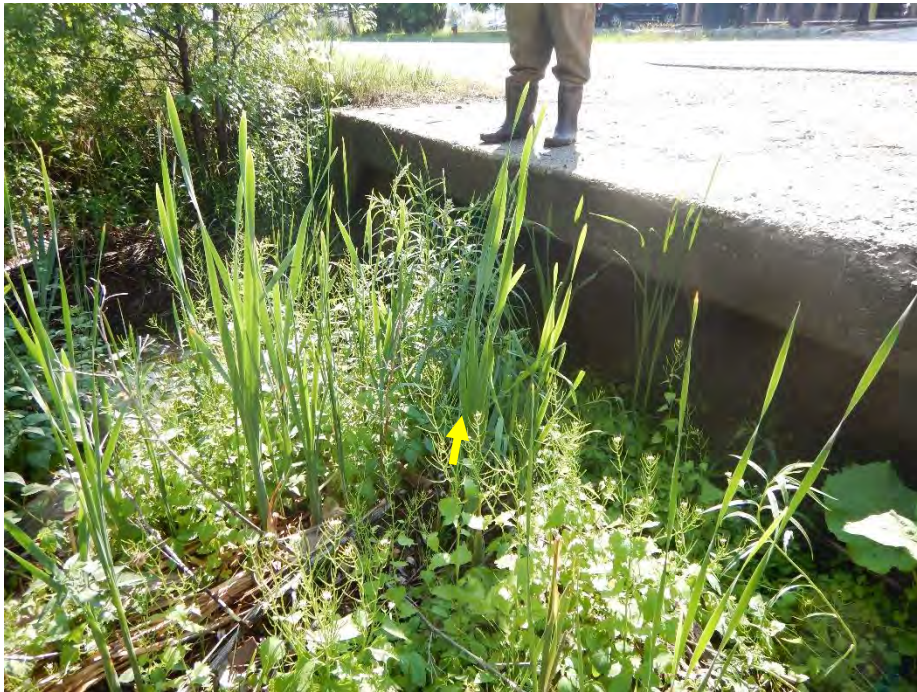
Photo 36  
Reach GO-1: 125 m north and south of Wyecroft Road

A well-vegetated bar blocked approximately two-thirds of the Wyecroft Road culvert outlet, on the eastern side.

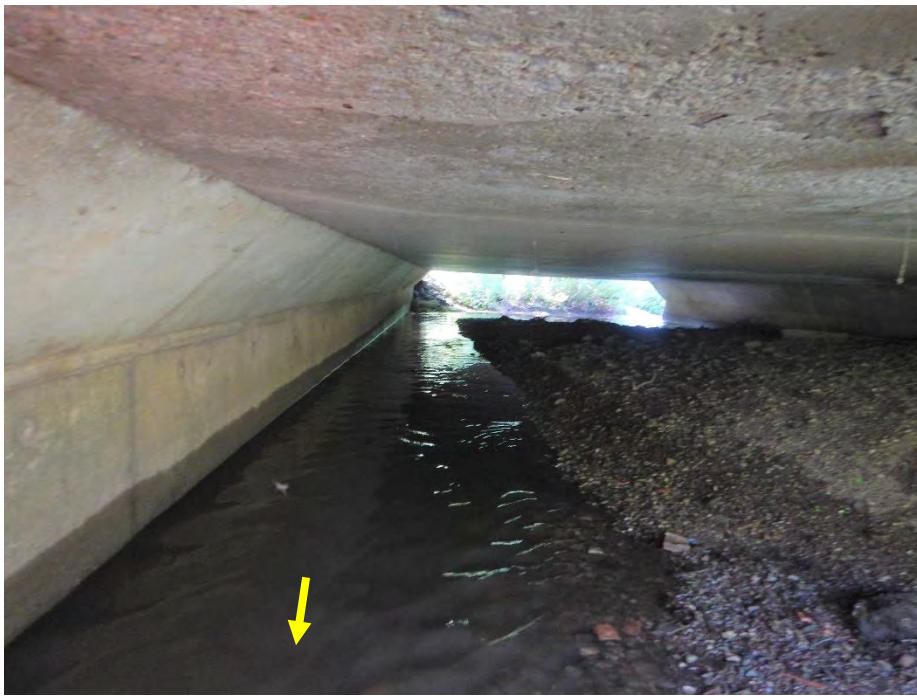
Photo 37  
Reach GO-1: 125 m north and south of Wyecroft Road

The channel makes a 90° turn upon entering the Wyecroft Road culvert before following the western wall to the outlet.

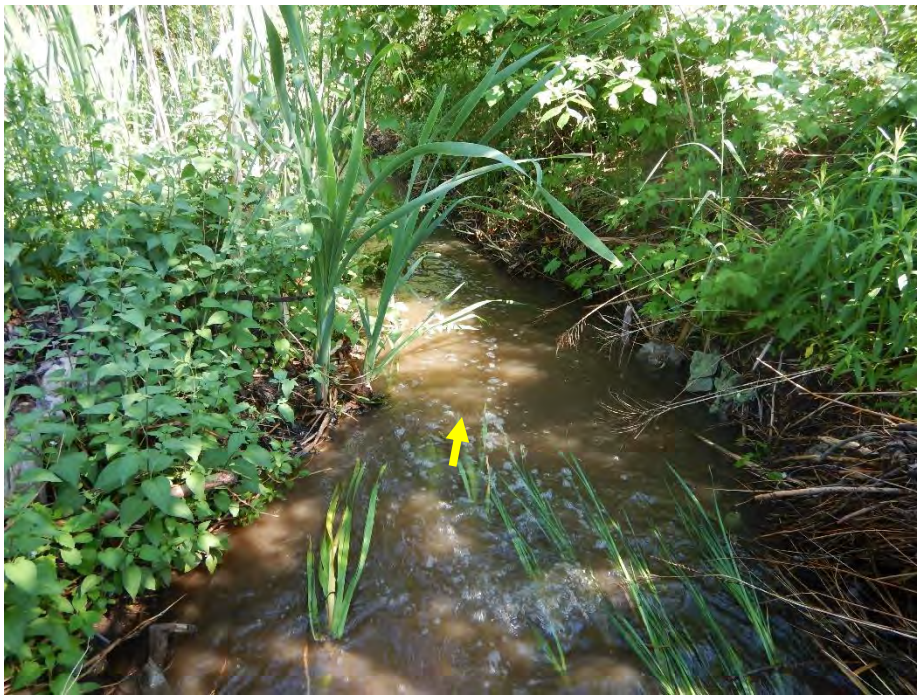
Photo 38  
Reach GO-1: 125 m north and south of Wyecroft Road

Downstream of Wyecroft Road, a continuous and narrow riparian buffer consisting of mature deciduous trees and herbaceous vegetation was present. The channel had a generally straight planform.

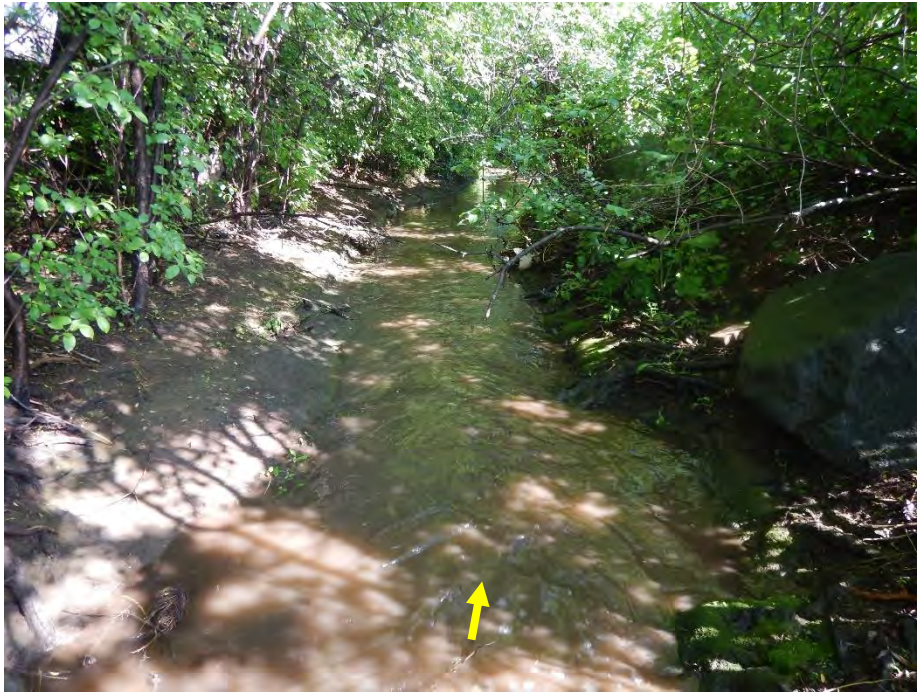
Photo 39  
Reach GO-1: 125 m north and south of Wycroft Road

Downstream of Wycroft Road, the channel bed was bedrock, and the banks had a low slope comprised of a silt and clay with willow rootlets.
