Re: #2266 Lakeshore Road W. and 83 East St. (Ward 1)

Arborist Report – Construction/Tree Protection

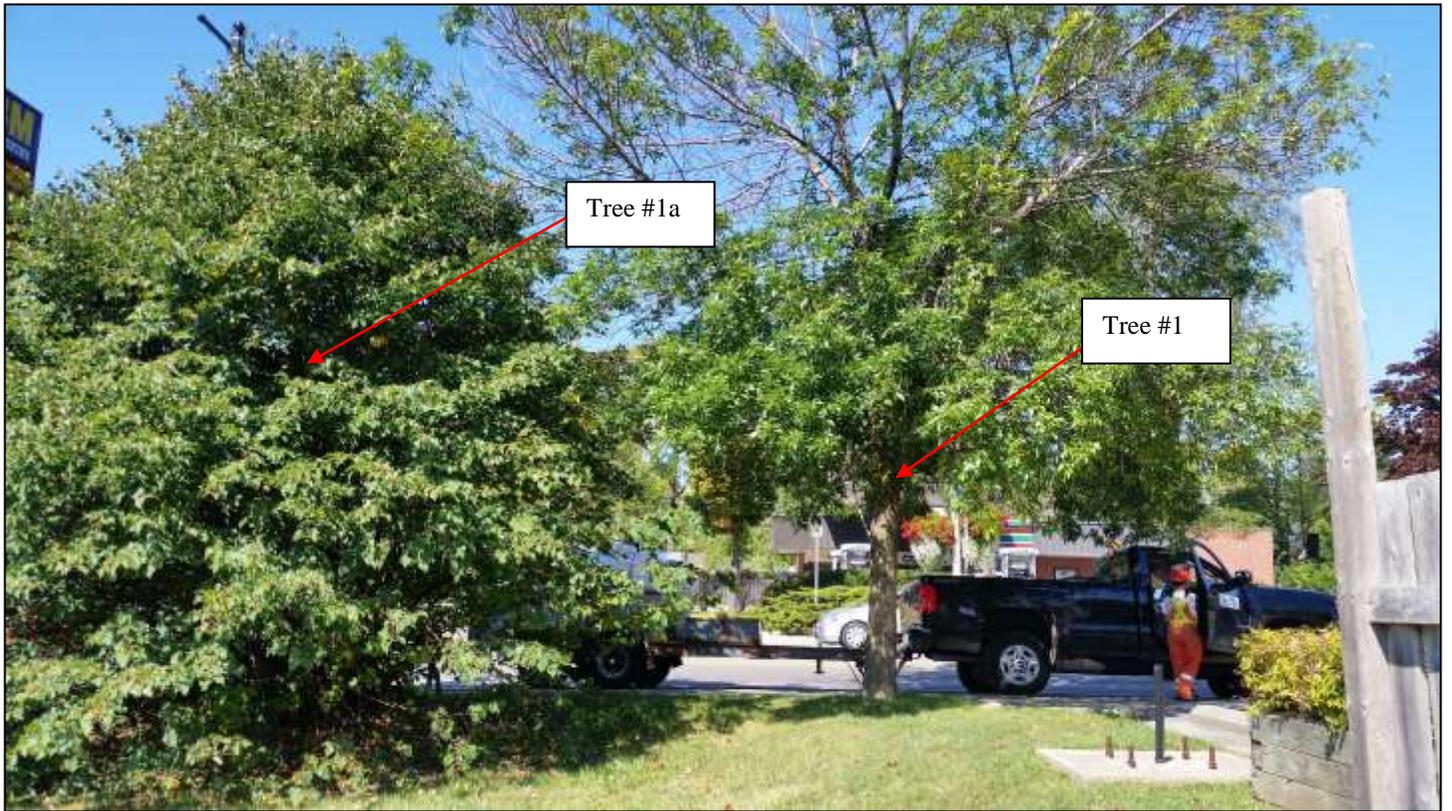
Photo 1: Trees #1a and 1.

Trees #1a, and 8 are located within the excavation footprint at 2266 Lakeshore Road West and 83 East Street, and will require removal. The subject trees are under 20cm in diameter, and are not protected under the Private Tree Bylaw.

Trees #1, 5, and 7 are located close to the construction footprint. Of these, trees #5 and 7 are located along the south property line of 2262 Lakeshore Road West. Trees #1 and 5 are located within the footprint of the proposed excavation area, and will require removal. These trees are in advanced stages of decline and are also recommended for removal on this basis.

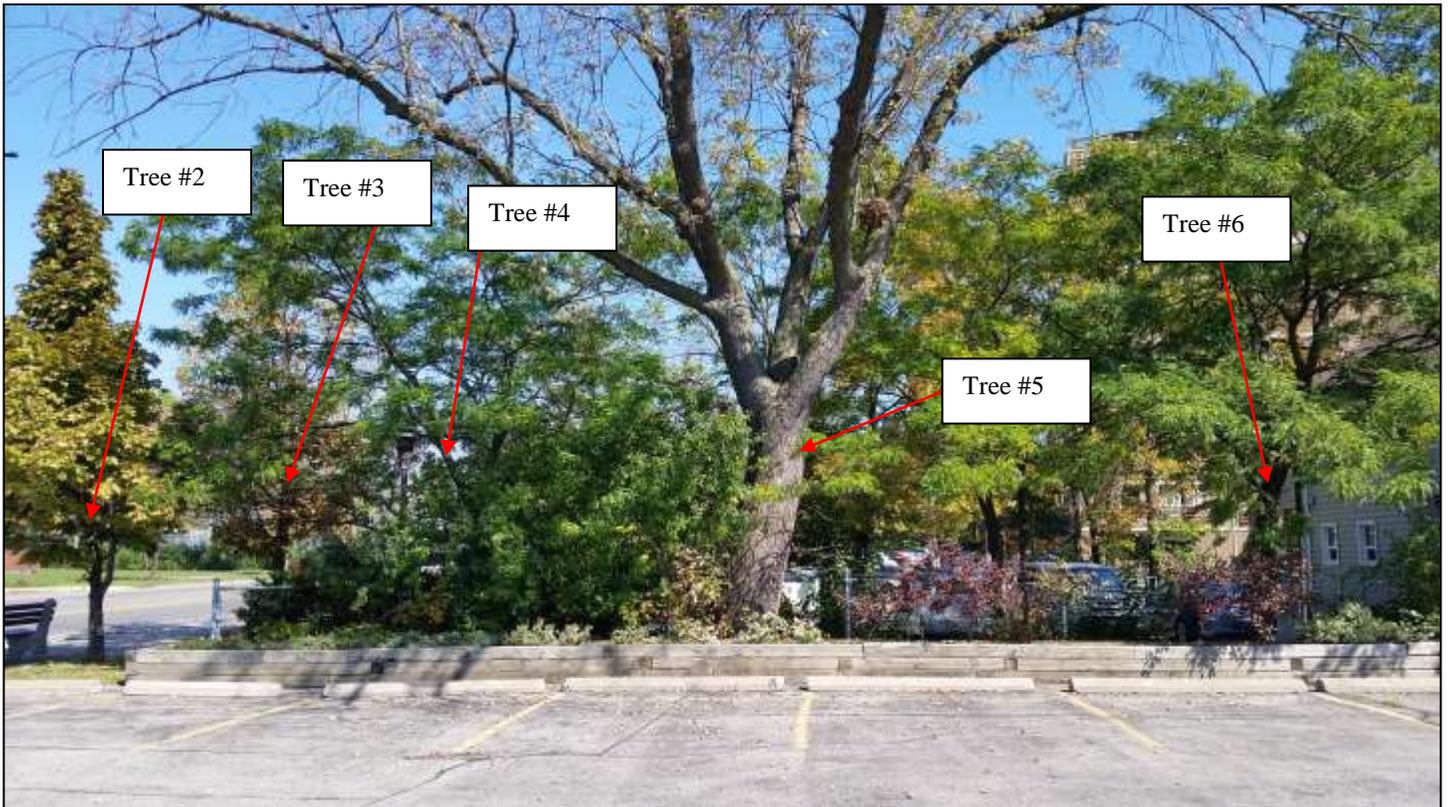
Photo 2: Trees #2 - 6.

Tree #2 is located on town property, at the northernmost corner of the property lines at 2266 Lakeshore Road West. The proposed excavation will encroach into the tree protection zone (TPZ), at 1.2m from the base of tree #2. It is expected that the subject tree will suffer some root loss due to the excavation. If the recommendations are adhered to, we expect the tree to tolerate the injury.

Tree #4 is located on the neighbouring property, at 2262 Lakeshore Road West. The proposed excavation will encroach into the tree protection zone (TPZ), at 1.6m from the base of tree #4. It is expected that the subject tree will suffer minor root loss due to the excavation. If the recommendations are adhered to, we expect the tree to tolerate the injury. In order to facilitate the construction, **tree #4 will require permission to be injured.**

Under the current plan, excavation work is required within the TPZ of trees #2 and 4. The following recommendations must be followed to minimize damage to the trees:

- A qualified arborist must be on site for the complete duration of each dig. It is the arborist duty to instruct the labourers, and minimize damage to the tree.
- The arborist is also responsible for all root pruning, and to promote 'working around' roots whenever possible.
- All excavation within the TPZ is to be done by hand in order to accurately locate roots.
- All excavation within the TPZ of a protected tree is to be documented; a report of the findings should then be submitted to the Forestry Department.
- Should the occasion arise, the onsite arborist must also determine if the impact is too great for the tree to be preserved the subject tree must then be considered for removal. Proper permit removal and replacement process must be followed in accordance with the Forestry Department standards.

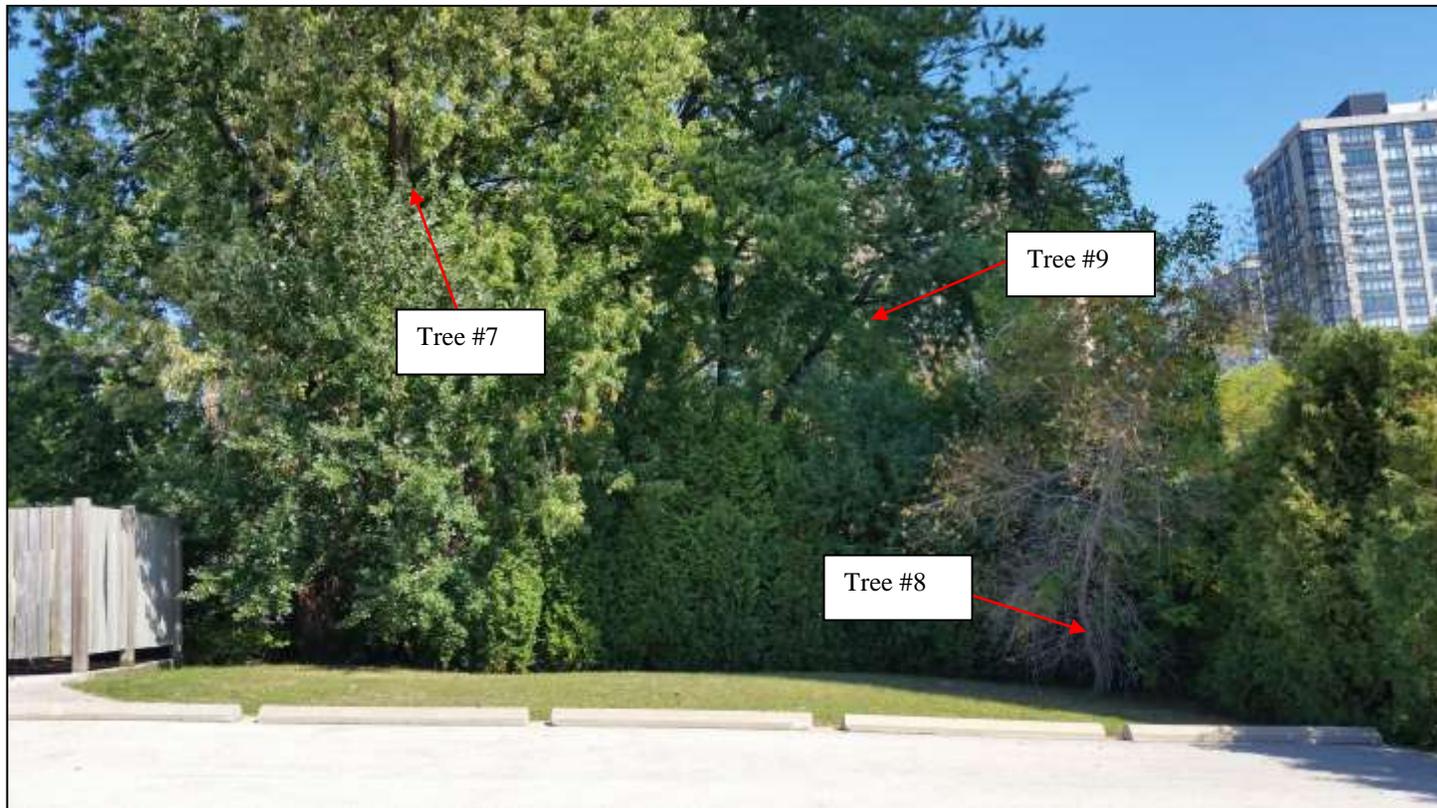
Photo 3: Trees #7 - 9.

8	Green Ash	<i>Fraxinus pennsylvanica</i>	Fair - Poor	Fair	8	1	1.8	Tree grows within the canopy of a dead willow tree, canopy is sparse.	Below the size of a protected tree; requires removal due to proposed development.
9	Silver Maple	<i>Acer saccharinum</i>	Fair	Fair	35, 40	3	2.4	Tree has branch failures due to ice storm. A leader has died back from one of the main stems, leaving a large cavity within. Some epicormic shoots grow along the main stems. Tree belongs to the neighbouring property of Lakeshore Rd W.	Outside of work area.

The excavation zone will encroach into the TPZ of tree #7 up to the base, which will cause destabilization from the root zone. It is expected that tree #7 will suffer intolerable root loss and is recommended for removal. **Trees #1, 5, and 7 will require removal due to the proposed excavation.**

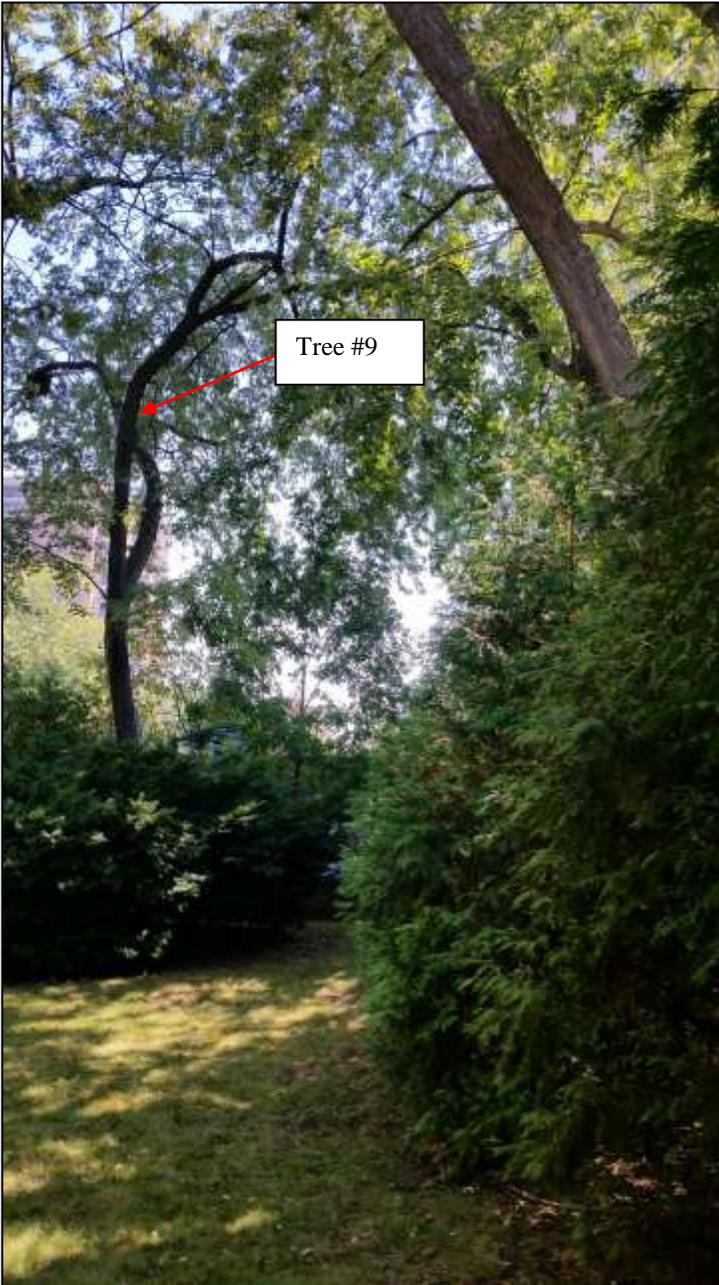
Photos 4 and 5: (Left) Alternate angle of tree #9. (Right) Tree #5, showing severe decline in the canopy.
