December 04, 2017

ARBORIST REPORT

3171 Lakeshore Rd West (Cudmore's Nursery Site), Oakville, Ontario

MHBC File: 11161E

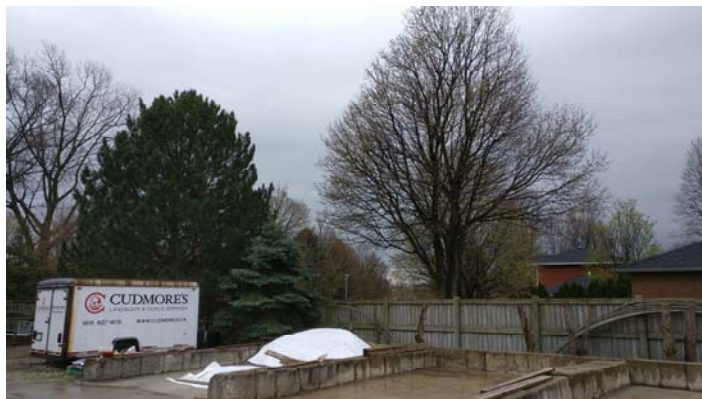
Trees 658,659,0.1 looking South West.

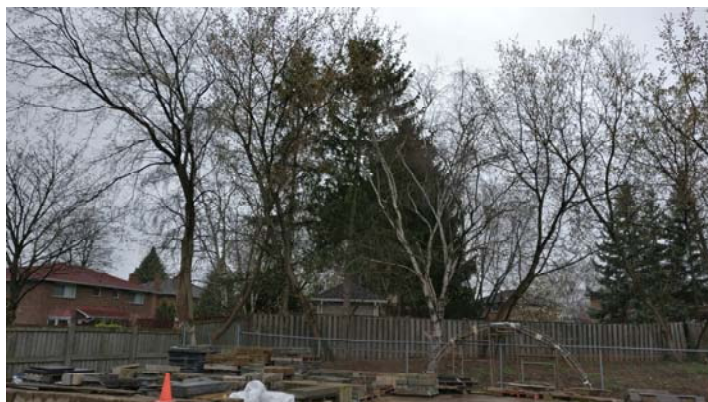
Trees 907 through 911 looking West.

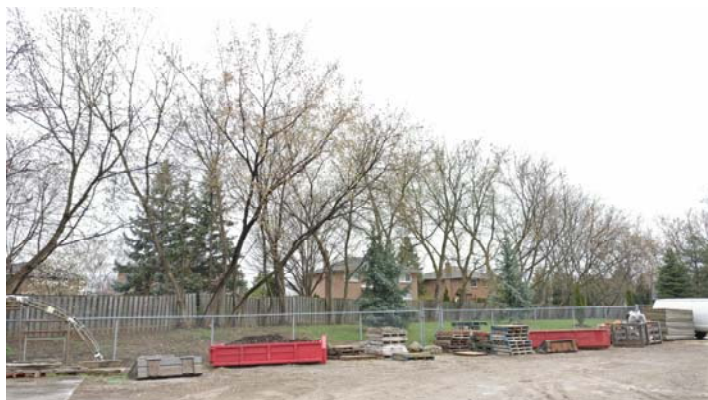
Trees 911 through 939, 955 through 959 looking North West.

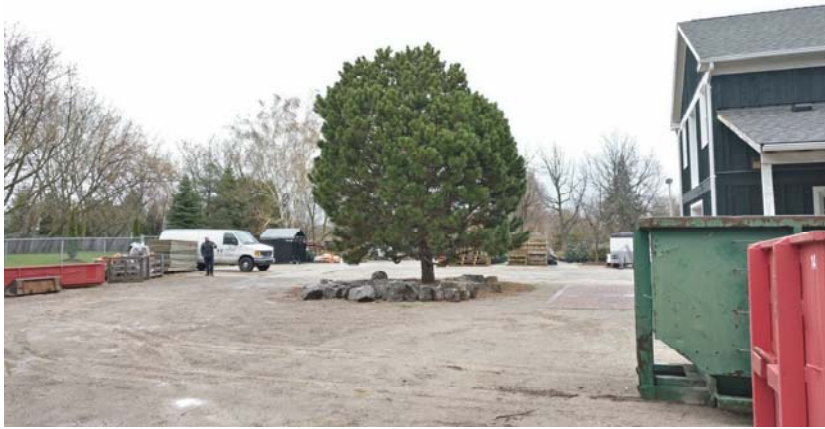
Tree 660 looking North.

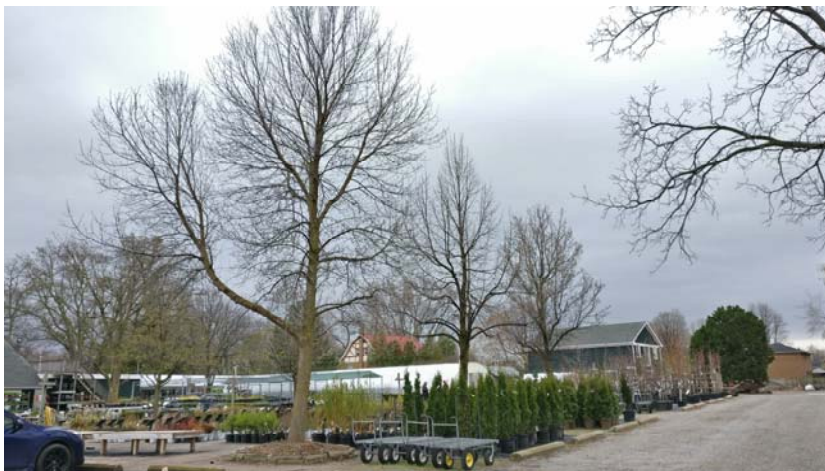
Trees 665 through 667 looking South.

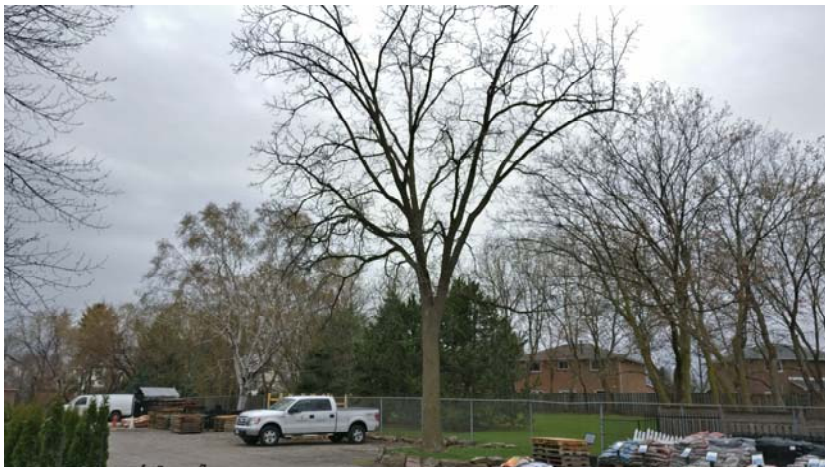
Trees 950 through 959, 661 looking South West.

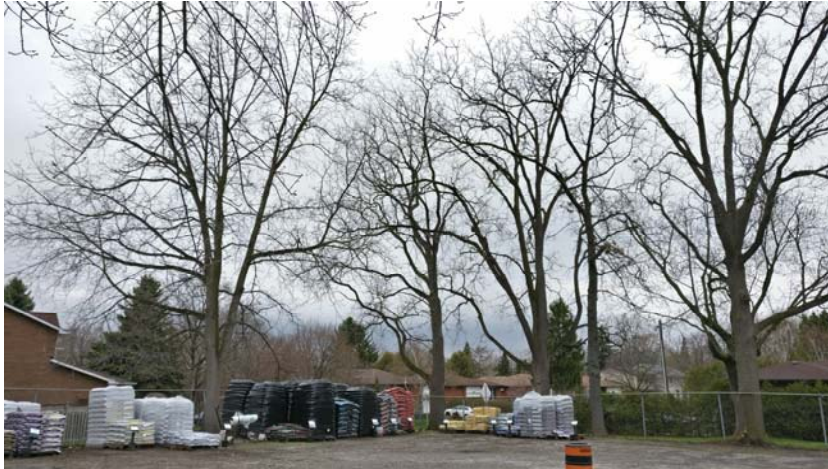
Trees 943 through 947 looking North East.

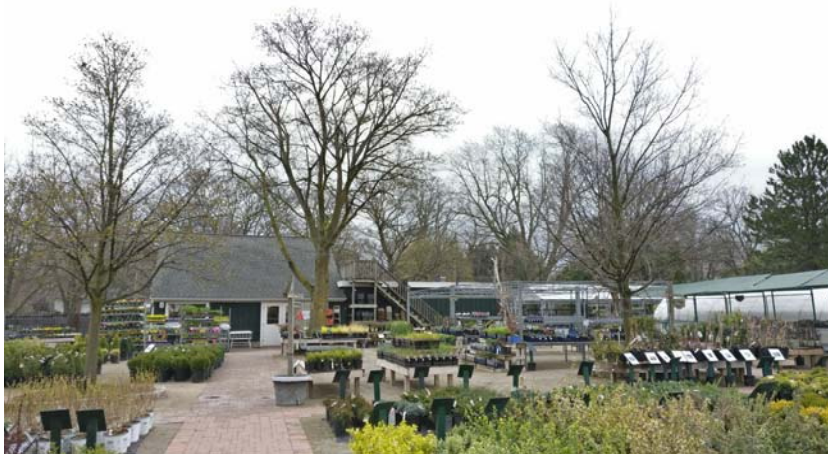
Trees 668 through 670 looking East.

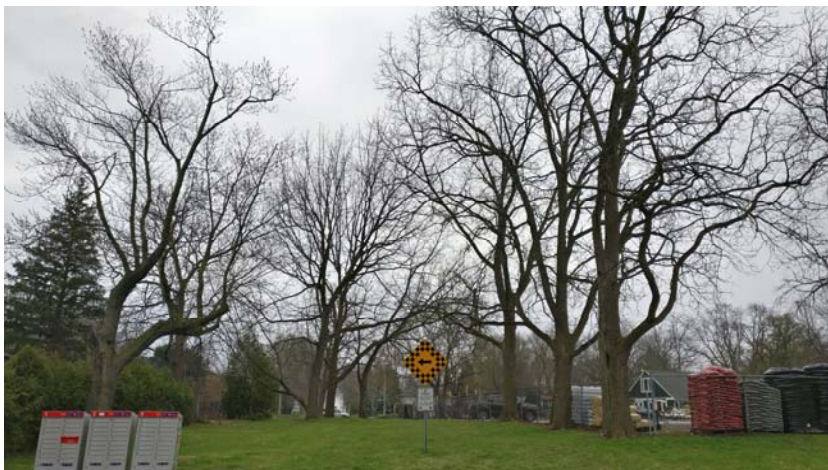
Trees 960 through 964, 697 through 700, 664 looking East.

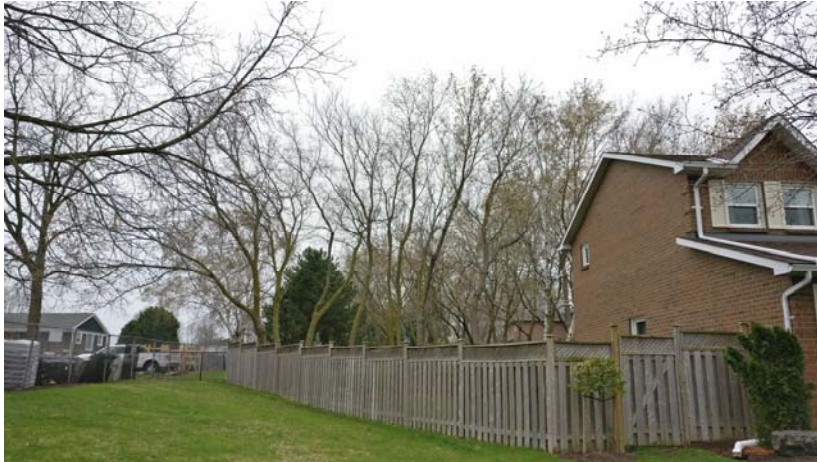
Trees 949 through 954 looking South.

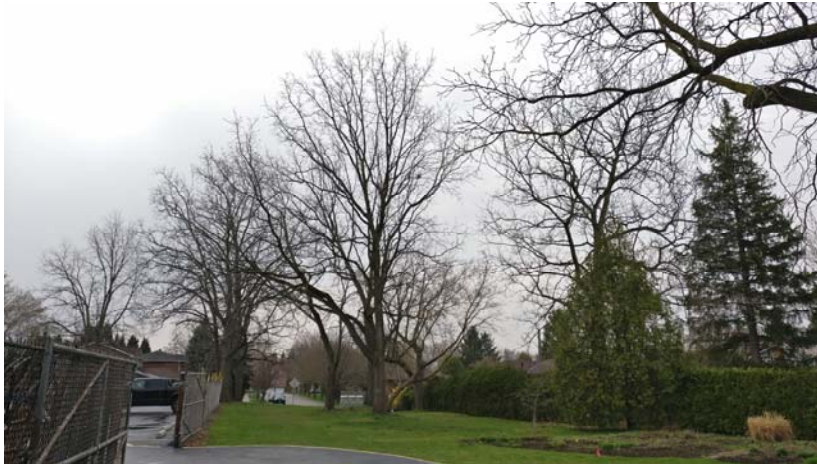
Trees 697 through 700, 960 through 964, 664 looking West.

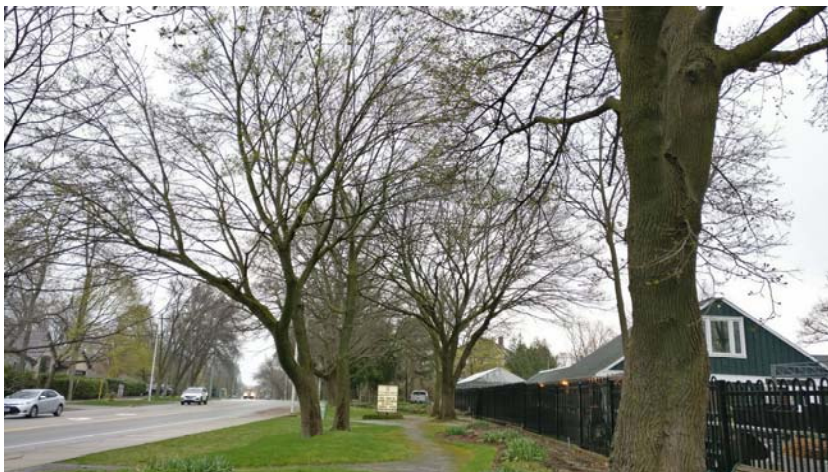
Trees 695 through 690 looking South.
