Conceptual Channel Design and Erosion Assessment Bronte River Limited Partnership (BRLP) Property Town of Oakville, Ontario

March 2023 PN23026

Report Title: Conceptual Channel Design and Erosion Assessment

Project Number: PN23026

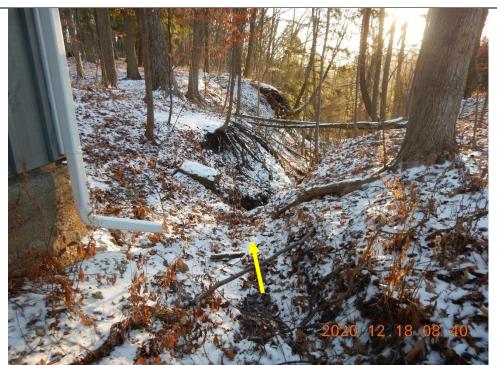
Ravine flows south between valley walls. Note exposed building foundation.

Valley wall contact on both banks of the channel. Bed substrate ranged from gravel to large cobble.

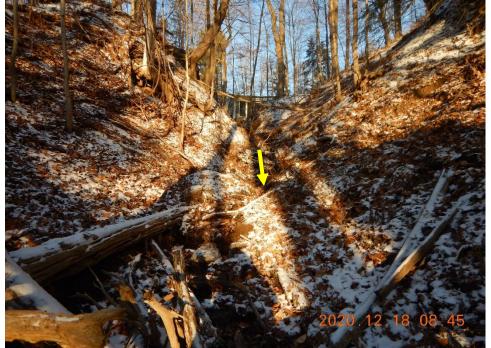
Ravine feature was straight with a steep gradient. Note small outbuilding at the top of slope.

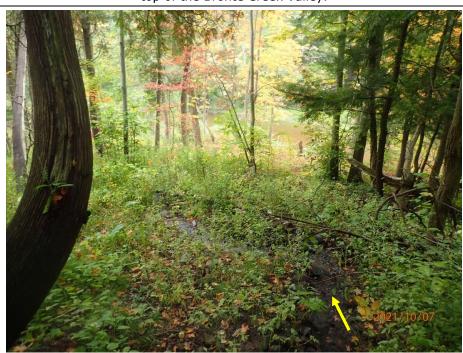
Photo 20 Proposed Outlet Location B

Secondary outlet location option at the upper extent of the alluvial fan. Bank protection is reduced and less stable, and impact to tree cover impact is increased. Significant flooding and erosion hazards are also presented from Bronte Creek.

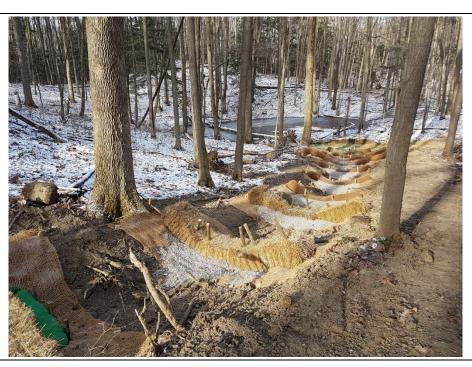
Photo 1

Gully erosion mitigation using a combination of materials including straw bales, coir logs, silt sock, 100% biodegradable erosion control blanket and pea gravel (provided as an alternative approach).

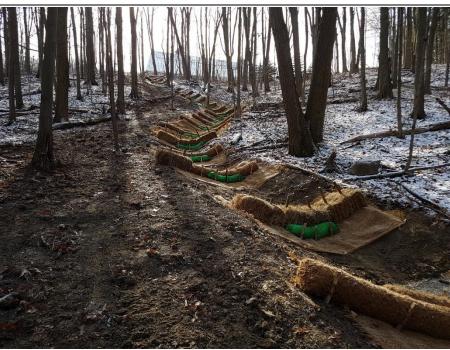
Photo 2

Gully erosion mitigation using a combination of materials including straw bales, coir logs, silt sock, 100% biodegradable erosion control blanket and pea gravel (provided as an alternative approach).

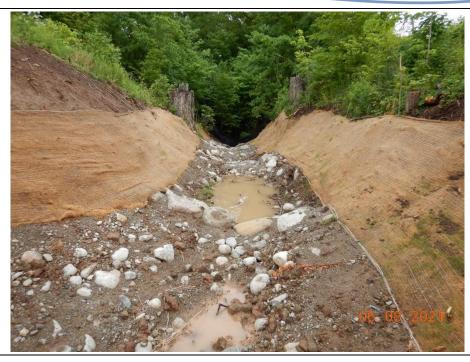
SWM Pond outlet within a natural gully feature using a rock weir and cascade bed treatment (this treatment is more extensive than proposed in this project).
