August 6, 2025

ARBORIST REPORT  
1493 Sixth Line, Oakville, Ontario

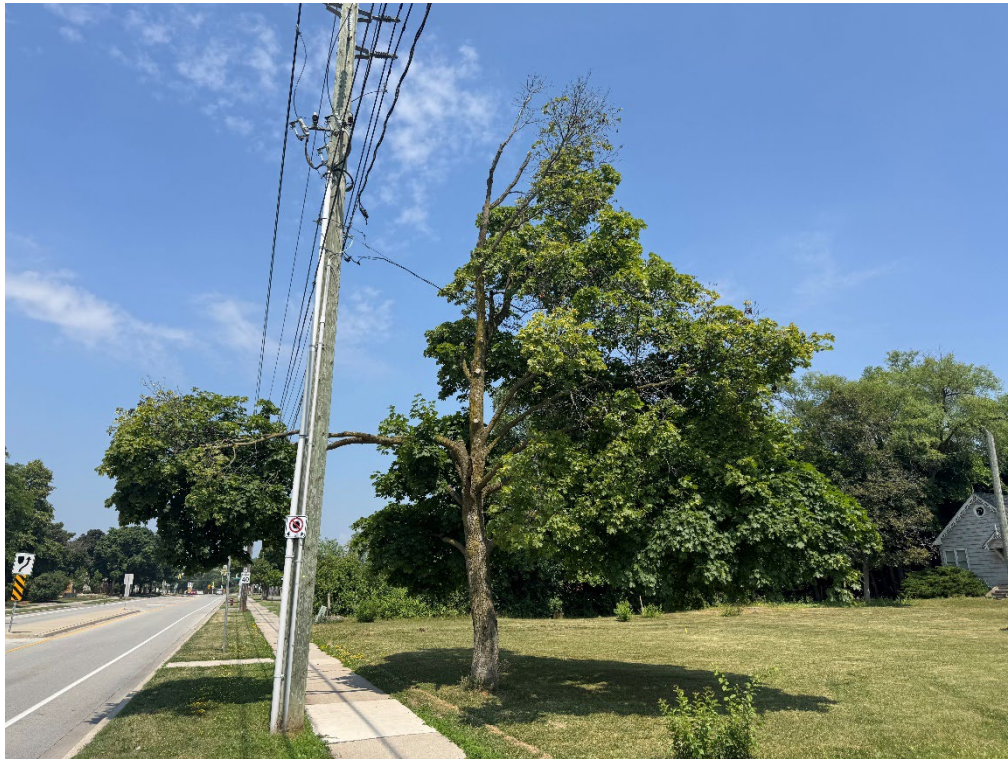
Tree 601

Tree No.	Owner	Common Name	Botanical Name	DBH (CM)	Min. TPZ Radius (M)	Cond.	Structure	Canopy Diameter (M)	Comments	Recommendation
601	Private	Norway Maple	Acer platanoides	37	3.0	F/P	P	12	Minor deadwood throughout, imbalanced canopy, growing in overhead wires, main leader is dead at top, heavily pruned previously	Remove due to construction
602	Neighbour/Boundary	Siberian Elm	Ulmus pumila	36	3.0	F	F	8	Multi-stem, growing through wire fence	Retain
603	Neighbour	Norway Maple	Acer platanoides	26	2.4	F	F	7	Growing through wire fence, minor deadwood throughout	Retain
604	Neighbour	Norway Maple	Acer platanoides	27	2.4	F	F	9		Retain
605	Neighbour	Norway Maple	Acer platanoides	30	2.4	F	F	8		Retain
606	Neighbour	Norway Maple	Acer platanoides	23	2.4	F	F	6	Mild lean away from subject site, imbalanced canopy with majority of limbs on northern side of tree	Retain
607	Neighbour/Boundary	Norway Maple	Acer platanoides	17	2.4	F	F	8	Growing through wire fence	Retain

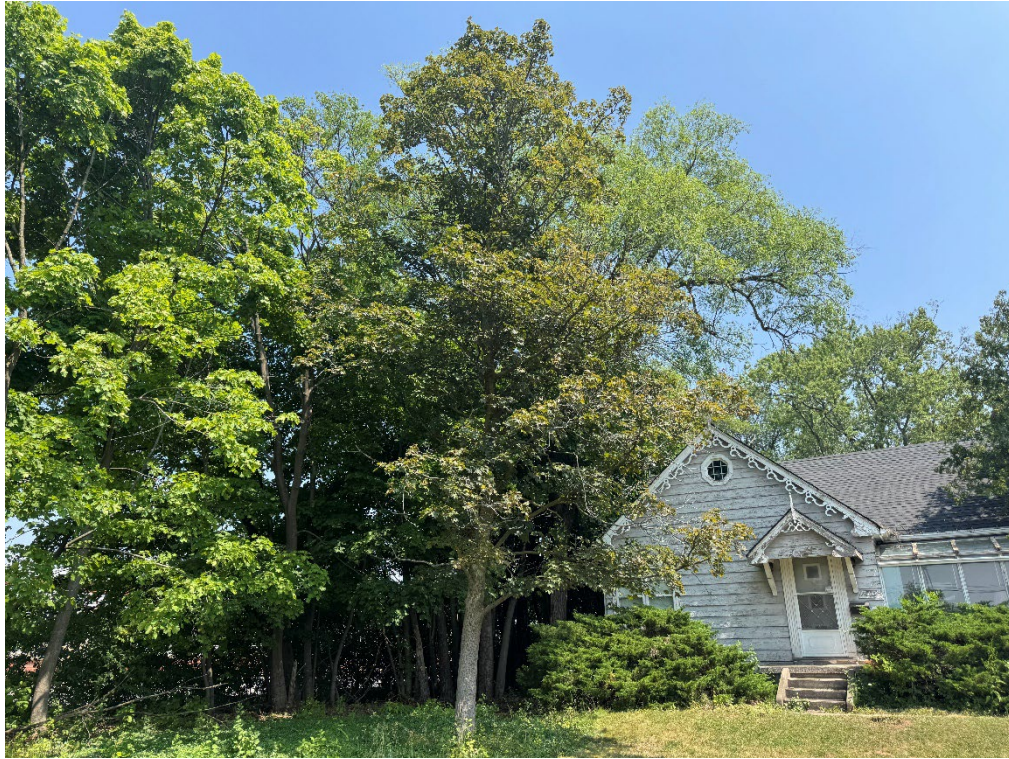
Tree 610

608	Neighbour/Boundary	Norway Maple	Acer platanoides	29	2.4	F/P	F/P	14	3 stem at 0.8 metres, moderate deadwood throughout	Retain
609	Neighbour/Boundary	Norway Maple	Acer platanoides	21	2.4	F	F	8	Elevated canopy	Retain
610	Private	Norway Maple	Acer platanoides	28	2.4	F/P	F/P	8	Moderate deadwood throughout, tree is in decline, mildew disease evident	Remove due to construction
611	Private	Cedar Sp.	Thuja Sp.	26	2.4	F	F	5		Remove due to construction
612	Private	Cedar Sp.	Thuja Sp.	27	2.4	F	F	6	Multi-stem	Remove due to construction
613	Neighbour	Norway Maple	Acer platanoides	33	3.0	F	F	16	3 stem at base, minor deadwood throughout	Retain
614	Neighbour	Norway Maple	Acer platanoides	18	2.4	F/P	F/P	8	Imbalanced canopy with majority of limbs on northern side of tree, cavity at 2.5 metres with signs of internal rot evident	Retain
615	Private	Siberian Elm	Ulmus pumila	27	2.4	F/P	F/P	4	Mild lean, elevated canopy, minor deadwood throughout	Retain

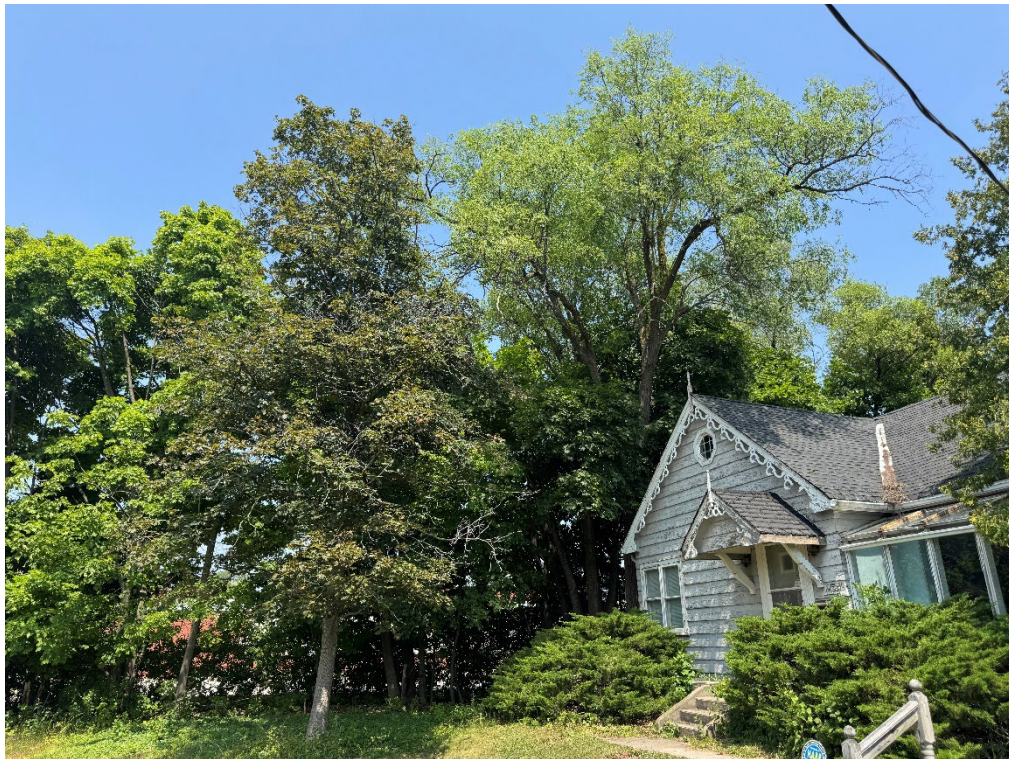
Trees 610, 613 – 618

616	Private	Siberian Elm	Ulmus pumila	47	3.0	F	F	18	2 stem at 0.9 metres, one main limb with mild to moderate lean	Remove due to construction
617	Private	Norway Maple	Acer platanoides	20	2.4	F	F/P	9	Minor to moderate deadwood throughout, moderate lean	Remove due to construction
618	Private	Siberian Elm	Ulmus pumila	47	3.0	F	F	16	Minor deadwood throughout	Remove due to construction
619	Private	Siberian Elm	Ulmus pumila	27	2.4	D	-	-	Tree is 100% dead	Remove due to condition
620	Private	Siberian Elm	Ulmus pumila	23	2.4	F	F	5	Moderate lean away from subject site	Retain

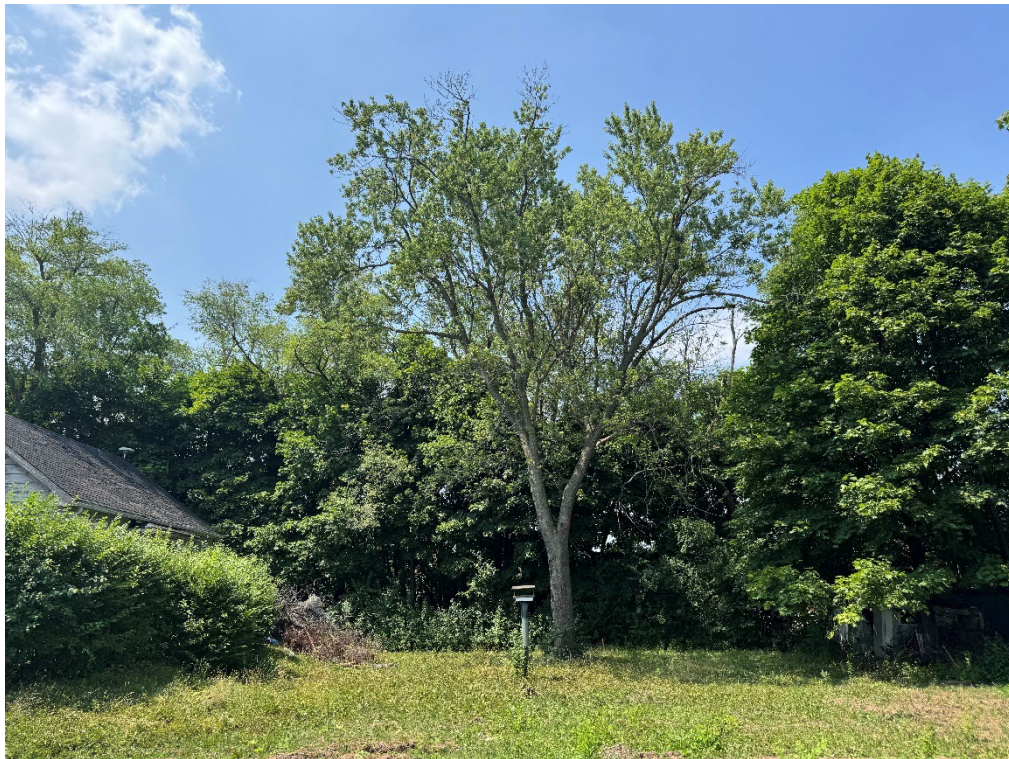
Tree 619 – 648, 660

621	Private	Siberian Elm	Ulmus pumila	33	3.0	P/D	P	4	2 stem at 1.3 metres, one stem dead, one stem 85% dead, significant deadwood throughout	Remove due to condition
622	Private	Siberian Elm	Ulmus pumila	18	2.4	P/D	P	2	Tree is 95% dead	Remove due to condition
623	Private	Norway Maple	Acer platanoides	21	2.4	F	F/P	7	Elevated canopy, moderate deadwood throughout	Retain
624	Private	Norway Maple	Acer platanoides	15	2.4	P	P	4	Significant deadwood throughout, tree is in decline	Retain
625	Private	Siberian Elm	Ulmus pumila	30	2.4	F	F	8	2 stem at 0.7 metres	Retain
626	Private	Siberian Elm	Ulmus pumila	46	3.0	F	F	10	Moderate lean away from subject site	Retain
627	Private	Siberian Elm	Ulmus pumila	34	3.0	F	F/P	8	One stem previously cut at 1.2 metres, moderate lean away from subject site, multiple bows throughout	Retain
628	Private	Siberian Elm	Ulmus pumila	31	3.0	F	F	10	Minor to moderate deadwood throughout	Retain

629	Private	Norway Maple	Acer platanoides	15	2.4	F	F/P	8	Moderate deadwood throughout	Retain
630	Private	Siberian Elm	Ulmus pumila	21	2.4	F	F	5	Moderate lean away from subject site	Retain
631	Private	Siberian Elm	Ulmus pumila	24	2.4	D	-	-	Tree is 100% dead	Remove due to condition
632	Private	Norway Maple	Acer platanoides	21	2.4	F/P	F/P	6	Moderate to significant deadwood throughout, elevated canopy	Retain
633	Private	Siberian Elm	Ulmus pumila	39	3.0	F	F	10	2 stem at base, smaller stem with significant lean into subject site	Retain
634	Private	Siberian Elm	Ulmus pumila	17	2.4	D	P		Tree is 98% dead, significant deadwood throughout	Remove due to condition

635	Private	Norway Maple	Acer platanoides	18	2.4	F	F/P	7	Moderate deadwood throughout, elevated canopy	Retain
636	Private	Siberian Elm	Ulmus pumila	29	2.4	F/P	P	10	2 stem at 1.1 metres, one of two stems is dead	Retain
637	Private	Norway Maple	Acer platanoides	20	2.4	F	F	7	Minor deadwood throughout, mild lean into subject site	Retain
638	Private/Boundary	Siberian Elm	Ulmus pumila	51	3.6	F	F	15		Retain
639	Private	Siberian Elm	Ulmus pumila	19	2.4	D	-	-	Tree is 100% dead	Remove due to condition
640	Private	Siberian Elm	Ulmus pumila	22	2.4	P/D	P	4	2 stem at 0.5 metres, one stem dead	Retain
641	Neighbour	Norway Maple	Acer platanoides	21	2.4	F	F/P	8	Moderate deadwood throughout, moderate lean away from subject site	Retain
642	Neighbour	Norway Maple	Acer platanoides	18	2.4	F	F	9	Minor deadwood throughout	Retain
643	Neighbour	Norway Maple	Acer platanoides	25	2.4	F	F	11	Minor deadwood throughout	Retain
644	Neighbour/Boundary	Siberian Elm	Ulmus pumila	24	2.4	D	-	-	Tree is 100% dead	Remove due to condition

645	Neighbour	Siberian Elm	Ulmus pumila	44	3.0	D	-	-	Tree is 100% dead	Remove due to condition
646	Neighbour/Boundary	Siberian Elm	Ulmus pumila	27	2.4	F	P	6	Significant bow at 7.0 metres into subject site	Retain
647	Neighbour	Norway Maple	Acer platanoides	43	3.0	F	F	15	Minor deadwood throughout	Retain
648	Private	Norway Maple	Acer platanoides	20	2.4	F	F	6		Remove due to construction
649	Private	Siberian Elm	Ulmus pumila	69	4.2	F	F	23	Minor deadwood throughout	Remove due to construction
650	Private	Siberian Elm	Ulmus pumila	25	2.4	F	F	9		Remove due to construction
651	Private	Norway Maple	Acer platanoides	35	3.0	F	F	17		Remove due to construction
652	Private	Norway Maple	Acer platanoides	17	2.4	F	F	6	Minor deadwood throughout	Remove due to construction

660	Private	Silver Maple	Acer saccharinum	60	3.6	F/P	F	14	Moderate deadwood throughout	Remove due to construction
661	Private	Norway Maple	Acer platanoides	18	2.4	P	P	3	Top of tree is dead, suckers throughout	Remove due to condition
662	Private	Basswood	Tilia americana	22	2.4	F	F	5	Minor deadwood throughout	Remove due to construction
663	Private	Norway Maple	Acer platanoides	50	3.0	F/P	P	8	Significant wound at 5.0 metres, suckers throughout, internal rot evident	Remove due to construction
664	Private	Elm Sp.	Ulmus Sp.	18	2.4	D	-	-	Tree is 100% dead	Remove due to construction
665	Private	Norway Maple	Acer platanoides	32	3.0	F	F	16	2 stem at 0.8 metres	Remove due to construction
666	Private	Norway Maple	Acer platanoides	33	3.0	F	F	14	Minor deadwood throughout	Remove due to construction
667	Private	Norway Maple	Acer platanoides	23	2.4	F	F	11	Mild lean, minor deadwood throughout	Remove due to construction

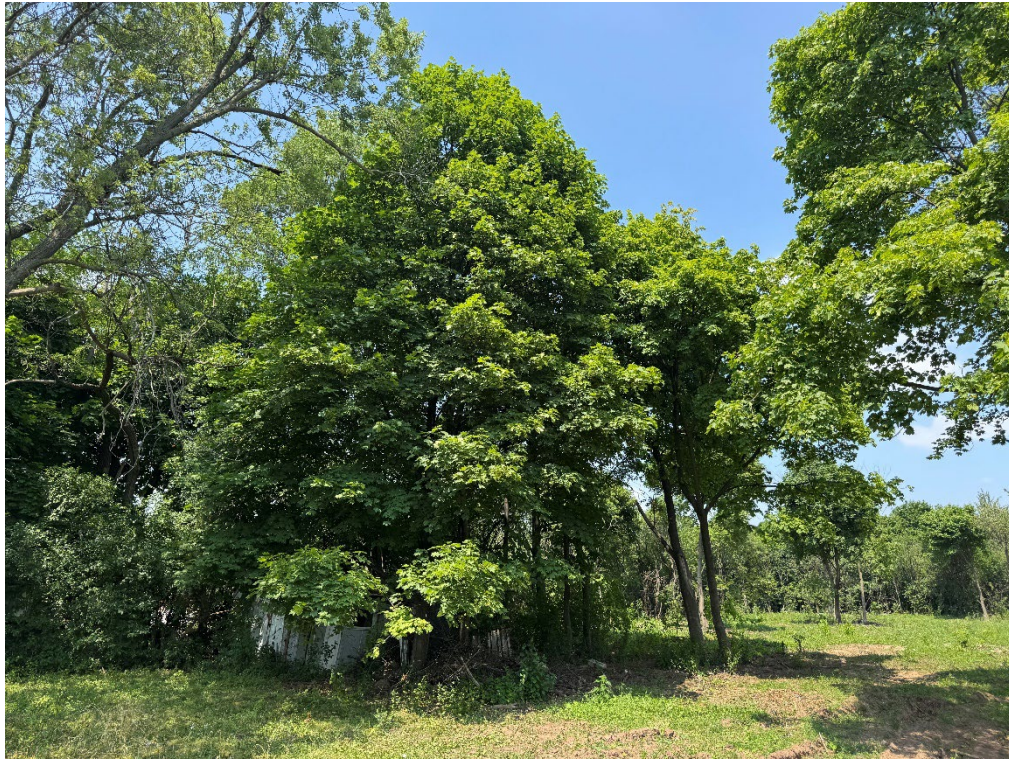
Trees 649 – 659

653	Private	Norway Maple	Acer platanoides	16	2.4	P	P	6	Moderate to significant deadwood throughout, signs of internal rot, tree is in decline	Remove due to construction
654	Private	Norway Maple	Acer platanoides	21	2.4	F	F	9	Minor deadwood throughout	Remove due to construction
655	Private	Norway Maple	Acer platanoides	17	2.4	F/P	F/P	6	Bow at base, suckers from 2 - 7 metres, minor deadwood throughout, elevated canopy	Remove due to construction
656	Private	Norway Maple	Acer platanoides	21	2.4	F	F	8		Remove due to construction
657	Private	Norway Maple	Acer platanoides	37	3.0	P	F/P	13	Cavity on south side of tree at 2.0 metres with evident internal rot, mild lean, minor deadwood throughout	Remove due to construction
658	Private	Norway Maple	Acer platanoides	27	2.4	F	F	14	Mild lean	Remove due to construction
659	Private	Norway Maple	Acer platanoides	32	3.0	F	F	12	Minor deadwood throughout	Remove due to construction

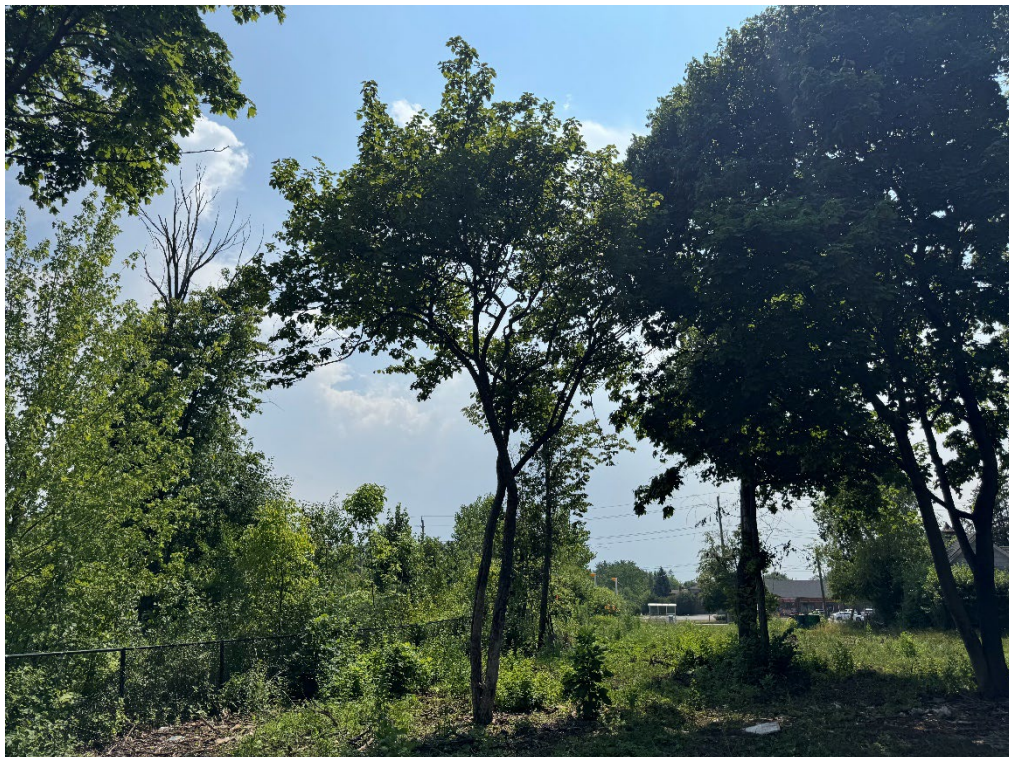
Tree 668

668	Private	Elm Sp.	Ulmus Sp.	19	2.4	F	F	10	2 stem at 0.4 metres, vertical cavity from 1 - 3 metres on southern stem	Remove due to construction
669	Private	Norway Maple	Acer platanoides	33	3.0	F/G	F	8		Remove due to construction
670	Private	Cherry Sp.	Prunus Sp.	24	2.4	F/P	F	5	Minor deadwood throughout	Remove due to construction
671	Private	Norway Maple	Acer platanoides	27	2.4	F	F	9	Minor deadwood throughout	Remove due to construction
672	Private	Cherry Sp.	Prunus Sp.	29	2.4	F/P	F	7	Moderate deadwood throughout	Remove due to construction
673	Private	Cherry Sp.	Prunus Sp.	24	2.4	F/P	F	8	Moderate deadwood throughout	Remove due to construction
674	Private	Cherry Sp.	Prunus Sp.	22	2.4	F/P	F	7	Minor deadwood throughout	Remove due to construction
675	Private	Elm Sp.	Ulmus Sp.	25	2.4	D	-	-	Tree is 100% dead	Remove due to construction
676	Private	Cherry Sp.	Prunus Sp.	20	2.4	F	F	5	Minor deadwood throughout	Remove due to construction

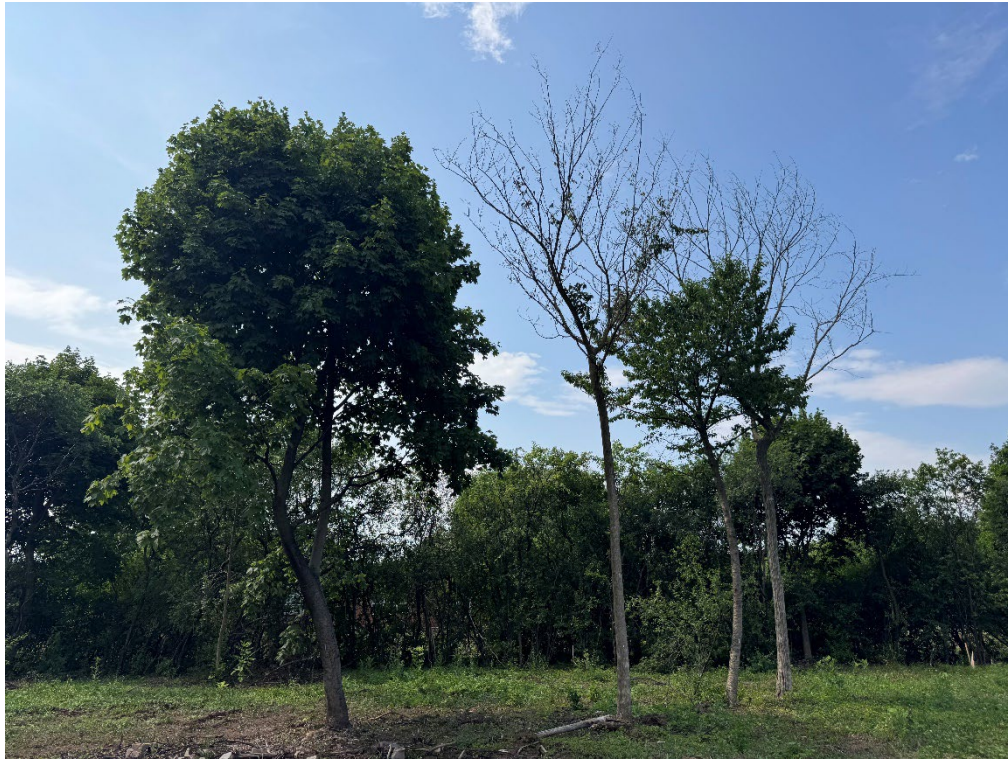
Trees 675 – 678

677	Private	Elm Sp.	Ulmus Sp.	19	2.4	P/D	P	2	Significant deadwood throughout, tree is 95% dead	Remove due to construction
678	Private	Norway Maple	Acer platanoides	29	2.4	F	F	8		Remove due to construction
679	Private	Common Buckthorn	Rhamnus cathartica	18	2.4	F/P	F/P	4	Moderate deadwood throughout	Remove due to construction
680	Private	Cherry Sp.	Prunus Sp.	28	2.4	F	F	7		Remove due to construction
681	Boundary	Norway Maple	Acer platanoides	25	2.4	F	F	9	Mild lean away from subject site, minor deadwood throughout	Remove due to construction
682	Private	Norway Maple	Acer platanoides	17	2.4	F	F	4		Retain
683	Neighbour	Norway Maple	Acer platanoides	20	2.4	F	F/P	6	Vertical wound from base to 3.0 metres callousing over, minor deadwood throughout	Retain
684	Boundary	Norway Maple	Acer platanoides	27	2.4	F	F	8	Minor deadwood throughout	Retain

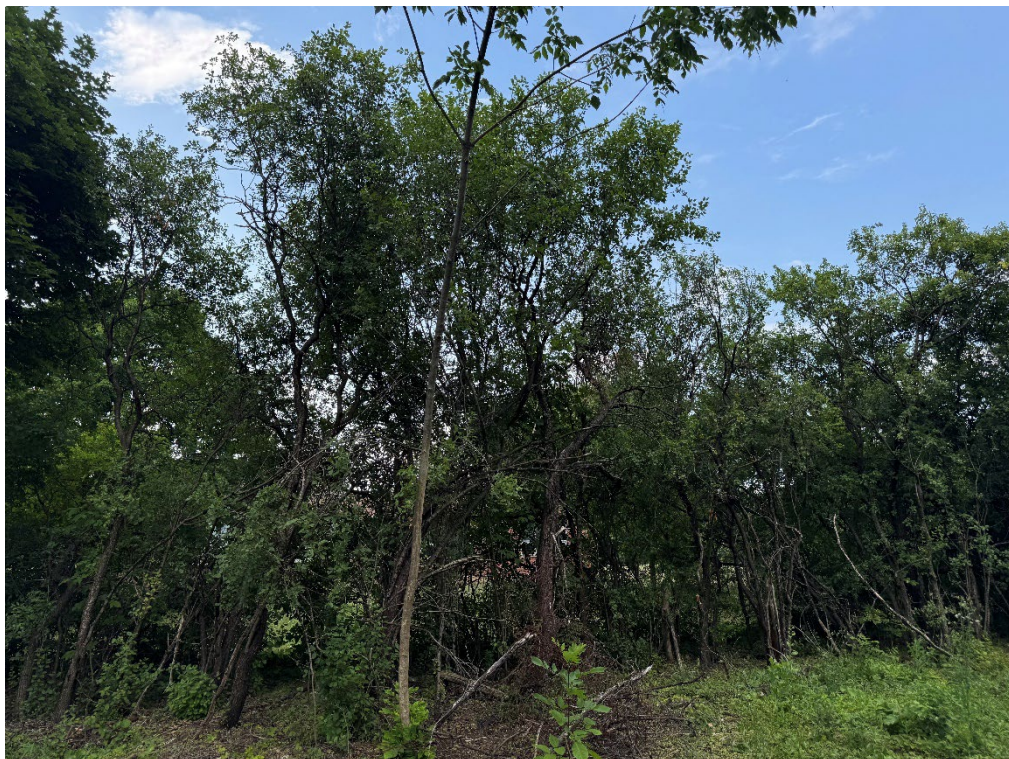
Trees 685, 686

685	Private	Common Buckthorn	Rhamnus cathartica	19	2.4	P	P	8	Significant deadwood throughout	Remove due to construction
686	Private	Common Buckthorn	Rhamnus cathartica	17	2.4	F/P	F/P	7	Moderate to significant lean, moderate deadwood throughout	Remove due to construction
687	Neighbour/Boundary	Norway Maple	Acer platanoides	28	2.4	F	F	8		Remove due to construction
688	Private	Norway Maple	Acer platanoides	26	2.4	F	F	8		Remove due to construction
O1	Municipal Parkland	Norway Maple	Acer platanoides	24	2.4	F	F	12	Growing through chain link fence	Retain
O2	Municipal Parkland	Norway Maple	Acer platanoides	19	2.4	F	F/P	13	2 stem at base, minor deadwood throughout, contorted stems	Retain
O3	Municipal Parkland	Manitoba Maple	Acer negundo	28	2.4	F	F	9	Bow in trunk, minor deadwood throughout	Retain
O4	Municipal Parkland	Common Buckthorn	Rhamnus cathartica	32	3.0	P/D	P	10	Water shoots throughout, significant deadwood throughout, tree is 85% dead	Retain
