# **Geotechnical Slope Stability Hazard and Risk Assessment - Desktop Study & Site Inspection Report**

**East Morrison Creek Erosion Mitigation Study  
Town of Oakville, Ontario**

**Client:** Matrix Solutions Inc.

**Date:** April 11, 2025

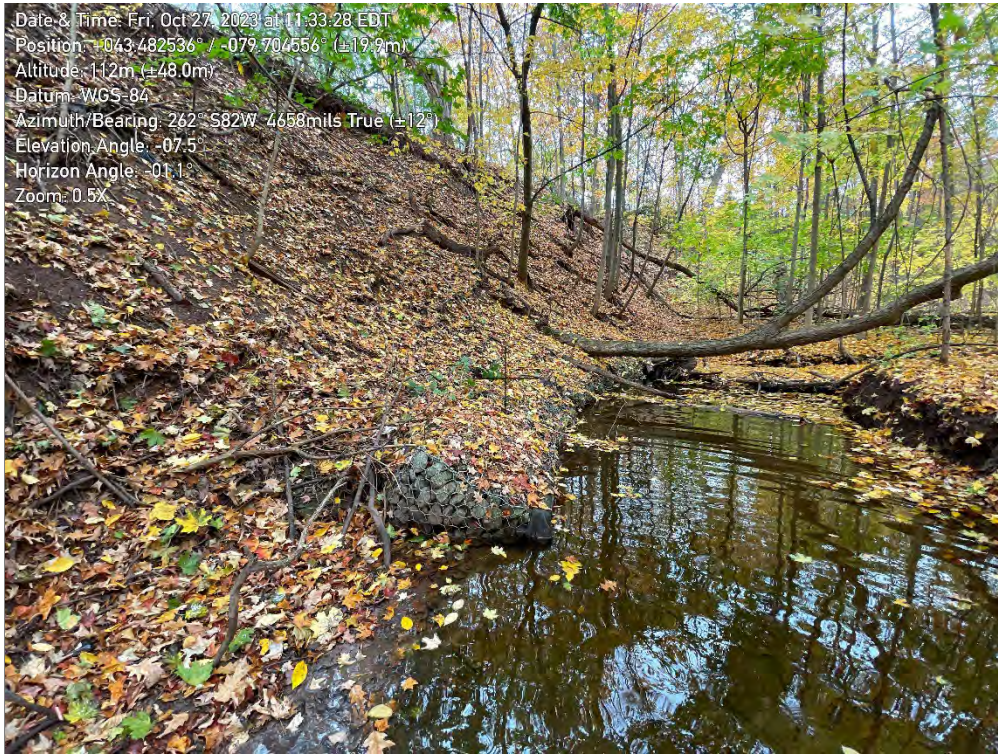
While creek erosion mitigation structures such as gabion baskets and rip rap were observed to be installed in the Study Area, the gabion baskets have failed by overturning and bursting in zones A22 and B13 (see photographs 1 and 2 respectively, in Appendix C). Generally, the toe erosion mitigation measures were observed to be intact and functional across the Study Area, although locally, the creek is undercutting the gabion baskets, such as in zone A19 and B17 (see photographs 3 and 4 respectively, in Appendix C). Culverts that drain into the valley were also observed in the Study Area. Those with greater flow volume tended to exhibit greater signs of erosion along the creek and outflow banks. Specifically, the culvert outlet in zone A7 (previous

Photo 1. View of failed gabion baskets in Zone A22-1 of the East Morrison Creek, looking Southwest.

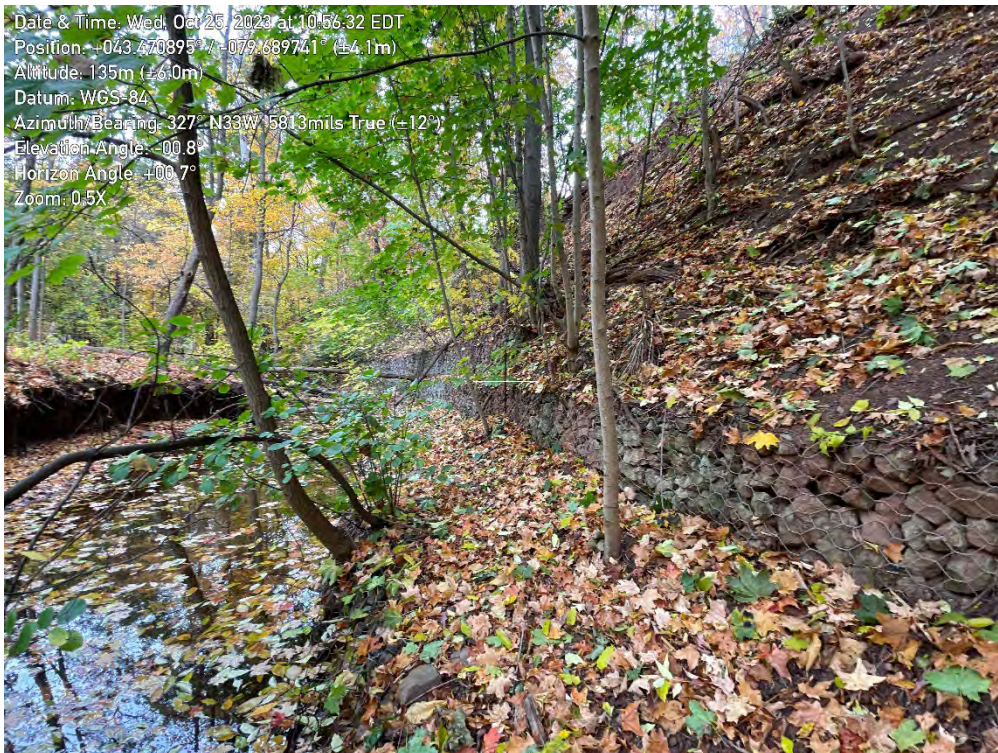
Photo 2. View of failed gabion baskets in Zone B13 of the East Morrison Creek, looking Northwest.

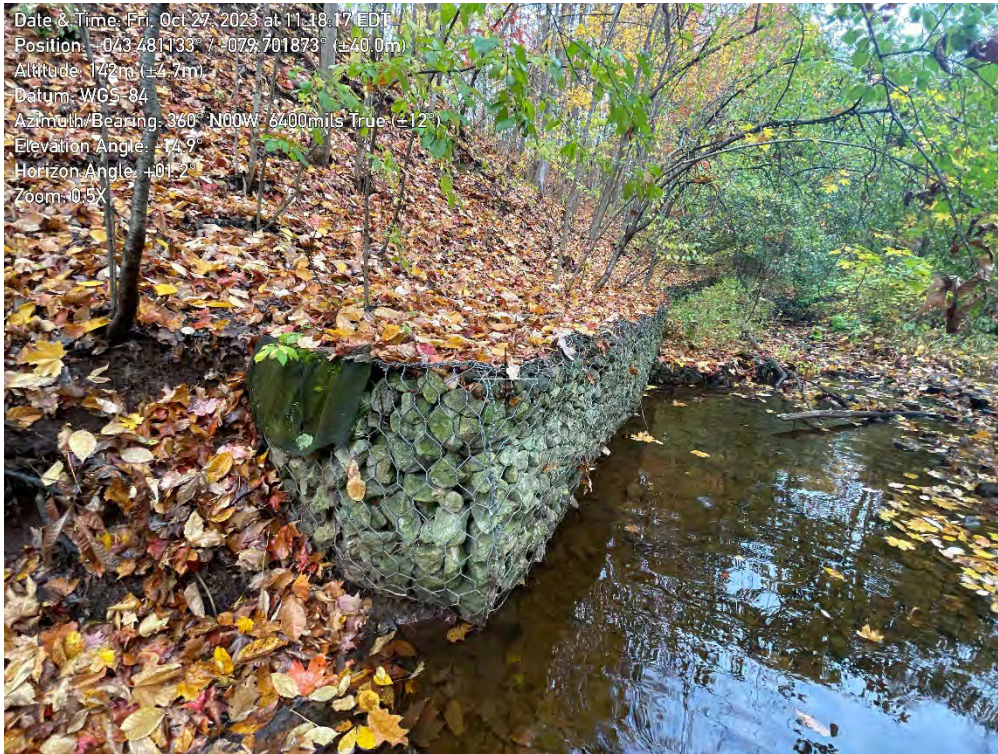
**Photo 3. View of undercut gabion baskets in Zone A19-2 of the East Morrison Creek, looking Northwest.**

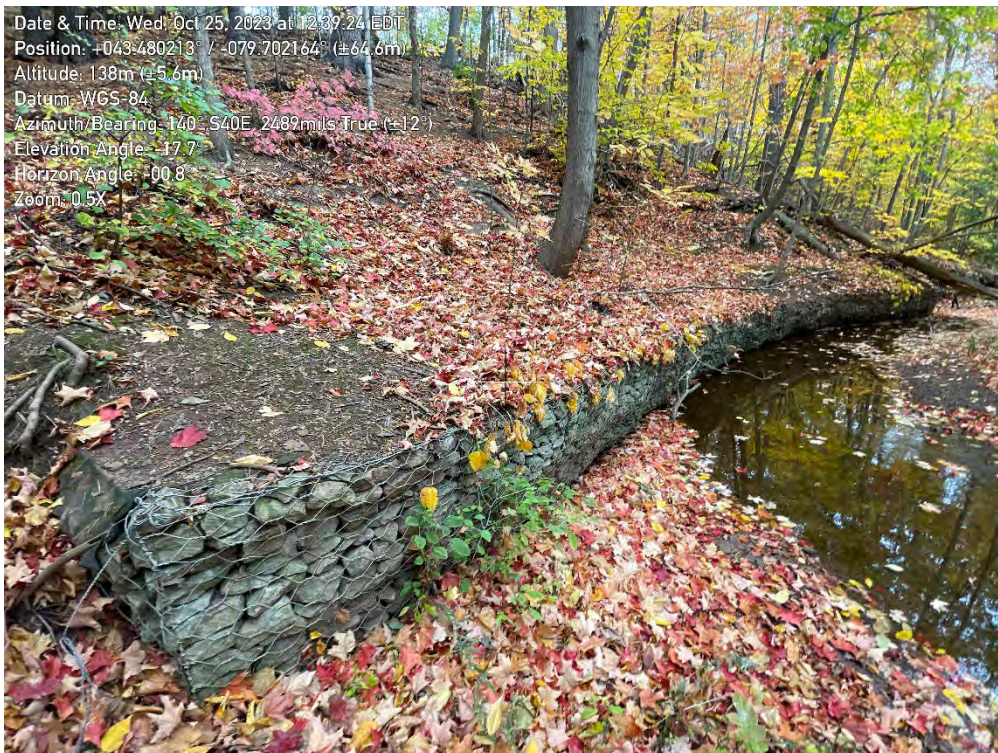
**Photo 4. View of undercut gabion baskets in Zone B17 of the East Morrison Creek, looking Southeast.**

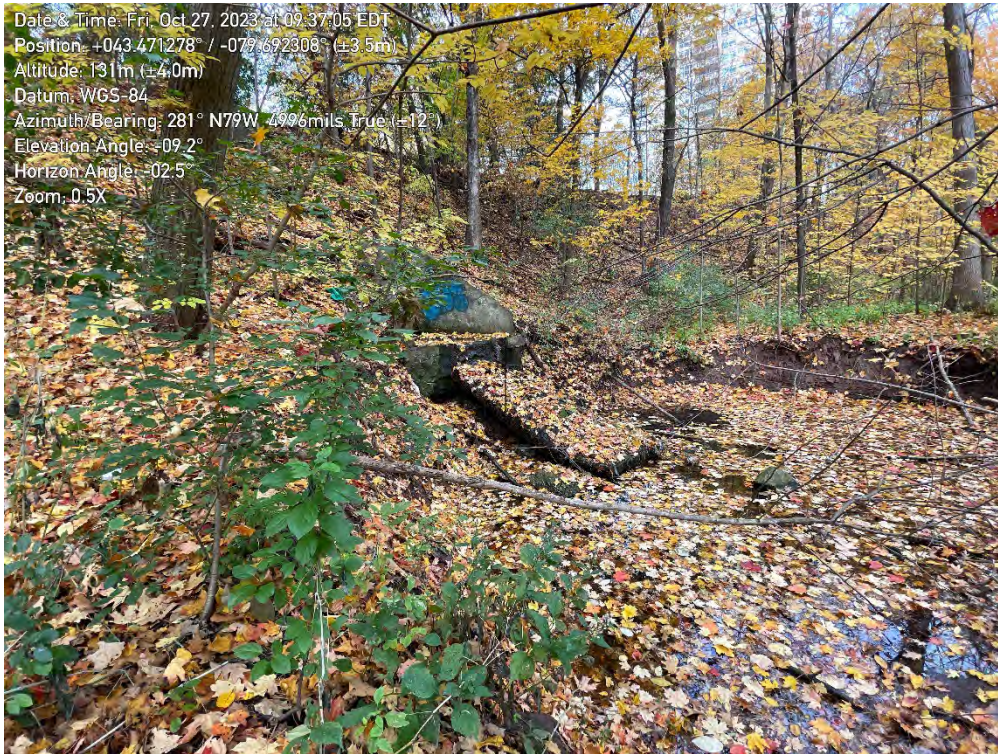
Site E-6) has failed, and the outlet flow appears to be significantly accelerating creek bank erosion, near the toe of the slope at previous Site E-7 (See photographs 5, 6 and 7 in Appendix C). As of the date of inspection, Thurber assessed zone A7 to have slight potential for slope instability based on the MNR ratings, however, it is noted that the erosion appears to be impacting the structure.

Photo 5. View of failed outflow culvert in Zone A7 of the East Morrison Creek, looking Northwest.

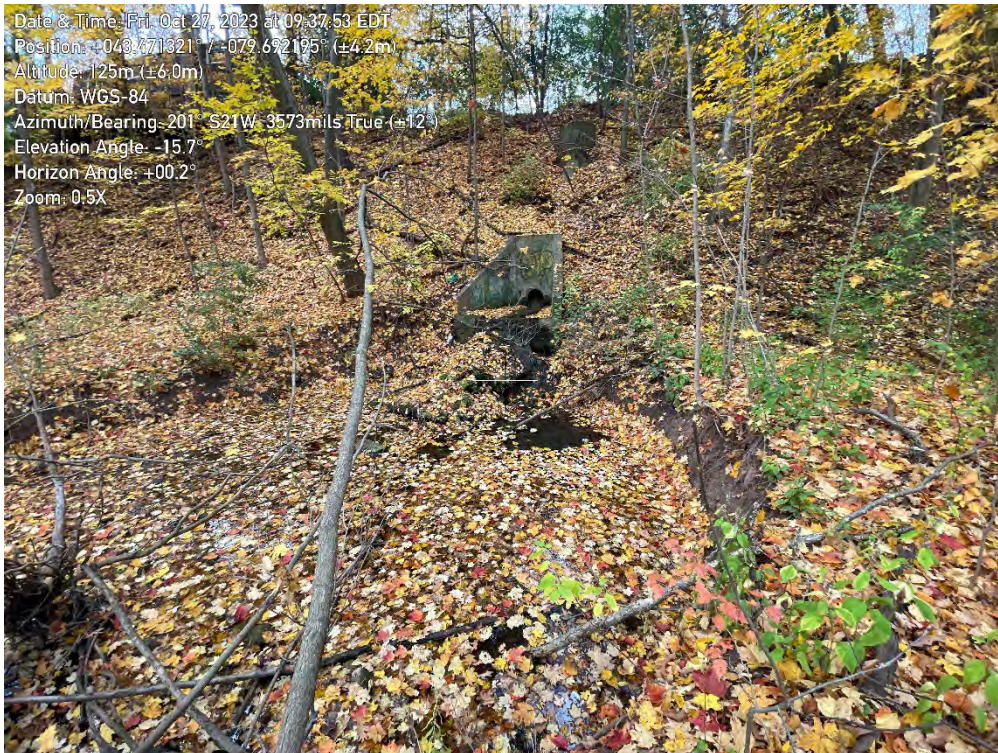
Photo 6. View of failed outflow culvert in Zone A7 of the East Morrison Creek, looking Southwest.

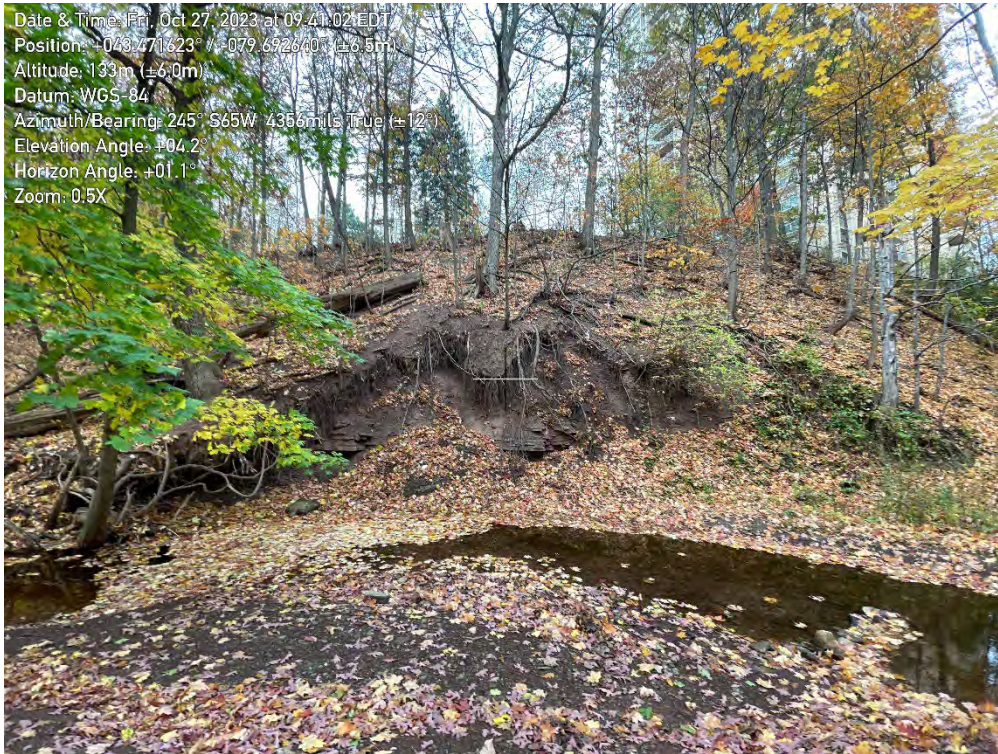
Photo 7. View of eroded slope in Zone A7 of the East Morrison Creek, looking Southwest.

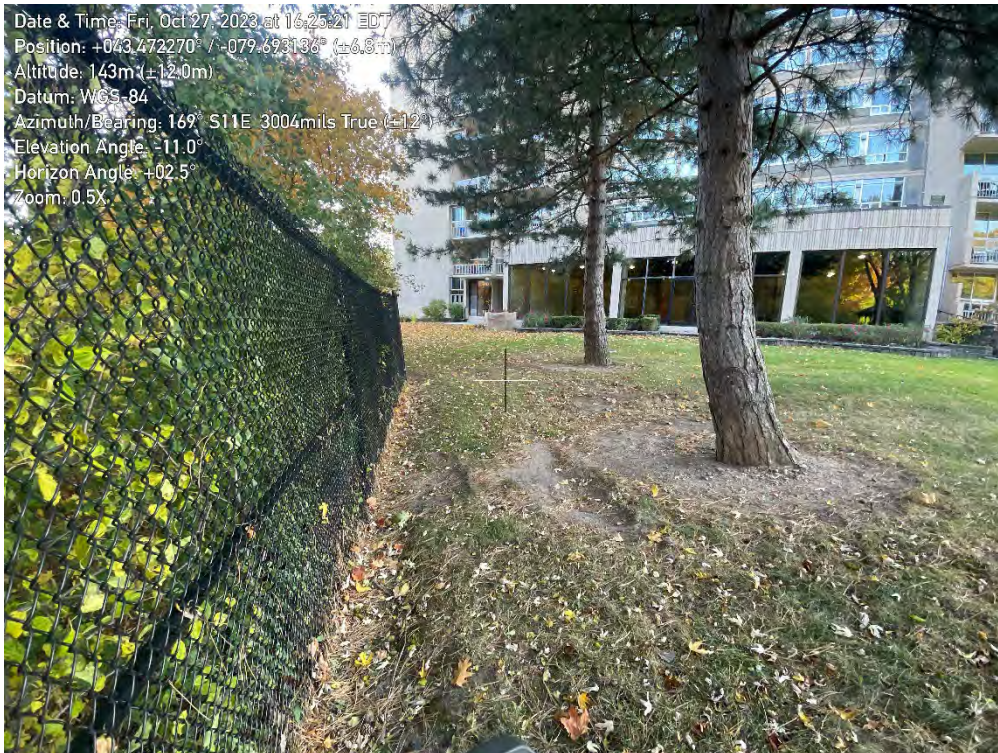
Photo 8. View of slope crest in Zone A8 at 1359 White Oaks Boulevard, looking Southeast.

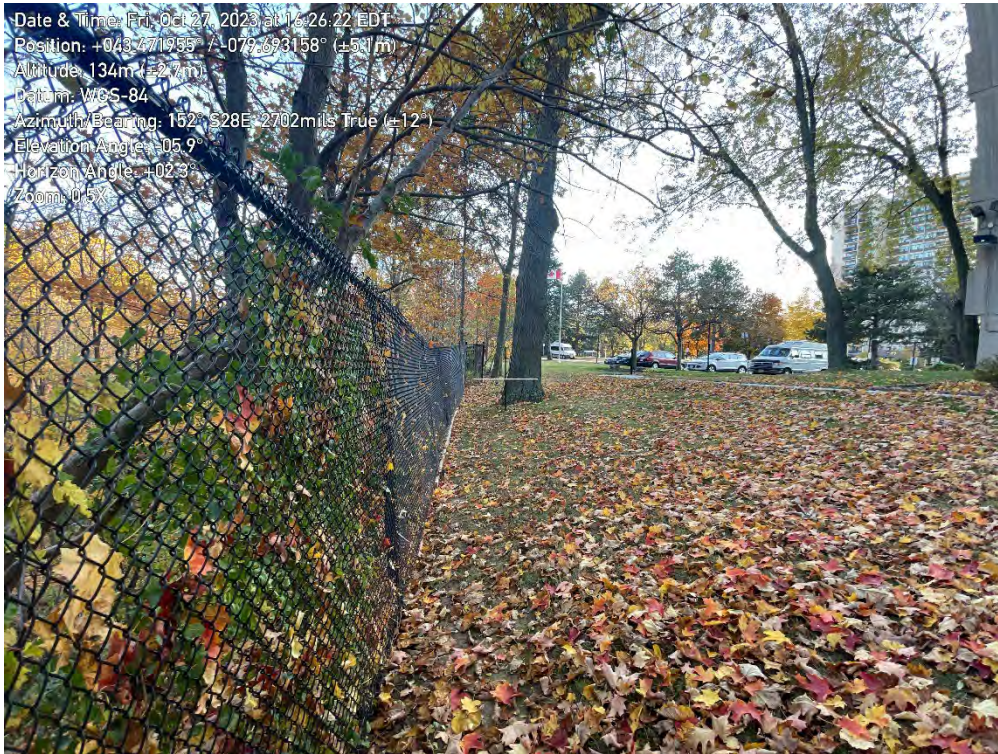
**Photo 9. View of slope crest in Zone A8 at 1359 White Oaks Boulevard, looking Southeast.**

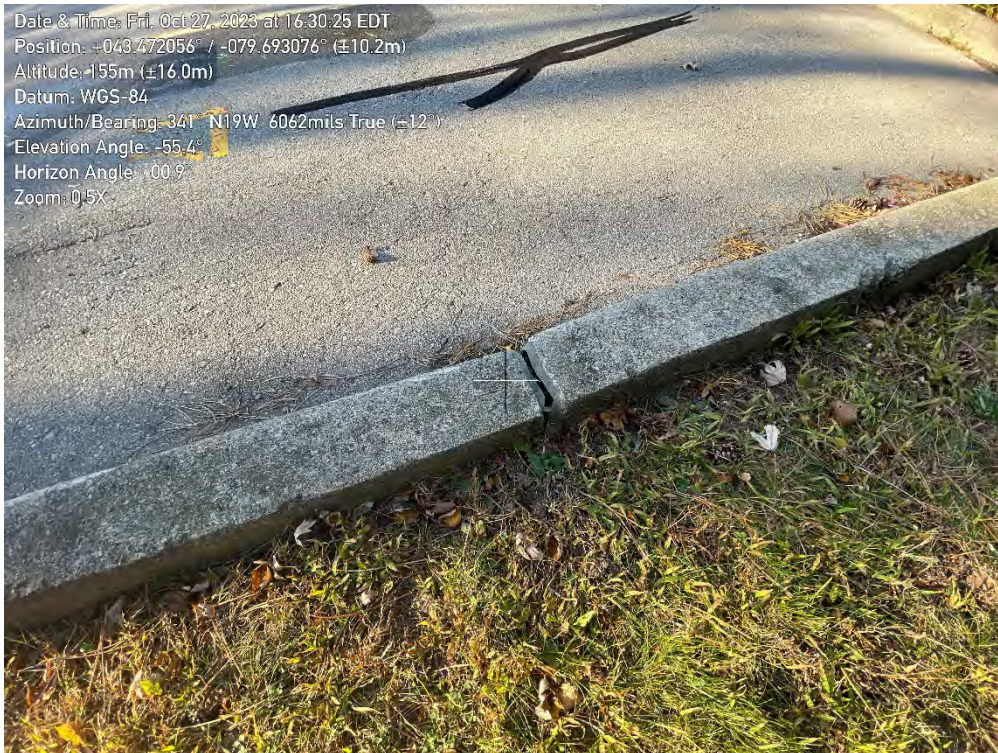
**Photo 10. View of separating parking lot curbs at 1359 White Oaks Boulevard, slope crest of Zone A7, looking Northwest.**

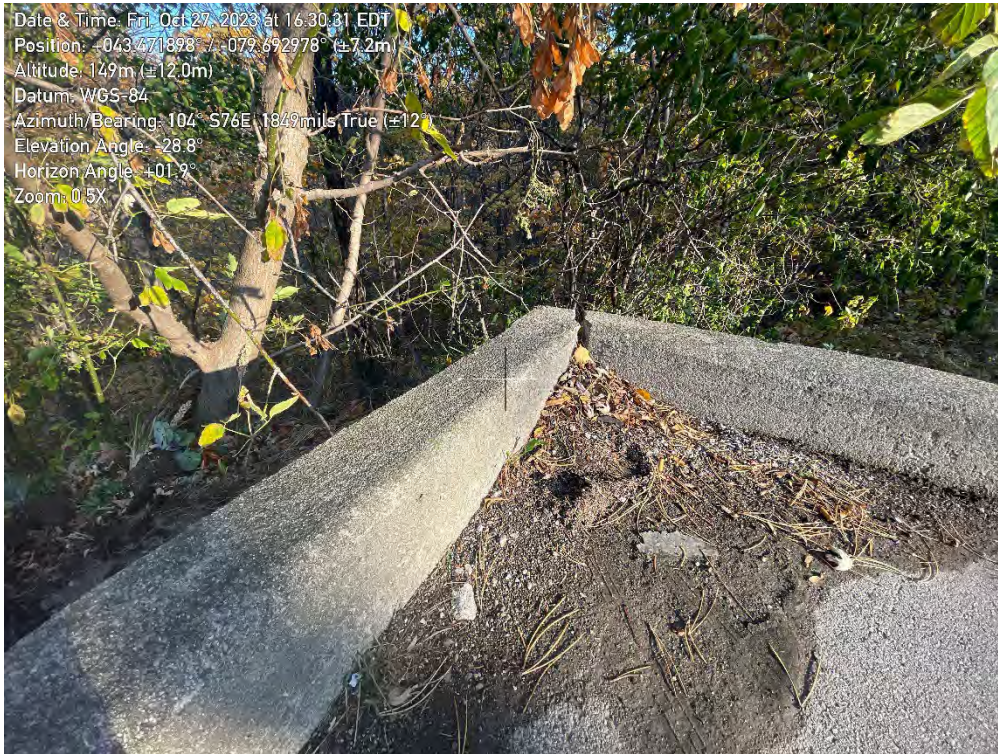
**Photo 11. View of separating parking lot curbs at 1359 White Oaks Boulevard, slope crest of Zone A7, looking Southeast.**

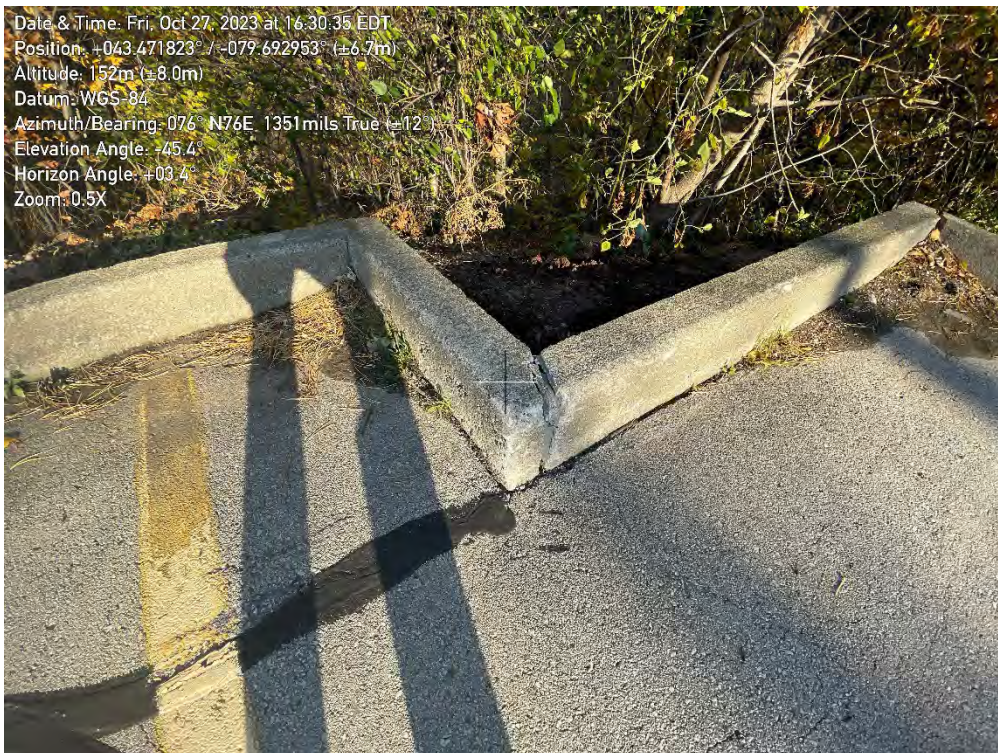
**Photo 12. View of separating parking lot curbs at 1359 White Oaks Boulevard, slope crest of Zone A7, looking Northeast**

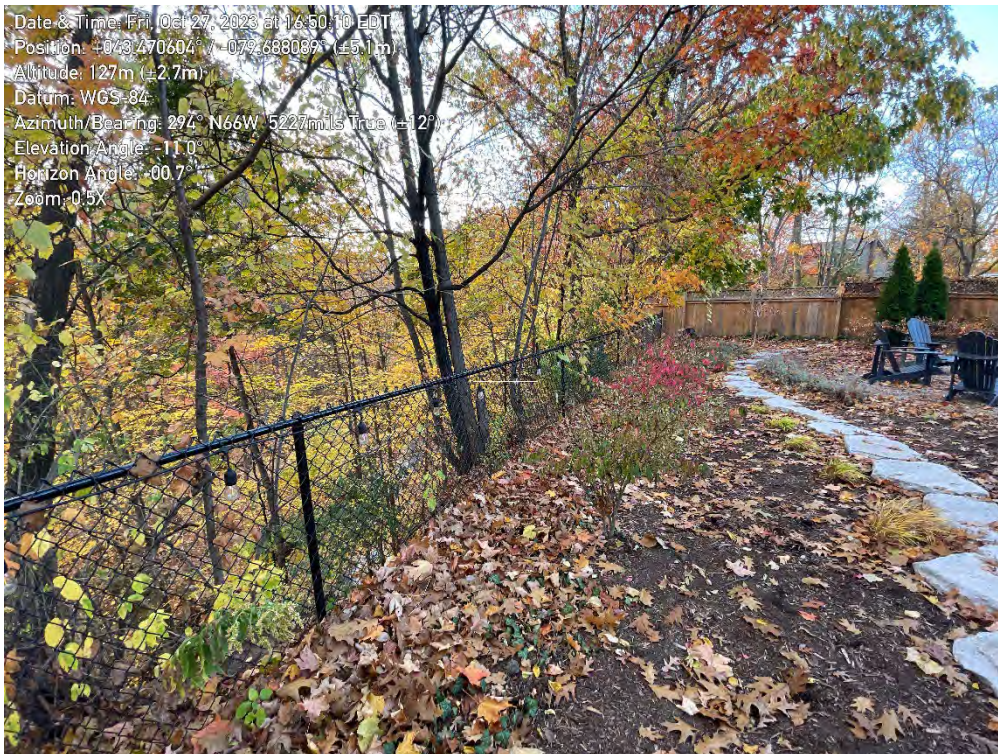
Curved trees, which are evidence of slope creep were observed at every zone with slight or moderate potential for slope instability, and often in the zones with low potential for instability. These trees varied from very young to mature. Potential evidence of displacement of man-made structures at the valley crests was observed at 1359 White Oaks Boulevard and at properties along Lambeth Road. At 1359 White Oaks Boulevard, the curbs of the East portion of parking lot appear to be separating, and the fence posts appear to be migrating down-slope (see photographs 8 to 13 in Appendix C). Between 1198 and 1208 Lambeth Road (zone B2), fence posts also appear to be migrating down-slope (see photograph 14 in Appendix C). No tension cracks were observed in the Study Area.

**Photo 144. View of slope crest in Zone B2 at 1208 Lambeth Road, looking Northwest.**

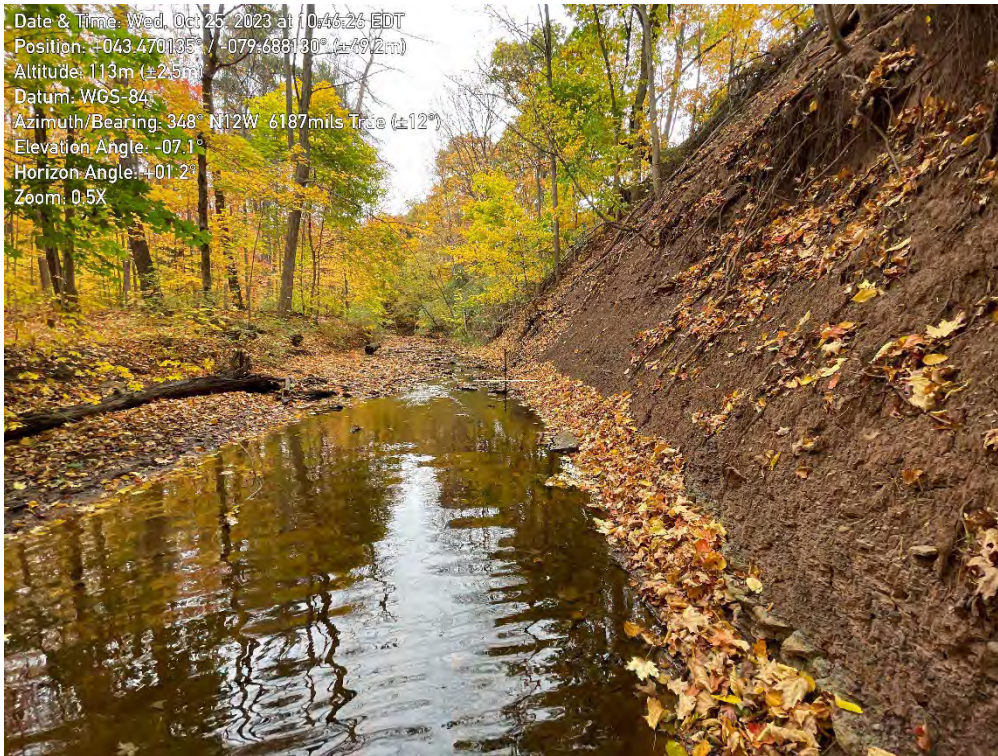
Active toe erosion that was observed in the Study Area was often accompanied by sloughing of the slope face, and evidence of previous landslides. Notably, between 1198 and 1208 Lambeth Road (zone B2) moderate to severe sloughing along the whole slope face was observed, burying the gabion baskets installed at the toe (previous Site E-4) (see photographs 15 to 17 in Appendix C). These gabion baskets appeared to be effective at mitigating toe erosion from the creek and were intact, however the additional sloughing observed indicates that the slope is still creeping due to another mode of instability.

**Photo 155. View of the slope face in Zone B2 of the East Morrison Creek, looking Northwest.**

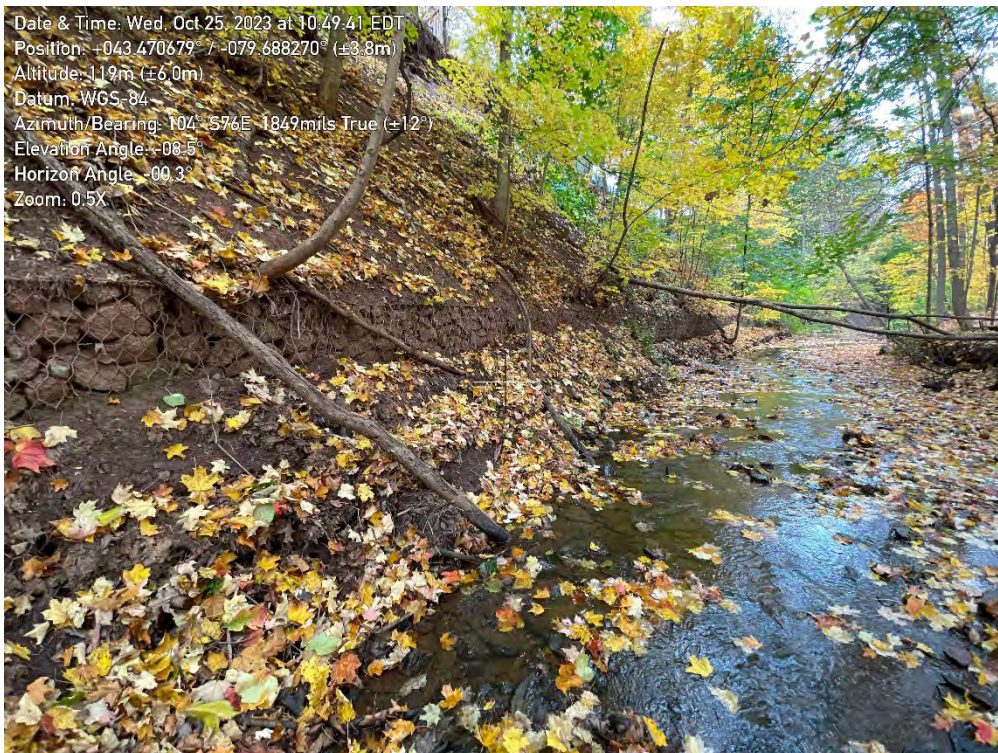
**Photo 166. View of the buried gabion baskets in Zone B2 of the East Morrison Creek, looking Southeast.**

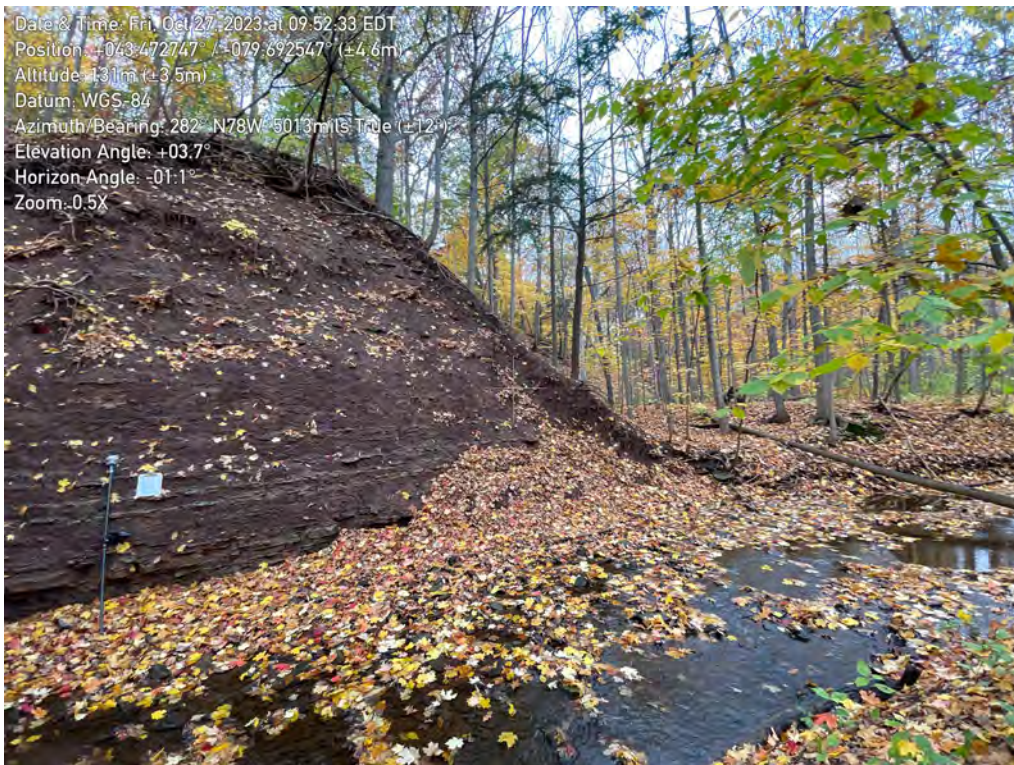
**Photo 188. View of erosion in Zone A9 of the East Morrison Creek, looking Northwest. Trimble R10 in photo is 2-meters tall.**

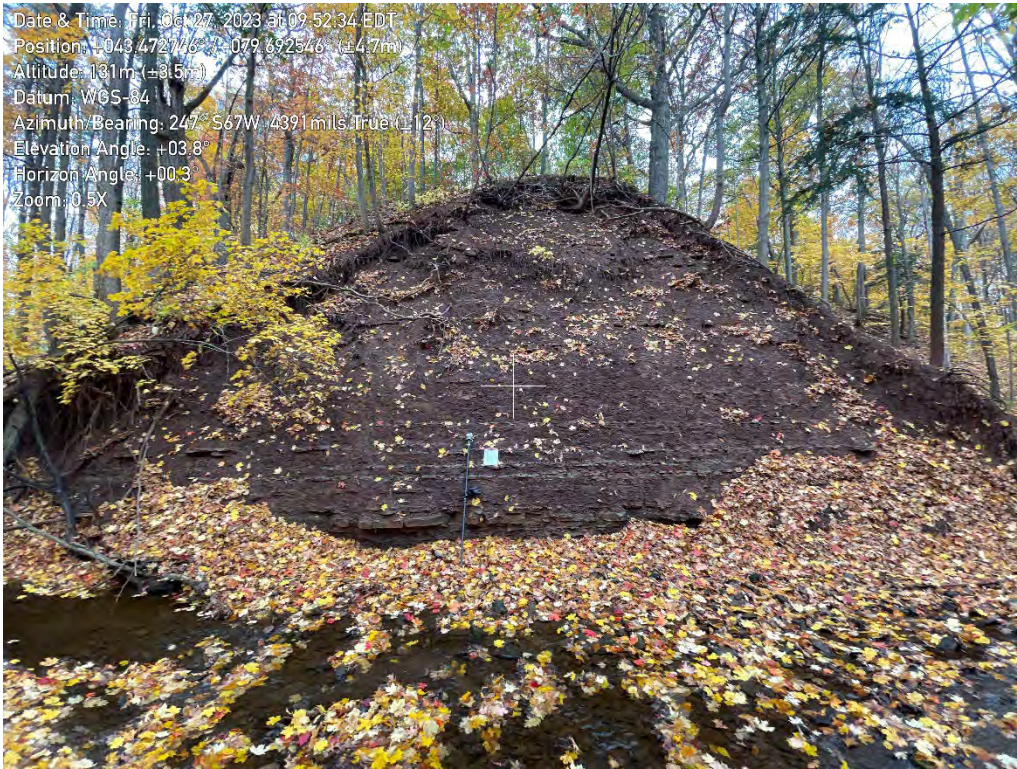
**Photo 199. View of erosion in Zone A9 of the East Morrison Creek, looking Southwest. Trimble R10 in photo is 2-meters tall.**

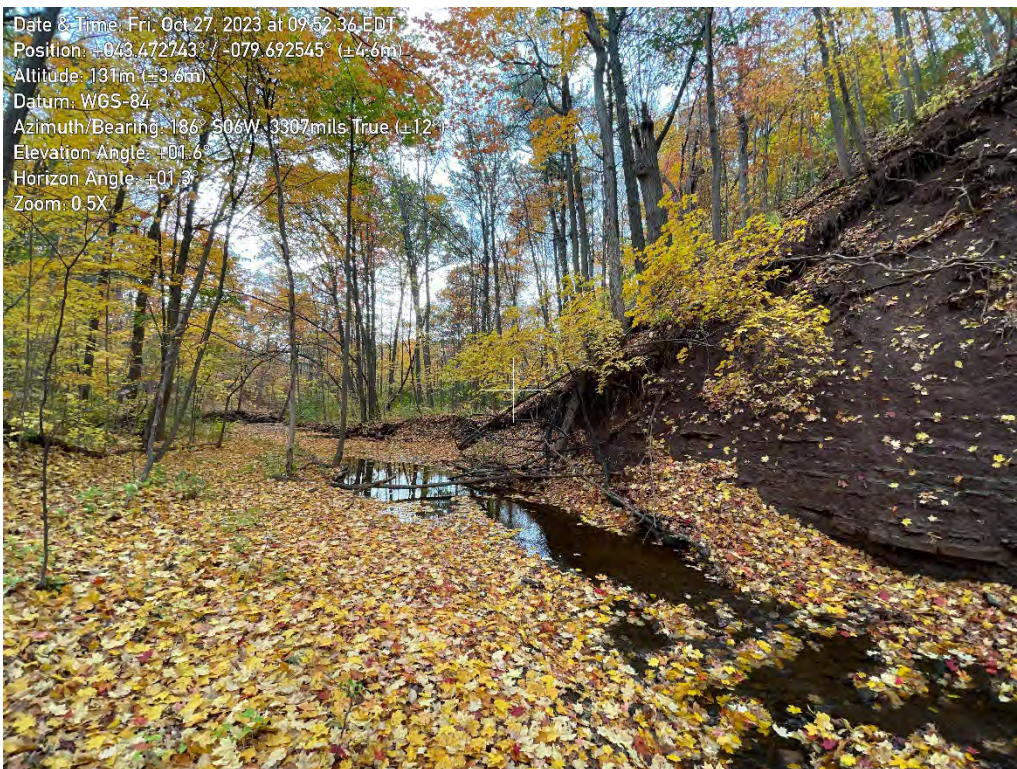
**Photo 20. View of erosion in Zone A9 of the East Morrison Creek, looking Southwest.**

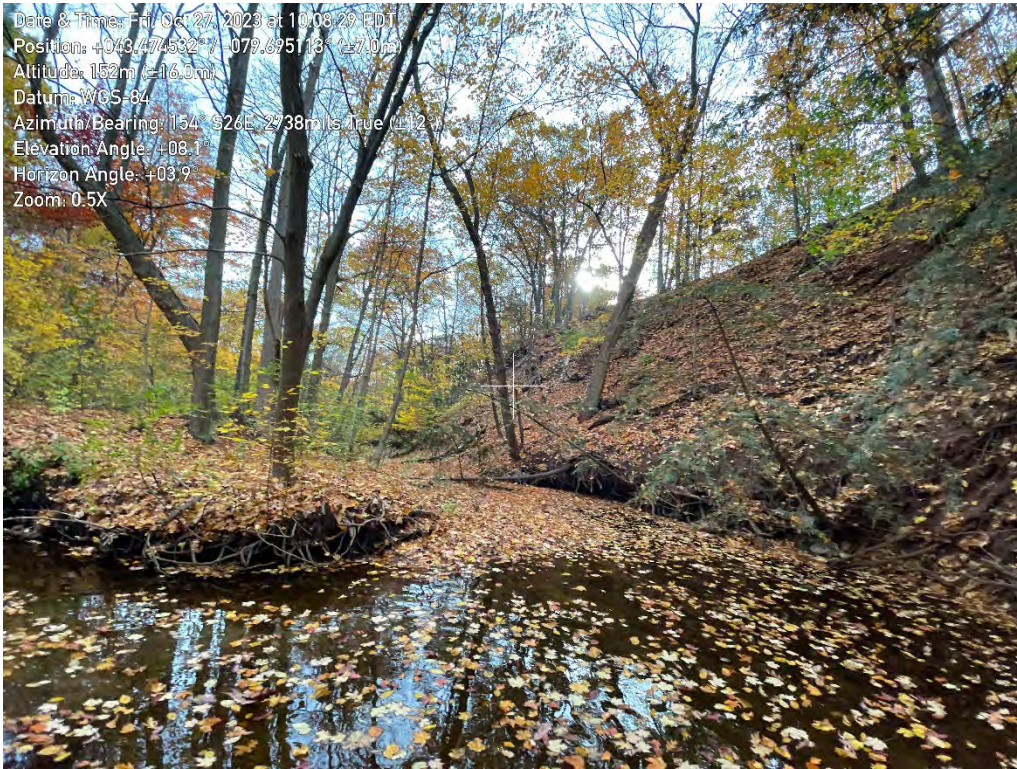
Photo 21. View of valley wall slope in Zone A11-2 of the East Morrison Creek, looking Southeast.

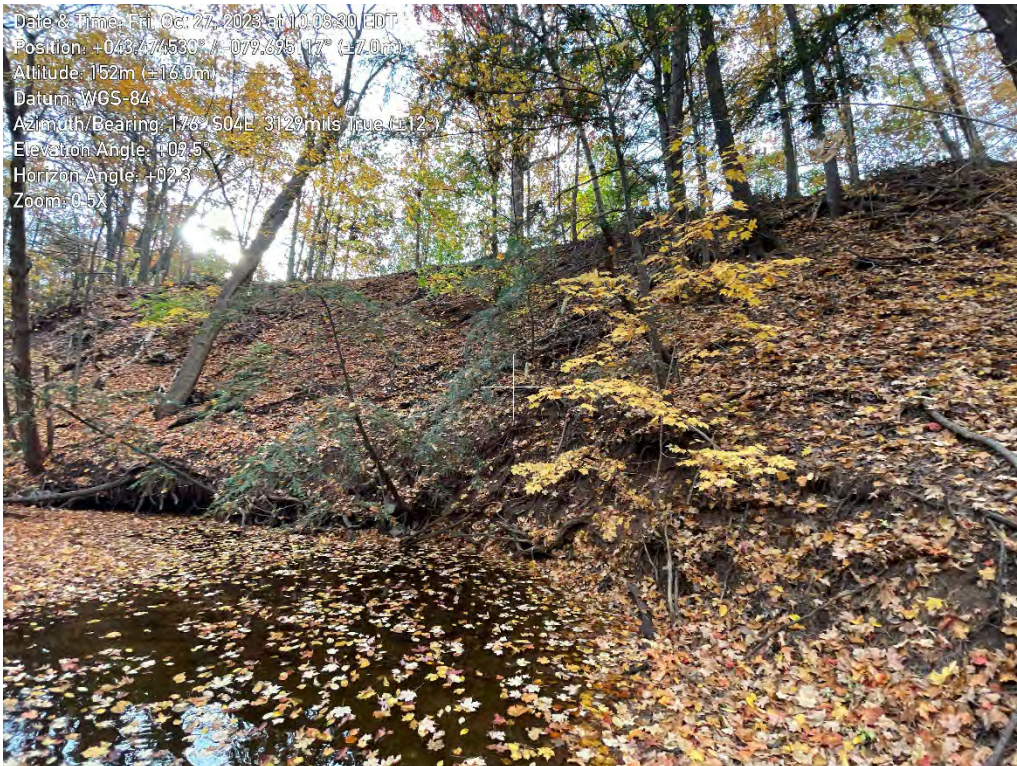
Photo 22. View of valley wall slope in Zone A11-2 of the East Morrison Creek, looking Southeast.

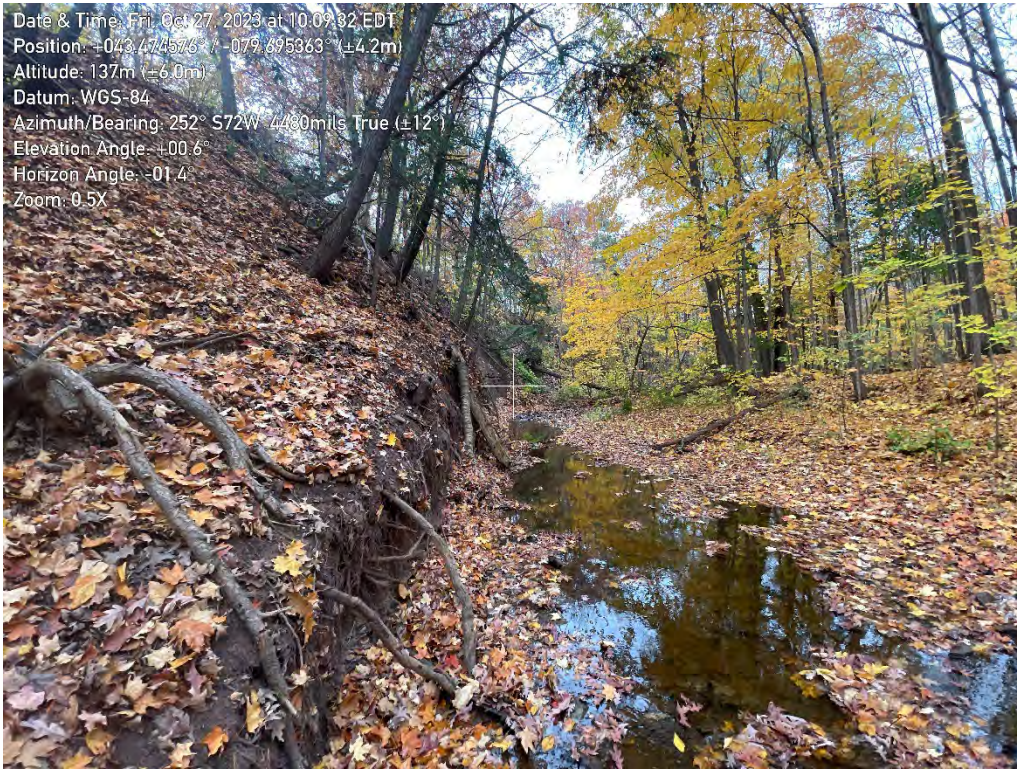
Photo 23. View of valley wall slope in Zone A11-2 of the East Morrison Creek, looking Southwest.

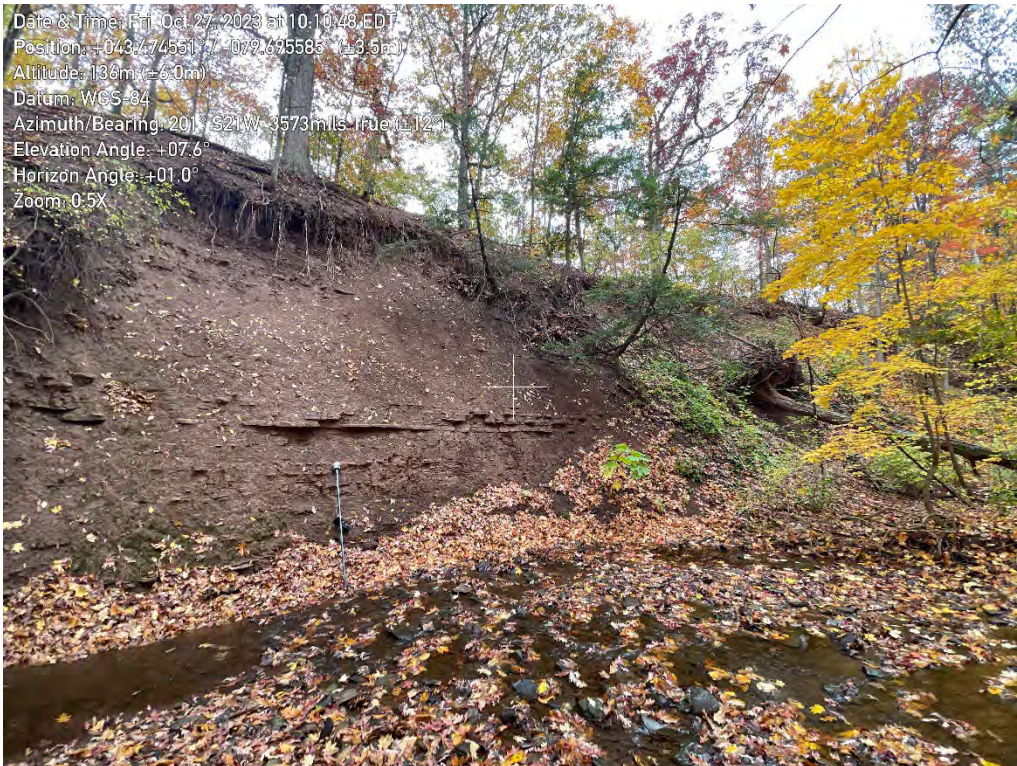
Photo 24. View of erosion in Zone A11-2 of the East Morrison Creek, looking Southwest. Trimble R10 in photo is 2-meters tall.

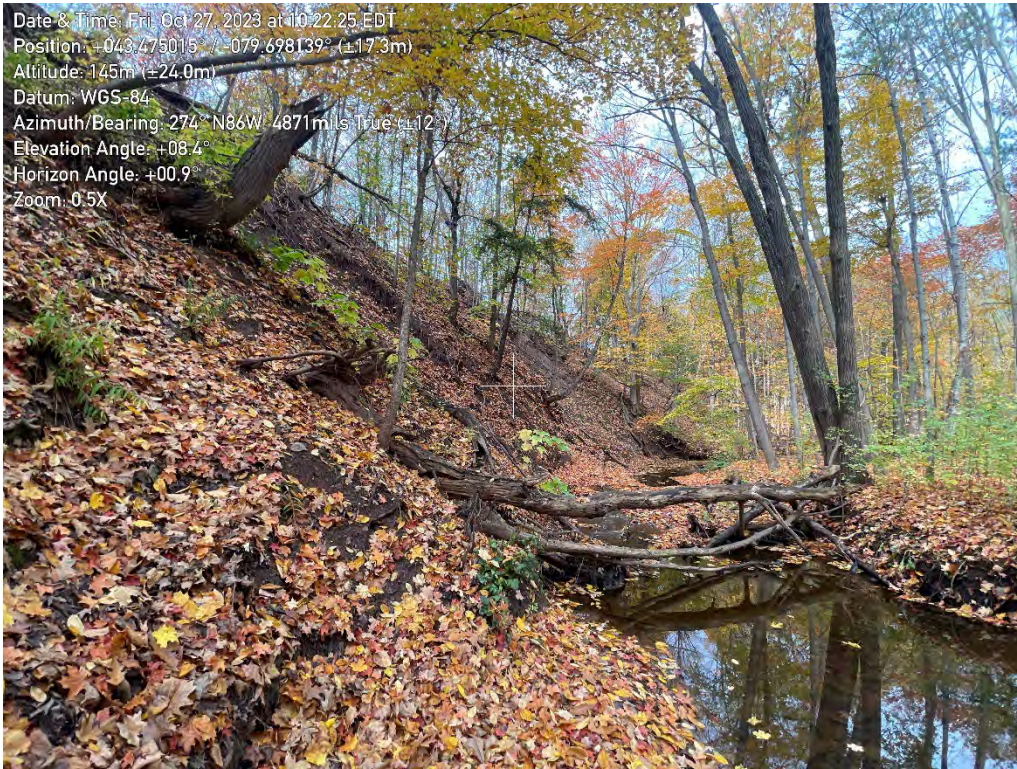
Photo 25. View of valley wall slope in Zone A13 of the East Morrison Creek, looking Northwest.

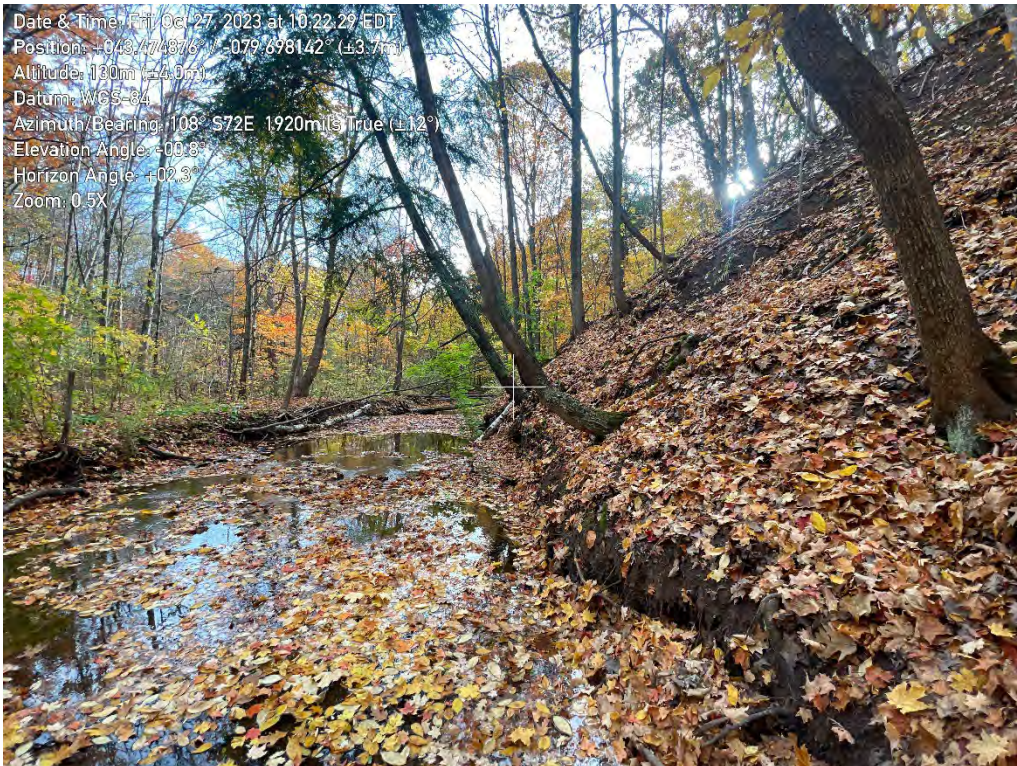
Photo 26. View of valley wall slope in Zone A13 of the East Morrison Creek, looking Southeast.

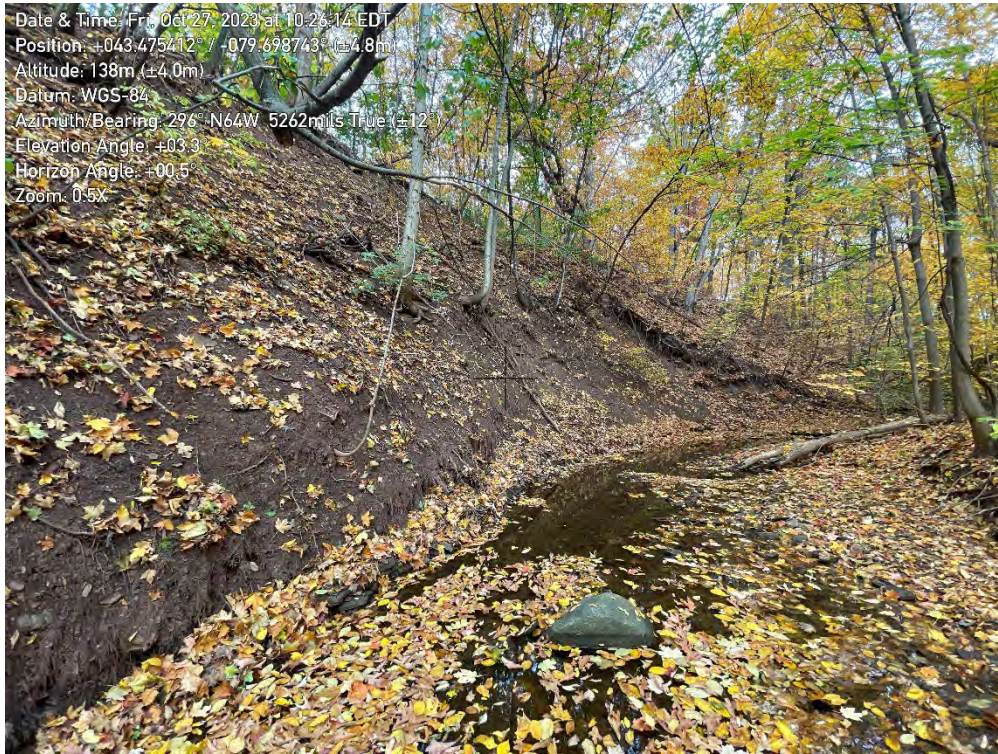
Photo 27. View of erosion in Zone A13 of the East Morrison Creek, looking Northwest.

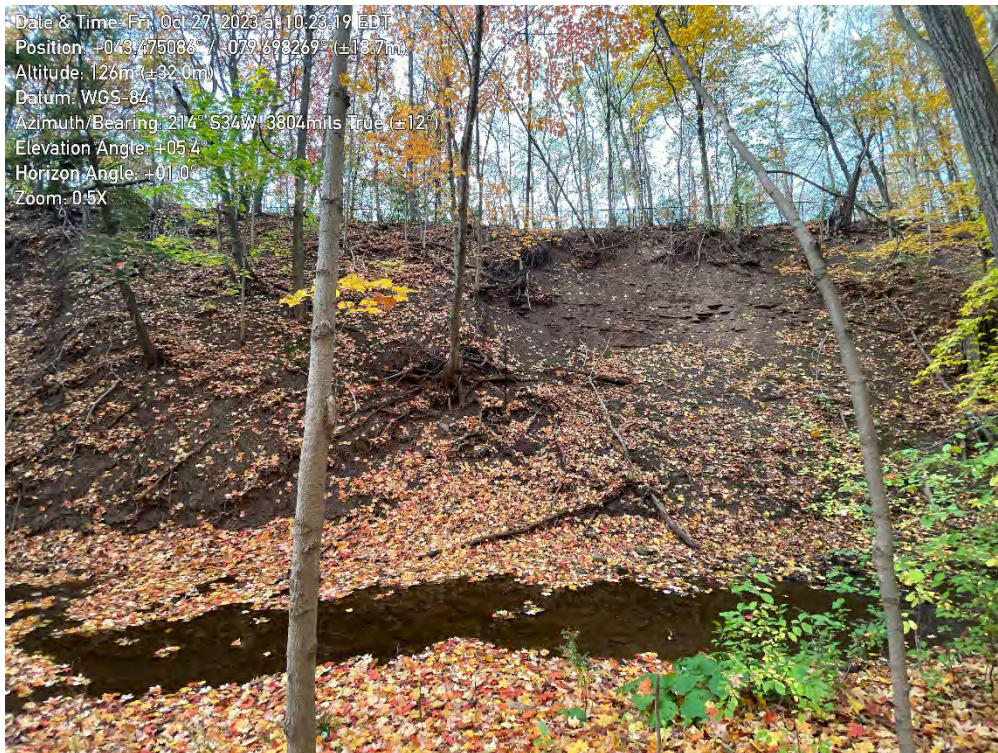
Photo 28. View of erosion in Zone A13 of the East Morrison Creek, looking Northwest.

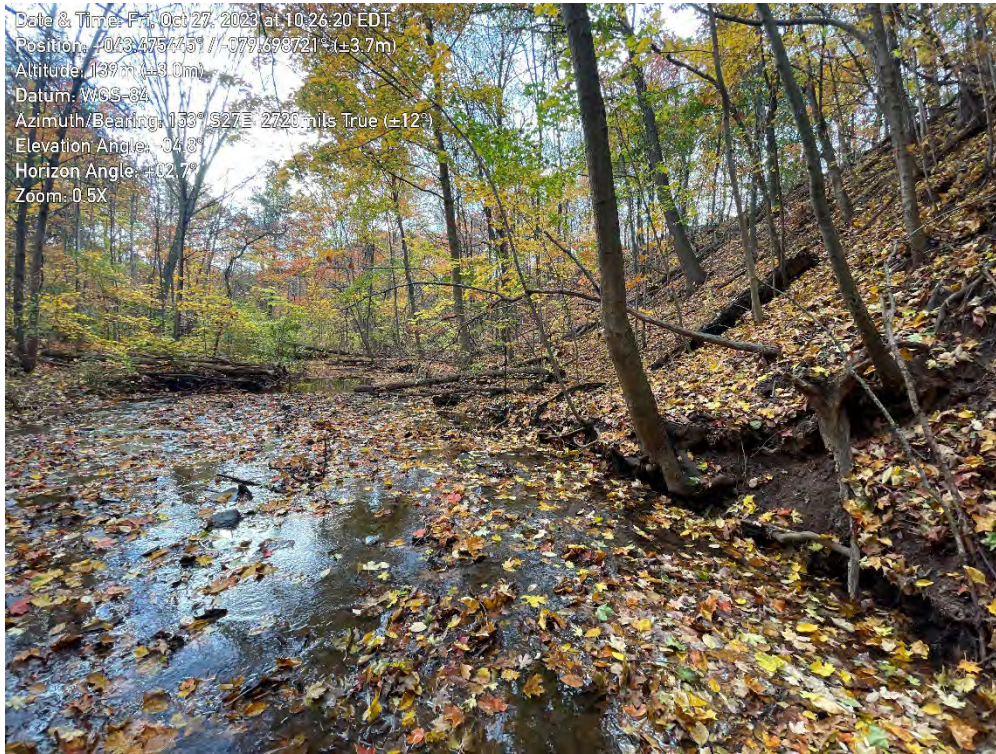
Photo 29. View of valley wall slope in Zone A13 of the East Morrison Creek, looking Southeast.

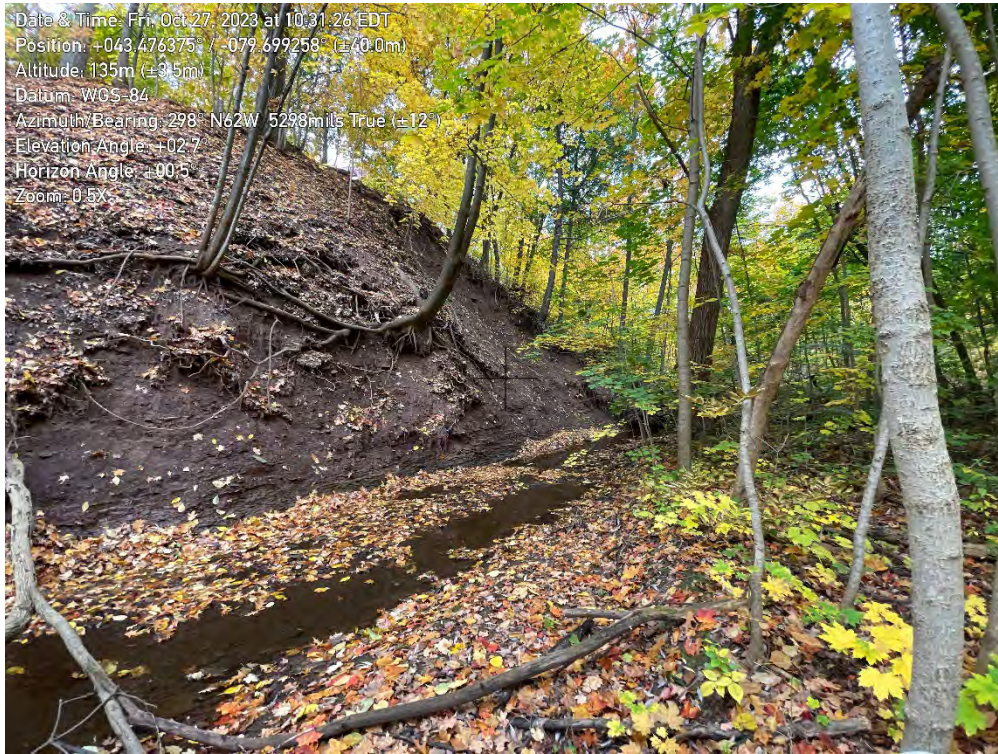
Photo 320. View of erosion in Zone A15 of the East Morrison Creek, looking Northwest.
