# **Geotechnical Slope Stability Hazard and Risk Assessment - Desktop Study & Site Inspection Report**

**East Morrison Creek Erosion Mitigation Study  
Town of Oakville, Ontario**

**Client:** Matrix Solutions Inc.

**Date:** April 11, 2025

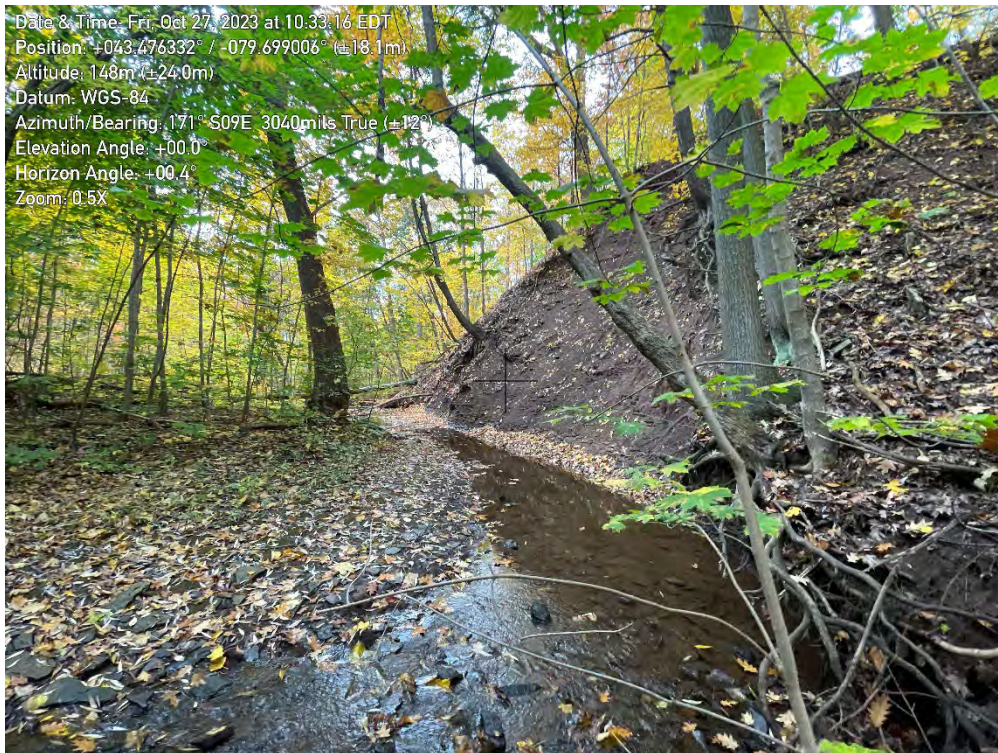
Photo 32. View of erosion in Zone A15 of the East Morrison Creek, looking Southeast.

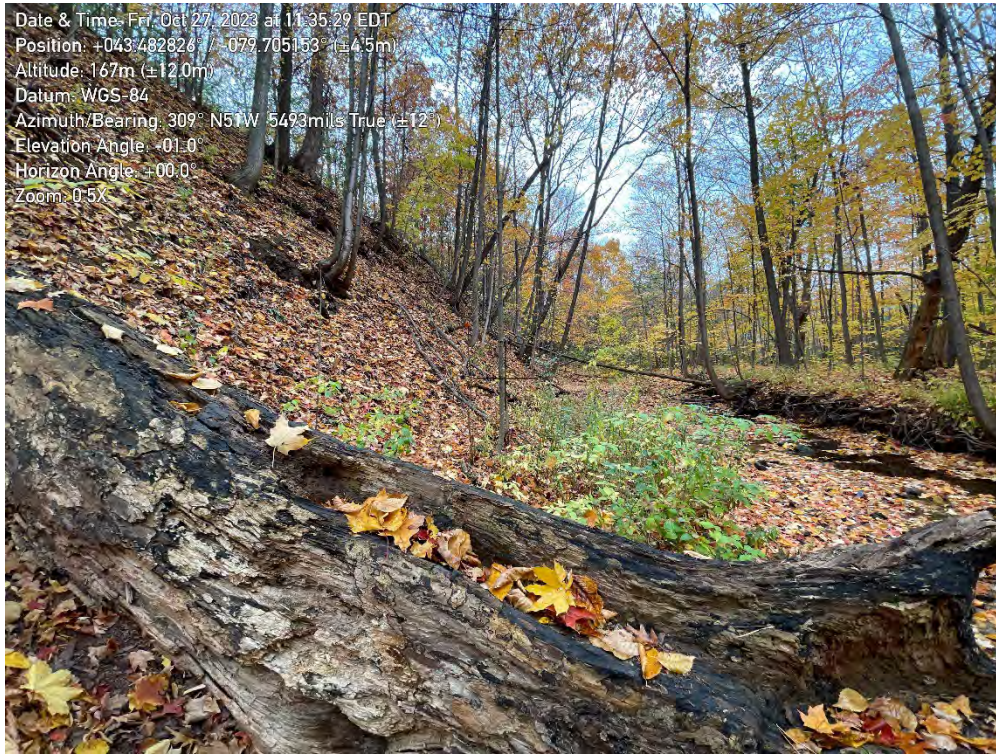
Photo 33. View of valley wall slopes in Zone A22-2 of the East Morrison Creek, looking Northwest.

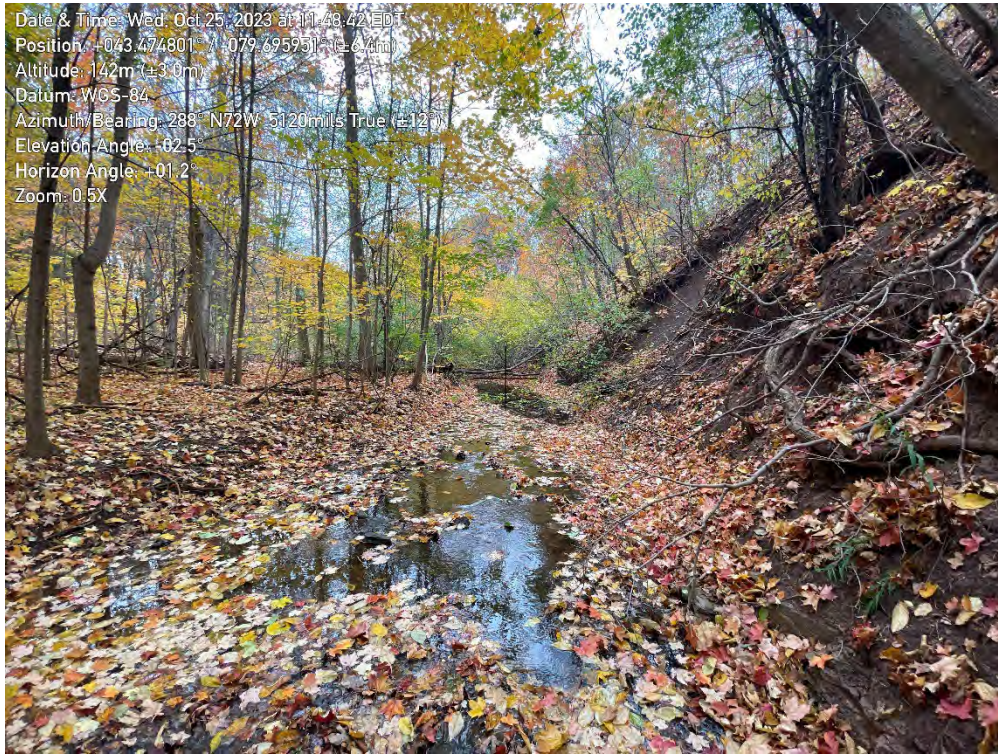
Photo 37. View of erosion in Zone B9 of the East Morrison Creek, looking Northwest.

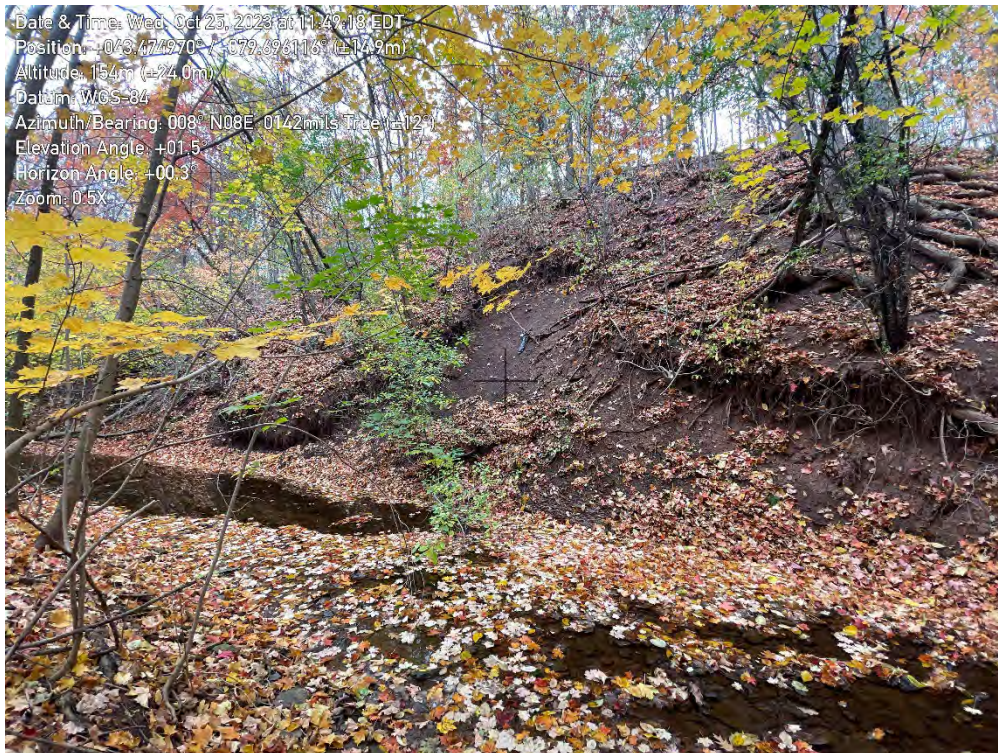
Photo 38. View of erosion in Zone B9 of the East Morrison Creek, looking Northeast.

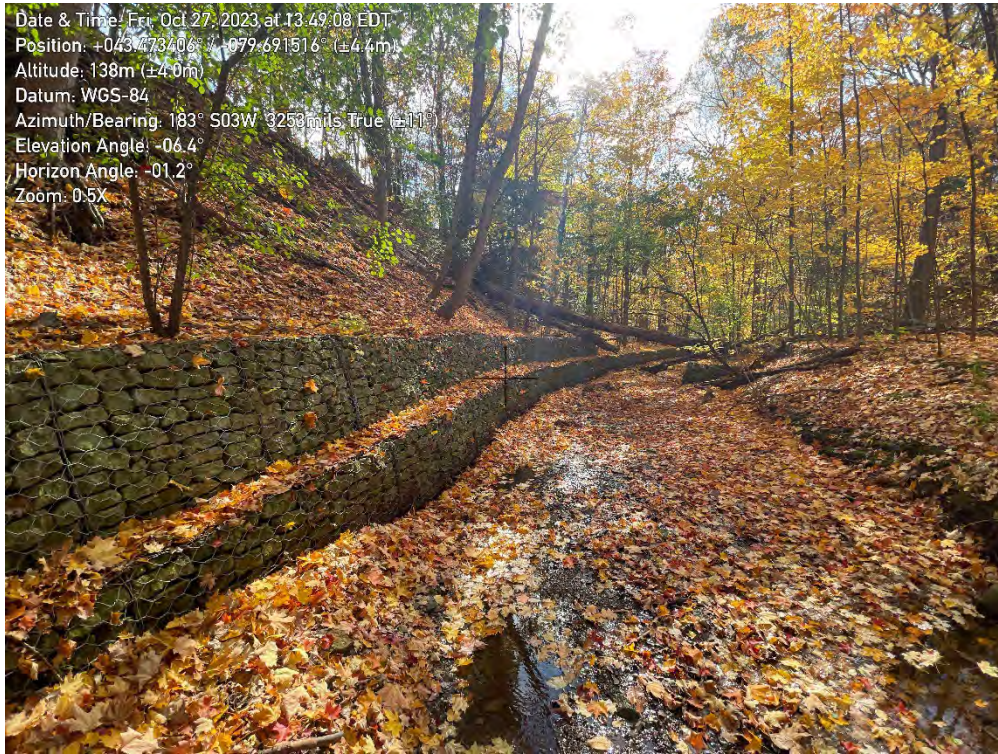
Photo 421. View of valley wall slope in Zone B32 of the East Morrison Creek, looking Southwest.

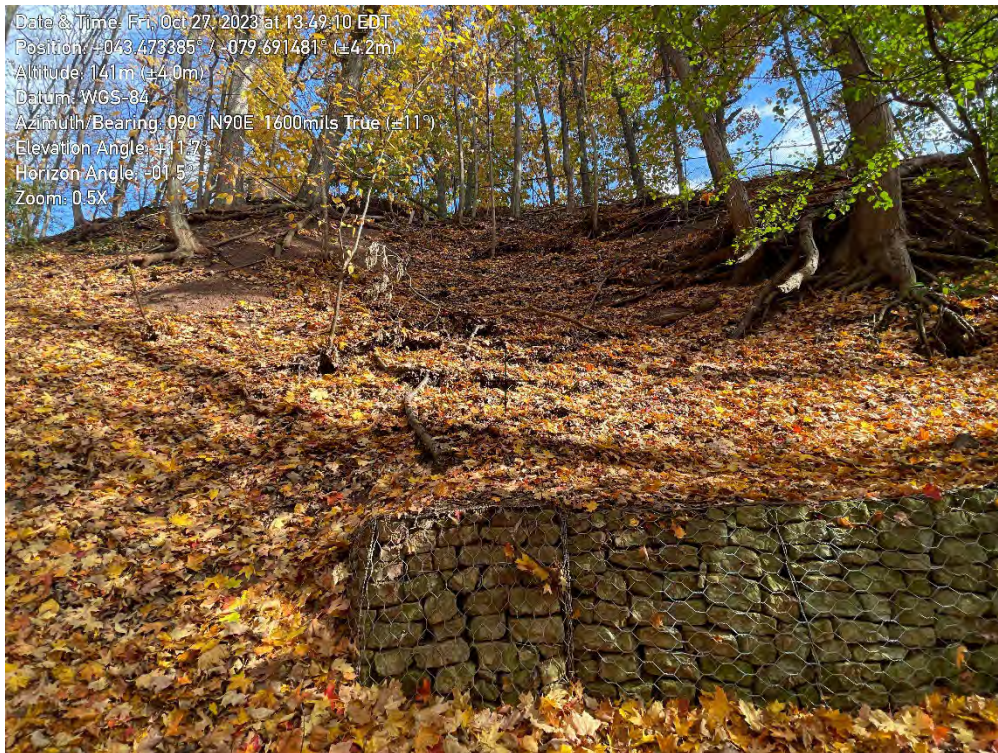
Photo 42. View of valley wall slope in Zone B32 of the East Morrison Creek, looking Northeast.
