ARBORIST REPORT

**PROPOSED RESIDENTIAL SUBDIVISION
(FORMER SCHOOL BLOCK)
193 NAUTICAL BOULEVARD
BLOCK 220 - PLAN 20M-840
TOWN OF OAKVILLE
ONTARIO**

**ISA CERTIFIED ARBORIST
MATTHEW GEHRES #ON-1114A
OUR PROJECT NO:
21-5711**

REVISED – October 14, 2022 Latest Draft Plan

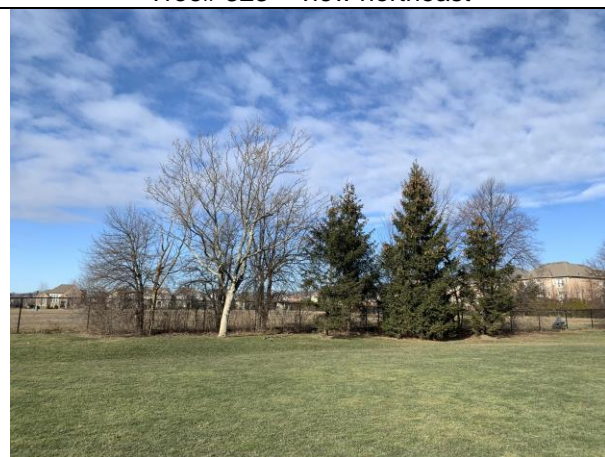
Tree# 328-340 – view north

338	London Plane Tree	<i>Platanus acerifolia</i>	34.0	11.0	Good	Good form	Minor epicormic growth on lower branches	Preserve	2.4	3	338
339	London Plane Tree	<i>Platanus acerifolia</i>	25.0	6.0	Poor	Dead leader	Basal decay, likely hollow stem, deadwood throughout	Preserve	1.8	3	339
340	Hawthorn	<i>Crataegus spp.</i>	17.0	5.0	Fair	Double stem	Crowded by adjacent tree	Preserve	1.8	3	340
341	Bur Oak	<i>Quercus macrocarpa</i>	6.0	2.0	Good	Good form	Immature tree	Preserve	1.2	3	341
342	Red Maple	<i>Acer rubrum</i>	6.0	2.0	Good	Good form	Immature tree	Preserve	1.2	3	342
343	Red Oak	<i>Quercus rubra</i>	10.0	3.0	Good	Good form	Immature tree	Preserve	1.2	3	343
344	Norway Spruce	<i>Picea abies</i>	38.0	6.0	Good	Good form	Branching to grade	Preserve	2.4	3	344
345	Norway Spruce	<i>Picea abies</i>	41.0	6.0	Good	Good form	Branching to grade	Preserve	3.0	3	345
346	Norway Spruce	<i>Picea abies</i>	33.0	7.0	Good	Good form	Branching to grade	Preserve	2.4	3	346
