November 11, 2020 [Revised, January 20, 2023]

ARBORIST REPORT

3171 Lakeshore Rd West (Cudmore's Nursery Site), Oakville, Ontario

MHBC File: 11161E

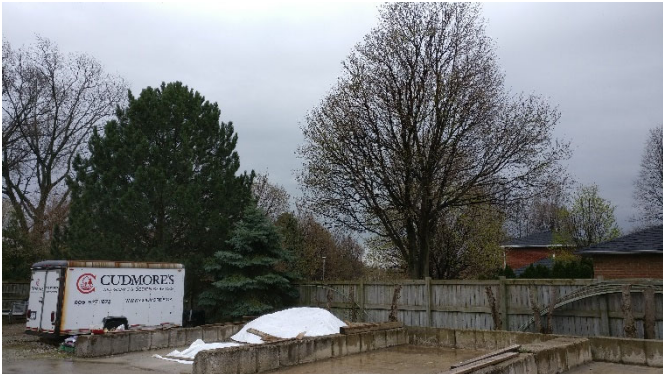
Trees 658, 659, O1 looking South West.

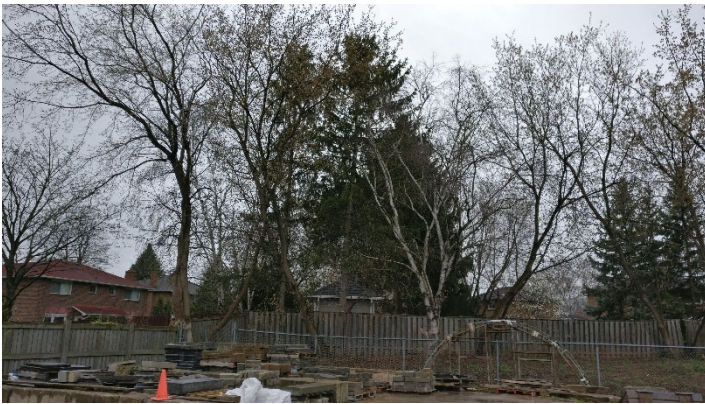
Trees 907 through 911 looking West.

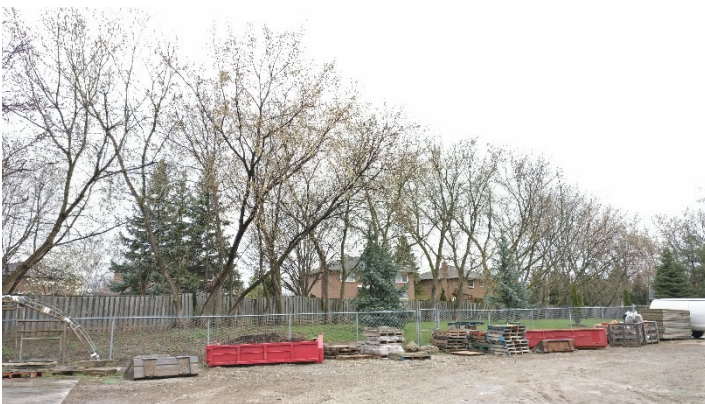
Trees 911 through 939, 955 through 959 looking North West.

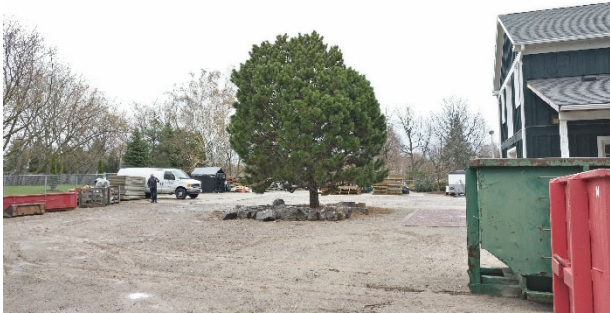
Tree 660 looking North.

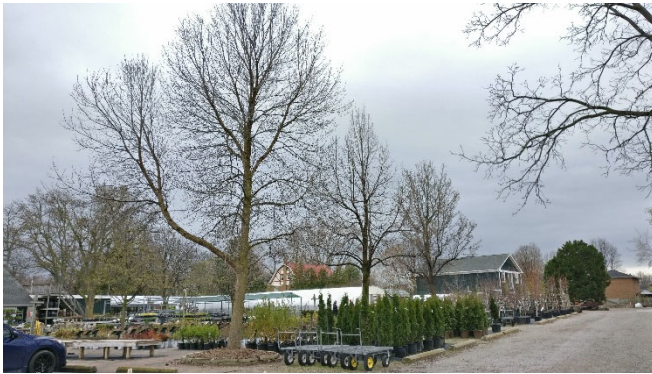
Trees 665 through 667 looking South.

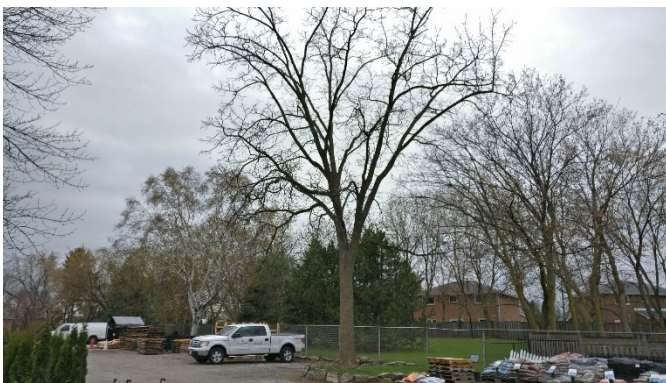
Trees 950 through 959, 661 looking South West.

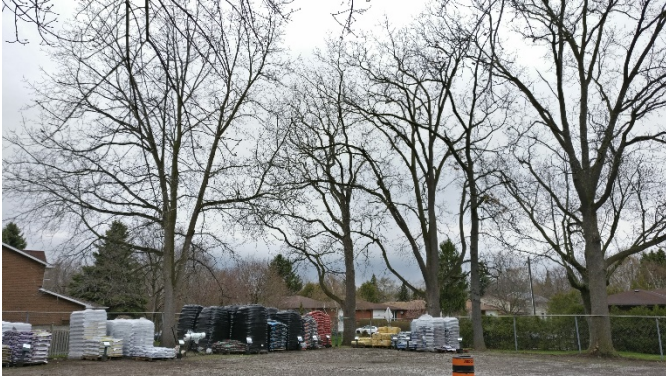
Trees 943 through 947 looking North East.

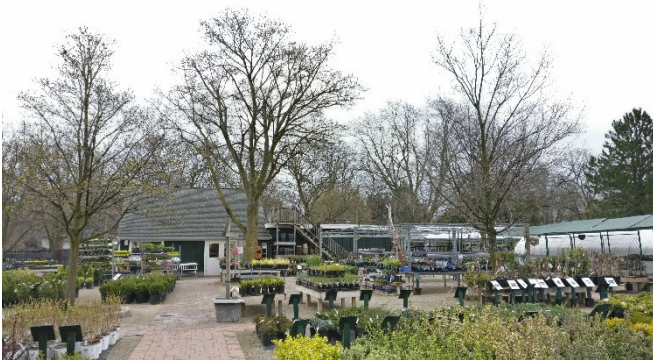
Trees 668 through 670 looking East.

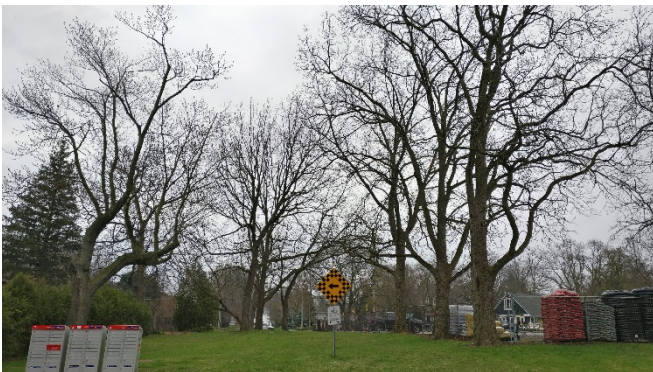
Trees 960 through 964, 697 through 700, 664 looking East.

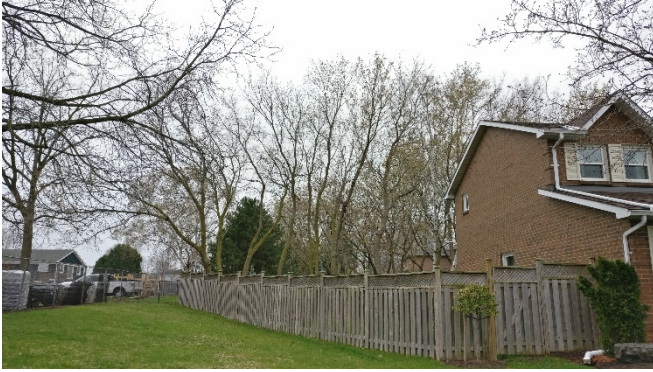
Trees 949 through 954 looking South.

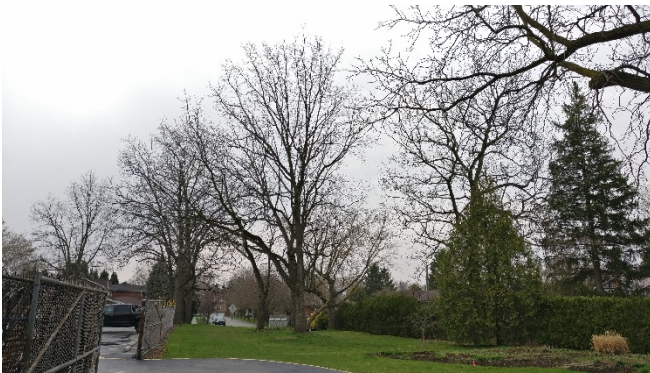
Trees 697 through 700, 960 through 964, 664 looking West.

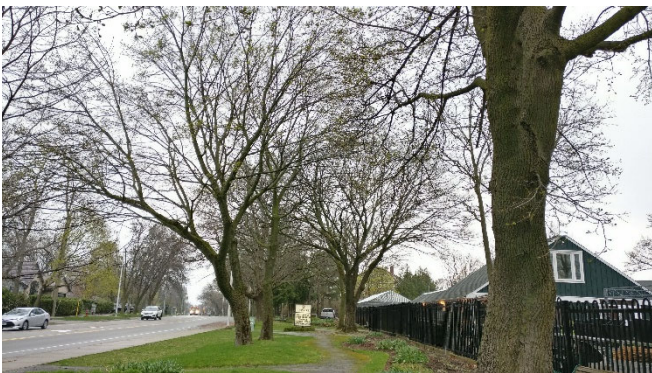
Trees 695 through 690 looking South.
