# Former Oakville Trafalgar High School Structural Condition Assessment

291 Reynolds Street  
Oakville, Ontario

TE-44882-25

October 2, 2025

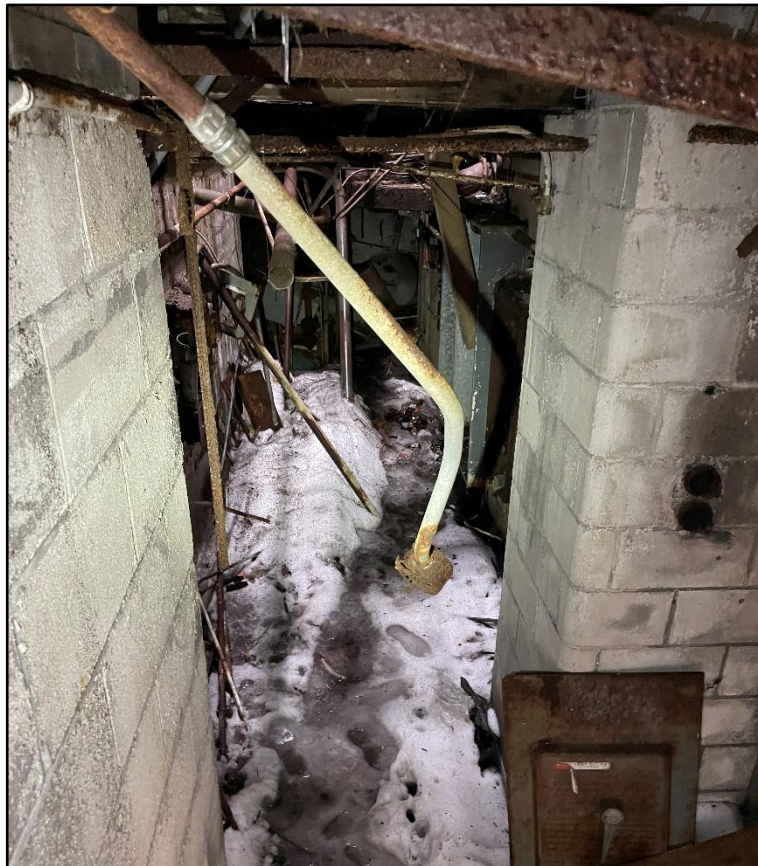
The basement was deemed unsafe for access at the time of the March 2025 site visit, and a review of the space could not be completed. The space towards the east area of the building, directly under the one-storey flat roof section, could be seen from grade through an opening in the exterior boarding on the East elevation. The basement currently is continuously exposed to the elements due to failures that have occurred in the floor and roof directly above this location. Standing water and snow were visible in the basement at the time of the site visit, which could lead to significant deterioration if left unaddressed.

**Photograph 4: Condition of basement observed from grade (March 2025 Assessment)**

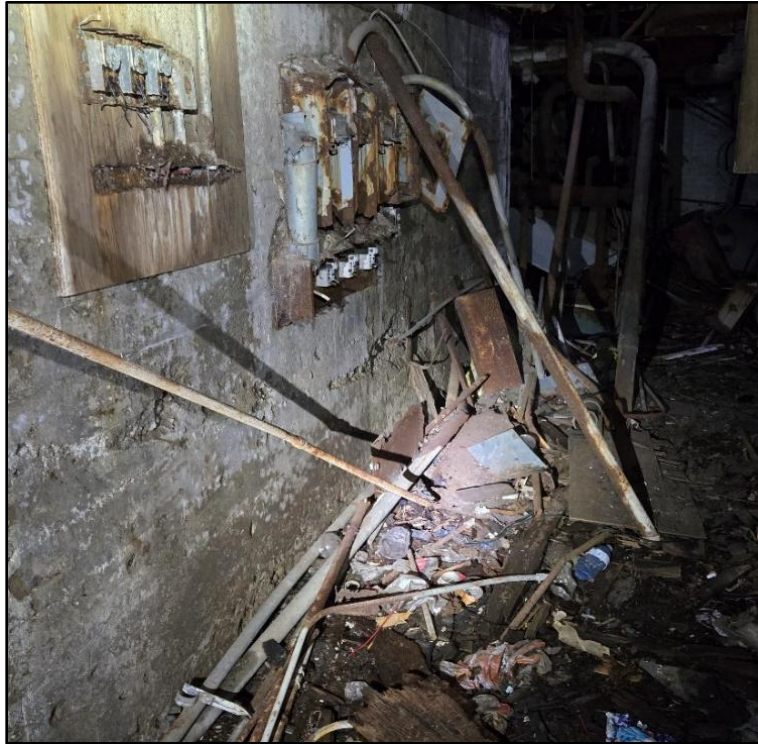
In early August of 2025, it was confirmed that the basement space had been cleared and water removed. Tacoma Engineers returned for a follow-up investigation of the basement on August 14<sup>th</sup>, 2025. Overall, the foundation walls were in good condition, with localized areas in fair condition. Below the exposed, damaged floor framing at the single storey eastern section of the building (see photograph 12), the interior foundation walls appear to have deteriorated due to continuous exposure to the elements as outlined above

(see snow accumulated at foundation walls in photograph 4). Spalling appeared to be concentrated at the base of the walls where exposure to water was the highest.

**Photograph 5: Condition of basement foundation wall (August 2025 assessment)**

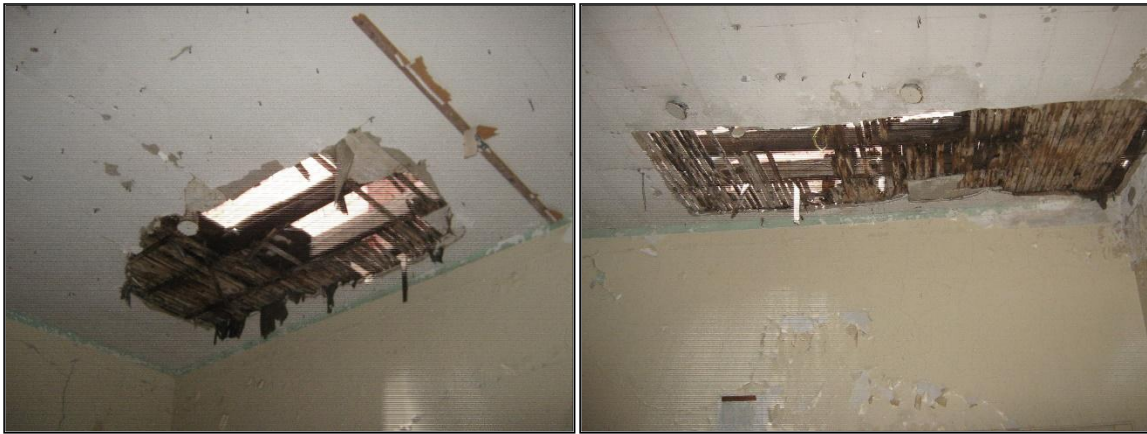
*Above the two classrooms along the west elevation, two open roof hatches that were identified in the 2009 ERA review had not been closed. The ERA report indicated that “the plaster ceiling below the two open roof access hatches is spalled and the wood lath is beginning to detach.” Currently, as seen in the photograph below, the ceiling plaster and lath directly below the hatch openings have collapsed and the ceiling joists are severely deteriorated. The roof framing in these areas appeared to be in good condition.*

**Photograph 7: Damage to ceiling framing due to open roof hatches (2016 Assessment)**

- Close and make watertight the open roof hatches to help preserve the surrounding roof framing, and to prevent further damage to the building structure.

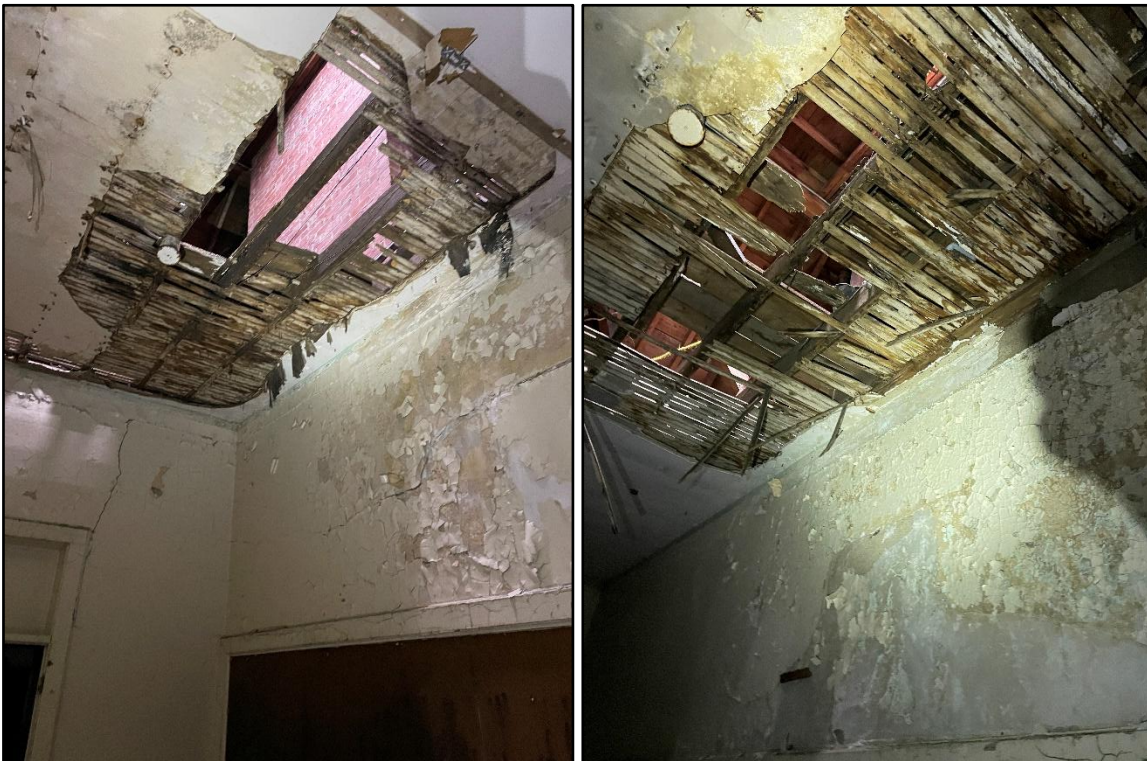
The attic was not safely accessible during the time of the site visit, and therefore a review of the space could not be completed. It was evident that the two (2) roof hatches mentioned in the 2016 assessment were still open or had been since re-opened. As such, damage to finishes has progressed significantly, as seen in the following pictures. Damage has also progressed through the second-floor framing to the main floor framing below. Degradation of finishes near the open hatches will continue if water ingress is not addressed and could evolve into significant damage to the exposed structural framing.

**Photograph 8: Damage to ceiling framing due to open roof hatches (March 2025 Assessment)**

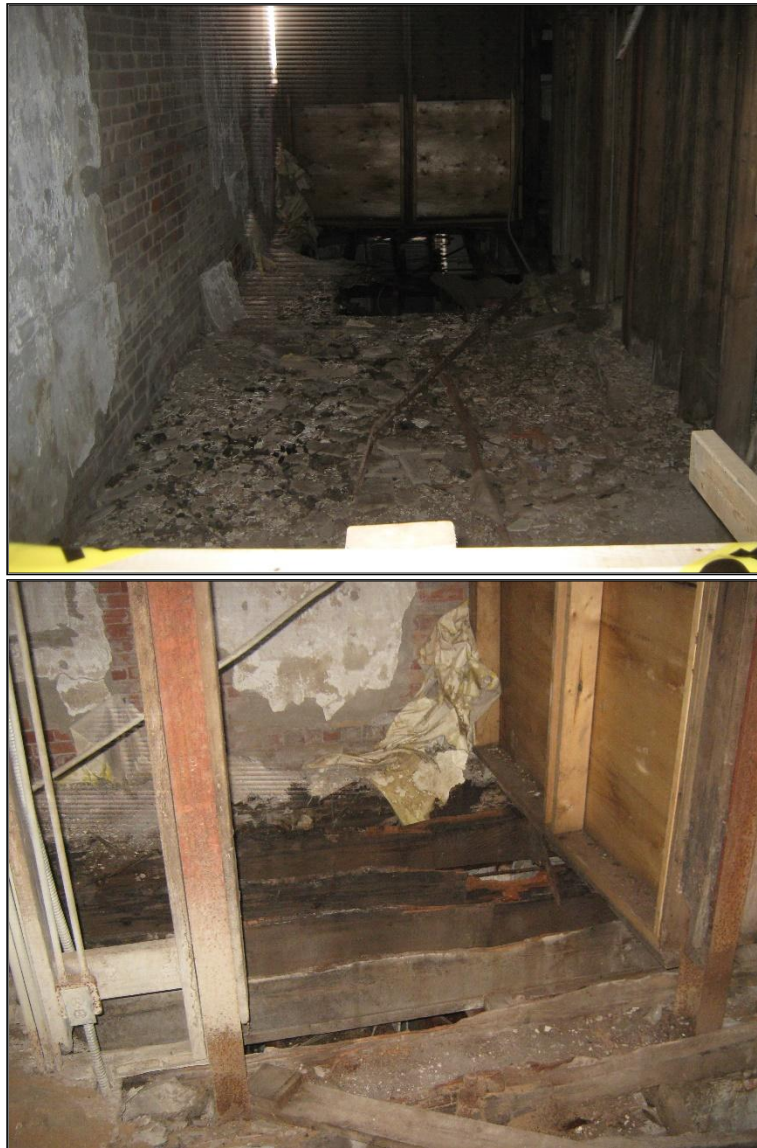
*A significant section of the main floor framing in the single storey, eastern most section of the building has collapsed, see the images below. The 2009 ERA Inspection Report indicated in Section 2.4.5 that "the single-storey east wing is missing the roof structure at the eave" and that "there is wood decay in the floor and one partition of the east addition*

**Photograph 10: Collapsed main-floor east framing (2016 Assessment)**

*Clearly, the extent of the deterioration of the floor in this area has progressed since the 2009 ERA review. The roof framing in this section appears intact and shows little evidence of ongoing water infiltration suggesting that the collapse of the main floor framing was due to the previously remediated hole in the roof over this section. It is possible that the downspouts are directing water into this area, accelerating the damage to the floor framing.*

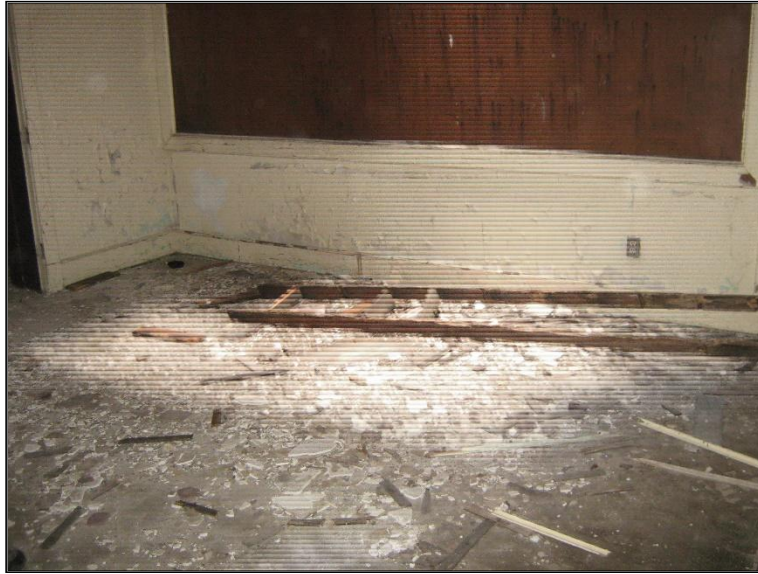
*observed in the second-floor framing from the infiltration of water directly below the open hatches, however there was a substantial amount of plaster debris piled on the floors in these locations. The image below shows one such location directly below the open roof hatch.*

**Photograph 11: Damage to second floor framing (2016 Assessment)**

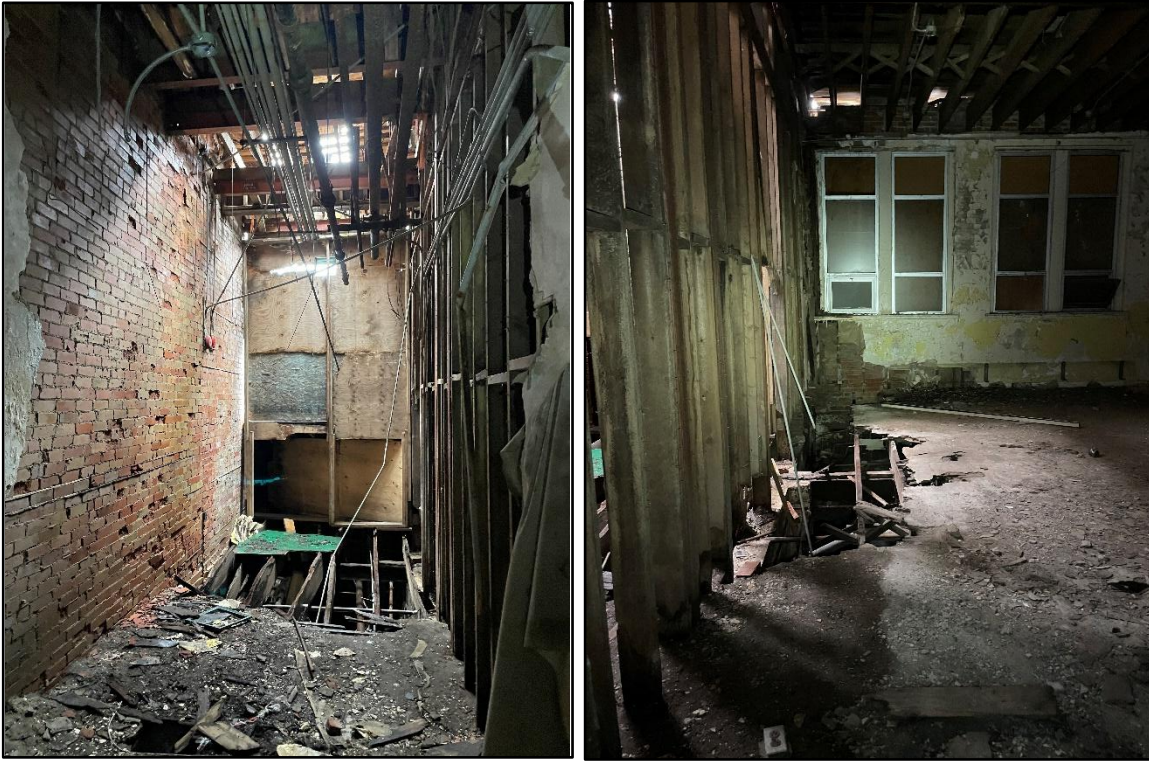
Degradation of the collapsed main floor framing in the single storey eastern section of the building has progressed significantly since the 2016 assessment. It is clear from multiple visible openings to the exterior that the area has been continuously exposed to the elements. The floor damage has spread further into the center of the building, with multiple holes through the flooring at the time of the site visit. The damage to the floor framing in the east classroom, adjacent to the collapsed corridor, has also progressed. Since the 2016 assessment, fencing has been put in place to restrict access to the collapsed areas.

**Photograph 12: Collapsed main-floor east framing (March 2025 Assessment); compare Photograph 9**

- Reconstruct damaged wall and roof framing as required to provide watertight exterior envelope (refer to section 6.3, photograph 12).
- Review and reinforce safety barriers as required.

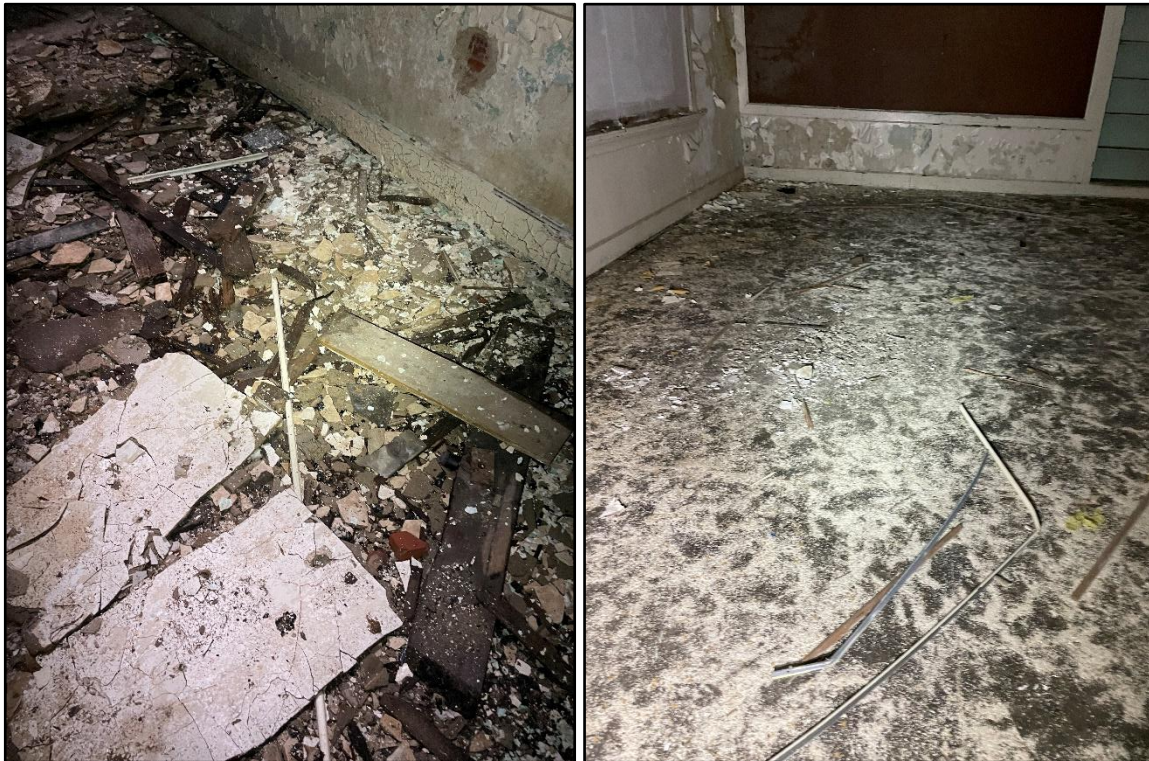
At the time of the site visit, water ingress had spread to the second floor (and first floor) framing near the open roof hatches, evident by the damp and decayed debris on the floor, and soft spots identified in the flooring.

**Photograph 13: Damage to second floor framing (March 2025 Assessment)**

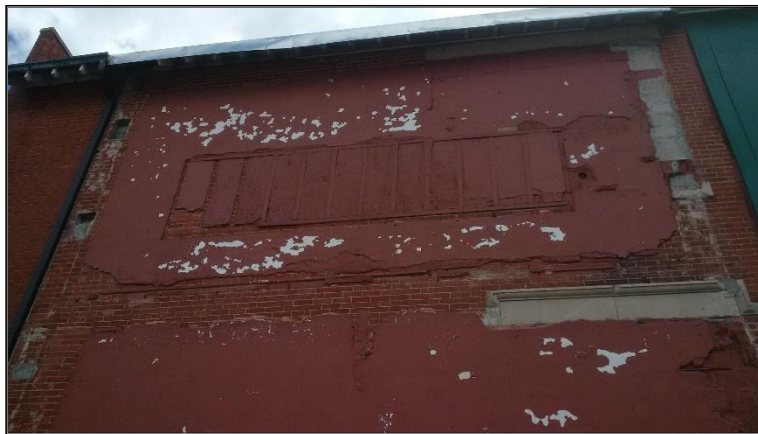
*Additionally, beam pockets were observed, where the former building additions tied into the multi wythe masonry walls of the original school. These pockets will need to be infilled as a part of any redevelopment of the building.*

**Photograph 14: Exterior beam pockets in load bearing wall (2016 Assessment)**

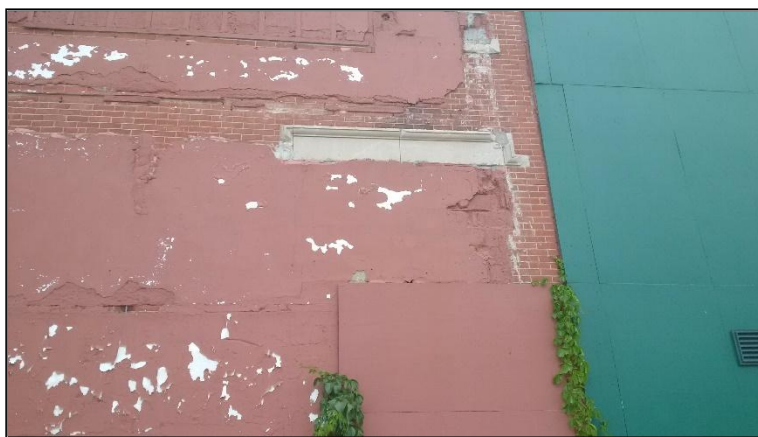
*The north and south elevations have been significantly altered from their original state. The entry doors and dormers have been removed and infilled with wood framing. The decorative stone lintels over the windows were damaged to facilitate the construction of the now demolished building additions. Depending on the scope of the redevelopment, these elements may be reintroduced, but the scope of this redevelopment is unknown at this time.*

**Photograph 15: Damaged decorative stone lintel (2016 Assessment)**

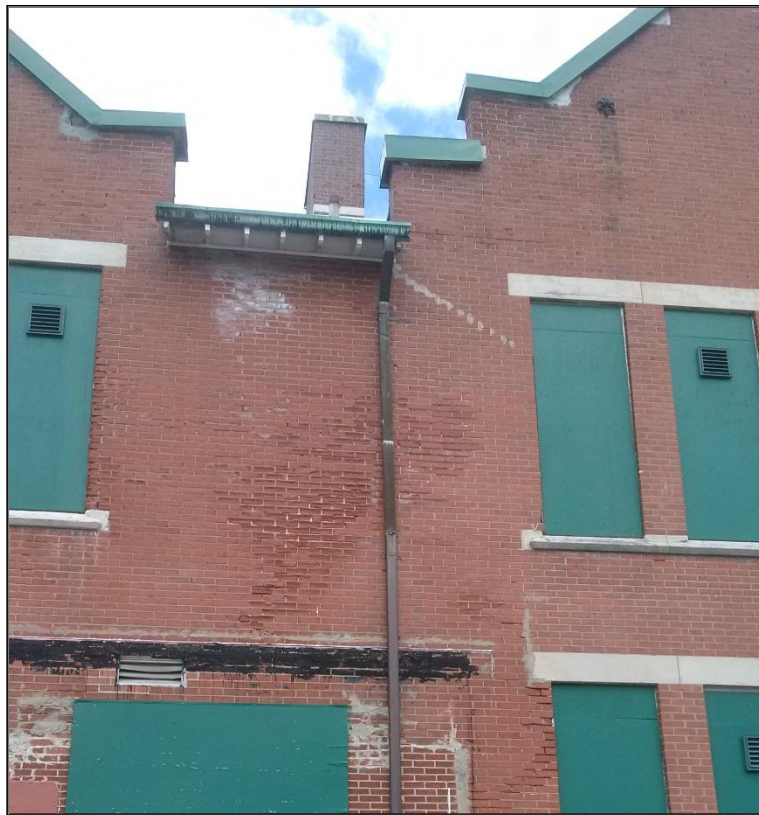
*The west (front) elevation has large areas of spalling brick. These were concentrated around the downspout locations. Likely, the downspouts do not function correctly, which is causing wetting of the brick surface during rain events. If the soft brick masonry is allowed to undergo freeze-thaw cycles in a saturated state, spalling such as this will occur at an accelerated rate.*

*Generally, on all elevations, the brick masonry appeared to be in good condition. Mortar loss is present in many brick joints, however at this point in time the repointing should be considered minor in nature, and a part of routine maintenance of the building envelope. It is estimated that approximately 25% of the mortar joints should be repointed at this point in time.*

**Photograph 16: Masonry spalling and mortar loss at west elevation (2016 Assessment)**

- Carry out masonry restoration and repointing, including replacement of spalled bricks. If mortar loss is allowed to continue, portions of the walls may become unstable and require more extensive repairs in the future. Mortar loss has increased since the 2016 assessment, and it is now estimated to include approximately 30-40% of joints.

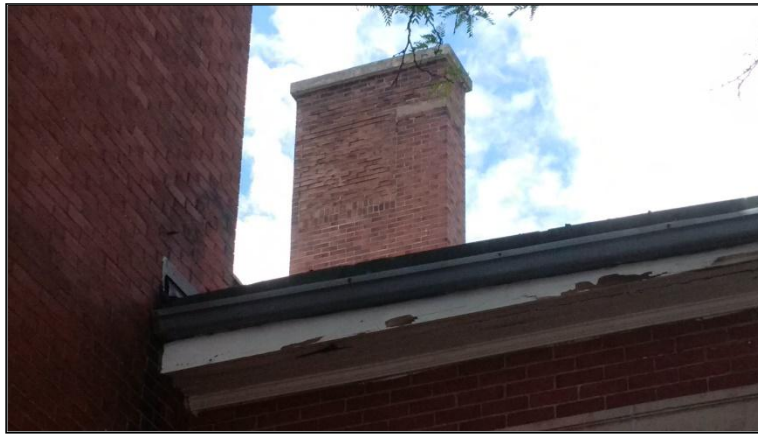
*There are four chimneys located at the subject building. The top 10'-0" of each chimney is in need of minor repairs to address mortar loss and brick damage. From the ground, the chimneys appeared to be stable, and in no danger of collapse under normal loading conditions such as snow and wind. As deterioration can continue if left unaddressed, the masonry repairs should be carried out to ensure the stability of the chimneys is not compromised in the future.*

**Photograph 17: Mortar loss and brick damage to chimney masonry (2016 assessment)**

- Re-point the brick chimney masonry, replacing damaged brick units as required.

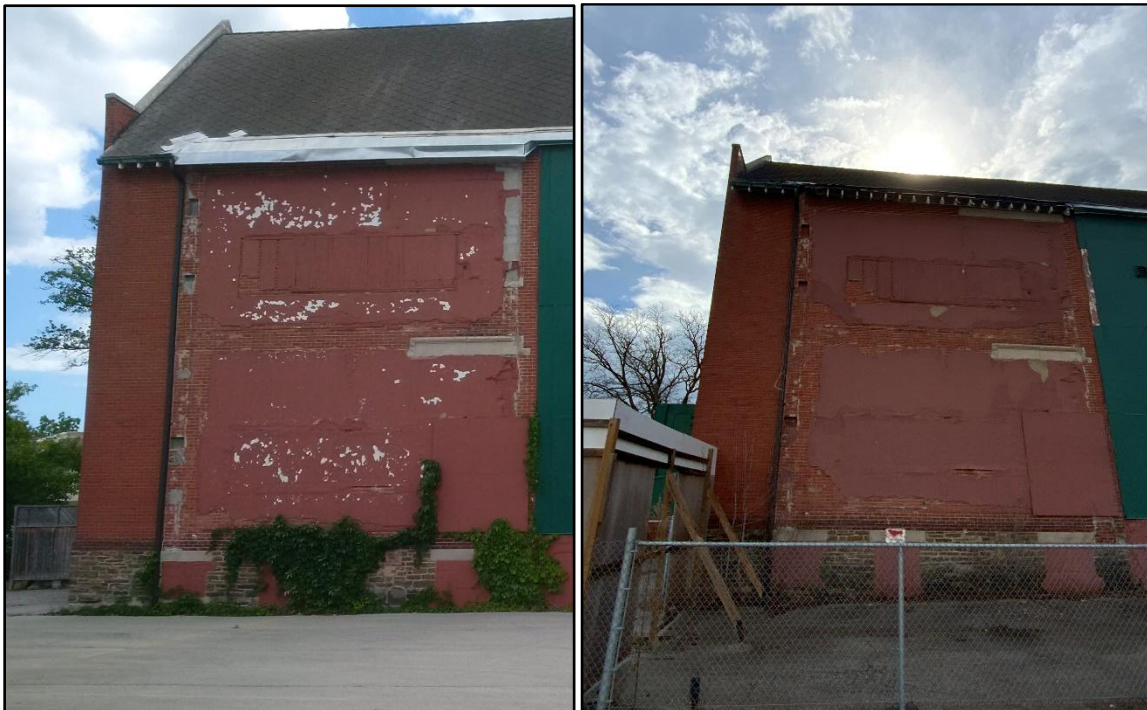
Overall, the masonry walls as reviewed from the exterior from grade were in similar condition as noted at the time of the 2016 condition assessment, with some local areas of progressed deterioration. The flashing to the east side of the elevation has failed, as shown in the photographs below. The masonry and parging directly below did not show signs of advanced deterioration at the time of the site visit, however further exposure could allow for deterioration to progress. It appeared that some of the walls have been partially re-painted since the 2016 assessment.

**Photograph 18: North elevation flashing failure (2016 – Left, March 2025 – Right)**

- Complete a thorough review of the roof condition, including an assessment of water control systems. Conduct the necessary repairs to ridge cap and eave flashing, downspouts, and gutters. Ensure water is properly diverted from all surfaces of the structure.

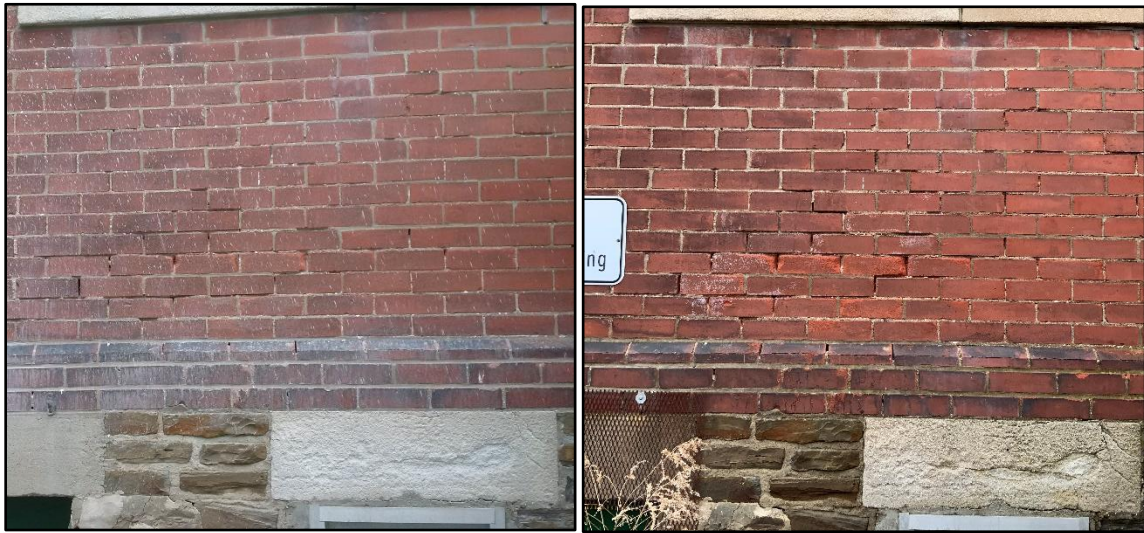
At multiple locations, a direct comparison of the masonry condition from both assessments found that mortar loss and brick spalling has progressed since the 2016 assessment. Masonry staining and efflorescence was also evident on multiple elevations.

**Photograph 19: East elevation brick spalling and mortar loss (2016 – Left, March 2025 – Right)**

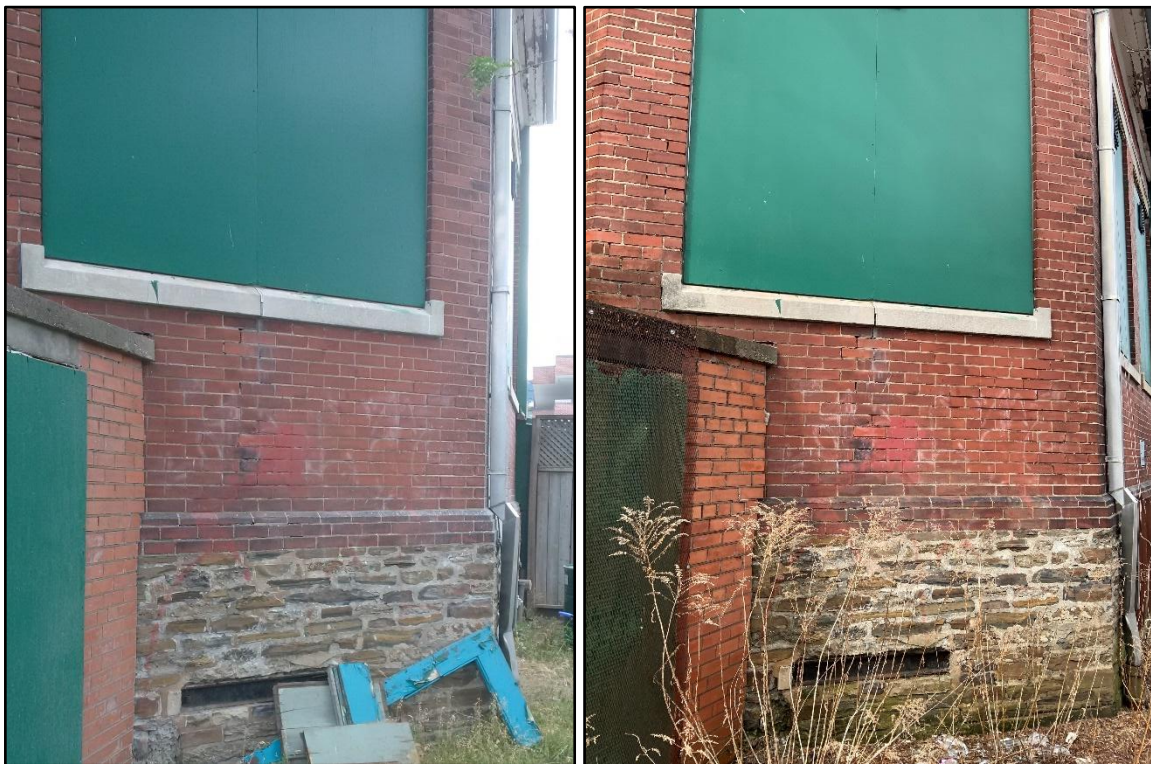
**Photograph 20: East elevation brick spalling and mortar loss (2016 – Left, March 2025 – Right)**

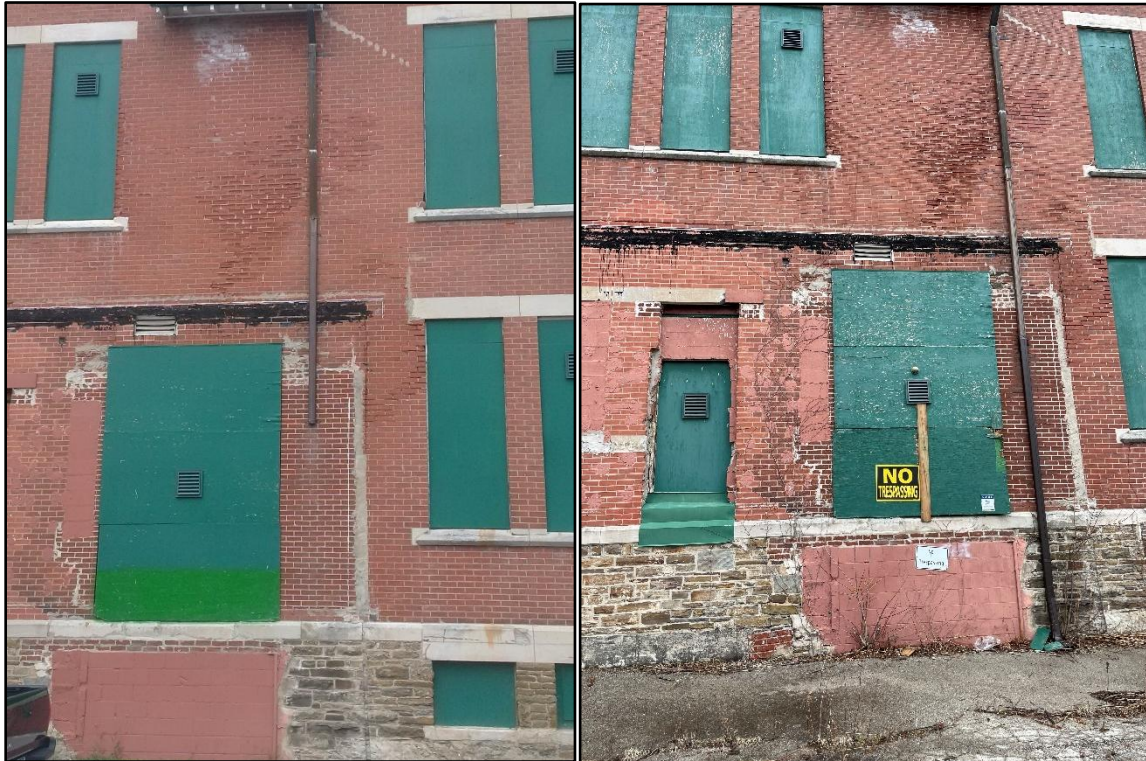
**Photograph 21: West elevation brick spalling and mortar loss (2016 – Left, March 2025 – Right)**

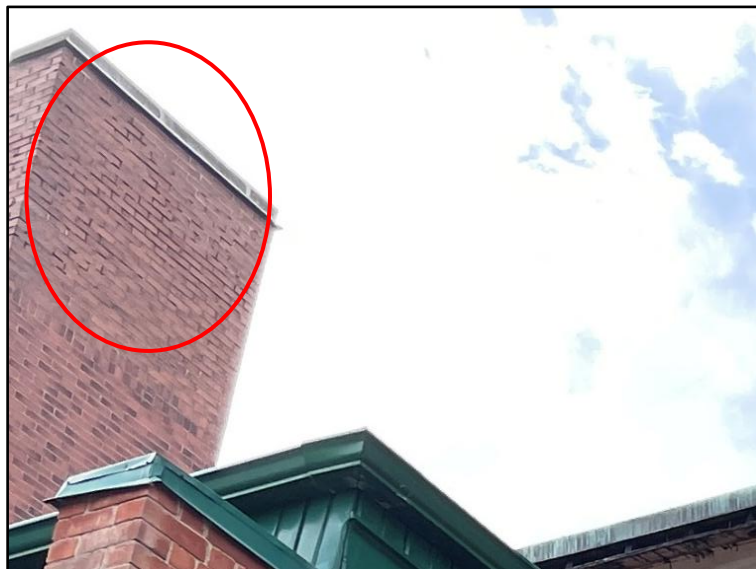
The repointing scope recommended for the four chimneys in the 2016 assessment was not completed, leading to further mortar loss. This condition should be addressed to avoid loss of stability and collapse of the chimney structures.

**Photograph 22: Mortar loss and brick damage to chimney masonry (March 2025 assessment)**
