UPDATED SLOPE **STABILITY ASSESSMENT**

Proposed Development

1260 & 1280 Dundas Street West, Oakville, ON

BIGC-GEO-185E

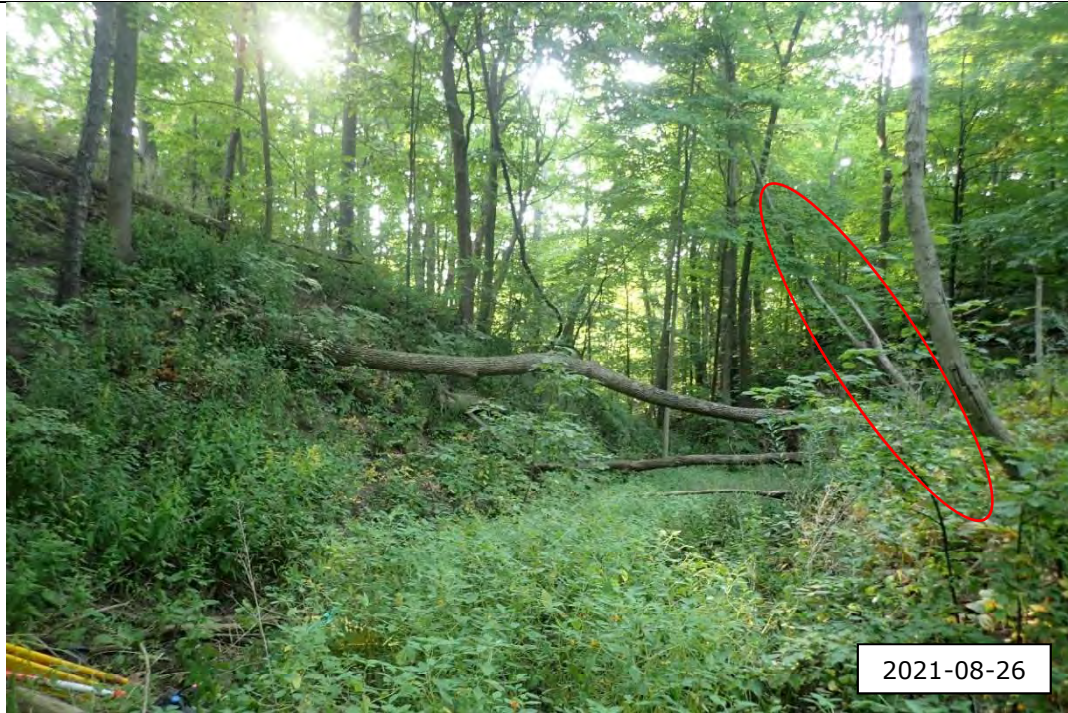
Photo 3
Reach GCT-1 – Tributary of Sixteen Mile Creek

The riparian buffer zone was 4 to 10 channel widths. Riparian vegetation was comprised of a mix of mature tree species. Leaning/fallen trees, indicated by the red circle were observed approximately every 50 meters in the channel.

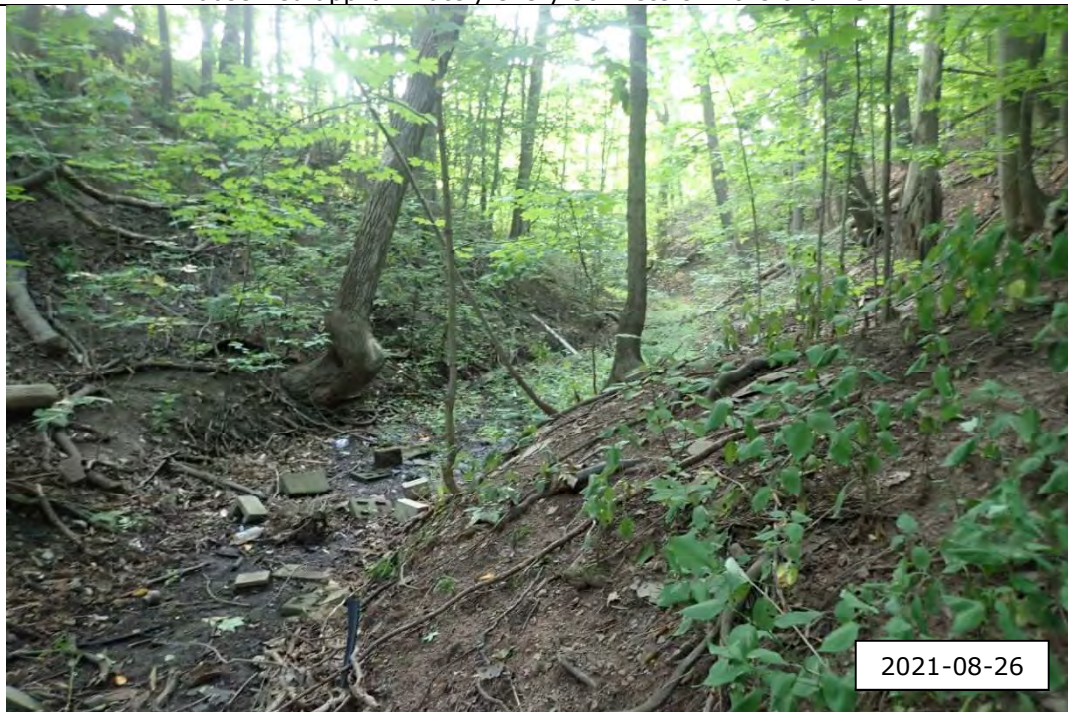
Photo 4
Reach GCT-1 – Tributary of Sixteen Mile Creek

Photograph taken looking downstream. The reach consisted of riffles and bed materials consisted primarily of cobble embedded by clay and silt. No shale bedrock was exposed in the channel bed or banks.

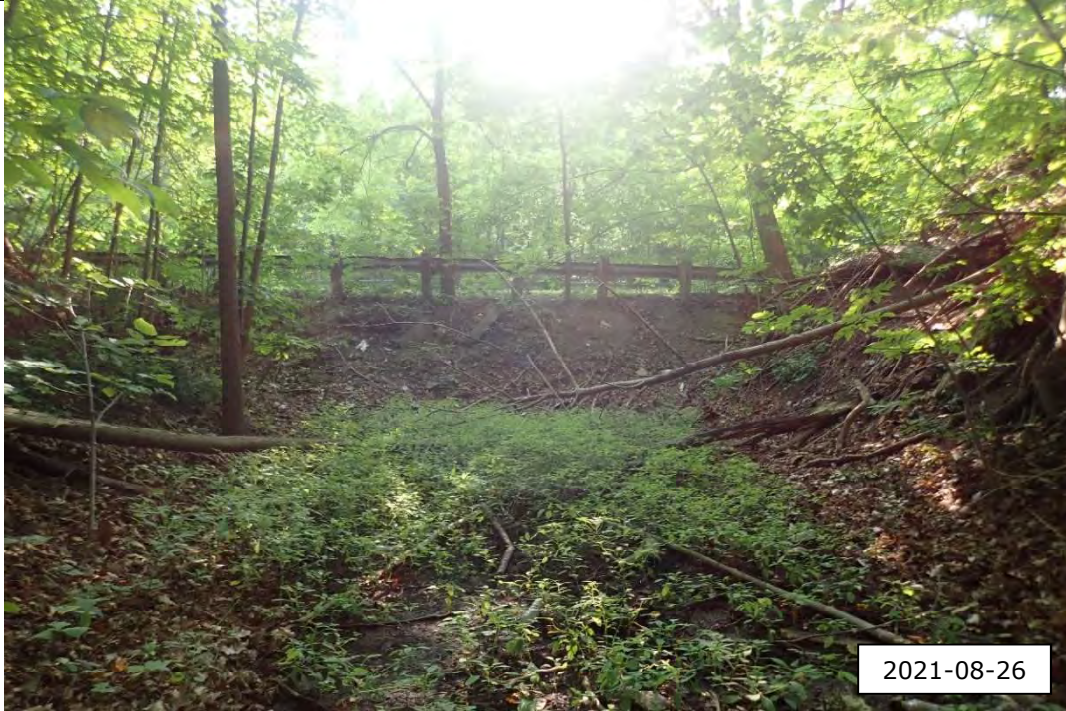
Photo 5
Reach GCT-1 – Tributary of Sixteen Mile Creek

Downstream view of the watercourse. The reach was dry at the time of assessment. Average bankfull width and depth were 3.08 m and 0.24 m, respectively.

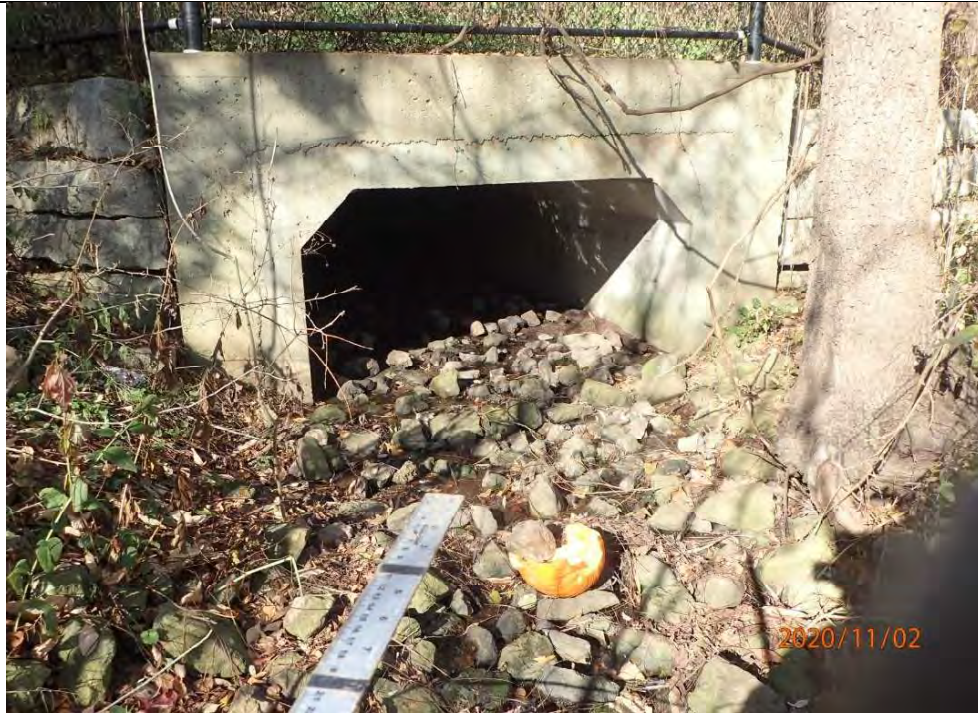
Photo 7
Reach GC-3 – Tributary of Sixteen Mile Creek

Flows exited the culvert south of Glenayr Gate into a stone treatment. No scour was noted downstream of the outlet.

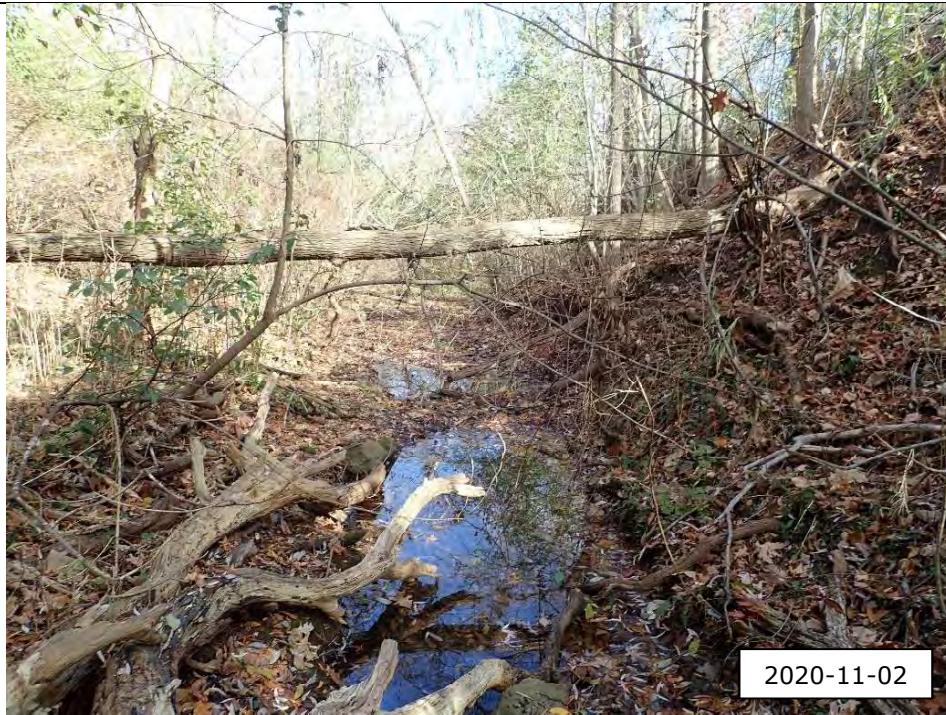
Photo 8
Reach GC-3 – Tributary of Sixteen Mile Creek

Reach **GC-3** was characterized as a narrow, confined, forested valley with a high gradient.

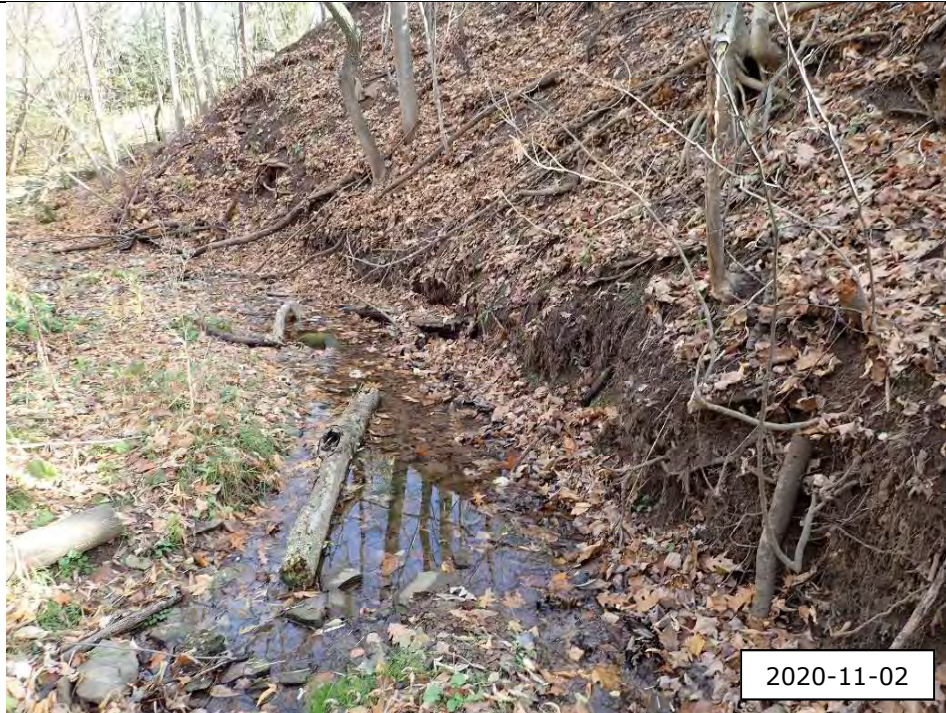
Photo 9
Reach GC-3 – Tributary of Sixteen Mile Creek

Several instances of valley wall contact and erosion were noted in **Reach GC-3**.

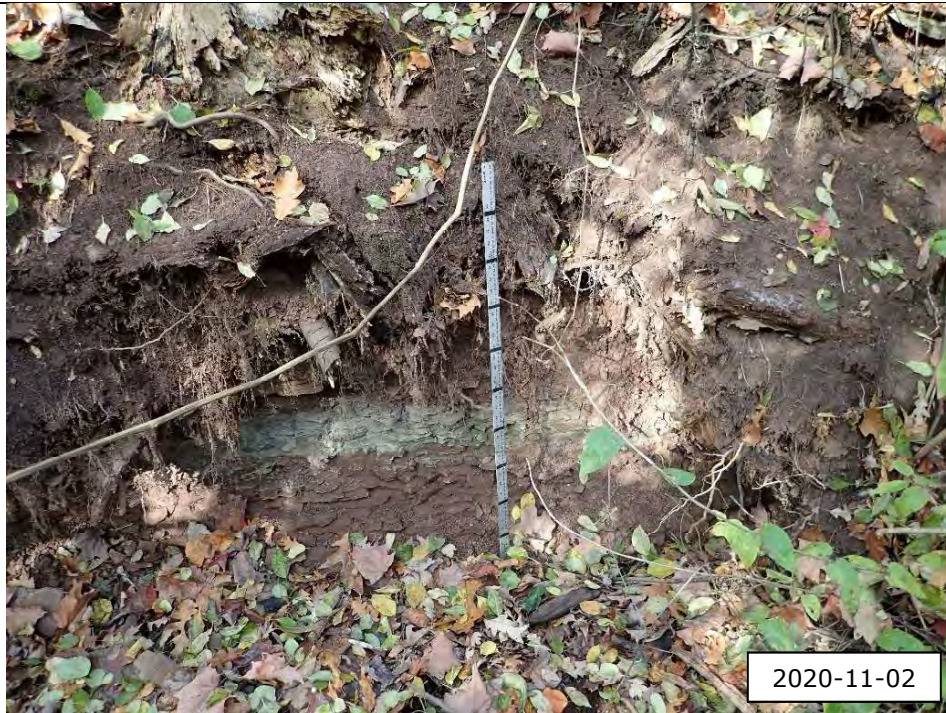
Photo 10
Reach GC-3 – Tributary of Sixteen Mile Creek

Exposed parent-material, Queenston shale, was frequently observed along the channel banks.

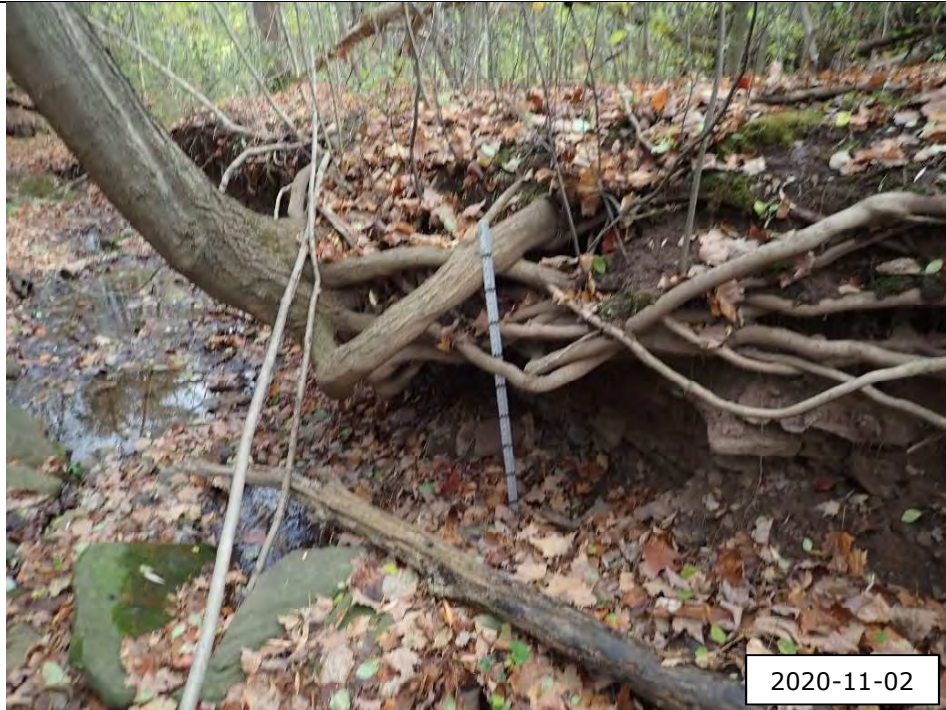
Photo 11
Reach GC-3 – Tributary of Sixteen Mile Creek

Mature tree roots were commonly exposed on the banks. Substrate was coarse and consisted of platy pebbles and cobbles derived from the shale material.

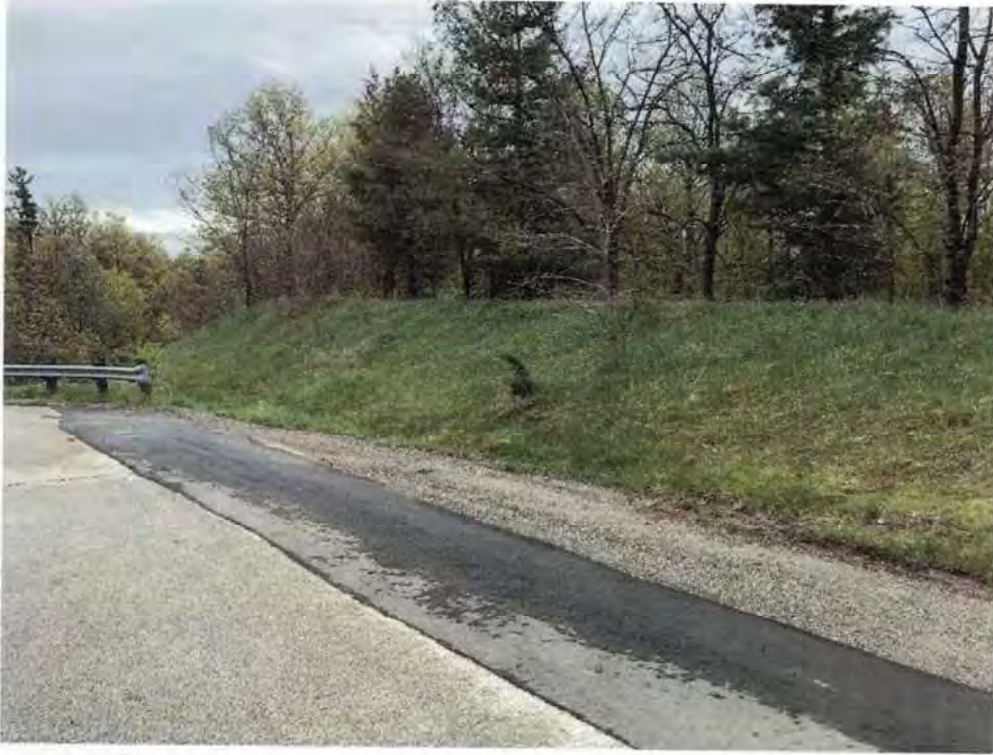
West Slope – Looking south, Cross Section C

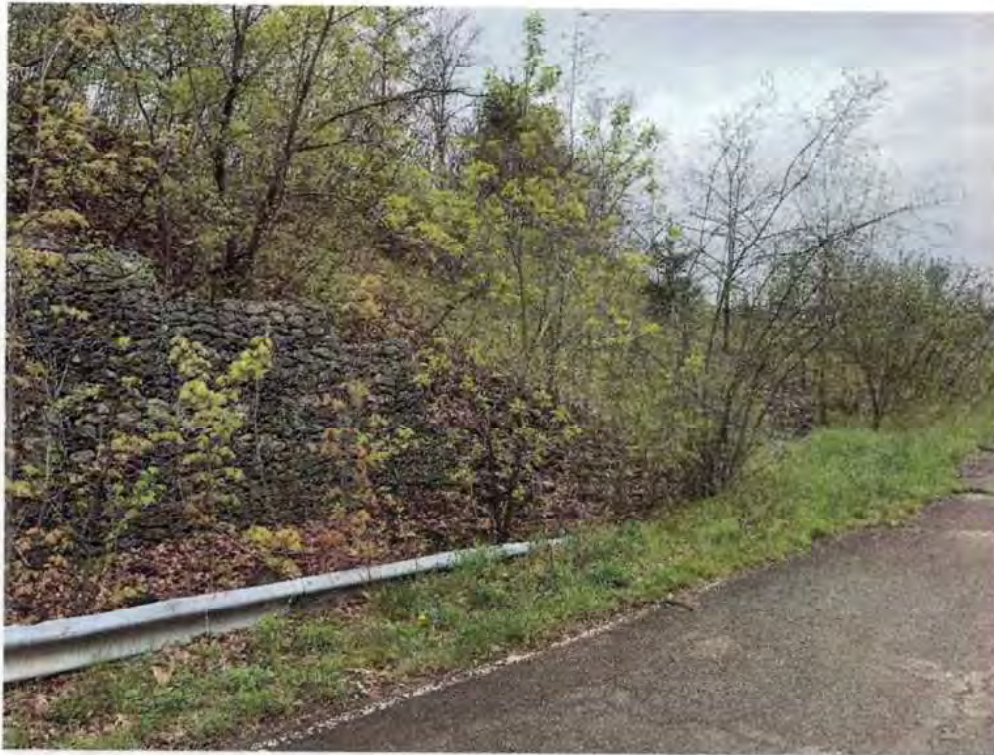
West Slope – Looking North, Gabion Retaining Wall

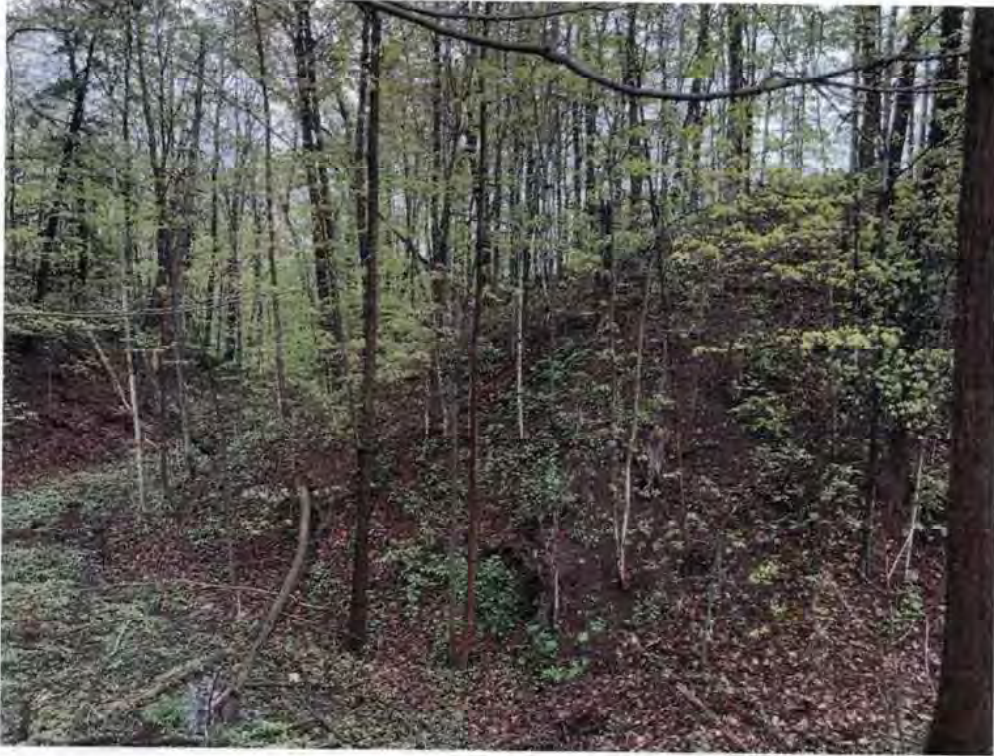
West Slope – Looking West, drainage flowing east toward Sixteen Mile Creek, Cross Section E

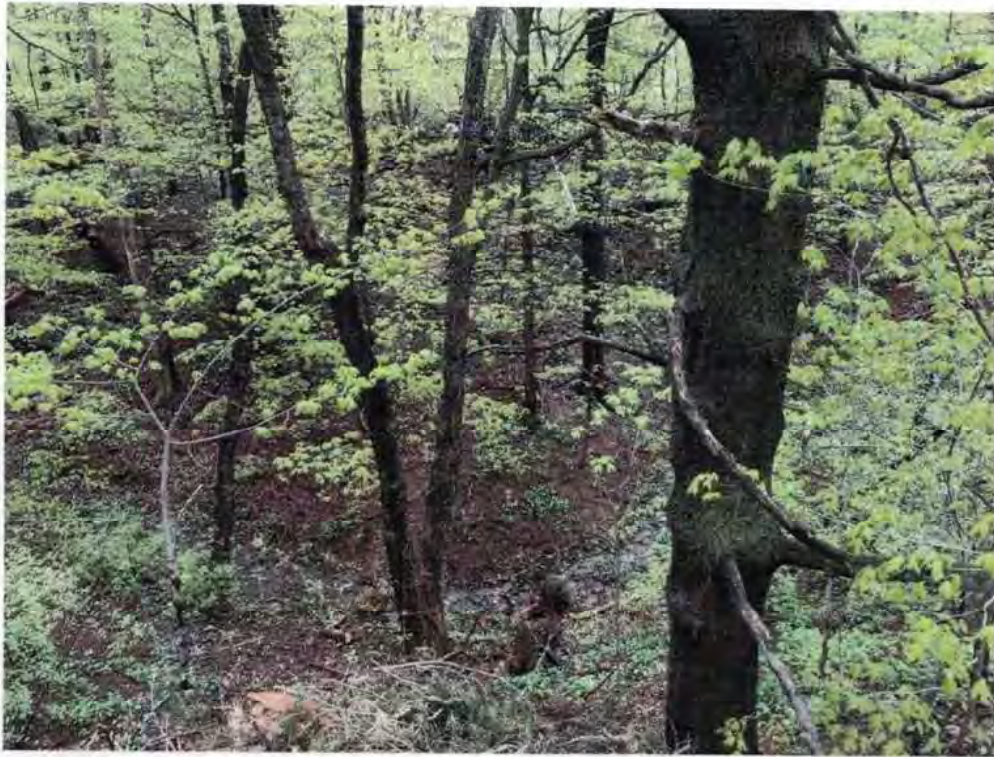
West Slope – Looking South, Cross Section E

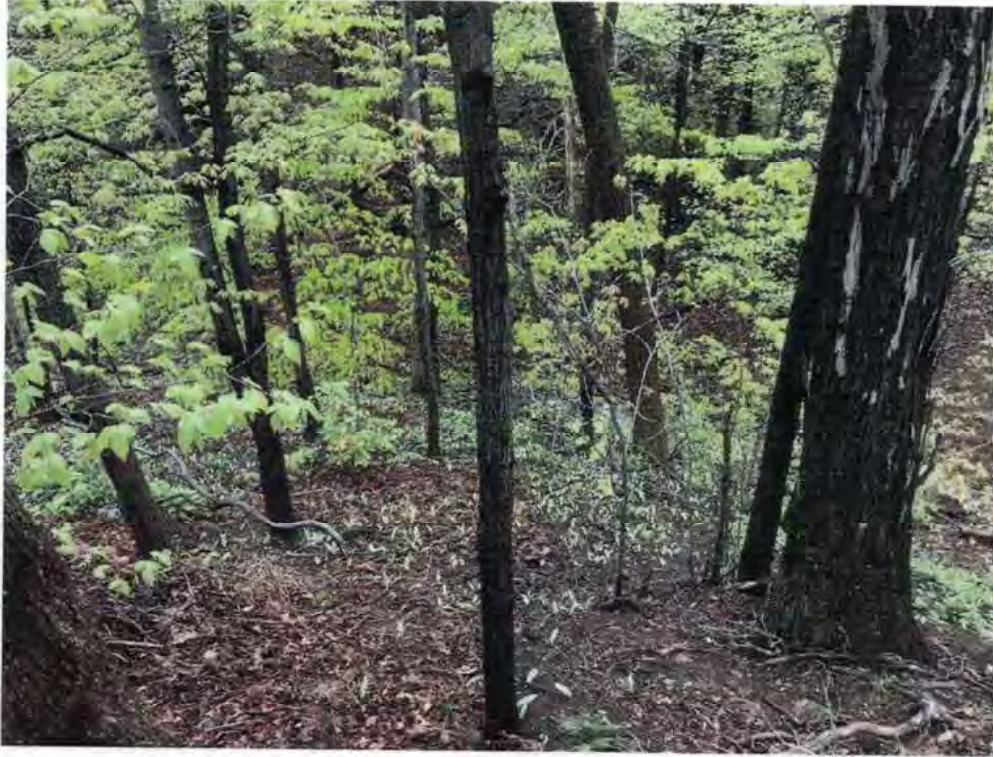
West Slope – Looking South, Cross Section D

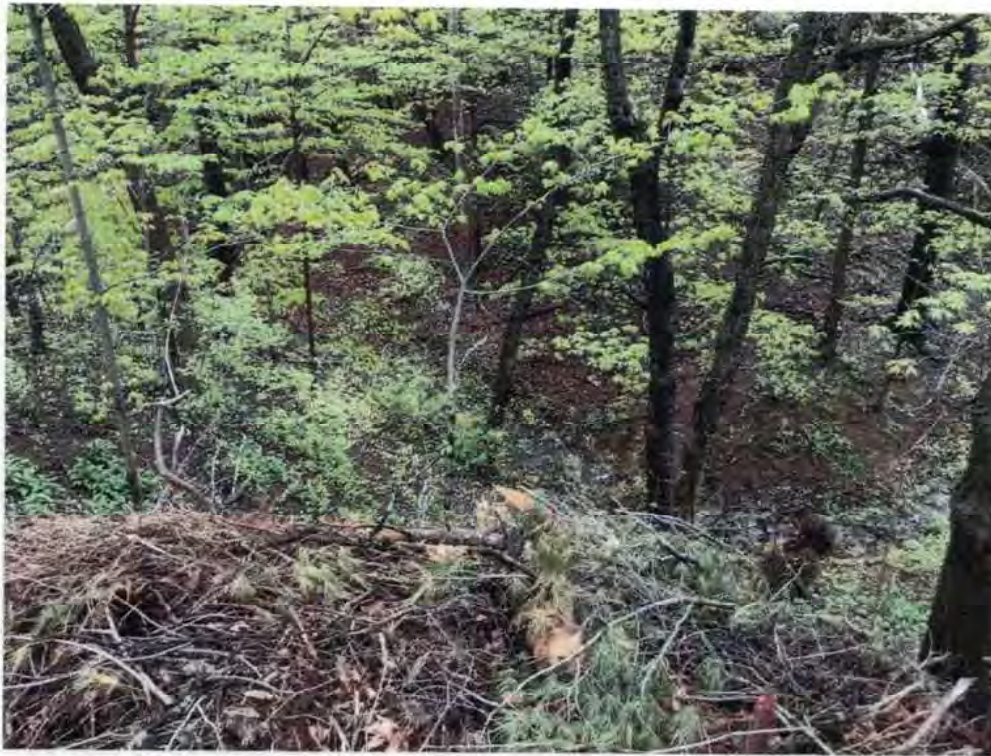
West Slope – Looking South, Cross Section D

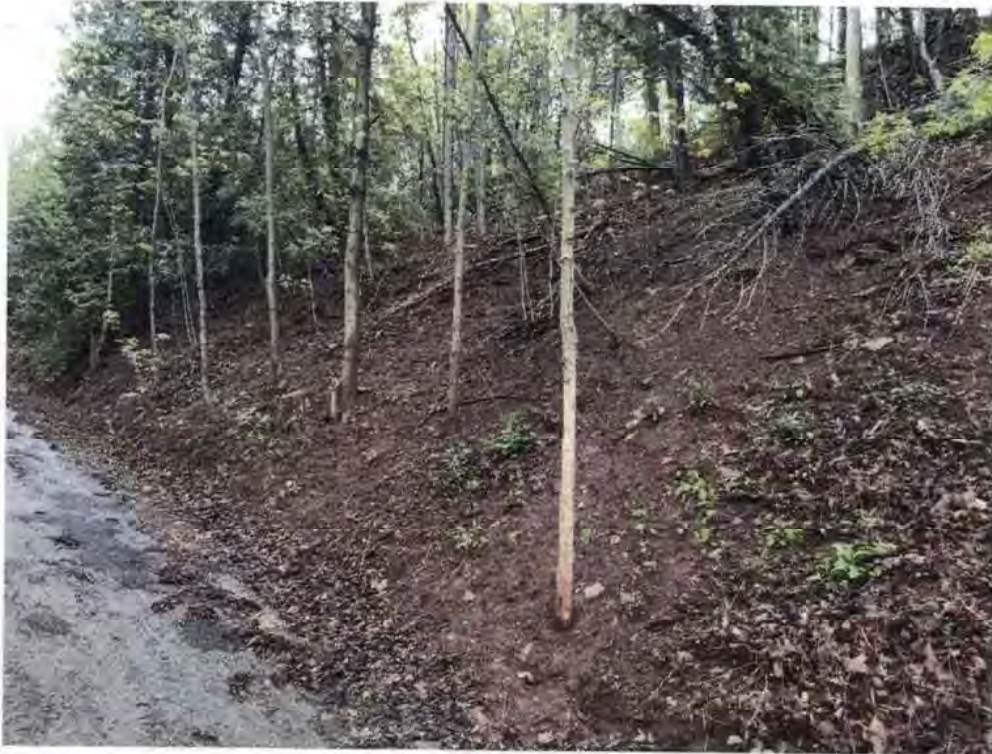
Sixteen Mile Creek Slope – Looking South, Cross Section C

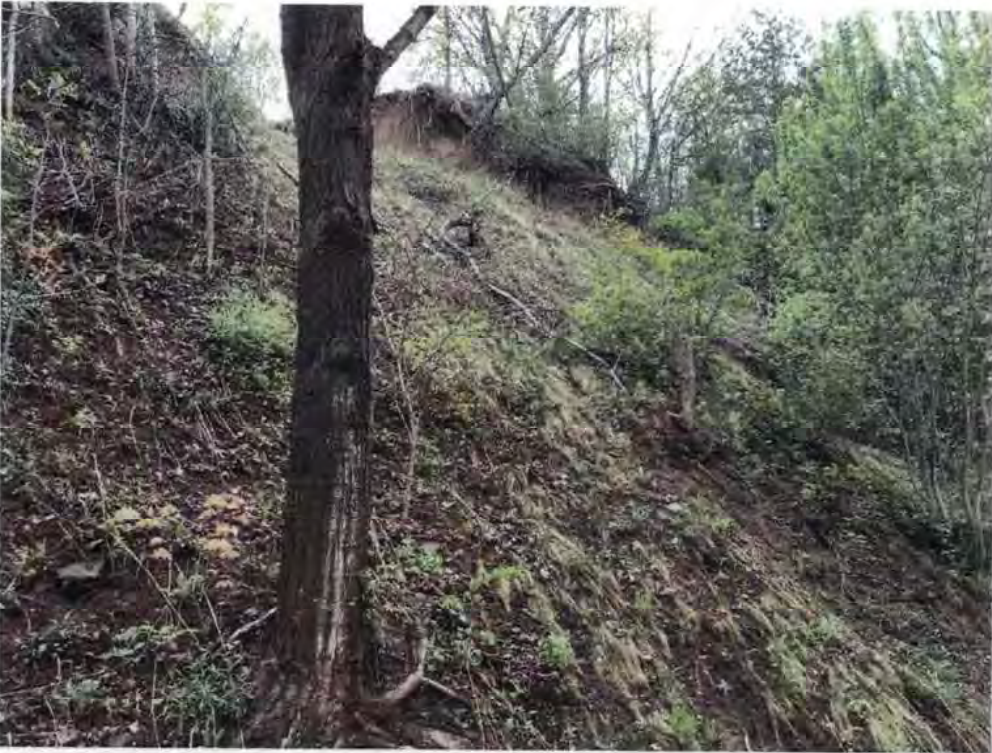
Sixteen Mile Creek Slope – Looking Northwest, Cross Section C

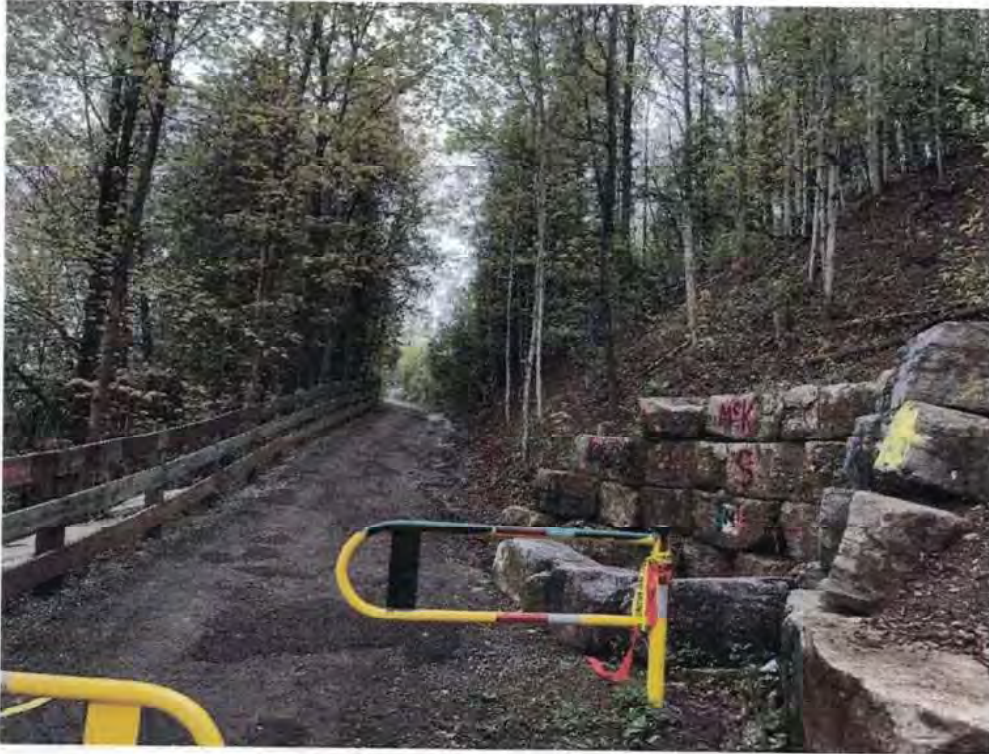
Sixteen Mile Creek Slope – Trail dividing the slope, looking Southeast

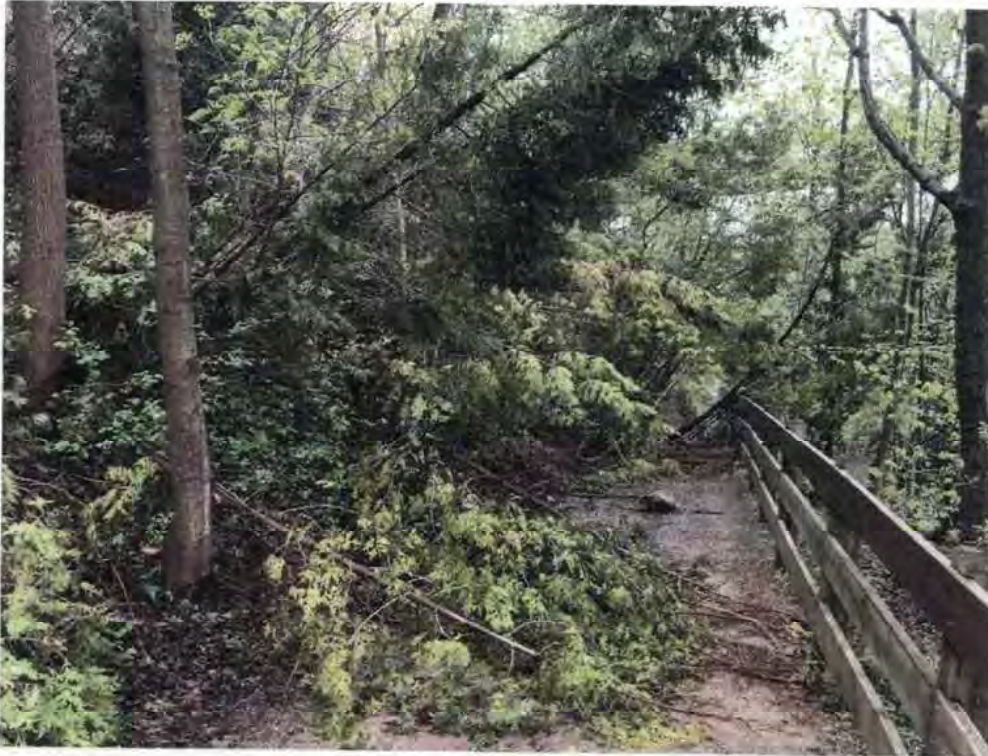
Sixteen Mile Creek Slope – Looking Southwest, slope overburden erosion impeding path, Cross Section B

6. Where erosion planes are present, slope treatment such as rip-wrap drainage and/or geogrid reinforcement and seeding of the slope surface is recommended.

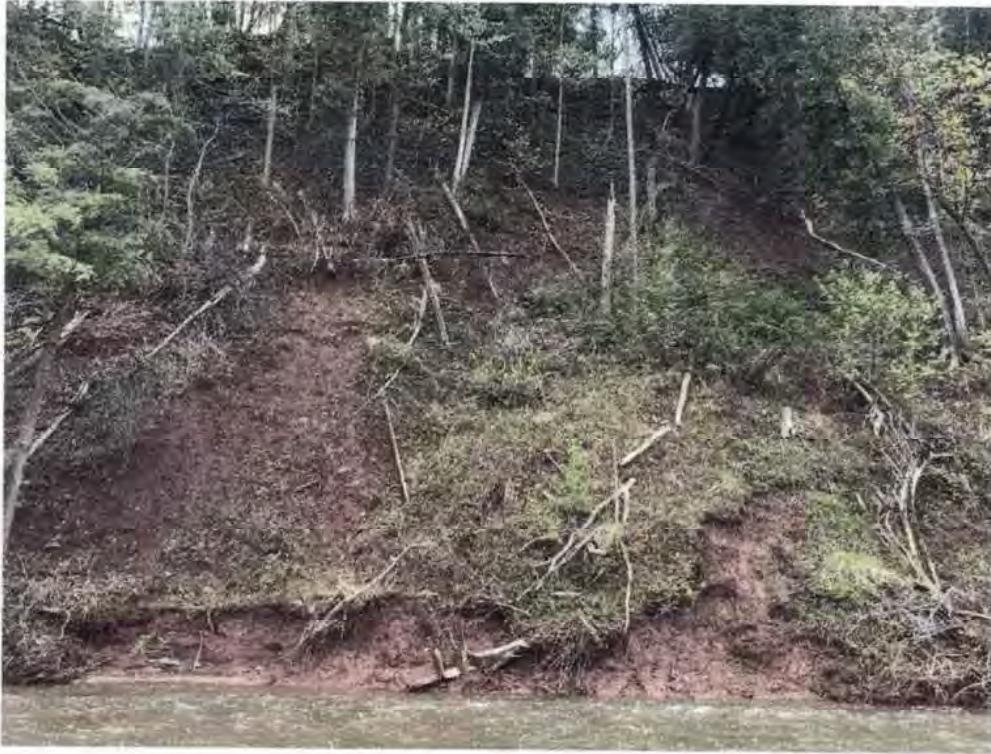
Sixteen Mile Creek Slope – Toe of slope, looking West

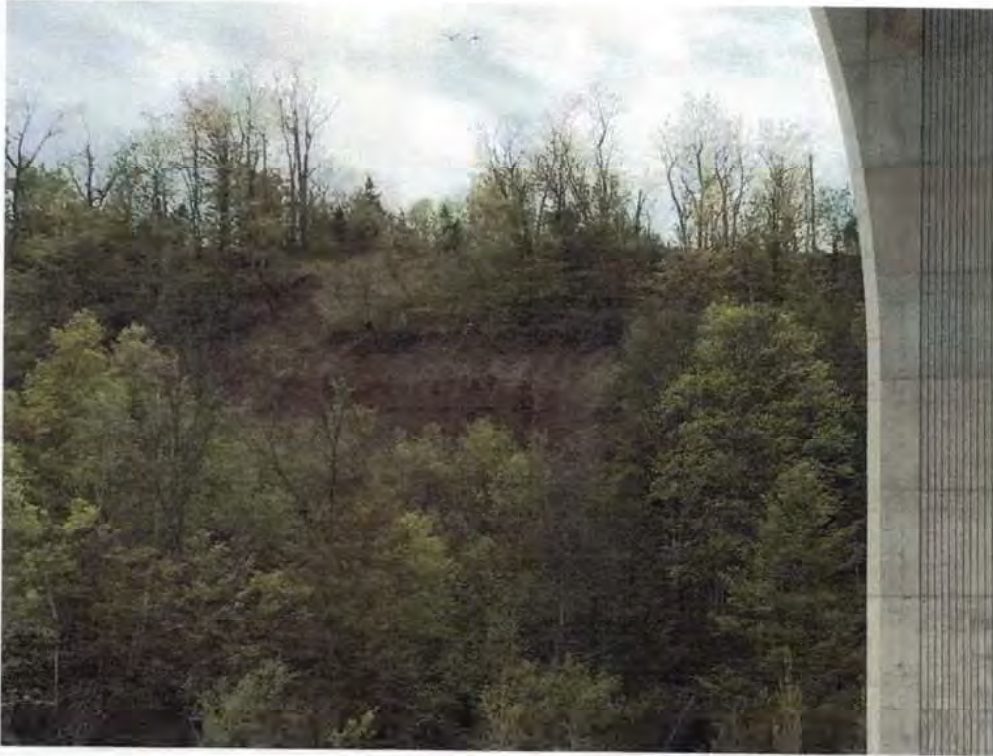
Sixteen Mile Creek Slope – Erosion of overburden on top of Queenston Shale, looking southwest, Cross Section A
