# **Arborist Report & Tree Preservation Plan**

1059, 1079, 1087 & 1095 Linbrook Road  
Oakville, ON

**July 6, 2026**

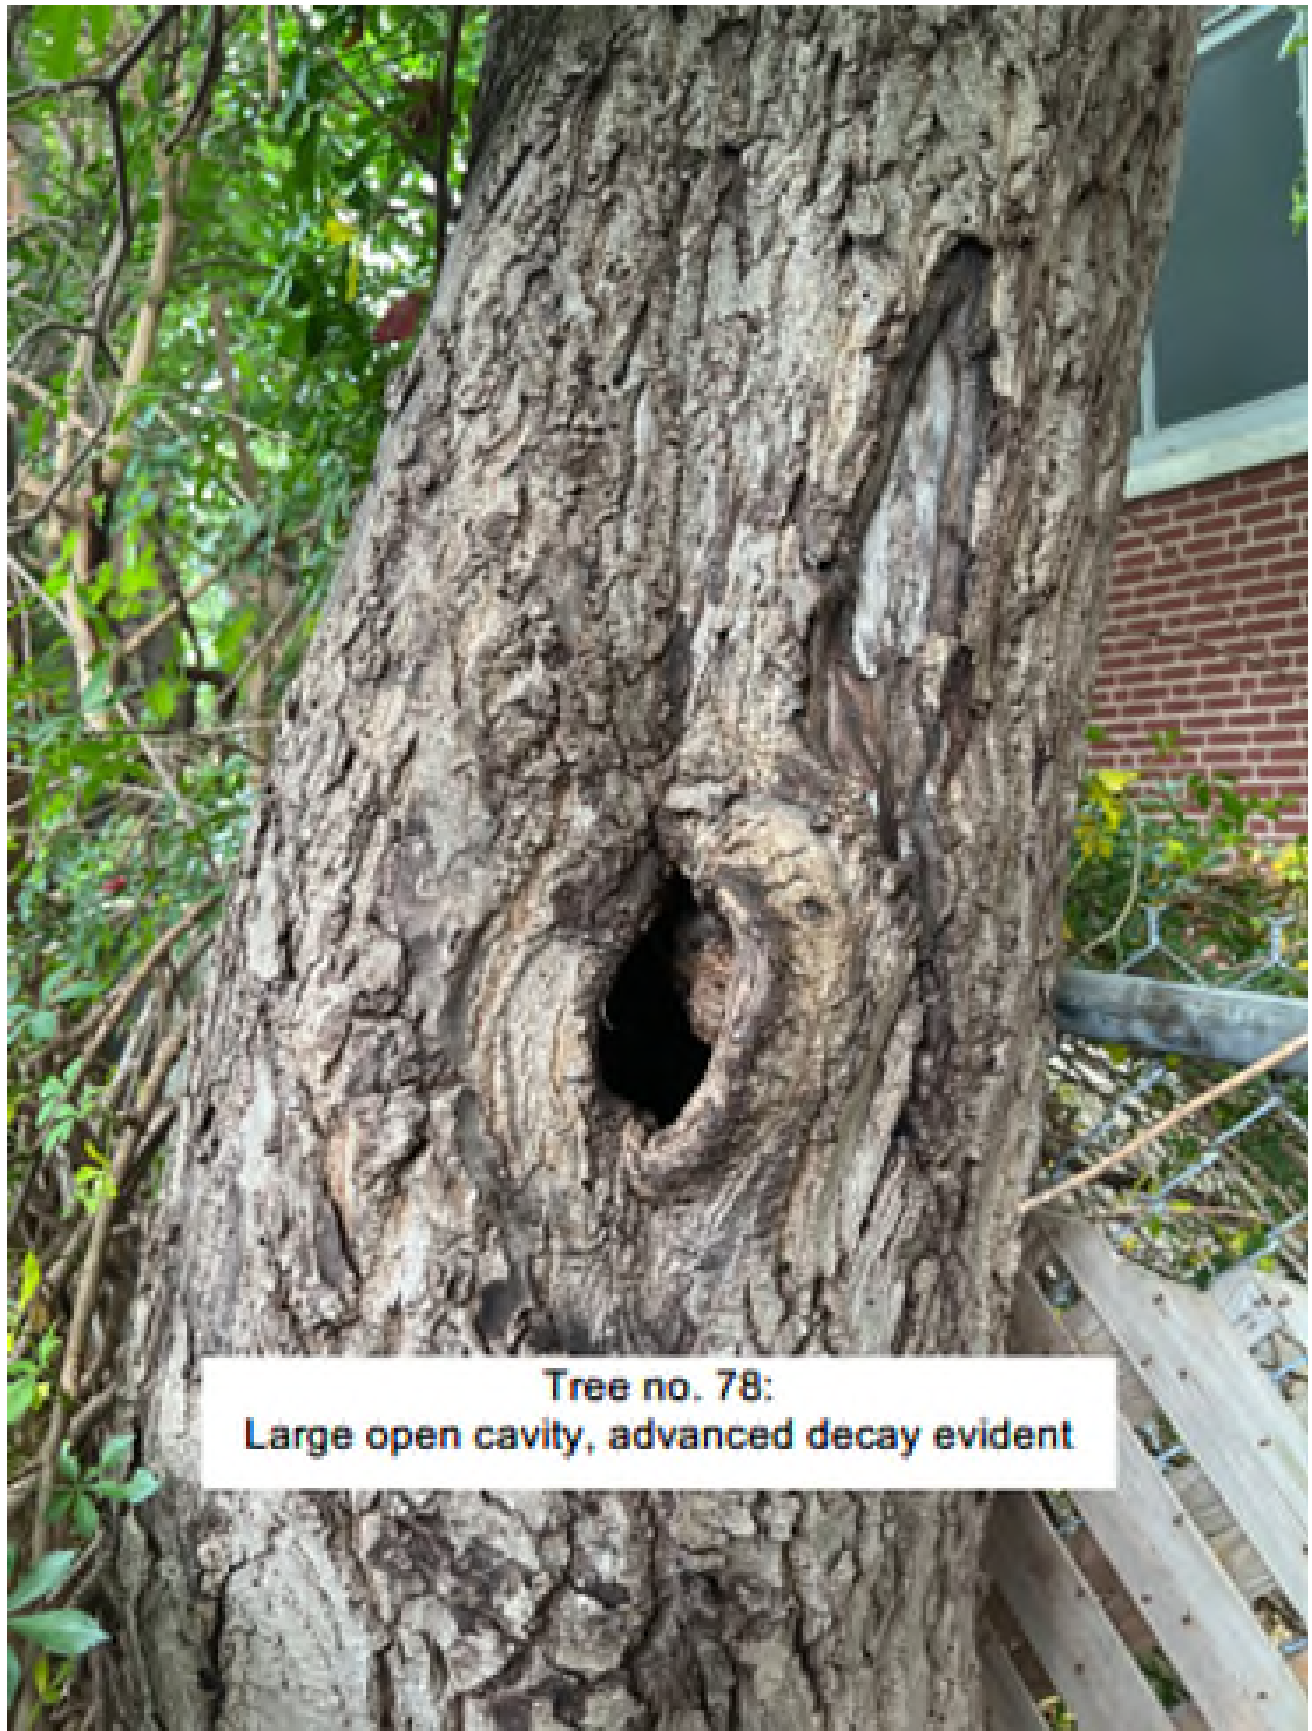
**Photo #30:**

| Tree # | Owner | Botanical Name | Common Name | DBH (cm) | Canopy Radius (m) | Vigour | Structure | Overall Condition | mTPZ (m) | Develop Impact | Action | Permit Required | Comments |
|---|---|---|---|---|---|---|---|---|---|---|---|---|---|
| 78 | P | <i>Juglans cinerea</i> | White walnut | 54 | - | P | P | P | 3.6 | High | R | Y | decay/open cavity in trunk, root rot at base; in conflict with proposed project |

**Tree no. 78:**  
**Large open cavity, advanced decay evident**

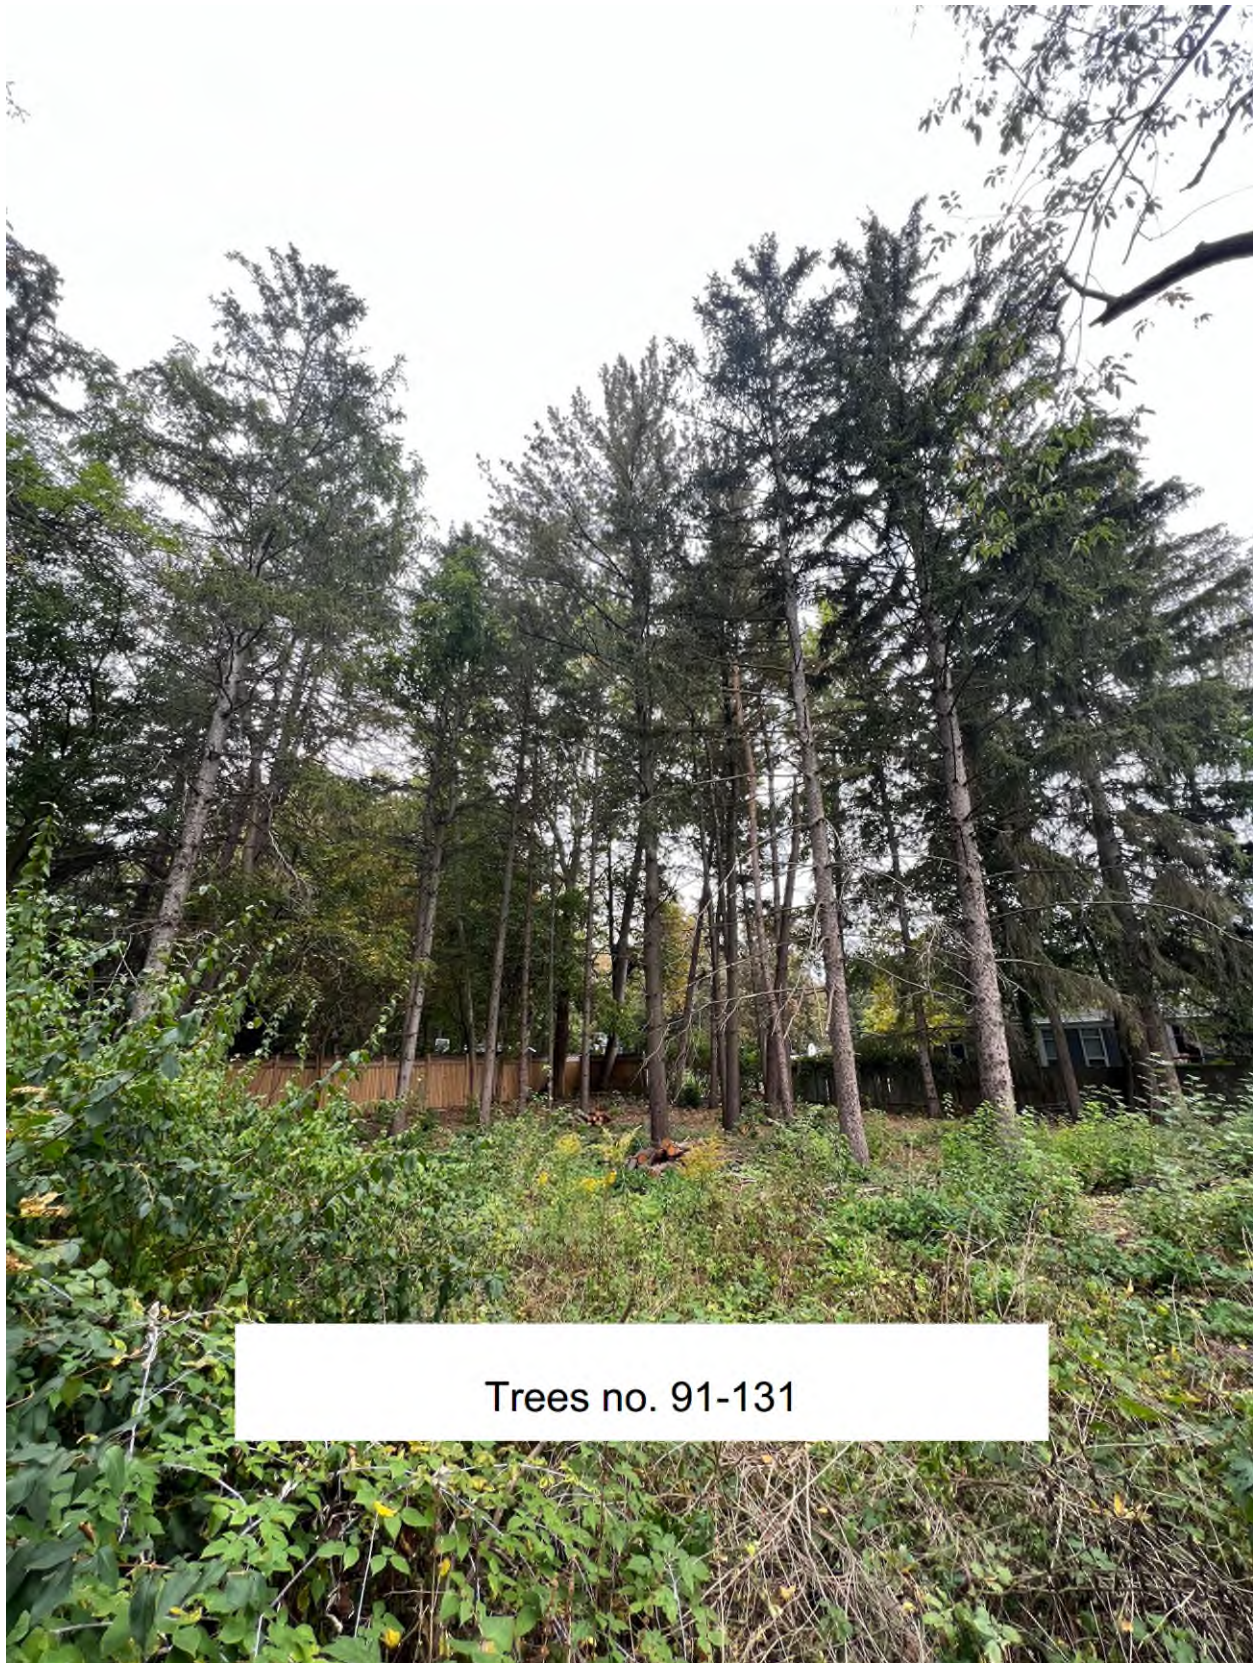
**Photo #34:**

Trees no. 91-131

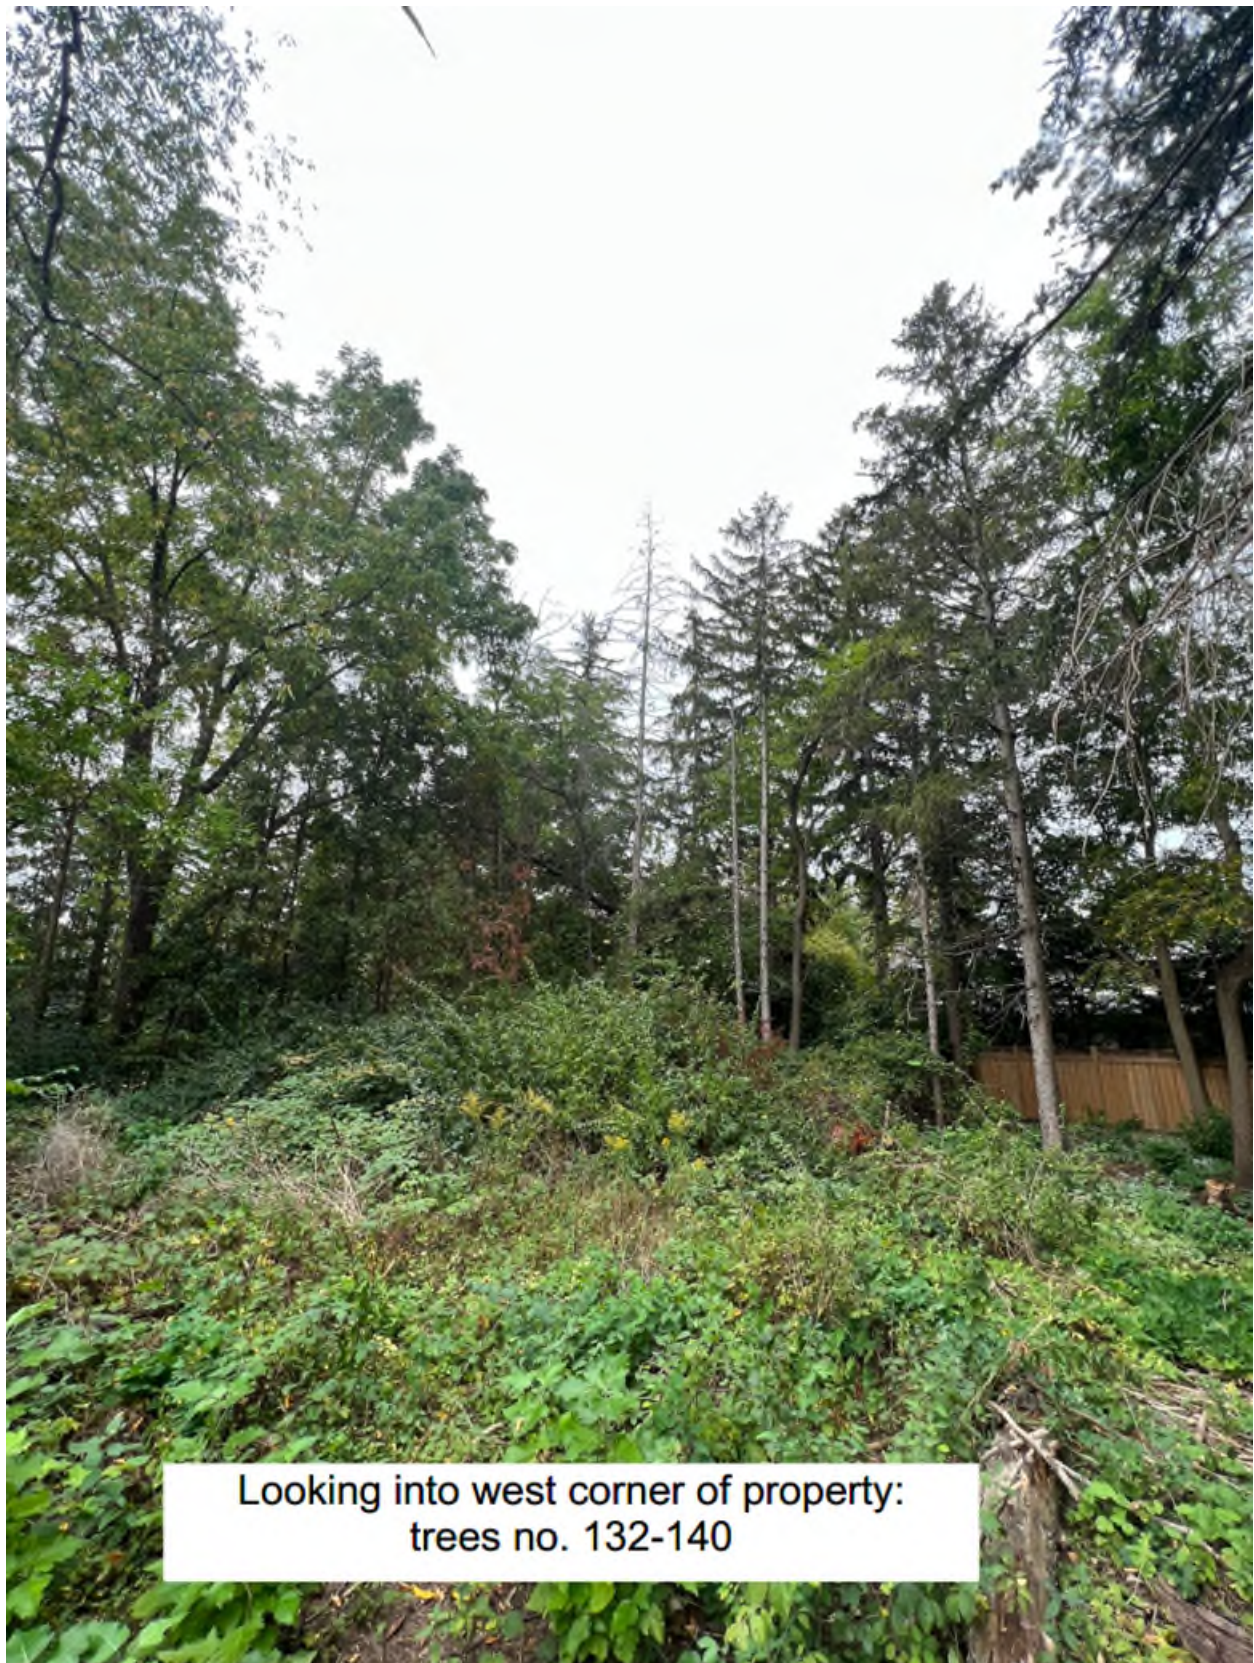
**Photo #35:**

Looking into west corner of property:  
trees no. 132-140

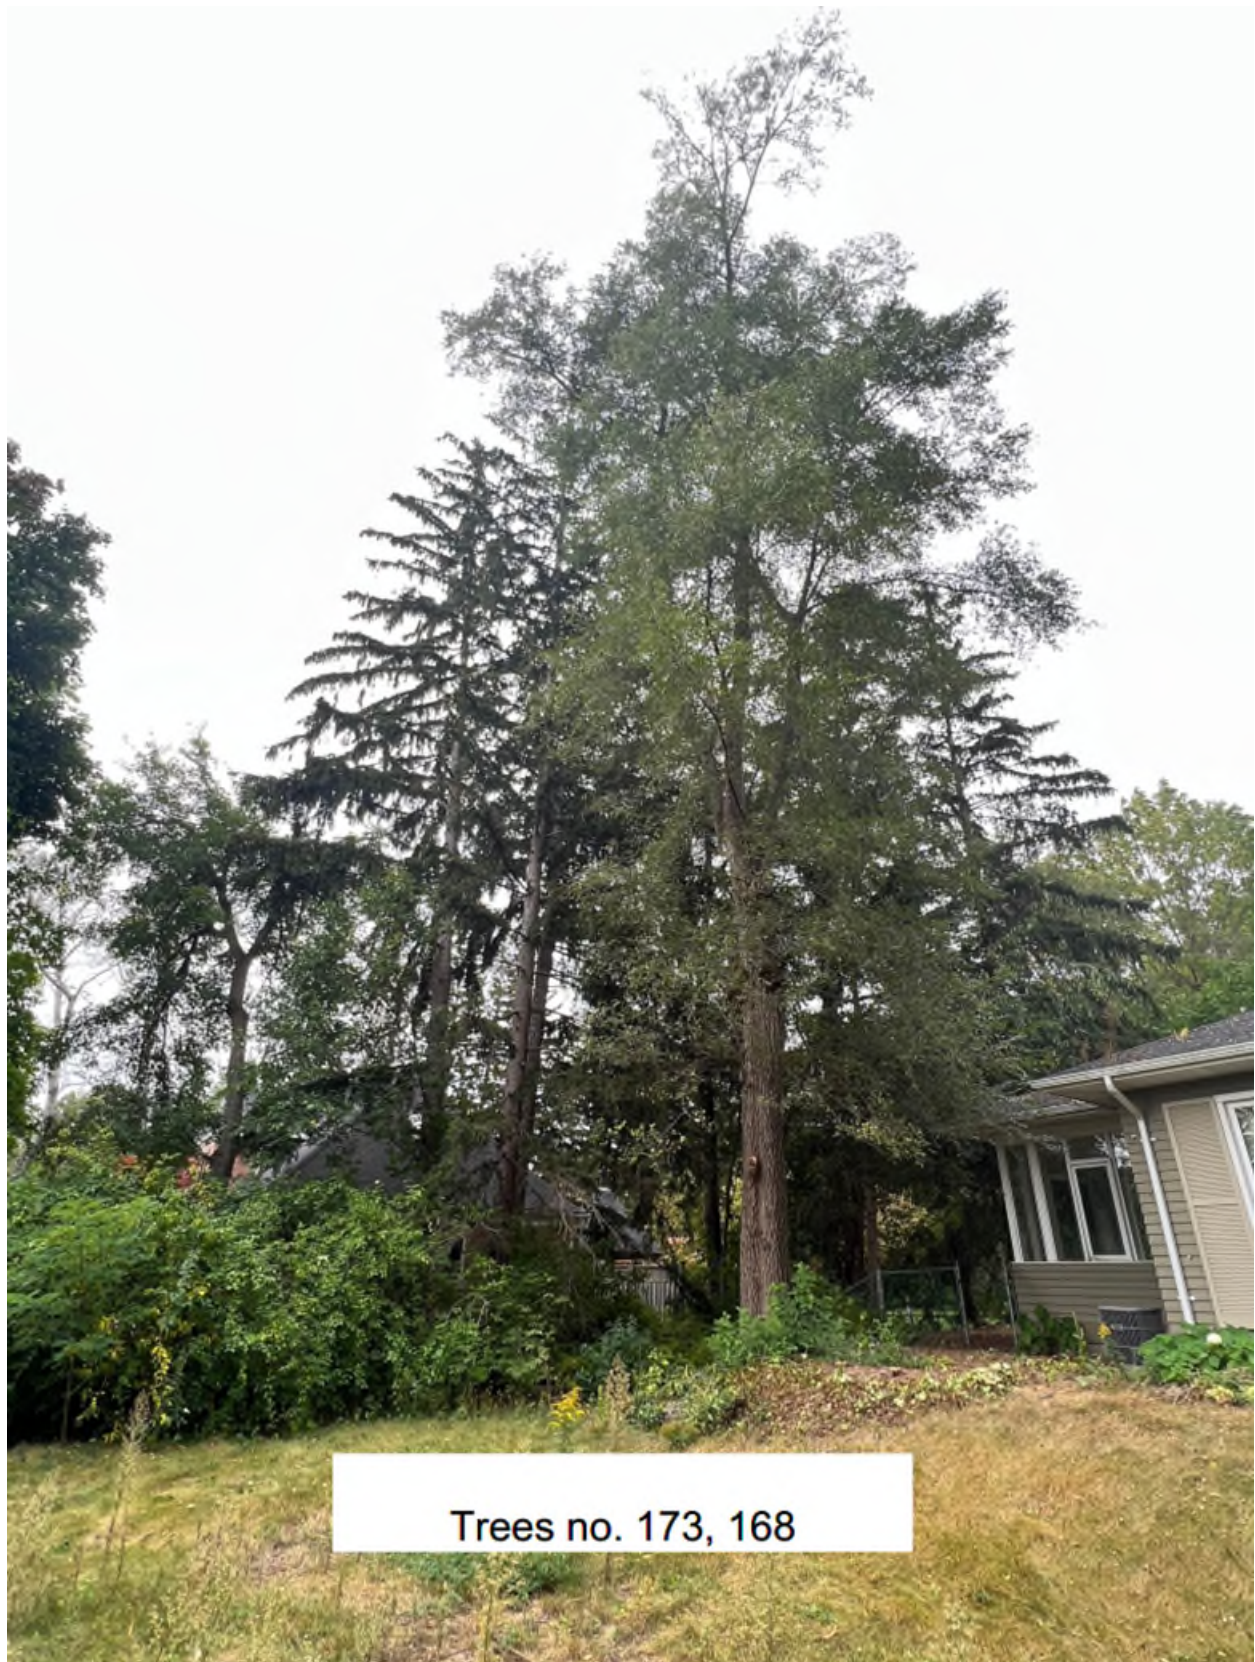
**Photo #41:**

Trees no. 173, 168
