June 19, 2019 [Revised, November 11, 2020]

ARBORIST REPORT

3171 Lakeshore Rd West (Cudmore's Nursery Site), Oakville, Ontario

MHBC File: 11161E

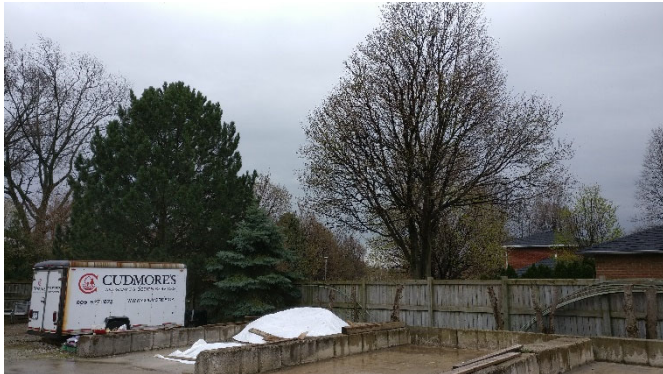
Trees 658, 659, O1 looking South West.

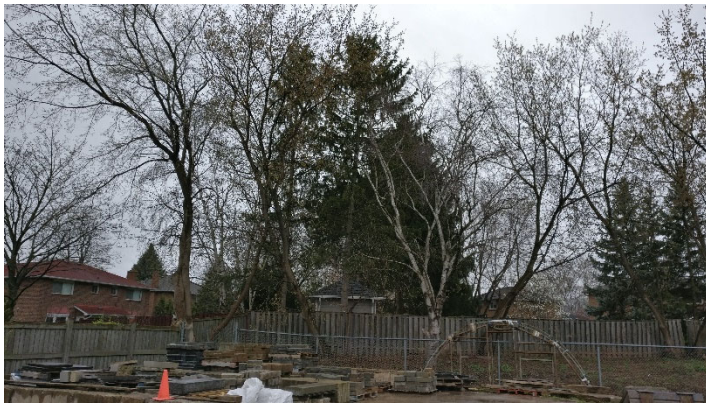
Trees 907 through 911 looking West.

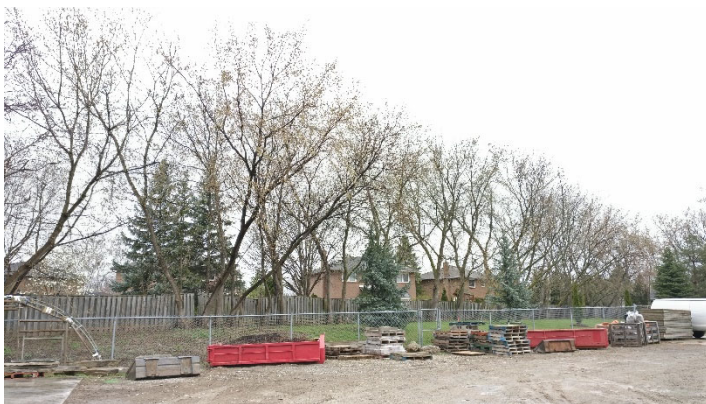
Trees 911 through 939, 955 through 959 looking North West.

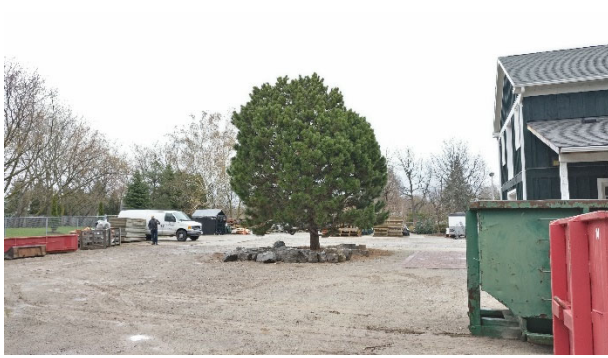
Tree 660 looking North.

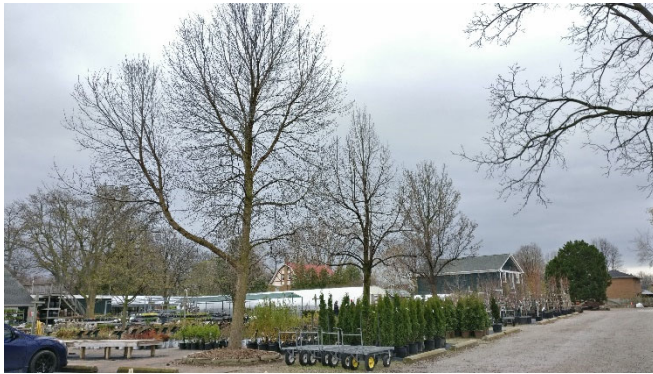
Trees 665 through 667 looking South.

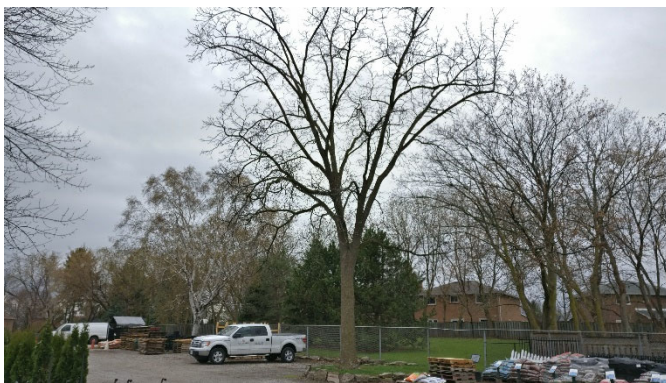
Trees 950 through 959, 661 looking South West.

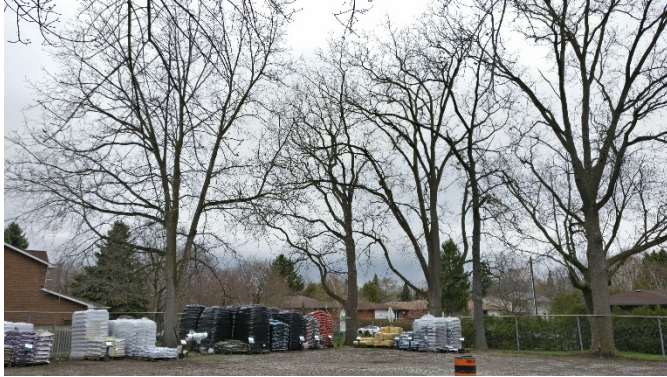
Trees 943 through 947 looking North East.

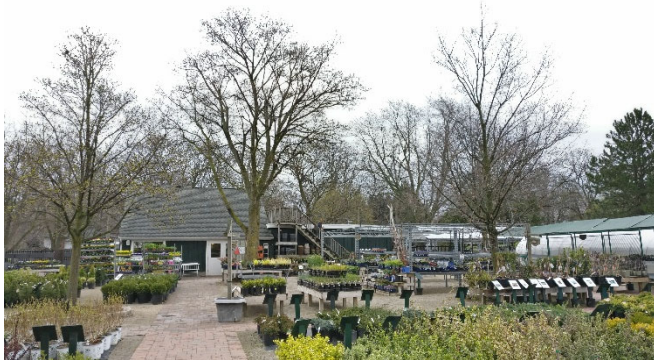
Trees 668 through 670 looking East.

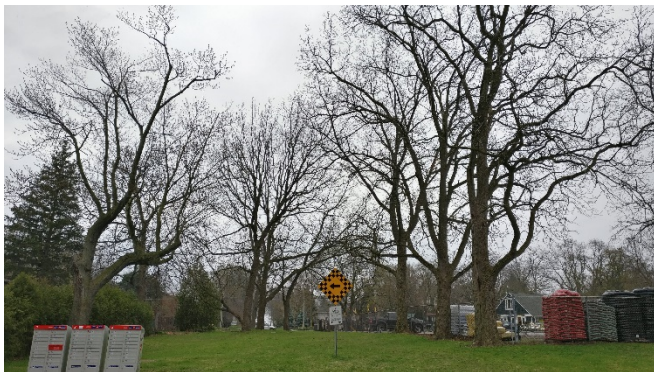
Trees 960 through 964, 697 through 700, 664 looking East.

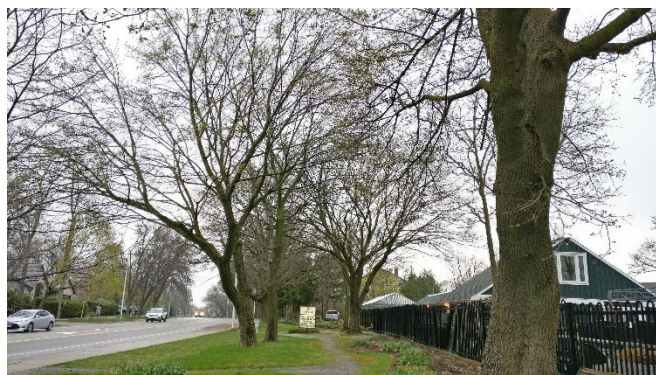
Trees 695 through 690 looking South.
