August 03, 2017  
[REVISED OCT 03, 2018]

ARBORIST REPORT  
2441 Lakeshore Road West,  
Oakville, Ontario

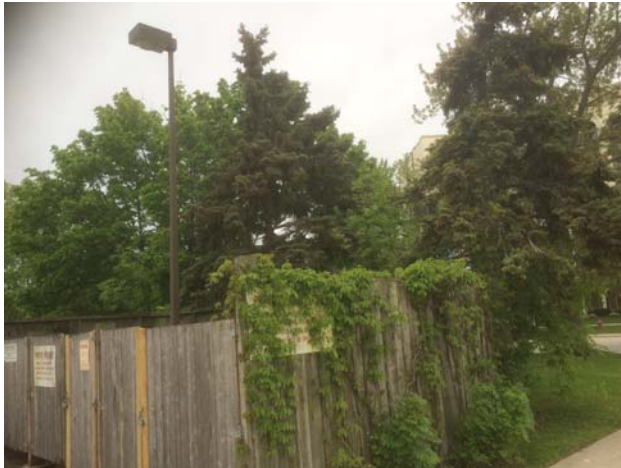
| Tree No. | Common Name | Botanical Name | Owner | DBH (CM) | Cond. | Structure | Canopy Diameter (m) | Comments | Recommendation |
|---|---|---|---|---|---|---|---|---|---|
| 1 | Spruce sp. | Picea sp. | P | 27 | F | F | 2 | Some deadwood in canopy | Remove - due to construction |
| 2 | Spruce sp. | Picea sp. | P | 24 | F | F | 4 | Some deadwood in canopy | Remove - due to construction |

Trees #1 and #2 looking South

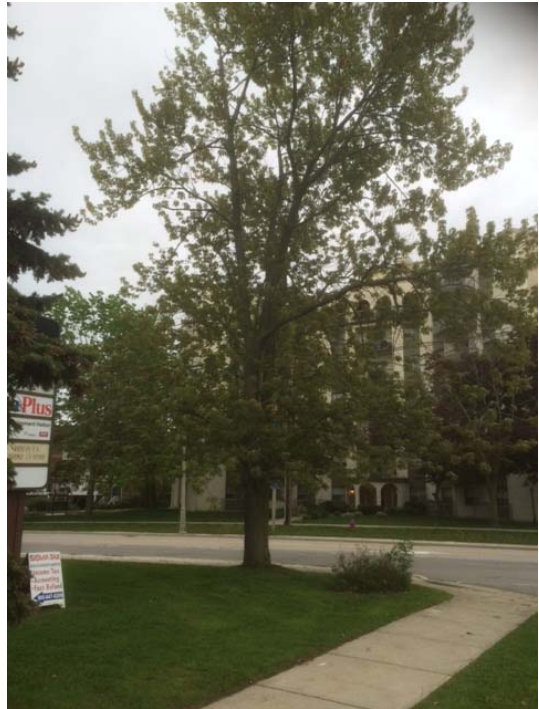
| Tree No. | Common Name | Botanical Name | Owner | DBH (CM) | Cond. | Structure | Canopy Diameter (m) | Comments | Recommendation |
|---|---|---|---|---|---|---|---|---|---|
| 3 | Silver Maple | Acer saccharinum | M | 43,36 | F | F-P | 8 | Co- dominant stems, light to moderate deadwood throughout tree. | Remove - due to construction |

Tree #3 looking South

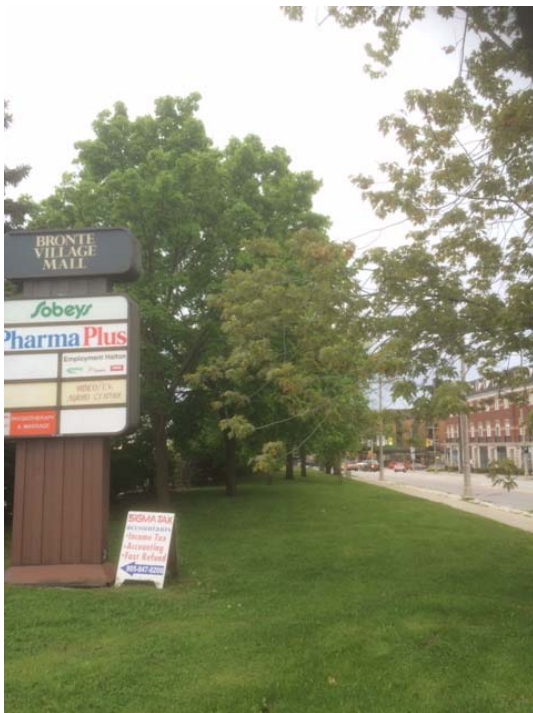
| Tree No. | Common Name | Botanical Name | Owner | DBH (CM) | Cond. | Structure | Canopy Diameter (m) | Comments | Recommendation |
|---|---|---|---|---|---|---|---|---|---|
| 4 | Norway Maple | Acer platanoides | P | 29 | F | F | 7 | Light deadwood throughout tree. | Remove - due to construction |
| 5 | Norway Maple | Acer platanoides | P | 34 | F | F | 9 | Some dieback at ends. | Remove - due to construction |
| 6 | Norway Maple | Acer platanoides | P | 20 | F-P | F-P | 4 | Dieback at crown, calloused wound at base, some evidence of decay. | Remove - due to construction |
| 7 | Norway Maple | Acer platanoides | P | 37 | F | F | 10 | Dieback in crown evident, Tree is beginning to decline. | Remove - due to construction |
| 8 | Norway Maple | Acer platanoides | M | 31 | F-P | F-P | 7 | Moderate to severe dieback in crown. | Remove - due to construction |

Trees #4 through #8 looking south east

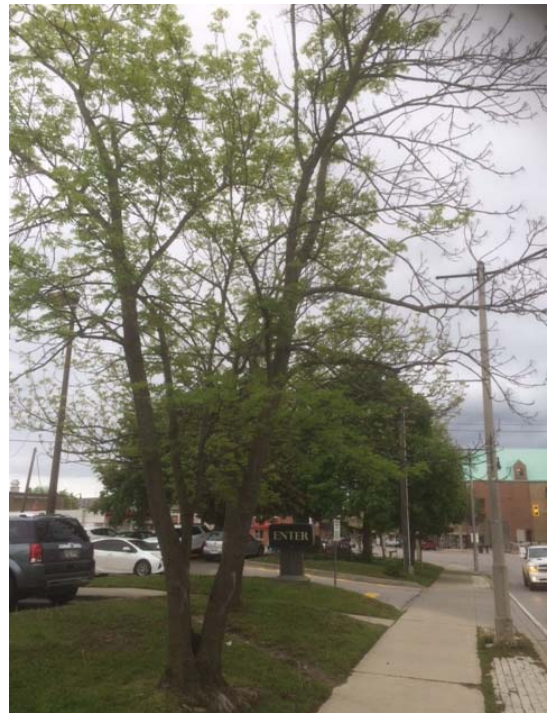
| 10 | Ash sp. | Fraxinus sp. | M | 20,20,11 | P | P | 3 | Tree struggling with EAB, Co-dominant stems, City marked tree with 'X'. | Remove - due to construction/health |
| 11 | Ash sp. | Fraxinus sp. | M | 25 | P | F-P | 6 | Tree struggling with EAB, City marked tree with 'X'. | Remove - due to construction/health |
| 12 | Spruce sp. | Picea sp. | P | 24 | F | F | 3 | Light deadwood throughout tree. | Remove - due to construction |

Trees #10 through #12 looking south east

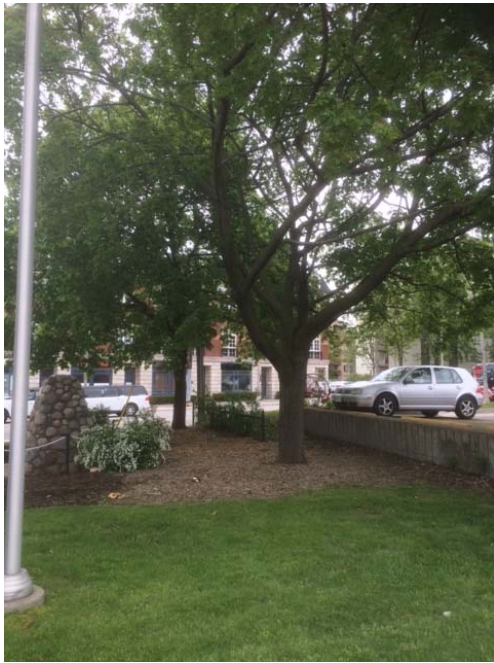
| 13 | Norway Maple | Acer platanoides | M1 | 38 | F | F | 12 | Light deadwood in canopy. | Retain |
| 14 | Norway Maple | Acer platanoides | M1 | 48 | F | F | 12 | Light deadwood in canopy. | Retain |

Trees # 13 and #14 looking South West

These two (2) publicly owned trees are situated on the parkland block on the northeast corner of Bronte and Lakeshore. These trees will require proper tree protection measures to ensure that they are not damaged or destabilized during shoring operations. Tree # 13 is approximately 2.8m from the property line and Tree # 14 is approximately 2.0m from the property line. The edge of the proposed underground garage slab will be approximately 1.15m from the property line, and the shoring will be within this area between the garage slab edge and the property line. The minimum TPZ for Tree # 13 appears as though it will be entirely unaffected, and it appears that there will be an encroachment of approximately 15% into the TPZ of Tree #14. We recommend that a certified arborist be present on site at the time of shoring excavation in order to guide root pruning as required and to ensure that the trees are not destabilized as a result of the excavation and any required root pruning.

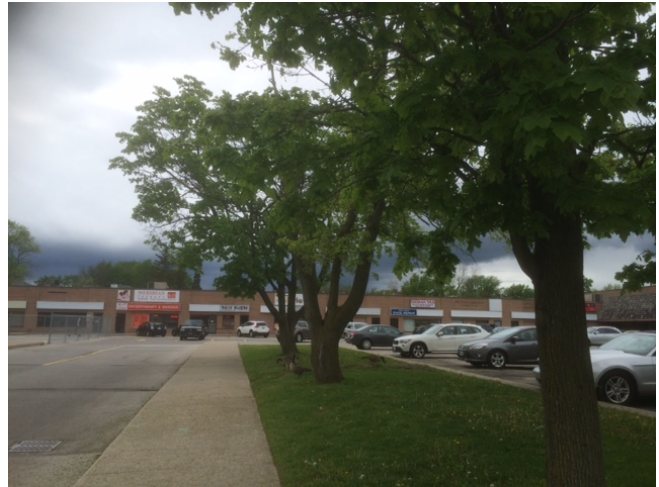
| 15 | Norway Maple | Acer platanoides | P | 33,32,28,29 | F-P | F | 11 | Co-dominant stems, Moderate to severe deadwood, Canopy dieoff at tips, Tree is in decline. | Remove - due to construction |
| 16 | Norway Maple | Acer platanoides | P | 36,35,16 | P | F-P | 9 | Half of tree is dead, Other half has moderate to severe dieback in crown. | Remove - due to construction |
| 17 | Norway Maple | Acer platanoides | M | 33 | F-P | F | 6 | Moderate dieback at branch ends (approaching severe). | Remove - due to construction |

Trees #15 through 17 looking North West

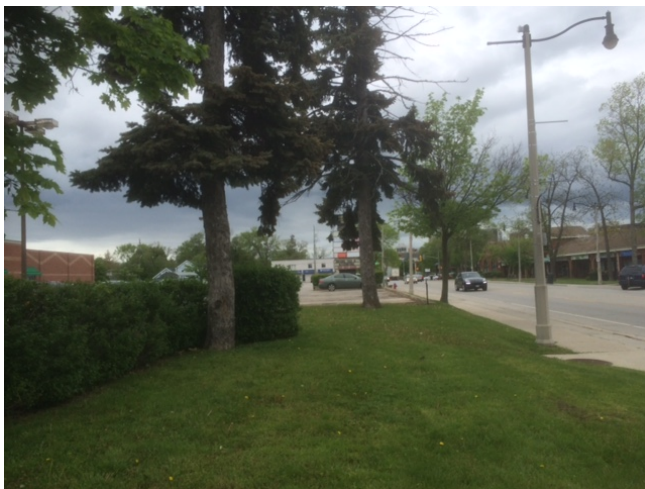
| 18 | Spruce sp. | Picea sp. | M | 40 | F | F | 3.5 | Moderate deadwood throughout tree. | Remove - due to construction |
| 19 | Spruce sp. | Picea sp. | M | 45 | F-P | F-P | 5 | Moderate to severe deadwood throughout tree, Leader broken off. | Remove - due to construction |
| 20 | Norway Maple | Acer platanoides | M | 23 | F-P | F | 4 | Moderate to severe dieoff. | Remove - due to construction |

Trees #18 through #20 looking North East

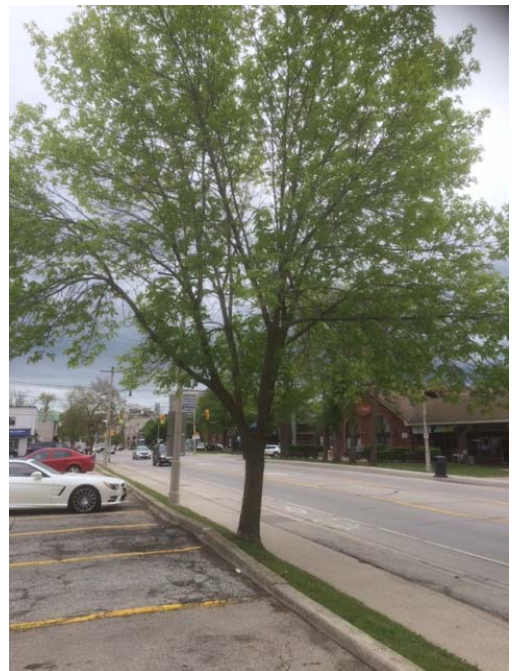
| 21 | Ash sp. | Fraxinus sp. | M | 34 | F | F | 7 | Beginning signs of EAB, Tree has been treated. | Remove - due to construction |

Tree #21 looking North East

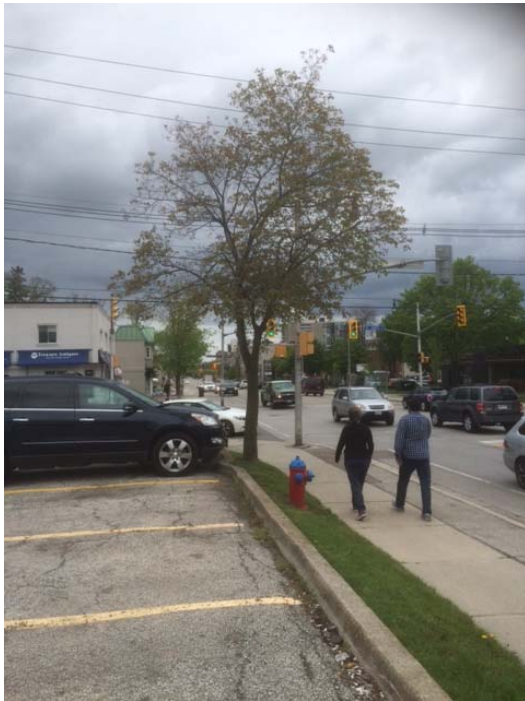
| 22 | Amur Maple | Acer ginnala | M | 26 | F | F | 4 | Moderate dieback in crown. | Remove - due to construction |

Tree #22 looking North East

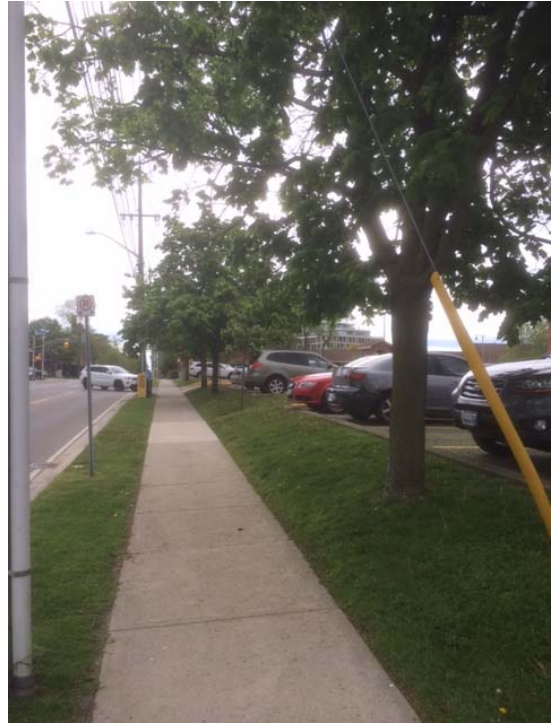
| 23 | Norway Maple | Acer platanoides | M | 33 | F | F | 7 | Old trunk split is healing, moderate dieback. | Retain |
| 24 | Norway Maple | Acer platanoides | M | 30 | F-P | F-P | 7 | Central leader dead, severe dieback in lower crown, fruiting bodies present, mechanical damage at base attempting to heal. | Retain |
| 25 | Norway Maple | Acer platanoides | M | 26 | F | F | 7 | Some dieback beginning. | Retain |
| 26 | Ivory Silk Lilac | Syringa reticulata | M | 4 | F-P | F | 2 | Moderate dieback in canopy, signs of urban stress. | Retain |
| 27 | Norway Maple | Acer platanoides | M | 32 | F | F | 6 | Mild to moderate dieback, tree is in decline. | Retain |

Trees #27 through #23 looking South East

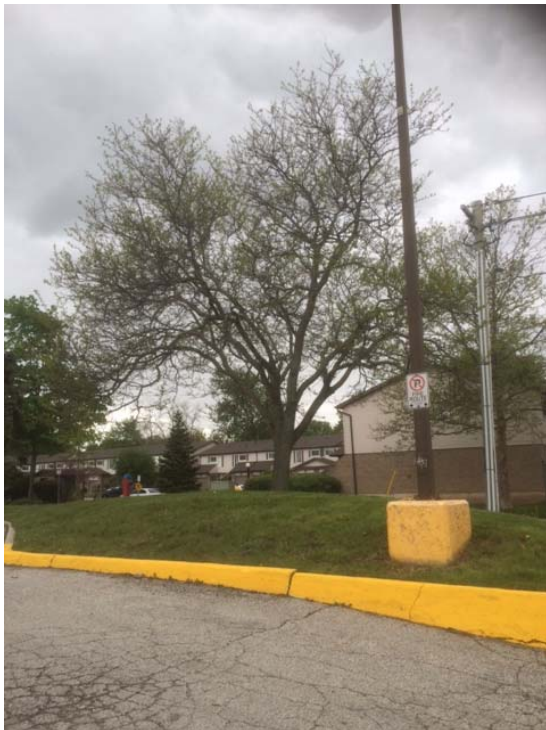
| 28 | Honey Locust | Gleditsia triacanthos | M | 48 | F | F | 13 | | Remove - due to construction |

Tree #28 looking West

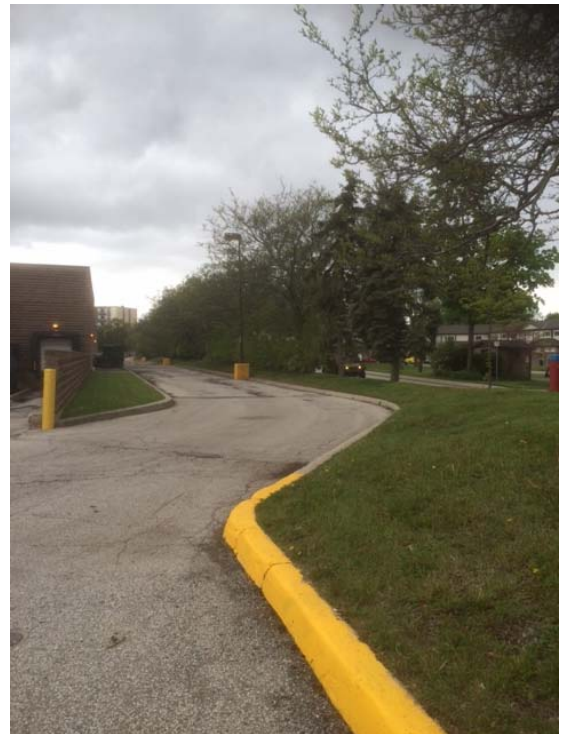
Trees #29 through #45 looking South West

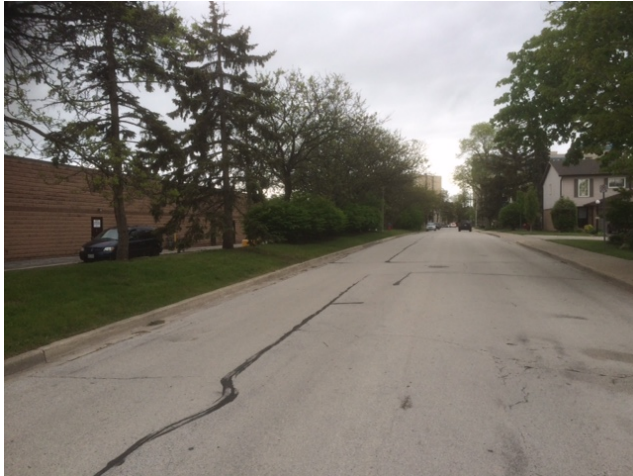
Trees #36 through #49 looking South West

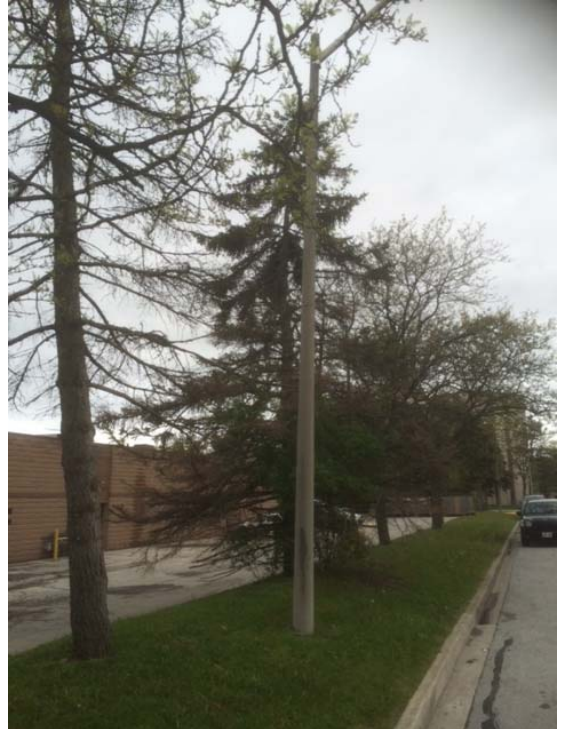
Trees #48 through #54 looking South West

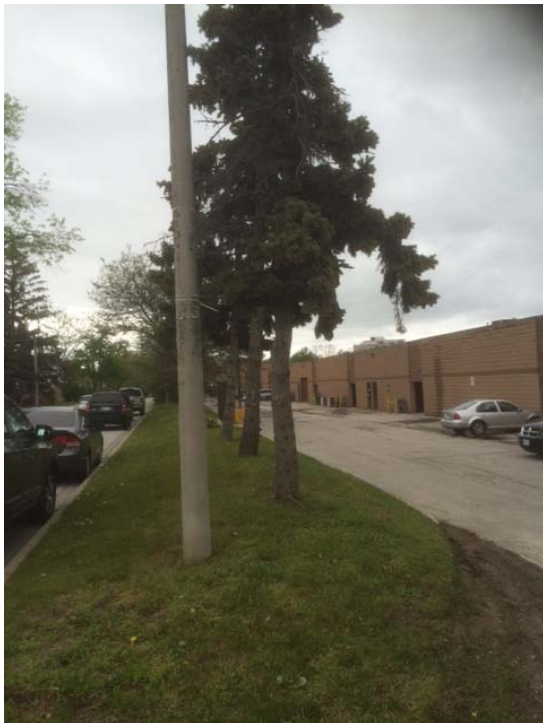
Trees #54 through #52 looking North East
