August 6, 2025 [Revised December 11, 2025]

ARBORIST REPORT  
1493 Sixth Line, Oakville, Ontario

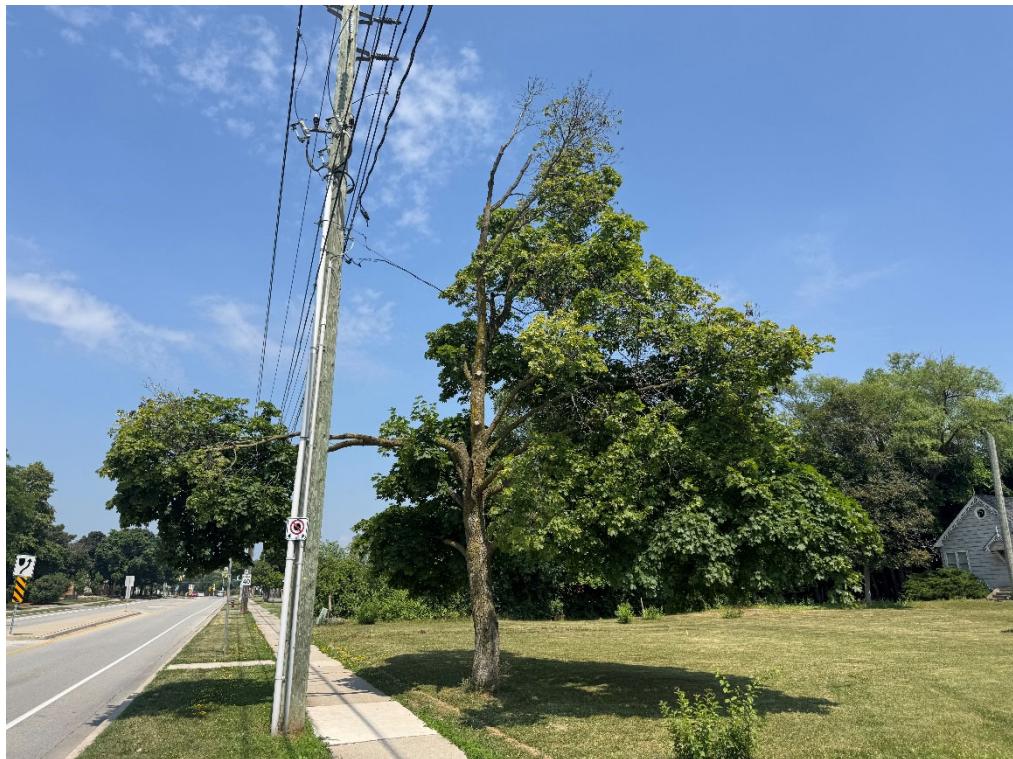
Tree 601

Tree No.	Owner	Common Name	Botanical Name	DBH (CM)	Min. TPZ Radius (M)	Cond.	Structure	Canopy Diameter (M)	Comments	Recommendation
601	Private	Norway Maple	Acer platanoides	37	3.0	F/P	P	12	Minor deadwood throughout, imbalanced canopy, growing in overhead wires, main leader is dead at top, heavily pruned previously	Remove due to construction
602	Neighbour/Boundary	Siberian Elm	Ulmus pumila	36	3.0	F	F	8	Multi-stem, growing through wire fence	Retain
603	Neighbour	Norway Maple	Acer platanoides	26	2.4	F	F	7	Growing through wire fence, minor deadwood throughout	Retain
604	Neighbour	Norway Maple	Acer platanoides	27	2.4	F	F	9		Retain
605	Neighbour	Norway Maple	Acer platanoides	30	2.4	F	F	8		Retain
606	Neighbour	Norway Maple	Acer platanoides	23	2.4	F	F	6	Mild lean away from subject site, imbalanced canopy with majority of limbs on northern side of tree	Retain
607	Neighbour/Boundary	Norway Maple	Acer platanoides	17	2.4	F	F	8	Growing through wire fence	Retain

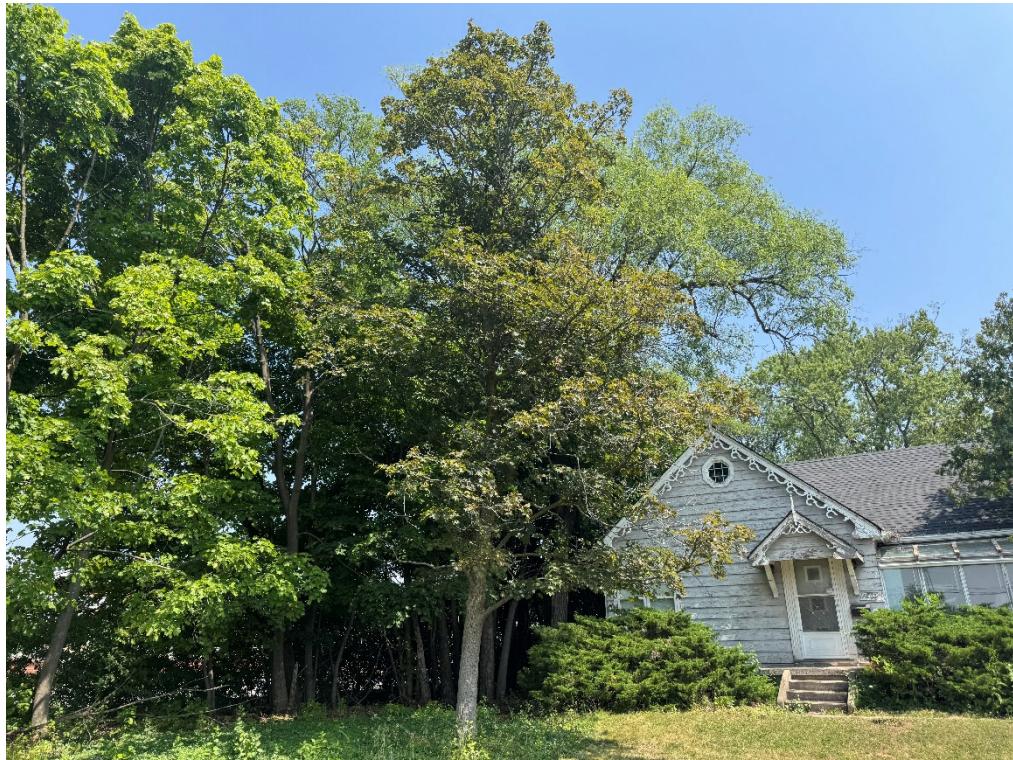
Tree 610

608	Neighbour/Boundary	Norway Maple	Acer platanoides	29	2.4	F/P	F/P	14	3 stem at 0.8 metres, moderate deadwood throughout	Retain
609	Neighbour/Boundary	Norway Maple	Acer platanoides	21	2.4	F	F	8	Elevated canopy	Retain
610	Private	Norway Maple	Acer platanoides	28	2.4	F/P	F/P	8	Moderate deadwood throughout, tree is in decline, mildew disease evident	Remove due to construction
611	Private	Cedar Sp.	Thuja Sp.	26	2.4	F	F	5		Remove due to construction
612	Private	Cedar Sp.	Thuja Sp.	27	2.4	F	F	6	Multi-stem	Remove due to construction
613	Neighbour	Norway Maple	Acer platanoides	33	3.0	F	F	16	3 stem at base, minor deadwood throughout	Retain
614	Neighbour	Norway Maple	Acer platanoides	18	2.4	F/P	F/P	8	Imbalanced canopy with majority of limbs on northern side of tree, cavity at 2.5 metres with signs of internal rot evident	Retain
615	Private	Siberian Elm	Ulmus pumila	27	2.4	F/P	F/P	4	Mild lean, elevated canopy, minor deadwood throughout	Retain

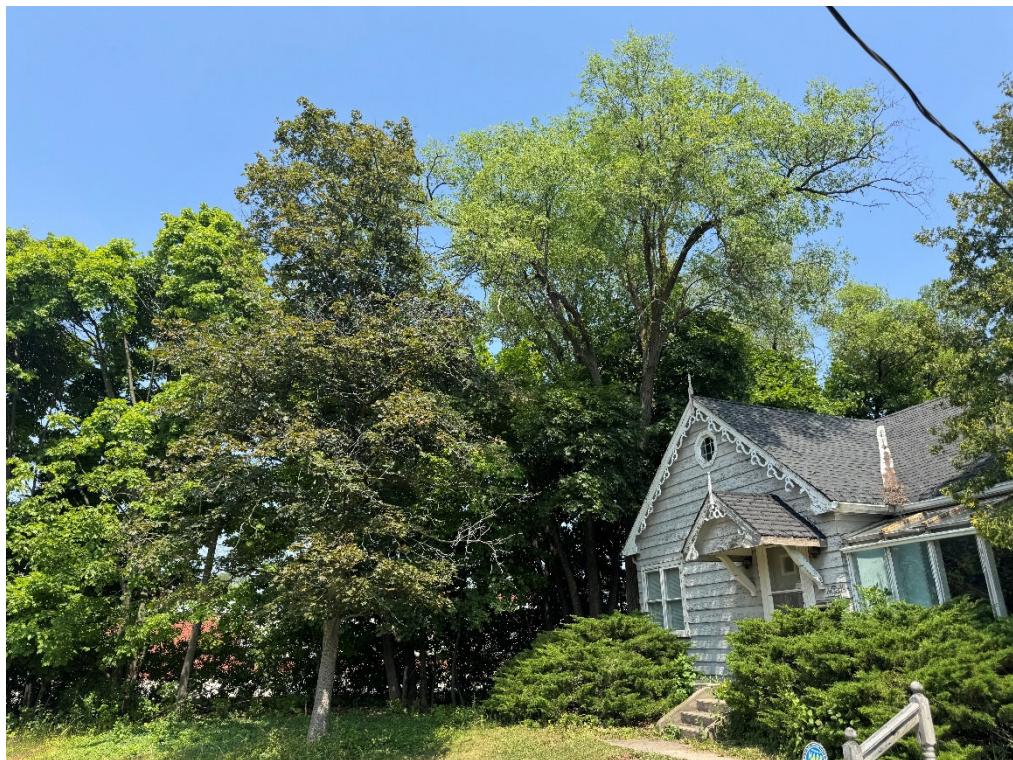
Trees 610, 613 – 618

616	Private	Siberian Elm	Ulmus pumila	47	3.0	F	F	18	2 stem at 0.9 metres, one main limb with mild to moderate lean	Retain
617	Private	Norway Maple	Acer platanoides	20	2.4	F	F/P	9	Minor to moderate deadwood throughout, moderate lean	Remove due to construction
618	Private	Siberian Elm	Ulmus pumila	47	3.0	F	F	16	Minor deadwood throughout	Remove due to construction
619	Private	Siberian Elm	Ulmus pumila	27	2.4	D	-	-	Tree is 100% dead	Remove due to condition
620	Private	Siberian Elm	Ulmus pumila	23	2.4	F	F	5	Moderate lean away from subject site	Retain

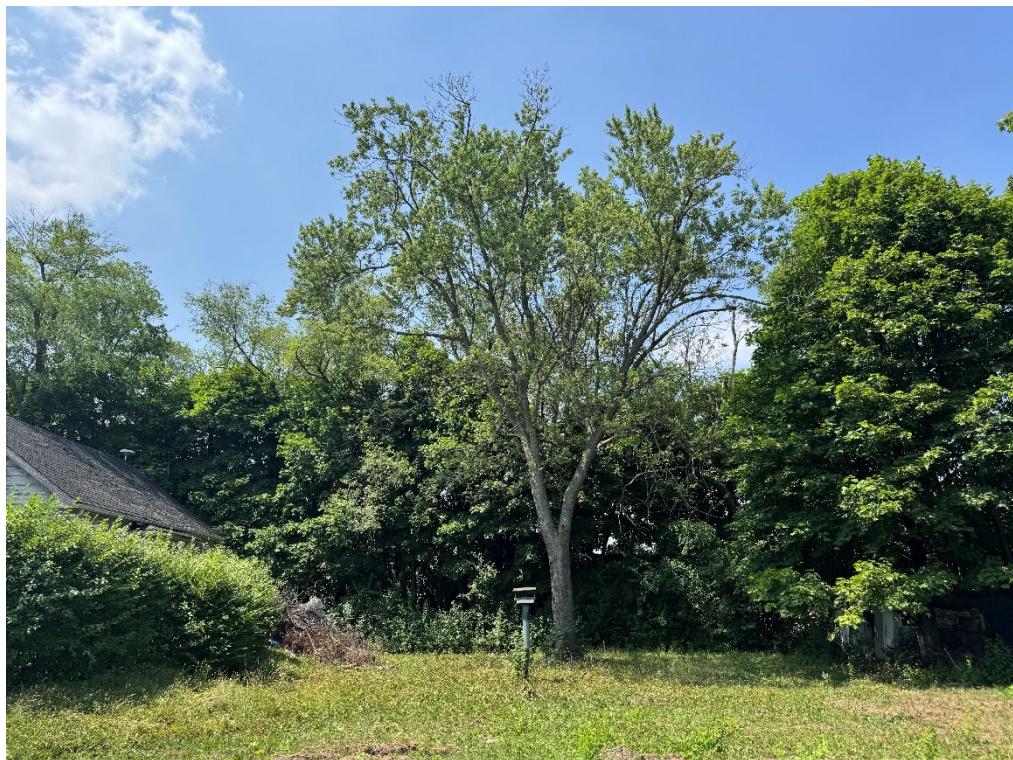
Tree 619 – 648, 660

621	Private	Siberian Elm	<i>Ulmus pumila</i>	33	3.0	P/D	P	4	2 stem at 1.3 metres, one stem dead, one stem 85% dead, significant deadwood throughout	Remove due to condition
622	Private	Siberian Elm	<i>Ulmus pumila</i>	18	2.4	P/D	P	2	Tree is 95% dead	Remove due to condition
623	Private	Norway Maple	<i>Acer platanoides</i>	21	2.4	F	F/P	7	Elevated canopy, moderate deadwood throughout	Retain
624	Private	Norway Maple	<i>Acer platanoides</i>	15	2.4	P	P	4	Significant deadwood throughout, tree is in decline	Retain
625	Private	Siberian Elm	<i>Ulmus pumila</i>	30	2.4	F	F	8	2 stem at 0.7 metres	Retain
626	Private	Siberian Elm	<i>Ulmus pumila</i>	46	3.0	F	F	10	Moderate lean away from subject site	Retain
627	Private	Siberian Elm	<i>Ulmus pumila</i>	34	3.0	F	F/P	8	One stem previously cut at 1.2 metres, moderate lean away from subject site, multiple bows throughout	Retain
628	Private	Siberian Elm	<i>Ulmus pumila</i>	31	3.0	F	F	10	Minor to moderate deadwood throughout	Retain

629	Private	Norway Maple	<i>Acer platanoides</i>	15	2.4	F	F/P	8	Moderate deadwood throughout	Retain
630	Private	Siberian Elm	<i>Ulmus pumila</i>	21	2.4	F	F	5	Moderate lean away from subject site	Retain
631	Private	Siberian Elm	<i>Ulmus pumila</i>	24	2.4	D	-	-	Tree is 100% dead	Remove due to condition
632	Private	Norway Maple	<i>Acer platanoides</i>	21	2.4	F/P	F/P	6	Moderate to significant deadwood throughout, elevated canopy	Retain
633	Private	Siberian Elm	<i>Ulmus pumila</i>	39	3.0	F	F	10	2 stem at base, smaller stem with significant lean into subject site	Retain
634	Private	Siberian Elm	<i>Ulmus pumila</i>	17	2.4	D	P		Tree is 98% dead, significant deadwood throughout	Remove due to condition

635	Private	Norway Maple	<i>Acer platanoides</i>	18	2.4	F	F/P	7	Moderate deadwood throughout, elevated canopy	Retain
636	Private	Siberian Elm	<i>Ulmus pumila</i>	29	2.4	F/P	P	10	2 stem at 1.1 metres, one of two stems is dead	Retain
637	Private	Norway Maple	<i>Acer platanoides</i>	20	2.4	F	F	7	Minor deadwood throughout, mild lean into subject site	Retain
638	Private/Boundary	Siberian Elm	<i>Ulmus pumila</i>	51	3.6	F	F	15		Retain
639	Private	Siberian Elm	<i>Ulmus pumila</i>	19	2.4	D	-	-	Tree is 100% dead	Remove due to condition
640	Private	Siberian Elm	<i>Ulmus pumila</i>	22	2.4	P/D	P	4	2 stem at 0.5 metres, one stem dead	Retain
641	Neighbour	Norway Maple	<i>Acer platanoides</i>	21	2.4	F	F/P	8	Moderate deadwood throughout, moderate lean away from subject site	Retain
642	Neighbour	Norway Maple	<i>Acer platanoides</i>	18	2.4	F	F	9	Minor deadwood throughout	Retain
643	Neighbour	Norway Maple	<i>Acer platanoides</i>	25	2.4	F	F	11	Minor deadwood throughout	Retain

644	Neighbour/Boundary	Siberian Elm	<i>Ulmus pumila</i>	24	2.4	D	-	-	Tree is 100% dead	Remove due to condition
645	Neighbour	Siberian Elm	<i>Ulmus pumila</i>	44	3.0	D	-	-	Tree is 100% dead	Remove due to condition
646	Neighbour/Boundary	Siberian Elm	<i>Ulmus pumila</i>	27	2.4	F	P	6	Significant bow at 7.0 metres into subject site	Retain
647	Neighbour	Norway Maple	<i>Acer platanoides</i>	43	3.0	F	F	15	Minor deadwood throughout	Retain
648	Private	Norway Maple	<i>Acer platanoides</i>	20	2.4	F	F	6		Retain
649	Private	Siberian Elm	<i>Ulmus pumila</i>	69	4.2	F	F	23	Minor deadwood throughout	Remove due to construction
650	Private	Siberian Elm	<i>Ulmus pumila</i>	25	2.4	F	F	9		Remove due to construction
651	Private	Norway Maple	<i>Acer platanoides</i>	35	3.0	F	F	17		Remove due to construction
652	Private	Norway Maple	<i>Acer platanoides</i>	17	2.4	F	F	6	Minor deadwood throughout	Remove due to construction

660	Private	Silver Maple	<i>Acer saccharinum</i>	60	3.6	F/P	F	14	Moderate deadwood throughout	Remove due to construction
661	Private	Norway Maple	<i>Acer platanoides</i>	18	2.4	P	P	3	Top of tree is dead, suckers throughout	Remove due to condition
662	Private	Basswood	<i>Tilia americana</i>	22	2.4	F	F	5	Minor deadwood throughout	Remove due to construction
663	Private	Norway Maple	<i>Acer platanoides</i>	50	3.0	F/P	P	8	Significant wound at 5.0 metres, suckers throughout, internal rot evident	Remove due to construction
664	Private	Elm Sp.	<i>Ulmus Sp.</i>	18	2.4	D	-	-	Tree is 100% dead	Remove due to construction
665	Private	Norway Maple	<i>Acer platanoides</i>	32	3.0	F	F	16	2 stem at 0.8 metres	Remove due to construction
666	Private	Norway Maple	<i>Acer platanoides</i>	33	3.0	F	F	14	Minor deadwood throughout	Remove due to construction
667	Private	Norway Maple	<i>Acer platanoides</i>	23	2.4	F	F	11	Mild lean, minor deadwood throughout	Remove due to construction

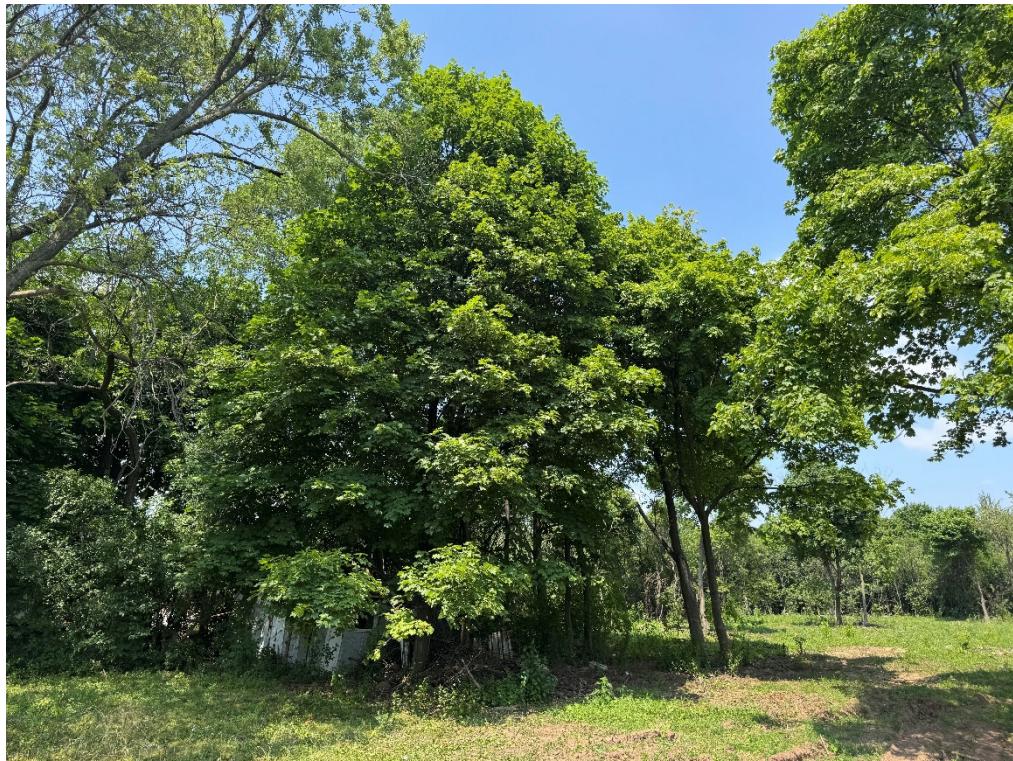
Trees 649 – 659

653	Private	Norway Maple	<i>Acer platanoides</i>	16	2.4	P	P	6	Moderate to significant deadwood throughout, signs of internal rot, tree is in decline	Remove due to construction
654	Private	Norway Maple	<i>Acer platanoides</i>	21	2.4	F	F	9	Minor deadwood throughout	Remove due to construction
655	Private	Norway Maple	<i>Acer platanoides</i>	17	2.4	F/P	F/P	6	Bow at base, suckers from 2 - 7 metres, minor deadwood throughout, elevated canopy	Remove due to construction
656	Private	Norway Maple	<i>Acer platanoides</i>	21	2.4	F	F	8		Remove due to construction
657	Private	Norway Maple	<i>Acer platanoides</i>	37	3.0	P	F/P	13	Cavity on south side of tree at 2.0 metres with evident internal rot, mild lean, minor deadwood throughout	Remove due to construction
658	Private	Norway Maple	<i>Acer platanoides</i>	27	2.4	F	F	14	Mild lean	Remove due to construction
659	Private	Norway Maple	<i>Acer platanoides</i>	32	3.0	F	F	12	Minor deadwood throughout	Remove due to construction

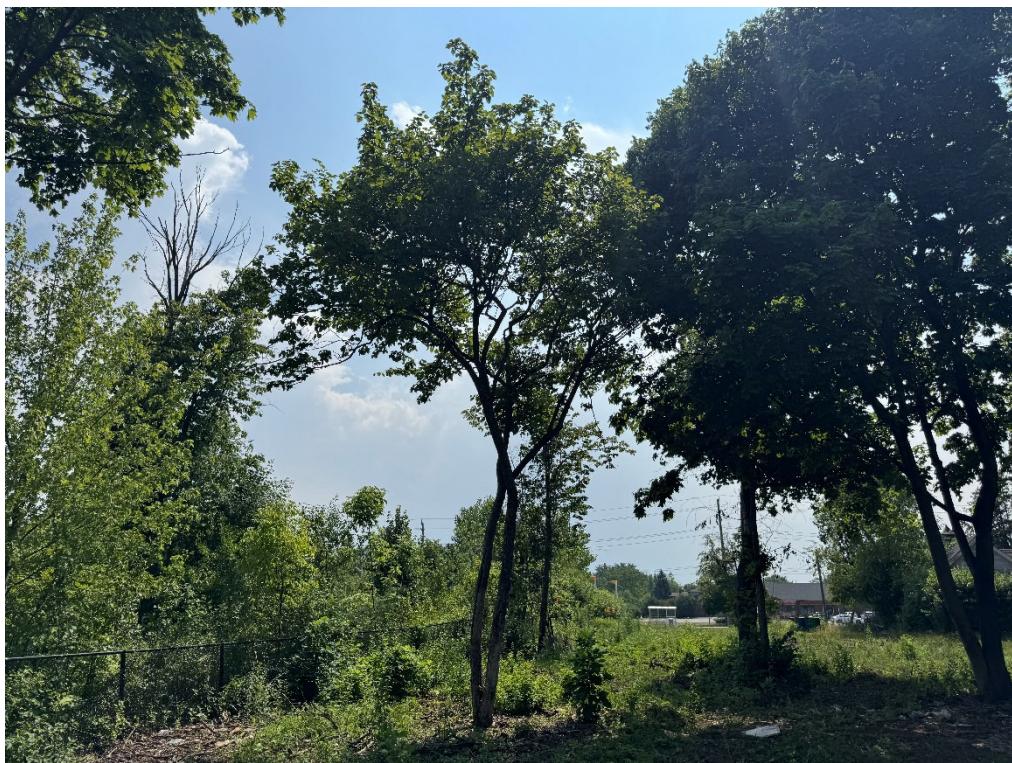
Tree 668

668	Private	Elm Sp.	Ulmus Sp.	19	2.4	F	F	10	2 stem at 0.4 metres, vertical cavity from 1 - 3 metres on southern stem	Remove due to construction
669	Private	Norway Maple	Acer platanoides	33	3.0	F/G	F	8		Remove due to construction
670	Private	Cherry Sp.	Prunus Sp.	24	2.4	F/P	F	5	Minor deadwood throughout	Remove due to construction
671	Private	Norway Maple	Acer platanoides	27	2.4	F	F	9	Minor deadwood throughout	Remove due to construction
672	Private	Cherry Sp.	Prunus Sp.	29	2.4	F/P	F	7	Moderate deadwood throughout	Remove due to construction
673	Private	Cherry Sp.	Prunus Sp.	24	2.4	F/P	F	8	Moderate deadwood throughout	Remove due to construction
674	Private	Cherry Sp.	Prunus Sp.	22	2.4	F/P	F	7	Minor deadwood throughout	Remove due to construction
675	Private	Elm Sp.	Ulmus Sp.	25	2.4	D	-	-	Tree is 100% dead	Remove due to construction
676	Private	Cherry Sp.	Prunus Sp.	20	2.4	F	F	5	Minor deadwood throughout	Remove due to construction

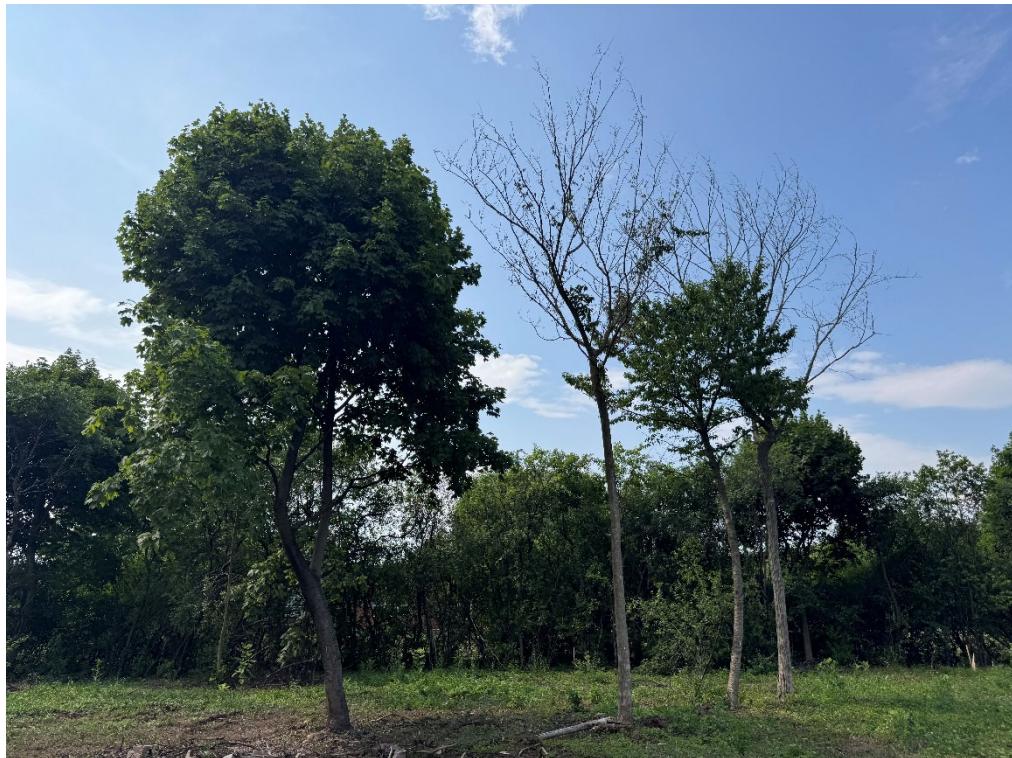
Trees 675 – 678

677	Private	Elm Sp.	Ulmus Sp.	19	2.4	P/D	P	2	Significant deadwood throughout, tree is 95% dead	Remove due to construction
678	Private	Norway Maple	Acer platanoides	29	2.4	F	F	8		Remove due to construction
679	Private	Common Buckthorn	Rhamnus cathartica	18	2.4	F/P	F/P	4	Moderate deadwood throughout	Remove due to construction
680	Private	Cherry Sp.	Prunus Sp.	28	2.4	F	F	7		Remove due to construction
681	Boundary	Norway Maple	Acer platanoides	25	2.4	F	F	9	Mild lean away from subject site, minor deadwood throughout	Remove due to construction
682	Private	Norway Maple	Acer platanoides	17	2.4	F	F	4		Retain
683	Neighbour	Norway Maple	Acer platanoides	20	2.4	F	F/P	6	Vertical wound from base to 3.0 metres callousing over, minor deadwood throughout	Retain
684	Boundary	Norway Maple	Acer platanoides	27	2.4	F	F	8	Minor deadwood throughout	Retain

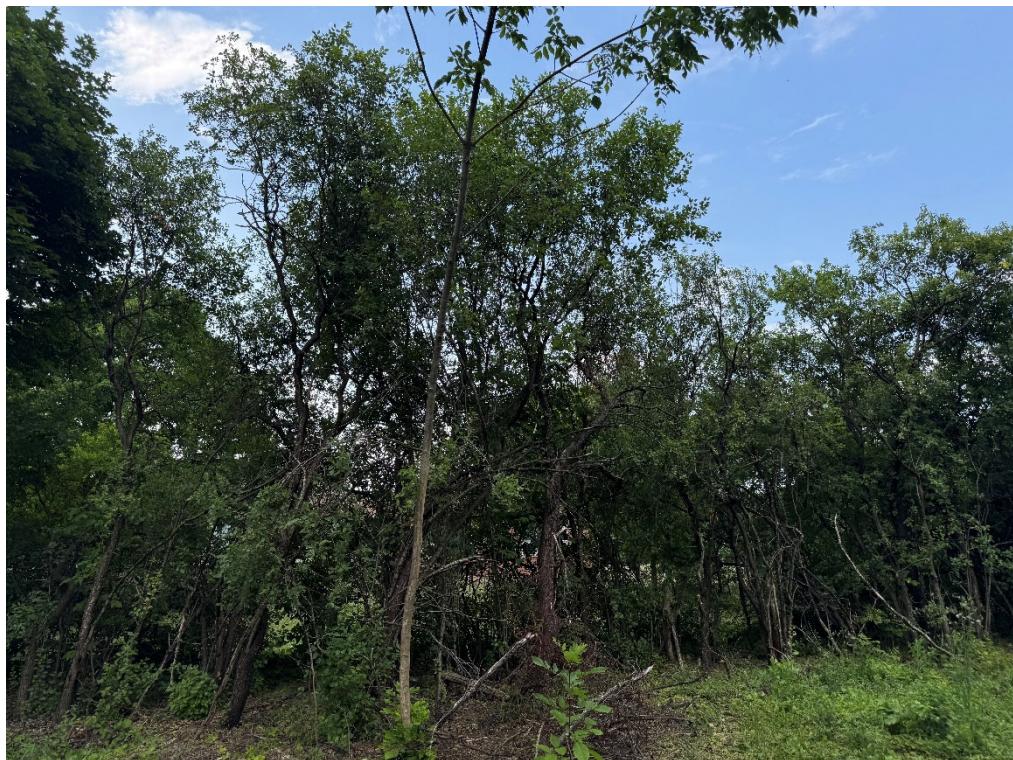
Trees 685, 686

685	Private	Common Buckthorn	Rhamnus cathartica	19	2.4	P	P	8	Significant deadwood throughout	Remove due to construction
686	Private	Common Buckthorn	Rhamnus cathartica	17	2.4	F/P	F/P	7	Moderate to significant lean, moderate deadwood throughout	Remove due to construction
687	Neighbour/Boundary	Norway Maple	Acer platanoides	28	2.4	F	F	8		Remove due to construction
688	Private	Norway Maple	Acer platanoides	26	2.4	F	F	8		Remove due to construction
O1	Municipal Parkland	Norway Maple	Acer platanoides	24	2.4	F	F	12	Growing through chain link fence	Remove due to retaining wall construction
O2	Municipal Parkland	Norway Maple	Acer platanoides	19	2.4	F	F/P	13	2 stem at base, minor deadwood throughout, contorted stems	Remove due to retaining wall construction
O3	Municipal Parkland	Manitoba Maple	Acer negundo	28	2.4	F	F	9	Bow in trunk, minor deadwood throughout	Remove due to retaining wall construction
O4	Municipal Parkland	Common Buckthorn	Rhamnus cathartica	32	3.0	P/D	P	10	Water shoots throughout, significant deadwood throughout, tree is 85% dead	Retain
