November 11, 2020 [Revised, June 07, 2023]

ARBORIST REPORT

3171 Lakeshore Rd West (Cudmore's Nursery Site), Oakville, Ontario

MHBC File: 11161E

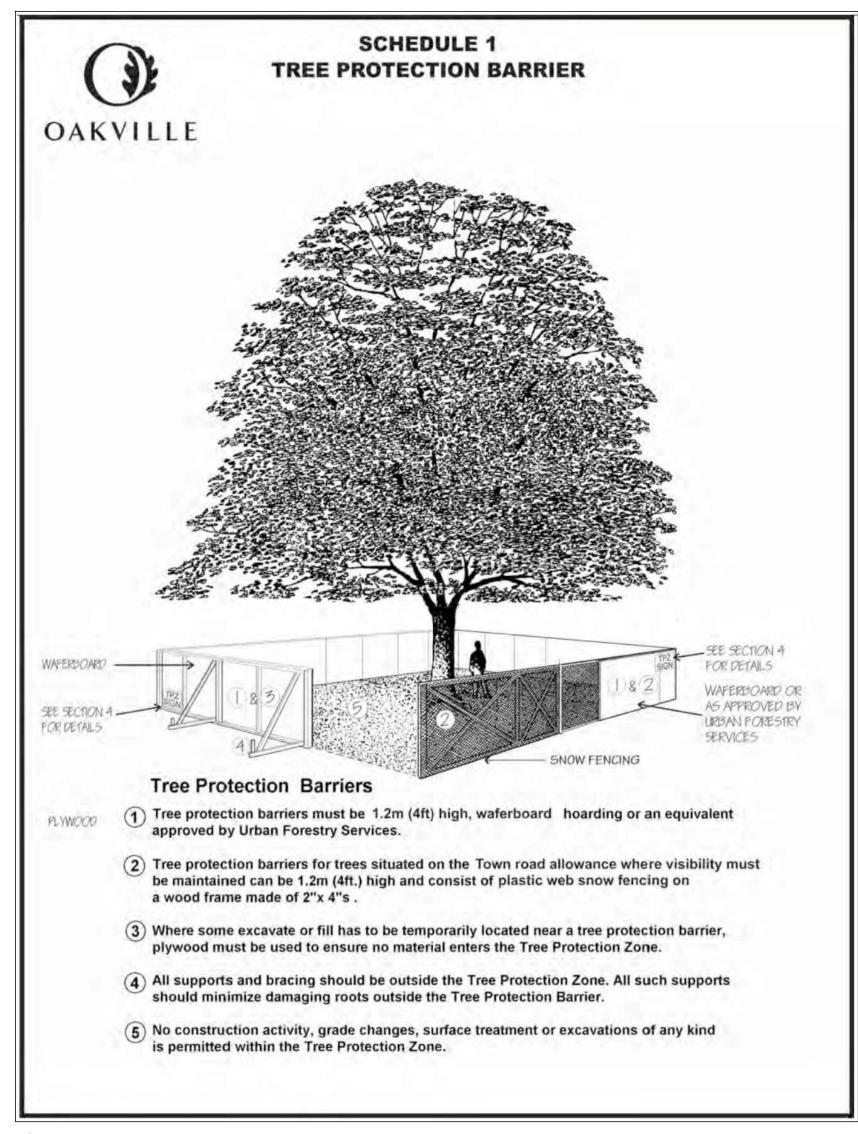
TI-2 N.T.S

TOWN OF OAKVILLE TREE PROTECTION DURING CONSTRUCTION
