# Arborist Report Argo Neyagawa Lands Town of Oakville

**Argo Neyagawa Corp.**

**Beacon Environmental Limited**

**December 2023 222272**

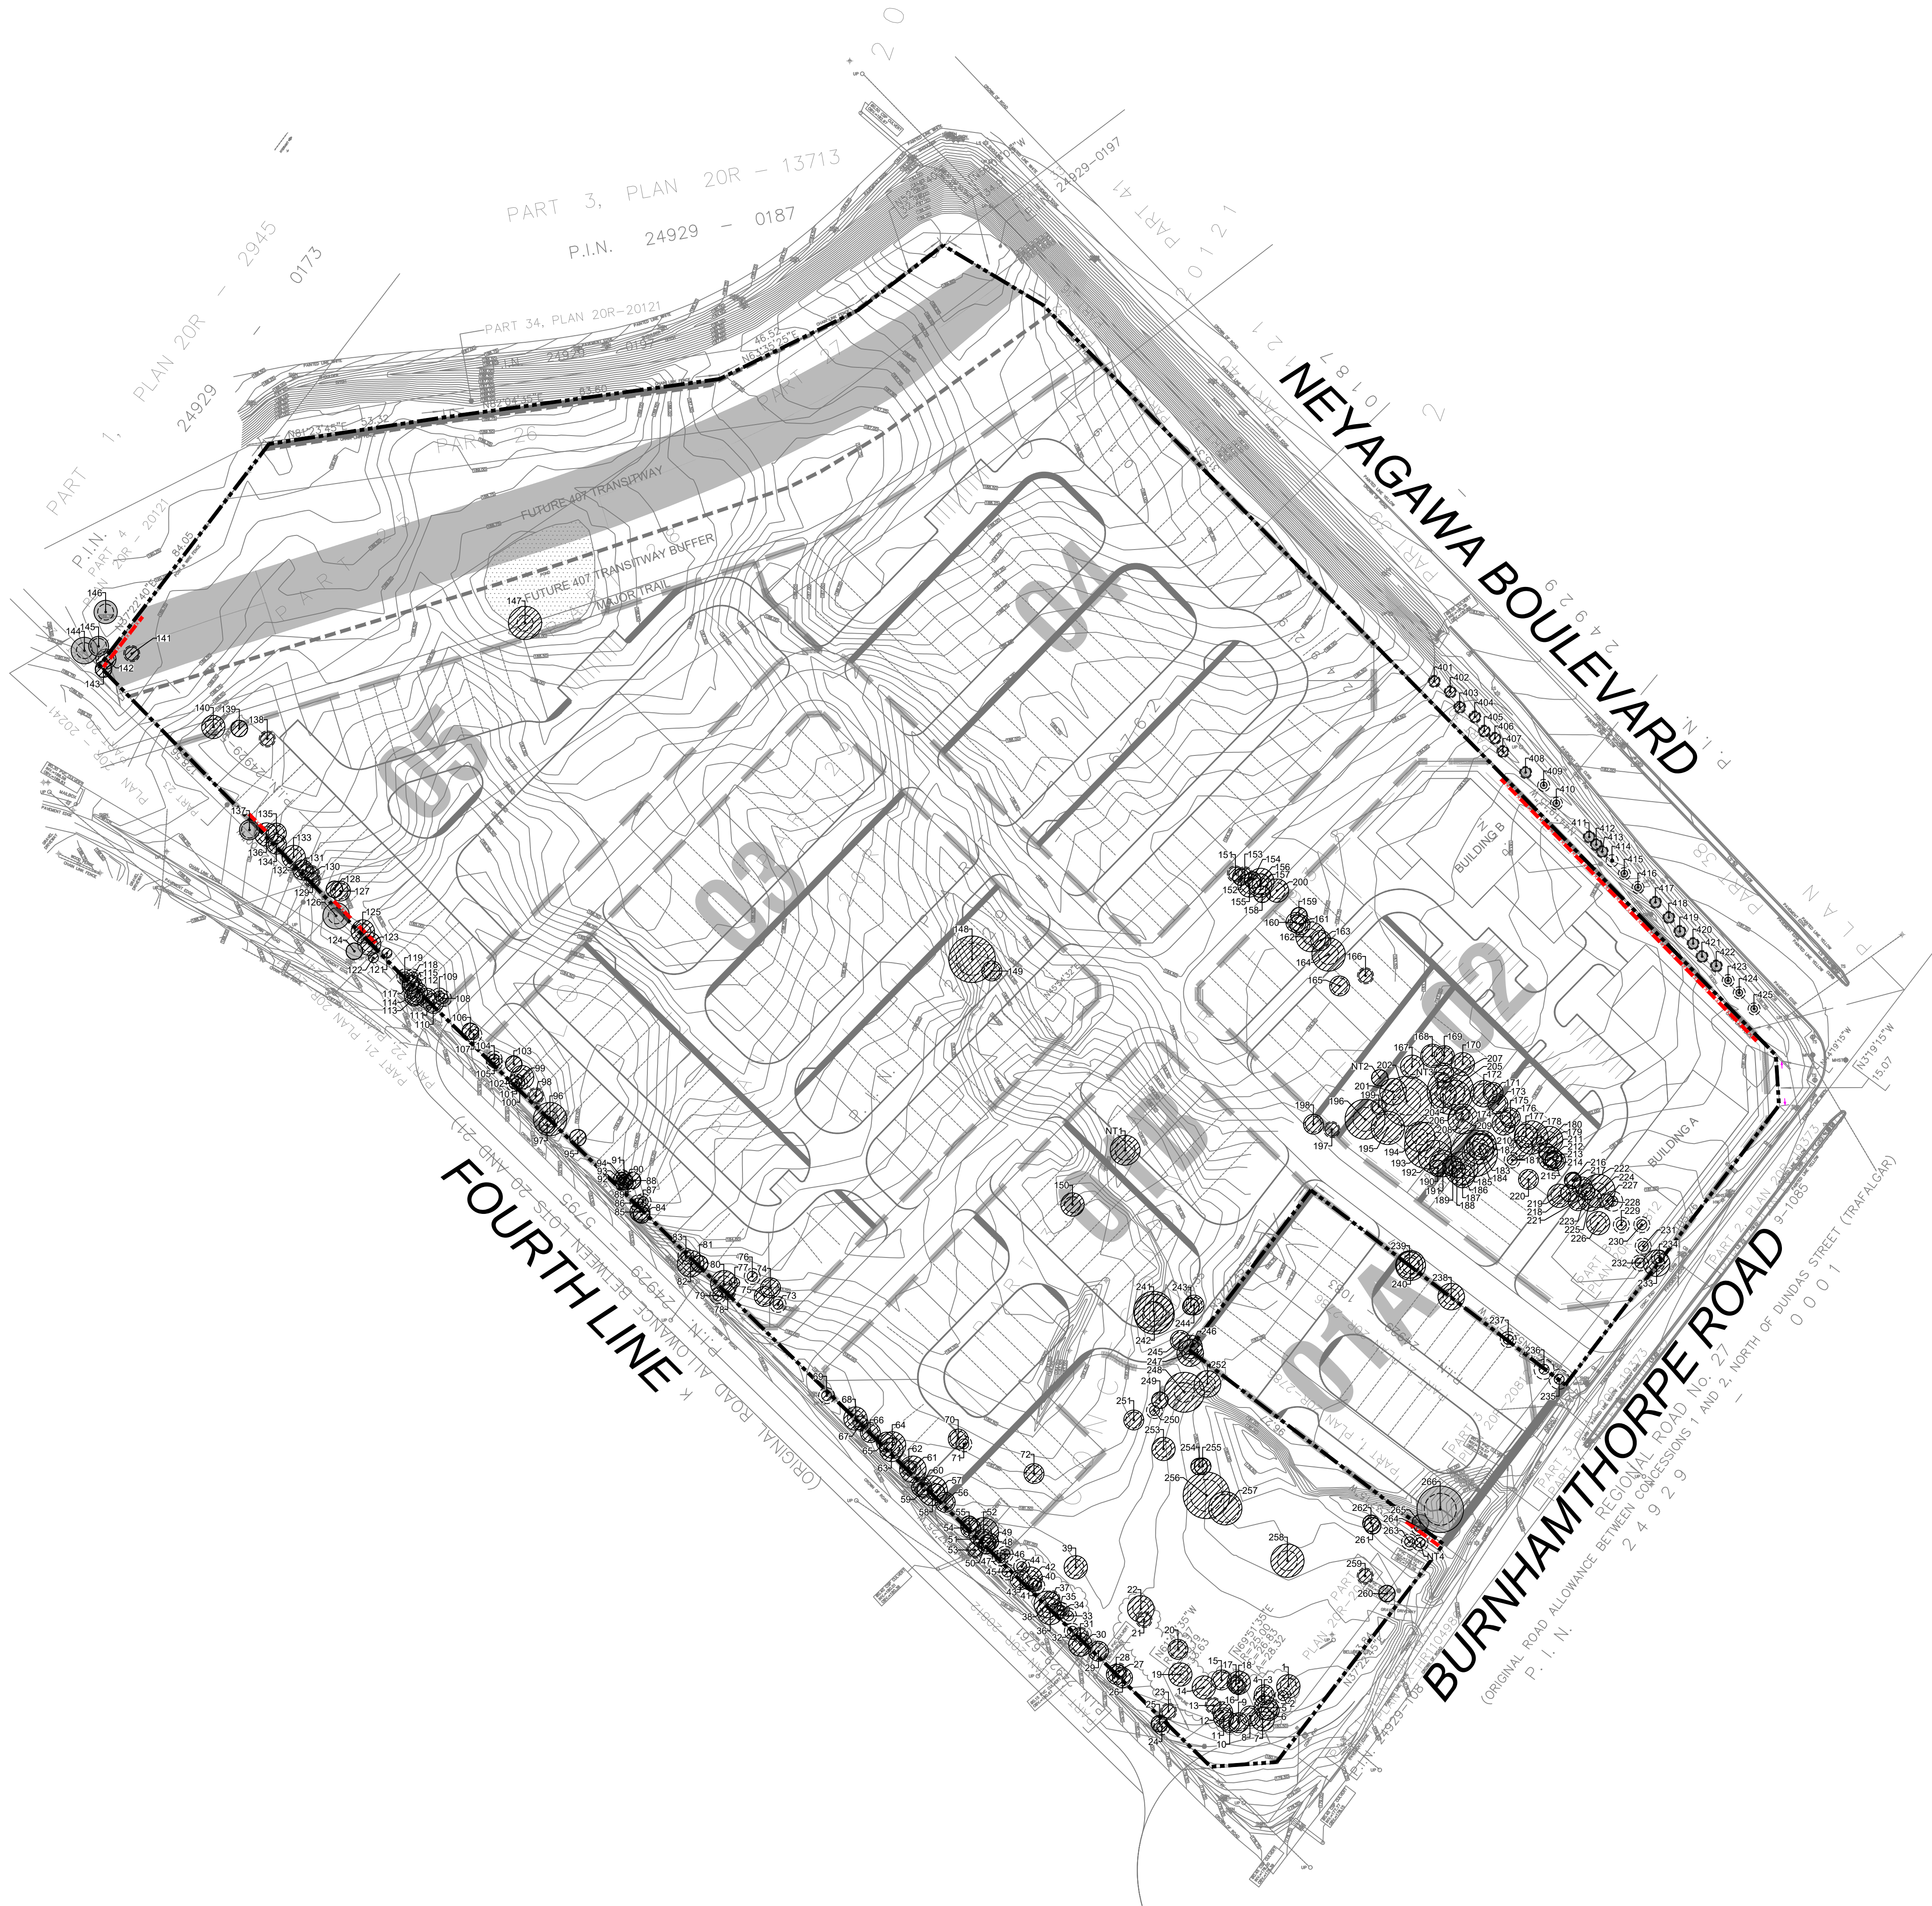
| DRAWN BY: JA | FIGURE №: TP-1 |

A total of 292 trees were inventoried on or adjacent to the subject property, including 187 trees on the property, and 105 trees on adjacent lands. A map showing tree locations is presented in the **Drawing TP-1 (Appendix B)**. Full inventory and assessment details are included in **Drawing TP-2 (Appendix B)**.

Based on a review of the proposed development plan and anticipated future upgrades to Fourth Line, a total of 266 trees will require removal due to site grading, servicing, and construction. Trees identified for removal are illustrated in **Drawing TP-1 (Appendix B)**.

Trees within or adjacent to a construction site must be protected during construction by means of a barrier installed at the minimum TPZ distances shown in **Table 2** and following the Town of Oakville’s design specification illustrated in **Drawing TP-2 (Attachment B)**. Tree protection barriers shall meet the following specifications:
