June 19, 2019 [Revised, October 14, 2022]

## ARBORIST REPORT

3171 Lakeshore Rd West (Cudmore's Nursery Site), Oakville, Ontario

MHBC File: 11161E

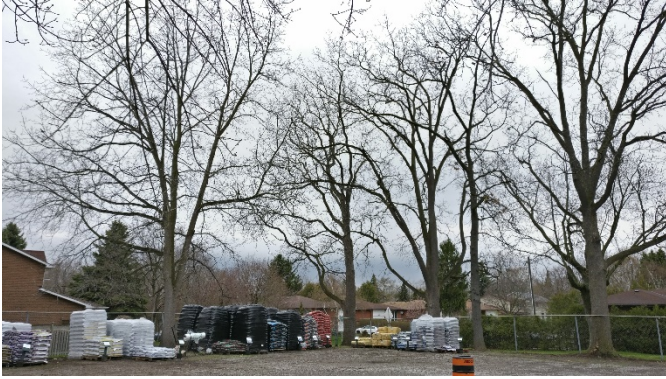
Trees 943 through 947 looking North East.

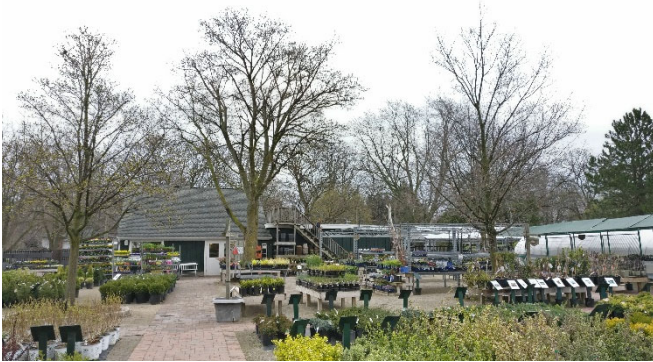
Trees 668 through 670 looking East.

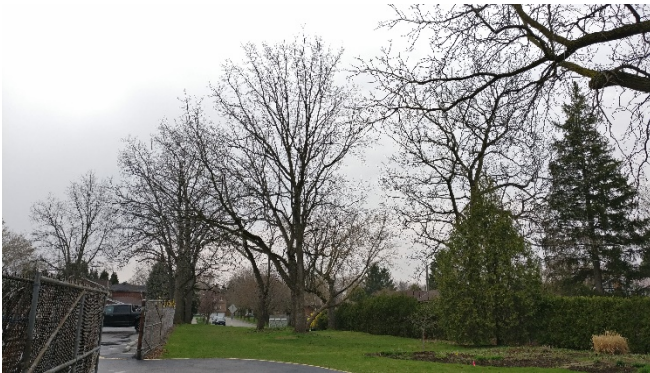
Trees 697 through 700, 960 through 964, 664 looking West.
