**GEOTECHNICAL SLOPE STABILITY
AND STREAMBANK EROSION STUDY
LONG TERM STABLE SLOPE CREST UPDATE
1300 BRONTE ROAD
OAKVILLE, ONTARIO**

Prepared for: Bronte River LP
c/o Argo Development Corporation
4900 Palladium Way, Unit 105
Burlington, Ontario
L7M 0W7

File No. 1-16-0035-02
December 21, 2021
© **Terraprobe Inc.**

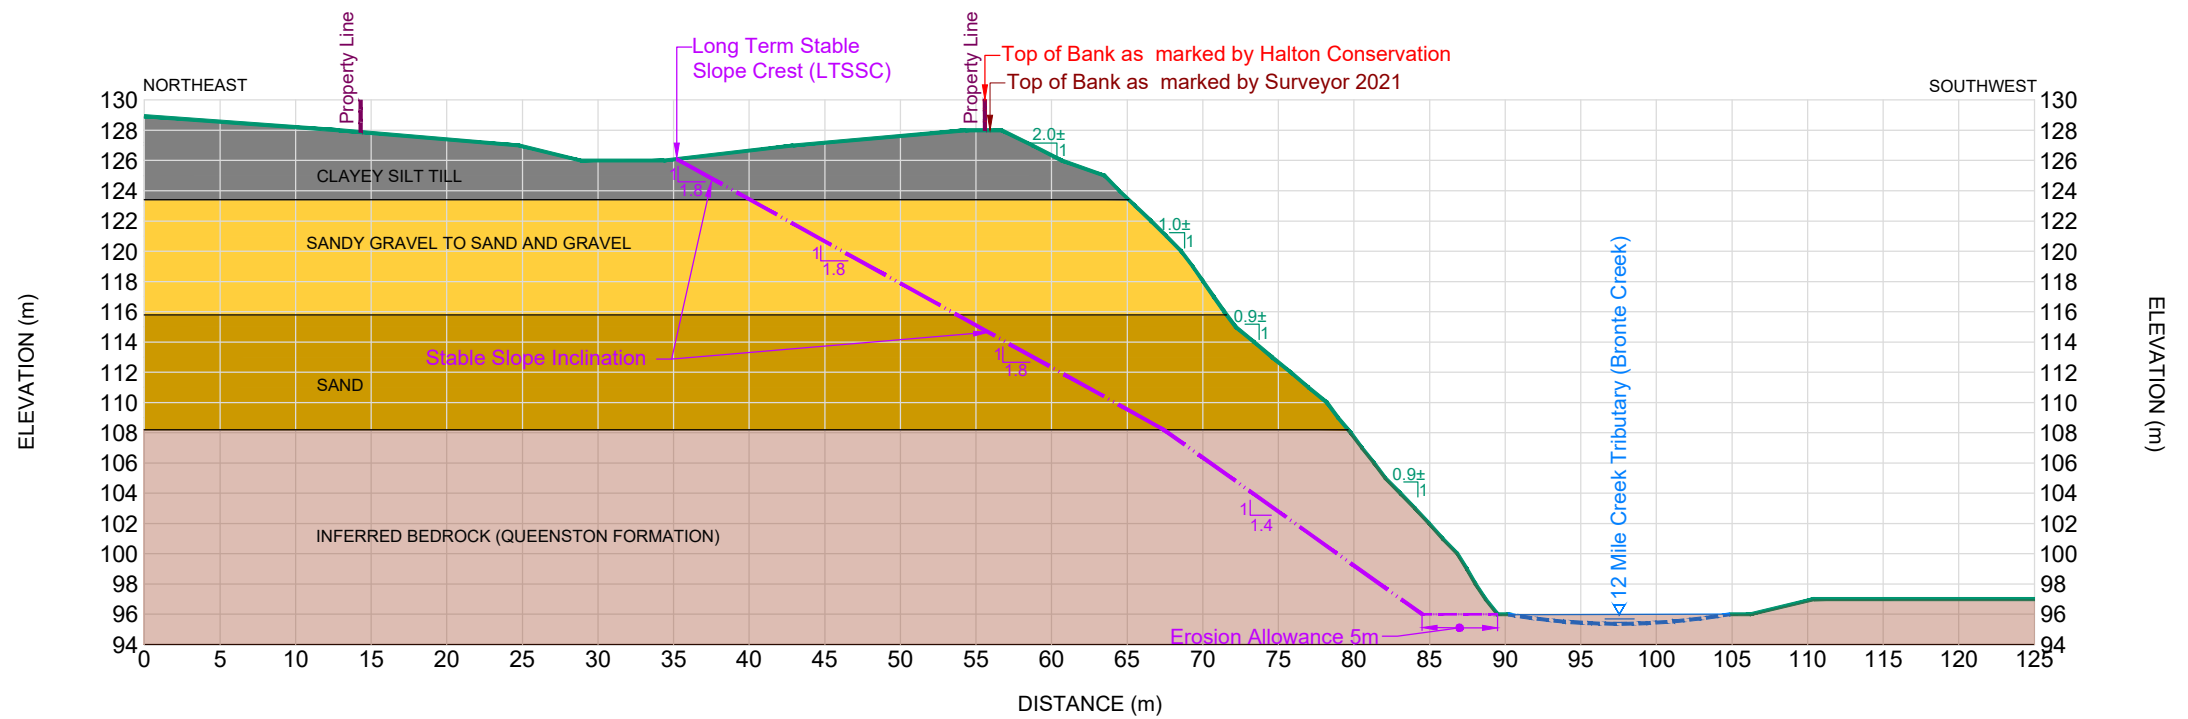
SECTION E-E'

The minimum factors of safety for Sections E-E' and G-G' were 1.02 and 1.01 for normal ground water level condition. As noted above both sections were not analysed for high/elevated ground water level condition as the Factors of Safety obtained from the normal ground water level condition were lower than the required Factor of Safety, and therefore, these slopes are considered to be unstable in the long-term.

The minimum factors of safety for Sections E-E' and G-G' were 1.02 and 1.01 for normal ground water level condition. Therefore, the minimum factors of safety obtained for both sections for the existing slope condition are lower than the minimum required factors of safety, and therefore are not considered adequate with respect to the long-term stability of the site slope.

Therefore, a slope inclination of 1.8 to 1.0 (horizontal to vertical) or flatter is required for the long-term stability of the native overburden portion. It is noted that the calculated long-term stable slope inclination for this site is consistent with our previous studies conducted at this site (File No. 1-16-0035-01) and the general area which is about 1.8 to 1.0 (horizontal to vertical) for the native overburden in the general area. As there were no significant/noticeable changes to the slope condition between the 2016 and 2021 inspections, the LTSSC from the 2016 report requires no changes at this time and is still considered to be valid for the 2016 Study Area.

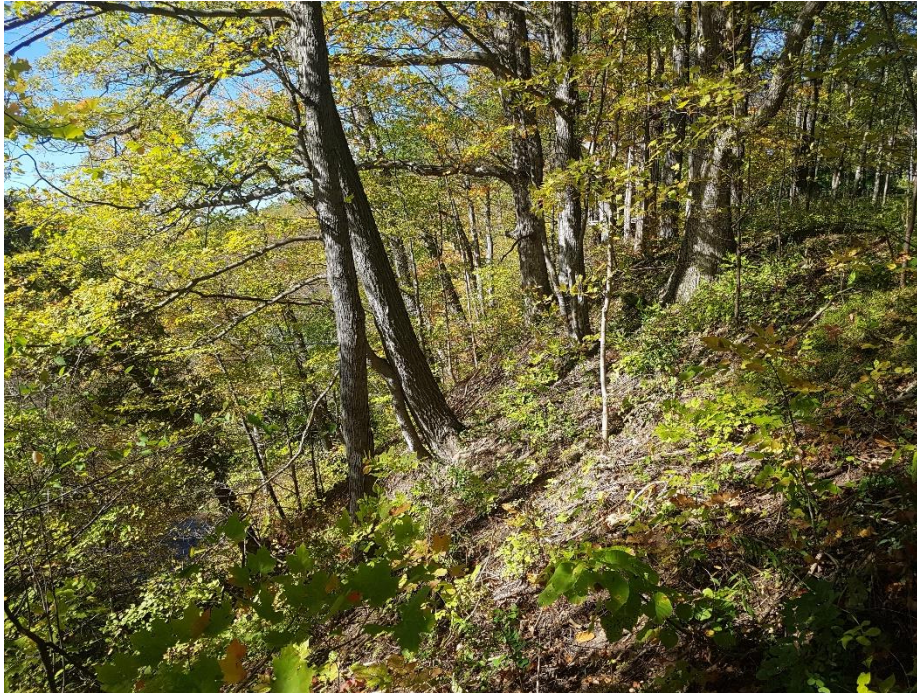
Photo 1. Looking north along the slope crest. The slope crest is well vegetated

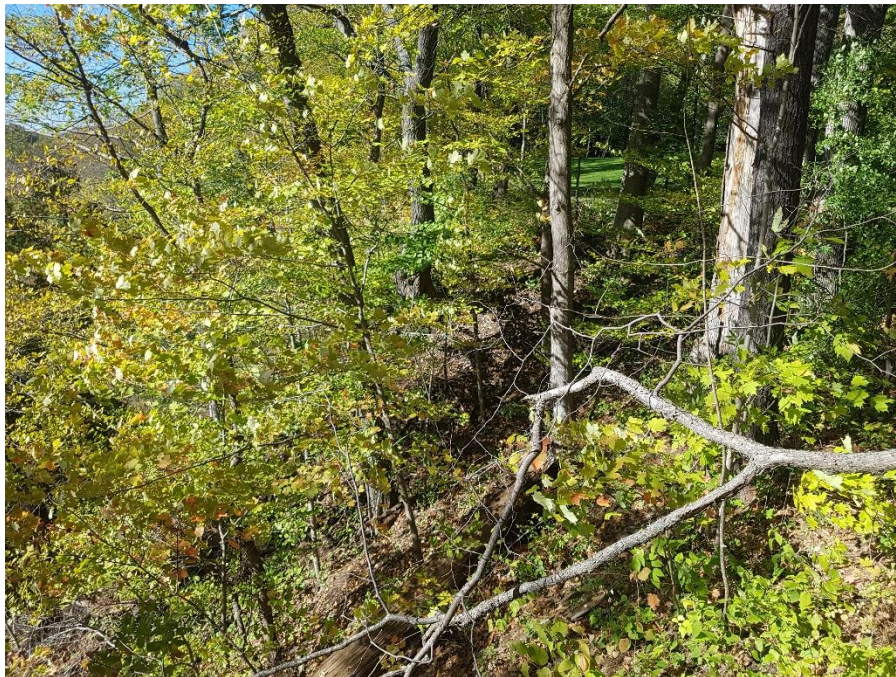
Photo 2. Looking north along the slope crest. The slope crest is well vegetated and shows no signs of recent failure.

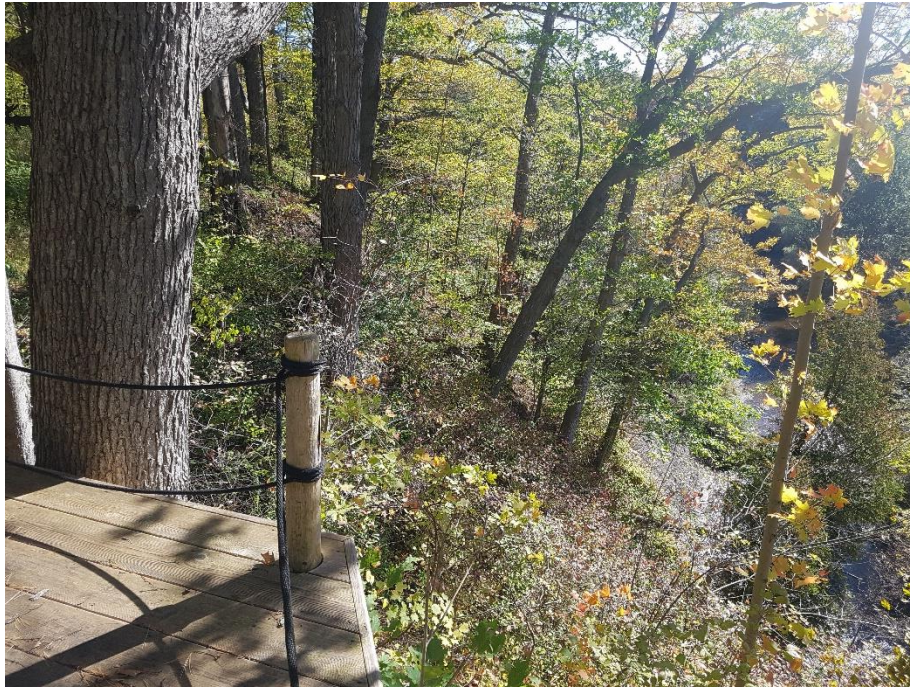
Photo 3. Looking south along the slope crest/upper slope. The slope is well vegetated and tree growth is generally upright and straight.

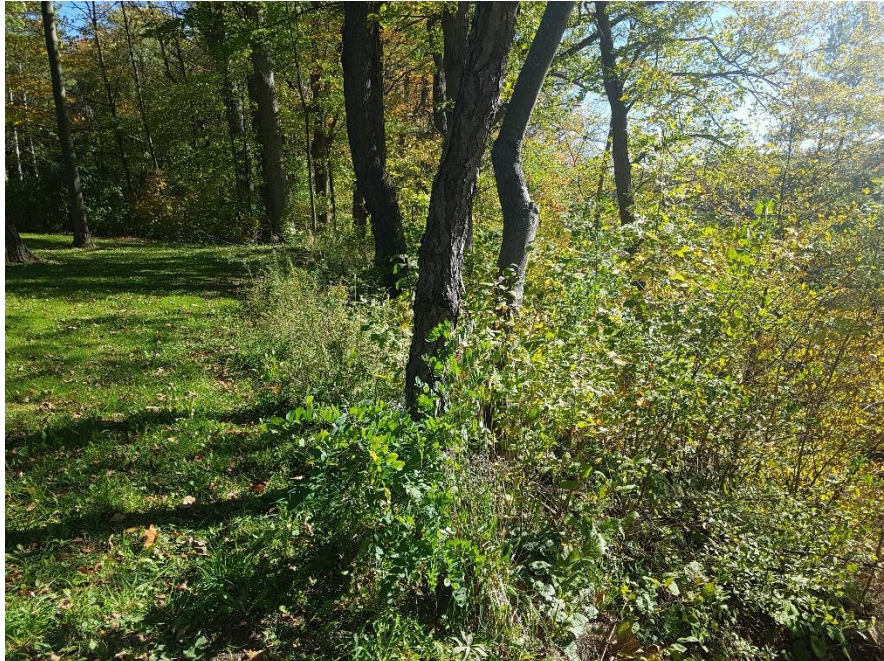
Photo 4. Looking south along the tableland/slope crest. The tableland is relatively flat and the slope crest is well vegetated with mature trees.

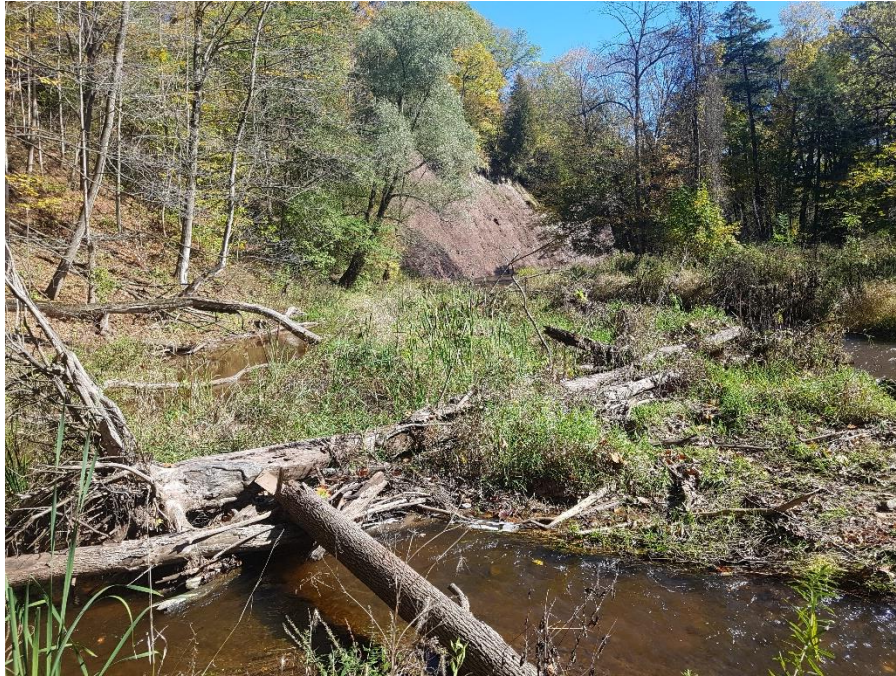
The slope within the study area is about 30 to 32 m high with inclinations varying from about 0.6 to 2.1 horiz. (with locally steeper or flatter inclinations). A near vertical bare scarp was noted at the central portion of the slope (refer to Photographs 6 and 7) which extended upward from the slope toe/water edge covering approximately three-quarters of the slope height (refer to the attached Figure 2 for the approximate extent of the scarp). The near vertical bare scarp is likely created by slope toe/creek bank erosion due to the presence of the creek at the slope toe. This erosion results in an oversteepened slope which is then subjected to progressive slumping. The slope surface outside of the scarp area is generally vegetated with numerous young to mature trees and saplings (refer to Photographs 1 to 4 & 9 to 16). The slope surface (outside of the scarp area) was noted to be leaf littered at the time of our inspection. The tree trunk growth was generally straight and upright except for a few leaning and fallen trees. There were no obvious signs of any slope instability such as tension cracks, slump or scarp zones outside of the scarp area. Further, there was no evidence of any significant surface or rill erosion outside of the scarp area (refer to the enclosed photographs and Figure 2 for photo locations). There is a small ravine/galley (about 1 to 6 m deep) within the southerly portion of the site that extends from the slope crest to the floodplain and Bronte Creek (refer to photographs 11, 12 and 15).

Photo 5. Looking south toward the relatively steep scarp. The slope north of the scarp is separated from the creek by a flood plain.

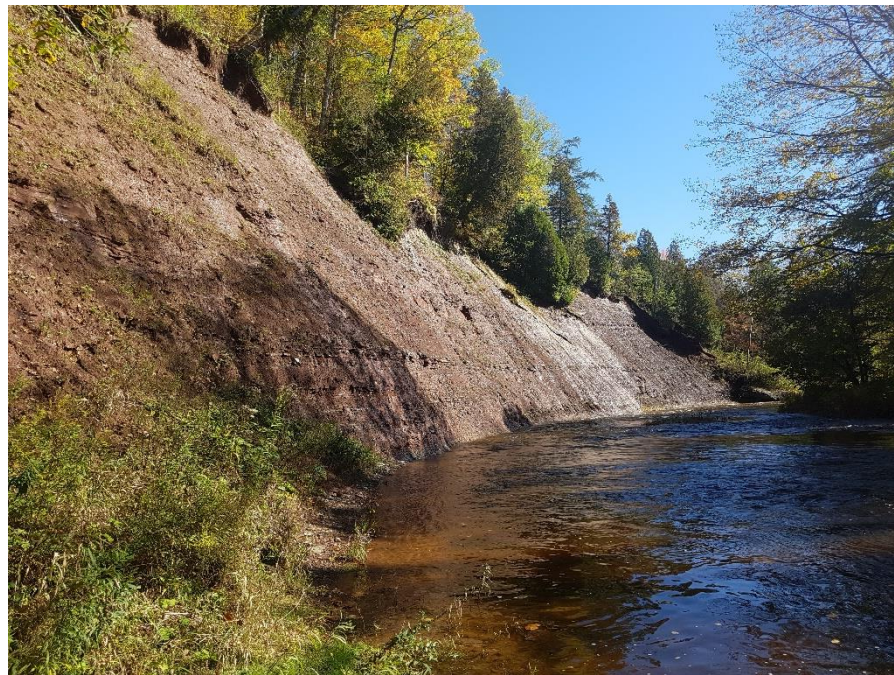
Photo 6. Looking south, a closer view of the relatively steep scarp located at the lower portion of the slope. The creek is in direct contact with the slope resulting in active toe erosion.

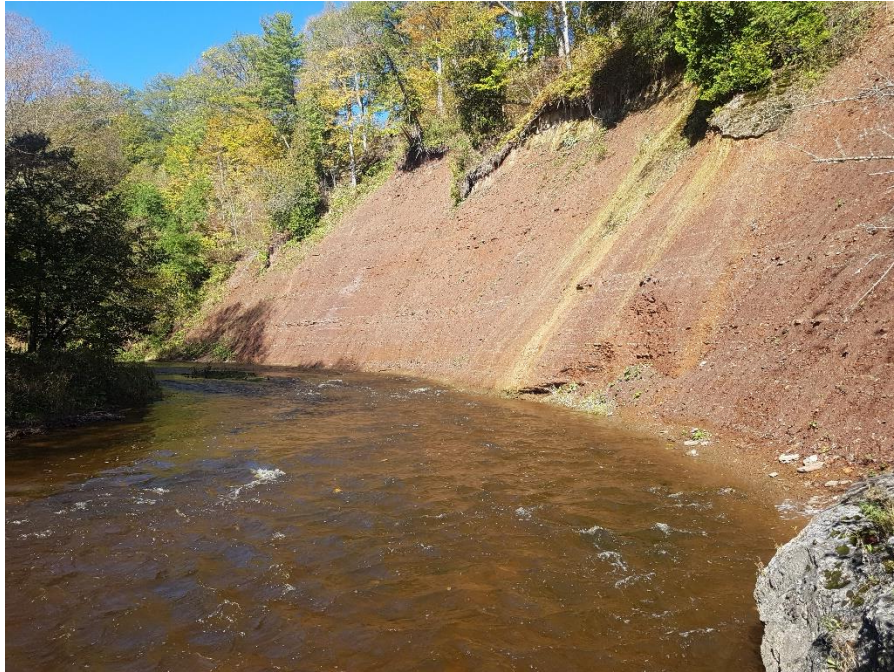
Photo 7. Looking north toward the relatively steep scarp. The scarp is predominately comprised of bare shale.

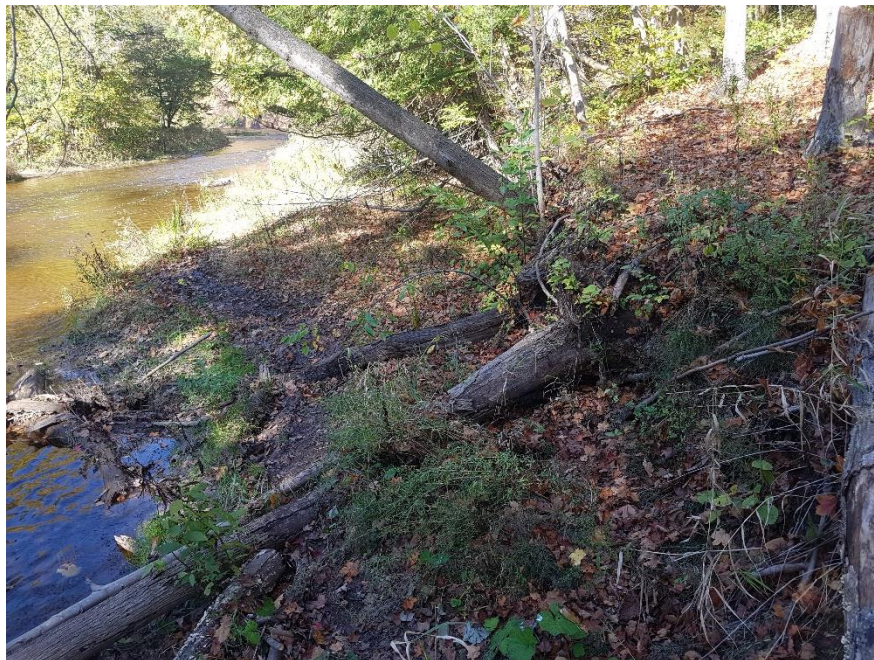
Photo 8. Looking north along the creek south of the scarp. The slope is separated from the creek by a floodplain and no active erosion was observed in this area.

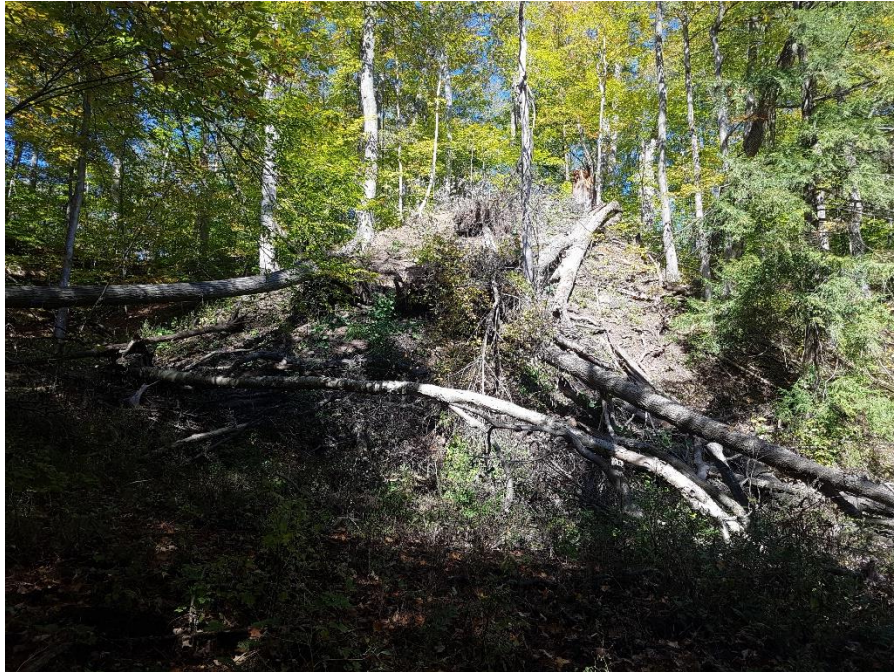
Photo 9. Looking east up slope, the slope is generally well vegetated with mature trees. There are occasional fallen trees but typically tree growth is upright and straight.

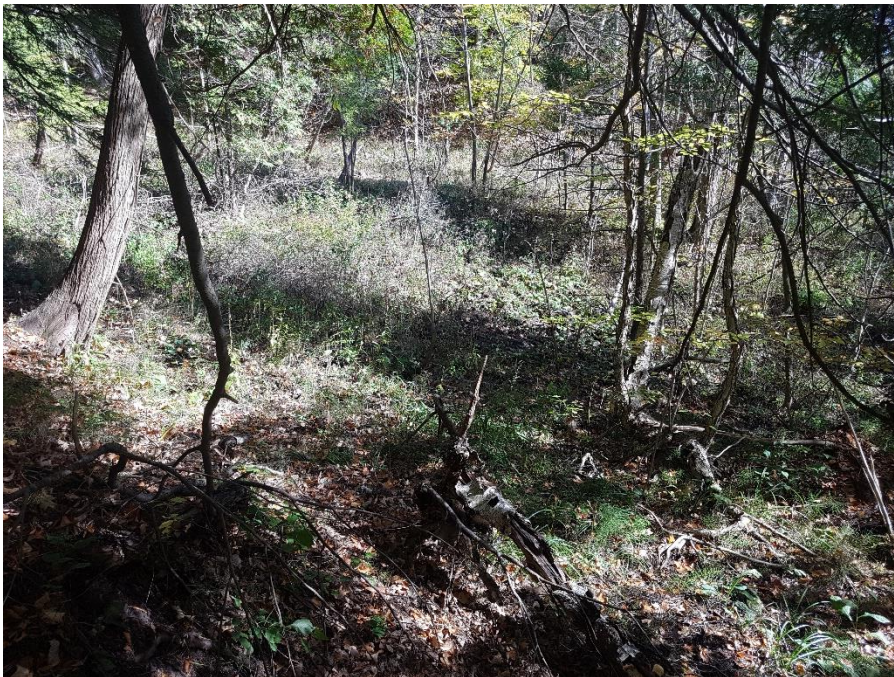
Photo 10. Looking south across the large flood plain separating the southern slope from the creek. The flood plain is well vegetated with young trees.

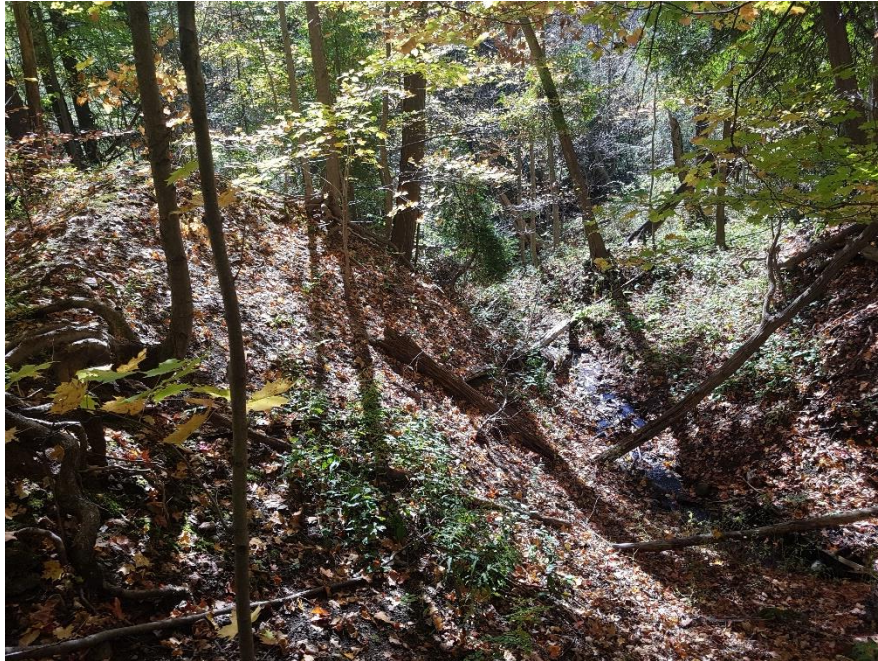
Photo 11. Looking west downslope along a small gully.

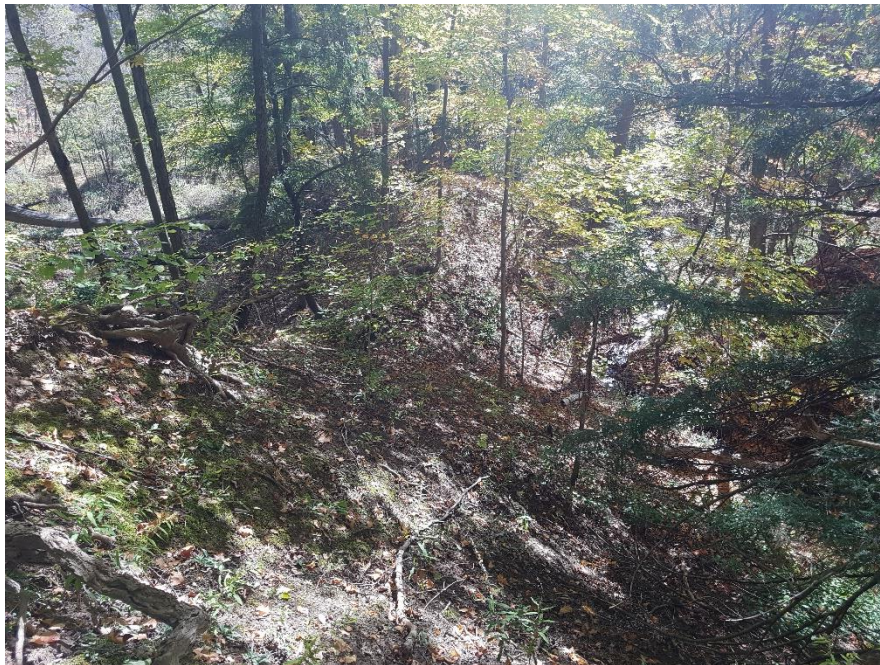
Photo 12. Looking west another view of the small gully.

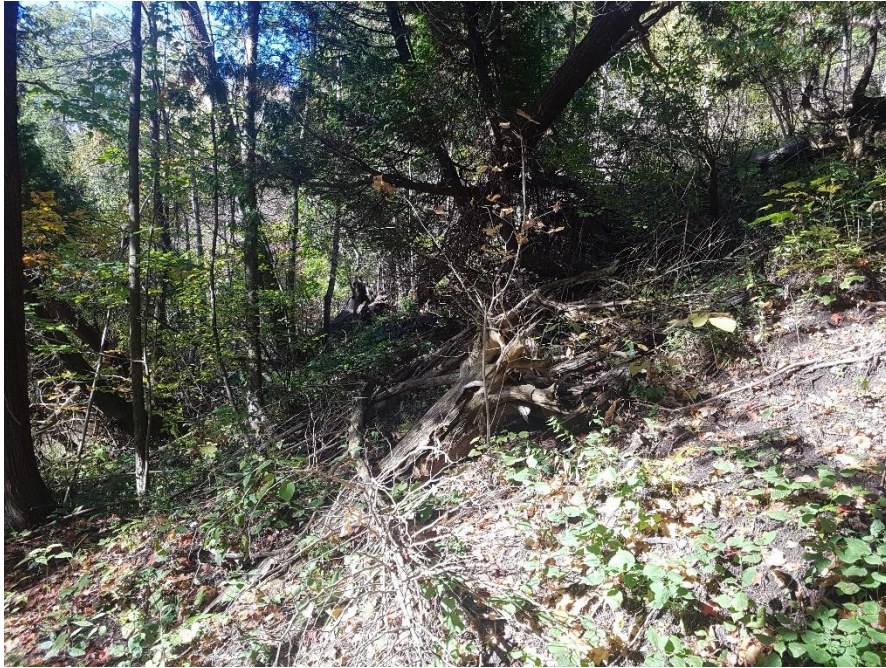
Photo 13. Looking north mid-slope toward the scarp. This section of the slope is well vegetated with young and mature trees.

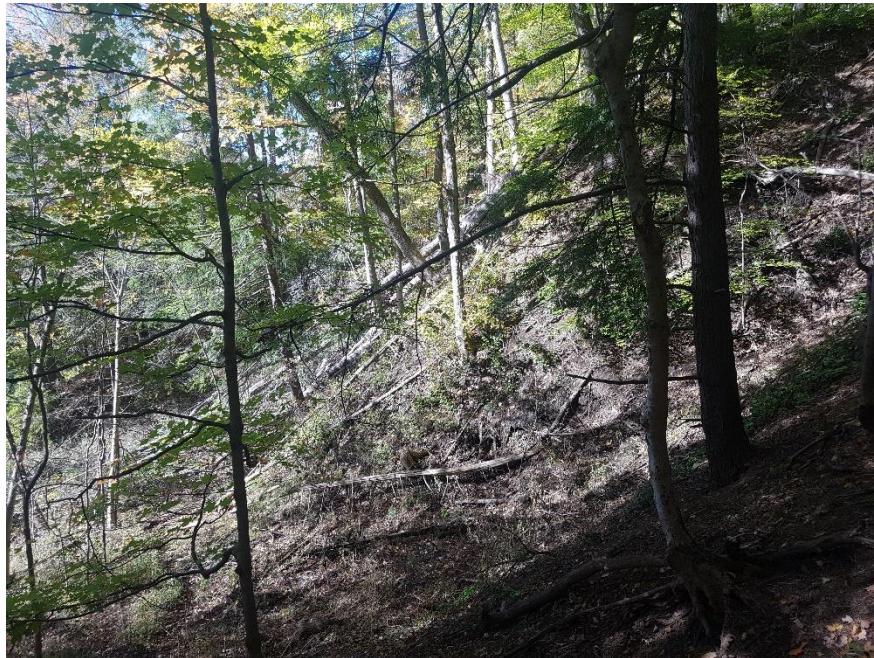
Photo 14. Looking north mid-slope at the southern extent of the site. The slope is well vegetated with mature trees, whose growth is generally upright and straight with some exceptions.

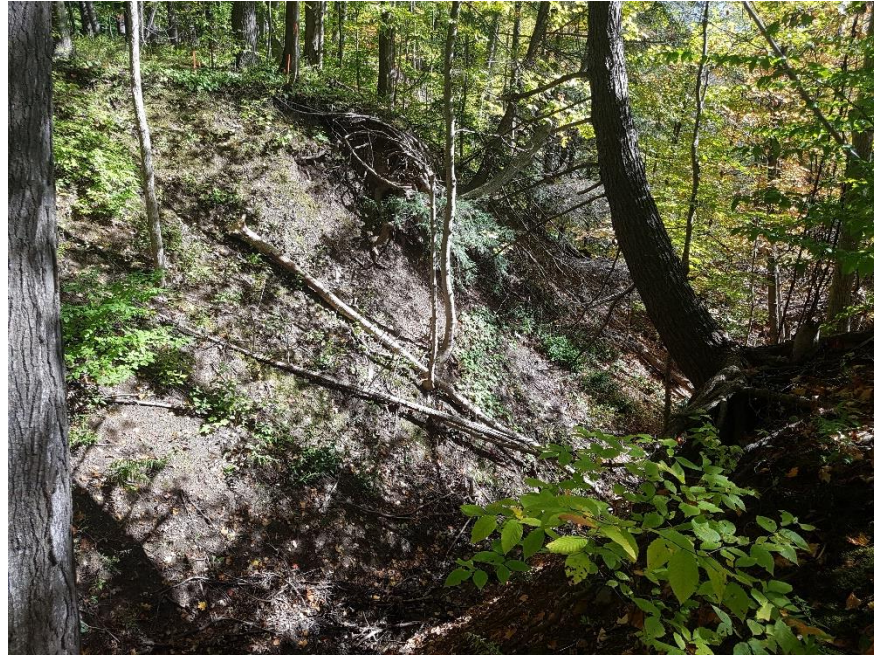
Photo 15. Looking south at the start of the small gulley containing intermitant drainage water flow.

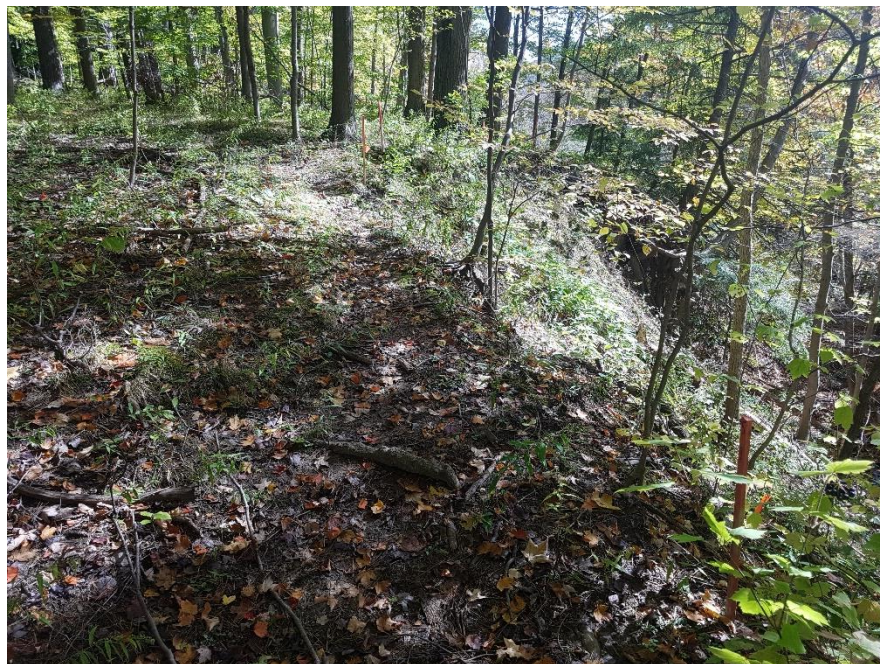
Photo 16. Looking south along the tableland and slope crest at the south end of the site. The tableland is relatively flat and the slope crest is vegetated with young and mature trees.
