SCOPED TREE ASSESSMENT REPORT

550 KERR STREET, OAKVILLE ONTARIO

MAY 2019

RKLA JOB # 18-201

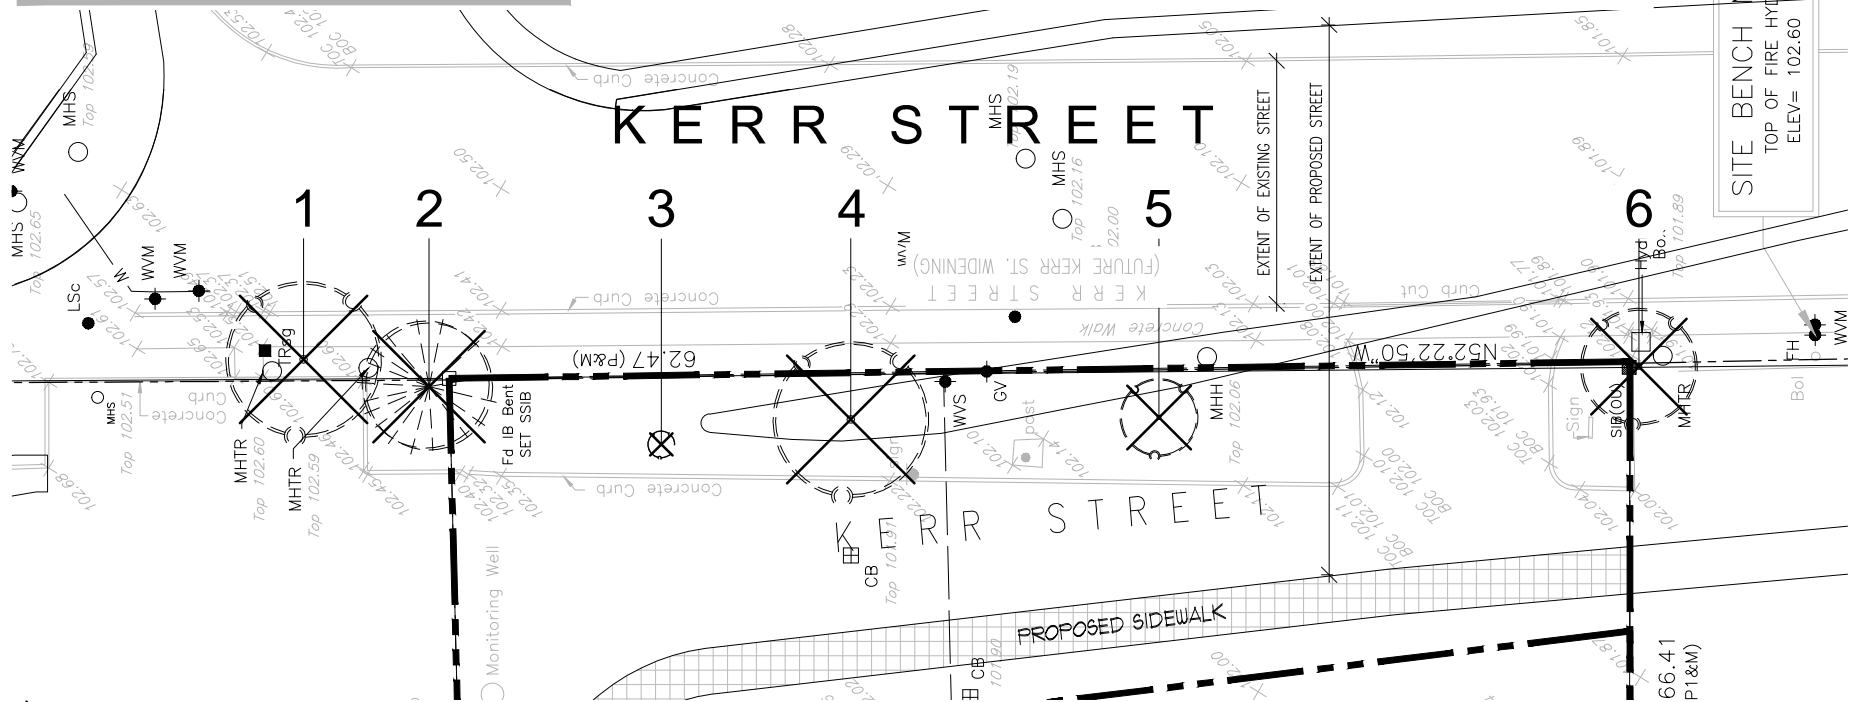
SCOPED TREE ASSESSMENT PLAN

| 1 | SHADEMASTER HONEYLOCUST | REMOVE |
| 2 | AUSTRIAN PINE | REMOVE |
| 3 | PYRAMIDAL ENGLISH OAK | REMOVE |
| 4 | NORWAY MAPLE | REMOVE |
| 5 | NORWAY MAPLE | REMOVE |
| 6 | SIBERIAN ELM | REMOVE |

All trees are to be removed in anticipation of the widening of Kerr Street.
