Erosion Hazard and Mitigation Assessment Sixteen Mile Creek Tributaries

Delmanor West Oak Development Oakville, Ontario

Report Title: Erosion Hazard and Mitigation Assessment
Sixteen Mile Creek Tributaries
Delmanor West Oak Development
Oakville, Ontario

Project Number: PN21077

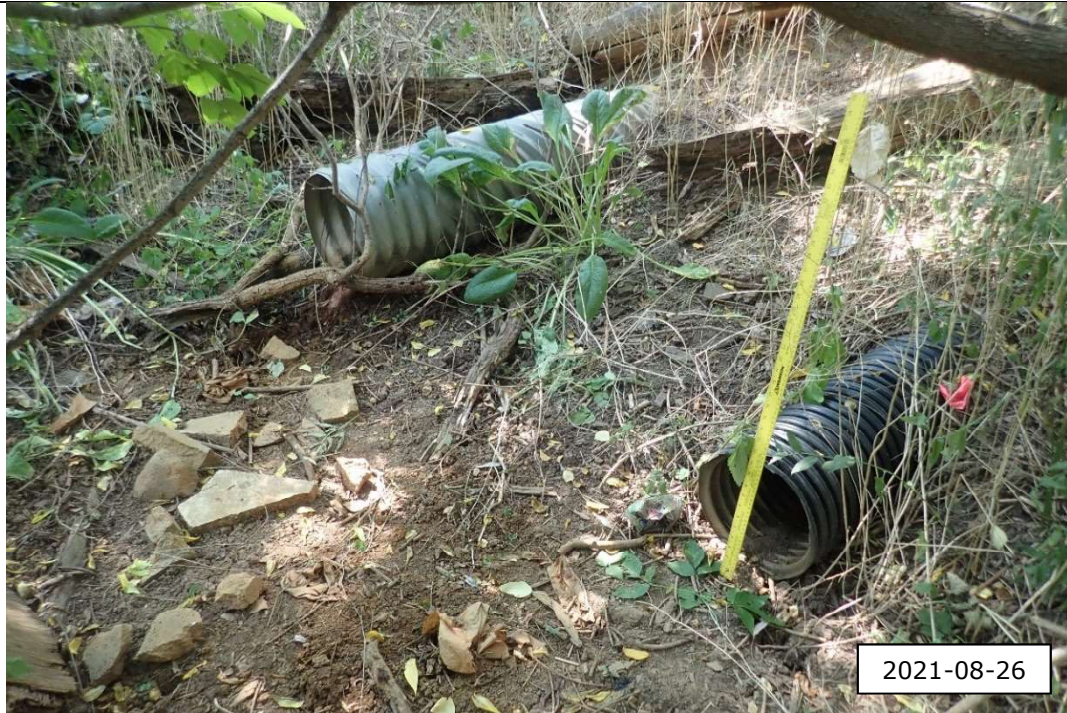
Photo 1
Reach GCT-1 – Tributary of Sixteen Mile Creek

Upstream view towards the upstream extent of the ravine feature. The two culverts, left to right, were approximately 0.40 m and 0.30 m in diameter.

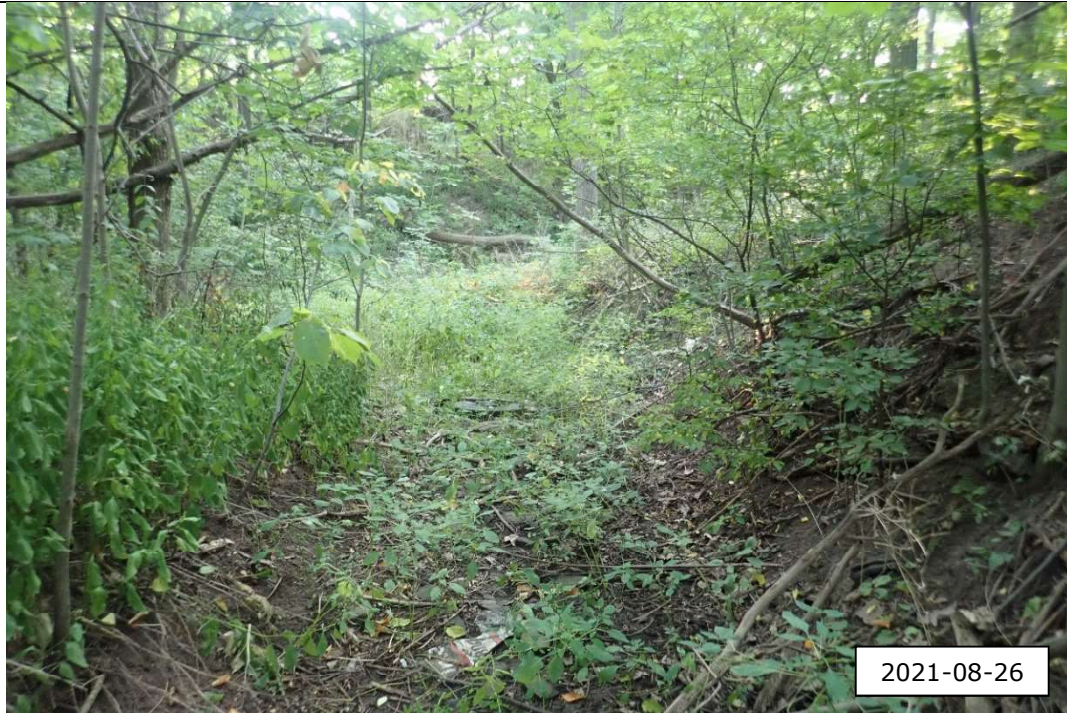
Photo 2
Reach GCT-1 – Tributary of Sixteen Mile Creek

Photograph taken in the upper section of the reach looking downstream where the channel gained definition.

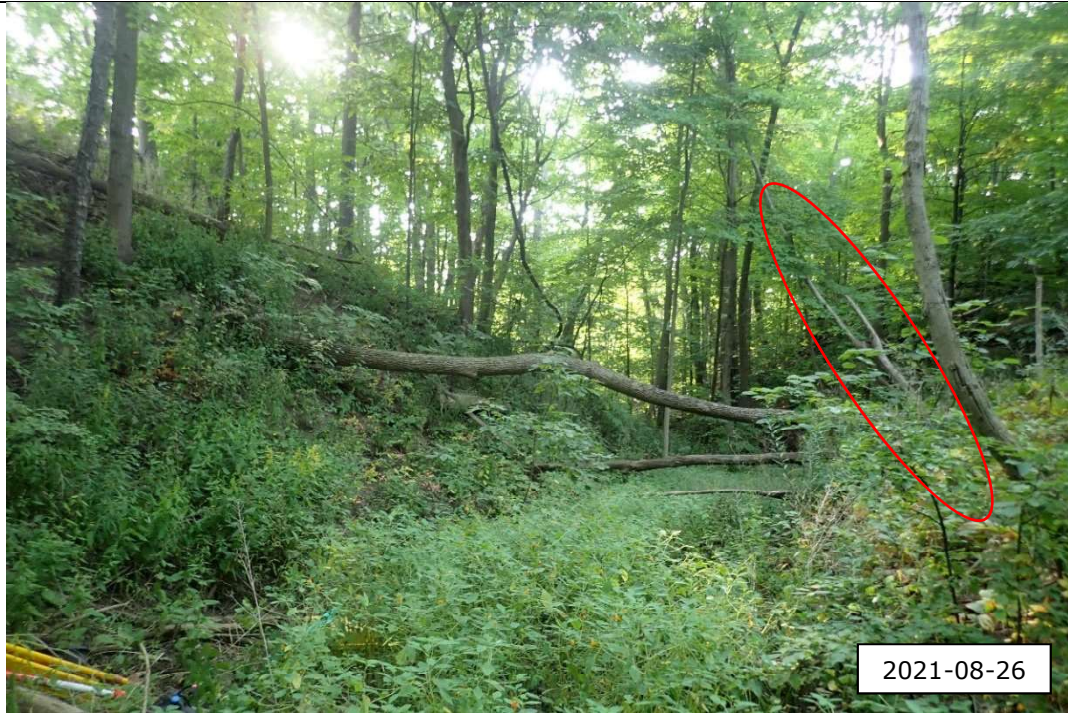
Photo 3
Reach GCT-1 – Tributary of Sixteen Mile Creek

The riparian buffer zone was 4 to 10 channel widths. Riparian vegetation was comprised of a mix of mature tree species. Leaning/fallen trees, indicated by the red circle were observed approximately every 50 meters in the channel.

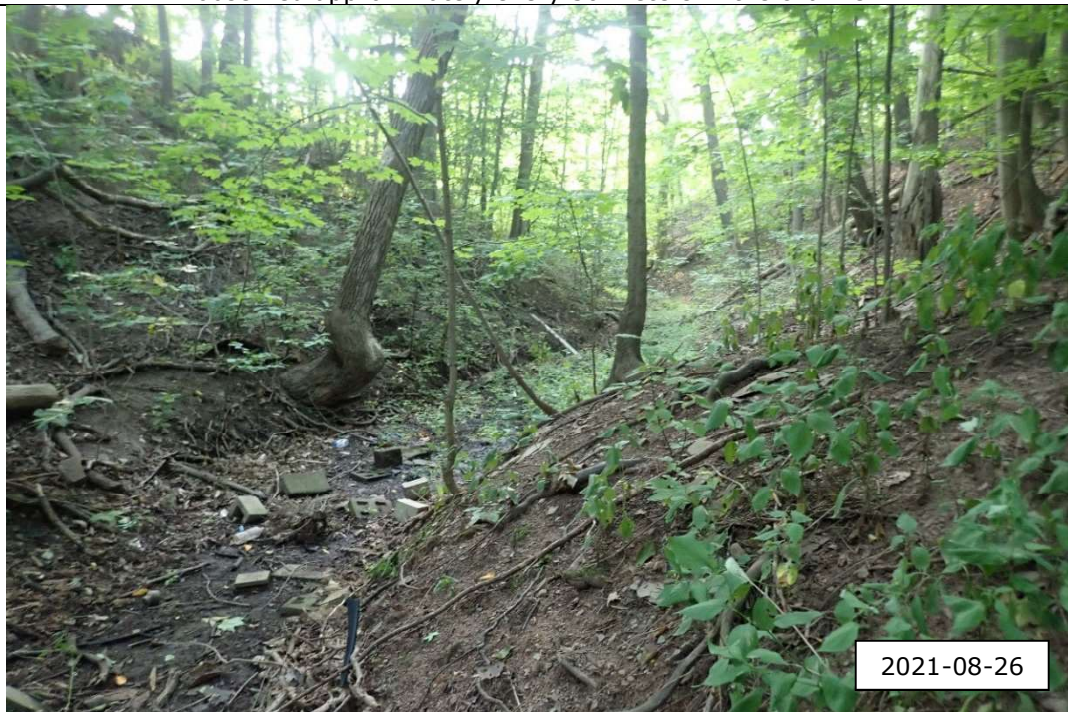
Photo 4
Reach GCT-1 – Tributary of Sixteen Mile Creek

Photograph taken looking downstream. The reach consisted of riffles and bed materials consisted primarily of cobble embedded by clay and silt. No shale bedrock was exposed in the channel bed or banks.

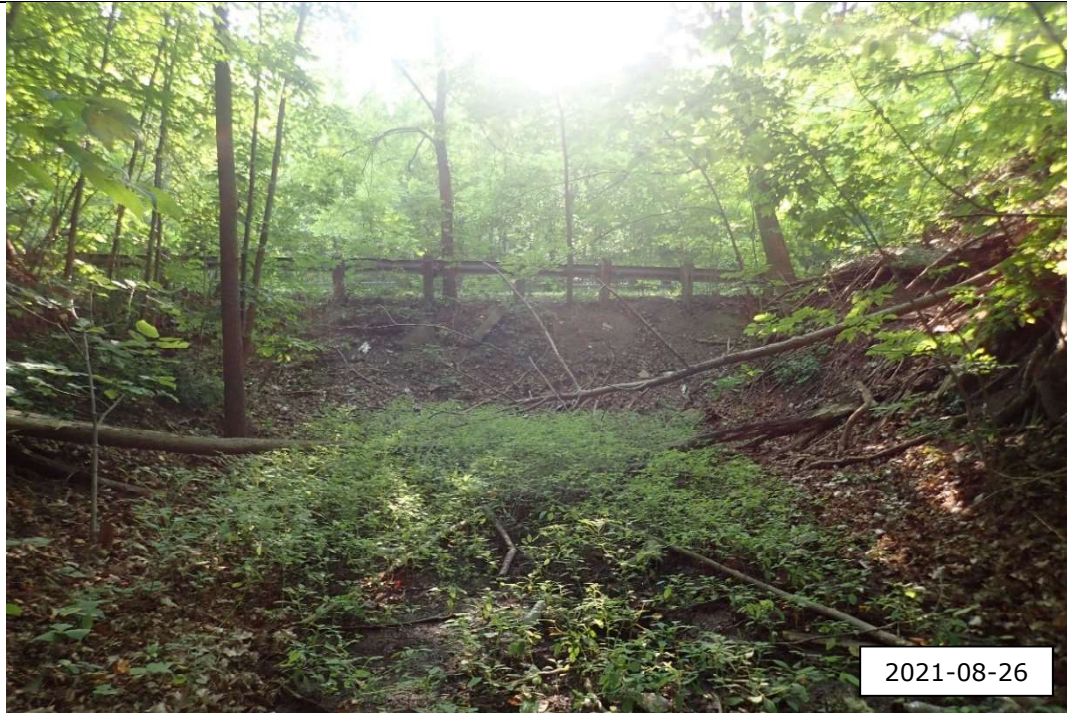
Photo 5
Reach GCT-1 – Tributary of Sixteen Mile Creek

Downstream view of the watercourse. The reach was dry at the time of assessment. Average bankfull width and depth were 3.08 m and 0.24 m, respectively.

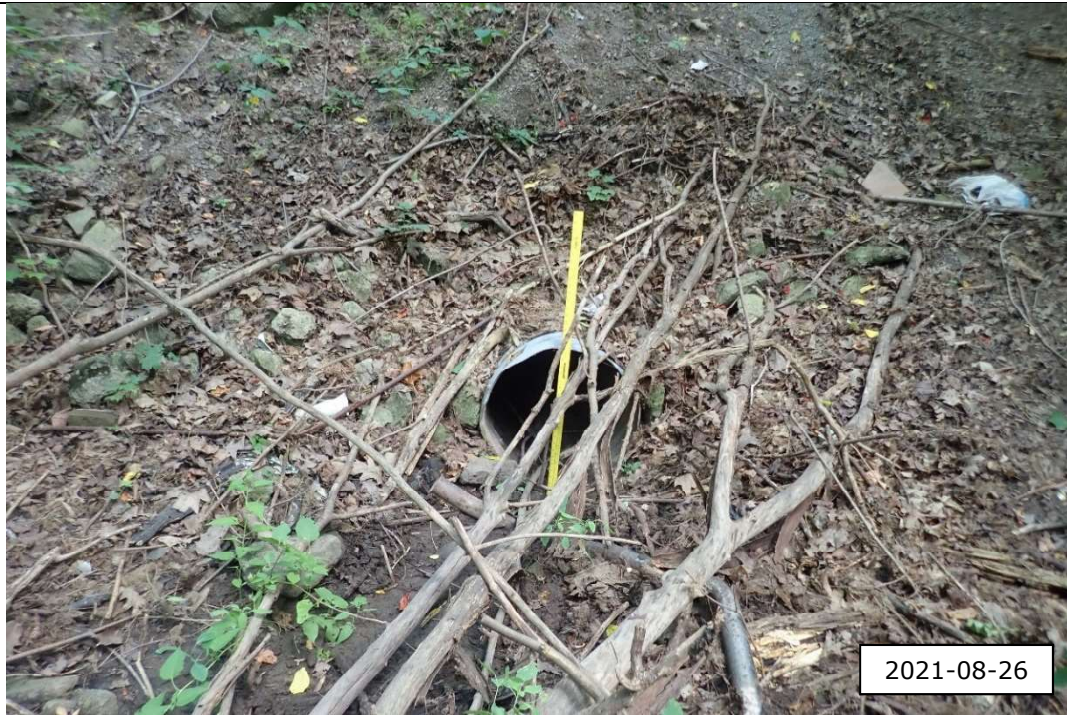
Photo 6
Reach GCT-1 – Tributary of Sixteen Mile Creek

Photo taken at the downstream extent of reach, facing downstream. The culvert connected to Reach GC2 and was approximately 0.5 m in diameter.

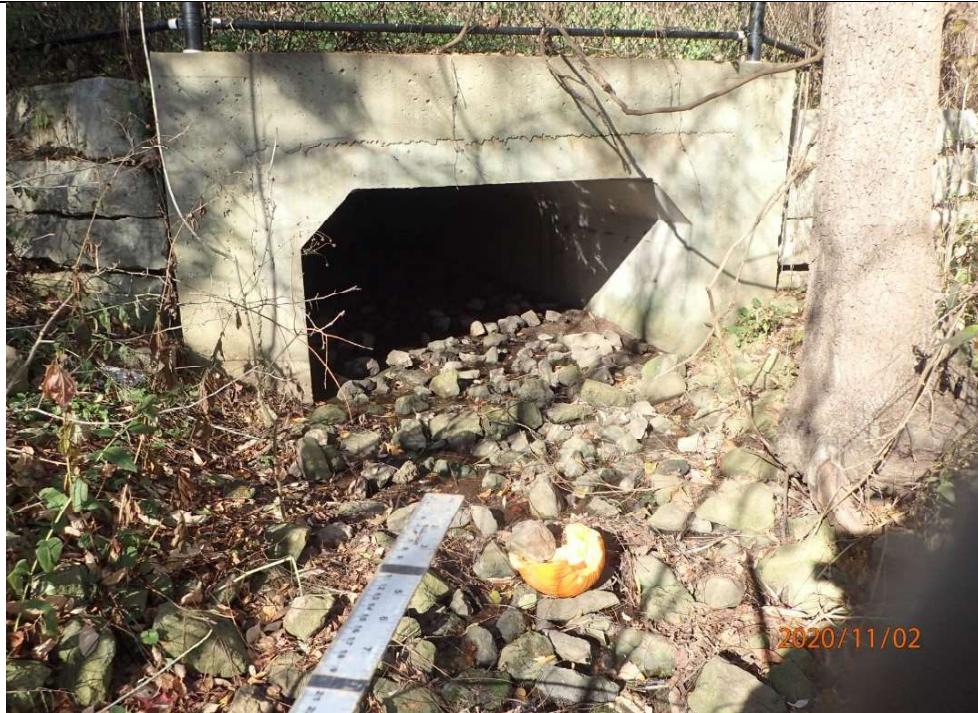
Photo 7
Reach GC-3 – Tributary of Sixteen Mile Creek

Flows exited the culvert south of Glenayr Gate into a stone treatment. No scour was noted downstream of the outlet.

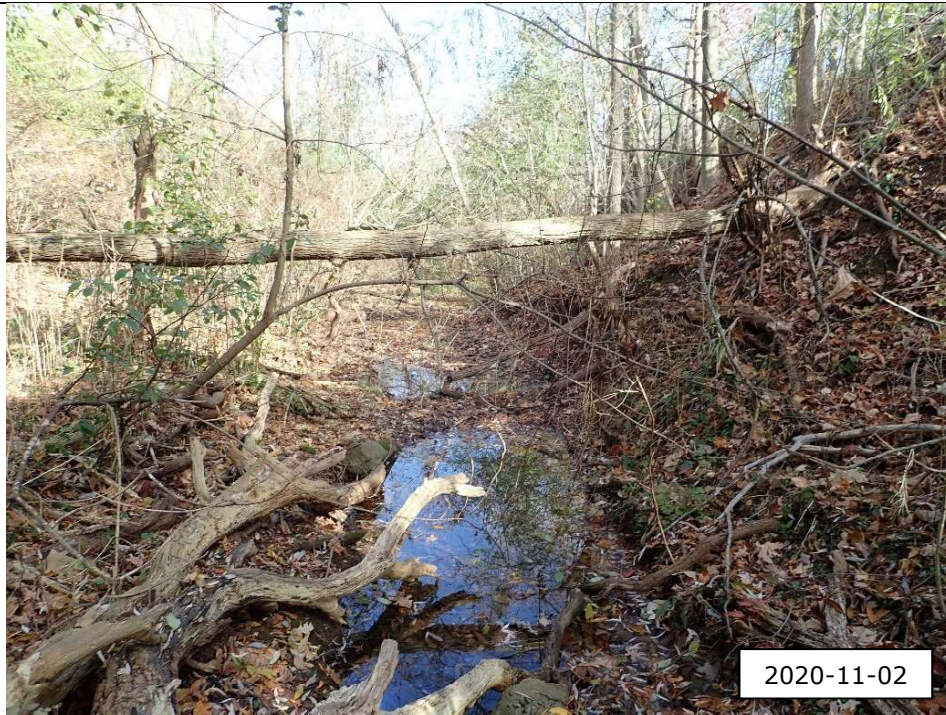
Photo 8
Reach GC-3 – Tributary of Sixteen Mile Creek

Reach **GC-3** was characterized as a narrow, confined, forested valley with a high gradient.

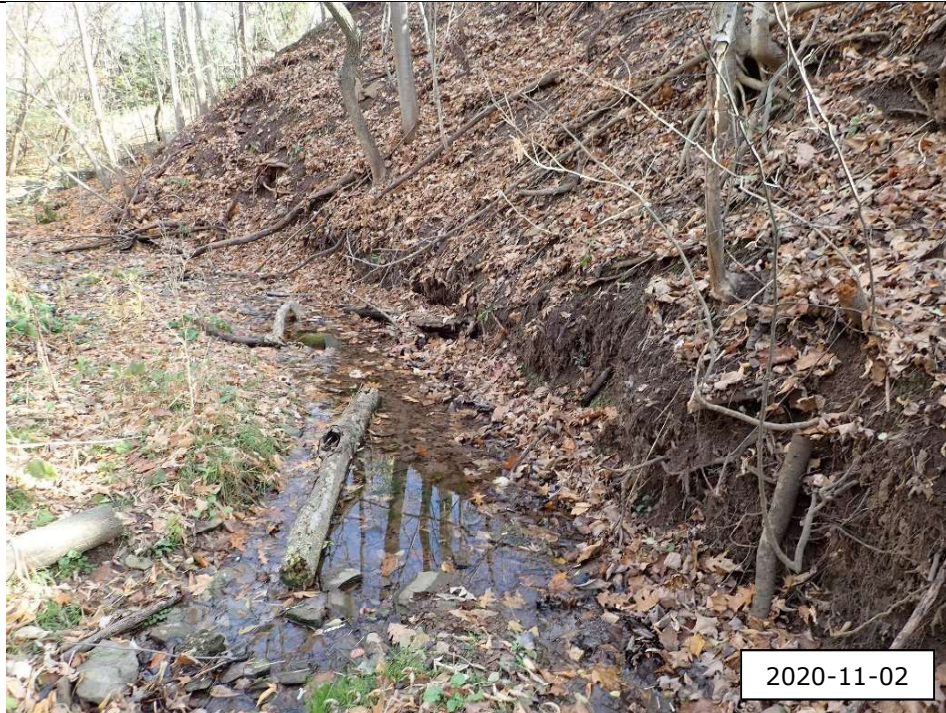
Photo 9
Reach GC-3 – Tributary of Sixteen Mile Creek

Several instances of valley wall contact and erosion were noted in **Reach GC-3**.

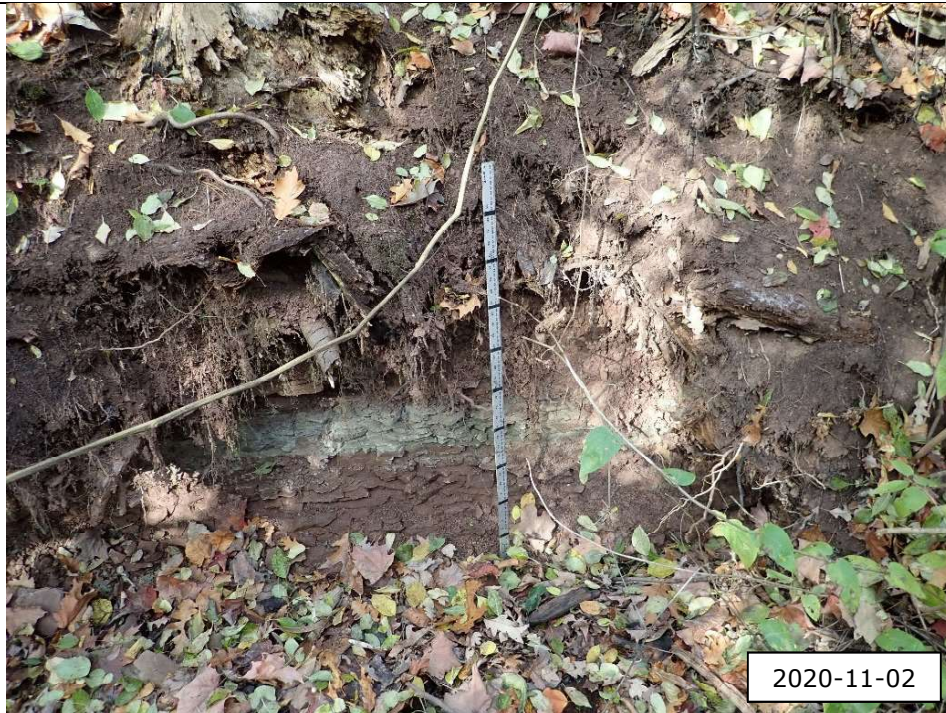
Photo 10
Reach GC-3 – Tributary of Sixteen Mile Creek

Exposed parent-material, Queenston shale, was frequently observed along the channel banks.

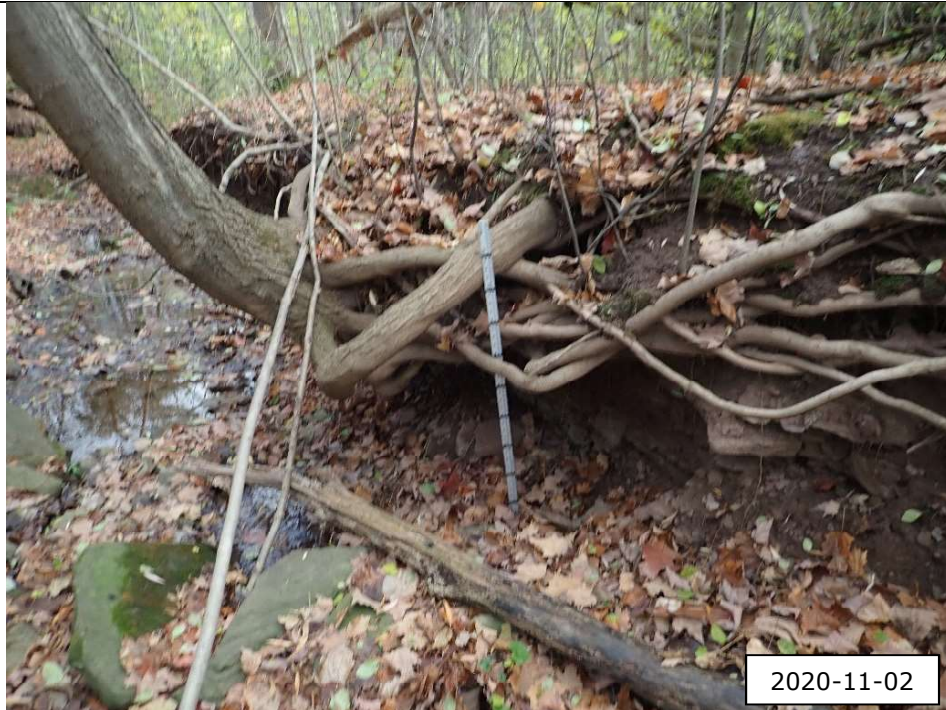
Photo 11
Reach GC-3 – Tributary of Sixteen Mile Creek

Mature tree roots were commonly exposed on the banks. Substrate was coarse and consisted of platy pebbles and cobbles derived from the shale material.

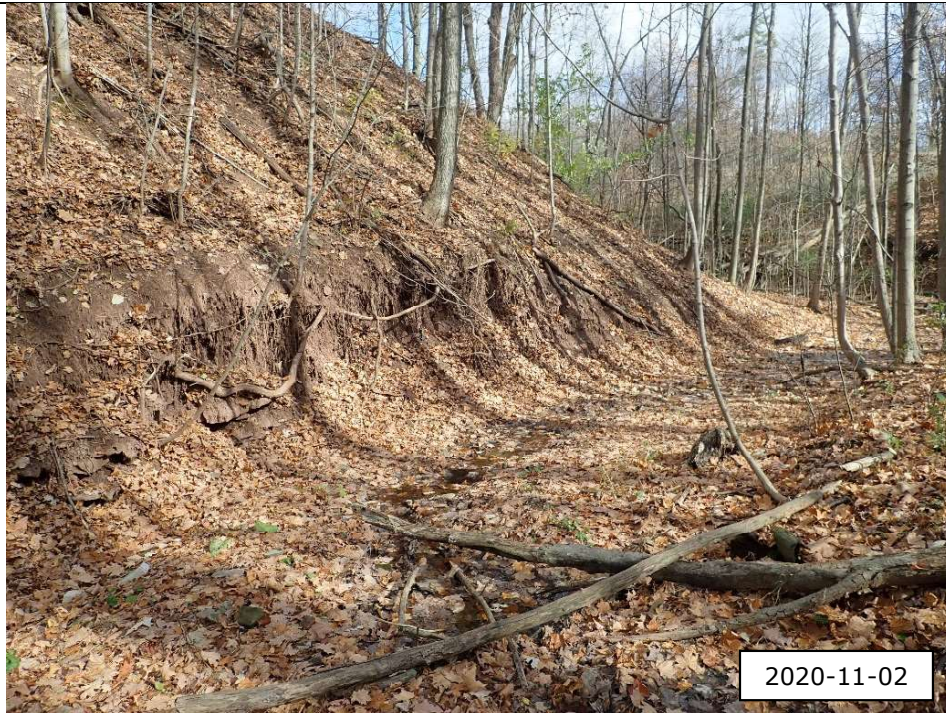
Photo 12
Reach GC-3 – Tributary of Sixteen Mile Creek

The meandering planform was constricted by the narrow valley corridor. Valley wall slopes were steep but well vegetated with mature trees. Grasses were largely absent.

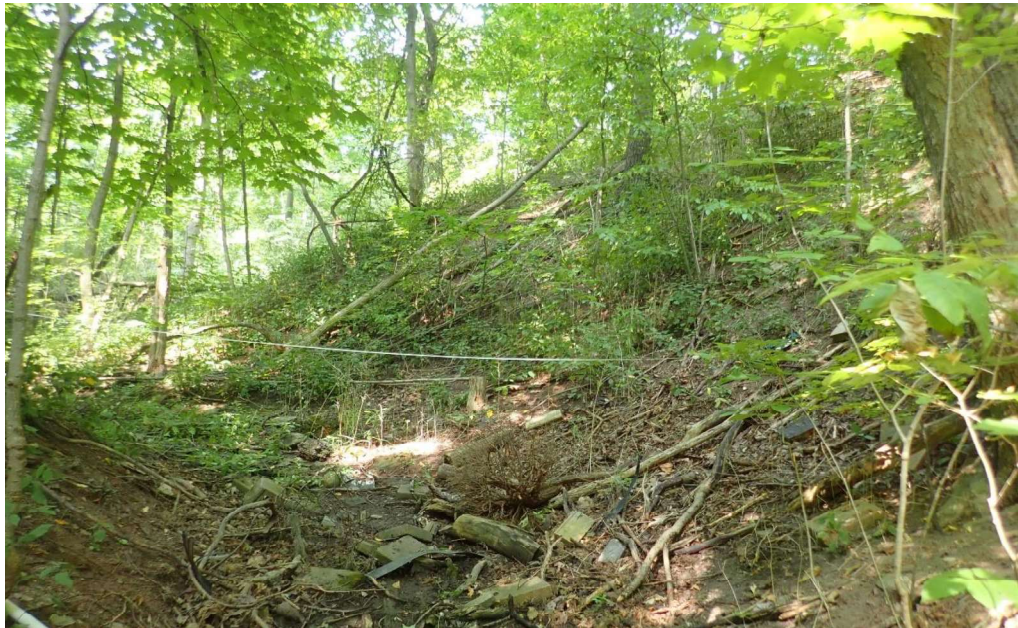
Cross Section 6 - Facing Upstream

Reach GCT1 flows through the ravine central to the subject property. The channel follows a meandering planform, confined within the valley and making contact with the valley walls in several locations. Evidence of active erosion was minimal, with undercutting up to only 0.06 m noted at two cross-sections. The channel was dry during the time of assessment. The riparian zone is confined to the valley extent, and is characterized by mature trees. Approximately 30% of the channel bed was encroached by herbaceous and grassy vegetation. Average bankfull width and depth were 3.08 and 0.24 m, respectively. Bed substrate ranges from silt to platy cobbles, while the bank material is characterized as a silty-clay loam throughout.
