ARBORIST REPORT

**PROPOSED EMPLOYMENT-RELATED DEVELOPMENT
4243 SIXTH LINE
TOWN OF OAKVILLE**

**ISA CERTIFIED ARBORIST
MATTHEW GEHRES ON-1114A
OUR PROJECT NO:
25-6122**

**REVISED
February 27, 2026 – Issued for Resubmission**

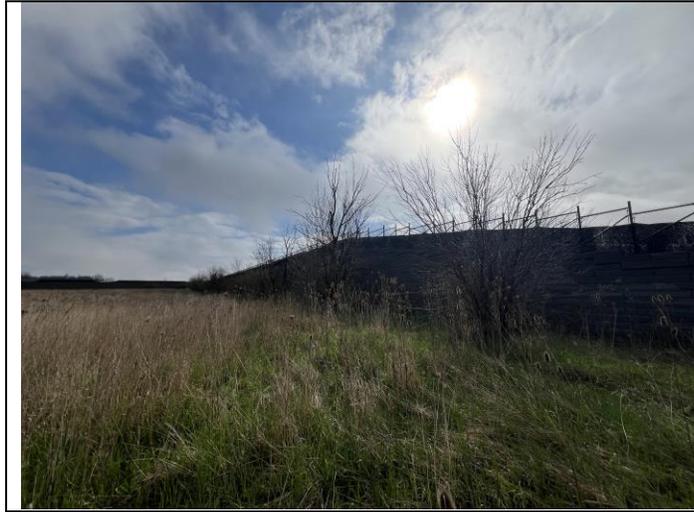
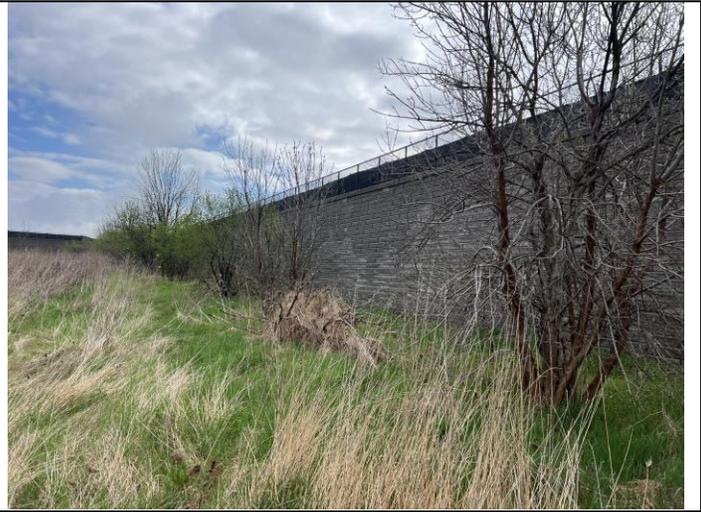
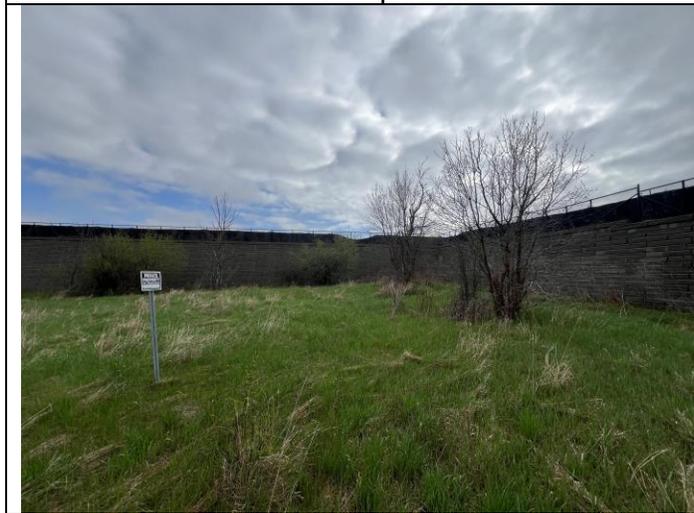
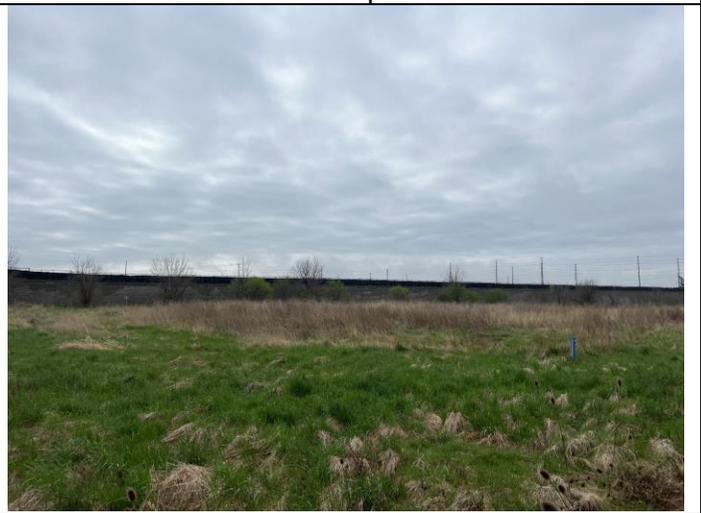
Tree Group # 210

EXISTING TREE INVENTORY											
KEY	SPECIES		DBH	CROWN	HEALTH	STRUCTURE	COMMENTS	PRESERVATION	CATEGORY	MIN. TPZ	KEY
	Common Name	Botanical Name	(cm)	(m)	G/F/P	Group		DIRECTION		(m)	
210	Ash	<i>Fraxinus spp.</i>			Dead	Group	Linear planting along south property line adjacent to retaining wall, all exhibit dead main leaders with vigorous basal epicormic growth below bylaw size, total of 14 trees observed: 10 dead trees ≥15 cm DBH, 4 dead trees <15 cm DBH, Buckthorn present and growing interspersed among dead ash (<15 cm DBH).	Remove	1		210
211	Ash	<i>Fraxinus spp.</i>	35	6	Dead	Asymmetrical	Multileader, epicormic growth, adjacent to end of retaining wall.	Remove	1	3.0	211
212	Ash	<i>Fraxinus spp.</i>			Dead	Group	Linear planting along east property line, majority of trees exhibit dead main leaders with occasional basal epicormic growth. Total of 15 trees observed: 10 trees <15cm DBH. 5 trees adjacent to pond: 4 trees between 30-40 cm DBH, 1 tree between 20-30cm DBH.	Remove	1		212

A linear planting of Ash trees (*Fraxinus spp.*) was observed along the southeast property boundary and extending partially along the northern boundary. A total of fourteen Ash trees were observed, all of which have dead main leaders. Most trees display vigorous basal epicormic growth, with invasive Common Buckthorn (*Rhamnus cathartica*) interspersed within understory. Additionally, one dead Ash tree (Tree #211) is located near the northern property line, in proximity to the end of the adjacent development's retaining wall. A second linear Ash planting is present along the northwest property boundary. Fifteen trees were recorded, all with dead main leaders, with basal epicormic growth observed on a select few.

All existing trees located within the subject property are recommended for removal. Multiple trees across the site were observed to be either dead or in advanced stages of decline. This includes Tree Groups #210 and #212, which consists entirely of dead Ash (*Fraxinus* spp.) trees with Buckthorn growth present. Group #210 includes a total of 14 trees, and Group #212 includes 15 trees, all of which are recommended for removal. Trees #211 and #214 are also dead and require removal. These trees are considered exempt from compensation due to their dead condition.

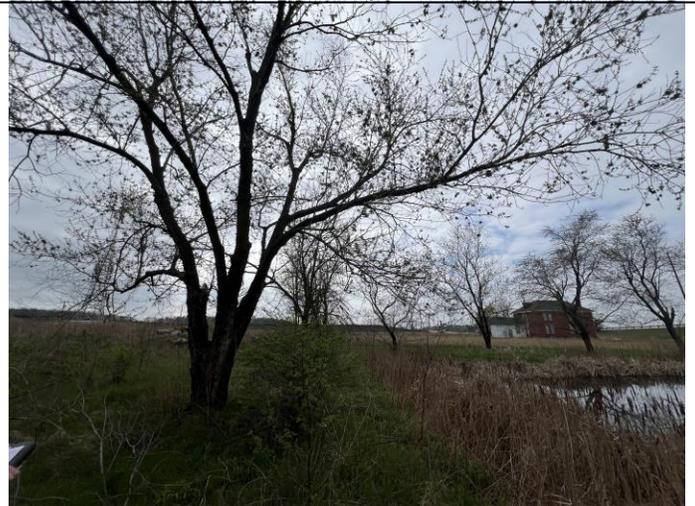
Trees # 213-219

213	Silver Maple	<i>Acer saccharinum</i>	38, 56	12	Fair	Asymmetrical	Adjacent to pond, crowded by adjacent tree, multileader, dieback throughout canopy, epicormic growth in canopy.	Remove	1	3.6	213
214	Ash	<i>Fraxinus spp.</i>	36	10	Dead	Irregular	Adjacent to pond, crowded by adjacent tree, basal epicormic growth (less than 15cm).	Remove	1	3.0	214
215	Silver Maple	<i>Acer saccharinum</i>	38	7	Fair	Asymmetrical	Adjacent to pond, crowded by adjacent tree, epicormic growth in canopy and base, slight lean, minor deadwood.	Remove	1	3.0	215
216	Silver Maple	<i>Acer saccharinum</i>	29	7	Fair	Irregular	Adjacent to pond, crowded by adjacent tree, epicormic growth in canopy and at base (less than 15cm), minor deadwood	Remove	1	2.4	216
217	Silver Maple	<i>Acer saccharinum</i>	22, 31	9	Fair	Asymmetrical	Adjacent to pond, minor deadwood, included bark in union at 1m.	Remove	1	3.0	217
218	Silver Maple	<i>Acer saccharinum</i>	47	10	Fair	Asymmetrical	Adjacent to pond, minor deadwood, broken branches.	Remove	1	3.0	218

219	Silver Maple	<i>Acer saccharinum</i>	40	8	Fair	Asymmetrical	Adjacent to pond, epicormic growth in canopy, major broken branches, minor deadwood, slight lean.	Remove	1	3.0	219
220	Silver Maple	<i>Acer saccharinum</i>	17, 17, 29	10	Fair	Asymmetrical	Adjacent to pond, epicormic growth in canopy, minor deadwood, broken branches.	Remove	1	2.4	220
221	Silver Maple	<i>Acer saccharinum</i>	30	7	Good	Asymmetrical	Crowded by adjacent trees, minor deadwood, adjacent to pond, epicormic growth in canopy.	Remove	1	2.4	221
222	Silver Maple	<i>Acer saccharinum</i>	58	12	Good	Asymmetrical	Crowded by adjacent trees, adjacent to pond, minor deadwood, broken branches.	Remove	1	3.6	222
223	Silver Maple	<i>Acer saccharinum</i>	38, 49	10	Fair	Asymmetrical	Minor deadwood, broken branches, epicormic growth in canopy.	Remove	1	3.0	223
224	Yew	<i>Taxus canadensis</i>	17, 20	5	Poor	Multi-stem	Adjacent to house, dieback throughout canopy, major deadwood.	Remove	1	2.4	224

A mix of mature Silver Maples (*Acer saccharinum*) and a single dead Ash tree encircle the pond. The Silver Maples vary in health, with conditions ranging from fair to good. Many show signs of canopy dieback, epicormic sprouting, and the presence of deadwood. Several landscape trees are present in proximity to the existing dwelling, including Yew (*Taxus spp.*), Sugar Maples (*Acer saccharum*), and White Spruce (*Picea glauca*). The general health of these trees can be described as poor.

Trees #213, & 215 - 228 are recommended for removal due to direct conflicts with the proposed development and associated construction activities.

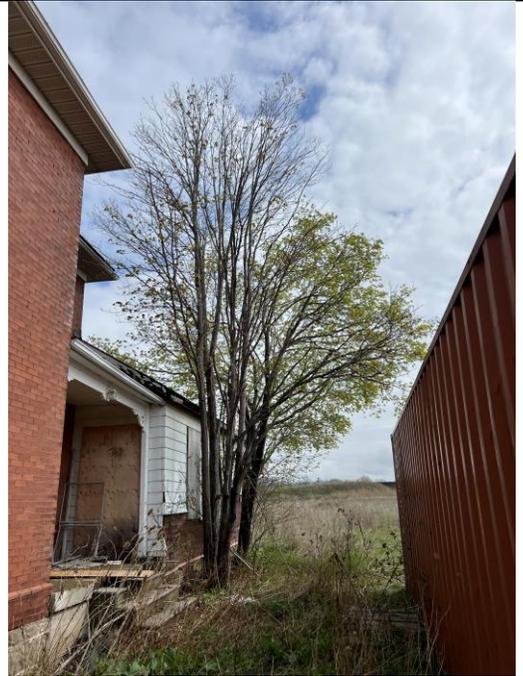
Trees # 225&226

225	Sugar Maple	<i>Acer saccharinum</i>	16, 23, 28	6	Poor	Multi-stem	Adjacent to house, major deadwood, poor pruning, dieback throughout canopy, crowded by adjacent tree.	Remove	1	3.0	225
226	Sugar Maple	<i>Acer saccharinum</i>	21, 22	10	Poor	Multi-stem	Adjacent to house, epicormic growth along trunk and at base, broken branches, minor deadwood, crowded by adjacent tree.	Remove	1	2.4	226
227	White Spruce	<i>Picea glauca</i>	26	6	Poor	Pyramidal	Dieback in inner canopy, dieback in lower branches, exposed roots, crowded by adjacent tree.	Remove	1	2.4	227
228	White Spruce	<i>Picea glauca</i>	21	5	Poor	Pyramidal	Dieback in inner canopy, dieback in lower branches, broken branches, crowded by adjacent tree.	Remove	1	2.4	228
229	Bur Oak	<i>Quercus macrocarpa</i>	5	1	Fair	Immature	Street Tree, Recently Planted, Tree is Staked, Rodant Guard, Adjacent to Ditch	Preserve	4	1.8	229
230	Bur Oak	<i>Quercus macrocarpa</i>	5	1	Fair	Immature	Street Tree, Recently Planted, Tree is Staked, Rodant Guard, Adjacent to Ditch	Preserve	4	1.8	230
