3437 TRAFALGAR ROAD & 340 BURNHAMTHORPE ROAD EAST Heritage Impact Assessment

April 6, 2026

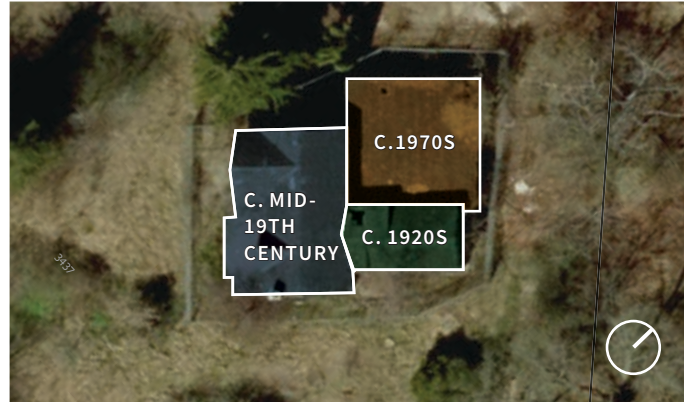
Aerial image indicating evolution of 3437 Trafalgar Road, with the approximate dates of each portion of the structure indicated (Town of Oakville, 2025; annotated by ERA).

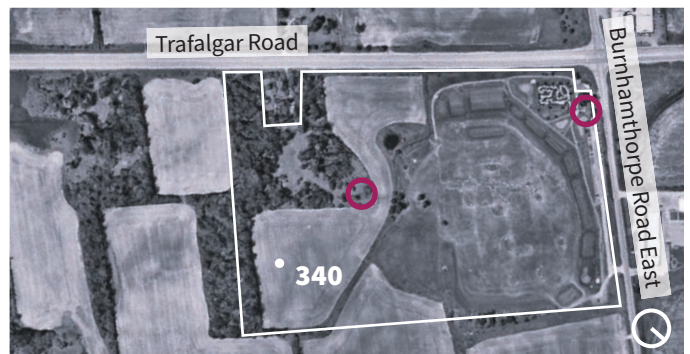
Aerial image showing the approximate location of structures at 340 Burnhamthorpe Road East, circled in pink (Town of Oakville, 2025; annotated by ERA).

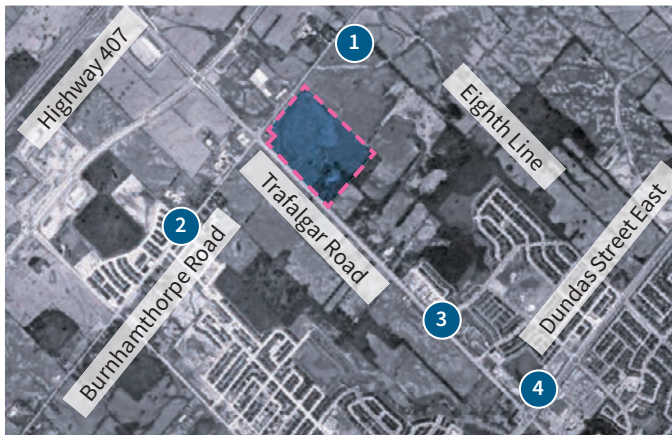
Current aerial photograph showing the Site and context, with the Site shaded in blue (Town of Oakville, 2025; annotated by ERA).

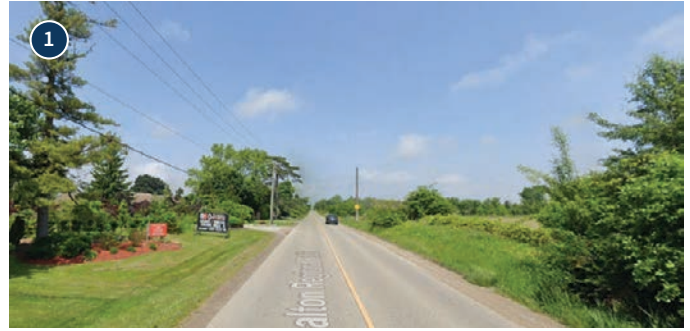
Rural stretch of Burnhamthorpe Road East to the northeast of the Site (Google, 2025).

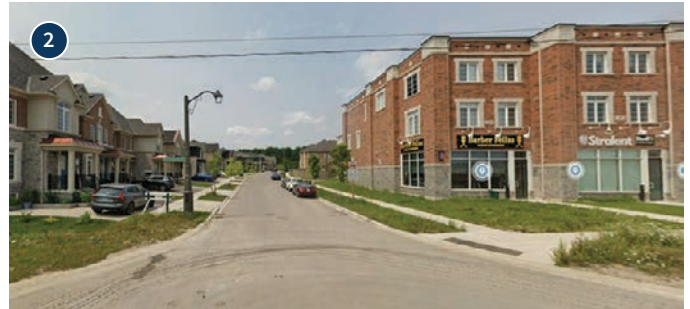
New residential subdivision with a mixed-use building fronting onto Burnhamthorpe Road East (Google, 2025).

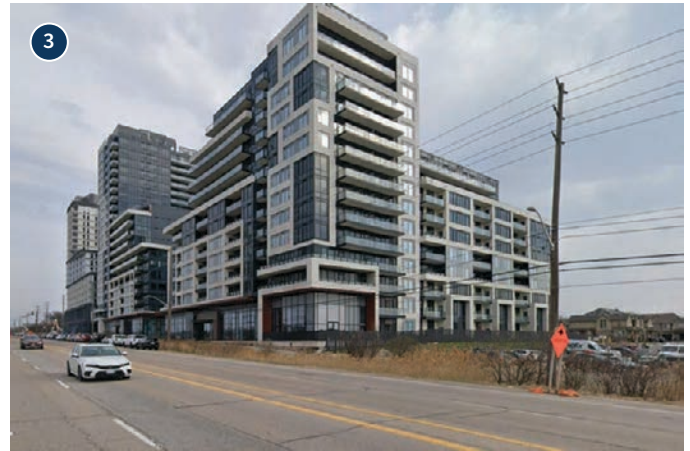
Recently-completed mid-rise building along Trafalgar Road, with low-scale residential beyond (Google, 2025).

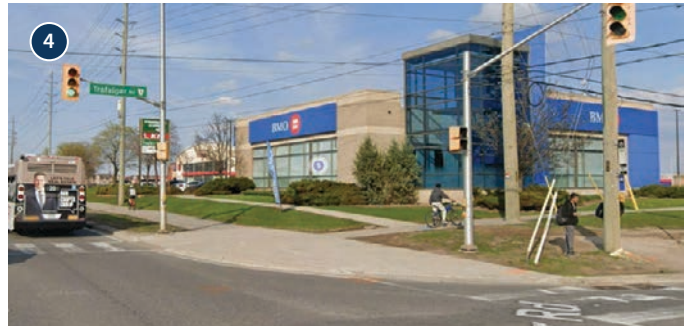
Southeast corner of Trafalgar and Burnhamthorpe Roads (Google, 2025).

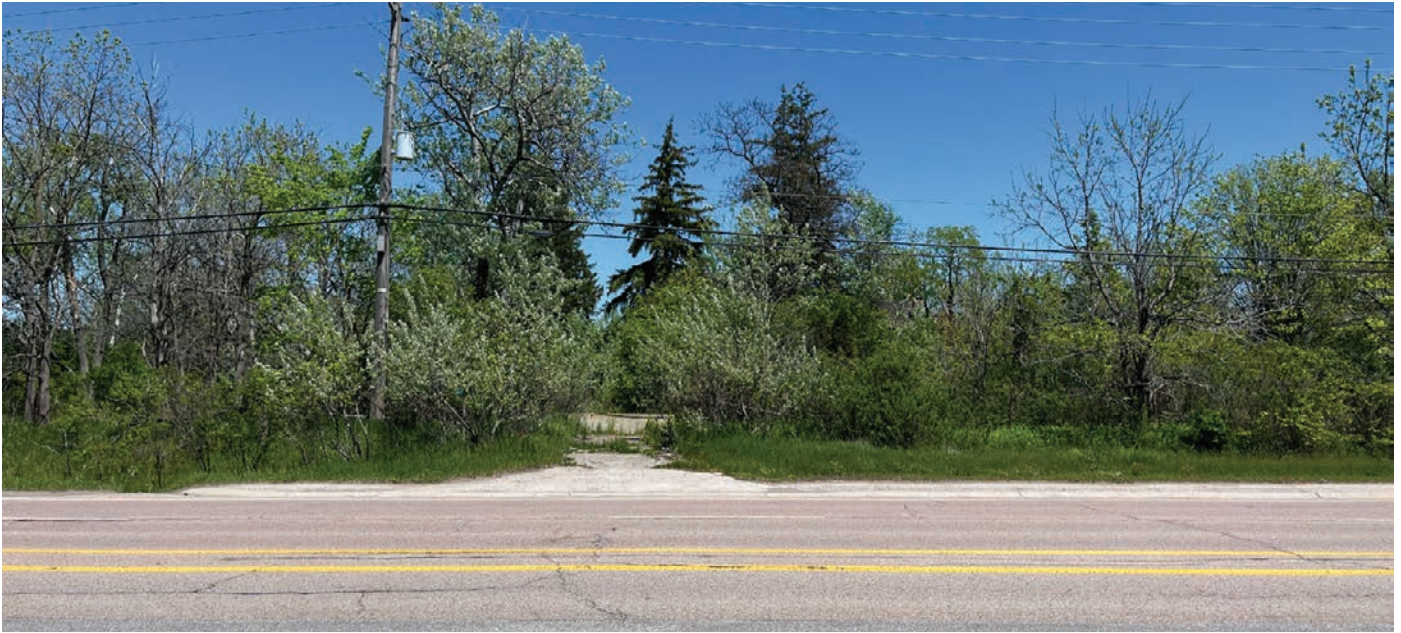
Looking east from Trafalgar Road towards 3437 Trafalgar Road. The building on the property is obscured by vegetation and is not visible (ERA, 2025).

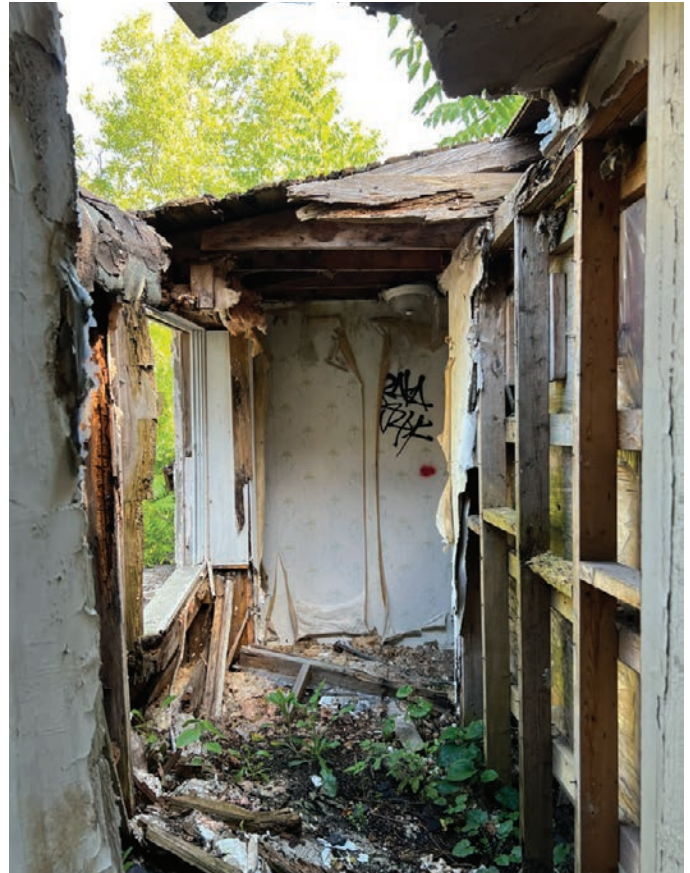
The roof in the 20th-century two-storey addition has failed (ERA, 2025).

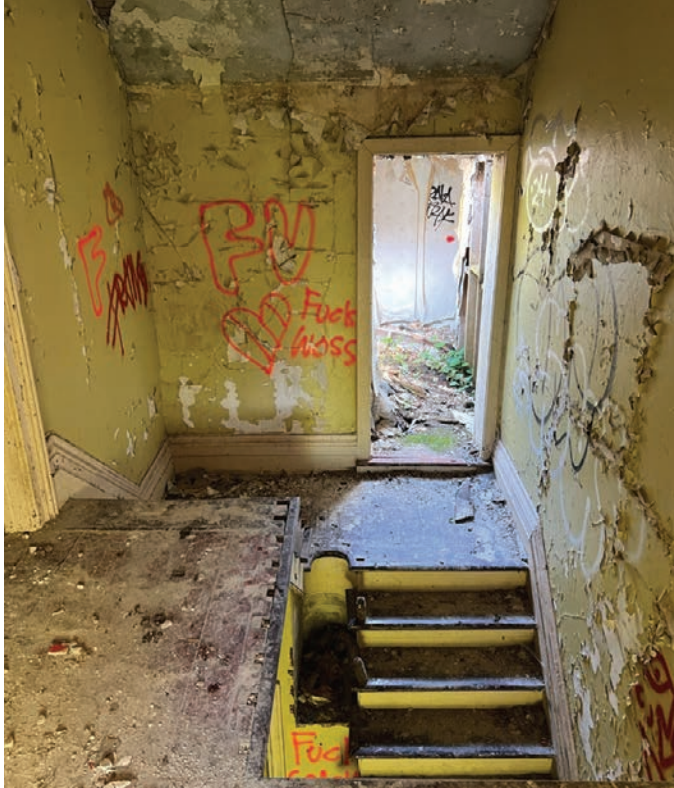
Looking towards the 20th-century rear addition from the second storey. Note the balustrade has been removed (ERA, 2025).

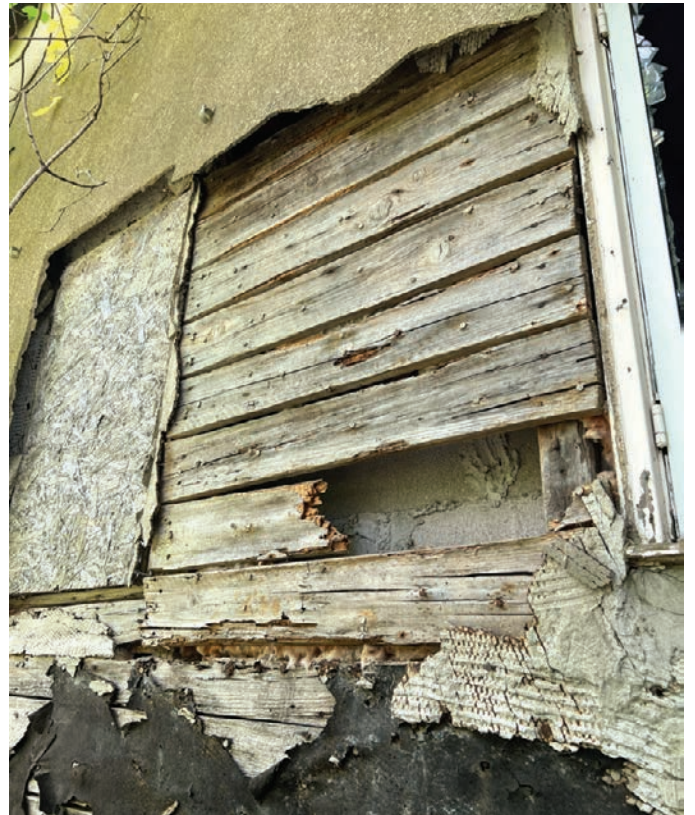
Concrete block structure visible underneath stucco at the two-storey rear addition (ERA, 2025).

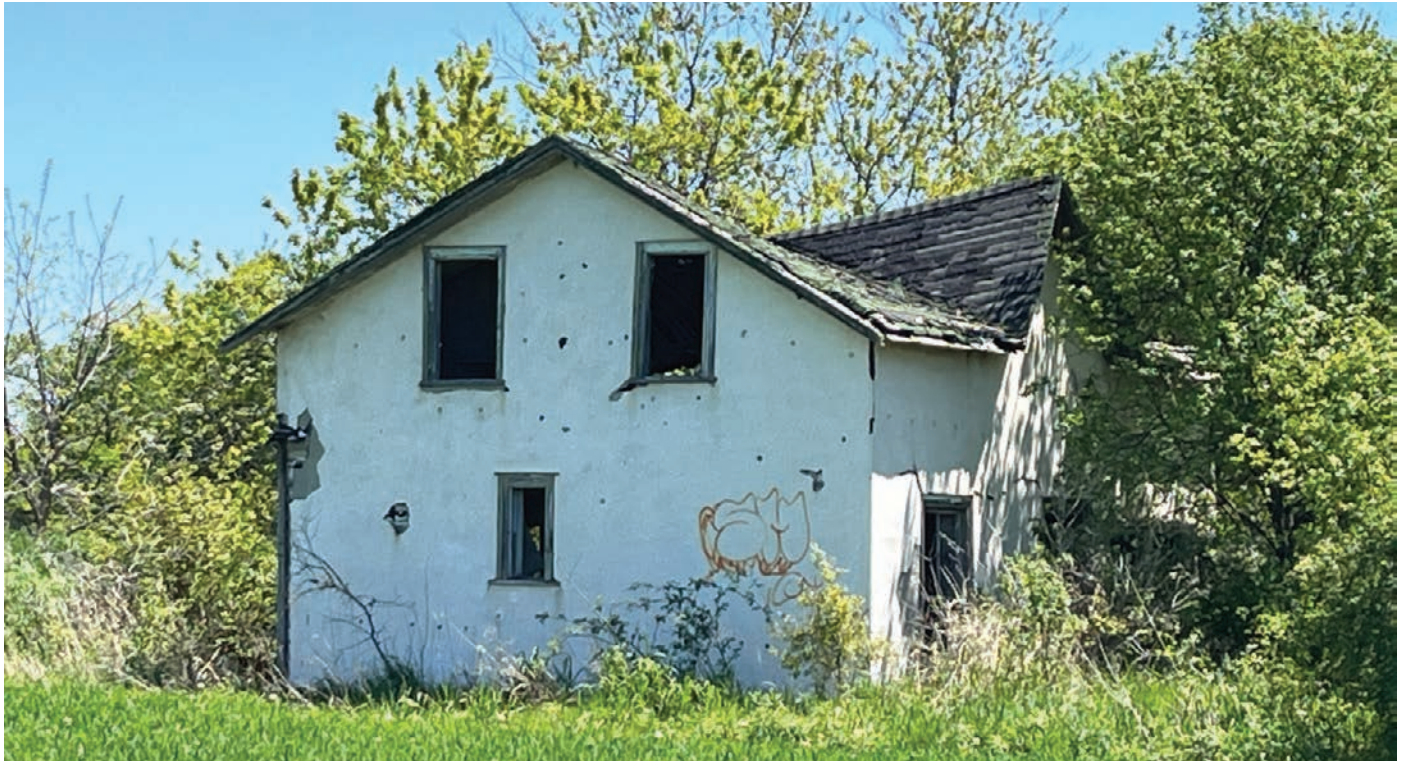
Principal (west) and side (north) elevations of the circa 1840s building at 340 Burnhamthorpe Road (ERA, 2025).

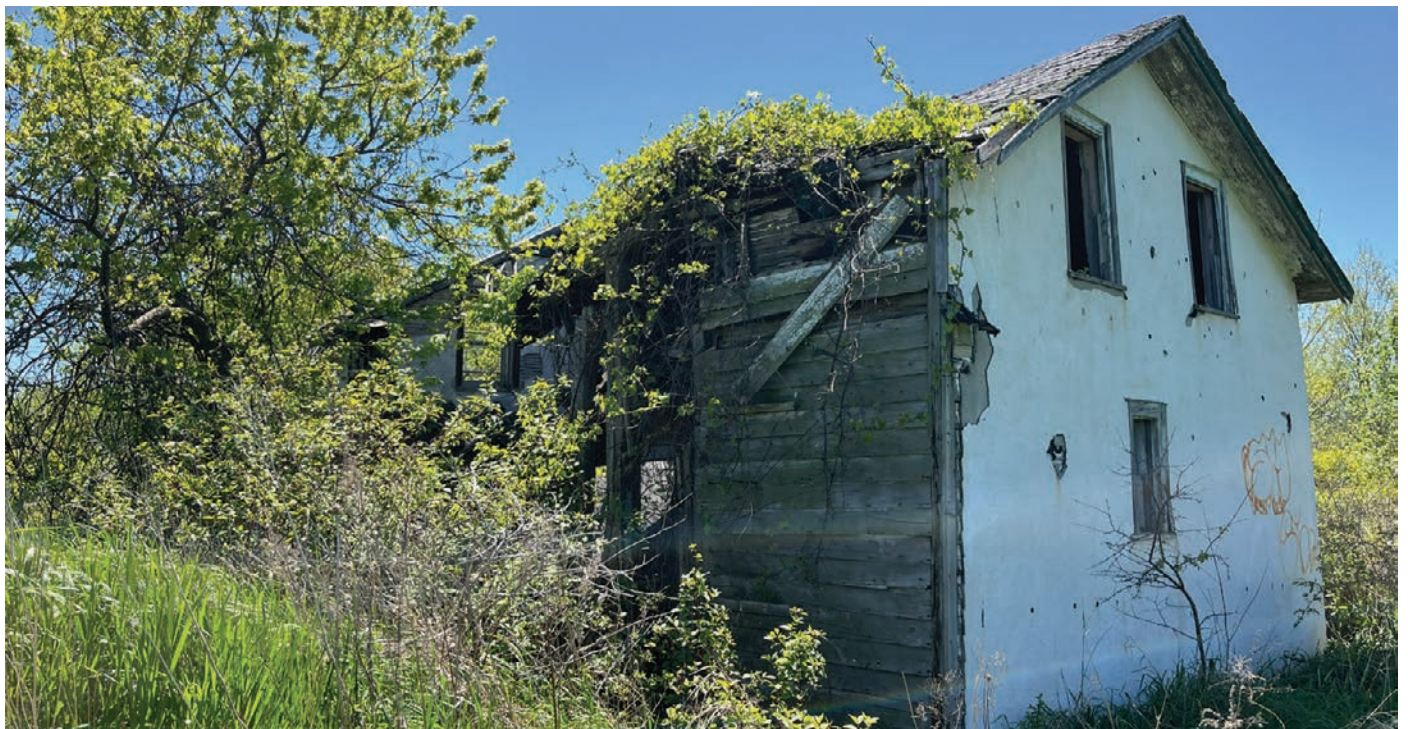
Side (south) and rear (east) elevations of the circa 1840s building at 340 Burnhamthorpe Road. Note the failure and collapse of the rear wall (ERA, 2025).

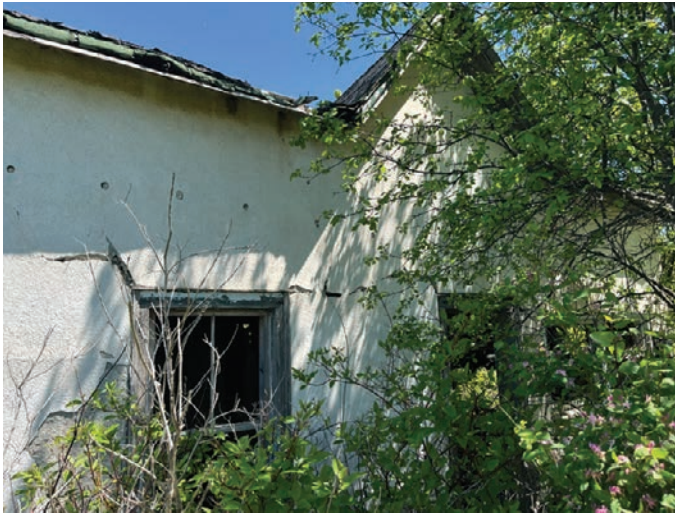
Dense vegetation at the principal (west) elevation (ERA, 2025).

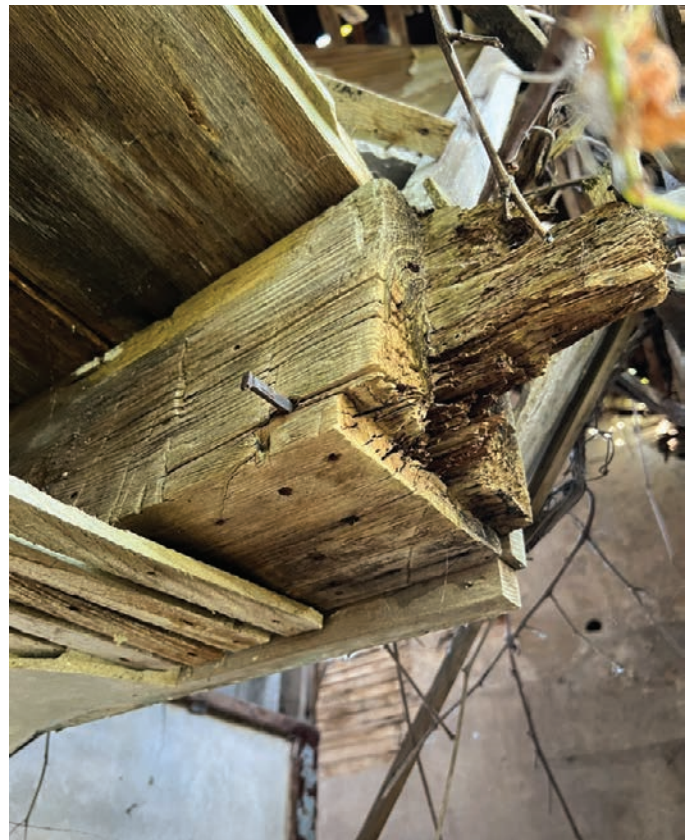
Beam tenon on the east elevation where the mortise-and-tenon connection has failed (ERA, 2025).

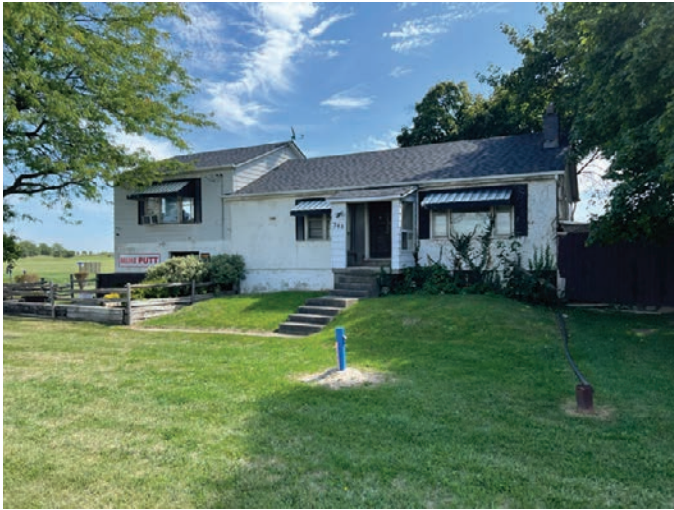
Mid 20th-century house-form building at 340 Burnhamthorpe Road, fronting on to Burnhamthorpe Road (ERA, 2025).

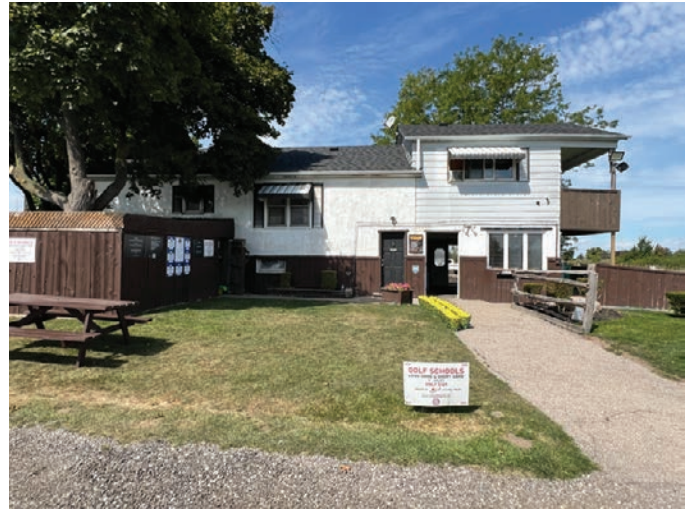
Rear (south) elevation of mid 20th-century house-form building at 340 Burnhamthorpe Road (ERA, 2025).

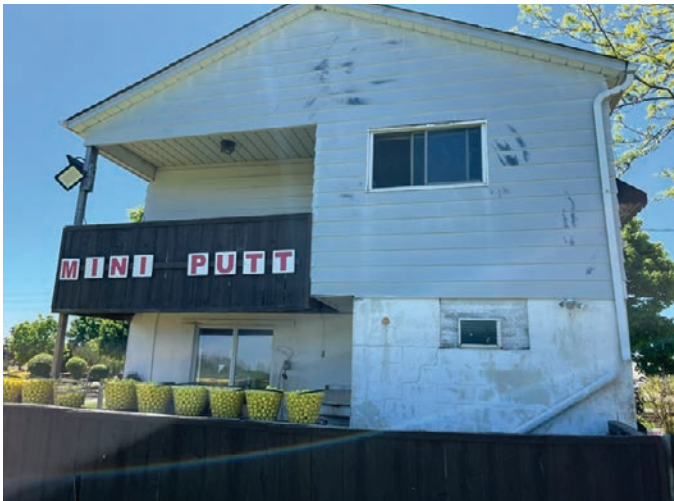
Side (east) elevation (ERA, 2025).

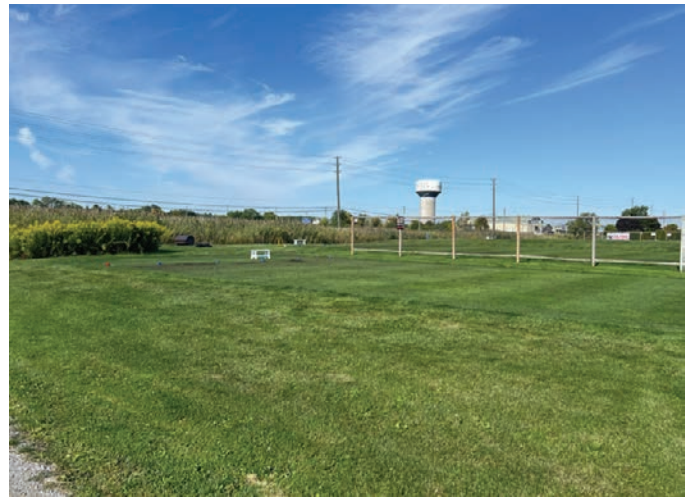
Looking northwest towards Trafalgar and Burnhamthorpe Roads (ERA, 2025).

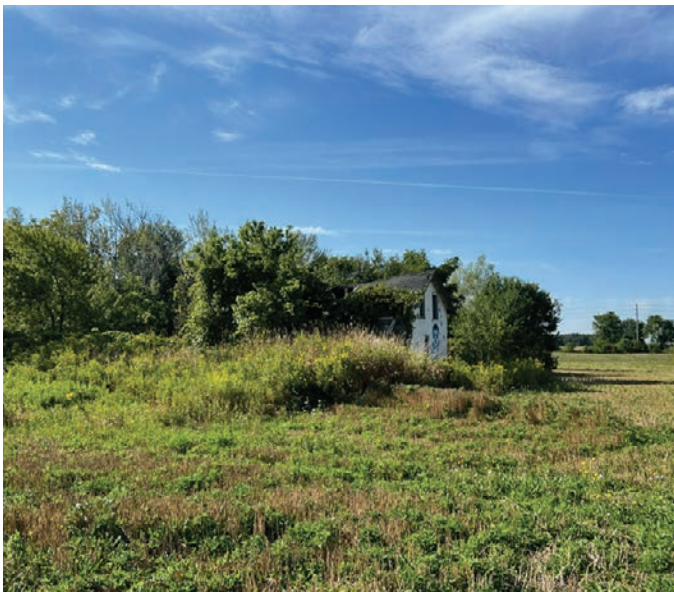
Looking southwest towards the 19th-century farmhouse at 340 Burnhamthorpe Road (ERA, 2025).

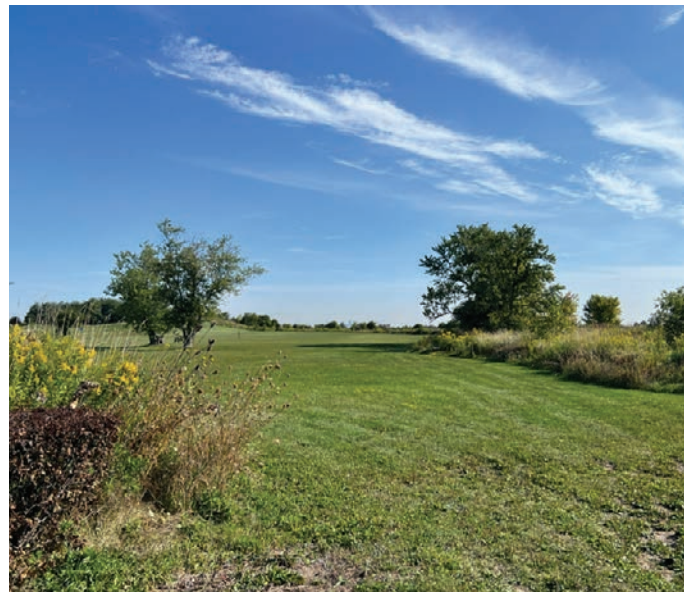
Looking northeast towards golf course and farm fields beyond (ERA, 2025).

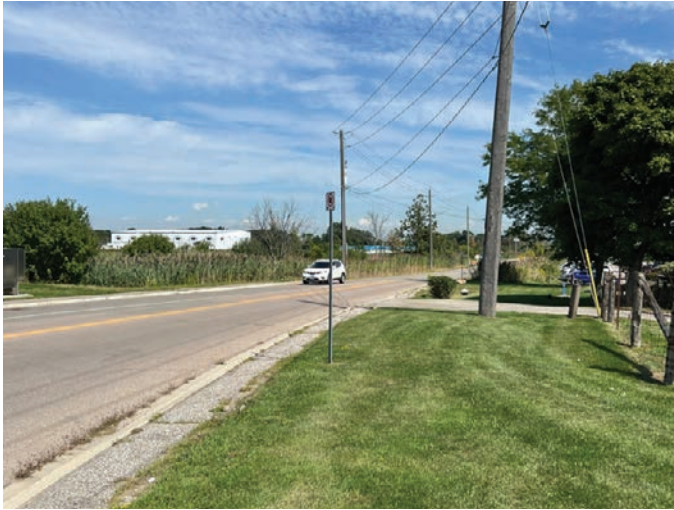
Looking east along Burnhamthorpe Road from the driveway to 340 Burnhamthorpe Road (ERA, 2025).

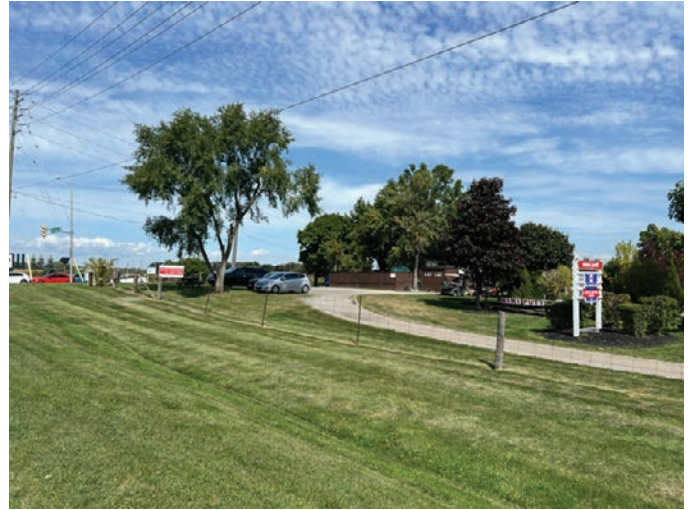
Looking north towards parking lot at the Vic Hadfield Golf and Learning Centre (ERA, 2025).

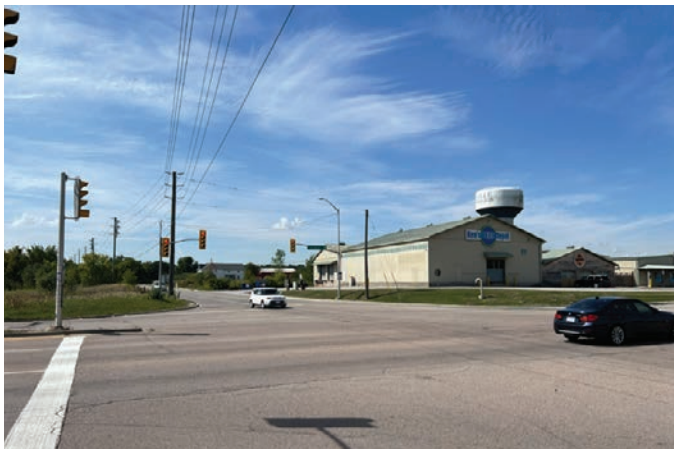
Looking northwest from the intersection of Trafalgar and Burnhamthorpe Roads (ERA, 2025).

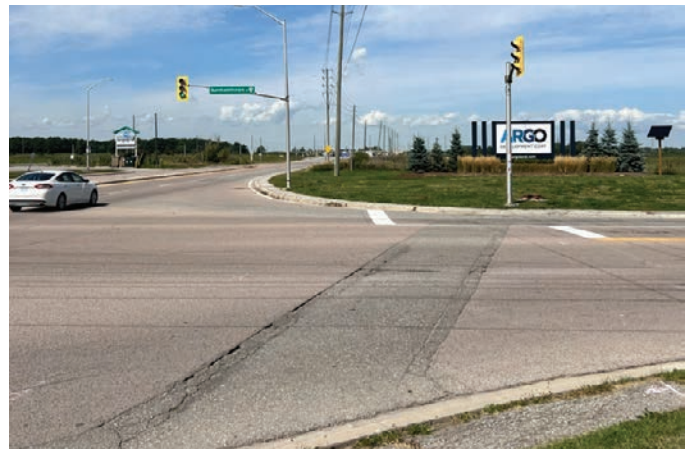
Looking north along Trafalgar Road from the intersection of Trafalgar and Burnhamthorpe Roads (ERA, 2025).

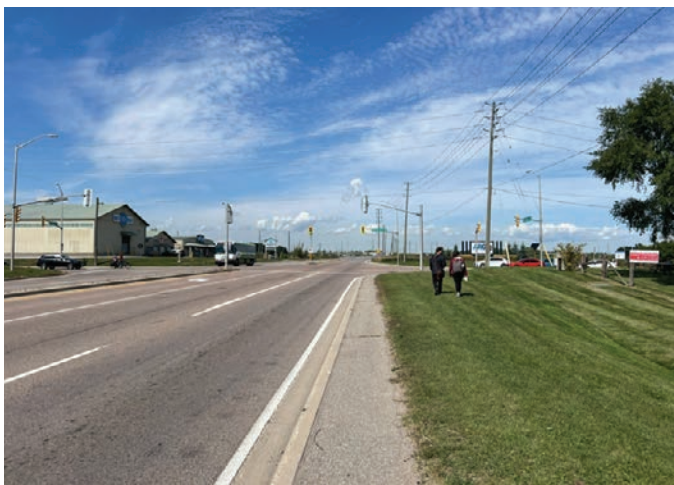
Looking north along Trafalgar Road towards the intersection of Trafalgar and Burnhamthorpe Roads (ERA, 2025).

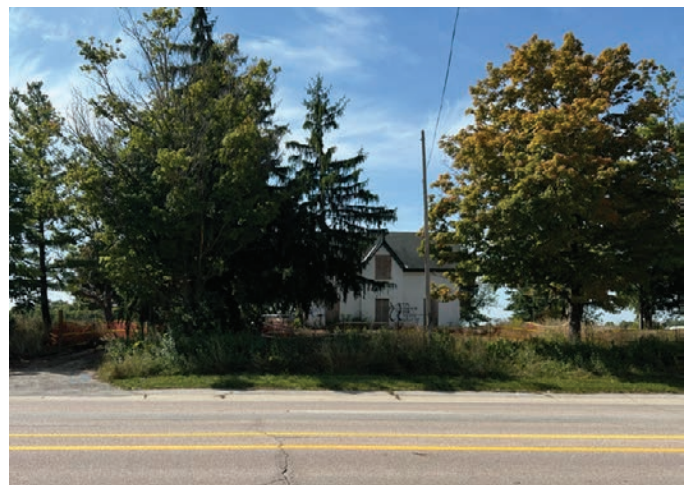
Looking west across Trafalgar Road towards 3444 Trafalgar Road (ERA, 2025).

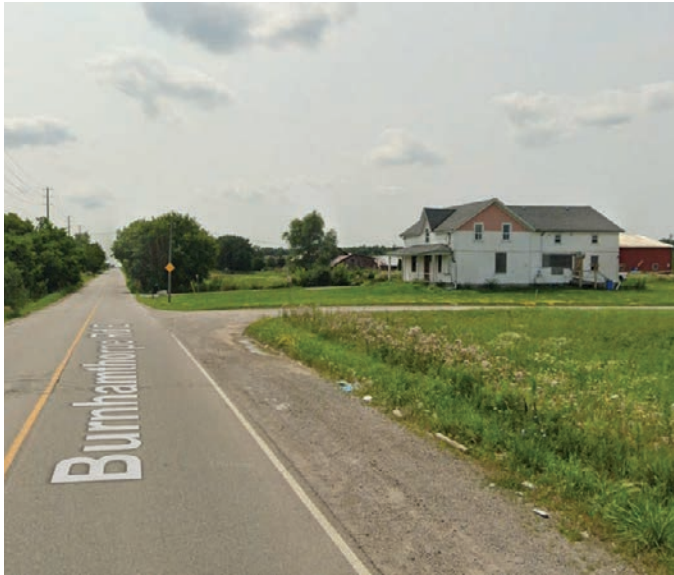
Looking west along Burnhamthorpe Road towards 273 Burnhamthorpe Road (Google, 2025).

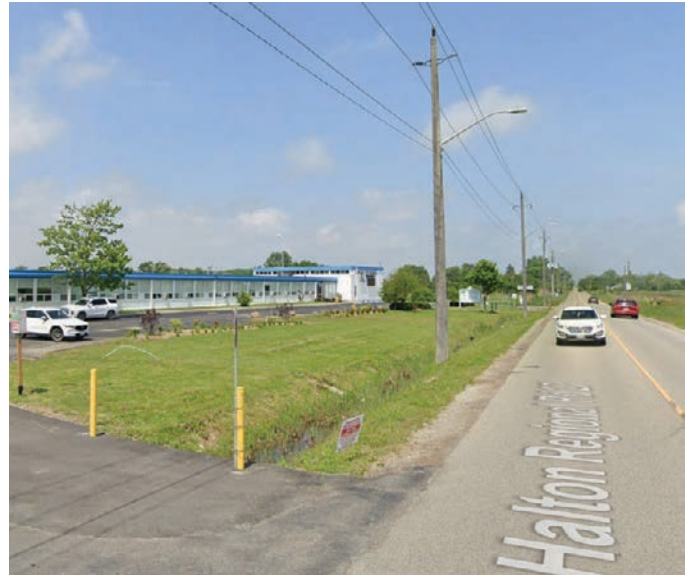
Looking east along Burnhamthorpe Road, with the Al Falah Islamic Centre on the left side of the photo (Google, 2025).

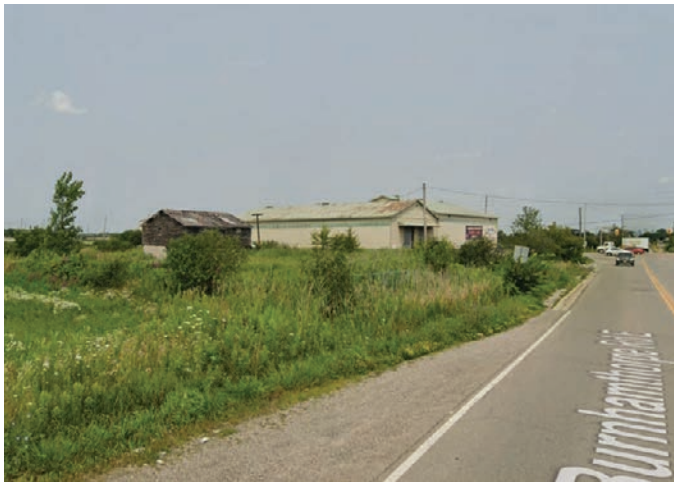
Looking east along Burnhamthorpe Road towards the Ren's Pets building at the corner of Trafalgar and Burnhamthorpe Roads (Google, 2025).

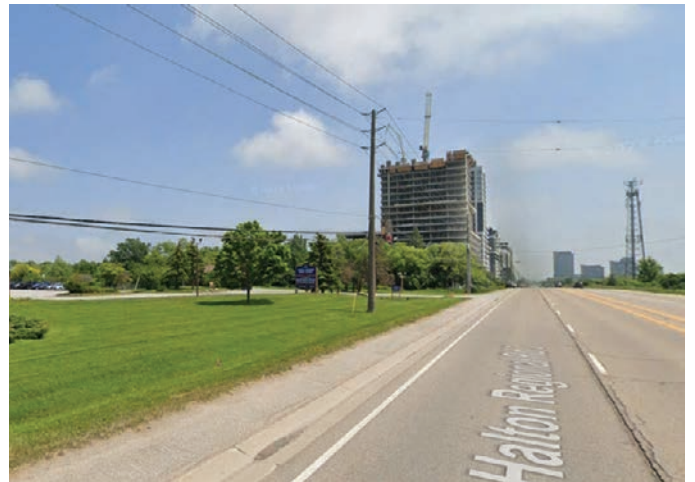
Looking south along Trafalgar Road from slightly south of the Site (Google, 2025).

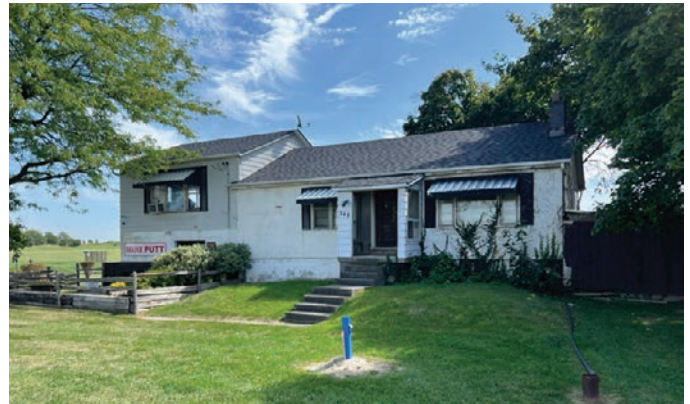
Mid 20th-century house-form building, constructed between 1954-1978 (ERA, 2025).

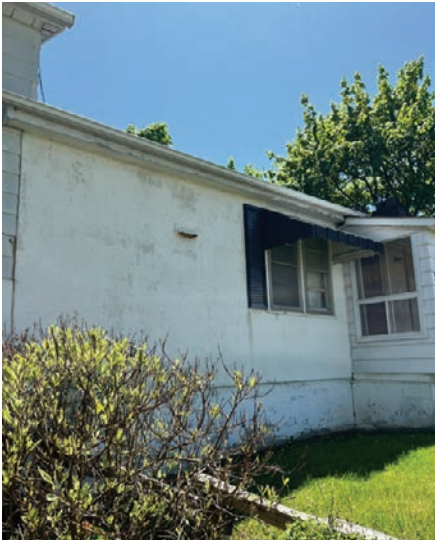
Stucco in poor condition (ERA, 2025).

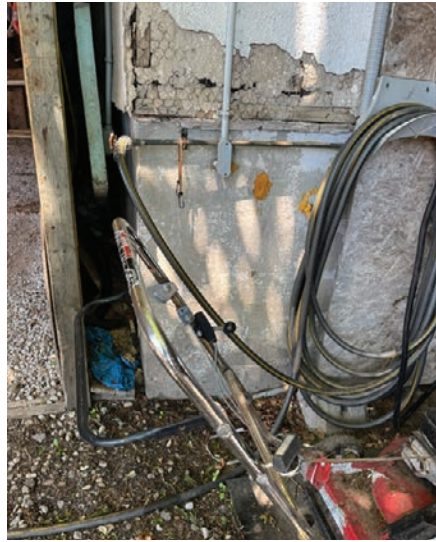
Stucco in poor condition, showing delamination (ERA, 2025).

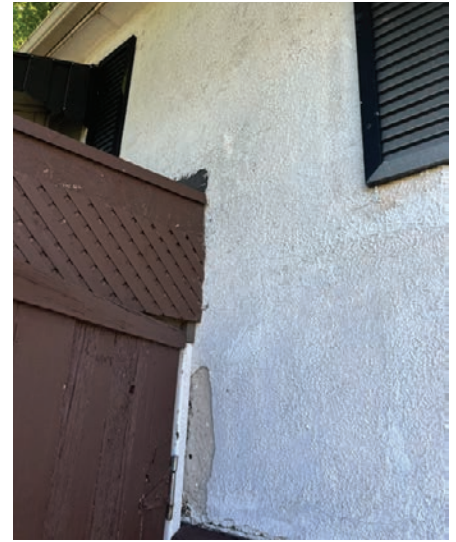
Stucco in poor condition, showing cracking and delamination (ERA, 2025).

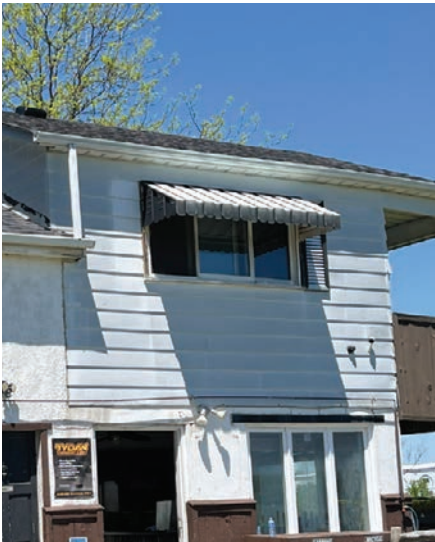
Metal siding in fair condition, with areas of poor condition (ERA, 2025).

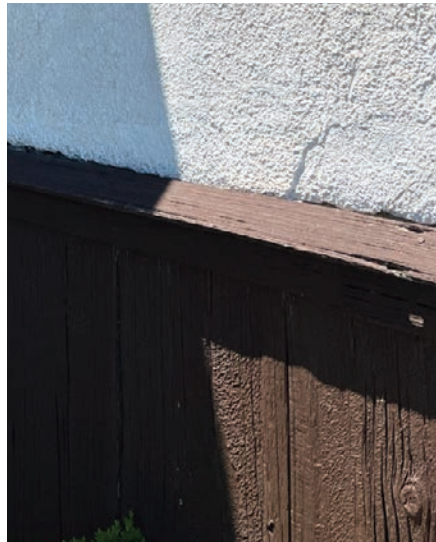
Wood siding in fair condition, with areas of poor condition (ERA, 2025).

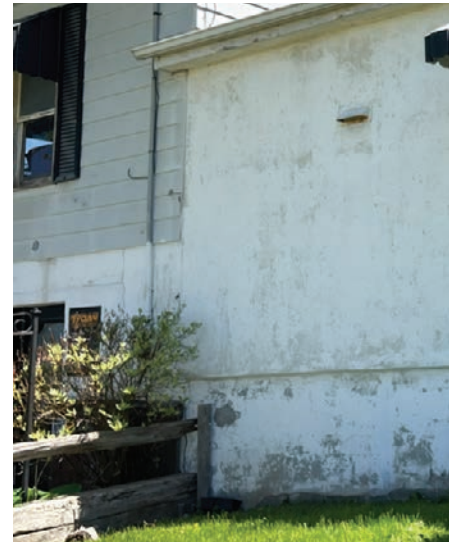
Concrete block wall mostly in fair condition despite defects (ERA, 2025).

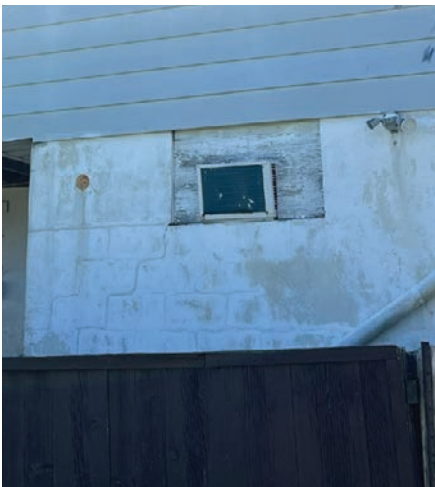
Concrete block wall with areas of poor condition, including step cracking (ERA, 2025).

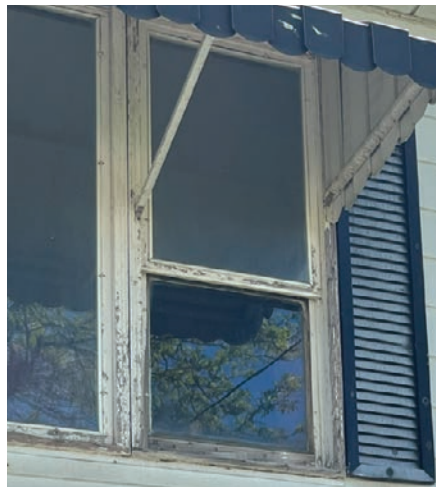
Wood windows in poor condition, with areas of wood rot (ERA, 2025).

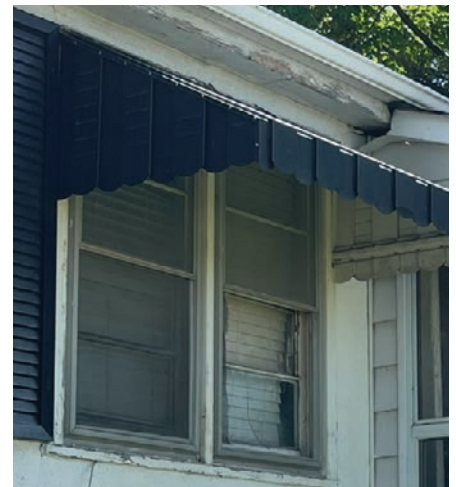
Metal windows in fair condition (ERA, 2025).

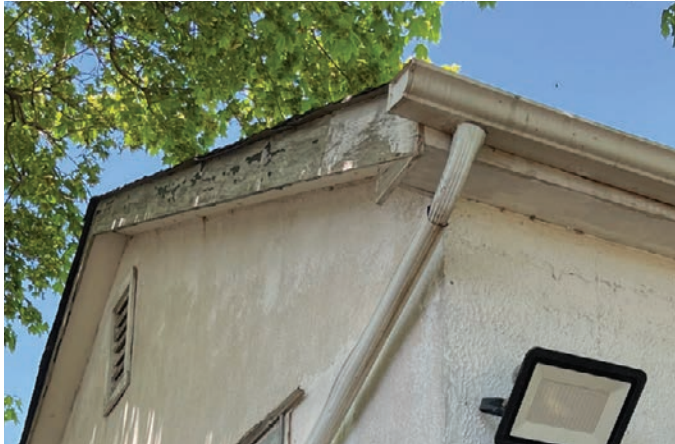
Bargeboard, fascia and soffit show paint flaking, wood rot and cracking (ERA, 2025).

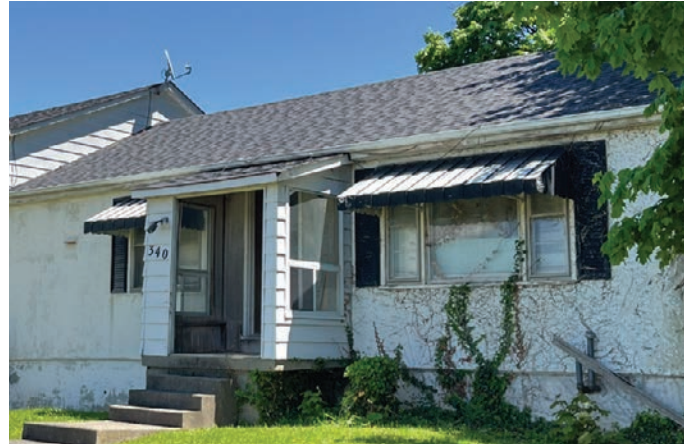
Asphalt roof shingles in good condition (ERA, 2025).

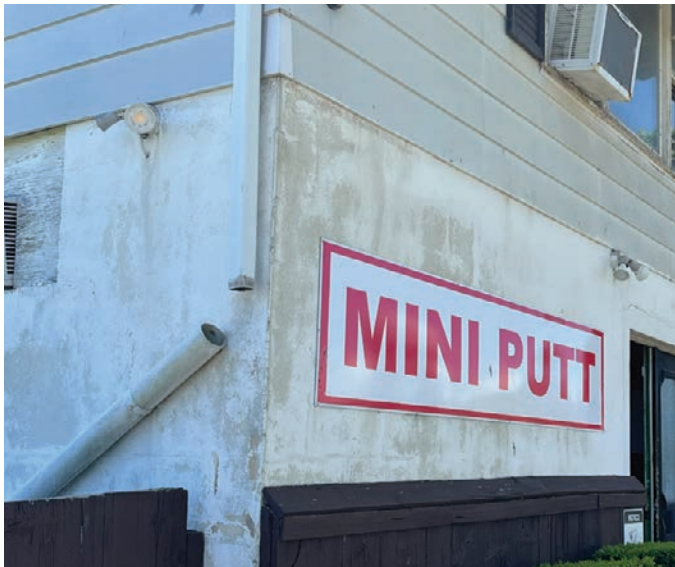
Metal eavestrough and downspouts in fair condition with an area of poor condition, with a missing downspout elbow (ERA, 2025).

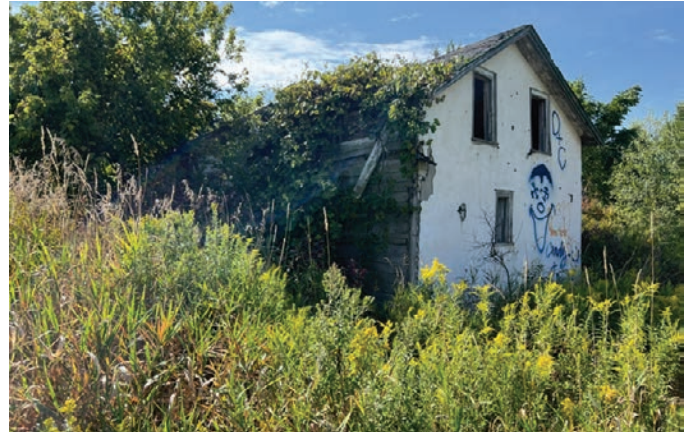
Stucco missing from entirety of rear (east) elevation (ERA, 2025).

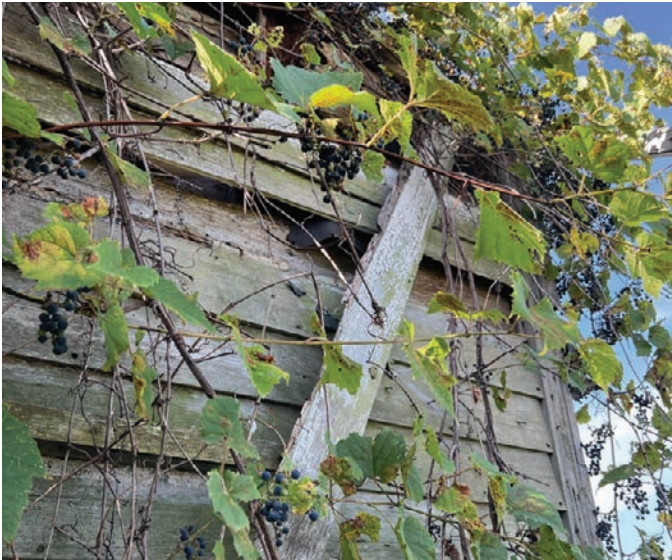
Close-up photo of rear (east) elevation wall, where the absence of stucco reveals the wooden siding and sheathing underneath which is in defective condition (ERA, 2025).

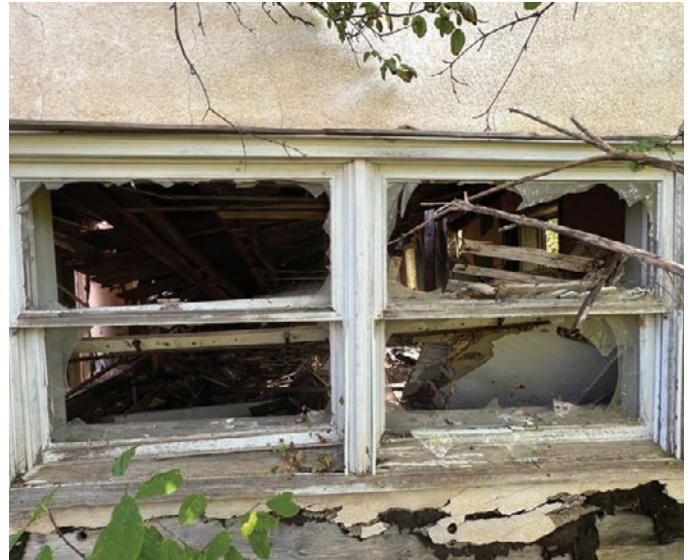
Close-up photo of window on principal (west) elevation in defective condition, with missing glazing (ERA, 2025).

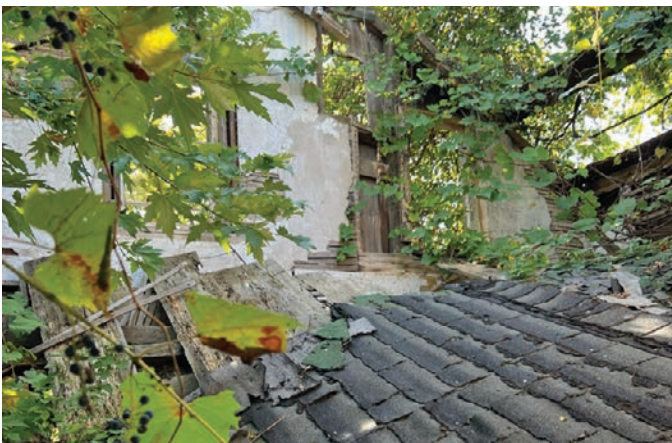
Partially collapsed roof and missing framing have exposed part of the second storey to the elements (ERA, 2025).

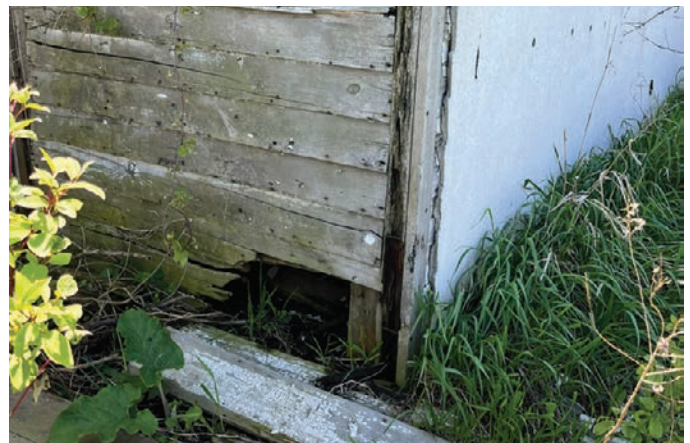
Significant wood rot at the exposed framing, particularly at grade as there is no foundation and the bottom of the walls sit below grade (ERA, 2025).

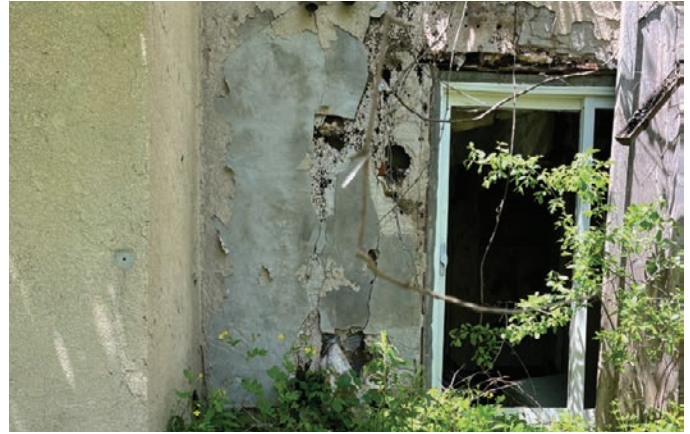
Stucco facade at the side (south) elevation in poor condition (ERA, 2025).

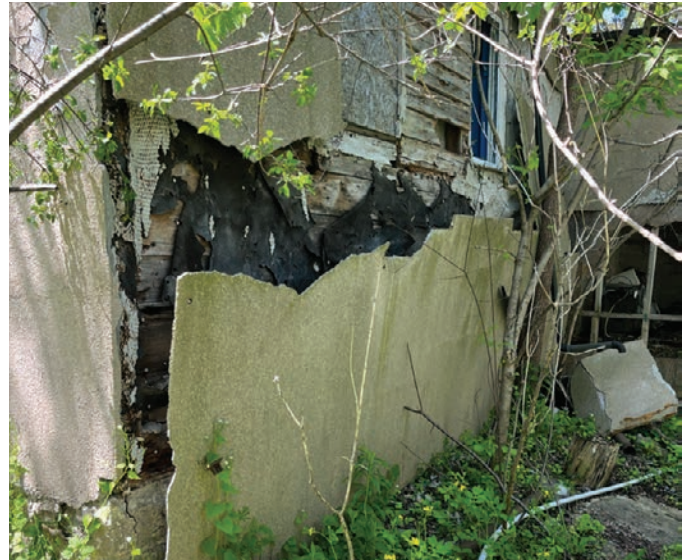
Areas of stucco in defective condition (ERA, 2025).

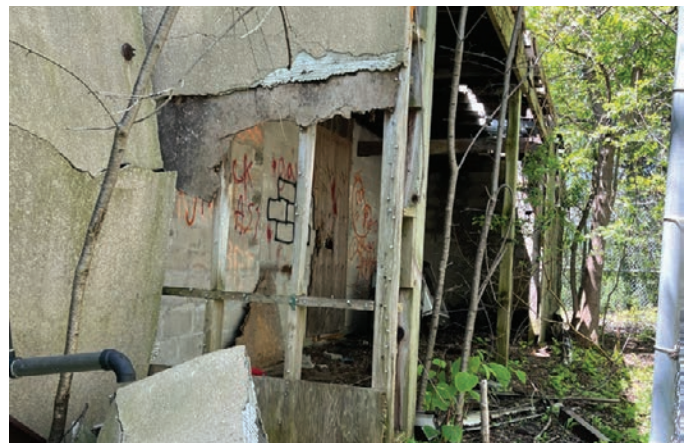
Concrete block wall in fair condition, with sections of graffiti (ERA, 2025).

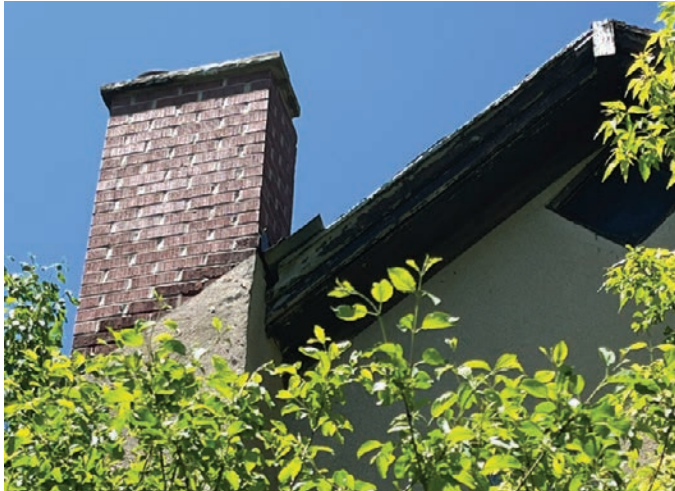
Exposed brick chimney at the roofline in fair condition (ERA, 2025).

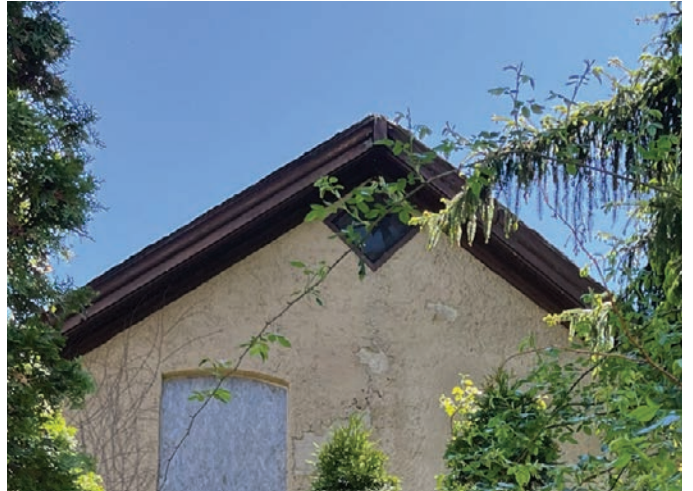
Wood fascia in poor condition (ERA, 2025).

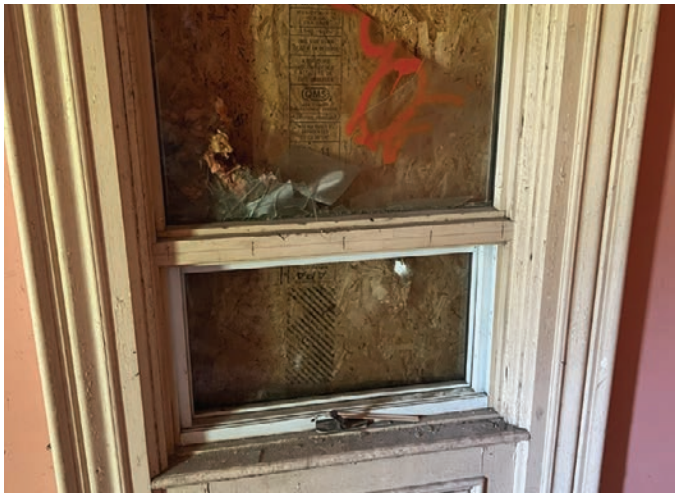
Window in defective condition, with extensive missing glazing (ERA, 2025).

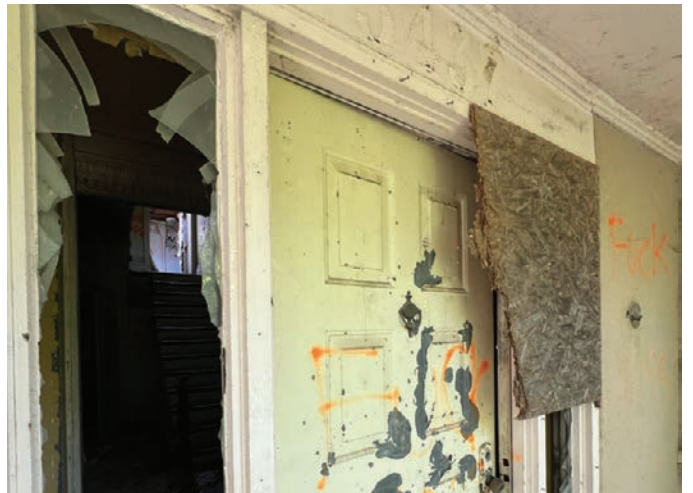
Main entry door in poor condition with sidelights in defective condition with broken glazing (ERA, 2025).

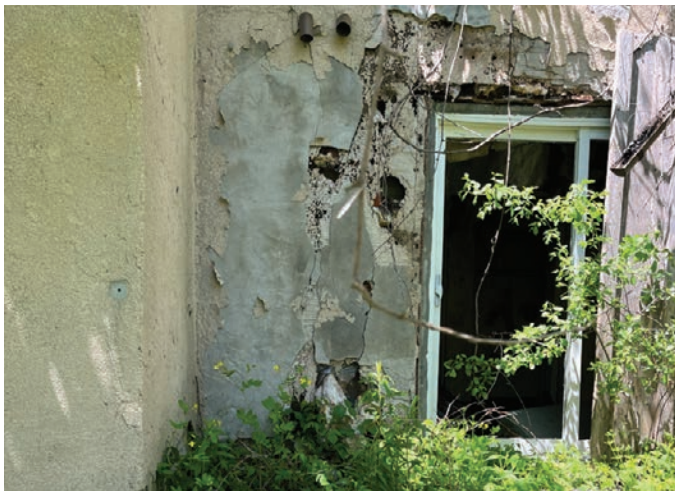
Sliding door on side (south) elevation in defective condition (ERA, 2025).

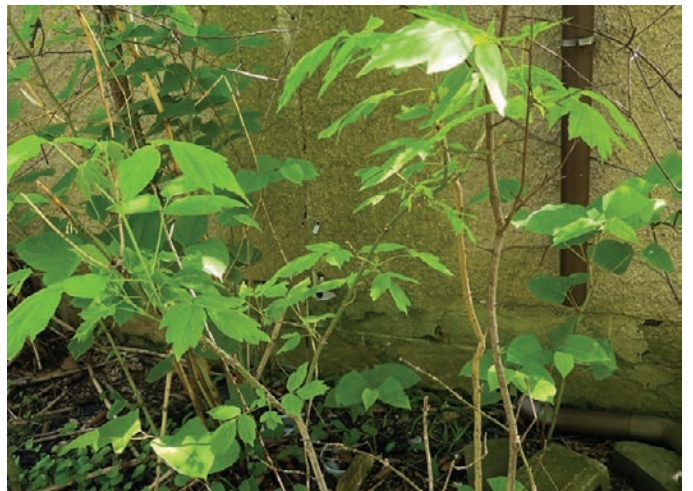
Missing downspout section near the foundation (ERA, 2025).

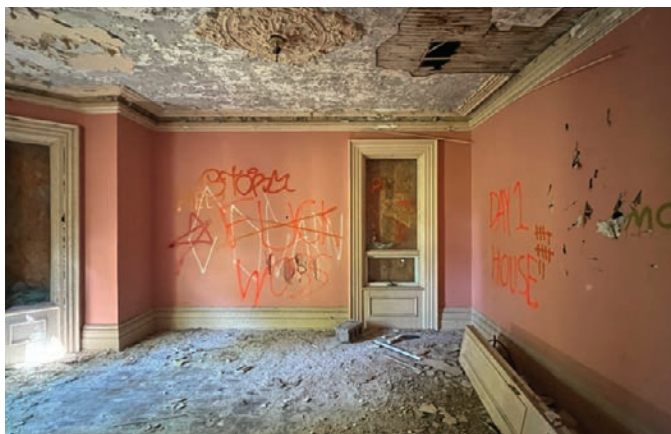
Interior spaces generally in defective condition (ERA, 2025).

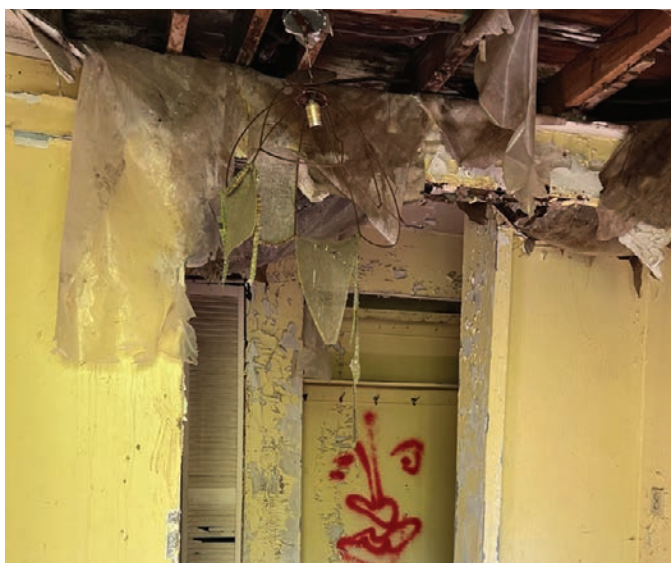
Interior spaces showing missing and damaged finished, revealing materials underneath (ERA, 2025).
