3437 TRAFALGAR ROAD & 340 BURNHAMTHORPE ROAD EAST Heritage Impact Assessment

April 6, 2026

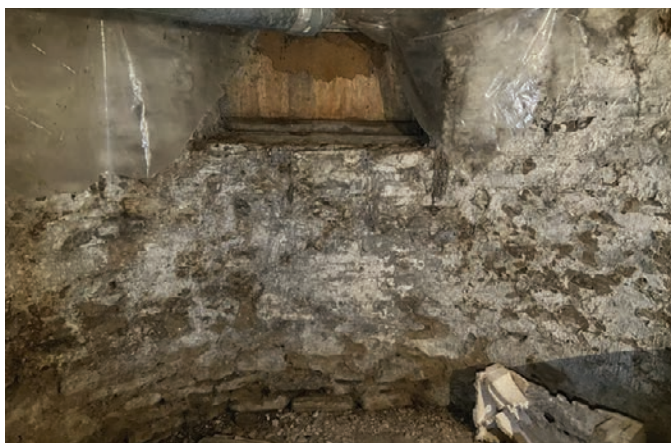
Fieldstone foundations, viewed from the basement, in poor condition (ERA, 2025).

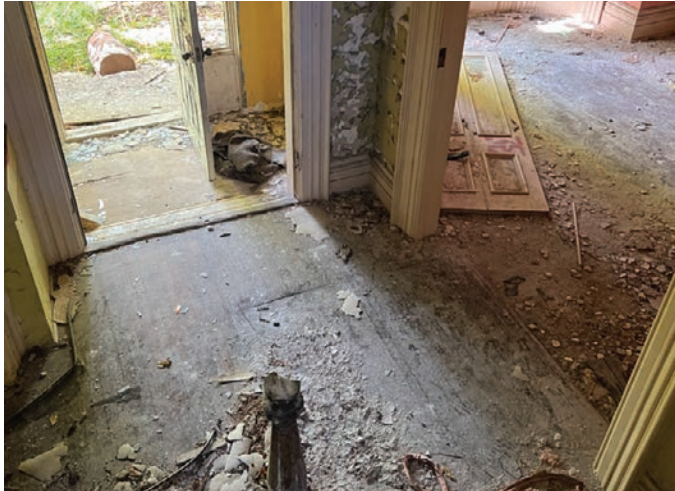
Floors at the original portion of building in fair to poor condition (ERA, 2025).

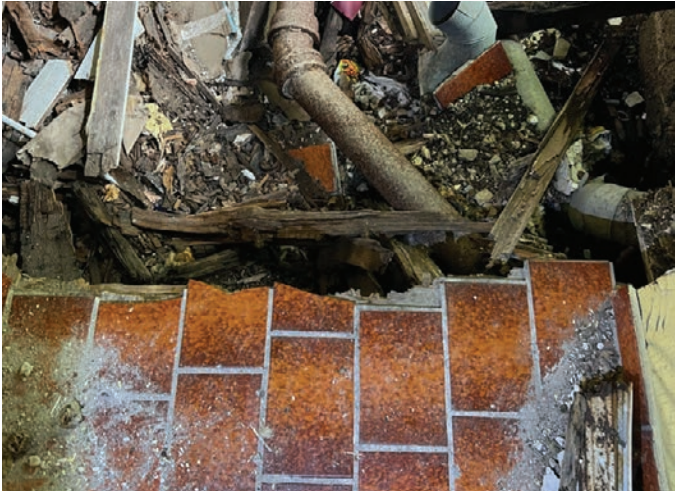
Tile floors at the later addition in defective condition (ERA, 2025).

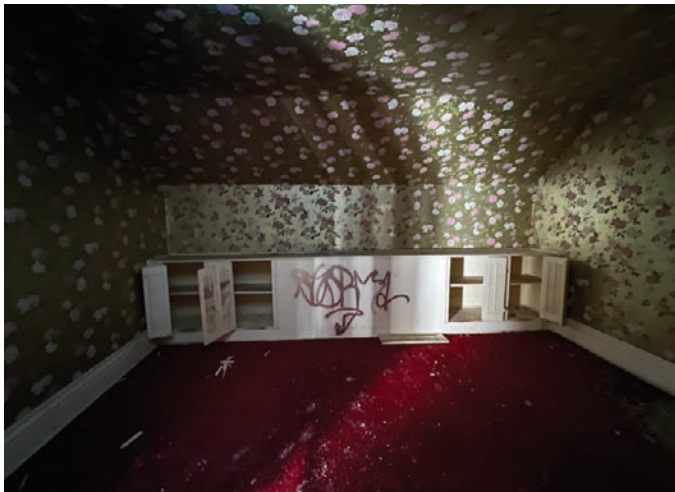
Carpet floors at the second floor in poor to defective condition, with extensive water damage (ERA, 2025).

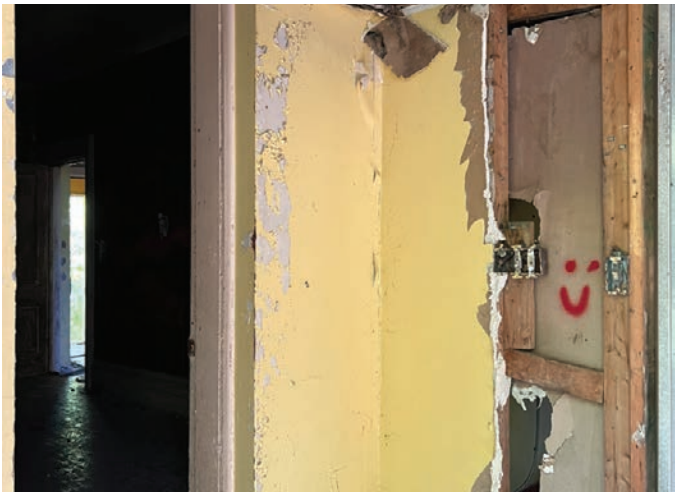
Drywall at the later addition in poor to defective condition (ERA, 2025).

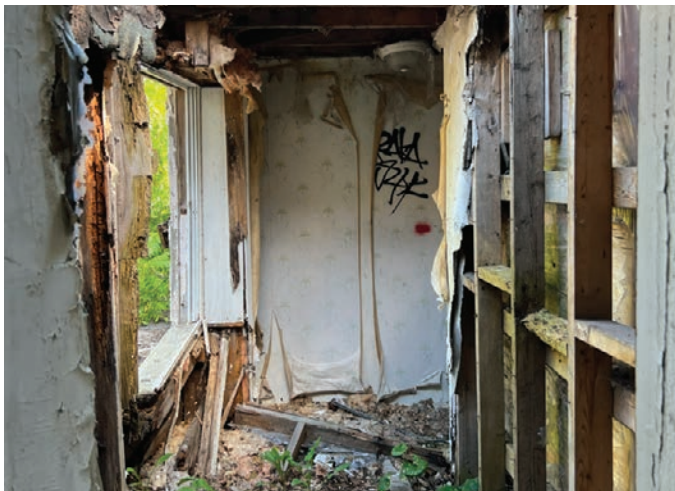
The roof of the south portion of the later addition is partially collapsed (ERA, 2025).

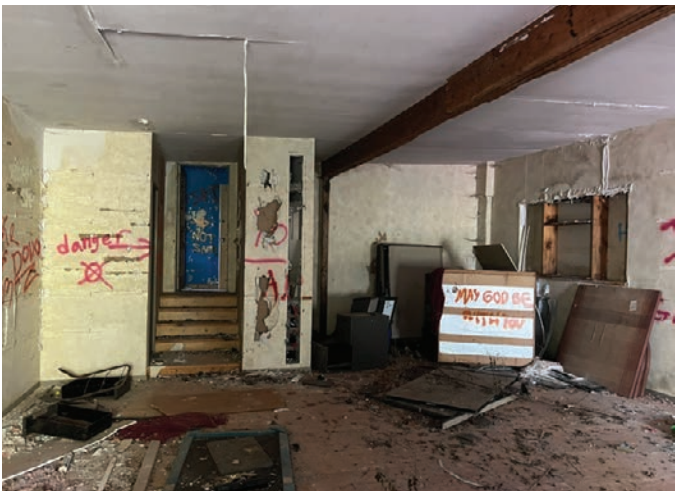
Ceiling at the north part of the later addition in poor condition (ERA, 2025).

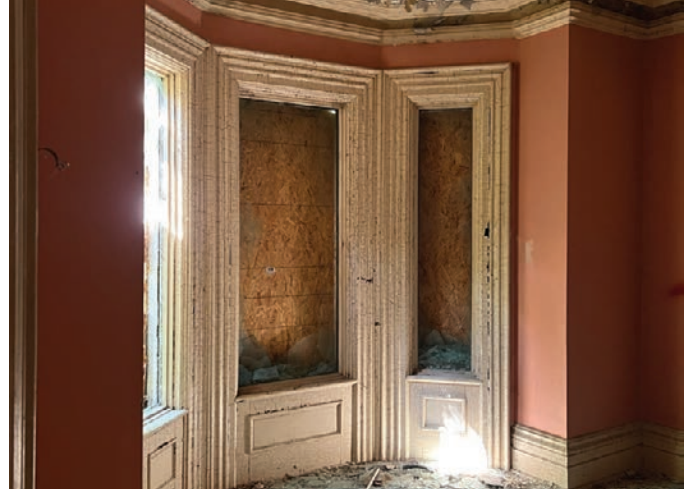
Window surrounds in fair condition (ERA, 2025).

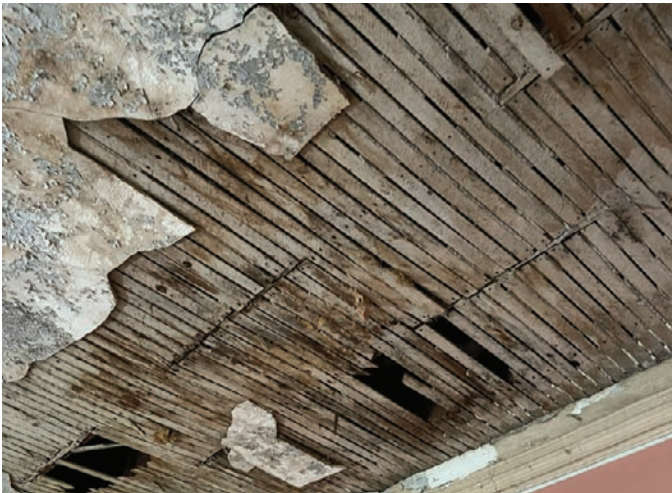
Plaster ceiling at original portion of building in poor to defective condition, showing large areas of missing material (ERA, 2025).

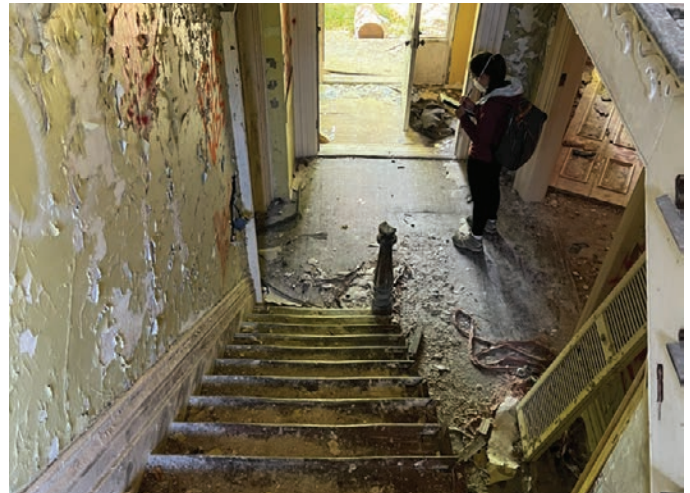
Staircase at original portion of building in defective condition, with significant damaged and missing sections (ERA, 2025).

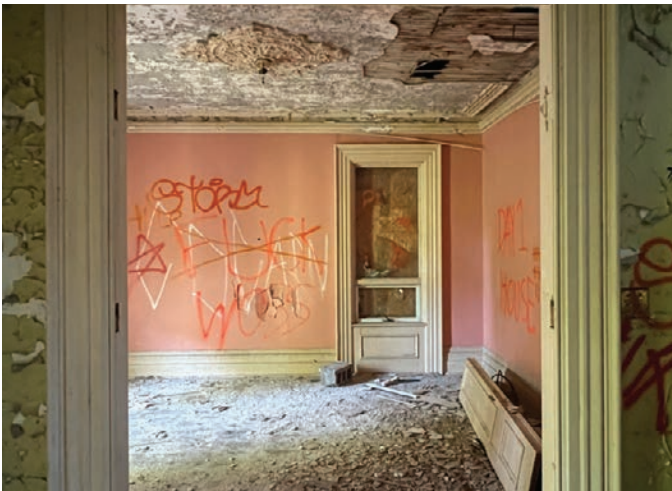
Wood trim at original portion of building in fair condition (ERA, 2025).

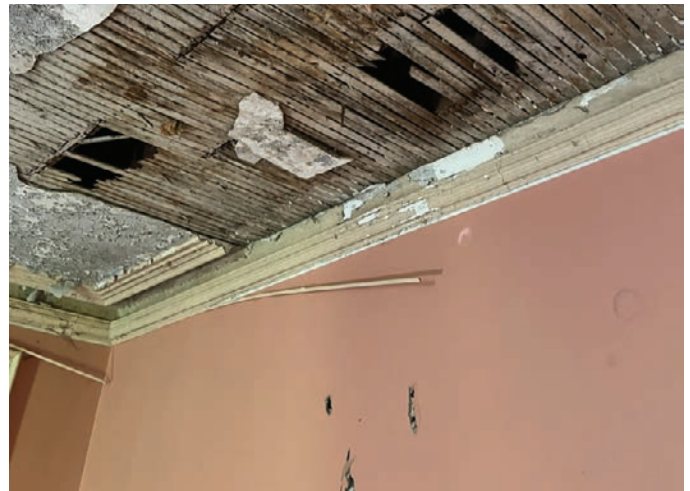
Plaster cornice in poor to defective condition (ERA, 2025).

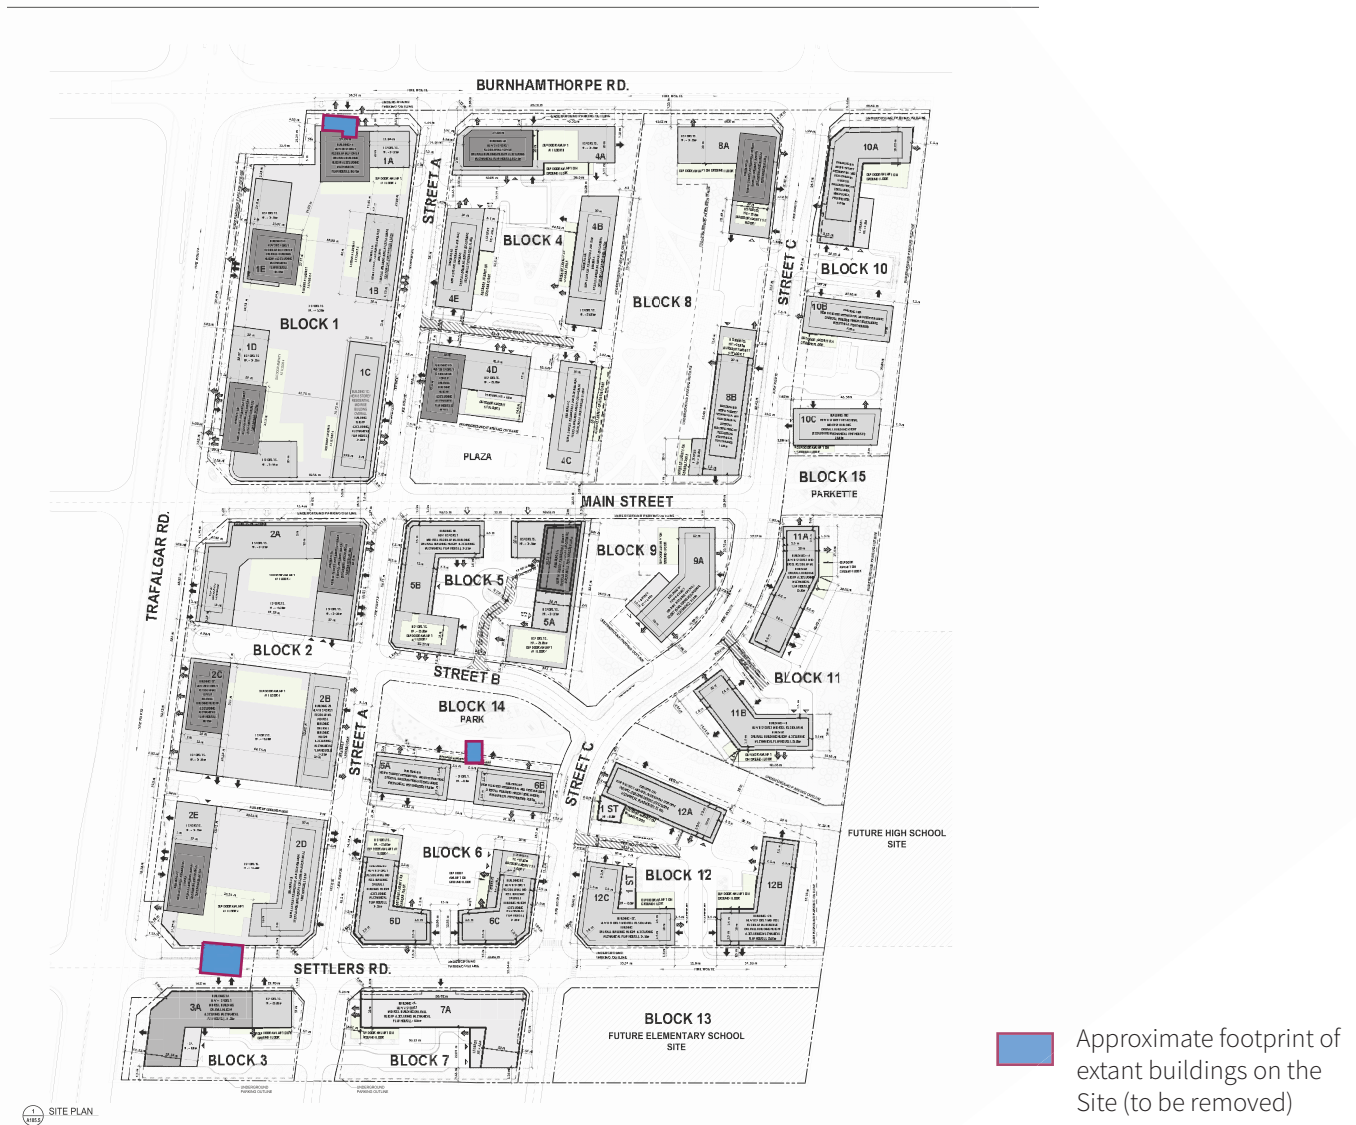
Site Plan (BDPQ, 2026; annotated by ERA).

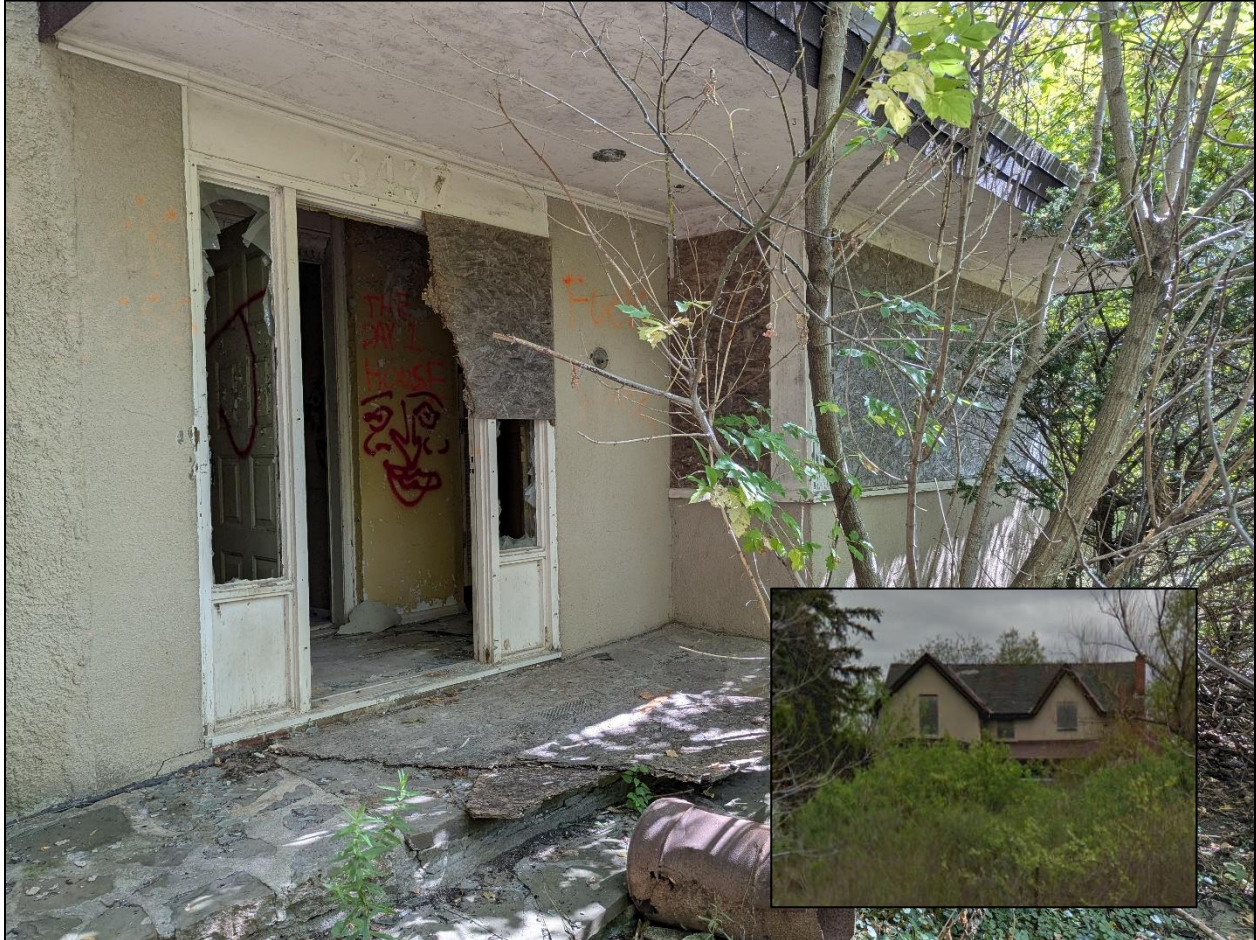
3437 Trafalgar Rd.
Oakville, Ontario

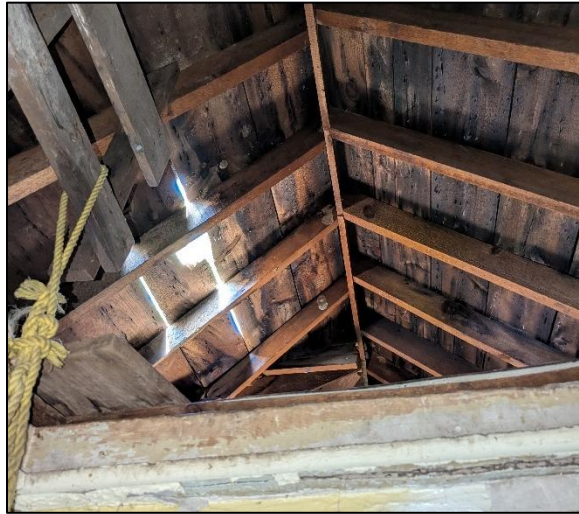
Photograph 1: Hole in Roof of Original Building

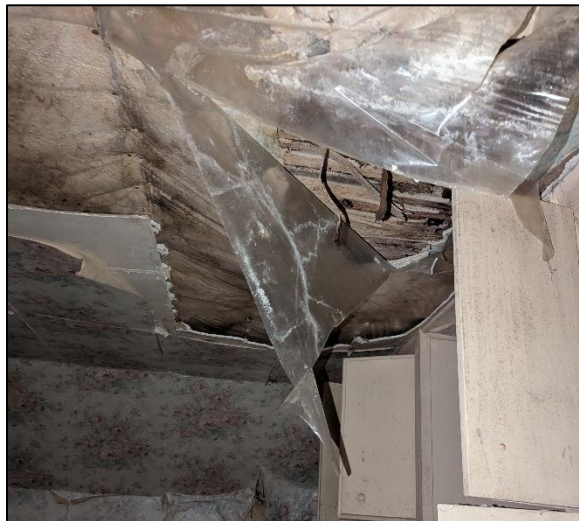
Photograph 2: Example of Water Damage of 2nd Floor Ceiling

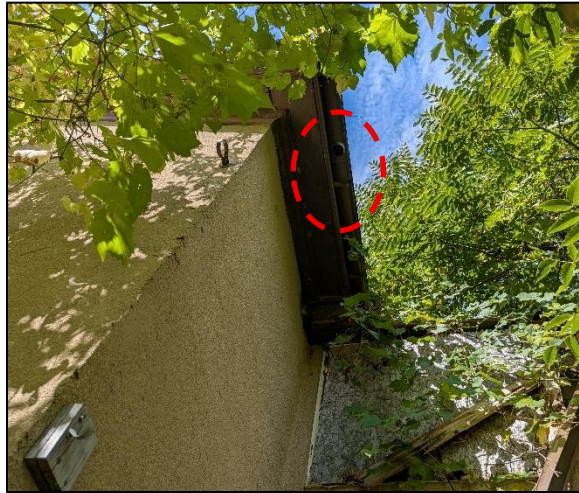
Photograph 3: Example of Downspout Disconnected from Eavestrough

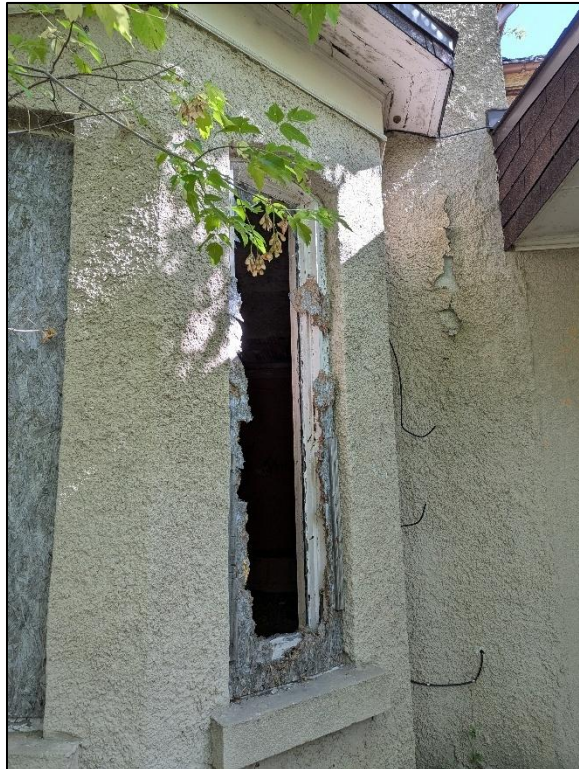
Photograph 4: Boarded Window with Damage Allowing Access to Interior

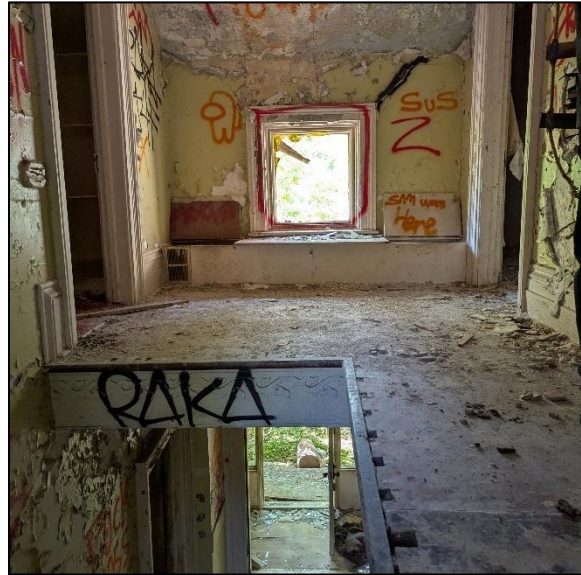
Photograph 5: Boarded Window with Damage on Second Floor

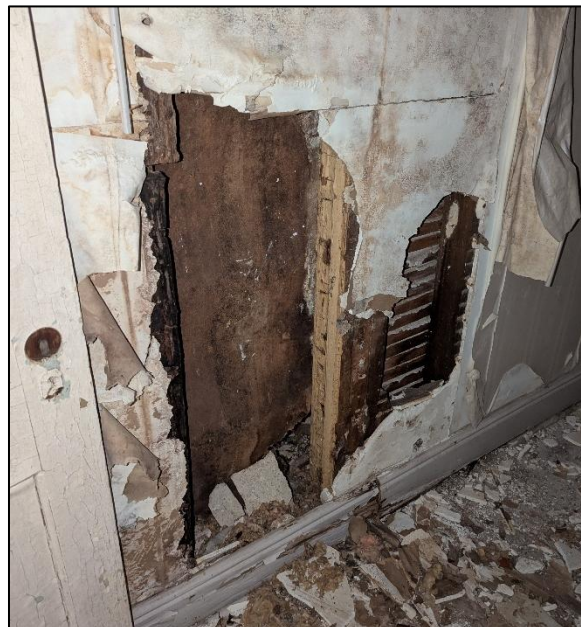
Photograph 6: Rot of Interior Wood Stud Wall Below Hole in Roof

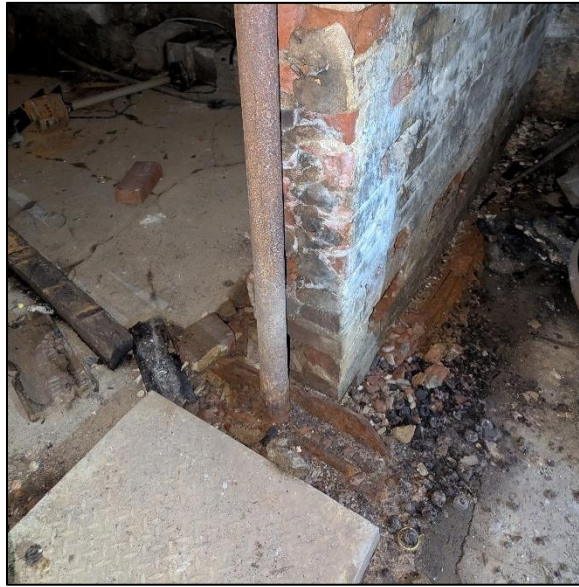
Photograph 7: Severe Corrosion at Base of Steel Telepost

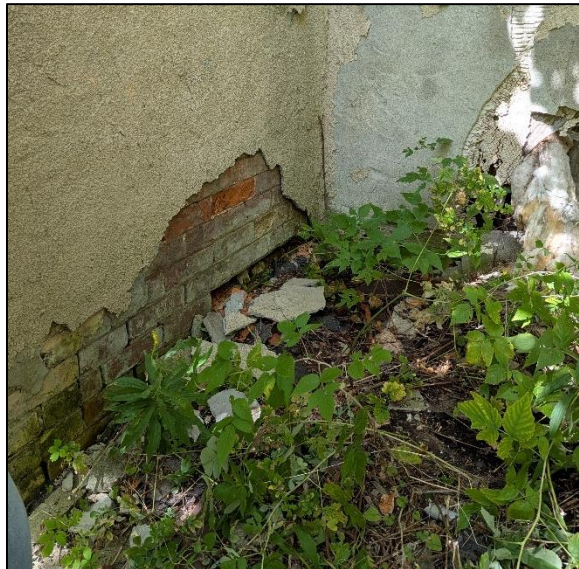
Photograph 8: Brick Spalling at South-East Corner of Original House

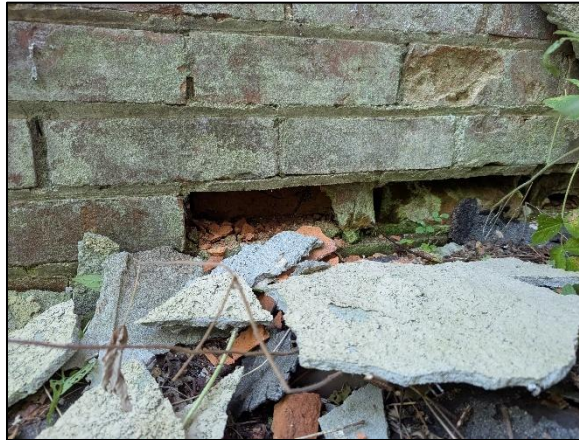
Photograph 9: Very Severe Masonry Deterioration at Grade

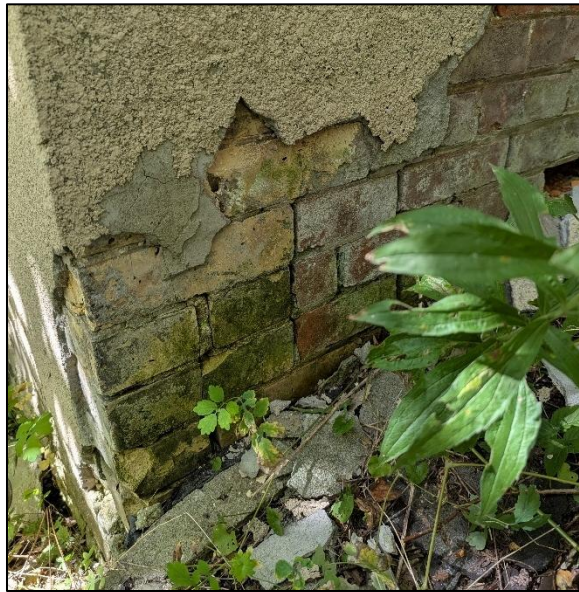
Photograph 10: Mortar Deterioration in Masonry Wall

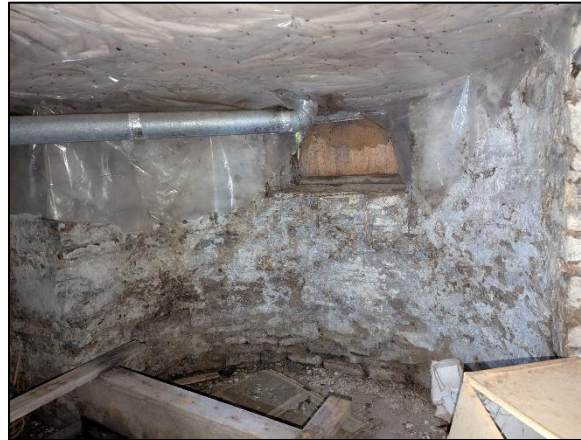
Photograph 11: Mortar Deterioration at Bottom of Stone Foundation Wall

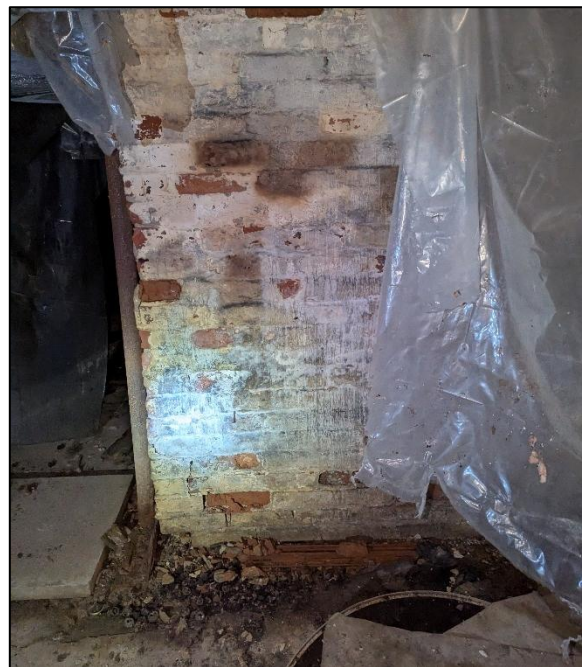
Photograph 12: Brick Spalling and Deterioration at Base of Interior Foundation Wall

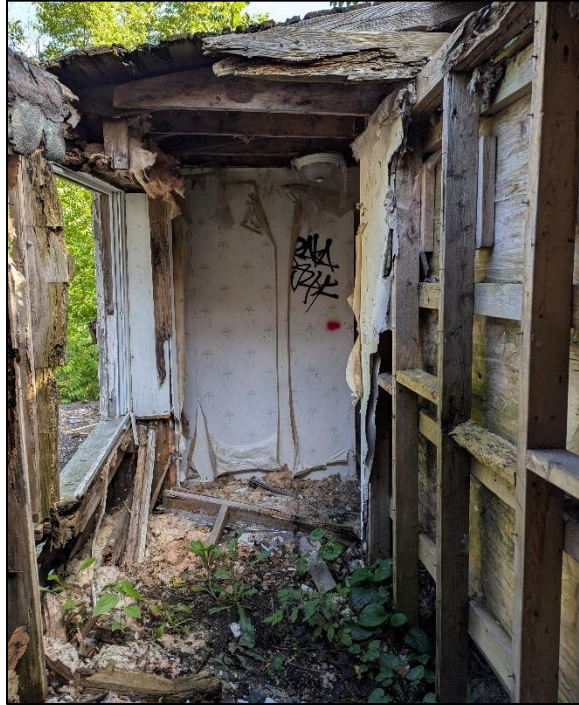
Photograph 13: Collapsed Roof of South Side Addition

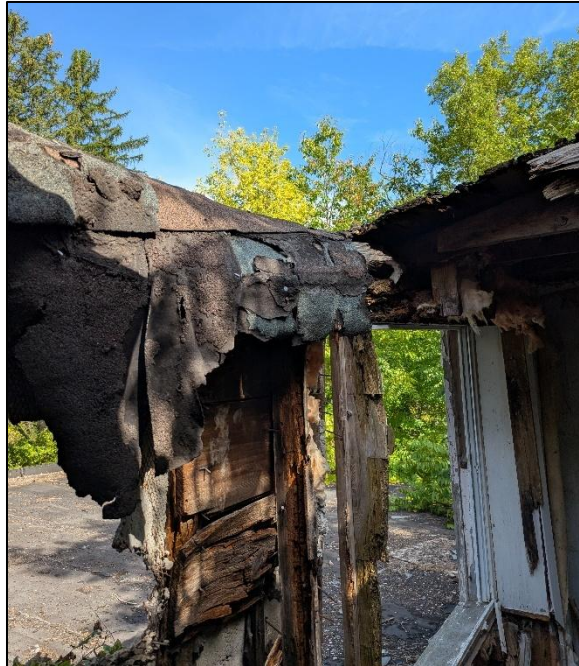
Photograph 14: Partial View of Flat Roof of North Addition

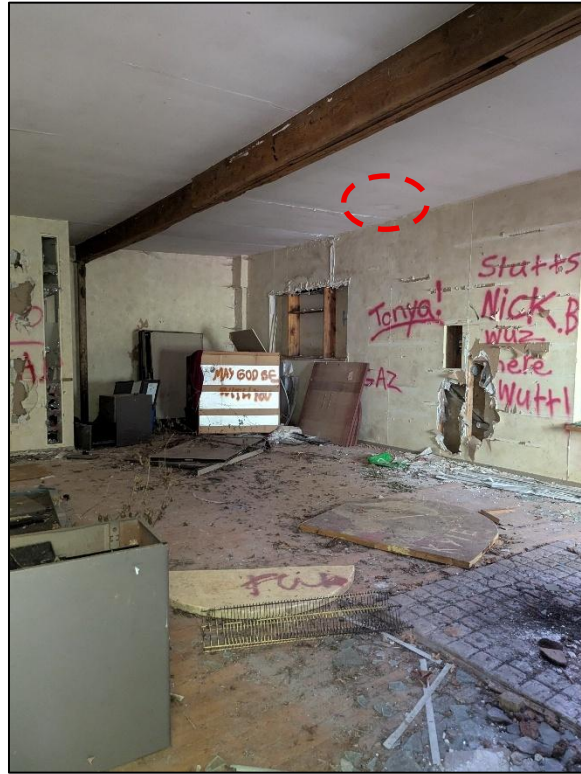
Photograph 15: Water Staining of North Addition Ceiling

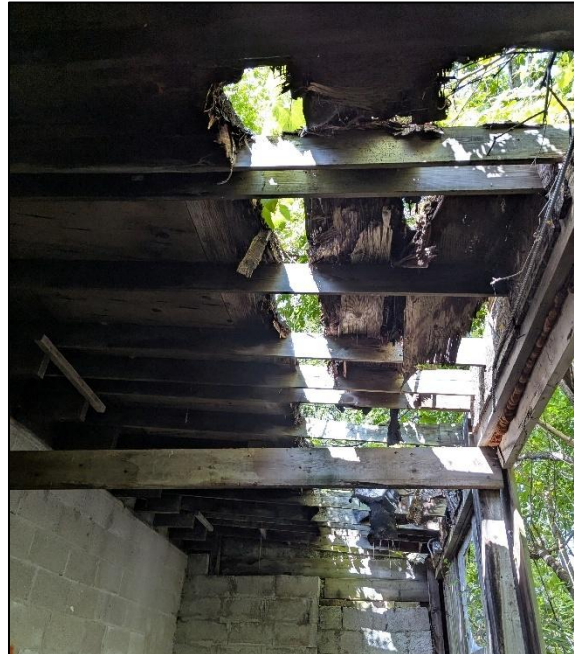
Photograph 16: Failed Roof at Back of North Addition

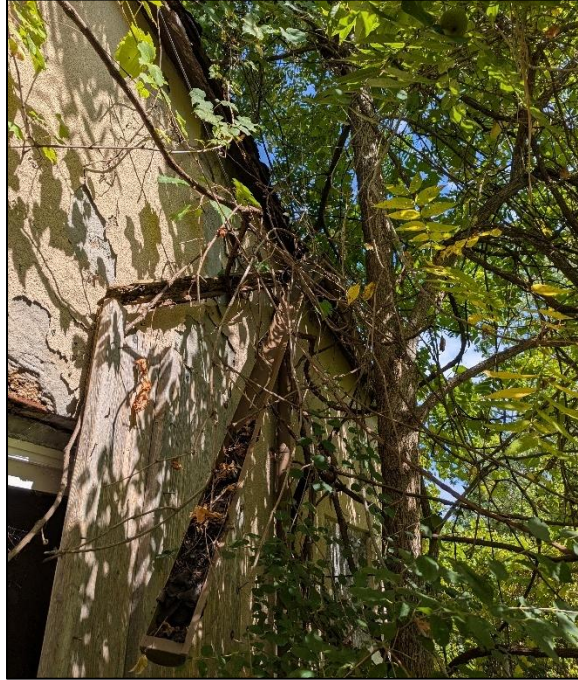
Photograph 17: Detached Eavestrough and Overgrown Trees

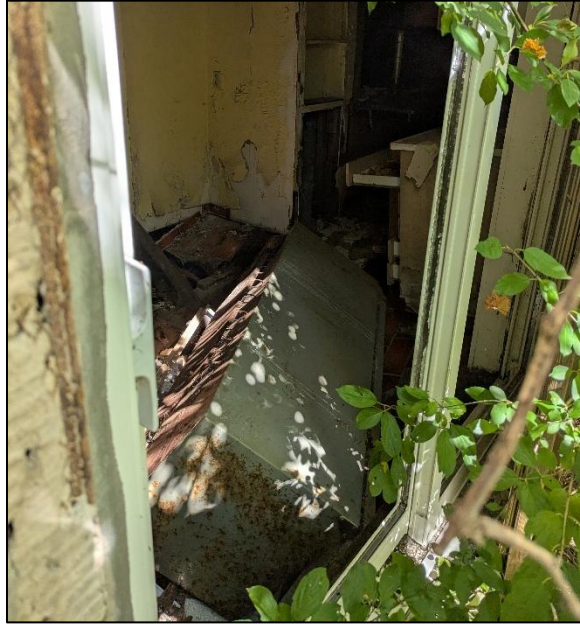
Photograph 18: Broken Sliding Glass Door on South Side of South Addition

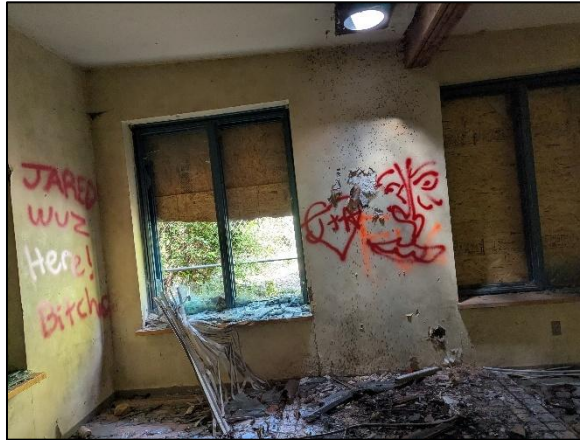
Photograph 19: Damaged Board Over Opening on Main Floor of North Addition

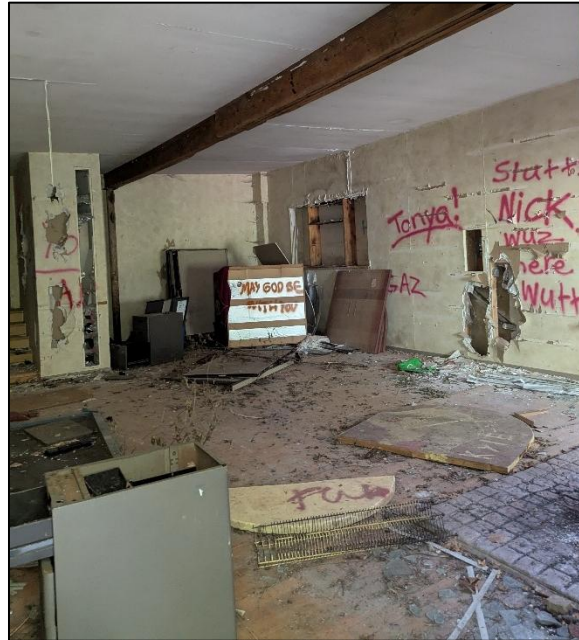
Photograph 20: Built-up Roof Beam in North Addition

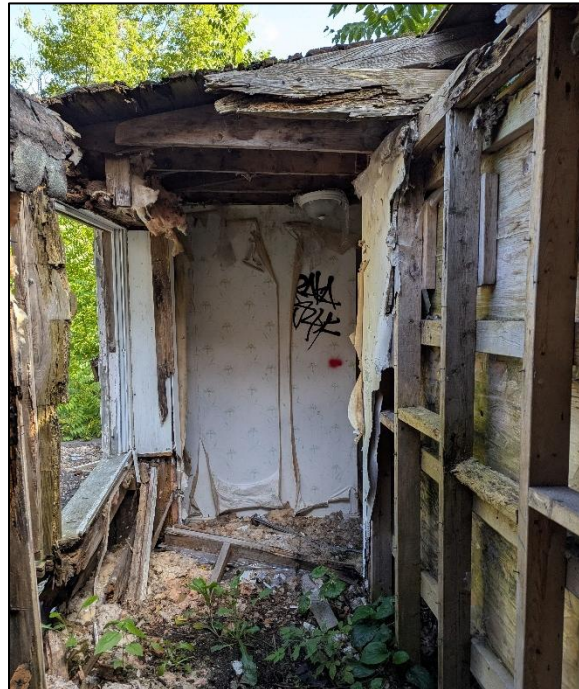
Photograph 21: Rot of Second Floor Wall Studs in South Addition

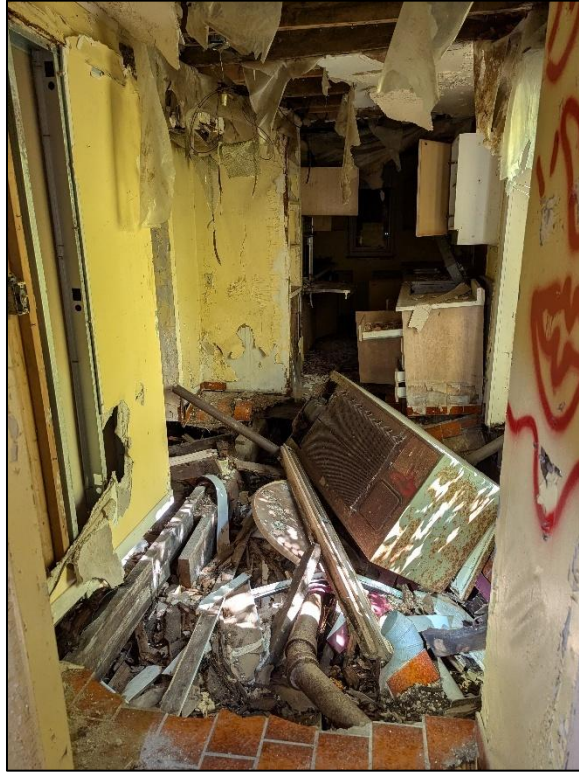
Photograph 22: Collapsed Main Floor in South Addition

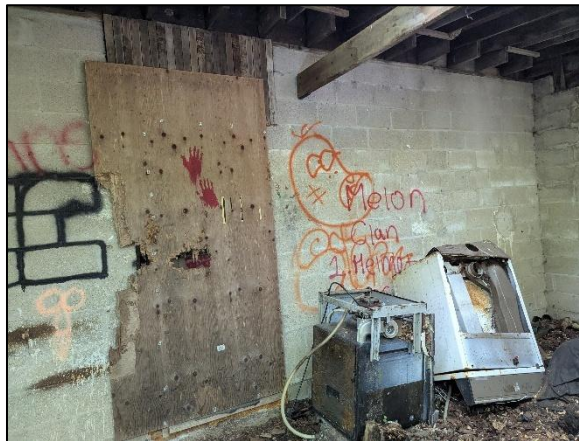
Photograph 23: Concrete Block Wall on East Side of Building

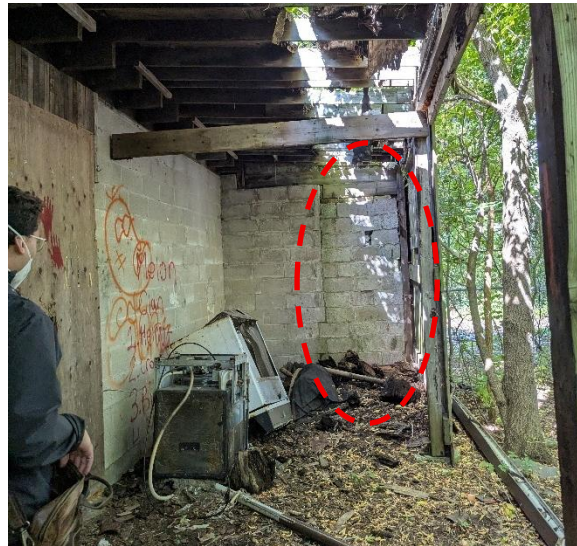
Photograph 24: Concrete Block Wall in Poor Condition at Northeast Corner

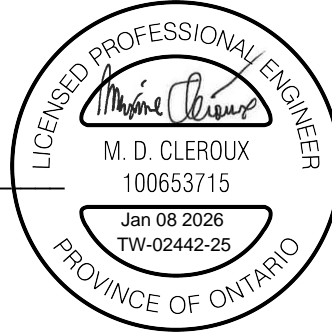
Appendix A: Material Condition Definitions

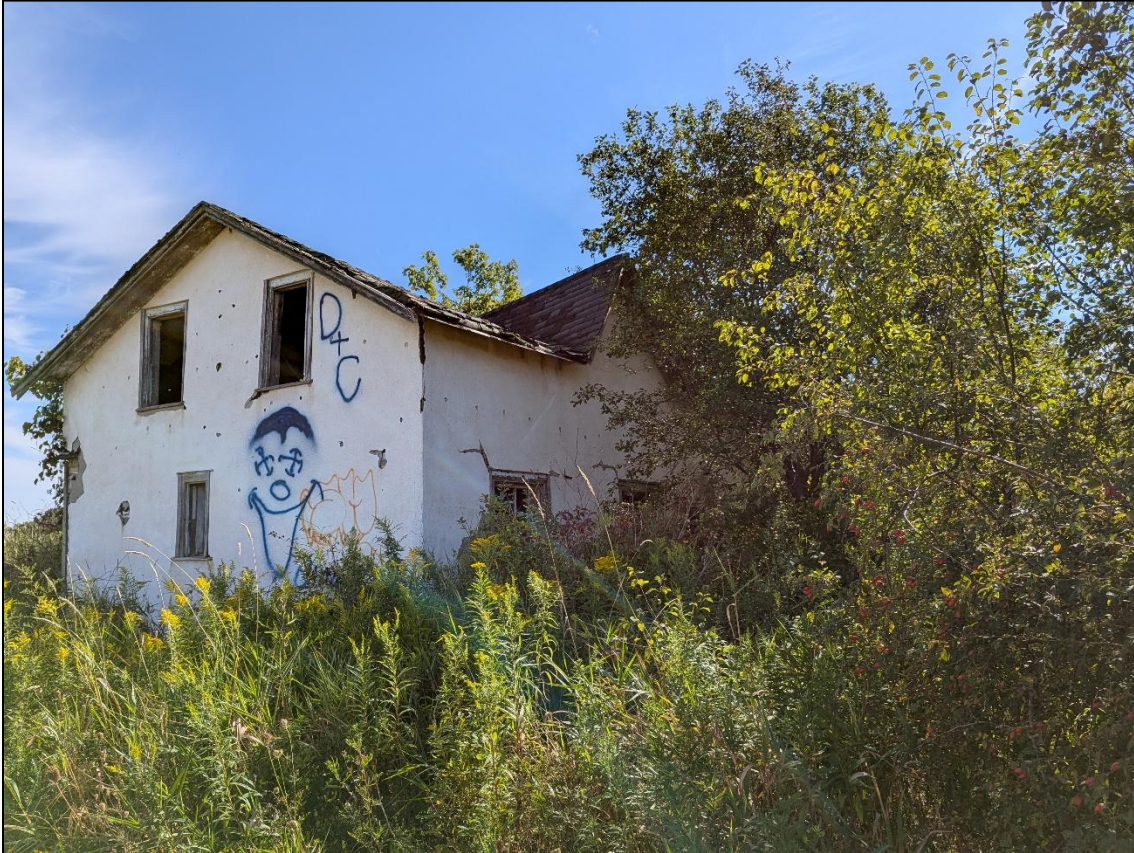
340 Burnhamthorpe Rd. E.
Oakville, Ontario

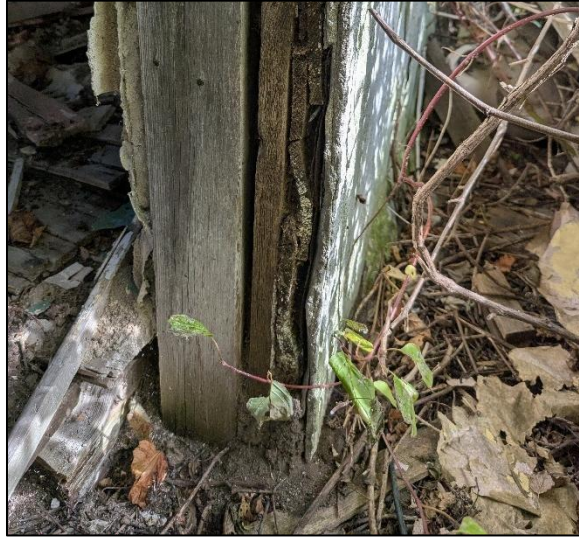
Photograph 1: Exterior Stud Below Grade & Wood Rot at Base

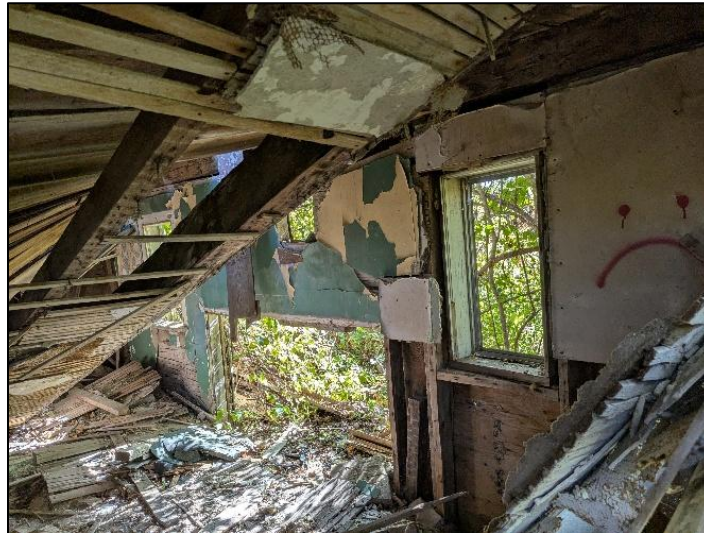
Photograph 2: Missing Chimney Walls and Broken Windows on South Elevation

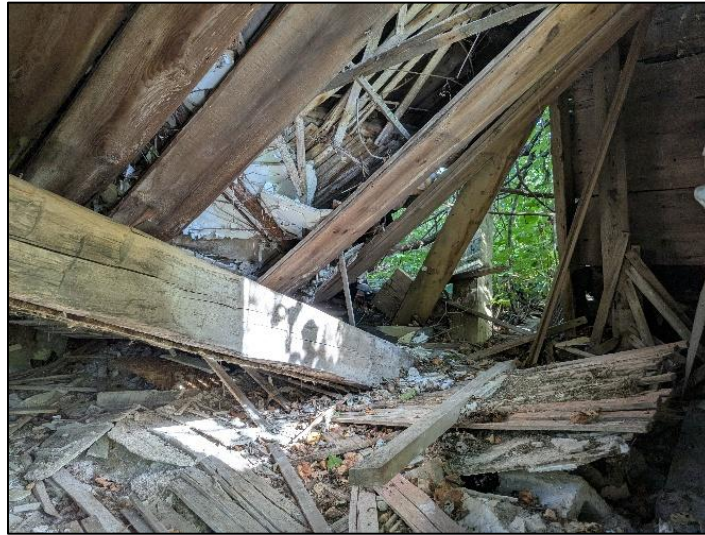
Photograph 3: Collapsed Exterior Wall on East Elevation

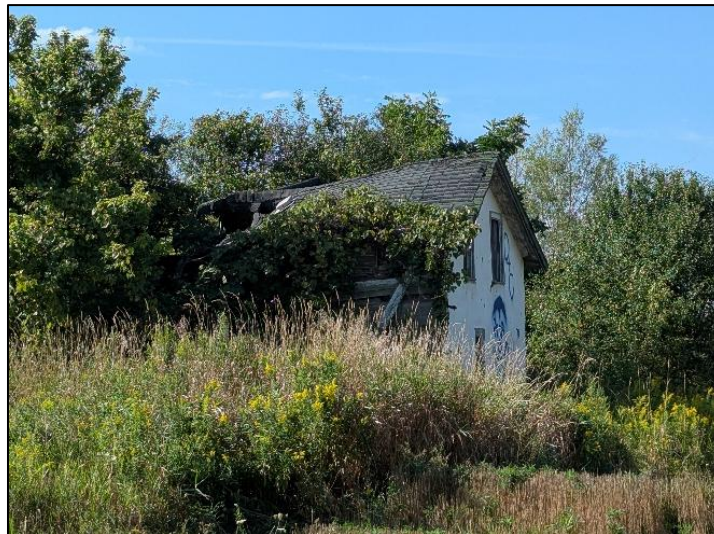
Photograph 4: Collapsed Roof on South-East Corner of House

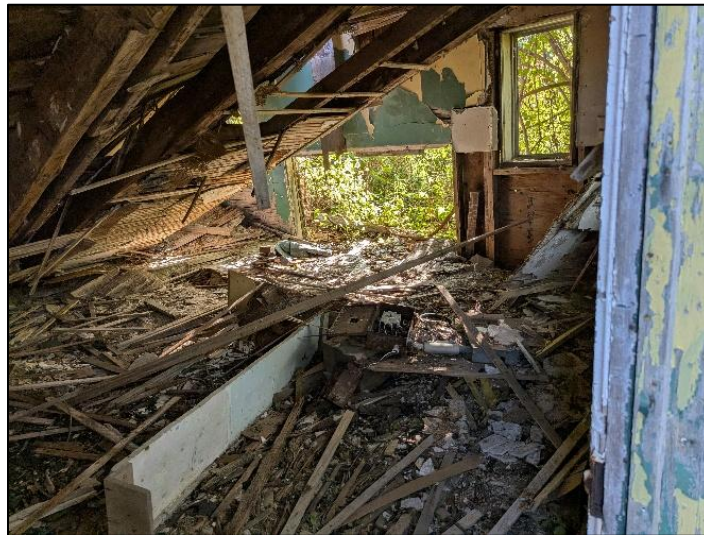
Photograph 5: Collapsed Floor on South Side of the House

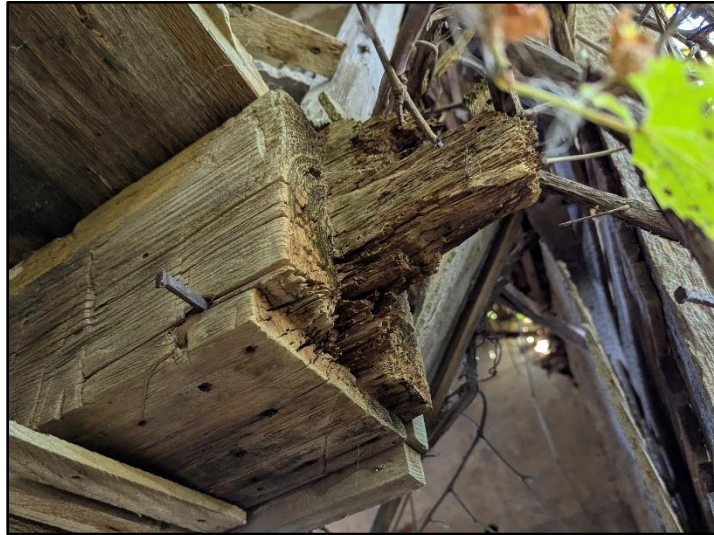
Photograph 6: Collapsed Floor on South Side of the House

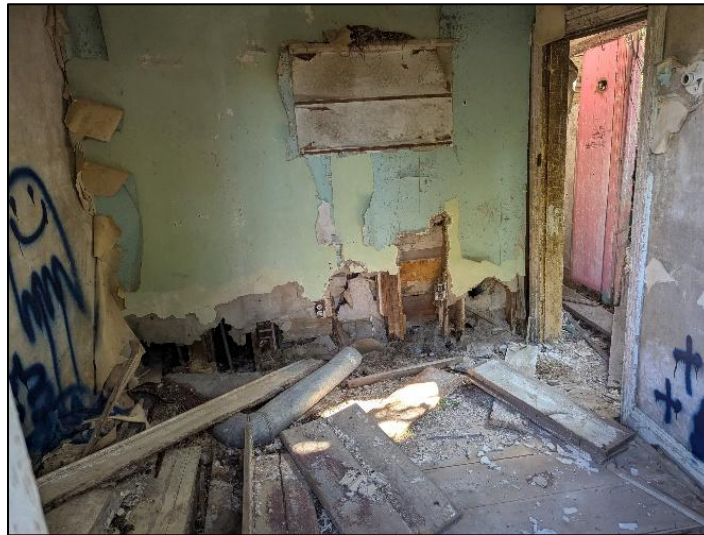
Photograph 7: Damage at Base of Interior Walls
