March 17, 2021
File No.: G20080

Re: Slope Stability Assessment for Proposed Housing Development
130 Cornwall Road, Oakville, Ontario

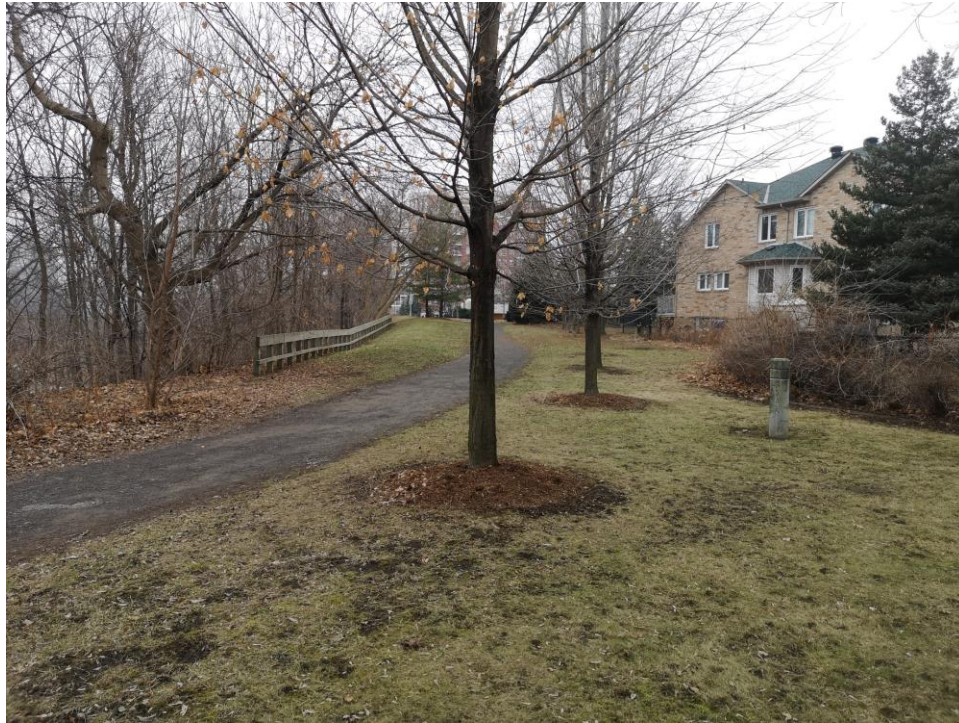
There was a wooden guardrail located near the top of the slope. The slope was vegetated with mature trees. There was no evidence of seepage from the slope face. Most mature tree trunks were straight and there was no evidence of major slumping along the slope.

Figure 1: Top of slope by wooden railing and existing house on site

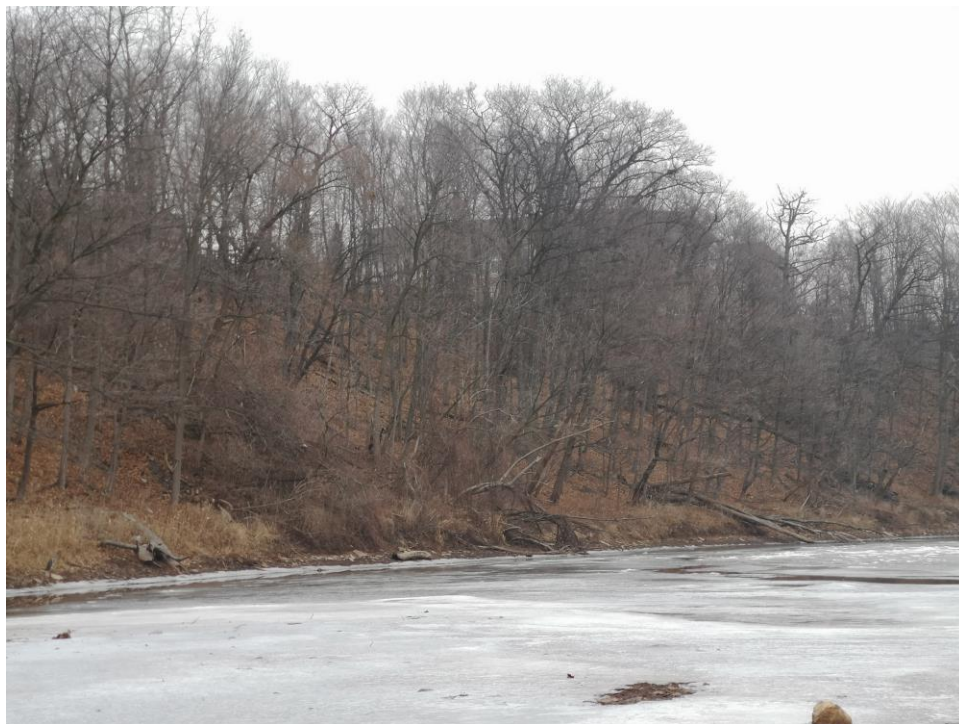
Figure 2: Slope as seen from the bottom

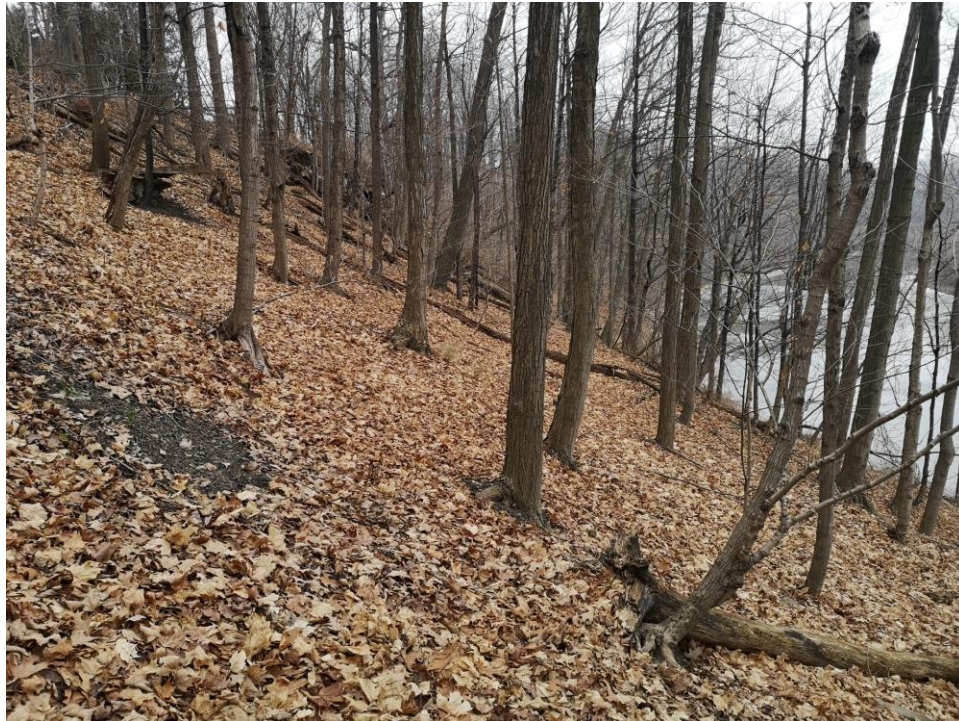
Figure 3: Typical vegetation on slope

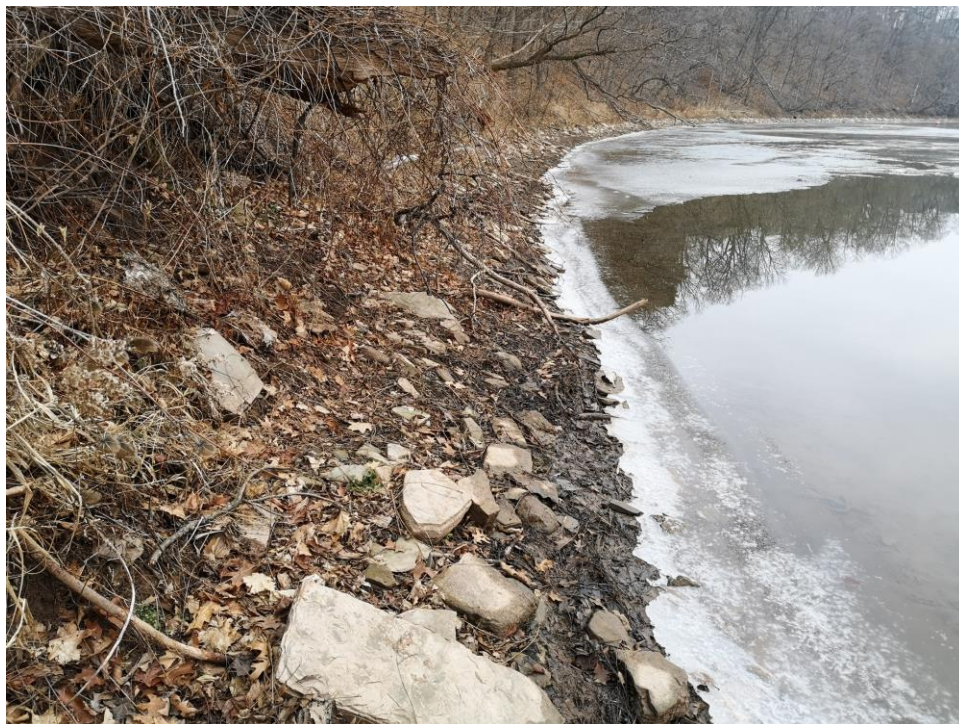
The toe of the slope is stable, and active erosion was not observed at the toe of the slope on the creek bank. The Sixteen Mile Creek is approximately 60 m wide at the site location, and the creek bed is composed of shale bedrock. Reference is made to Table 3 on Page 38 of the "Technical Guide – River and Stream Systems: Erosion Hazard Limit", published in 2002 by the Ontario Ministry of Natural Resources. Potential erosion due to the stream action (over 30 m wide channel, no apparent toe erosion in shale bedrock) is 2 m (Toe Erosion Allowance).

Figure 4: Sixteen Mile Creek at toe of slope with exposed river bed.

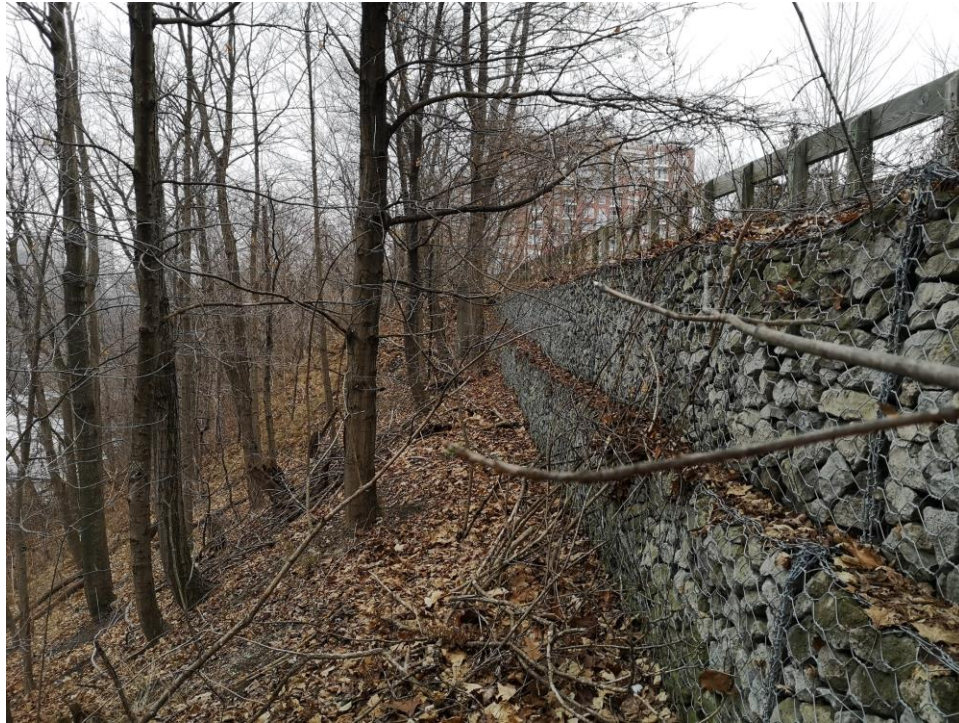
Figure 5: Retaining wall at top of slope, just west of site

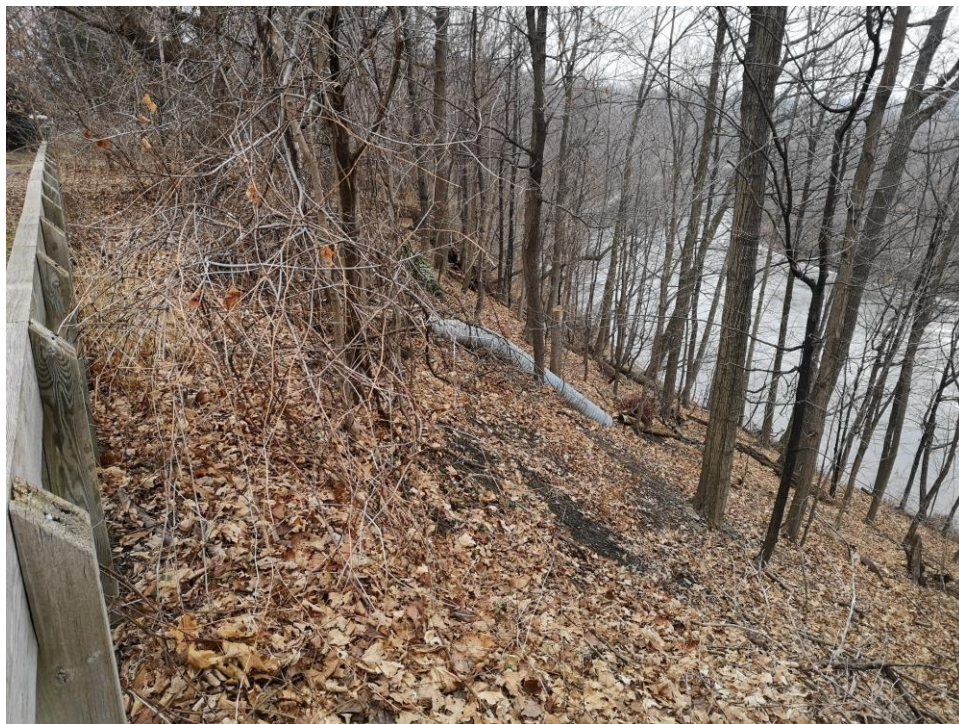
A corrugated drainpipe has been placed on the slope surface and extended a few meters down the slope where the open end was exposed. No water flow from the pipe was observed at the time of the inspection, and no evidence of active erosion at the end of the pipe was noted. The source of the pipe is unknown.

Figure 6: Storm water drain pipe laying on slope

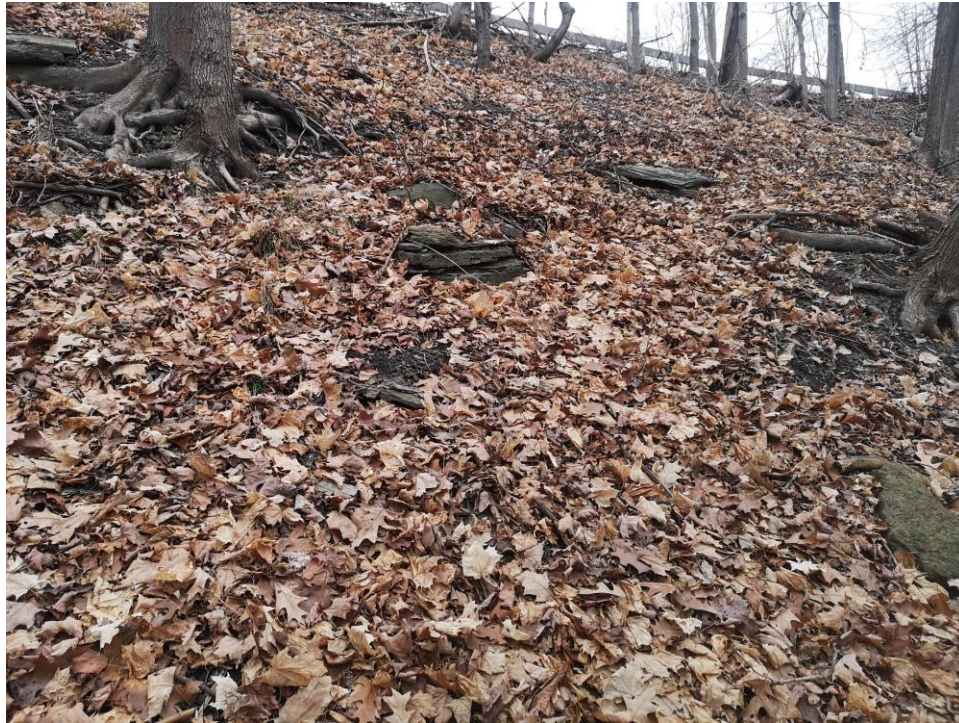
Minor bedrock outcrops were observed along the slope face. Sixteen Mile Creek runs along the toe of the slope and is approximately 60 m wide. At the time of inspection, the low water level exposed the river channel and the shale bedrock. The exposed riverbank was about 1 m high with no evidence of active erosion. Selected site photographs have been attached in Appendix C.

Figure 7: Minor bedrock outcrops visible in face of slope

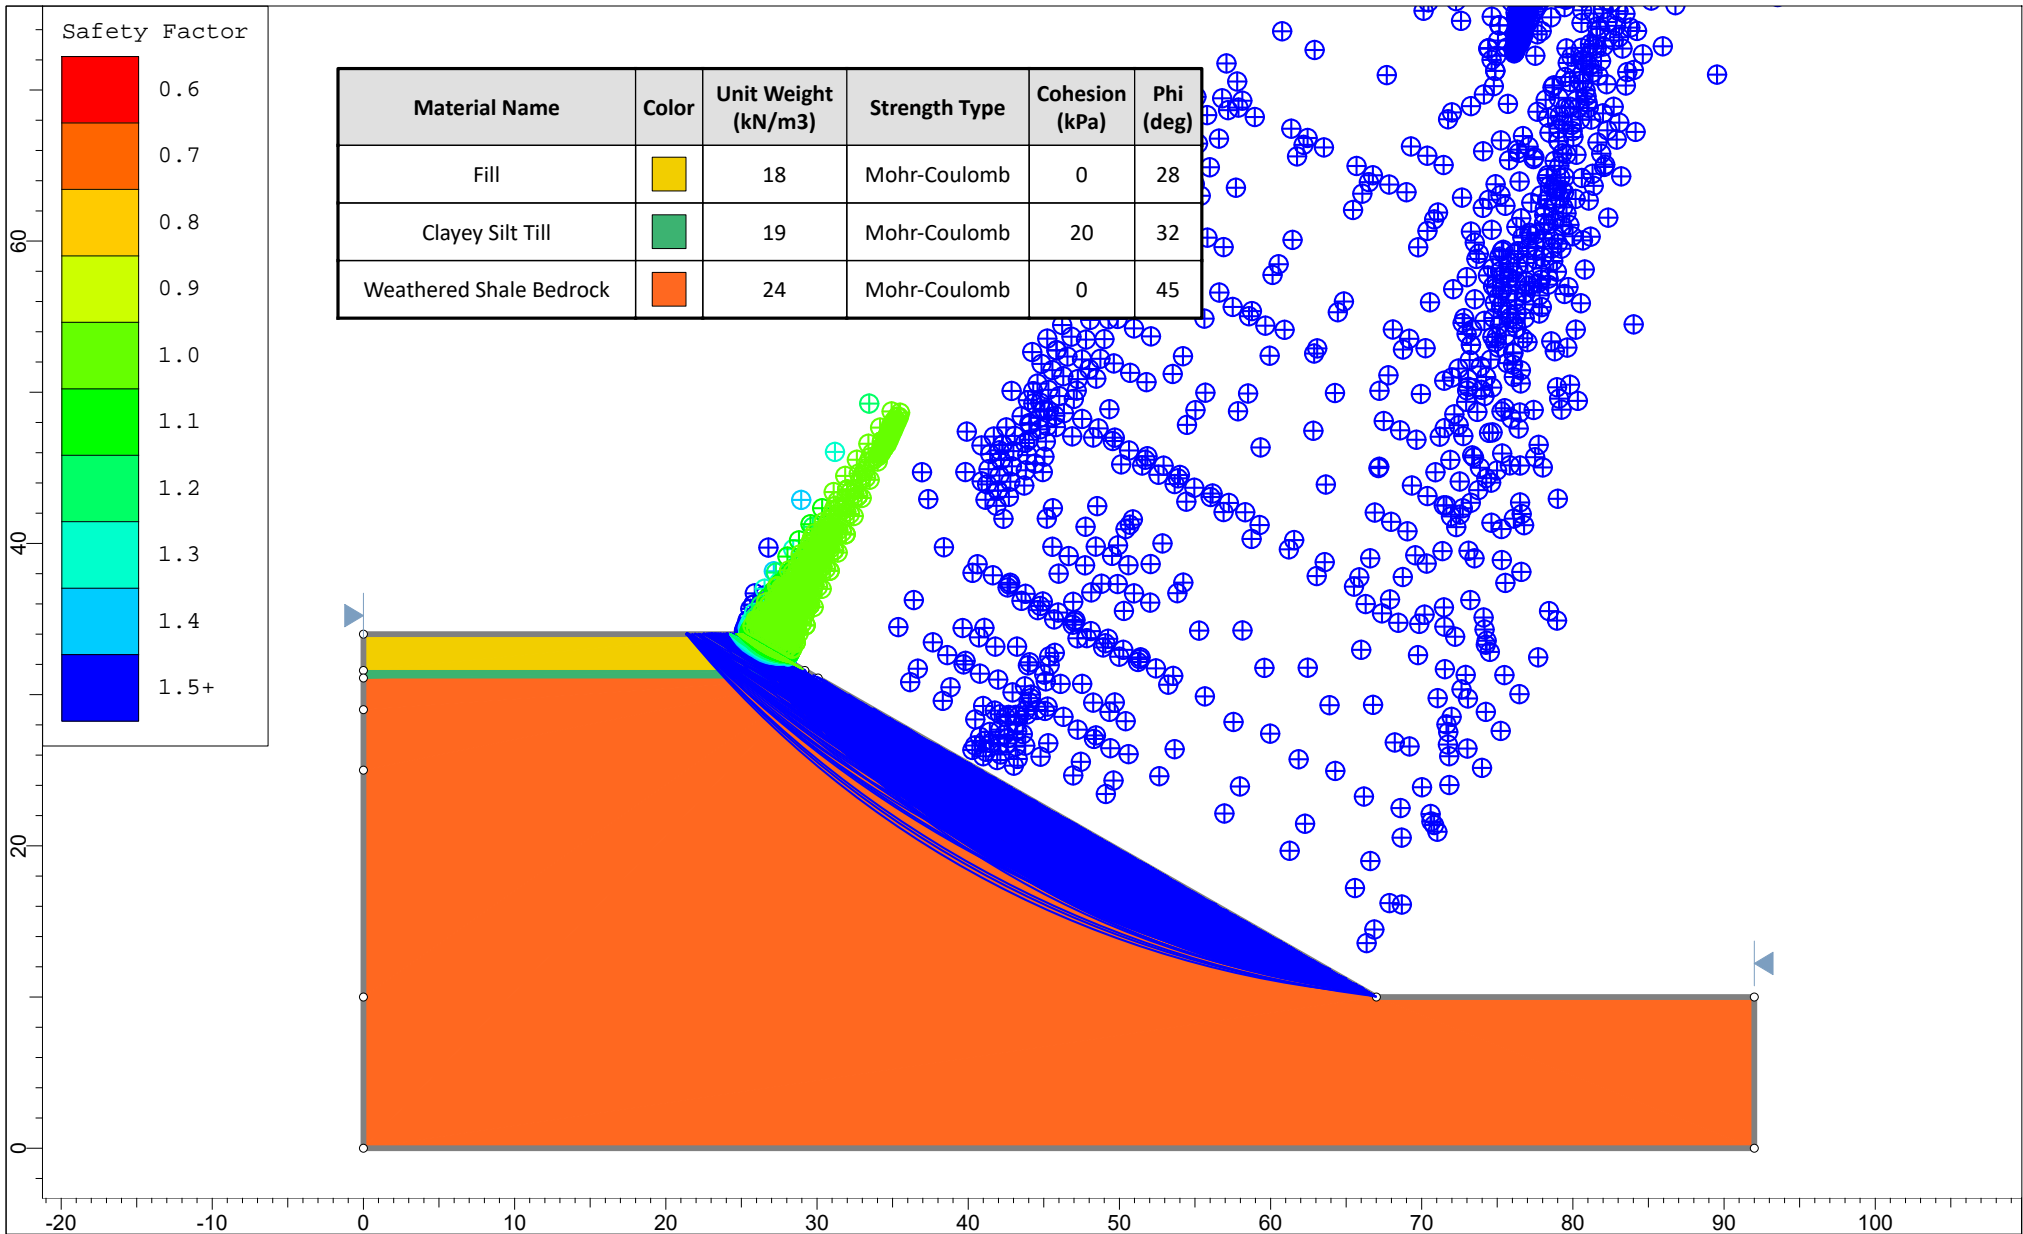
Project			G20080 - 130 Cornwall Rd., Oakville	
	Analysis Description			Long Term Slope Stability - Overall Slope	
	Drawn By		Chris Sternik	Scale	1:500
	Date		2/25/2021, 11:30:30 AM	Company	CVD
				File Name	Figure No. 1

The analysis shows that the overall slope has a factor greater than 1.5, apart for the top of the slope where the fill materials can be found. Figure No. 1, illustrates the analysis results for the overall slope. The overburden was found to have a factor of safety less than 1.5, as shown in Figure No. 2, where only slip surfaces with a factor of safety of less than 1.5 are shown. The slip surfaces with a factor of safety less than 1.5 extend approximately 0.7 m beyond the top of the slope.

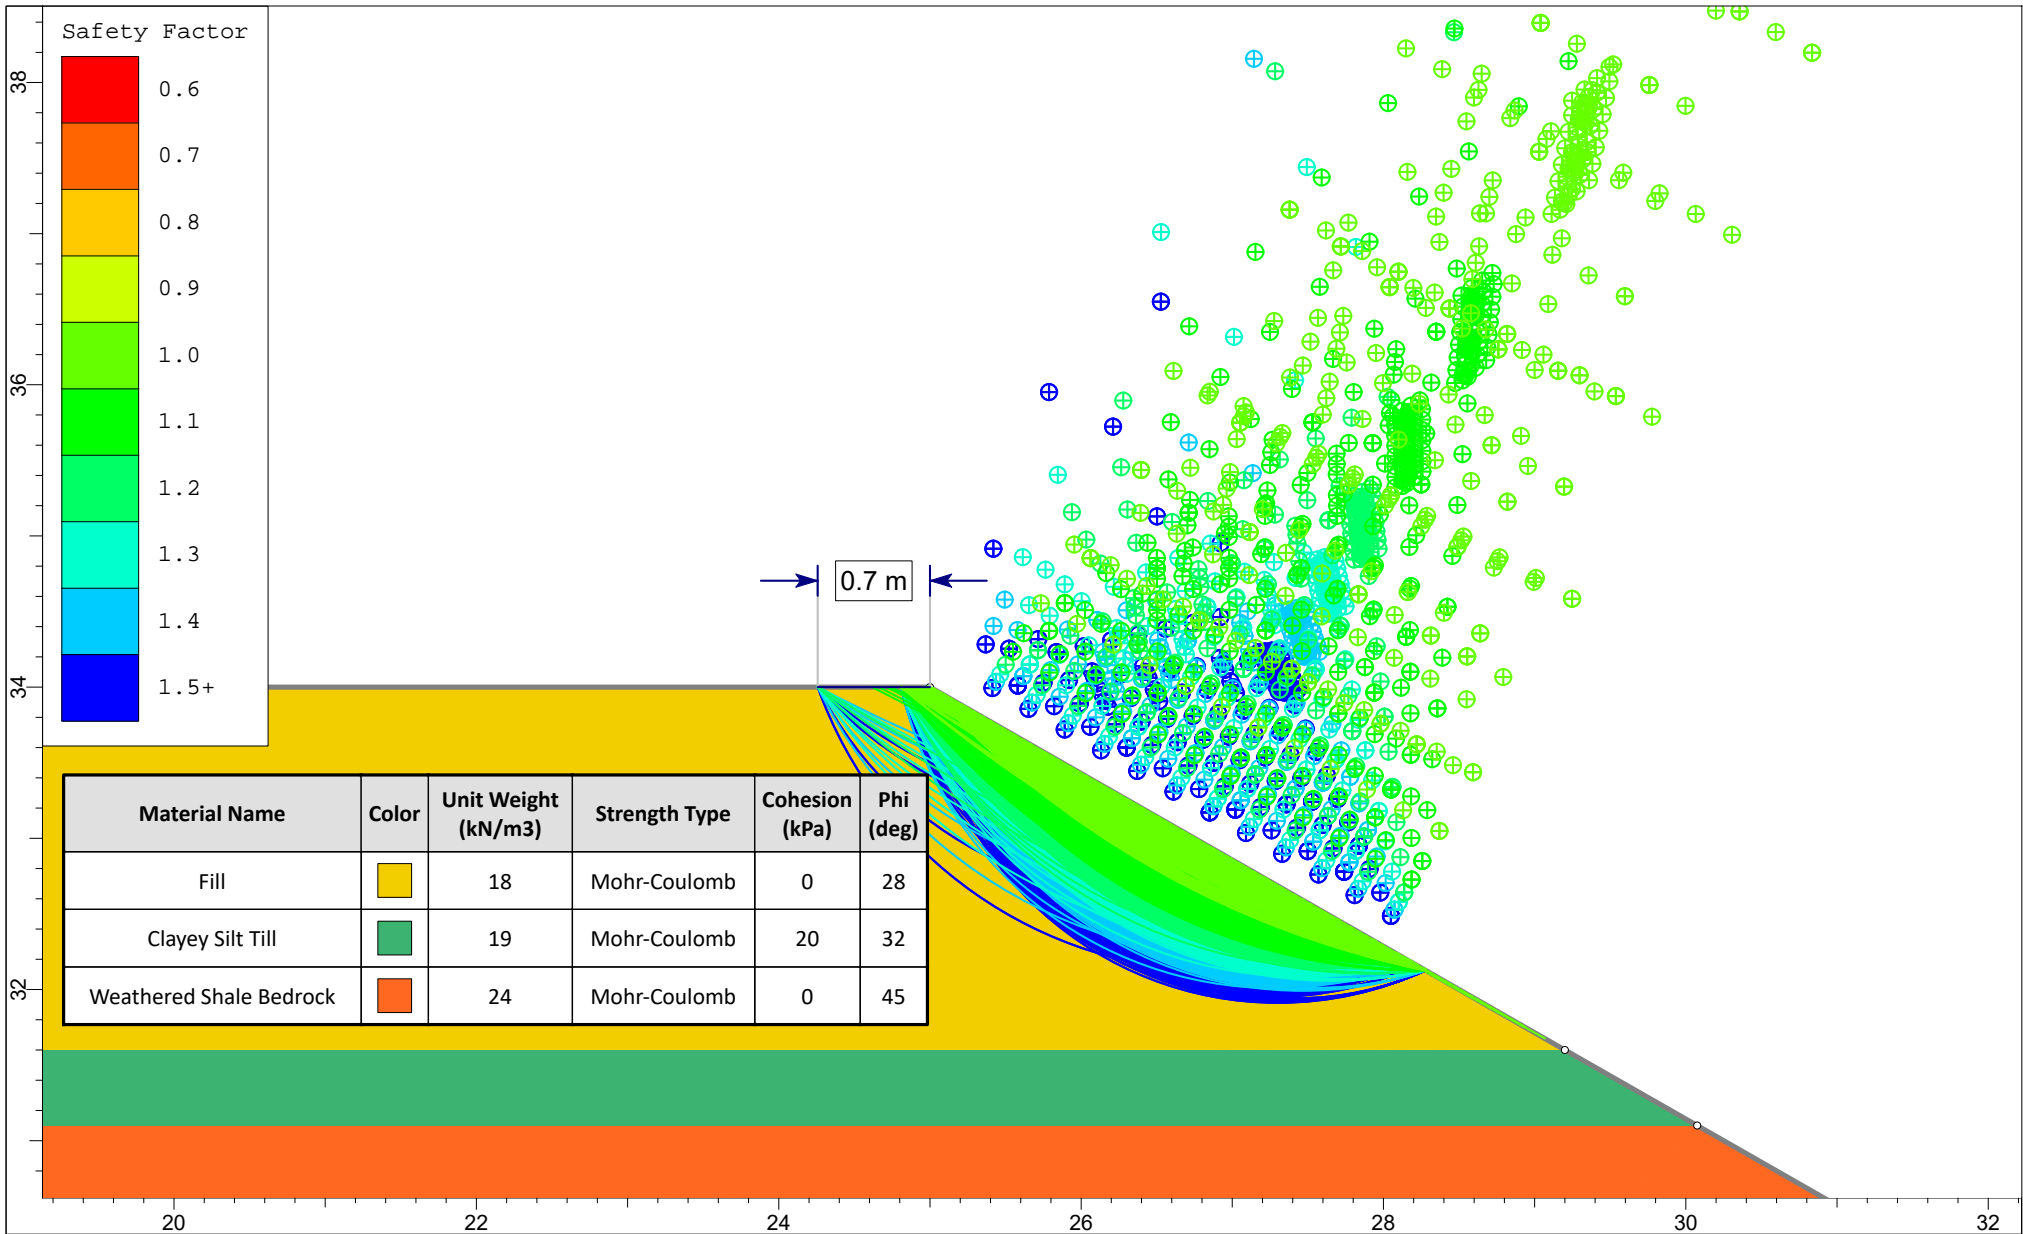
Project			G20080 - 130 Cornwall Rd., Oakville		
Analysis Description			Long Term Slope Stability - Top of Slope		
Drawn By		Chris Sternik	Scale	1:50	Company
Date		2/25/2021, 11:30:30 AM	File Name		CVD
			Figure No. 2

The stable top of slope (bank) was determined to be approximately 0.7 m from the existing top of slope (Stable Slope Allowance, see Figure No. 2, Appendix E) based on stability analysis. Consequently, the long-term stable top of slope is 2.7 m from the present top of slope. It is understood that Halton Conservation will require a 15 m allowance for development adjacent to the stable top of slope (bank).

Given that the existing top of the slope is located approximately 16± m from the southern limit of the site and the proposed building will have a 3 m setback from the south property line, the proposed building will meet the setback requirement from Halton Conversation.
