Arborist Report

Pre-Construction Report

Site Address:
579 Speers Rd
Oakville, ON L6K 2G4

November 8th, 2019

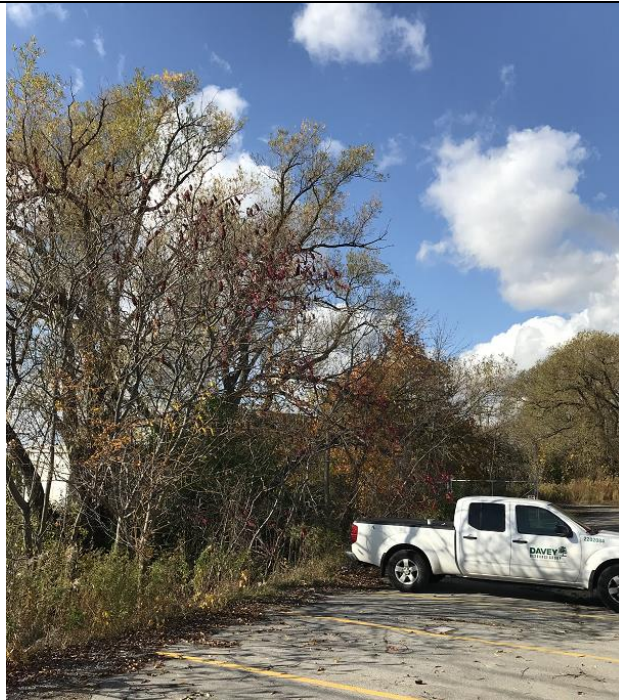
- Trees #3, 4, 5, 7, and 9, all Green Ash trees, were found with extensive Emerald Ash Borer symptoms and are recommended for removal. None of these trees are regulated.

Photo 1: View of Trees #1-8 along existing asphalt lot, with #28-29 in background

- Tree #20: a 107cm Willow in fair condition
 - Tree #20 is on city property within the natural area surrounding the creek.
- We recommend the removal of Trees #1, 3, 4, 5, 7, 9, and 19 from the property prior to construction to allow for asphalt paving and construction access. These trees are not regulated by Oakville by-laws.

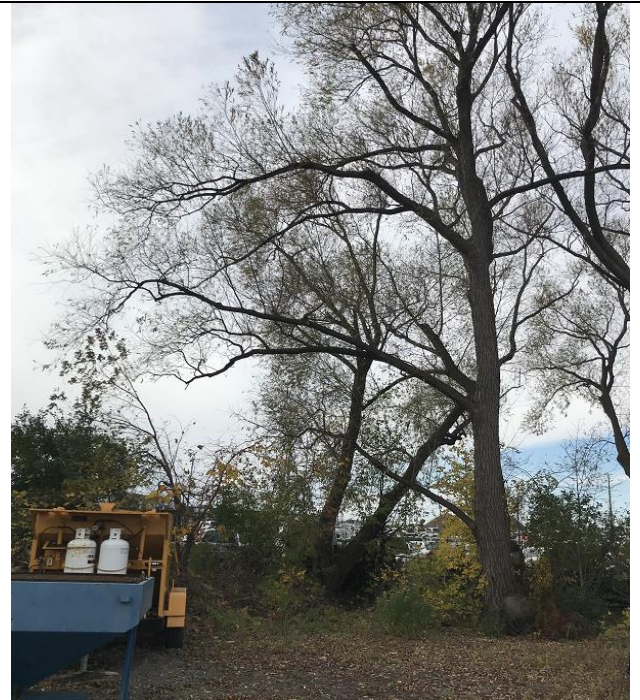
- Trees #10 and #13, two large Willows, and Trees #11 and #26, two Manitoba Maples, are within or on the edge of the proposed parking lot in the rear of the property and will require removal. These trees are regulated by the Town of Oakville and will require permits for removal.

Photo 2: View looking southeast at Trees #9-13 (left to right)

- Submit a Tree Removal Permit application to the Town of Oakville pertaining to the following trees:
 - Tree #10: a 135cm Willow in good condition
 - Tree #11, a 16cm Manitoba Maple in good condition

- Tree #13: an 86cm Willow in good condition
 - Tree #25, an 88cm Willow in fair condition
 - Tree #26, a 64cm Manitoba Maple in fair condition
 - All trees to be removed are within the private property of the client.

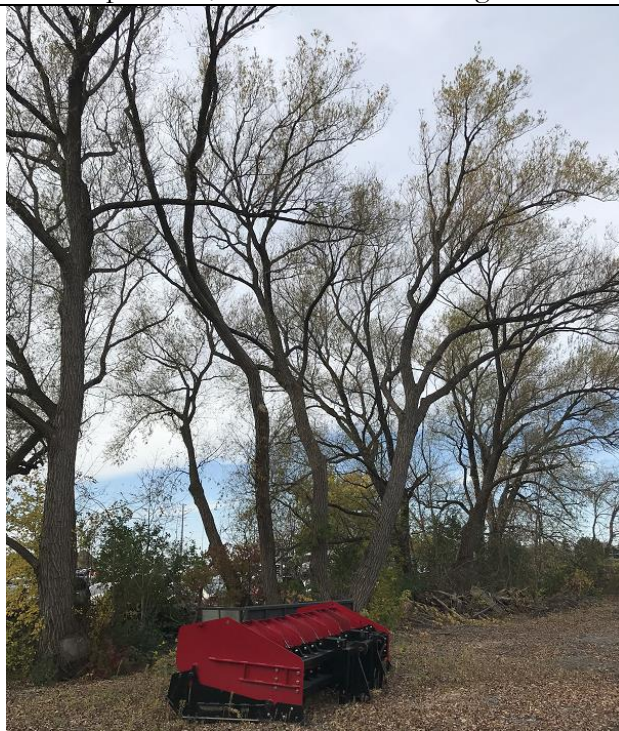
- Trees #17 and #20, two large Willows, are not within the proposed parking area and may be retained with extensive protection measures made to ensure preservation of their roots.

Photo 3: View looking west along the creek bank at trees #13-22 (left to right). The foreground is to be paved with asphalt

- Submit a Tree Protection Zone Encroachment Permit application to the Town of Oakville pertaining to the following trees:
 - Tree #17: a 111cm Willow in fair condition

- We recommend any excavation or construction work required within the TPZ of Trees #17 and #20 to be monitored by a qualified arborist, who shall provide Air-Spade root excavation and pruning as necessary and write follow-up reports detailing the work.

- We recommend proposed asphalt paving be done above a permeable aggregate and solid geotextile root protection material installed beneath the surface and above existing roots to be retained within the TPZ's of Trees #17 and #20.

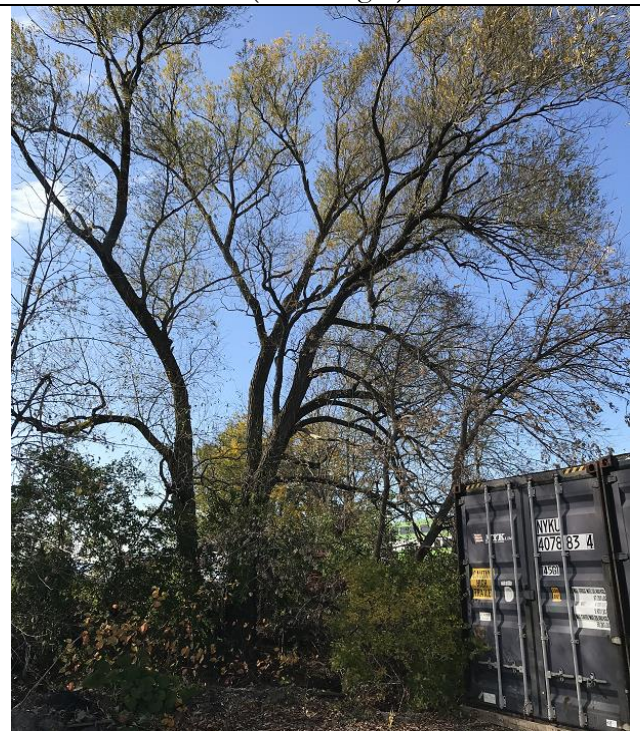
Photo 4: View looking west at Trees #23 (right) and #24 (left)

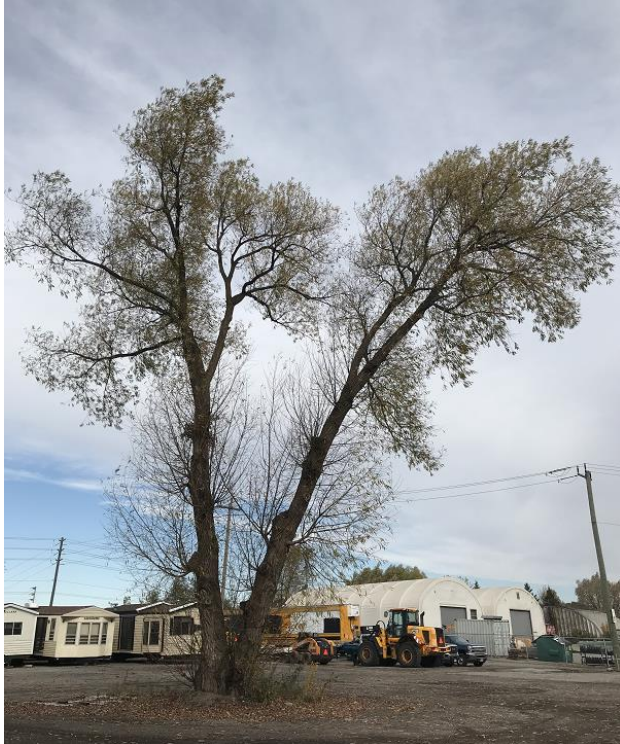
- Tree #25, a large Willow tree in the center of the rear gravel lot, will require removal to pave the proposed parking area. A permit from the Town will be required.

Photo 5: View of Tree #25 in the center of the back lot; to be removed.

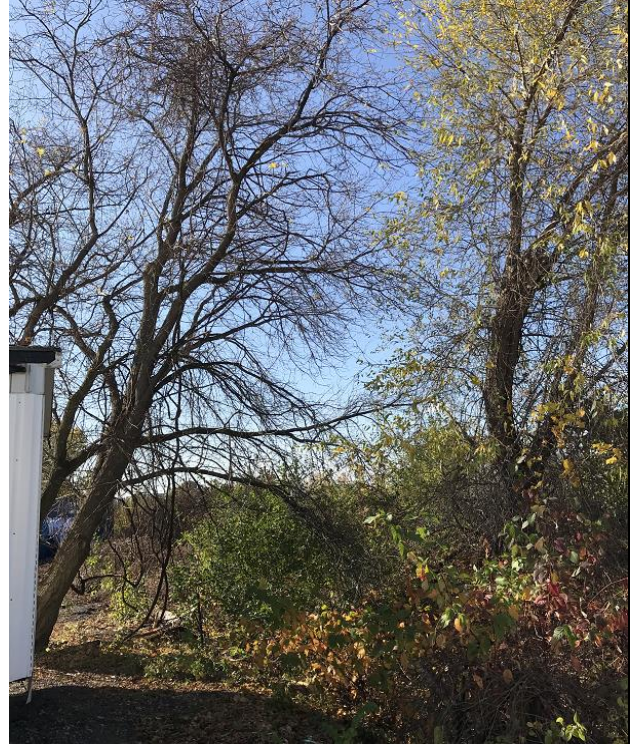
Photo 6: Trees #26 (left) and #27 (right) at the rear of the property. Tree #27 may be fully protected, #26 is recommended for removal

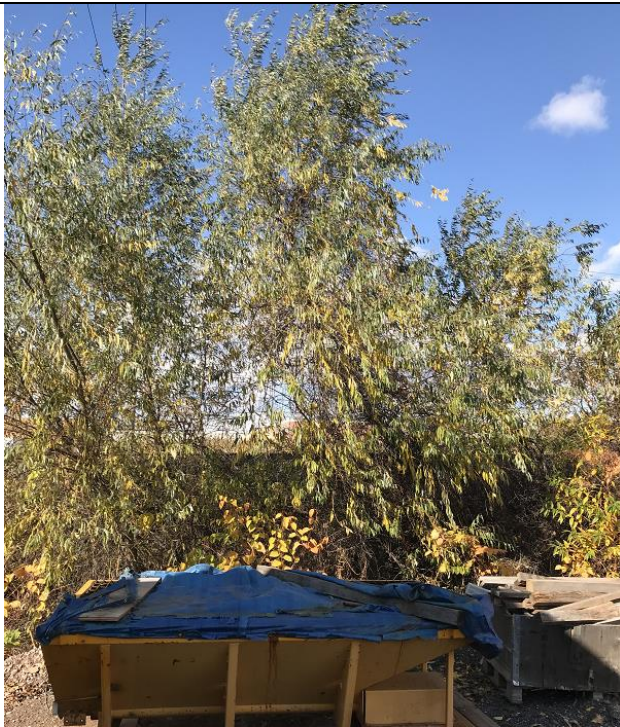
Photo 6: Tree #30 at the northeast end of the property, within a steep ditch.

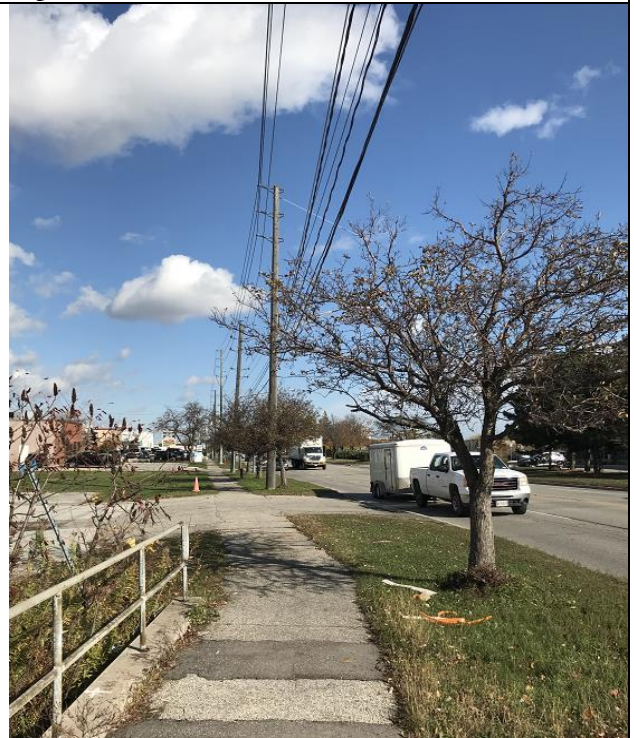
Photo 7: Trees #31-35, along Speers Rd. No work is proposed near these trees, they may be fully protected.
