August 03, 2017  
[REVISED April 27, 2018]

ARBORIST REPORT  
2441 Lakeshore Road West,  
Oakville, Ontario

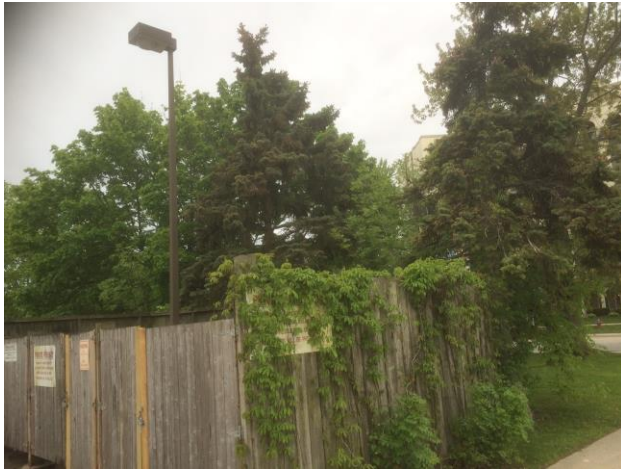
| Tree No. | Common Name | Botanical Name | Owner | DBH (CM) | Cond. | Structure | Canopy Diameter (m) | Comments | Recommendation |
|---|---|---|---|---|---|---|---|---|---|
| 1 | Spruce sp. | Picea sp. | P | 27 | F | F | 2 | Some deadwood in canopy | Remove - due to construction |
| 2 | Spruce sp. | Picea sp. | P | 24 | F | F | 4 | Some deadwood in canopy | Remove - due to construction |

Trees #1 and #2 looking South

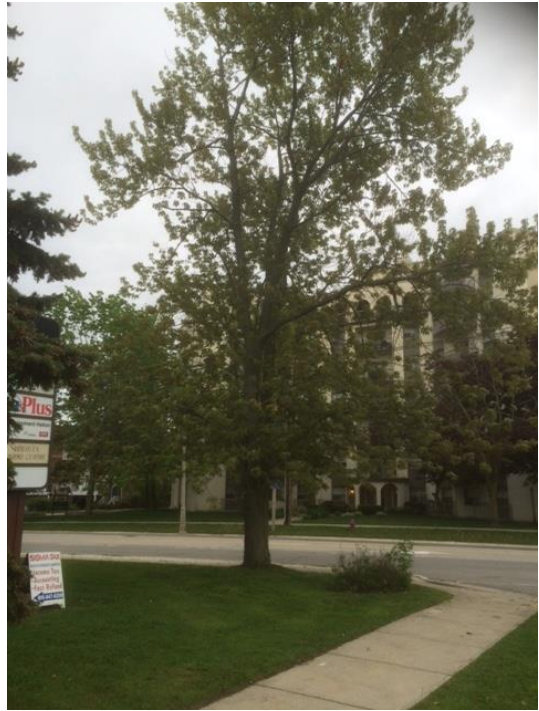
| Tree No. | Common Name | Botanical Name | Owner | DBH (CM) | Cond. | Structure | Canopy Diameter (m) | Comments | Recommendation |
|---|---|---|---|---|---|---|---|---|---|
| 3 | Silver Maple | Acer saccharinum | M | 43,36 | F | F-P | 8 | Co- dominant stems, light to moderate deadwood throughout tree. | Remove - due to construction |

Tree #3 looking South

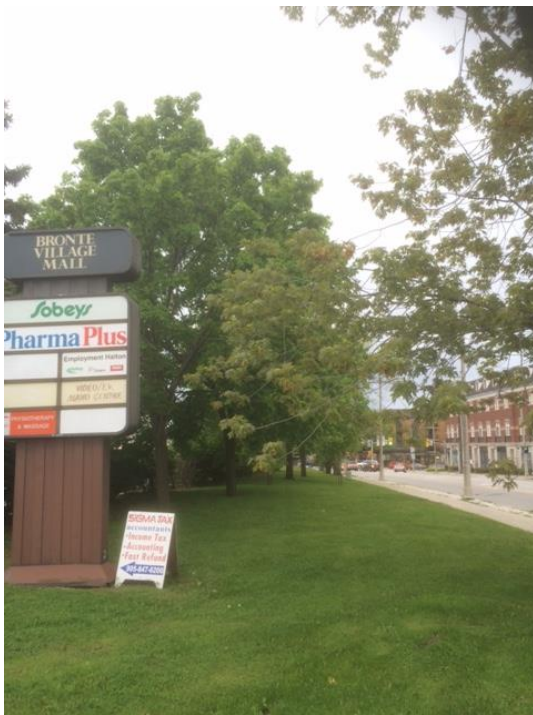
| Tree No. | Common Name | Botanical Name | Owner | DBH (CM) | Cond. | Structure | Canopy Diameter (m) | Comments | Recommendation |
|---|---|---|---|---|---|---|---|---|---|
| 4 | Norway Maple | Acer platanoides | P | 29 | F | F | 7 | Light deadwood throughout tree. | Remove - due to construction |
| 5 | Norway Maple | Acer platanoides | P | 34 | F | F | 9 | Some dieback at ends. | Remove - due to construction |
| 6 | Norway Maple | Acer platanoides | P | 20 | F-P | F-P | 4 | Dieback at crown, calloused wound at base, some evidence of decay. | Remove - due to construction |
| 7 | Norway Maple | Acer platanoides | P | 37 | F | F | 10 | Dieback in crown evident, Tree is beginning to decline. | Remove - due to construction |
| 8 | Norway Maple | Acer platanoides | M | 31 | F-P | F-P | 7 | Moderate to severe dieback in crown. | Remove - due to construction |

Trees #4 through #8 looking south east

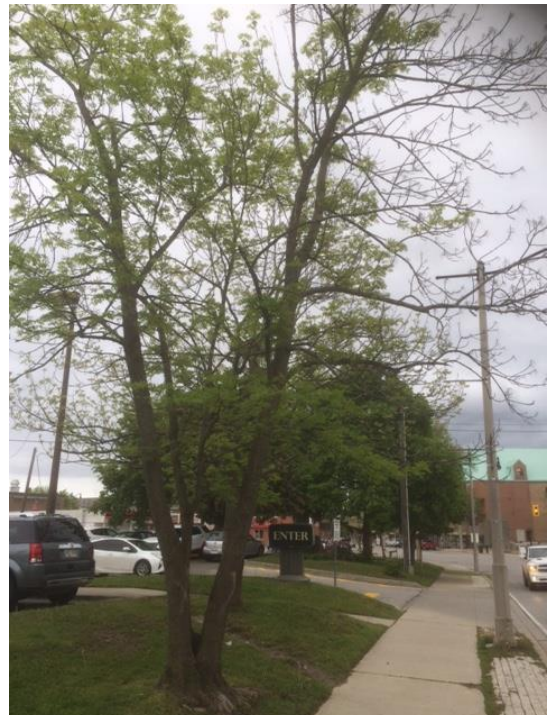
| 10 | Ash sp. | Fraxinus sp. | M | 20,20,11 | P | P | 3 | Tree struggling with EAB, Co-dominant stems, City marked tree with 'X'. | Remove - due to construction/health |
| 11 | Ash sp. | Fraxinus sp. | M | 25 | P | F-P | 6 | Tree struggling with EAB, City marked tree with 'X'. | Remove - due to construction/health |
| 12 | Spruce sp. | Picea sp. | P | 24 | F | F | 3 | Light deadwood throughout tree. | Remove - due to construction |

Trees #10 through #12 looking south east

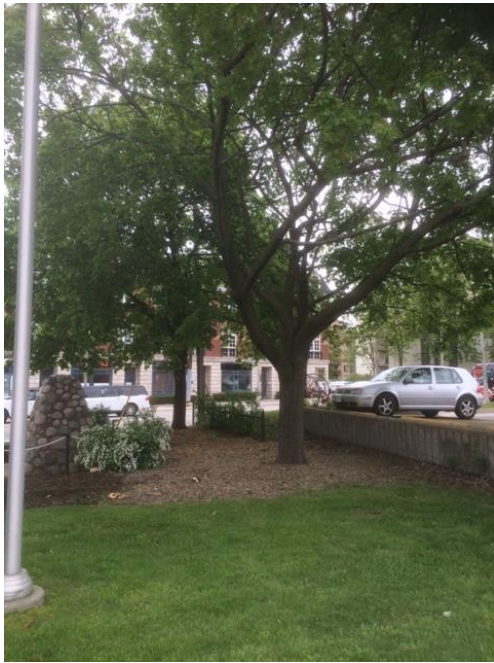
| 13 | Norway Maple | Acer platanoides | M1 | 38 | F | F | 12 | Light deadwood in canopy. | Retain |
| 14 | Norway Maple | Acer platanoides | M1 | 48 | F | F | 12 | Light deadwood in canopy. | Retain |

Trees # 13 and #14 looking South West

These two (2) publicly owned trees are situated on the parkland block on the northeast corner of Bronte and Lakeshore. These trees will require proper tree protection measures to ensure that they are not damaged or destabilized during shoring operations. Tree # 13 is approximately 2.8m from the property line and Tree # 14 is approximately 2.0m from the property line. The edge of the proposed underground garage slab will be approximately 1.15m from the property line, and the shoring will be within this area between the garage slab edge and the property line. The minimum TPZ for Tree # 13 appears as though it will be entirely unaffected, and it appears that there will be an encroachment of approximately 15% into the TPZ of Tree #14. We recommend that a certified arborist be present on site at the time of shoring excavation in order to guide root pruning as required and to ensure that the trees are not destabilized as a result of the excavation and any required root pruning.

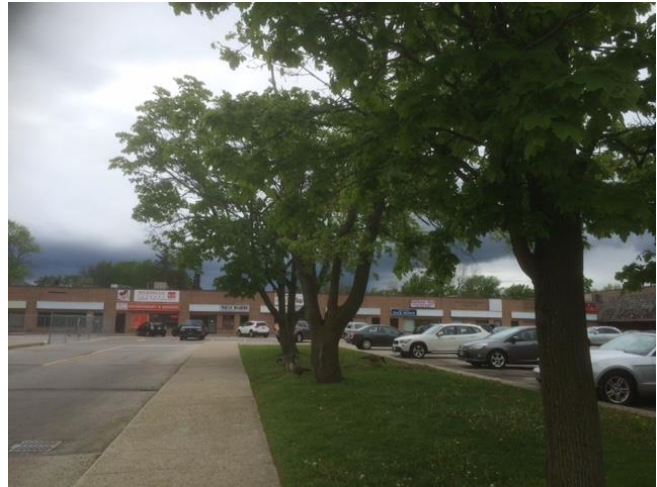
| 15 | Norway Maple | Acer platanoides | P | 33,32,28,29 | F-P | F | 11 | Co-dominant stems, Moderate to severe deadwood, Canopy dieoff at tips, Tree is in decline. | Remove - due to construction |
| 16 | Norway Maple | Acer platanoides | P | 36,35,16 | P | F-P | 9 | Half of tree is dead, Other half has moderate to severe dieback in crown. | Remove - due to construction |
| 17 | Norway Maple | Acer platanoides | M | 33 | F-P | F | 6 | Moderate dieback at branch ends (approaching severe). | Remove - due to construction |

Trees #15 through 17 looking North West

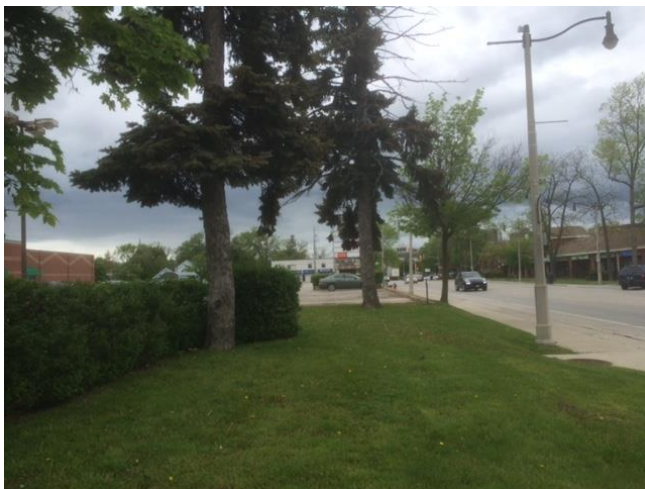
| 18 | Spruce sp. | Picea sp. | M | 40 | F | F | 3.5 | Moderate deadwood throughout tree. | Remove - due to construction |
| 19 | Spruce sp. | Picea sp. | M | 45 | F-P | F-P | 5 | Moderate to severe deadwood throughout tree, Leader broken off. | Remove - due to construction |
| 20 | Norway Maple | Acer platanoides | M | 23 | F-P | F | 4 | Moderate to severe dieoff. | Remove - due to construction |

Trees #18 through #20 looking North East

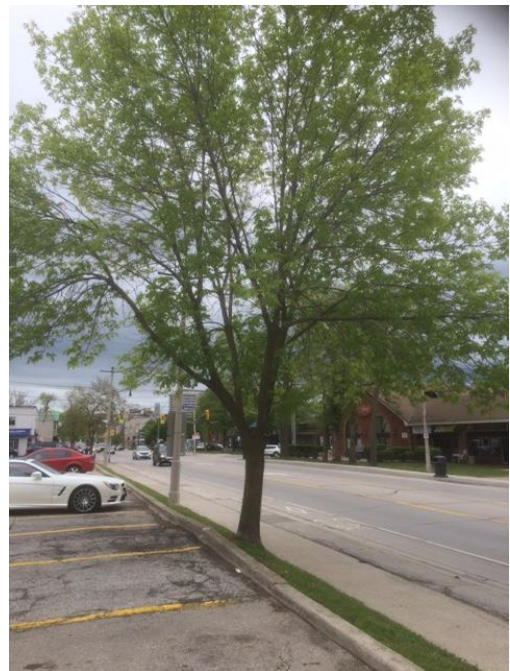
| 21 | Ash sp. | Fraxinus sp. | M | 34 | F | F | 7 | Beginning signs of EAB, Tree has been treated. | Remove - due to construction |

Tree #21 looking North East

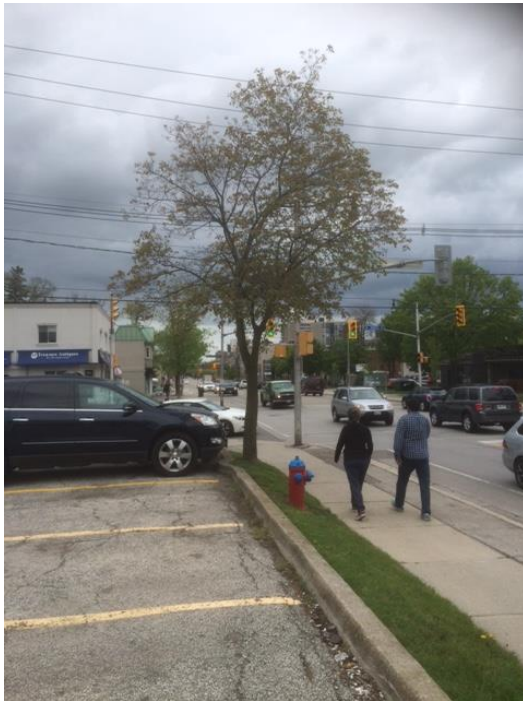
| 22 | Amur Maple | Acer ginnala | M | 26 | F | F | 4 | Moderate dieback in crown. | Remove - due to construction |

Tree #22 looking North East

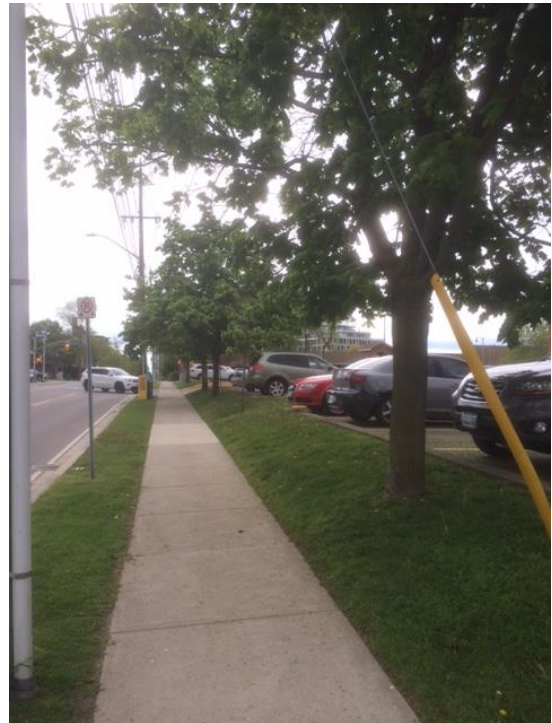
| 23 | Norway Maple | Acer platanoides | M | 33 | F | F | 7 | Old trunk split is healing, moderate dieback. | Retain |
| 24 | Norway Maple | Acer platanoides | M | 30 | F-P | F-P | 7 | Central leader dead, severe dieback in lower crown, fruiting bodies present, mechanical damage at base attempting to heal. | Retain |
| 25 | Norway Maple | Acer platanoides | M | 26 | F | F | 7 | Some dieback beginning. | Retain |
| 26 | Ivory Silk Lilac | Syringa reticulata | M | 4 | F-P | F | 2 | Moderate dieback in canopy, signs of urban stress. | Retain |
| 27 | Norway Maple | Acer platanoides | M | 32 | F | F | 6 | Mild to moderate dieback, tree is in decline. | Retain |

Trees #27 through #23 looking South East

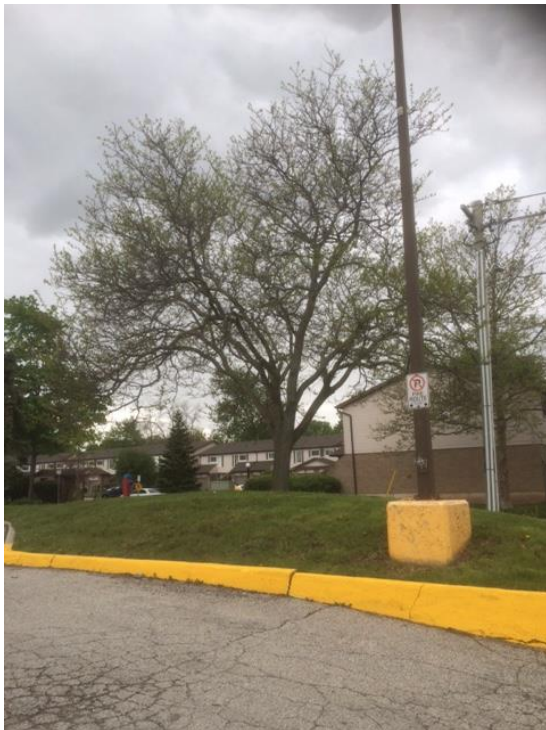
| 28 | Honey Locust | Gleditsia triacanthos | M | 48 | F | F | 13 | | Remove - due to construction |

Tree #28 looking West

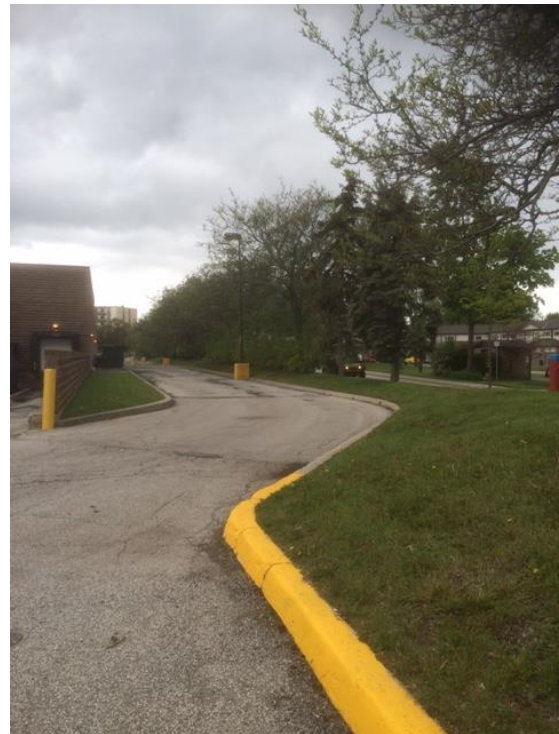
Trees #29 through #45 looking South West

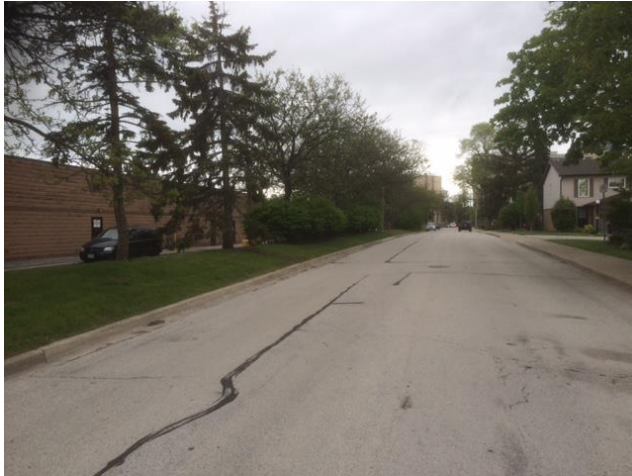
Trees #36 through #49 looking South West

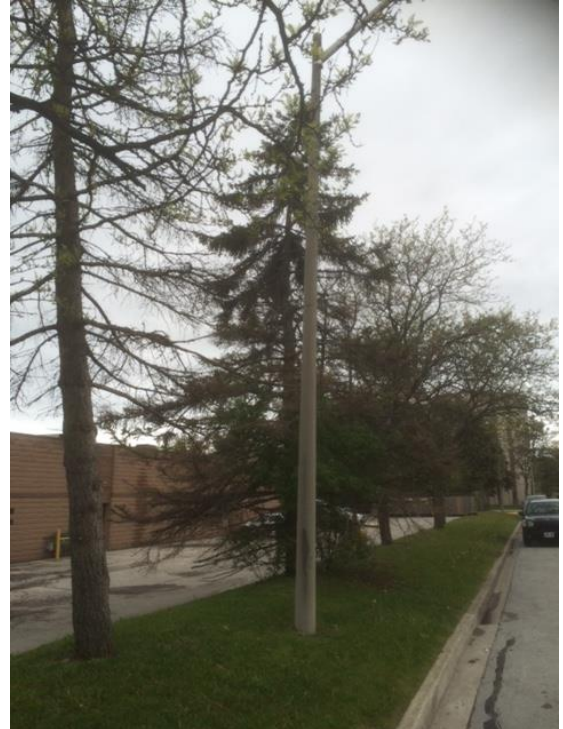
Trees #48 through #54 looking South West

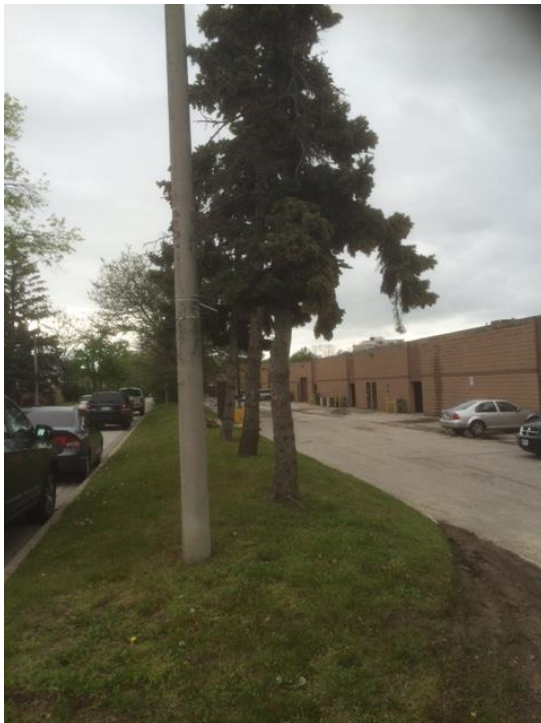
Trees #54 through #52 looking North East
