June 19, 2019 [Revised: August 19, 2019]

## ARBORIST REPORT

3171 Lakeshore Rd West (Cudmore's Nursery Site), Oakville, Ontario

MHBC File: 11161E

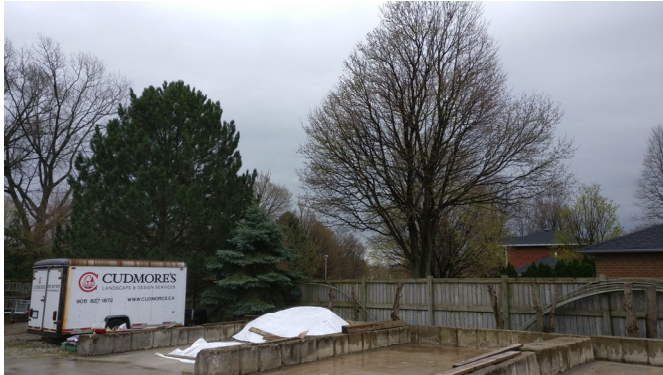
Trees 658, 659, O1 looking South West.

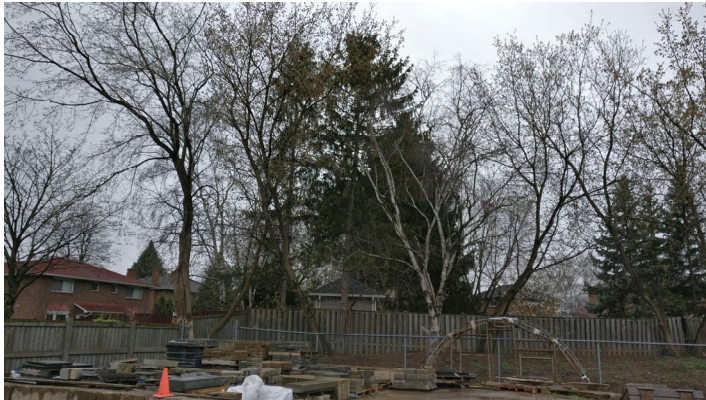
Trees 907 through 911 looking West.

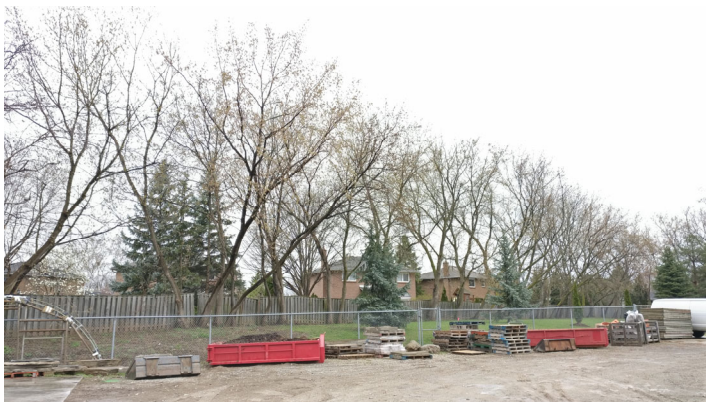
Trees 911 through 939, 955 through 959 looking North West.

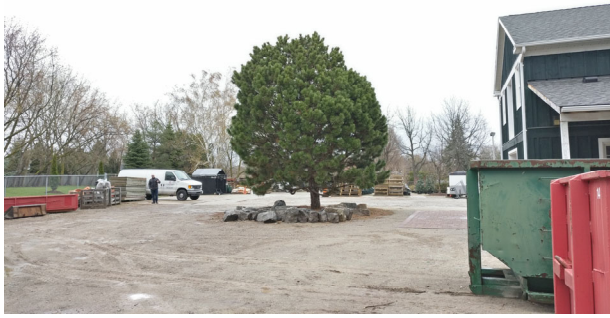
Tree 660 looking North.

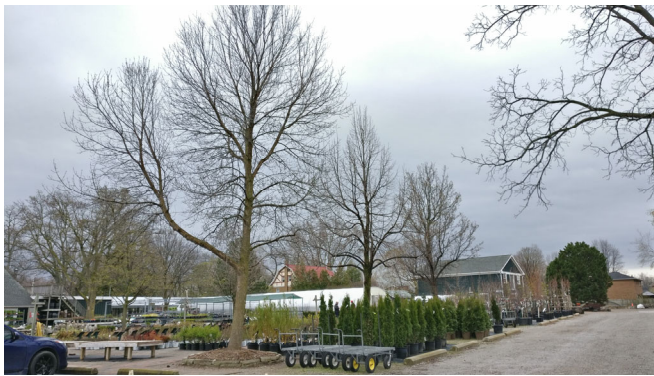
Trees 665 through 667 looking South.

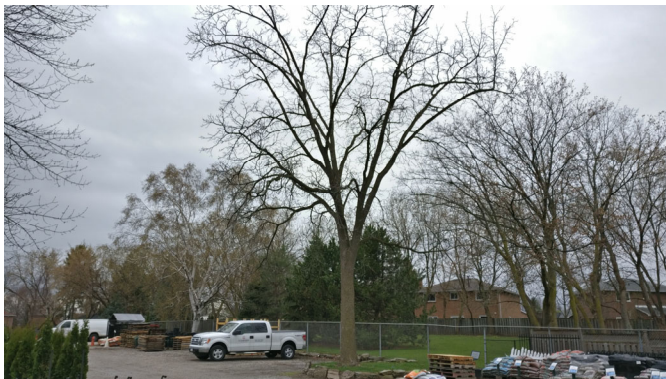
Trees 950 through 959, 661 looking South West.

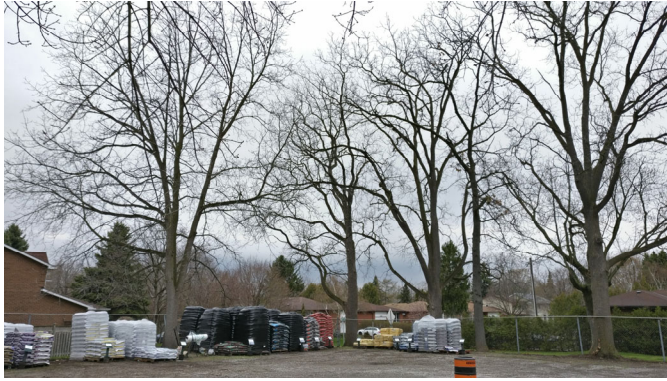
Trees 943 through 947 looking North East.

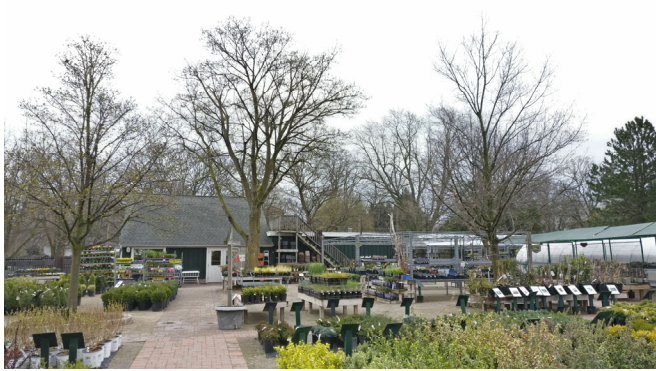
Trees 668 through 670 looking East.

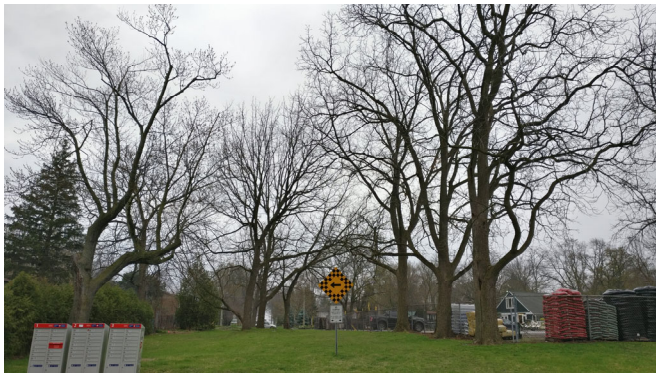
Trees 960 through 964, 697 through 700, 664 looking East.

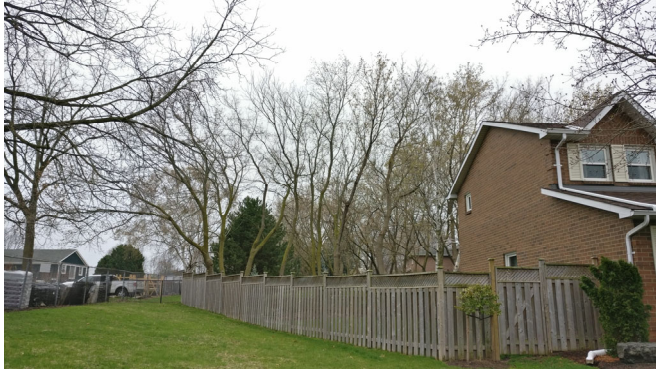
Trees 949 through 954 looking South.

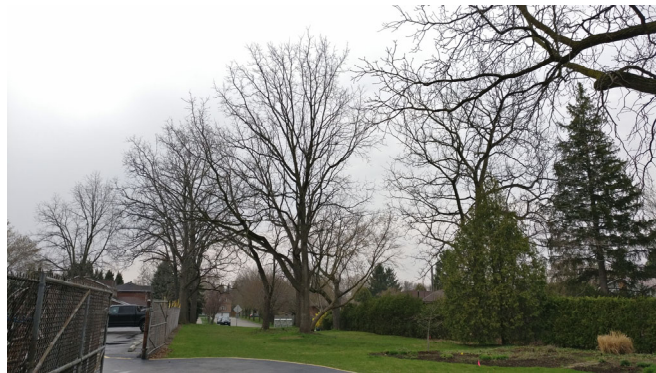
Trees 697 through 700, 960 through 964, 664 looking West.

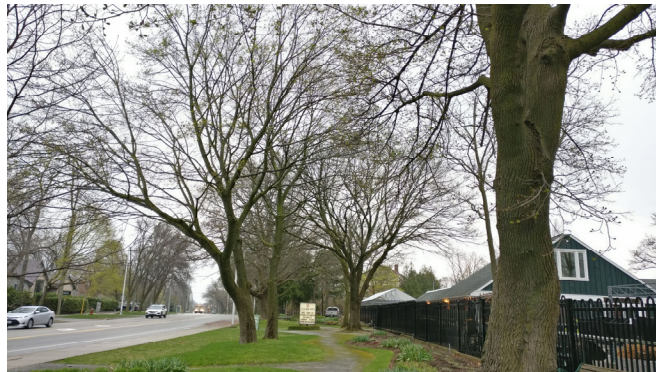
Trees 695 through 690 looking South.
