August 03, 2017

ARBORIST REPORT  
2441 Lakeshore Road West,  
Oakville, Ontario

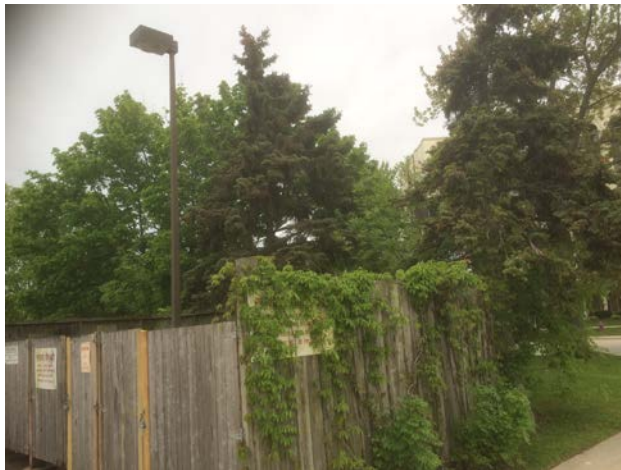
Trees #1 and #2 looking South

| Tree No. | Common Name | Botanical Name | Owner | DBH (CM) | Cond. | Structure | Canopy Diameter (m) | Comments | Recommendation |
|---|---|---|---|---|---|---|---|---|---|
| 1 | Spruce sp. | Picea sp. | P | 27 | F | F | 2 | Some deadwood in canopy | Remove - due to construction |
| 2 | Spruce sp. | Picea sp. | P | 24 | F | F | 4 | Some deadwood in canopy | Remove - due to construction |

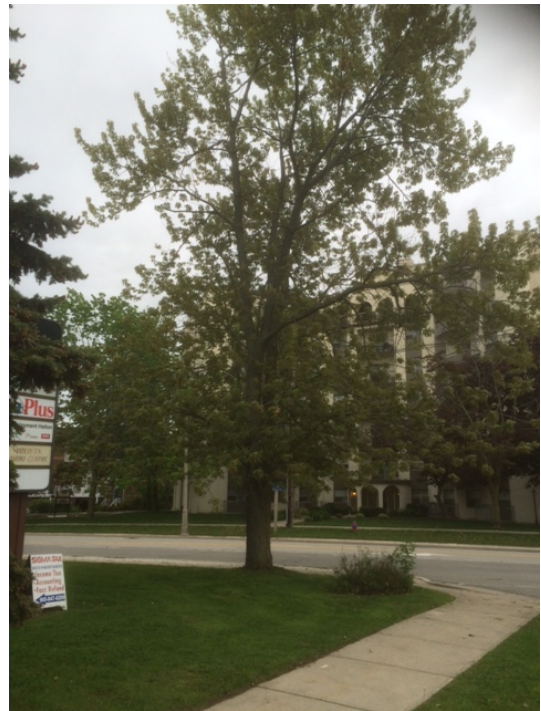
Tree #3 looking South

| Tree No. | Common Name | Botanical Name | Owner | DBH (CM) | Cond. | Structure | Canopy Diameter (m) | Comments | Recommendation |
|---|---|---|---|---|---|---|---|---|---|
| 3 | Silver Maple | Acer saccharinum | M | 43,36 | F | F-P | 8 | Co- dominant stems, light to moderate deadwood throughout tree. | Retain |

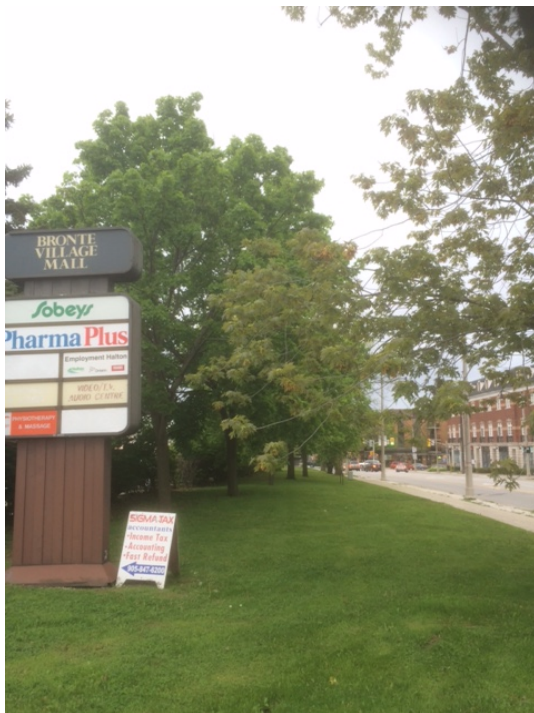
Trees #4 through #8 looking south east

| Tree No. | Common Name | Botanical Name | Owner | DBH (CM) | Cond. | Structure | Canopy Diameter (m) | Comments | Recommendation |
|---|---|---|---|---|---|---|---|---|---|
| 4 | Norway Maple | Acer platanoides | P | 29 | F | F | 7 | Light deadwood throughout tree. | Remove - due to construction |
| 5 | Norway Maple | Acer platanoides | P | 34 | F | F | 9 | Some dieback at ends. | Remove - due to construction |
| 6 | Norway Maple | Acer platanoides | P | 20 | F-P | F-P | 4 | Dieback at crown, calloused wound at base, some evidence of decay. | Remove - due to construction |
| 7 | Norway Maple | Acer platanoides | P | 37 | F | F | 10 | Dieback in crown evident, Tree is beginning to decline. | Remove - due to construction |
| 8 | Norway Maple | Acer platanoides | M | 31 | F-P | F-P | 7 | Moderate to severe dieback in crown. | Remove - due to construction |

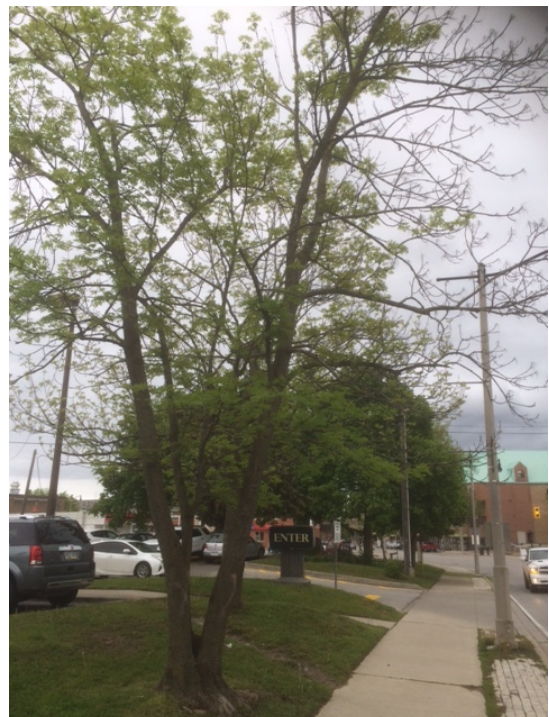
Trees #10 through #12 looking south east

| Tree No. | Common Name | Botanical Name | Owner | DBH (CM) | Cond. | Structure | Canopy Diameter (m) | Comments | Recommendation |
|---|---|---|---|---|---|---|---|---|---|
| 10 | Ash sp. | Fraxinus sp. | M | 20,20,11 | P | P | 3 | Tree struggling with EAB, Co-dominant stems, City marked tree with 'X'. | Remove - due to construction/health |
| 11 | Ash sp. | Fraxinus sp. | M | 25 | P | F-P | 6 | Tree struggling with EAB, City marked tree with 'X'. | Remove - due to construction/health |
| 12 | Spruce sp. | Picea sp. | P | 24 | F | F | 3 | Light deadwood throughout tree. | Remove - due to construction |

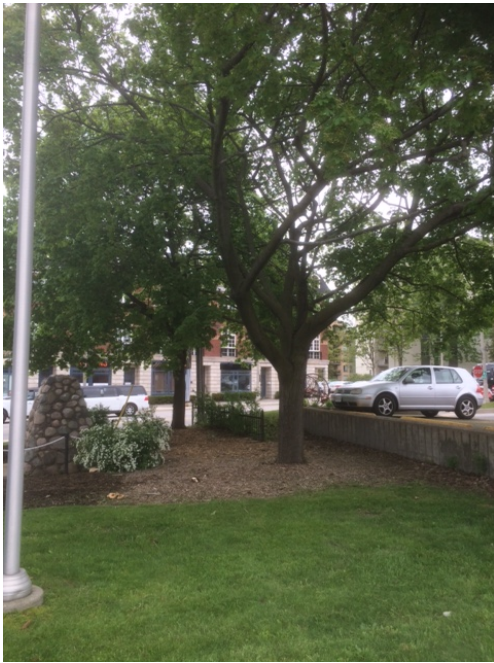
Trees # 13 and #14 looking South West

| Tree No. | Common Name | Botanical Name | Owner | DBH (CM) | Cond. | Structure | Canopy Diameter (m) | Comments | Recommendation |
|---|---|---|---|---|---|---|---|---|---|
| 13 | Norway Maple | Acer platanoides | M1 | 38 | F | F | 12 | Light deadwood in canopy. | Retain |
| 14 | Norway Maple | Acer platanoides | M1 | 48 | F | F | 12 | Light deadwood in canopy. | Retain |

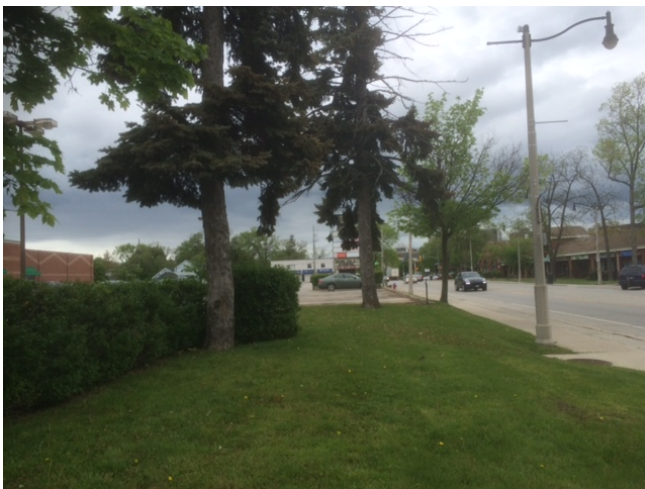
Trees #18 through #20 looking North East

| Tree No. | Common Name | Botanical Name | Owner | DBH (CM) | Cond. | Structure | Canopy Diameter (m) | Comments | Recommendation |
|---|---|---|---|---|---|---|---|---|---|
| 18 | Spruce sp. | Picea sp. | M | 40 | F | F | 3.5 | Moderate deadwood throughout tree. | Remove - due to construction |
| 19 | Spruce sp. | Picea sp. | M | 45 | F-P | F-P | 5 | Moderate to severe deadwood throughout tree, Leader broken off. | Remove - due to construction |
| 20 | Norway Maple | Acer platanoides | M | 23 | F-P | F | 4 | Moderate to severe dieoff. | Remove - due to construction |

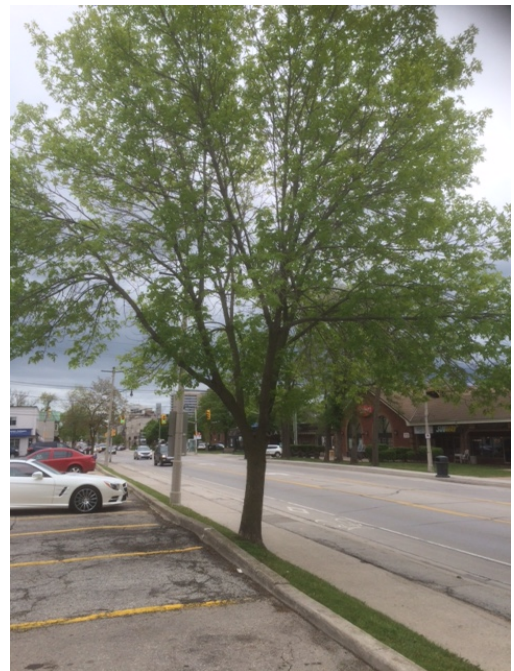
Tree #21 looking North East

| Tree No. | Common Name | Botanical Name | Owner | DBH (CM) | Cond. | Structure | Canopy Diameter (m) | Comments | Recommendation |
|---|---|---|---|---|---|---|---|---|---|
| 21 | Ash sp. | Fraxinus sp. | M | 34 | F | F | 7 | Beginning signs of EAB, Tree has been treated. | Retain |

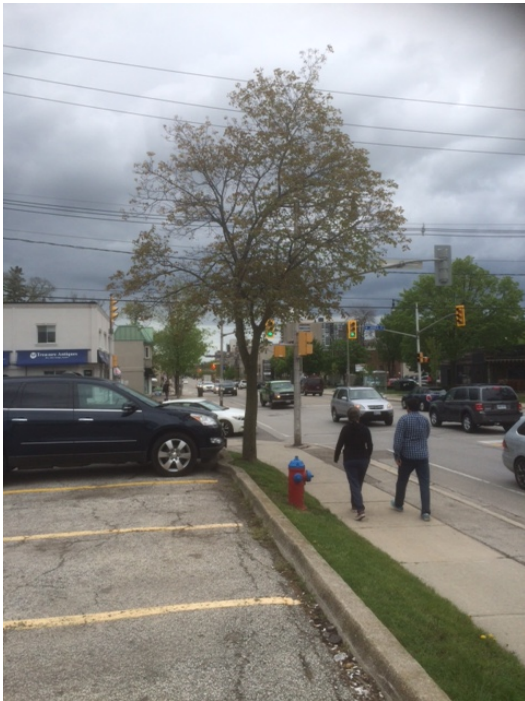
Tree #22 looking North East

| Tree No. | Common Name | Botanical Name | Owner | DBH (CM) | Cond. | Structure | Canopy Diameter (m) | Comments | Recommendation |
|---|---|---|---|---|---|---|---|---|---|
| 22 | Amur Maple | Acer ginnala | M | 26 | F | F | 4 | Moderate dieback in crown. | Retain |

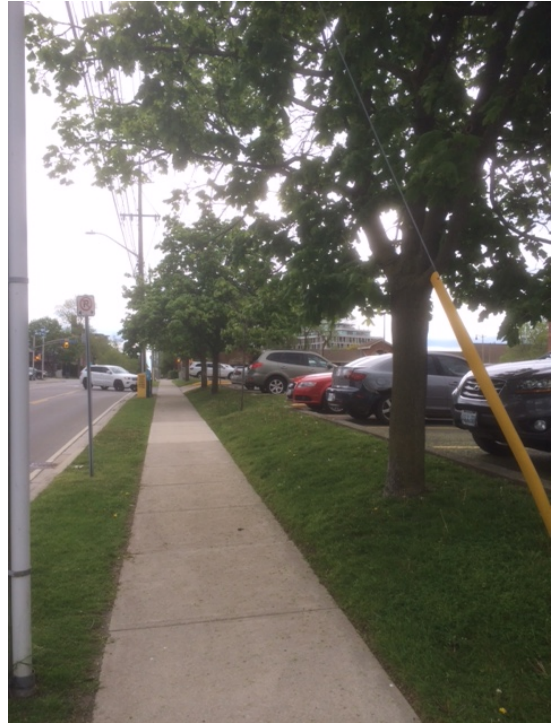
Trees #27 through #23 looking South East

| Tree No. | Common Name | Botanical Name | Owner | DBH (CM) | Cond. | Structure | Canopy Diameter (m) | Comments | Recommendation |
|---|---|---|---|---|---|---|---|---|---|
| 23 | Norway Maple | Acer platanoides | M | 33 | F | F | 7 | Old trunk split is healing, moderate dieback. | Retain |
| 24 | Norway Maple | Acer platanoides | M | 30 | F-P | F-P | 7 | Central leader dead, severe dieback in lower crown, fruiting bodies present, mechanical damage at base attempting to heal. | Retain |
| 25 | Norway Maple | Acer platanoides | M | 26 | F | F | 7 | Some dieback beginning. | Retain |
| 26 | Ivory Silk Lilac | Syringa reticulata | M | 4 | F-P | F | | Moderate dieback in canopy, signs of urban stress. | Retain |

| 27 | Norway Maple | Acer platanoides | M | 32 | F | F | 6 | Mild to moderate dieback, tree is in decline. | Retain |

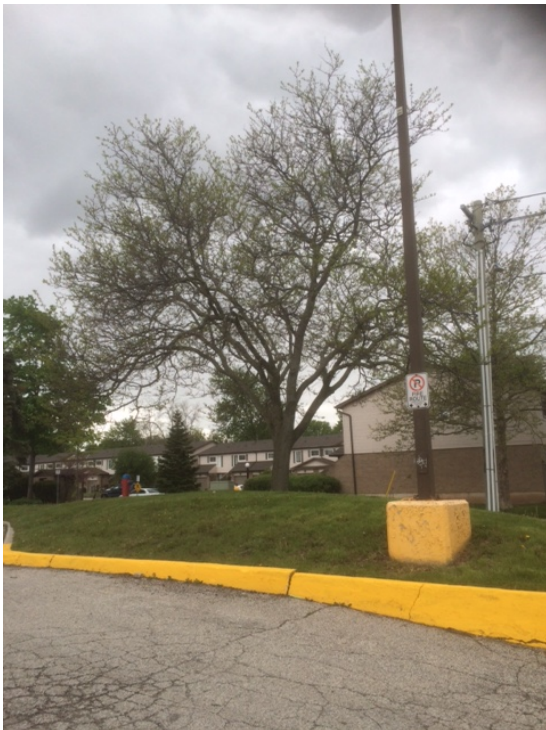
Tree #28 looking West

| 28 | Honey Locust | Gleditsia triacanthos | M | 48 | F | F | 13 | | Remove - due to construction |

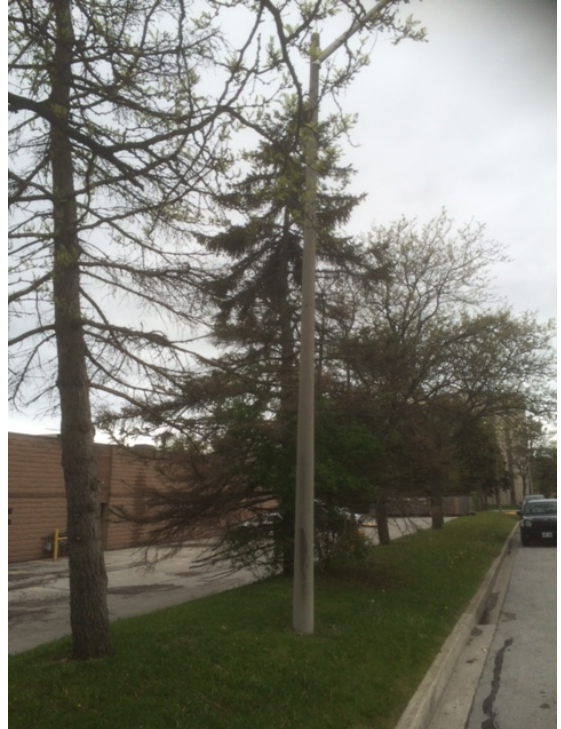
Trees #48 through #54 looking South West

| 48 | Spruce sp. | Picea sp. | M | 29 | D | D | 2.5 | | Remove - due to construction |
| 49 | Spruce sp. | Picea sp. | M | 28 | F | F-P | 6 | Lower 2/3 branches are dead. | Remove - due to construction |
| 50 | Honey Locust | Gleditsia triacanthos | M | 29 | F | F | 7 | Moderate deadwood, dieback at tips. | Remove - due to construction |
| 51 | Honey Locust | Gleditsia triacanthos | M | 36 | F | F | 7 | Moderate deadwood, dieback at tips. | Remove - due to construction |
| 52 | Spruce sp. | Picea sp. | M | 20 | F | F | 2 | Some deadwood throughout tree. | Remove - due to construction |
| 53 | Spruce sp. | Picea sp. | M | 22 | F | F | 1.5 | Some deadwood throughout tree. | Remove - due to construction |
| 54 | Spruce sp. | Picea sp. | M | 19 | F | F | 1.5 | Some deadwood throughout tree. | Remove - due to construction |
