January 10, 2019 [*Revised June 16, 2022*]

**ARBORIST REPORT**  
560 Winston Churchill Blvd,  
Oakville, Ontario

## **BACKGROUND**

MHBC was retained to conduct a detailed tree assessment and arborist report for the existing trees pertaining to the Town of Oakville's Tree By-Laws within the property known as 560 Winston Churchill Blvd in Oakville, Ontario.

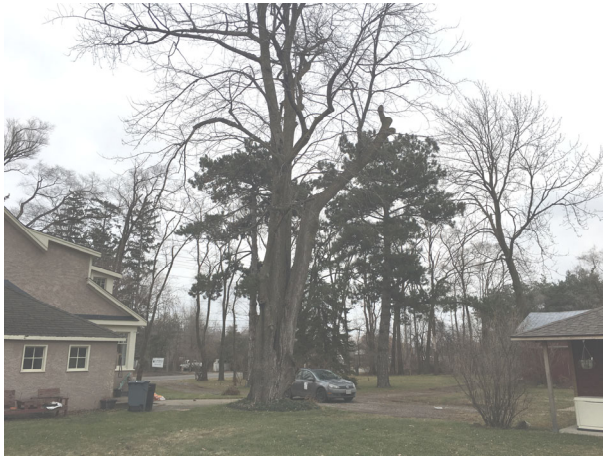
| Tree No. | Owner | Common Name | Botanical Name | DBH (cm) | Canopy Diameter (m) | Condition | Structure | Comments - Condition Related | Recommendation |
|---|---|---|---|---|---|---|---|---|---|
| 1 | N | Silver Maple | Acer saccharinum | 132 | 12 | P | P | Signs of rot typical of an older growth tree | P |

Tree #1 looking East

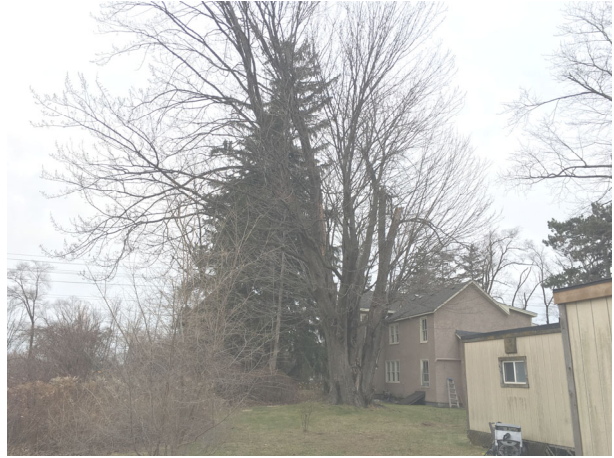
| Tree No. | Owner | Common Name | Botanical Name | DBH (cm) | Canopy Diameter (m) | Condition | Structure | Comments - Condition Related | Recommendation |
|---|---|---|---|---|---|---|---|---|---|
| 2 | N | Silver Maple | Acer saccharinum | 180 | 12 | P | P | Signs of rot typical of an older growth tree | P |

Tree #2 looking East

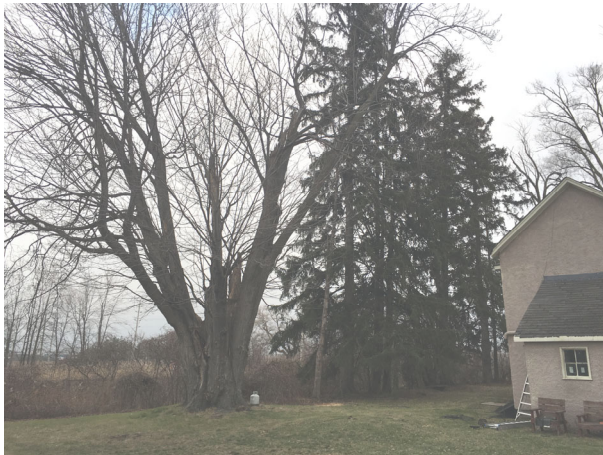
| Tree No. | Owner | Common Name | Botanical Name | DBH (cm) | Canopy Diameter (m) | Condition | Structure | Comments - Condition Related | Recommendation |
|---|---|---|---|---|---|---|---|---|---|
| 3 | N | Dead Coniferous | - | 30 | 0 | D | D | Tree is Dead | P |
| 5 | N | Norway Spruce | Picea abies | 45 | 6 | F | P | Co-dominant stems | P |
| 8 | SN | Ash sp. | Fraxinus Sp. | 39 | 6 | P | P | 2 stem, tree is nearly dead due to EAB | P |

Trees #3 through #8 looking North

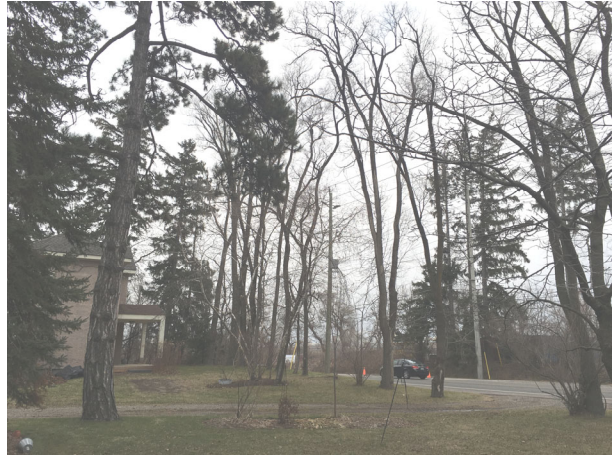
| Tree No. | Owner | Common Name | Botanical Name | DBH (cm) | Canopy Diameter (m) | Condition | Structure | Comments - Condition Related | Recommendation |
|---|---|---|---|---|---|---|---|---|---|
| 11 | M | Siberian Elm | Ulmus pumila | 53 | 8 | P | P | Significant deadwood in canopy | P |
| 14 | M | Siberian Elm | Ulmus pumila | 76 | 8 | P | P | Fruiting bodies present | P |
| 22 | M | Siberian Elm | Ulmus pumila | 33 | 8 | P | P | Internal trunk rot and fruiting bodies are evident | P |

Trees #9 through #22 looking North

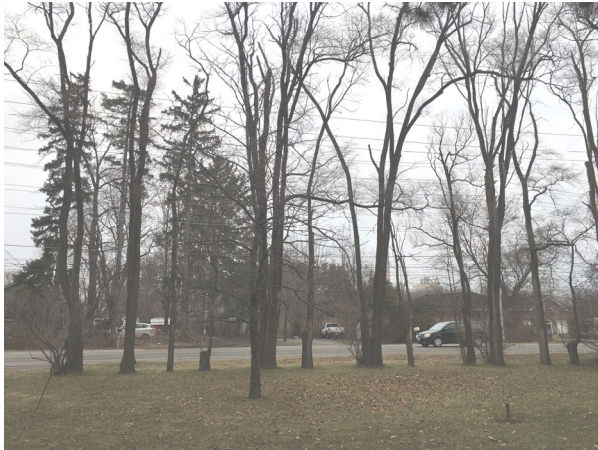
| Tree No. | Owner | Common Name | Botanical Name | DBH (cm) | Canopy Diameter (m) | Condition | Structure | Comments - Condition Related | Recommendation |
|---|---|---|---|---|---|---|---|---|---|
| 24 | M | Siberian Elm | Ulmus pumila | 29 | 6 | P | P | Co-dominant stems, included bark | P |
| 26 | M | Siberian Elm | Ulmus pumila | 70 | 12 | P | P | Co-dominant stems, included bark | P |
| 27 | M | Siberian Elm | Ulmus pumila | 44 | 4 | P | P | Co-dominant stem was cut | P |
| 28 | M | Siberian Elm | Ulmus pumila | 46 | 10 | P | P | Co-dominant stem was cut | P |
| 29 | M | Siberian Elm | Ulmus pumila | 28 | 0 | D | D | Tree is Dead | P |
| 30 | M | Siberian Elm | Ulmus pumila | 26 | 4 | P | P | Ash growing out of base | P |

Trees #23 through #32 looking East

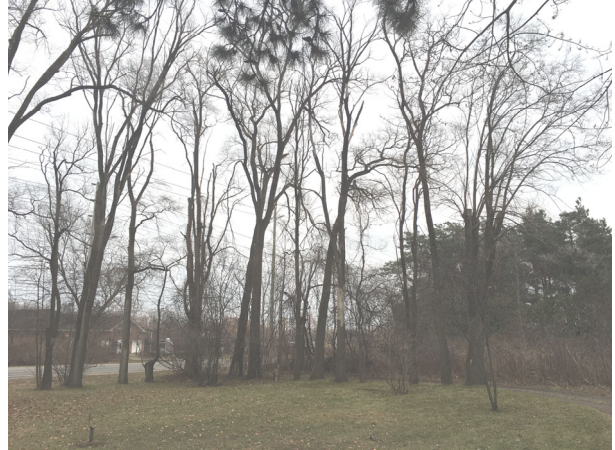
| 33 | M | Siberian Elm | Ulmus pumila | 16 | 2 | P | P | Main leader was cut | P |
| 34 | M | Siberian Elm | Ulmus pumila | 68 | 4 | P | P | Co-dominant stems | P |
| 37 | N | Siberian Elm | Ulmus pumila | 16 | 0 | D | D | Tree is Dead | P |
| 40 | N | Siberian Elm | Ulmus pumila | 43 | 0 | D | D | Tree is Dead | P |
| 42 | N | Siberian Elm | Ulmus pumila | 21 | 6 | P | P | Co-dominant stems, signs of internal rot | P |

Trees #33 through #44 looking East

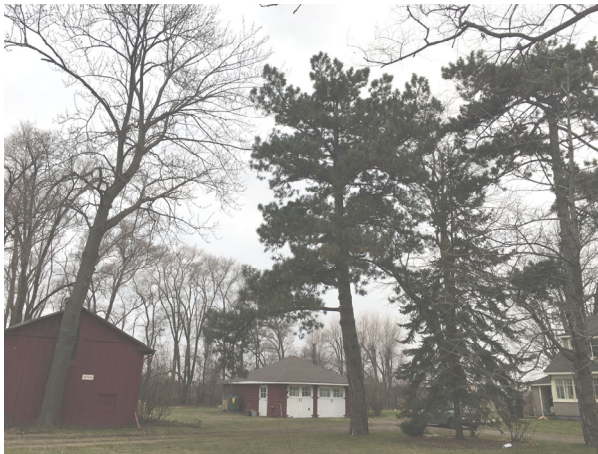
| 49 | N | Red Maple | Acer rubrum | 70 | 12 | F | F | Root flare is grown into garage | P |

Trees #45 through #49 looking West

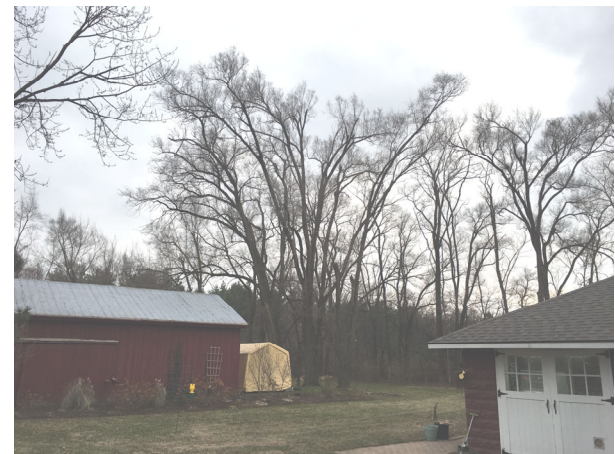
| 53 | N | Siberian Elm | Ulmus pumila | 43 | 0 | D | D | Tree is Dead | P |
| 56 | N | Siberian Elm | Ulmus pumila | 53 | 8 | P | P | Co-dominant stems | P |
| 57 | N | Siberian Elm | Ulmus pumila | 61 | 10 | P | P | Signs of rot | P |

Trees #50 through #57 looking South

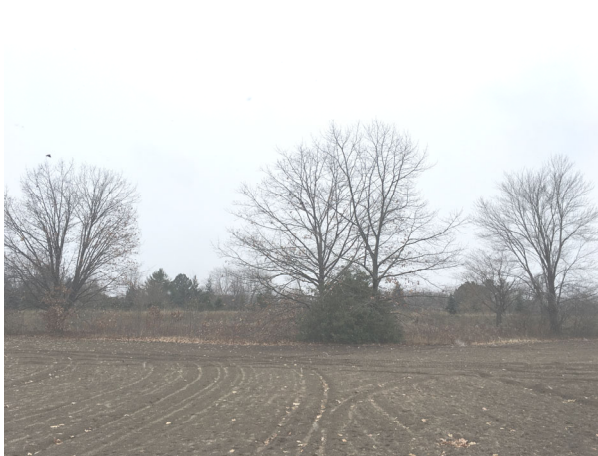
| 58 | P | Red Oak | Quercus rubra | 104 | 12 | F | F | Moderate deadwood in canopy | P |
| 62 | P | Red Maple | Acer rubrum | 41 | 8 | F-P | F-P | Trunk cavity present. Signs of internal rot. | P |

Trees #58 through #63 looking Southwest

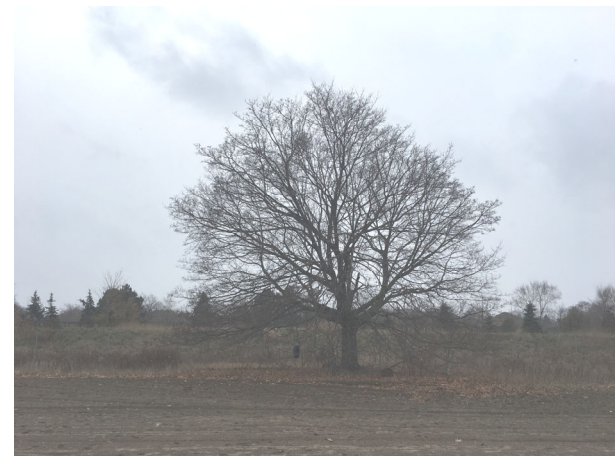
| 64 | P | Red Maple | Acer rubrum | 64 | 12 | F | F | Trunk cavity present. Signs of internal rot. Significant structural failures on one side of the tree | P |

Tree #64 looking Southwest
