September 28, 2021

File No. 1-17-0348-41.1
Brampton Office

UPDATED PHASE ONE ENVIRONMENTAL SITE ASSESSMENT 70 OLD MILL ROAD, OAKVILLE, ON

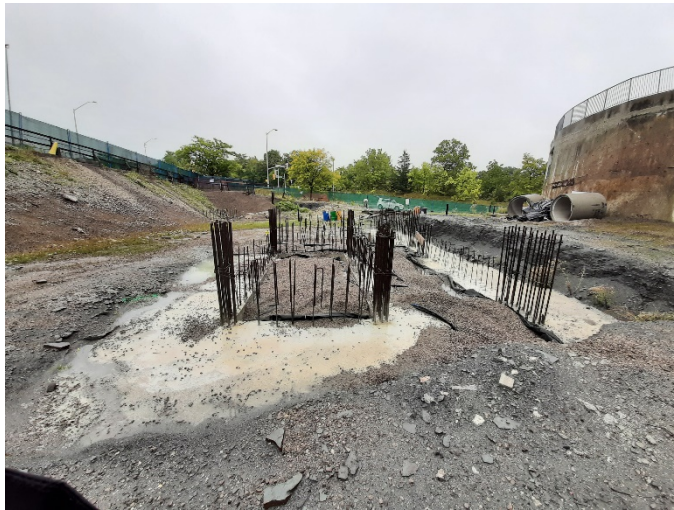
Photograph 1

The Phase Two ESA completed in October 2018 indicated that the Property was undergoing pre-construction earthwork. The latest inspection completed at the Property in September 2021 indicated that the below grade level constructions were undergoing at the time of the site visit. The following items were observed on Site.

Location: 70 Old Mill Road (The Property)
Viewing: South
Description: Viewing the below grade level construction at 70 Old Mill Road

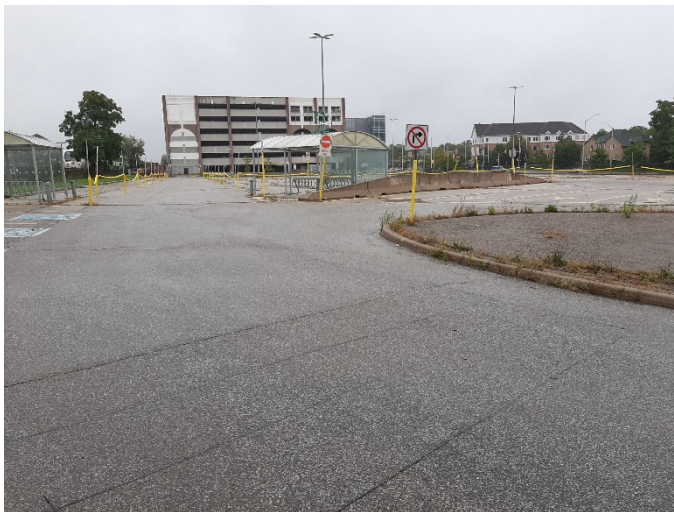
Photograph 2

Location: 73 Old Mill Road
Viewing: North
Description: Viewing the Public parking area located at north of 70 Old Mill Road

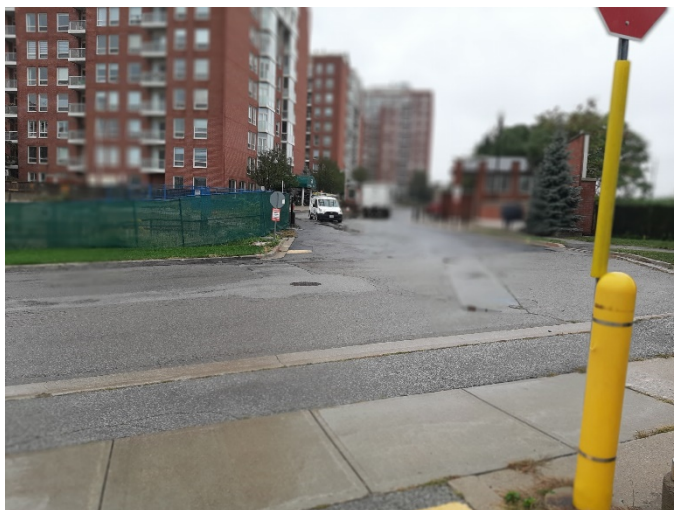
Photograph 3

Location: Old Mill Road
Viewing: Northwest
Description: Viewing Residential Buildings located Southwest of the Property

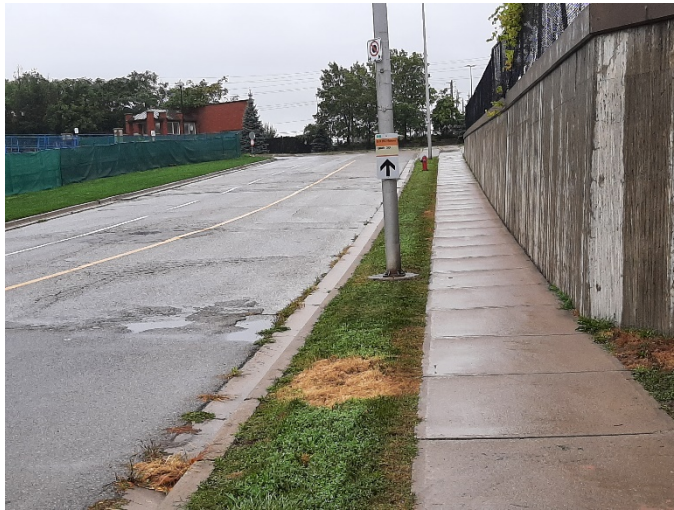
Photograph 4

Location: Old Mill Road
Viewing: North
Description: Viewing Rail track fence located northwest of the Property

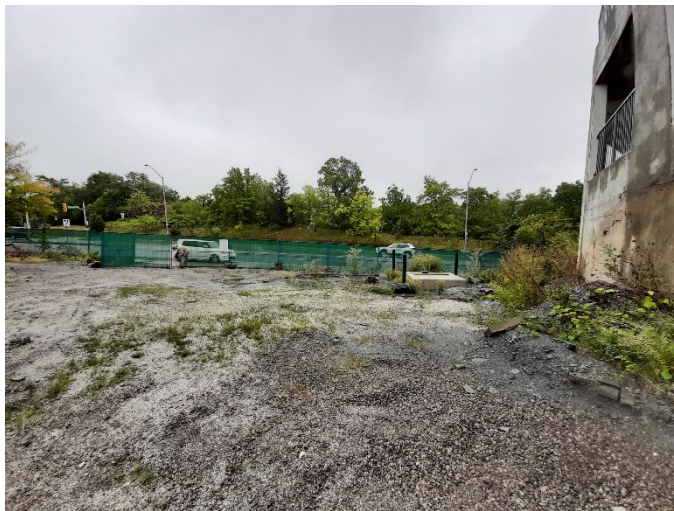
Photograph 5

Location: 70 Old Mill Road (The Property)
Viewing: Southeast
Description: Viewing Sixteen Mile Creek trail 60m southeast the Property

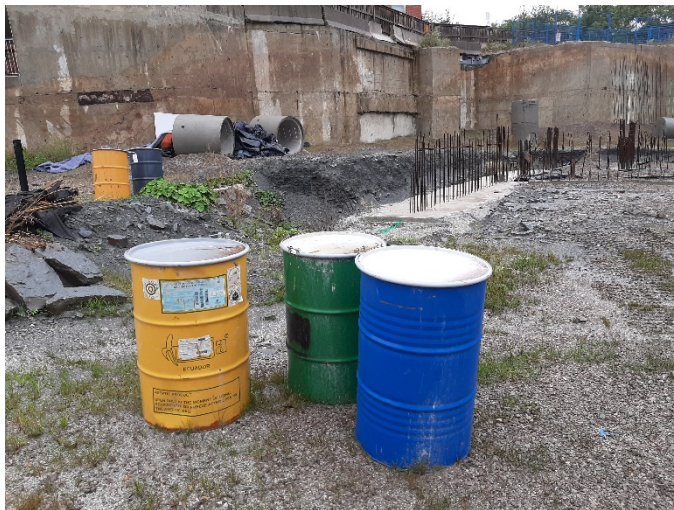
Photograph 6

- Imported crushed limestone and gravel used as engineering fill for the ongoing construction work were identified at the northern side along the Old Mill Road.
- Five barrels containing construction material contents were observed at the Property. No staining or damage was observed on or around the barrels.
- Six precast concrete stormwater sumps/pipes were identified at the Property.

No potential evidence of spills, staining, chemical or fuel storage, or other possible environmental concerns were noted during the site visit.

Location: 70 Old Mill Road (The Property)
Viewing: Southwest
Description: Viewing the barrels and Concrete sumps in the construction Site
