January 10, 2019 [*Revised December 19, 2023*]

**ARBORIST REPORT**  
560 Winston Churchill Blvd,  
Oakville, Ontario

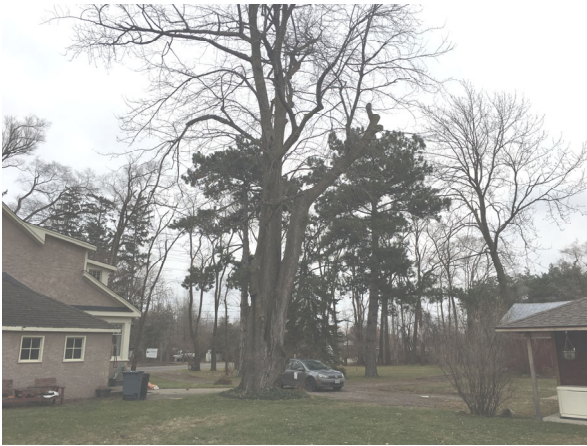
Tree #1 looking East

| Tree No. | Owner | Common Name | Botanical Name | DBH (cm) | Canopy Diameter (m) | Condition | Structure | Comments - Condition Related | Recommendation |
|---|---|---|---|---|---|---|---|---|---|
| 1 | N | Silver Maple | Acer saccharinum | 132 | 12 | P | P | Signs of rot typical of an older growth tree | P |

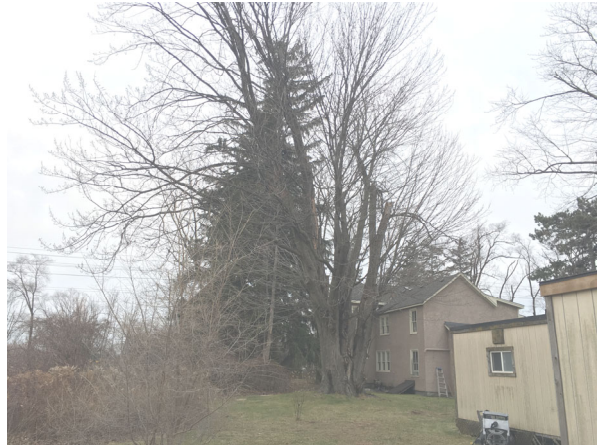
Tree #2 looking East

| Tree No. | Owner | Common Name | Botanical Name | DBH (cm) | Canopy Diameter (m) | Condition | Structure | Comments - Condition Related | Recommendation |
|---|---|---|---|---|---|---|---|---|---|
| 2 | N | Silver Maple | Acer saccharinum | 180 | 12 | P | P | Signs of rot typical of an older growth tree | P |

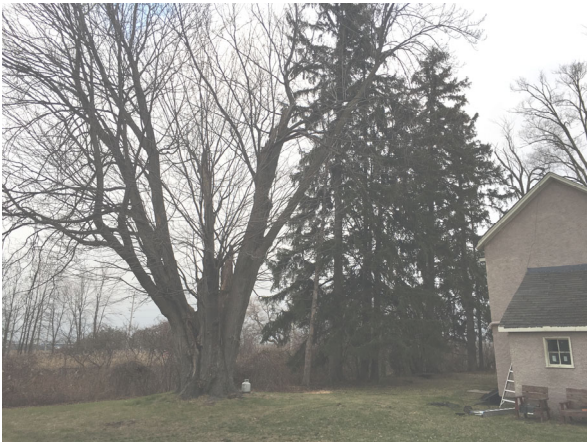
Trees #3 through #8 looking North

| Tree No. | Owner | Common Name | Botanical Name | DBH (cm) | Canopy Diameter (m) | Condition | Structure | Comments - Condition Related | Recommendation |
|---|---|---|---|---|---|---|---|---|---|
| 3 | N | Dead Coniferous | - | 30 | 0 | D | D | Tree is Dead | P |
| 5 | N | Norway Spruce | Picea abies | 45 | 6 | F | P | Co-dominant stems | P |
| 8 | SN | Ash sp. | Fraxinus Sp. | 39 | 6 | P | P | 2 stem, tree is nearly dead due to EAB | P |

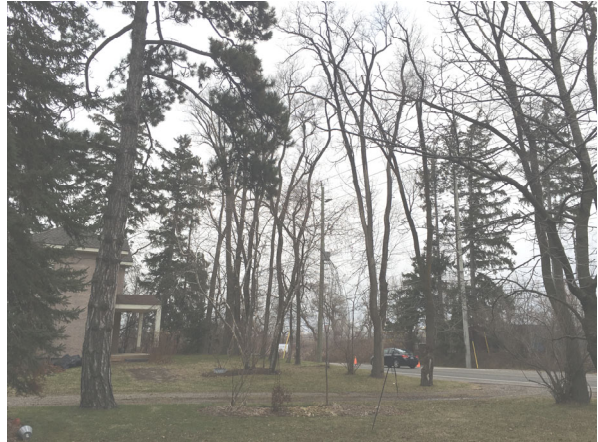
Trees #9 through #22 looking North

| Tree No. | Owner | Common Name | Botanical Name | DBH (cm) | Canopy Diameter (m) | Condition | Structure | Comments - Condition Related | Recommendation |
|---|---|---|---|---|---|---|---|---|---|
| 11 | M | Siberian Elm | Ulmus pumila | 53 | 8 | P | P | Significant deadwood in canopy | P |
| 14 | M | Siberian Elm | Ulmus pumila | 76 | 8 | P | P | Fruiting bodies present | P |
| 22 | M | Siberian Elm | Ulmus pumila | 33 | 8 | P | P | Internal trunk rot and fruiting bodies are evident | P |

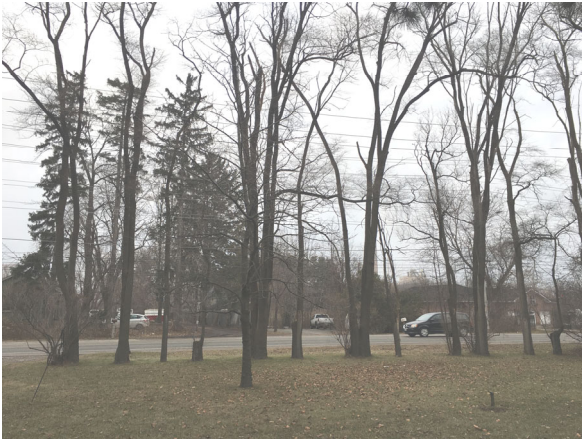
Trees #23 through #32 looking East

| 24 | M | Siberian Elm | Ulmus pumila | 29 | 6 | P | P | Co-dominant stems, included bark | P |
| 26 | M | Siberian Elm | Ulmus pumila | 70 | 12 | P | P | Co-dominant stems, included bark | P |
| 27 | M | Siberian Elm | Ulmus pumila | 44 | 4 | P | P | Co-dominant stem was cut | P |
| 28 | M | Siberian Elm | Ulmus pumila | 46 | 10 | P | P | Co-dominant stem was cut | P |
| 29 | M | Siberian Elm | Ulmus pumila | 28 | 0 | D | D | Tree is Dead | P |
| 30 | M | Siberian Elm | Ulmus pumila | 26 | 4 | P | P | Ash growing out of base | P |

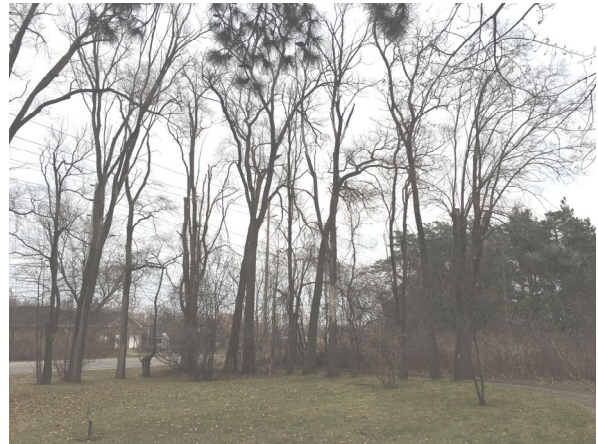
Trees #33 through #44 looking East

| 33 | M | Siberian Elm | Ulmus pumila | 16 | 2 | P | P | Main leader was cut | P |
| 34 | M | Siberian Elm | Ulmus pumila | 68 | 4 | P | P | Co-dominant stems | P |
| 37 | N | Siberian Elm | Ulmus pumila | 16 | 0 | D | D | Tree is Dead | P |
| 40 | N | Siberian Elm | Ulmus pumila | 43 | 0 | D | D | Tree is Dead | P |
| 42 | N | Siberian Elm | Ulmus pumila | 21 | 6 | P | P | Co-dominant stems, signs of internal rot | P |

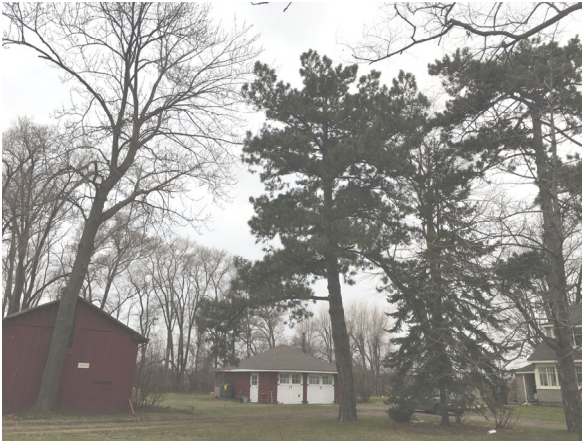
Trees #45 through #49 looking West

| 49 | N | Red Maple | Acer rubrum | 70 | 12 | F | F | Root flare is grown into garage | P |

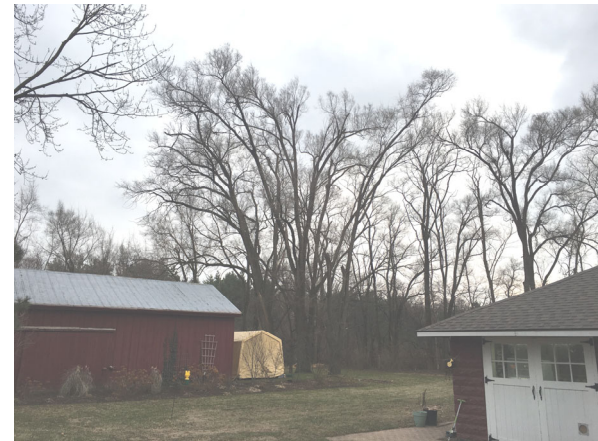
Trees #50 through #57 looking South

| 53 | N | Siberian Elm | Ulmus pumila | 43 | 0 | D | D | Tree is Dead | P |
| 56 | N | Siberian Elm | Ulmus pumila | 53 | 8 | P | P | Co-dominant stems | P |
| 57 | N | Siberian Elm | Ulmus pumila | 61 | 10 | P | P | Signs of rot | P |

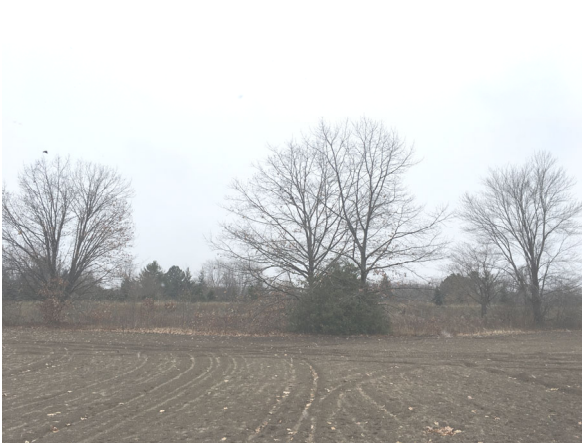
Trees #58 through #63 looking Southwest

| 58 | P | Red Oak | Quercus rubra | 104 | 12 | F | F | Moderate deadwood in canopy | P |
| 62 | P | Red Maple | Acer rubrum | 41 | 8 | F-P | F-P | Trunk cavity present. Signs of internal rot. | P |

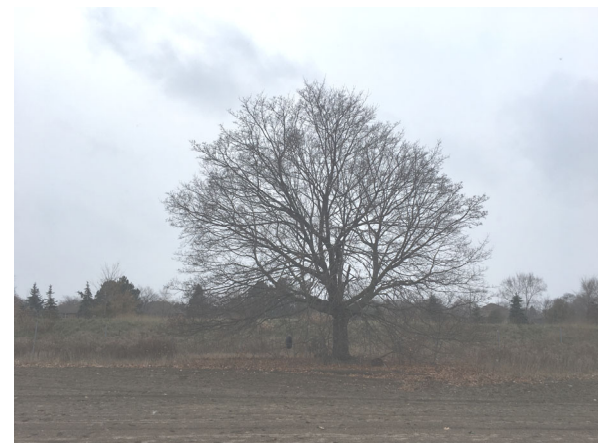
Tree #64 looking Southwest

| 64 | P | Red Maple | Acer rubrum | 64 | 12 | F | F | Trunk cavity present. Signs of internal rot. Significant structural failures on one side of the tree | P |

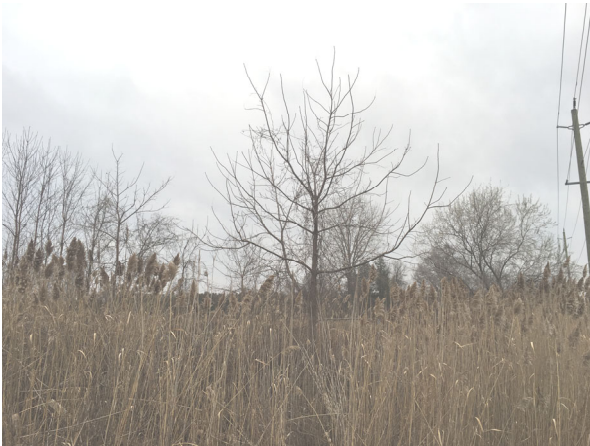
Tree #72 looking Northwest

| 72 | M | Black Walnut | Juglans nigra | 16 | 4 | F | F | | P |

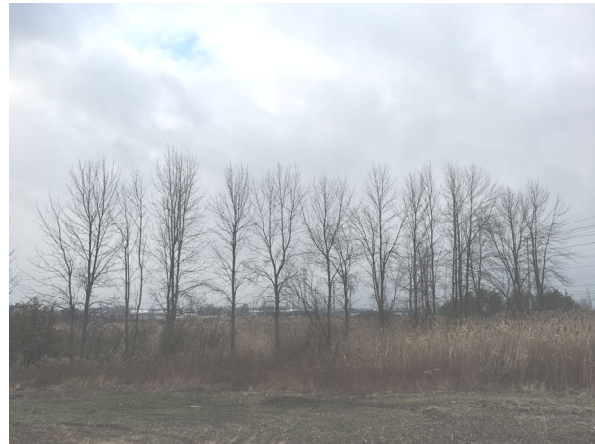
Trees 1479-1494 looking Northwest

| 1484 | N | Burr Oak | Quercus macrocarpa | 64 | 20 | F/P | F | Signs of internal rot | P |
