**Arborist Report - St. Thomas Aquinas
Rezoned Lands
304, 312, 324, & 332 Rebecca St,
Oakville, ON L6K 1K3**

**Halton Catholic District School Board
802 Drury Lane
Burlington, ON L7R 2Y2**

**May 2017
300040708.0000**

Drawn Title
ADDITIONAL LANDS: ST. THOMAS AQUINAS
TREE PRESERVATION PLAN

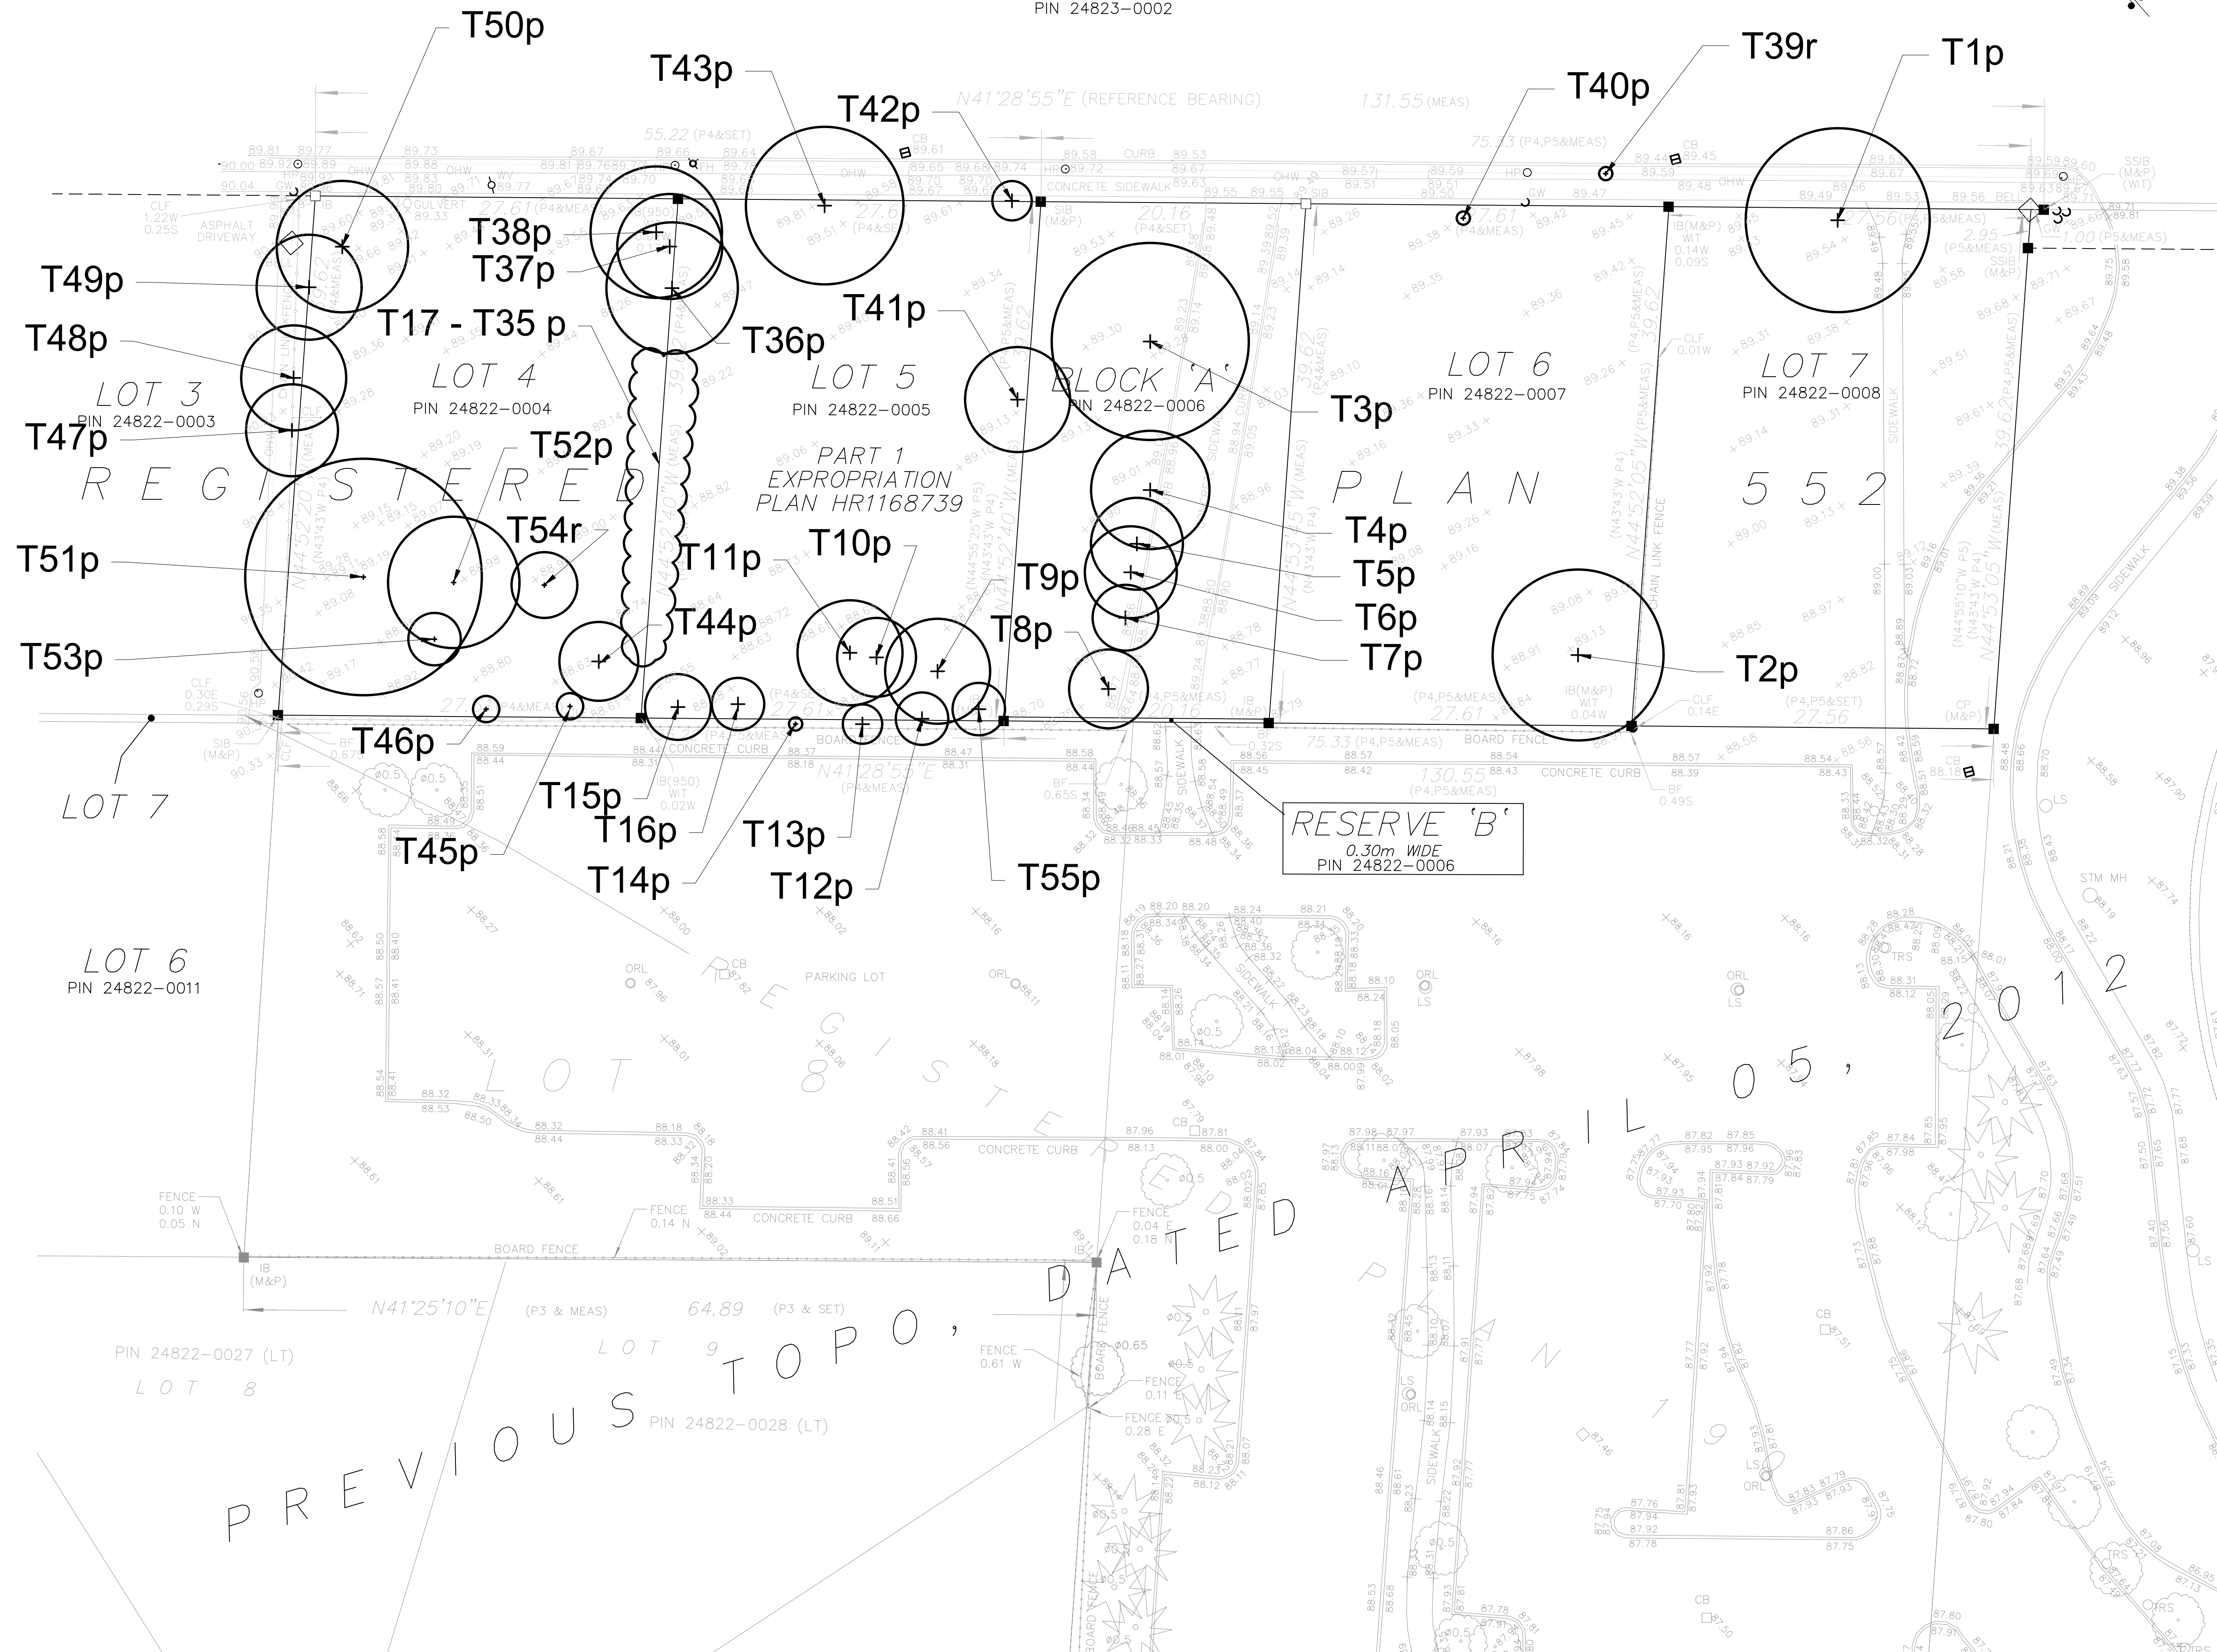
Figure T1
Tree Preservation Plan

The lots within the study area contain open grown individuals and groupings of trees. Some of these trees have been subject to past pruning by the previous landowners. It is anticipated that two individuals (T39 and T40) were recently planted by the Town and T40 is found within the municipal road right-of-way. A series of fruit bearing trees including Common Pear (*Pyrus communis*), Cherry (*Prunus* sp.) and Crabapple (*Malus coronaria*) are found in the southwest corner of the study area. Cedar fencerows are found along the southern property boundary as well as in a hedgerow oriented north-south in the western area of the property.

A total of 53 trees are recommended for preservation based on their existing condition.

A total of 2 trees are recommended for removal based on their existing condition.
