Joshua's Creek Environmental Implementation Report (EIR) Addendum 1086 Burnhamthorpe Road East Town of Oakville, Ontario

Fluvial Geomorphological Assessment

June 28, 2020
Project No. 17051

Report Title: Environmental Implementation Report
1086 Burnhamthorpe Road East
Town of Oakville, Ontario
Joshua's Creek Fluvial Geomorphological Assessment

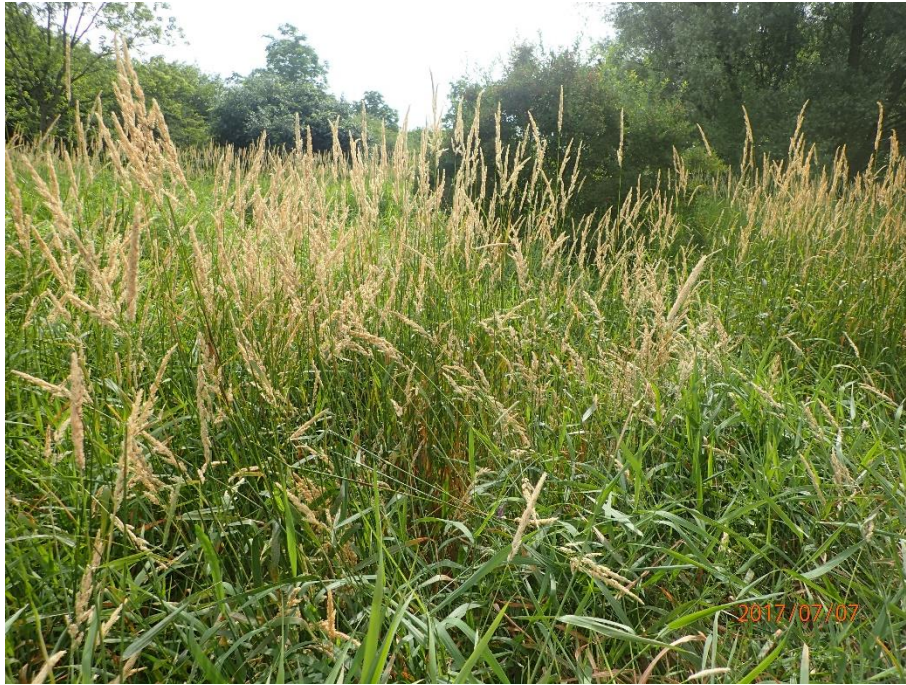
**Photo
1
Reach
JC-7**

Downstream view of Reach JC-7, which was confined and surrounded by agricultural and residential land uses.

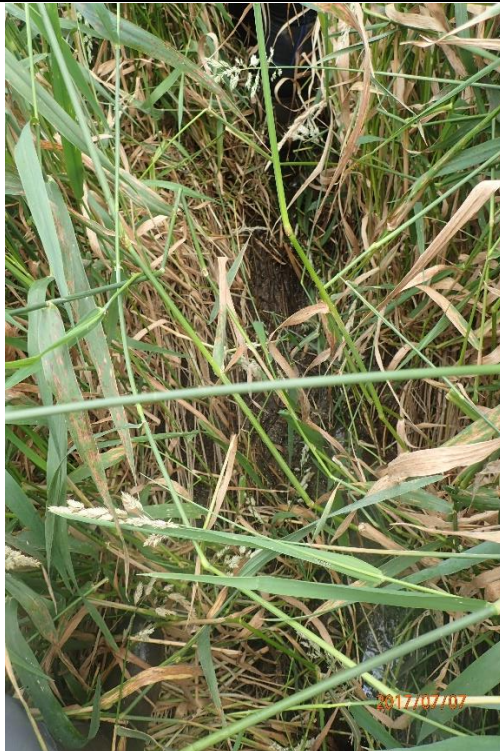
**Photo
2
Reach
JC-7**

Within the downstream portion of the reach the channel was narrow with extensive vegetation encroachment. The riparian vegetation was dominated by grasses.

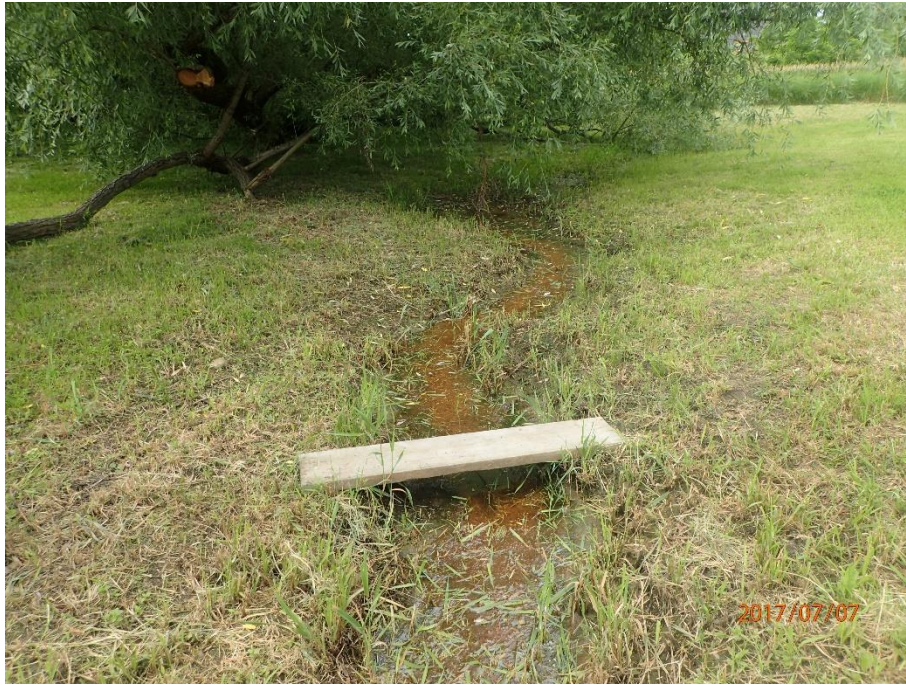
**Reach
JC-7
Photo
3**

Within the upstream section of the reach, riparian areas consisted of manicured lawn. Iron staining was indicative of groundwater contributions.

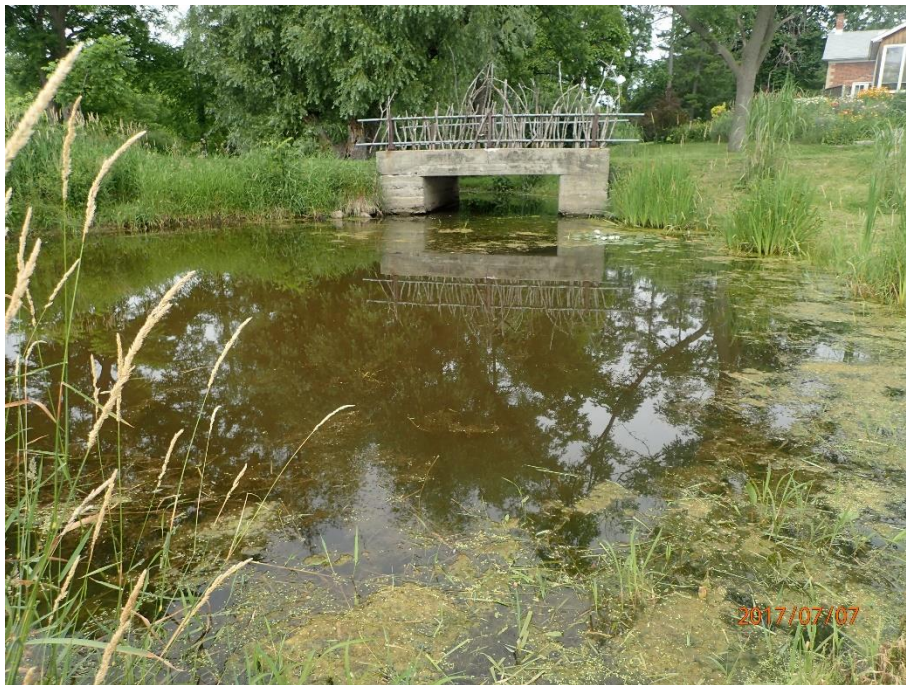
**Reach
JC-7a
Photo
4**

The reach contained online ponds and manicured areas in vicinity of the rural residence. This pond was located downstream of the southern internal driveway crossing.

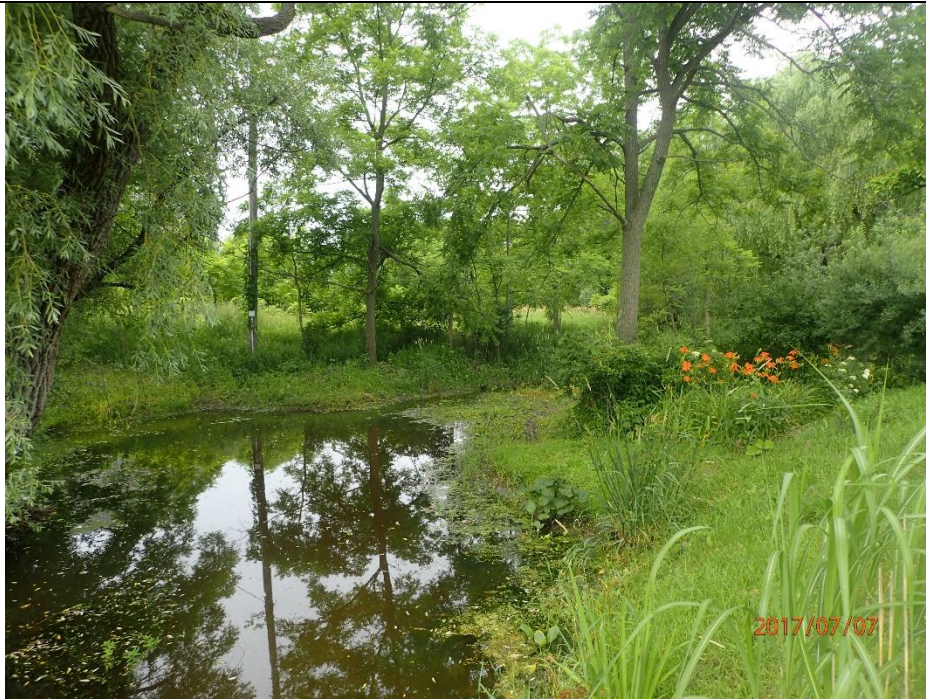
**Photo
5**

Upstream of the crossing, the pond transitioned to a relatively narrow watercourse with limited flow at the time of the assessment.

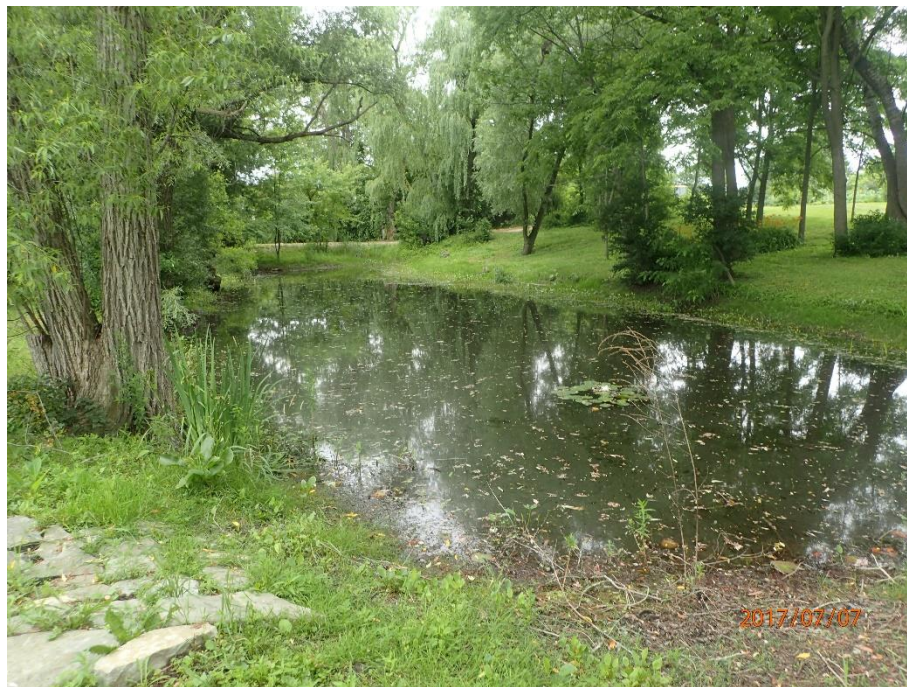
**Photo
6**

View of the earthen berm separating the offline pond located north of the channel.

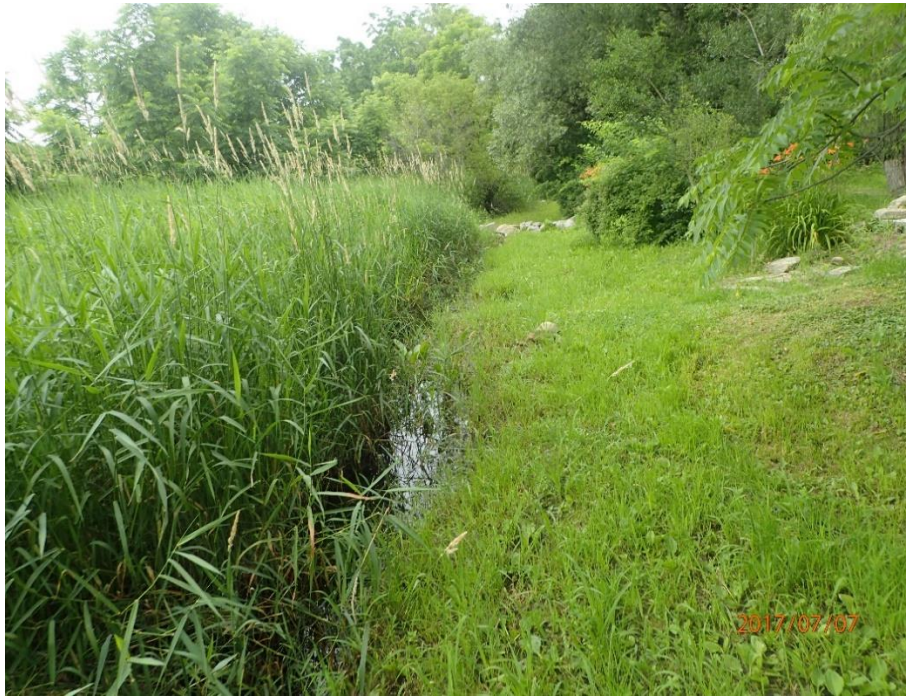
**Photo
7**
**Reach
JC-7a**

Upstream view of the watercourse prior to the culvert at the upstream driveway. Note the earthen berm (right of image) separating the offline pond from the channel.

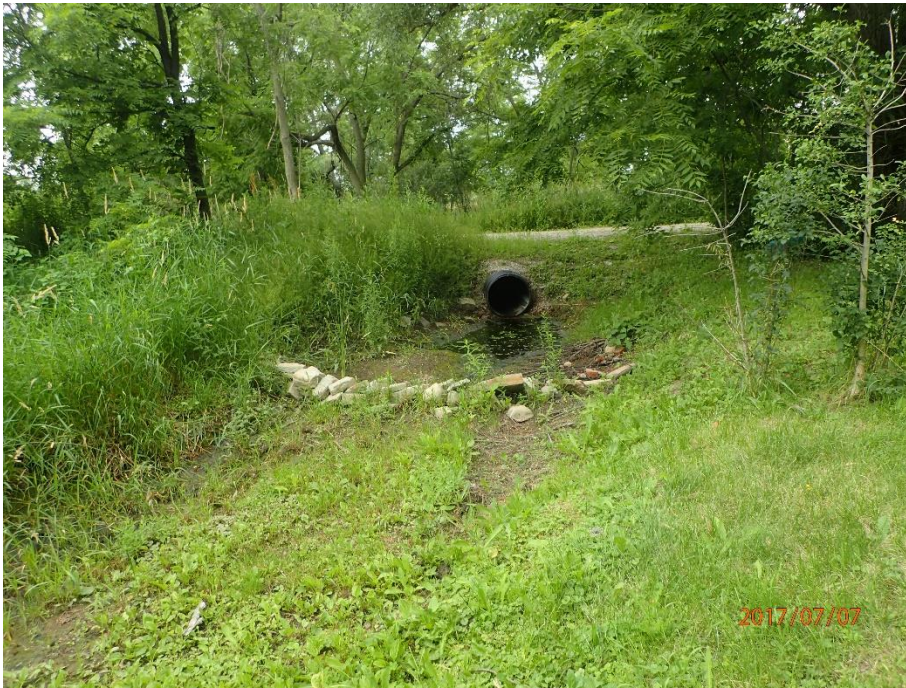
**Photo
8**
**Reach
JC-7a**

Photograph taken facing upstream towards a driveway crossing. Rip rap was placed at 3 locations across the channel as weir structures.

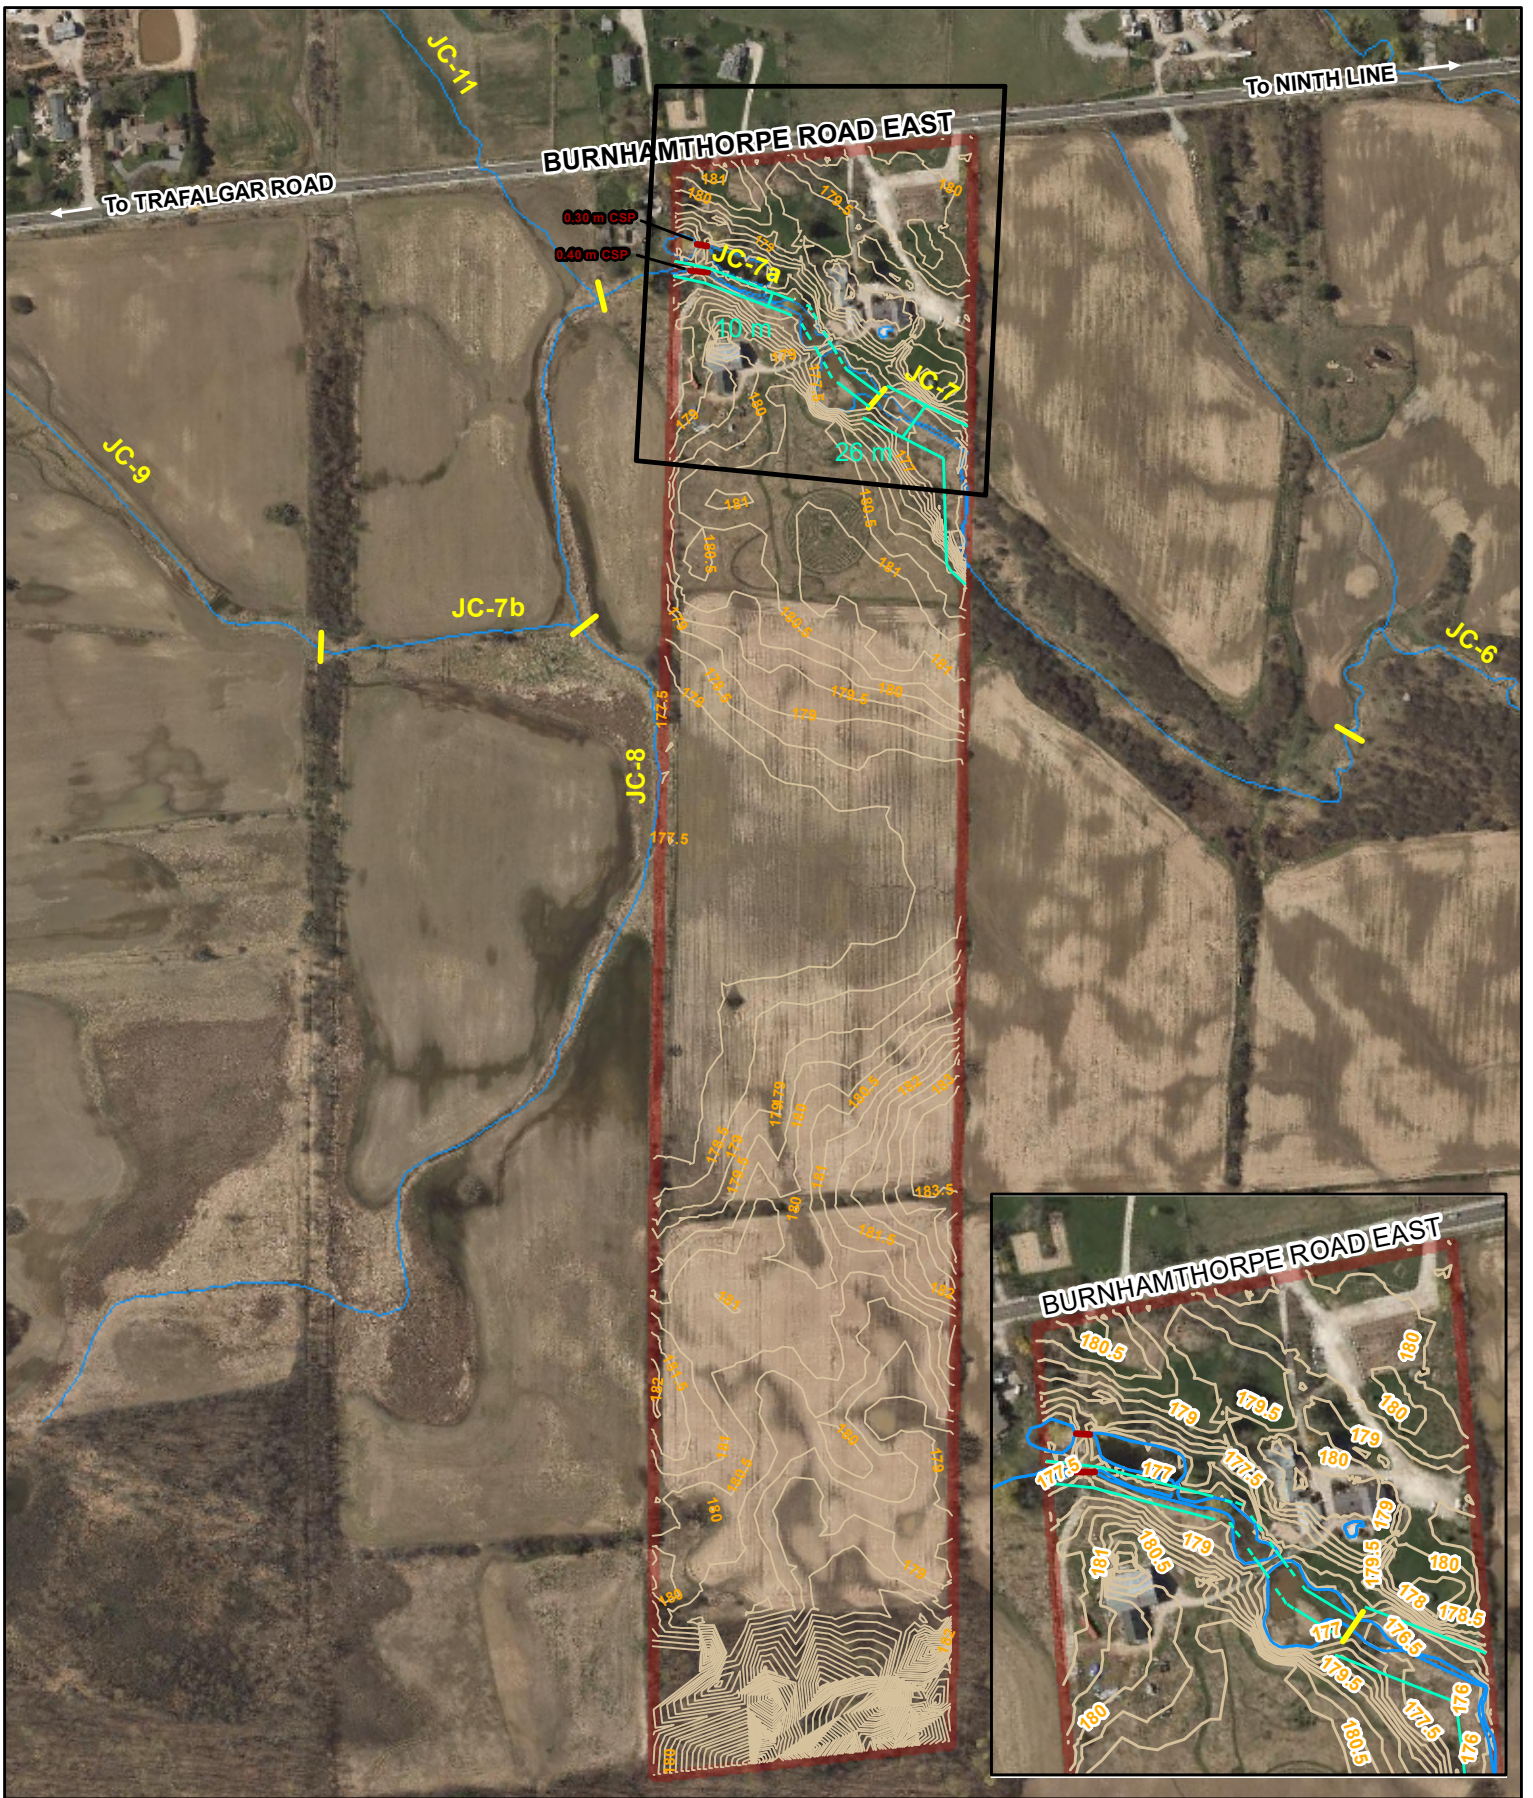
Sixteen Mile Creek Meander Belt Width Delineation

Because **Reach JC-7** has been further divided into subreaches (**JC-7a** and **JC-7b**) as part of the current study, refinement of the meander belt width is required for Reach **JC-7a** within the subject lands. As this reach was previously modified, the empirical approach consistent with that used for lands to the east was employed. The bankfull width measured for **Reach JC-7a** was 0.6 m, resulting in a nominal meander belt width of 4 m. Therefore, as a conservative approach, the maximum bankfull width (1.55 m) measured within the subject lands along the downstream

section of Reach JC-7 was used. Following Eq.1 above, this results in a meander belt width of 10 m (**Appendix E**). It should be noted that due to the high degree of channel stability observed in the field and intermittent flow conditions, there is limited potential for channel migration and an erosion hazard along **Reach JC-7a**.
