# **Arborist Report**

**Pre-Construction Assessment**

2360 Bristol Cir, Oakville, ON L6H 6M5

Revised May 30th, 2023

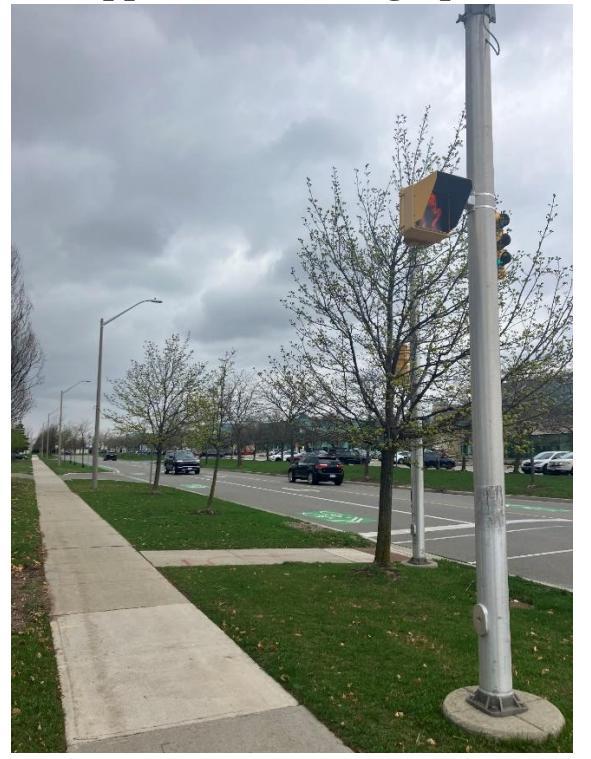
Figure 1 Tree #1-3

- **Trees #1-11** are in front of the existing building's sidewalk within the town's property. These trees' overall condition is good except tree #2 is in fair condition. The proposed construction should not harm these trees. Trees (#6-11) are protected with TPF and hoarding.

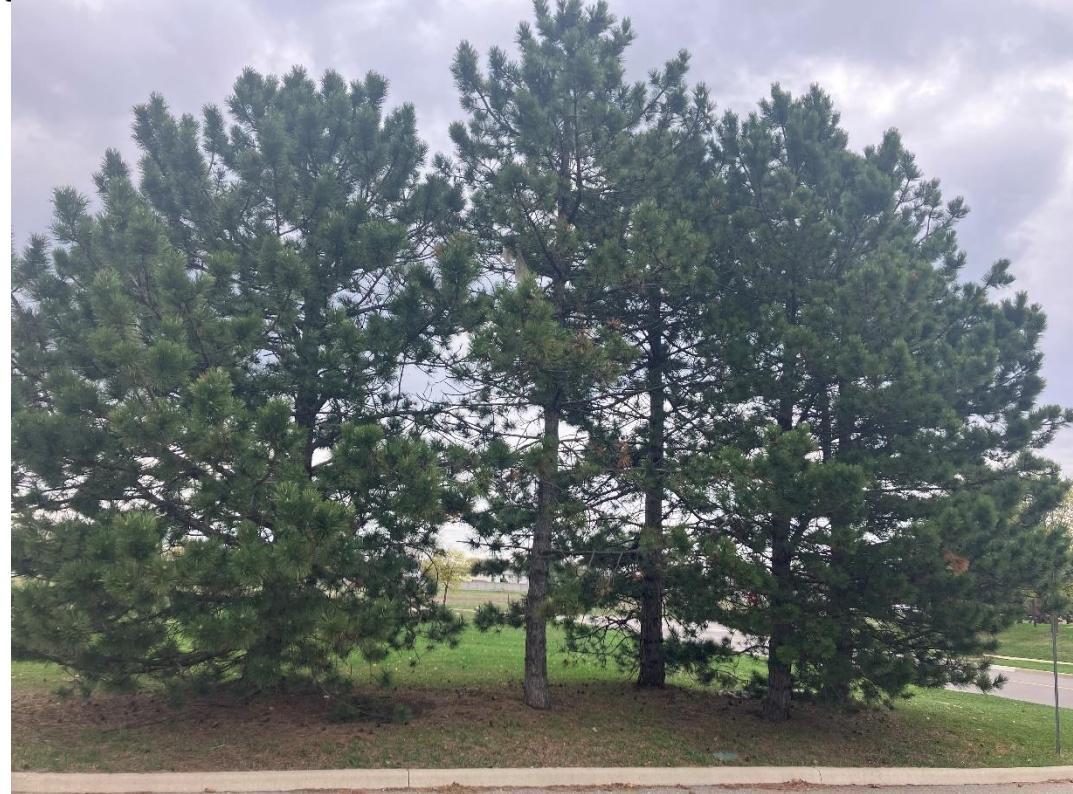
Figure 6 Trees#12-16

- **Trees #12-21** are on the south side of the property away from the existing building. These trees' overall condition is good. Trees #12-16 are within the proposed warehouse construction area, and trees #17-21 are close to the existing driveway and entrance. Based on the footprint of the new building and reconfigured entrance, these trees are recommended for removal.

16	austrian pine	Pinus nigra	44	Private	3.0	Good	Good	Good	8	5	80	0	Y	High	Remove	Y	Remove for new warehouse

**19 trees** (#12-24,26-27and49-52) are recommended to be removed as all trees are within the proposed construction area for the new warehouse and driveway. All trees are >20 cm DBH, therefore a permit is required except trees #17,22 and 49.

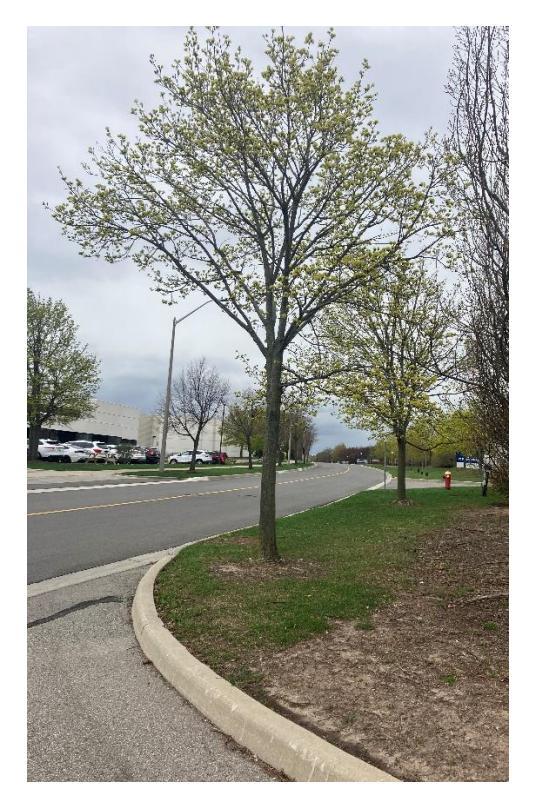
Figure 9 Trees 22-23

- **Trees #22-23** are on the south side of the existing property within the town right-of-way. These trees' overall condition is good. Trees #22 and 23 are within the proposed driveway construction area and recommended for removal.

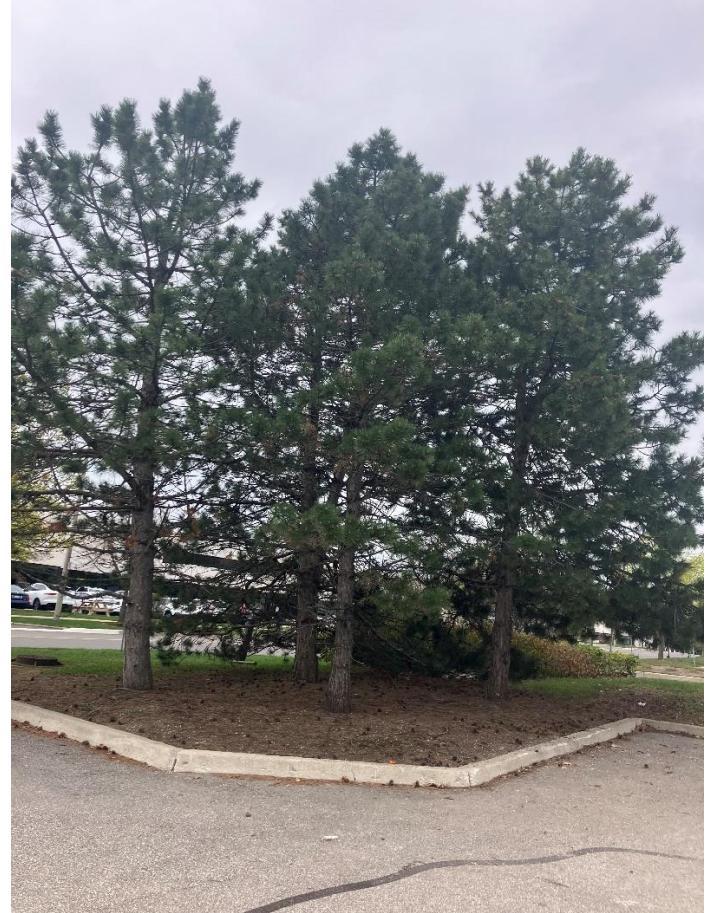
Figure 10 Trees#24-27

- **Trees #24-30** are on the south side of corner of property. These trees' overall condition is good. Tree #24 and 27 TPZs encroach within the proposed construction zone for the driveway and will require root-safe excavation and pruning under arborist supervision. Tree Protection Fencing (TPF) shall be installed.

- Trees expected to be injured are marked with "injury" in the "Action" column in the TPAK.
  - We expect that trees #24 and 27 will sustain a minor impact from work inside their TPZs. And all trees are above the by-law threshold of 20 cm, a TPZ Encroachment Permit will be required to be issued prior to the work.

- We recommend excavation within the TPZ of trees #24 and 27 be done first in a low-impact manner (Hydro-Vac, Air Spade, or hand-digging) to expose roots for pruning and documentation by a certified arborist. Once roots are pruned, excavation may continue conventionally.
- Exposed root ends are recommended to be covered with native topsoil after completion of excavation work.

- We recommend excavation within the TPZ of tree #25 be done first in a low-impact manner (Hydro-Vac, Air Spade, or hand-digging) to expose roots for pruning and documentation by a certified arborist. Once roots are pruned, excavation may continue conventionally.

- Exposed roots are to be covered with native topsoil after excavation.
  - It will be required to install vertical hoarding constructed of 3/4" plywood affixed to a 2\*4 frame outside of new driveway areas.

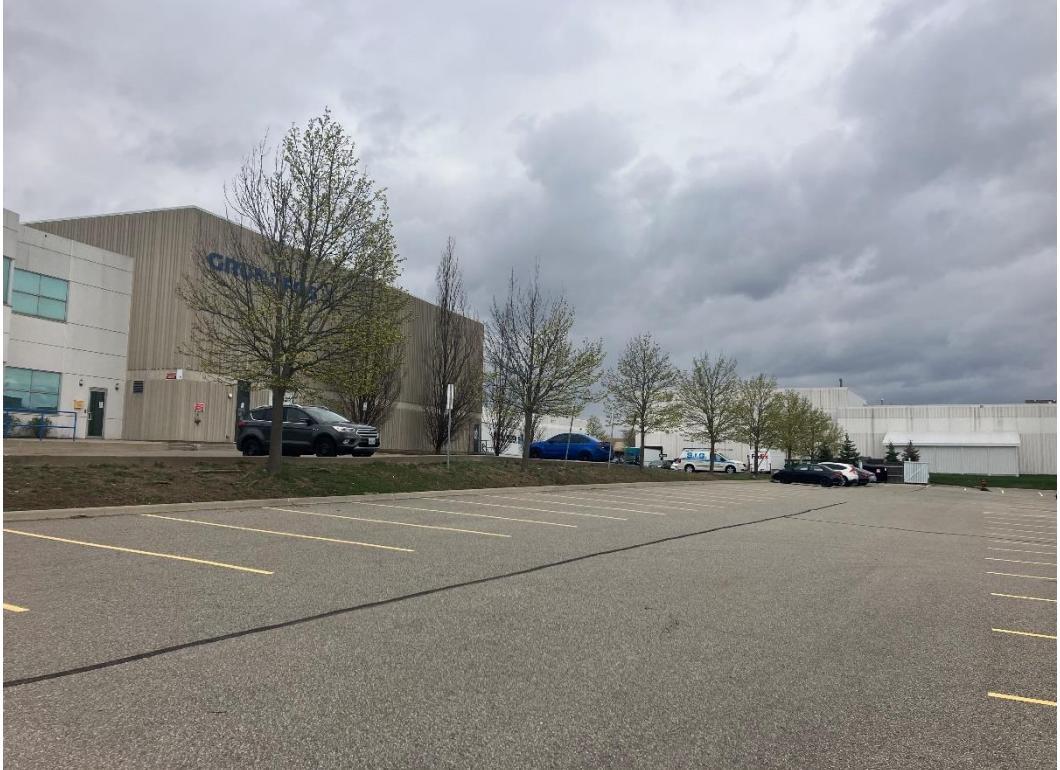
Figure 12 Trees 29-34

- **Trees #31-47** are in the rear areas of the property. These trees' overall condition is good. The proposed construction should not harm these trees. These trees are sufficiently far from construction such that TPF is not required.

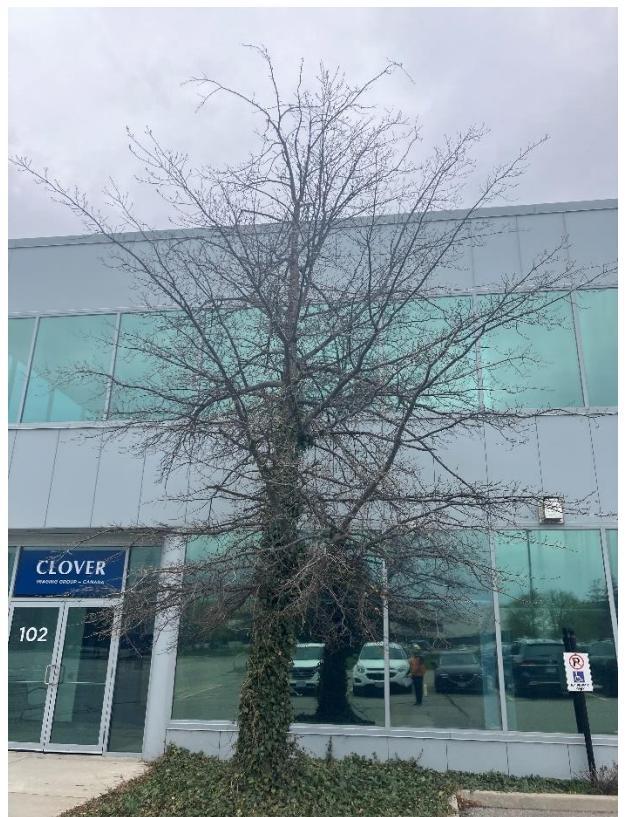
Figure 18 Tree#48

- **Trees #48-50** are on the west side of the existing building of the city's property. These trees' overall condition is good. Tree #50 is within the proposed construction area and recommended for removal and Tree #49 TPZs encroach within the proposed construction zone and Tree Protection Fencing (TPF) should installed to prevent injury.

• Tree Protection Fencing (TPF) shall be installed around their Tree Protection Zones (TPZ), to protect their roots from soil compaction and damage during construction and movement of equipment or materials.

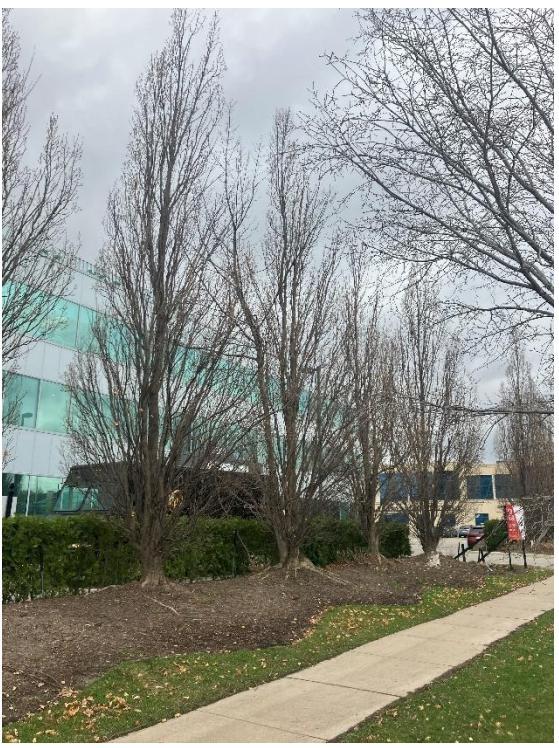
Figure 23 Trees 57-60

- **Trees #51-65** are in front of the existing building on the property. These trees' overall condition is good. Tree #51 is within the proposed construction area and recommended for removal and the proposed construction should not harm these trees. Trees (# 52-55) are protected with TPF and hoarding.

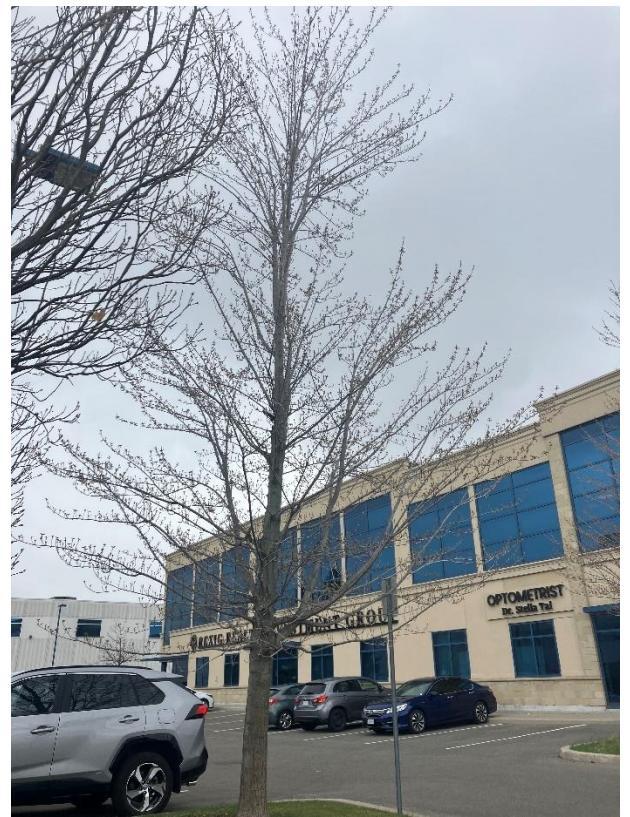
Figure 26 Trees#66

- Tree# 66 is located on the side neighboring property. This tree's overall condition is good. The

proposed construction should not harm this tree.
