**TREE VEGETATION STUDY
&
TREE LOCATION PLAN**

**530, 550, 580 Kerr Street and
131, 171 Speers Road
Oakville, ON**

Date: Jan. 22, 2022
Revised: Jan. 31, 2022

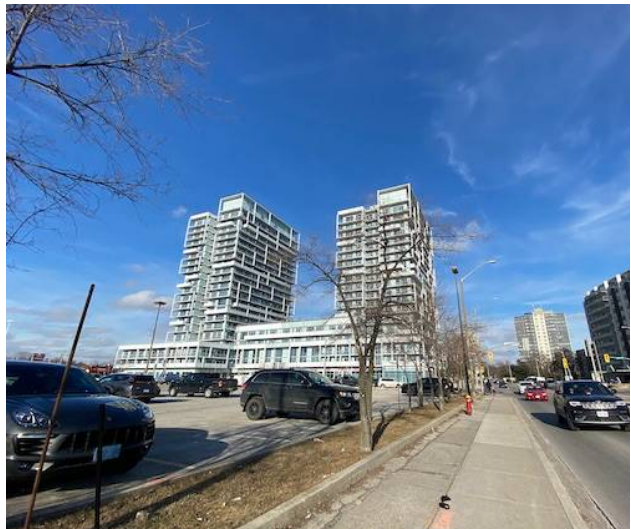
Photo 1. Siberian elms in boulevard adjacent to Speers Rd., looking east.

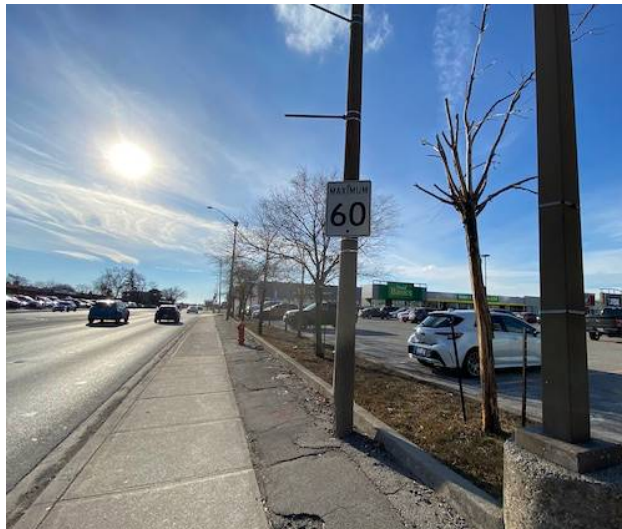
Photo 2. Siberian elms in boulevard adjacent to Speers Rd., looking west.

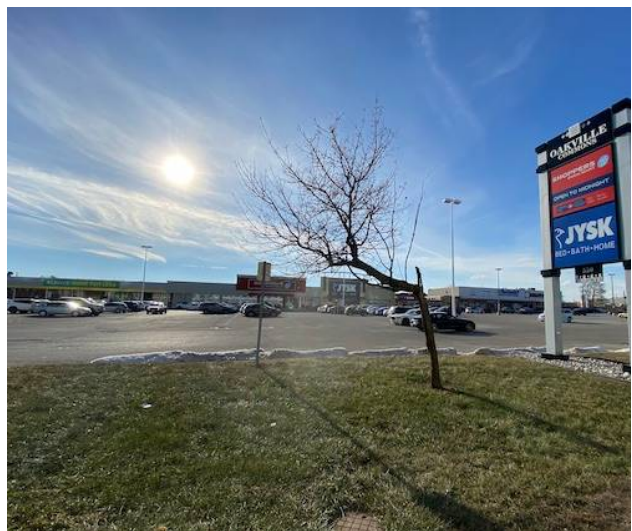
Photo 5. Tree 22

Tree #	Common Name	Botanical Name	DBH (cm)	Crown Diameter (m)	Condition Rating	Observations	TPZ (m)	Ownership Category
22	Norway maple	<i>Acer platanoides</i>	17	4	Poor	Poor trunk; poor crown; fair health; trunk wound 75cm length, 1/3 circumference; almost 90 degree bend in trunk; minor lean; very asymmetrical crown, only extending south.	2.4	Private (Metrolinx)
23	Norway maple	<i>Acer platanoides</i>	27.5	7	Poor	Central stem dead; no trunk flare; crown asymmetrical; 65% live crown.	2.4	Private (Metrolinx)
24	Columnar English oak	<i>Quercus robur</i> 'Fastigiata'	6, 5	1.5	Fair	Memorial tree; poorly planted, structural roots exposed, damaged within 30cm of base of trunk; good aboveground structure; good health.	1.8	Private (Metrolinx)
25	Austrian pine	<i>Pinus nigra</i>	23	6	Poor	30% live crown; live crown limited to south; good trunk structure; poor crown structure; poor health.	2.4	Private (Metrolinx)

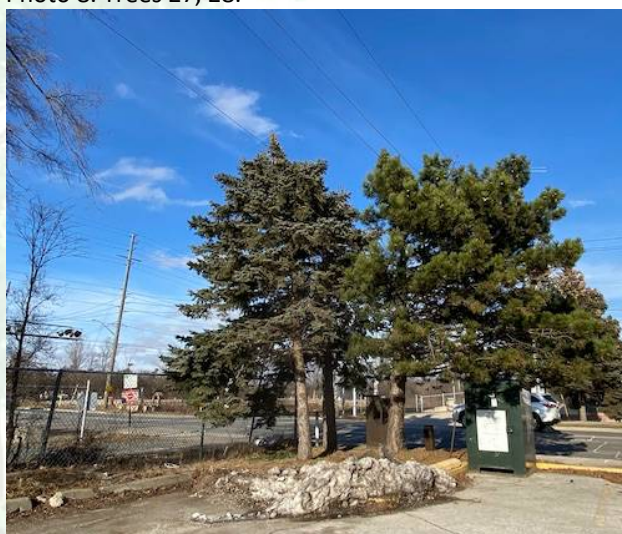
Photo 10. Trees 30, 31, 32.

Tree #	Common Name	Botanical Name	DBH (cm)	Crown Diameter (m)	Condition Rating	Observations	TPZ (m)	Ownership Category
31	Colorado spruce	<i>Picea pungens</i>	30	6	Poor	Leader topped due to OH wires; very asymmetrical, no branches to south; cohort with adjacent trees.	2.4	Private (Metrolinx)
32	Colorado spruce	<i>Picea pungens</i>	24	6	Poor	Leader topped due to OH wires; very asymmetrical, no branches to east; cohort with adjacent trees; outcompeted; old planting ties exposed around base.	2.4	Private (Metrolinx)
33	Siberian elm	<i>Ulmus pumila</i>	70-80	12	Fair	Located north of fence, base under fence; pruned all branches to south due to OH wires; fair unions between 3 main stems; starting to grow into CL fence; vigorous at old tear outs.	4.8	Private (Metrolinx)
34	Siberian elm	<i>Ulmus pumila</i>	<6	2	Poor	Grouping of small diameter Siberian elm trees growing through the CL fence; some topped at top rail.	1.8	Private (Metrolinx)

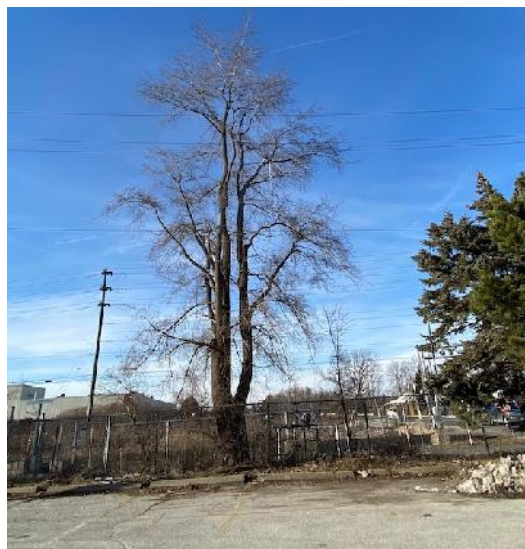
Photo 11. Tree 33.

Inventoried trees on the subject site ranged from 3 cm DBH to between 70-80 cm DBH. The largest tree on the site was Tree 33, a Siberian elm, located on Metrolinx property.

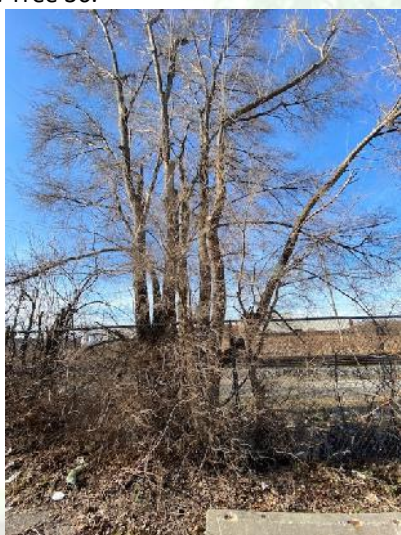
Photo 15. Trees 38, 39, 40.

Tree #	Common Name	Botanical Name	DBH (cm)	Crown Diameter (m)	Condition Rating	Observations	TPZ (m)	Ownership Category
38	Siberian elm	<i>Ulmus pumila</i>	24, 20	6	Poor	Mostly on subject site, trunk through fence; asphalt up to base of tree; smaller stem topped at top rail of fence; codominant limb removed over subject site; old tear outs with sucker growth; asymmetrical; poor structure; fair health.	3	Boundary, private (subject site and Metrolinx)
39	Siberian elm	<i>Ulmus pumila</i>	30-40 x2, 15-25	8	Poor	Located mostly north of fence; starting to conflict with fence; tear outs with sucker growth; pruned from subject site; asymmetrical; moderate small dead wood; included bark at union with seam, stems fused above.	4.2	Private (Metrolinx)
40	Siberian elm	<i>Ulmus pumila</i>	20-30, 25-35	7	Poor	Joined near ground level; branch from adjacent tree growing into union of west stem; fair to poor structure; good health.	3	Private (Metrolinx)

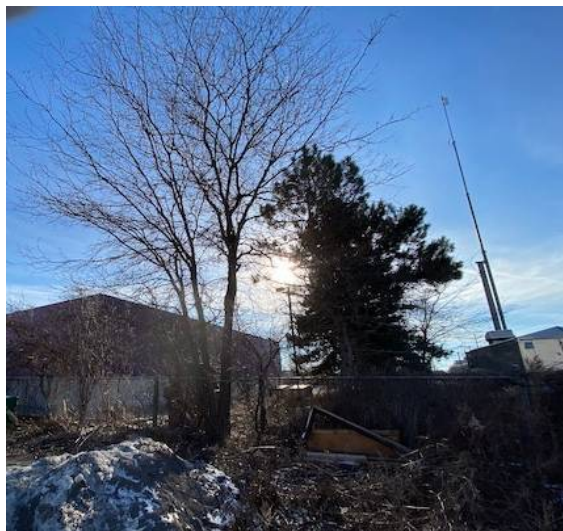
Photo 17. Trees 46, 47 (honey locust), Tree 51 on right.

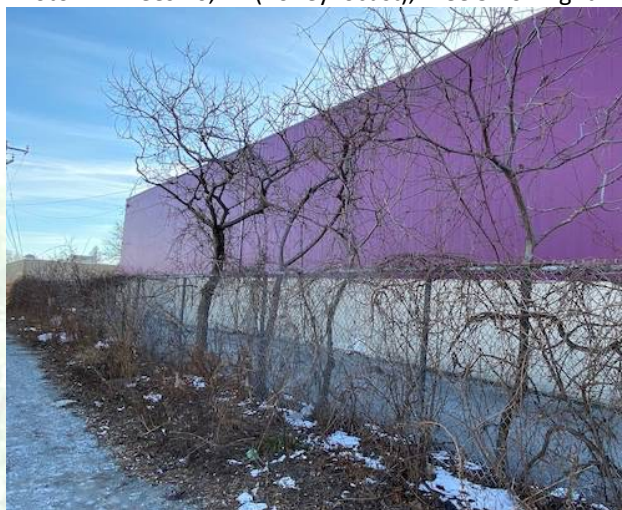
Photo 19. Tree 50 and small diameter sumac, grape vine along fence.
