**Tree Inventory and Preservation Plan  
118 – 132 Cross Avenue  
Oakville, Ontario**

21 November 2025; revised 7 August 2026

KUNTZ FORESTRY CONSULTING INC. Project P4799

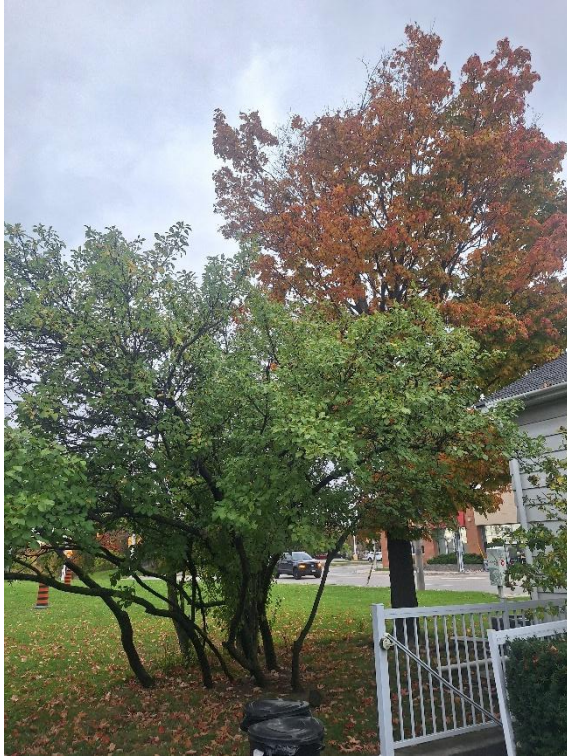
Image 1. Trees 396 – 372

| Tree # | Common Name | Scientific Name | DBH | TI | CS | CV | CDB | DL | Oakville Tree # | mTPZ | A. mTPZ | Comments | Action | Owner | Comp. |
|---|---|---|---|---|---|---|---|---|---|---|---|---|---|---|---|
| 369 | Sugar Maple | <i>Acer saccharum</i> | 43.5 | F | F | F | 20 | 4.0 | 488440 | 3.0 | - | Growth deficit (M), epicormic branching (L), exposed roots (L) with wounds | Remove | Town | - |
| 370 | Cherry species | <i>Prunus sp.</i> | 17.5 | P | P | P | 80 | 1.5 | 65442 | 2.4 | 1.3 | Epicormic branching (M), moribund, lean (L), decay (M) in trunk | Preserve (Injure) | Town | - |
| 371 | Cherry species | <i>Prunus sp.</i> | 11 | PF | F | F | 10 | 3.0 | 488439 | 2.4 | - | Lean (H), epicormic branching (L) | Remove | Town | - |
| 372 | Cherry species | <i>Prunus sp.</i> | 10, 9 | PF | F | F | 10 | 3.0 | 102362 | 2.4 | - | Lean (H), v-union at 1m with included bark, epicormic branching (L) | Remove | Town | - |

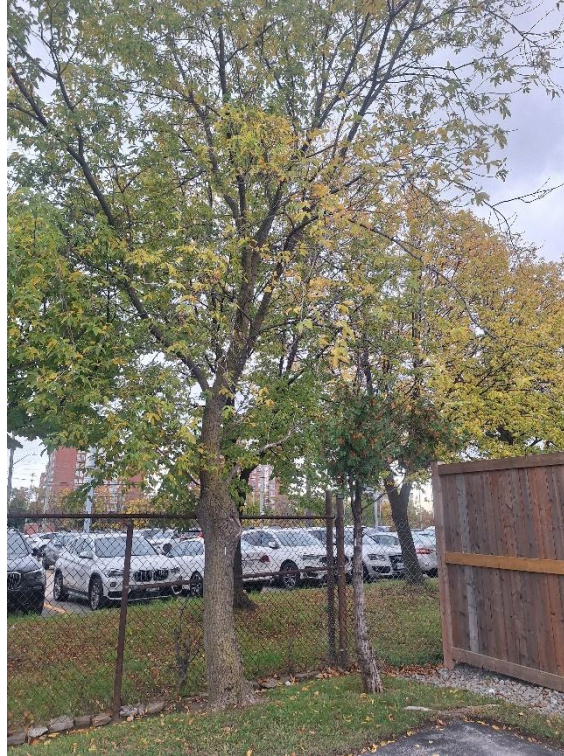
Image 2. Trees 373 and 374

| Tree # | Common Name | Scientific Name | DBH | TI | CS | CV | CDB | DL | Oakville Tree # | mTPZ | A. mTPZ | Comments | Action | Owner | Comp. |
|---|---|---|---|---|---|---|---|---|---|---|---|---|---|---|---|
| 373 | Manitoba Maple | <i>Acer negundo</i> | 30.5 | PF | F | F | 10 | 4.5 | - | 2.4 | - | Lean (L), included fence (M), pruning wounds (M), epicormic branching (L) | Remove | Subject | 0 |
| 374 | Eastern White Cedar | <i>Thuja occidentalis</i> | 10 | F | PF | PF | 40 | 1.0 | - | 2.4 | - | Top dead, decay (L) in trunk | Remove | Subject | 0 |

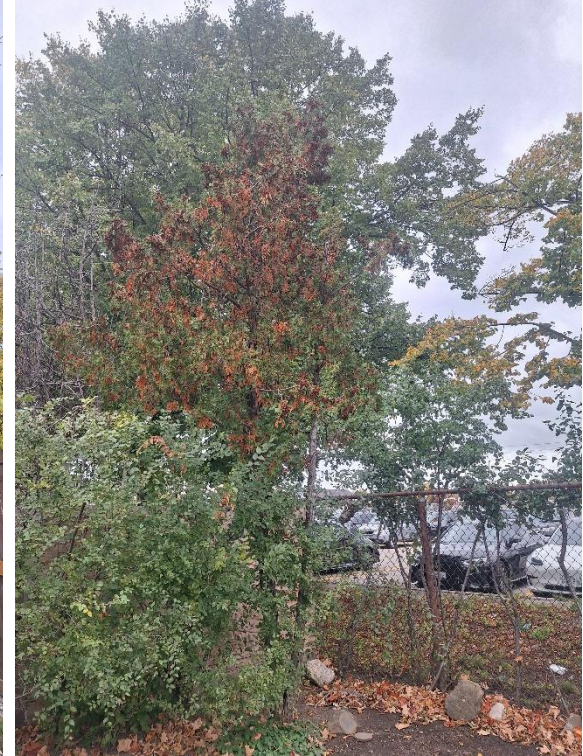
Image 3. Tree 375

| Tree # | Common Name | Scientific Name | DBH | TI | CS | CV | CDB | DL | Oakville Tree # | mTPZ | A. mTPZ | Comments | Action | Owner | Comp. |
|---|---|---|---|---|---|---|---|---|---|---|---|---|---|---|---|
| 375 | Eastern White Cedar | <i>Thuja occidentalis</i> | 11, 8 | F | F | F | 10 | 1.5 | - | 2.4 | - | V-union at base with included bark | Remove | Subject | 0 |

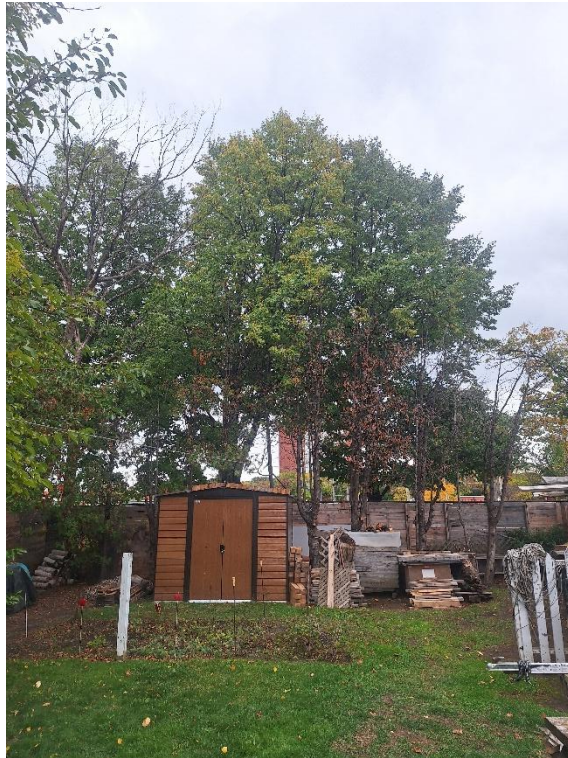
Image 4. Trees 376 – 378

| Tree # | Common Name | Scientific Name | DBH | TI | CS | CV | CDB | DL | Oakville Tree # | mTPZ | A. mTPZ | Comments | Action | Owner | Comp. |
|---|---|---|---|---|---|---|---|---|---|---|---|---|---|---|---|
| 376 | Eastern White Cedar | <i>Thuja occidentalis</i> | 16 | G | P | P | 70 | 2.0 | - | 2.4 | - | | Remove | Subject | 0 |
| 377 | Eastern White Cedar | <i>Thuja occidentalis</i> | 12 | F | P | P | 70 | 1.5 | - | 2.4 | - | Decay (M) in trunk | Remove | Subject | 0 |
| 378 | Eastern White Cedar | <i>Thuja occidentalis</i> | 12 | F | P | P | 60 | 2.0 | - | 2.4 | - | Sweep (L), top dead | Remove | Subject | 0 |

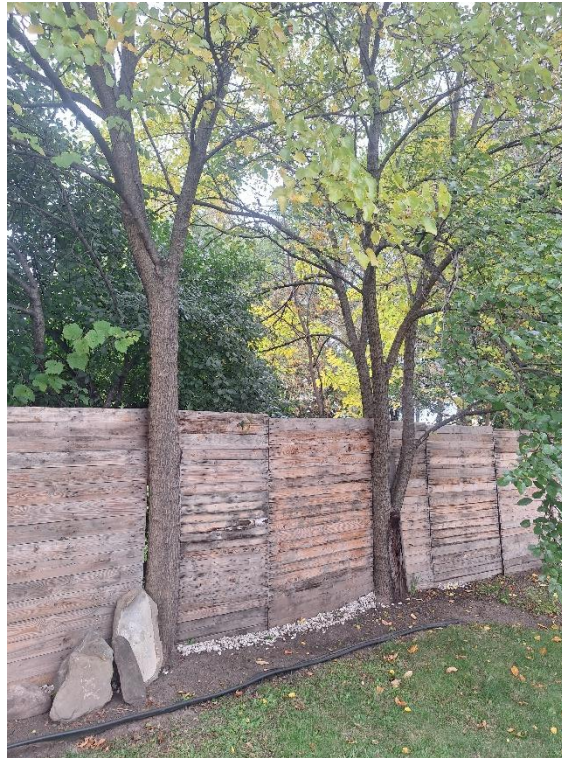
Image 5. Trees 379 and 380

| Tree # | Common Name | Scientific Name | DBH | TI | CS | CV | CDB | DL | Oakville Tree # | mTPZ | A. mTPZ | Comments | Action | Owner | Comp. |
|---|---|---|---|---|---|---|---|---|---|---|---|---|---|---|---|
| 379 | White Mulberry | <i>Morus alba</i> | ~20, 13 | F | F | F | 10 | 5.5 | - | 2.4 | - | V-union at 1m and 1.5m with included bark, epicormic branching (L) | Remove | Subject | 1 |
| 380 | White Mulberry | <i>Morus alba</i> | 21.5 | FG | F | F | 10 | 4.5 | - | 2.4 | - | Lean (L), epicormic branching (L) | Remove | Subject | 2 |

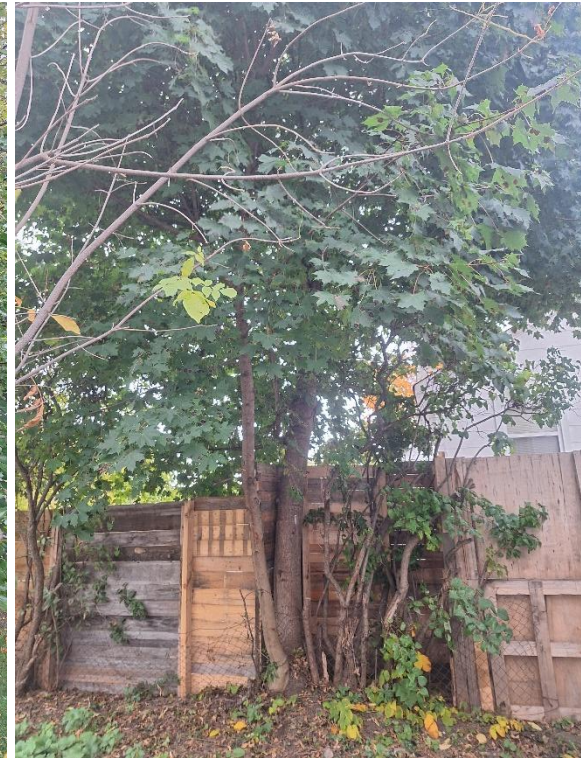
Image 6. Tree 381

| Tree # | Common Name | Scientific Name | DBH | TI | CS | CV | CDB | DL | Oakville Tree # | mTPZ | A. mTPZ | Comments | Action | Owner | Comp. |
|---|---|---|---|---|---|---|---|---|---|---|---|---|---|---|---|
| 381 | Norway Maple | <i>Acer platanoides</i> | 25, 11 | F | F | G | | 4.5 | - | 2.4 | - | Bow (L), multiple branch attachments, v-union at base with included bark, included fence (L) | Remove | Subject | 3 |

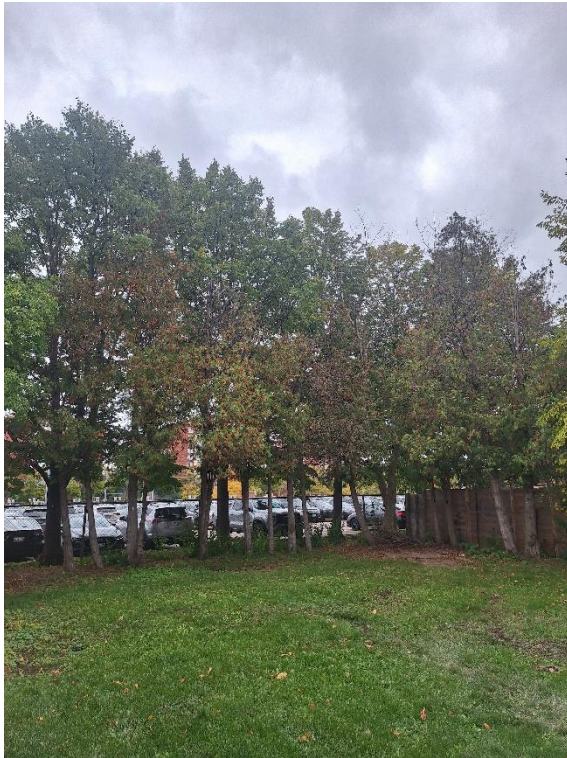
Image 7. Trees 382 – 390

| Tree # | Common Name | Scientific Name | DBH | TI | CS | CV | CDB | DL | Oakville Tree # | mTPZ | A. mTPZ | Comments | Action | Owner | Comp. |
|---|---|---|---|---|---|---|---|---|---|---|---|---|---|---|---|
| 382 | Eastern White Cedar | <i>Thuja occidentalis</i> | 27 | F | F | F | 30 | 2.5 | - | 2.4 | - | V-union at 4m with included bark | Remove | Subject | 3 |
| 383 | Eastern White Cedar | <i>Thuja occidentalis</i> | 25.5 | FG | FG | F | 10 | 2.5 | - | 2.4 | - | Lean (L) | Remove | Subject | 3 |
| 384 | Eastern White Cedar | <i>Thuja occidentalis</i> | 18.5 | F | FG | F | 10 | 2.0 | - | 2.4 | - | V-union at 2m with included bark, lean (L) | Remove | Subject | 2 |
| 385 | Eastern White Cedar | <i>Thuja occidentalis</i> | 14 | F | F | F | 30 | 2.0 | - | 2.4 | - | Top dead, lean (L) | Remove | Subject | 0 |
| 386 | Eastern White Cedar | <i>Thuja occidentalis</i> | 19 | F | FG | F | 10 | 2.0 | - | 2.4 | - | Sweep (M) | Remove | Subject | 2 |
| 387 | Eastern White Cedar | <i>Thuja occidentalis</i> | 16.5 | F | FG | F | 10 | 2.0 | - | 2.4 | - | V-union at 2m with included bark | Remove | Subject | 2 |
| 388 | Eastern White Cedar | <i>Thuja occidentalis</i> | 17.5, 11 | F | F | F | 30 | 3.0 | - | 2.4 | - | Union at base, lean (L), v-union at 2m with included bark, top of largest stem dead | Remove | Subject | 2 |
| 389 | Eastern White Cedar | <i>Thuja occidentalis</i> | 21.5, 10.5 | FG | FG | F | 10 | 3.0 | - | 2.4 | - | Union at 0.5m, lean (L) | Remove | Subject | 2 |
| 390 | Eastern White Cedar | <i>Thuja occidentalis</i> | 14 | FG | F | F | 20 | 2.5 | - | 2.4 | - | Lean (L) | Remove | Subject | 0 |

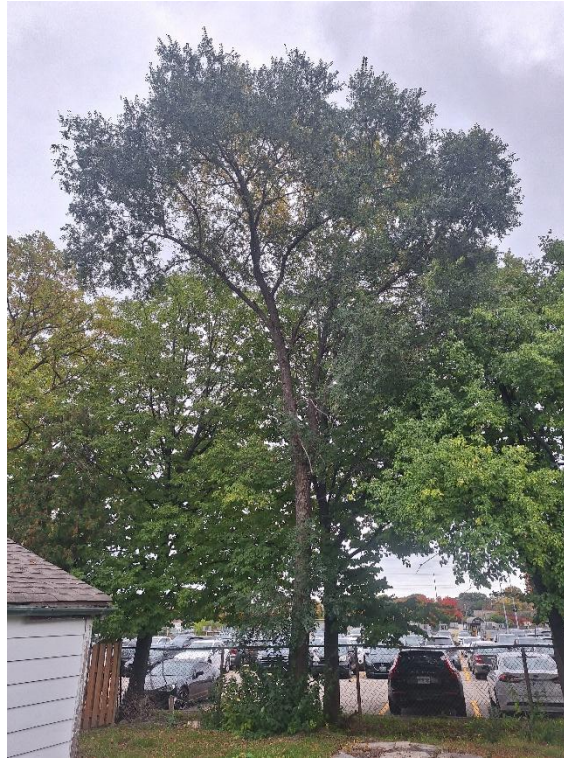
Image 8. Tree 975

| Tree # | Common Name | Scientific Name | DBH | TI | CS | CV | CDB | DL | Oakville Tree # | mTPZ | A. mTPZ | Comments | Action | Owner | Comp. |
|---|---|---|---|---|---|---|---|---|---|---|---|---|---|---|---|
| 975 | Siberian Elm | <i>Ulmus pumila</i> | 39 | FG | F | F | 10 | 6.0 | - | 3.0 | - | Bow (L), epicormic branching (L) | Remove | Subject | 4 |

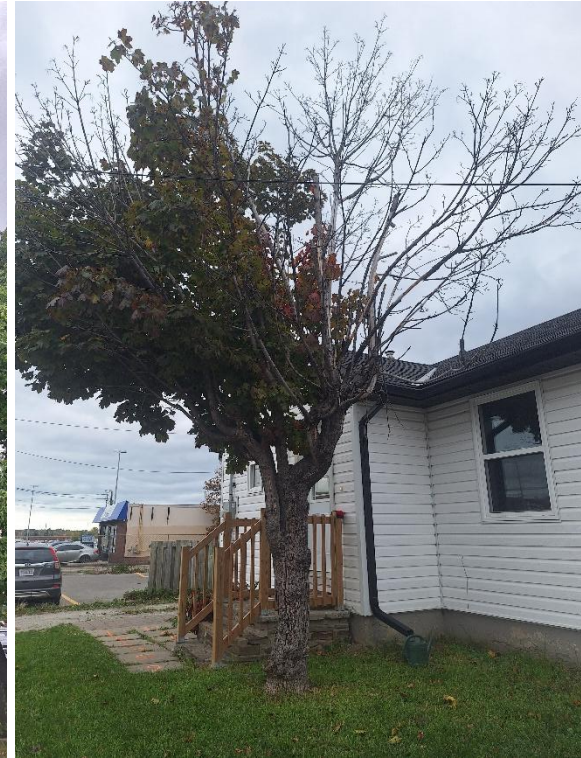
Image 9. Tree 976

| Tree # | Common Name | Scientific Name | DBH | TI | CS | CV | CDB | DL | Oakville Tree # | mTPZ | A. mTPZ | Comments | Action | Owner | Comp. |
|---|---|---|---|---|---|---|---|---|---|---|---|---|---|---|---|
| 976 | Norway Maple | <i>Acer platanoides</i> | 33 | P | P | P | 60 | 3.5 | - | 3.0 | - | Multiple branch attachments, poor branch unions, decay (H) in trunk, crook (M) | Remove | Subject | 0 |

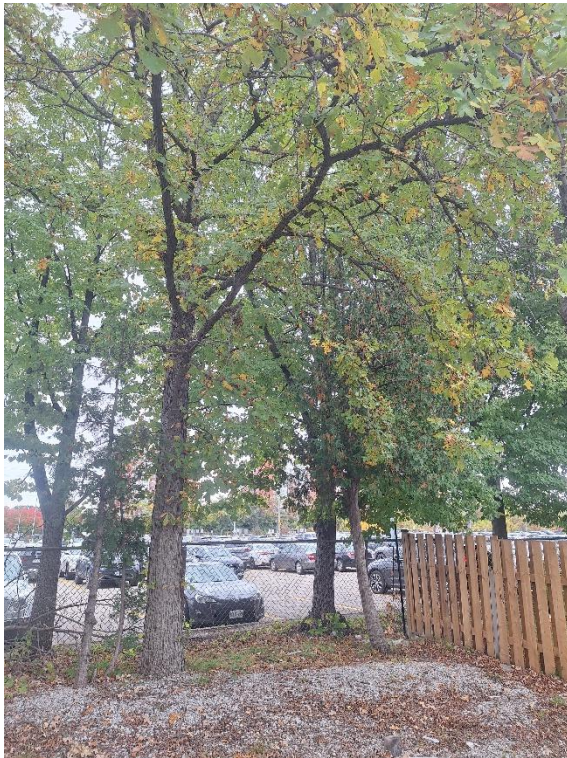
Image 10. Trees 977 and 978

| Tree # | Common Name | Scientific Name | DBH | TI | CS | CV | CDB | DL | Oakville Tree # | mTPZ | A. mTPZ | Comments | Action | Owner | Comp. |
|---|---|---|---|---|---|---|---|---|---|---|---|---|---|---|---|
| 977 | Eastern White Cedar | <i>Thuja occidentalis</i> | 14.5, 13 | FG | FG | G | | 2.5 | - | 2.4 | - | V-union at base, bow (L) | Remove | Subject | 0 |
| 978 | Bur Oak | <i>Quercus macrocarpa</i> | 39 | G | F | F | 20 | 6.0 | - | 3.0 | - | Epicormic branching (M) | Remove | Subject | 4 |

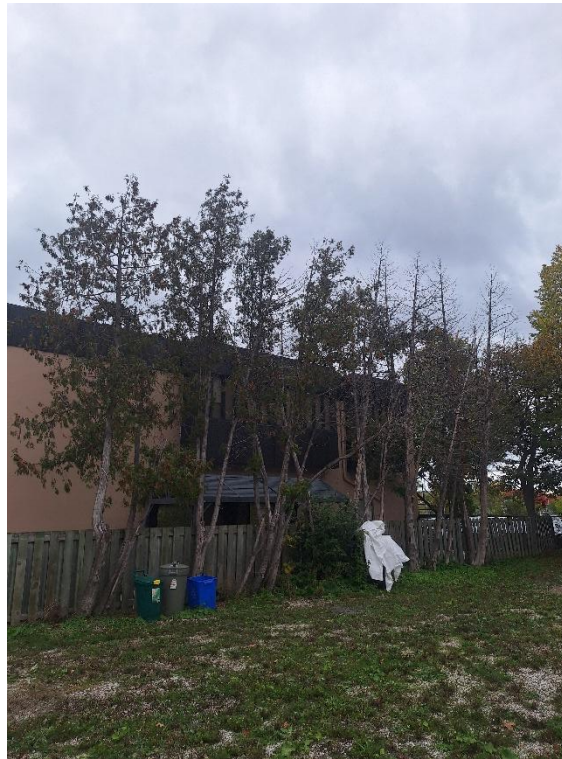
Image 11. Trees 979 – 985

| 979 | Eastern White Cedar | <i>Thuja occidentalis</i> | 21 | P | P | P | 80 | 2.0 | - | 2.4 | - | V-union at base with included bark and one 22.5cm DBH stem dead, epicormic branching (H), moribund | Remove | Subject | 0 |
| 980 | Eastern White Cedar | <i>Thuja occidentalis</i> | 10.5 | P | P | P | 90 | 0.5 | - | 2.4 | - | Lean (M), girdled stem, moribund | Remove | Subject | 0 |
| 981 | Eastern White Cedar | <i>Thuja occidentalis</i> | 25 | PF | P | P | 70 | 3.0 | - | 2.4 | - | V-union at 2m and 3.5m with included bark, decay (M) in trunk, epicormic branching (H) | Remove | Subject | 0 |
| 982 | Eastern White Cedar | <i>Thuja occidentalis</i> | 14, 12 | PF | P | P | 60 | 3.5 | - | 2.4 | - | V-union at base with included bark and one 12cm DBH stem dead, epicormic branching (M), decay (L) in trunk | Remove | Subject | 0 |
| 983 | Eastern White Cedar | <i>Thuja occidentalis</i> | 13 | PF | P | P | 60 | 3.5 | - | 2.4 | - | V-union at base with included bark and one 18cm DBH stem dead, epicormic branching (M), decay (L) in trunk, sweep (M) | Remove | Subject | 0 |
| 984 | Eastern White Cedar | <i>Thuja occidentalis</i> | 17 | F | F | F | 30 | 2.5 | - | 2.4 | - | V-union at 2m with included bark, epicormic branching (M) | Remove | Subject | 2 |
| 985 | Eastern White Cedar | <i>Thuja occidentalis</i> | 21, 12 | F | F | F | 20 | 2.5 | - | 2.4 | - | Union at base, lean (L), pruning wounds (M) | Remove | Subject | 2 |

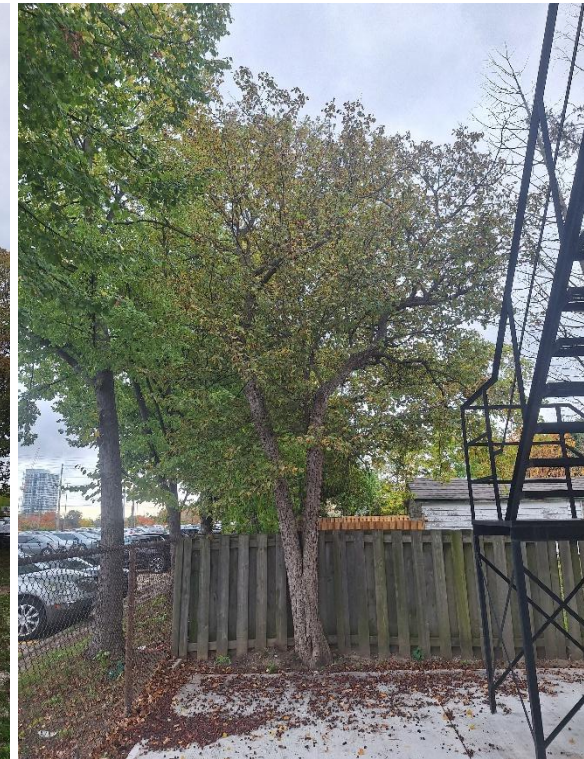
Image 12. Tree 986

| 986 | Hawthorn species | <i>Crataegus sp.</i> | 22, 22 | F | F | F | | 5.0 | - | 2.4 | - | V-union at base with included bark, asymmetrical crown (M), epicormic branching (L), pruning wounds (M), cavity (L) | Remove | Subject | 2 |

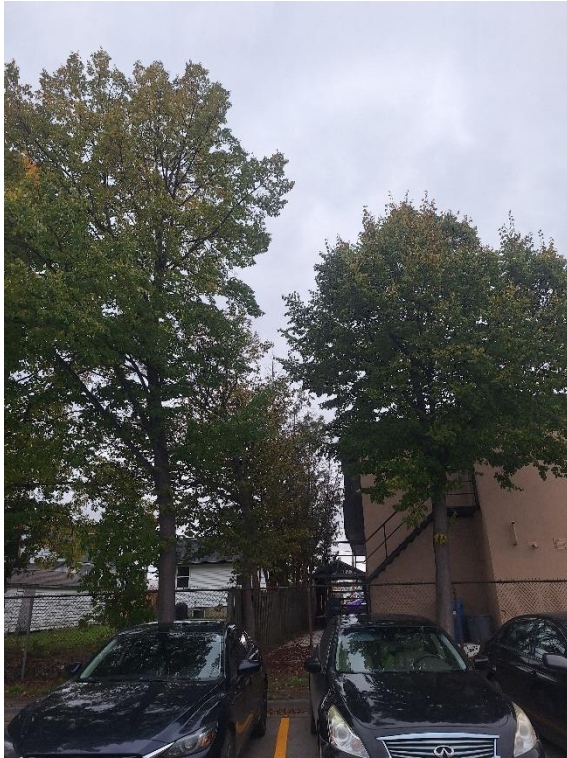
Image 13. Trees A and B

| A | Little-leaf Linden | <i>Tilia cordata</i> | 31 | F | FG | F | | 5.0 | - | 3.0 | 3.0 | Lean (L), epicormic branching (L), bulge at base | Preserve | Neighbour | - |
| B | Little-leaf Linden | <i>Tilia cordata</i> | 33 | F | FG | F | | 6.0 | - | 3.0 | 1.2 | Bow (L), epicormic branching (L), bulge at base | Preserve (Injure) | Neighbour | - |

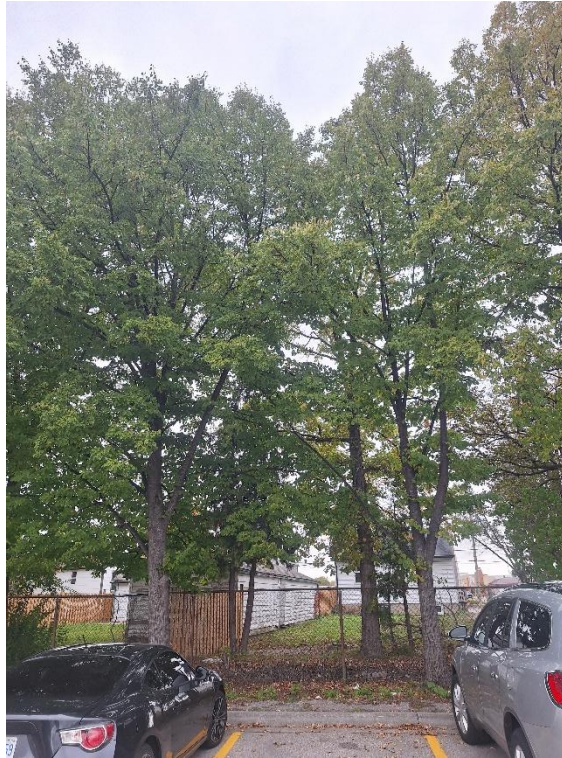
Image 14. Trees C and D

| C | Little-leaf Linden | <i>Tilia cordata</i> | 28 | F | F | F | | 5.5 | - | 2.4 | 1.5 | V-union at 2m with included bark, bow (L), epicormic branching (L), bulge at base | Preserve (Injure) | Neighbour | - |
| D | Little-leaf Linden | <i>Tilia cordata</i> | 36.5 | F | FG | F | | 6.0 | - | 3.0 | 1.8 | Lean (L), epicormic branching (L), bulge at base | Preserve (Injure) | Neighbour | - |

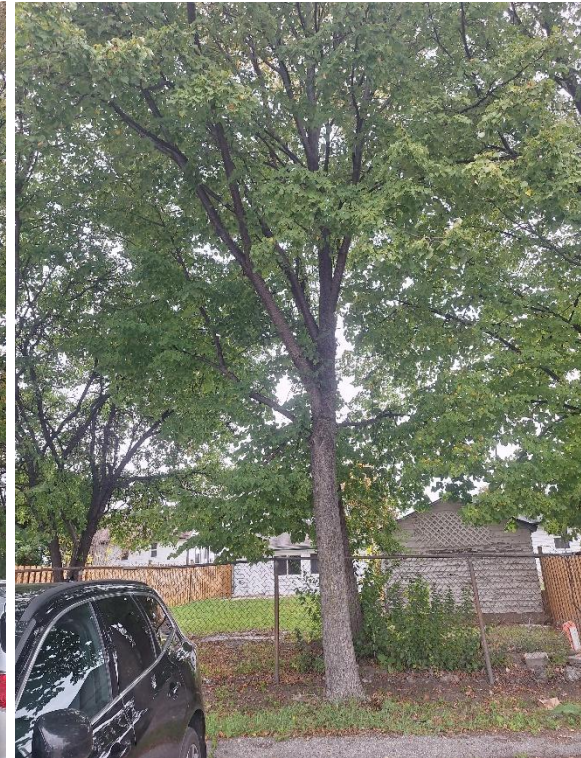
Image 15. Tree E

| E | Little-leaf Linden | <i>Tilia cordata</i> | 33 | G | FG | F | | 6.0 | - | 3.0 | 1.7 | Epicormic branching (L) | Preserve (Injure) | Neighbour | - |

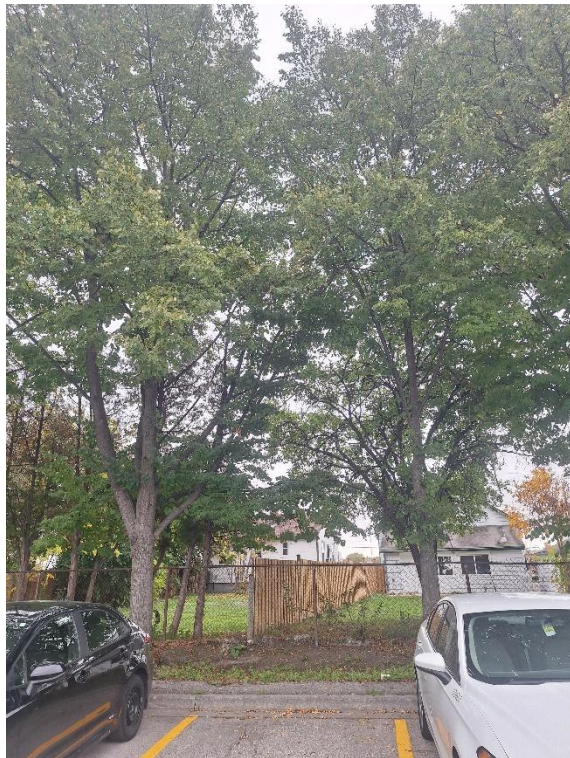
Image 16. Trees F and G

| F | Little-leaf Linden | <i>Tilia cordata</i> | 28 | PF | FG | F | | 6.0 | - | 2.4 | 1.3 | Lean (L), crook (L), cavity (M), epicormic branching (L) | Preserve (Injure) | Neighbour | - |
| G | Little-leaf Linden | <i>Tilia cordata</i> | 38 | F | F | F | | 7.0 | - | 3.0 | 2.0 | Lean (L), bulge at base, v-union at 2m with included bark, epicormic branching (L) | Preserve (Injure) | Neighbour | - |

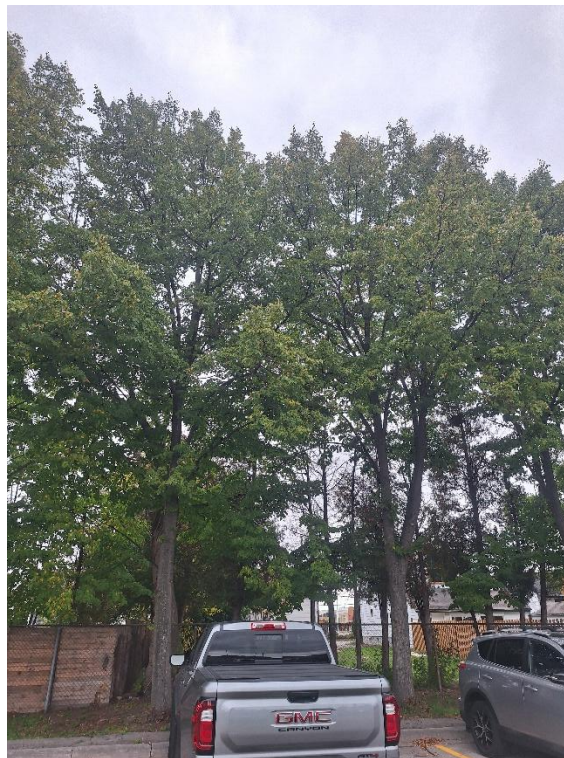
Image 17. Trees H and I

| H | Little-leaf Linden | <i>Tilia cordata</i> | 37 | F | F | F | | 6.0 | - | 3.0 | 2.0 | V-union at 3m with included bark, bulge at base, epicormic branching (L) | Preserve (Injure) | Neighbour | - |
| I | Little-leaf Linden | <i>Tilia cordata</i> | 32 | FG | FG | F | | 6.0 | - | 3.0 | 2.2 | Bulge at base, epicormic branching (L) | Preserve (Injure) | Neighbour | - |

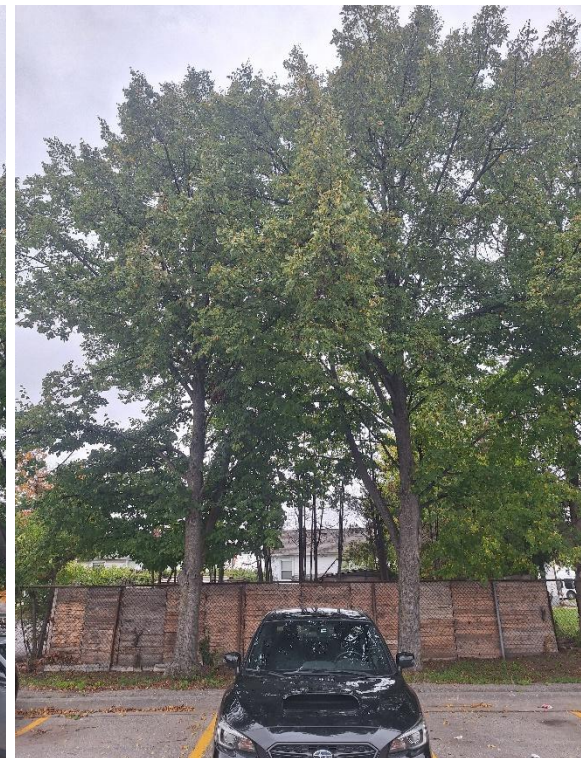
Image 18. Trees J and K

| J | Little-leaf Linden | <i>Tilia cordata</i> | 40 | G | FG | F | | 7.0 | - | 3.0 | 2.5 | Epicormic branching (L) | Preserve (Injure) | Neighbour | - |
| K | Little-leaf Linden | <i>Tilia cordata</i> | 39 | FG | FG | F | | 6.0 | - | 3.0 | 2.4 | Bulge at base, epicormic branching (L) | Preserve (Injure) | Neighbour | - |

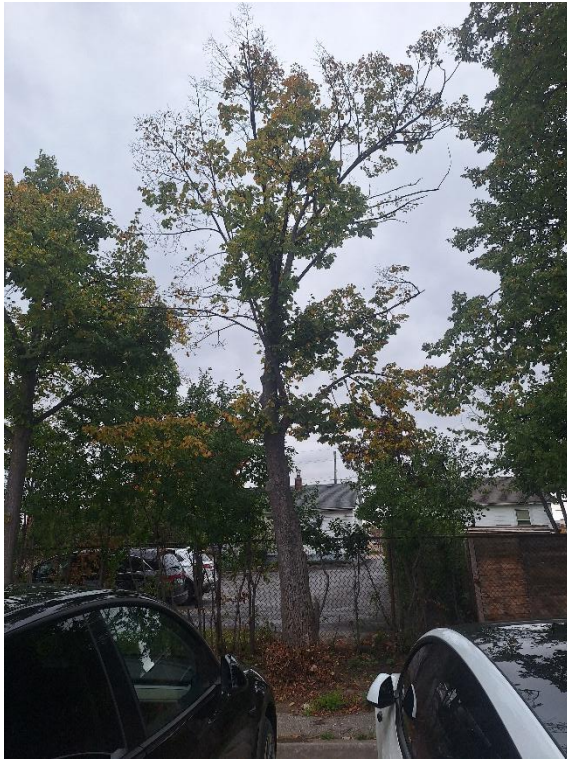
Image 19. Tree L

| L | Little-leaf Linden | <i>Tilia cordata</i> | 38 | P | PF | PF | 40 | 4.0 | - | 3.0 | 2.4 | Part of stem torn out, epicormic branching (M), decay (H) in trunk | Preserve (Injure) | Neighbour | - |

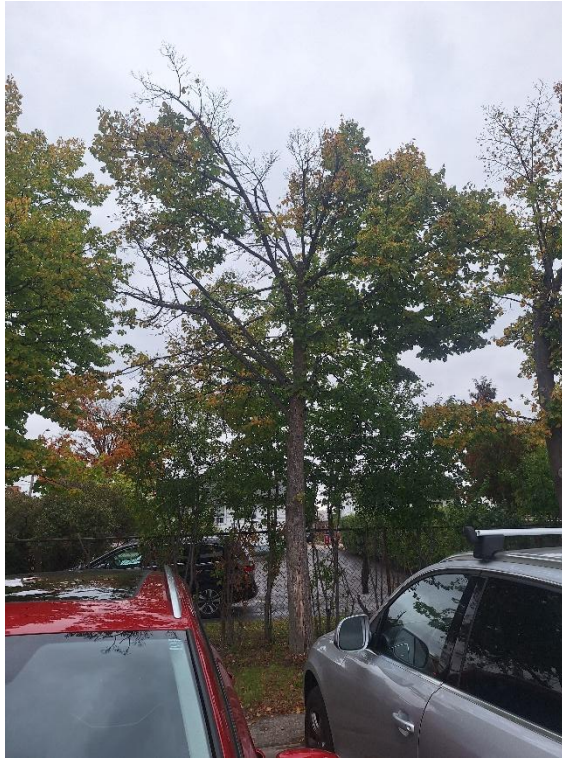
Image 20. Tree M

| M | Little-leaf Linden | <i>Tilia cordata</i> | 25 | PF | PF | PF | 40 | 4.0 | - | 2.4 | 2.4 | Decay (M) in trunk, epicormic branching (M) | Preserve | Neighbour | - |

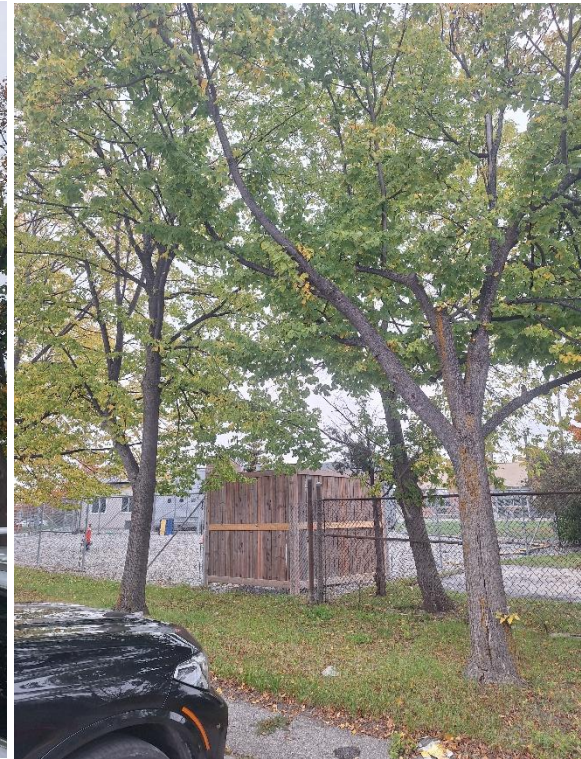
Image 21. Trees N and O

| N | Little-leaf Linden | <i>Tilia cordata</i> | 27 | PF | F | PF | 10 | 4.0 | - | 2.4 | 2.4 | Decay (M) in trunk, epicormic branching (M), v-union at 2m with included bark, bulge at base | Preserve | Neighbour | - |
| O | Little-leaf Linden | <i>Tilia cordata</i> | 28 | FG | F | F | 10 | 4.0 | - | 2.4 | 2.4 | Bulge at base, epicormic branching (L) | Preserve | Neighbour | - |
