Welcome to the September 17, 2024
Public Information Center for the
East Morrison Creek Erosion Mitigation Study
Municipal Class Environmental Assessment
Schedule B

### East Morrison Creek Erosion Sites Reaches 43-45

### East Morrison Creek Erosion Sites Reaches 39-42

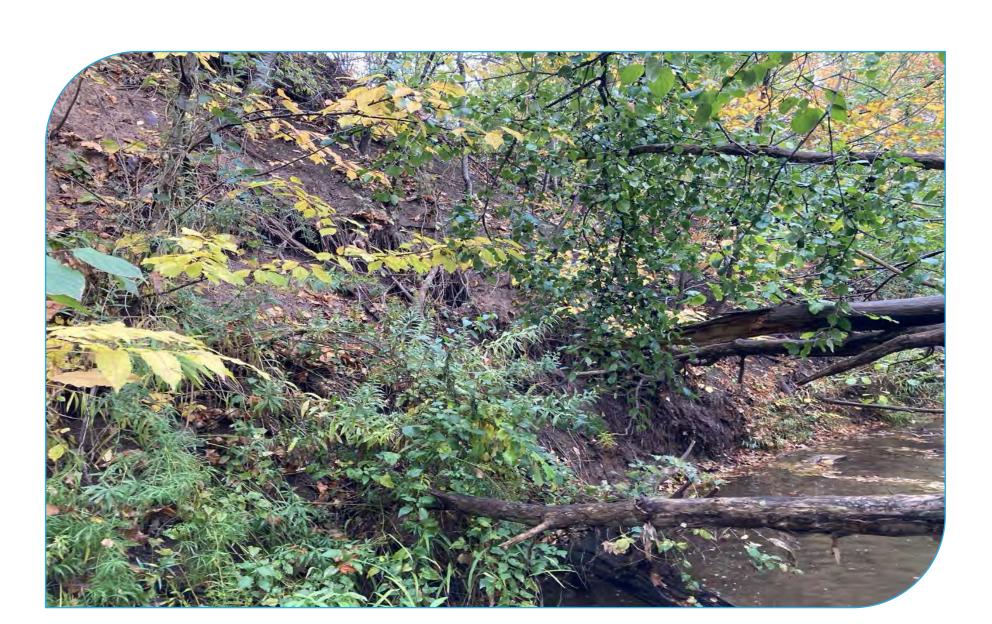
**Site:** E23 Score: 37

Issue: Valley wall contact; eroding valley

slope

Risk: Potential risk to pedestrian trail

system and private property

**Length:** 10 – 20 m

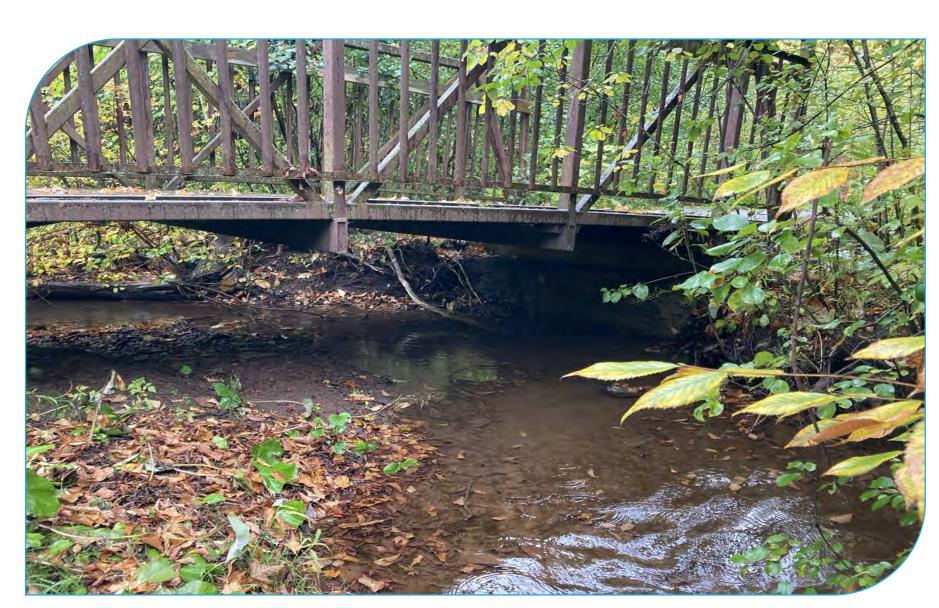
Site: E21 Score: 43

Issue: Erosion around pedestrian bridge; footing exposed within the channel. No damage to the concrete footing

currently.

Risk: Trail infrastructure including pedestrian trail and pedestrian bridge

crossing Length: < 10 m

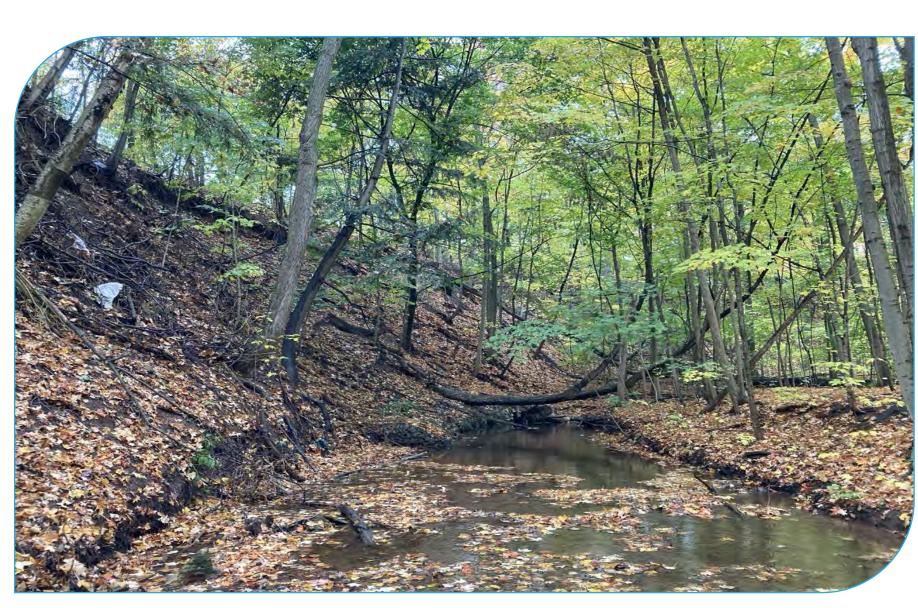
**Site:** E19 Score: 44

**Issue:** Valley wall contact along meander bend (90 degrees); gabion basket protection in fair condition (leaning)

Risk: Pedestrian trail system; private

property

**Length:** 20 – 50 m

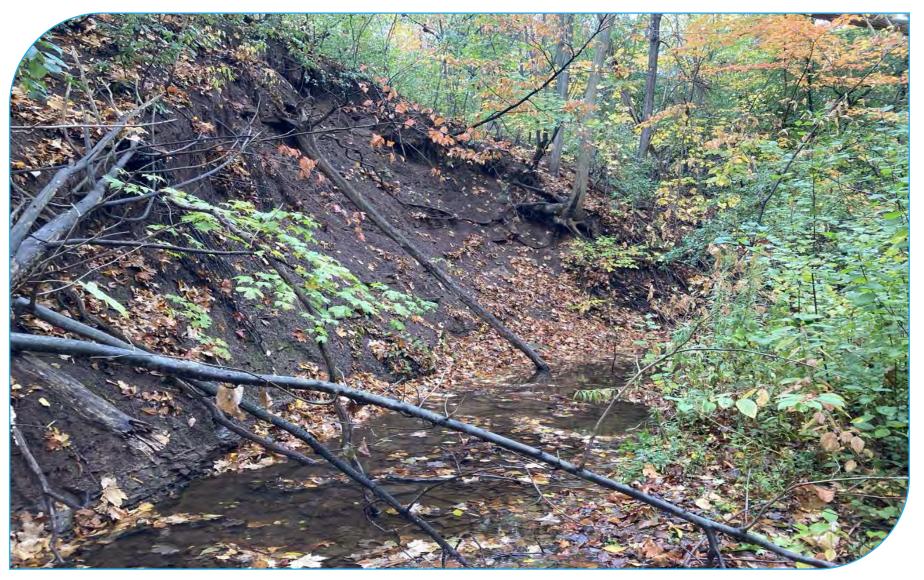
Site: E22 Score: 44

**Issue:** Valley wall contact; eroding valley

slope

Risk: Potential risk to pedestrian trail

system and private property

**Length:** 10 – 20 m

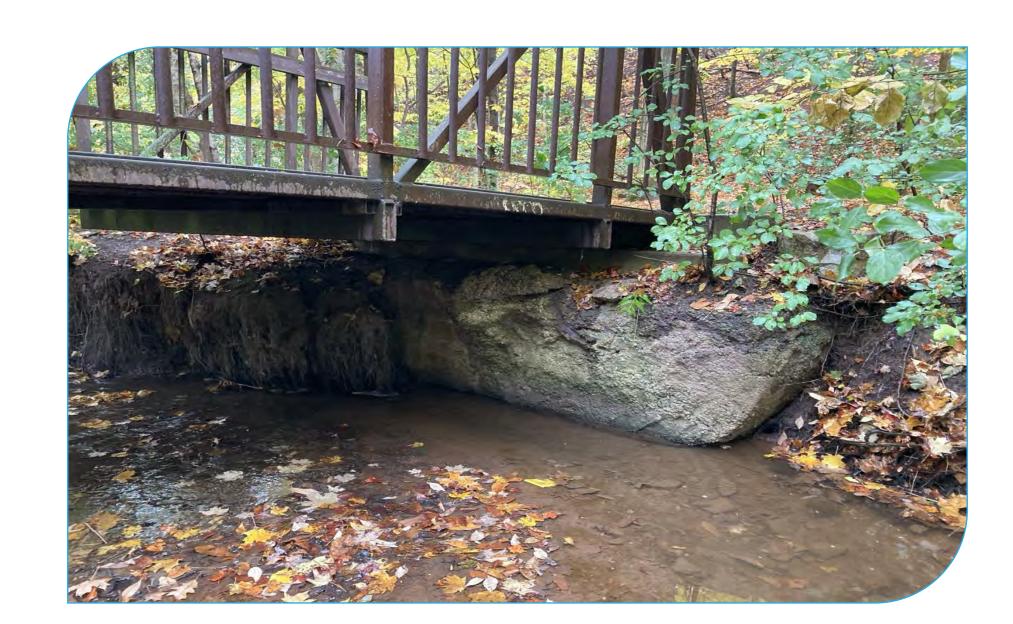
Site: E20 Score: 43

Issue: Erosion around pedestrian bridge crossing; footing exposed on the outer

meander bend.

**Risk:** Trail infrastructure including pedestrian trail and pedestrian bridge

crossing **Length:** < 10 m

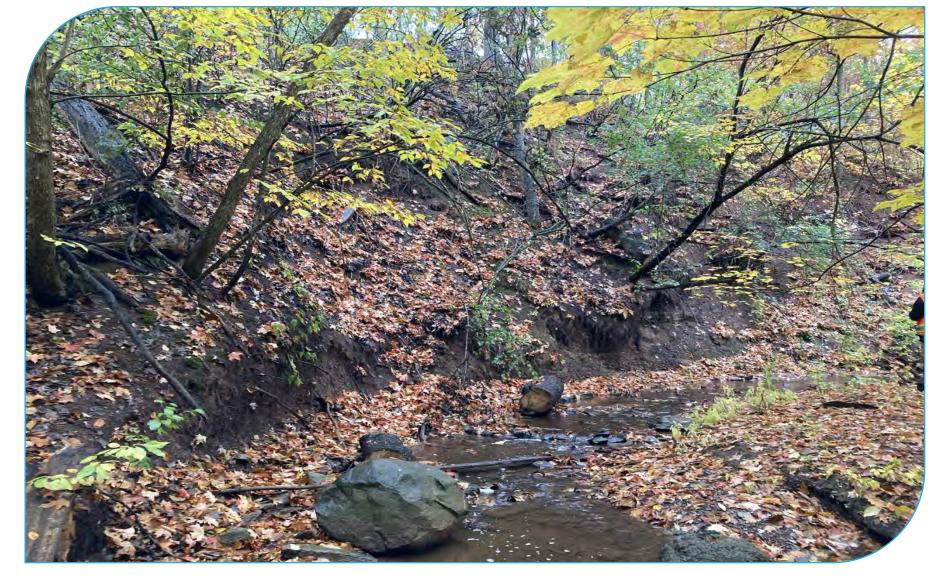
**Site:** E18 **Score:** 39

**Issue:** Valley wall contact; toe erosion

along valley slope

Risk: Pedestrian trail system; park

**Length:** 20 – 50 m

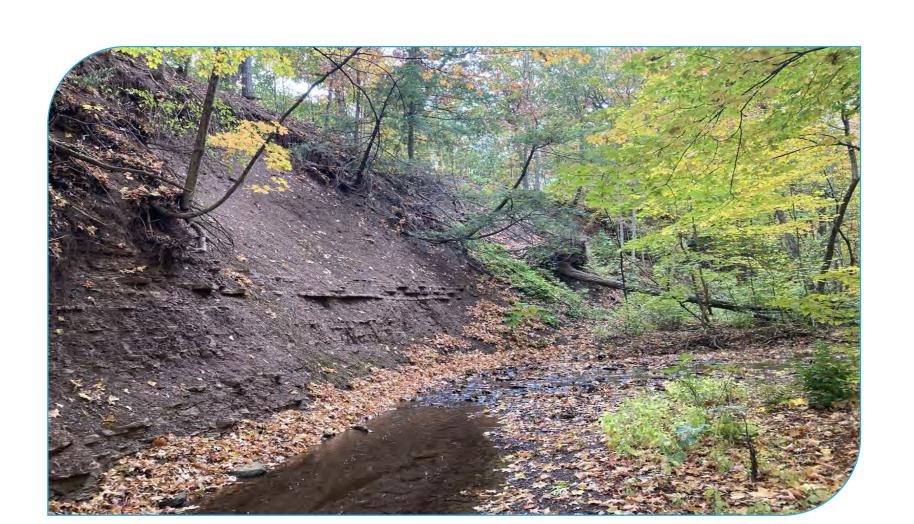
**Site:** E14, E15, E16, E17 **Score:** 54, 53, 53, 51

**Issue:** Toe erosion at valley contact (unprotected).

~5 to 10 m from fence line.

**Risk:** Private property, pedestrian trail

**Length:** 20 – 50 m

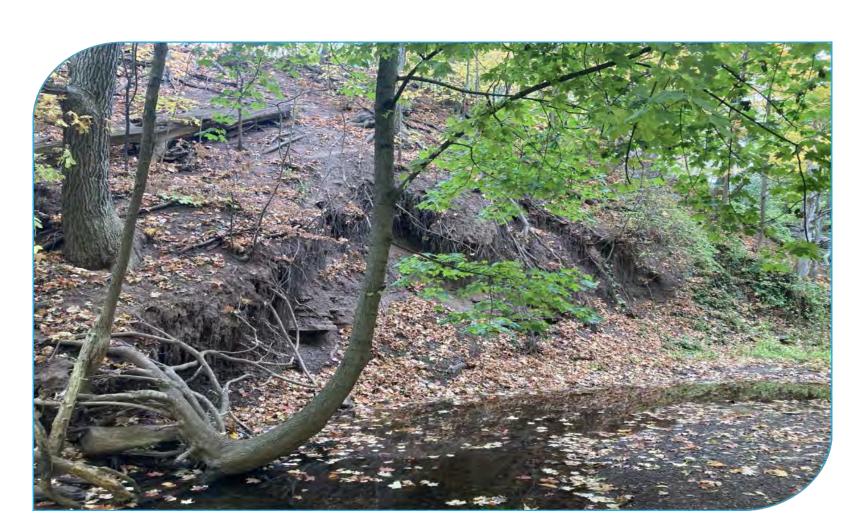
**Site:** E7, E9 **Score:** 56, 53

**Issue:** Toe erosion of valley slope (unprotected)

**Risk:** Private property (parking lot)

**Length:** 10 – 20 m

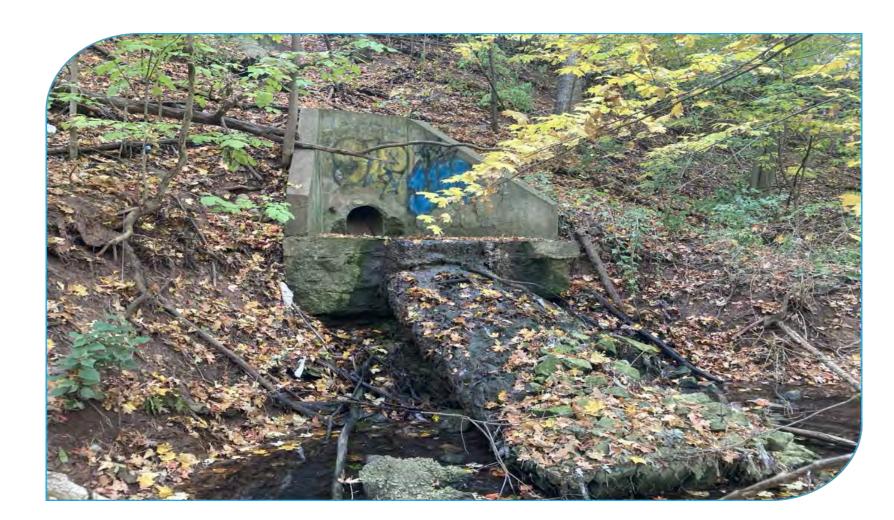
Site: E6 Score: 64

**Issue:** Perched outfall on valley slope, outfall drop

structure suspended, scour pool below

**Risk:** Private property; secondary infrastructure

(outfall)

**Length:** 50 – 100 m

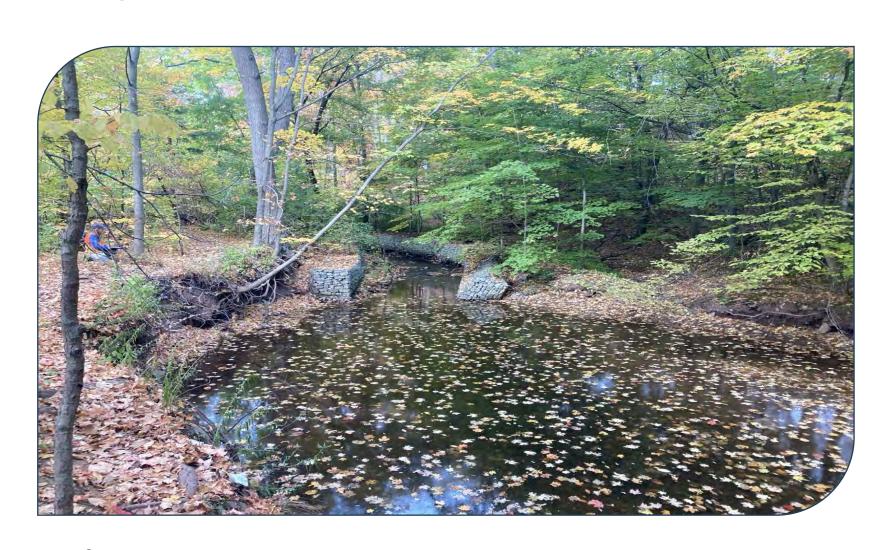
Site: E5 **Score:** 51

**Issue:** Gabion baskets lining both banks. Failing at downstream end and large scour pool.

Risk: Secondary infrastructure (gabion baskets),

pedestrian trail **Length:** 20 – 50 m

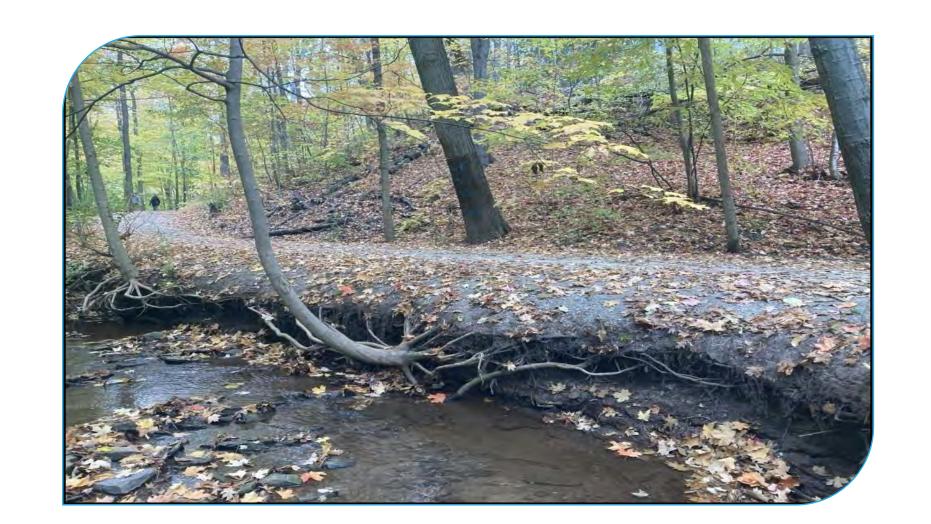
**Site:** E1, E2, E3, E8, E12, E13 (not included in EA)

**Score:** 35, 26, 34, 38, 42, 43

**Issue:** Bank erosion in proximity to pedestrian

trail system; not valley contacts.

**Risk:** Mainly pedestrian trail system, pedestrian bridge (E13), secondary infrastructure (stormwater outfall - E12)

Length: varies

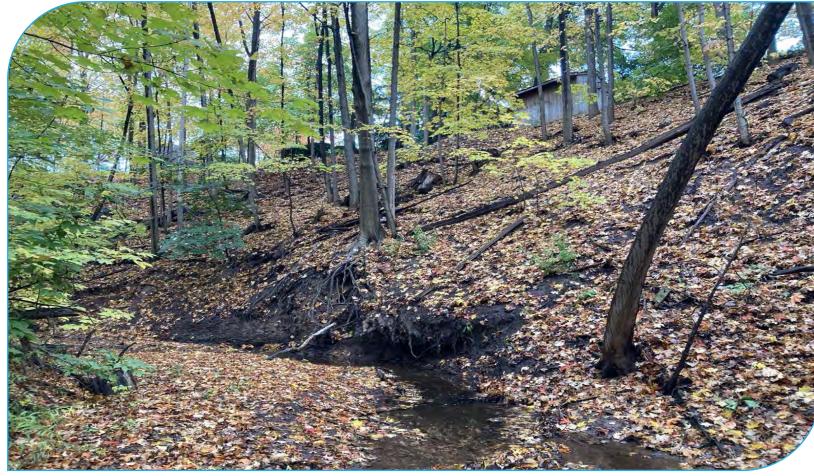
**Site:** E10 Score: 60

**Issue:** Erosion at toe of valley slope in tributary (unprotected); private property at top of slope.

**Risk:** Private property **Length:** 10 – 20 m

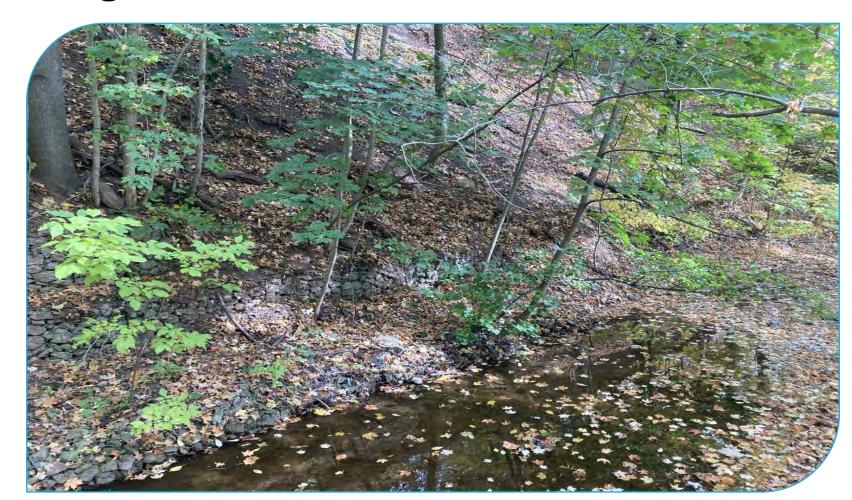
Site: E24 (new site)

**Score:** 59

**Issue:** Valley contact/slope erosion. Gabion toe protection - fair condition (functioning, some

wire failure at toe) **Risk:** Private property **Length:** 20 – 50 m

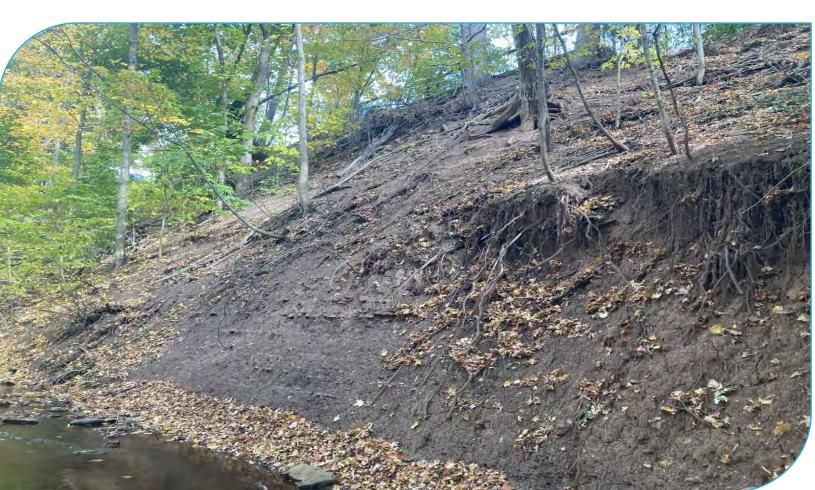
Site: E4 Score: 65

**Issue:** Valley wall contact and slope erosion. Gabion protection near upstream end of erosion is in poor condition (bottom tier corroded/emptied)

**Risk:** Private property **Length:** > 100 m
