**Tree Inventory & Preservation Plan Report  
1258 Rebecca Street  
Oakville, Ontario**

25 March 2022

KUNTZ FORESTRY CONSULTING Inc. Project P3087

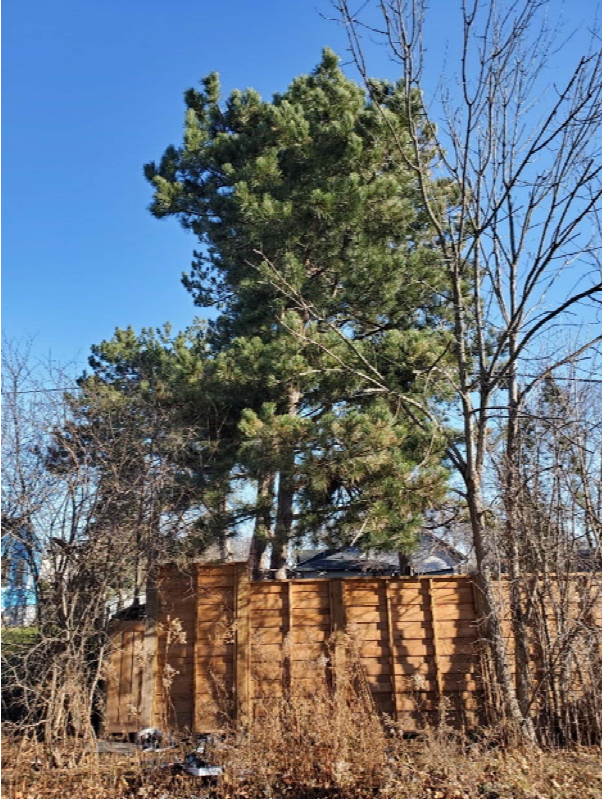
Image 2. Tree 2 behind the fence

- 1) Use air-spading to excavate a trench outside of the TPZ. Exposed roots must be pruned in accordance with Good Arboricultural Standards, and the area backfilled with native topsoil. These operations must be supervised by a certified Arborist. If structural roots or a significant quantity of feeder roots are encountered, the work must be stopped, and Urban Forestry contacted immediately.
- 2) Install vertical tree protection hoarding per Figure 1 during construction.

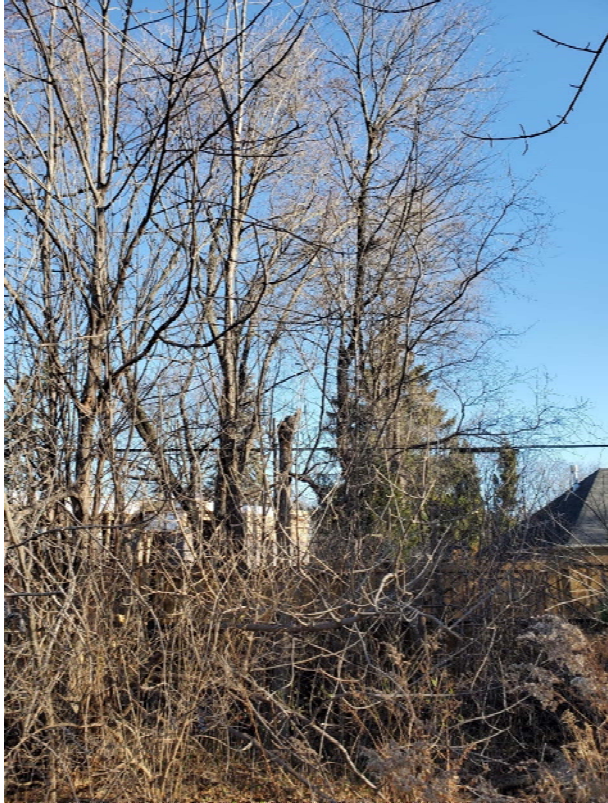
Image 4. Tree 5 (left), Tree 6 (right)

Trees 5 and 6 are located in the neighbouring property, so permission from the respectful landowner to injure these trees will be required. If the following protection and mitigation measures are employed before, during and after construction, long-term adverse effects are not anticipated to this tree.

- 1) Use air-spading to excavate a trench outside of the TPZ. Prune roots inside trench according to Good Arboricultural Practices. Back fill trench with clean topsoil. These operations must be supervised by a certified Arborist. If structural roots or a significant quantity of feeder roots are encountered, the work must be stopped, and Urban Forestry contacted immediately.
- 2) Erect TPZ fencing around the mTPZ as shown on Figure 1. See preservation plan notes on Figure 1.
- 3) Maintain TPZ during construction. Required work post construction must be conducted by hand including final landscaping. Changes to grades inside TPZ area not permitted ever. The elevation of the grades inside the TPZ must factoring into final grading for

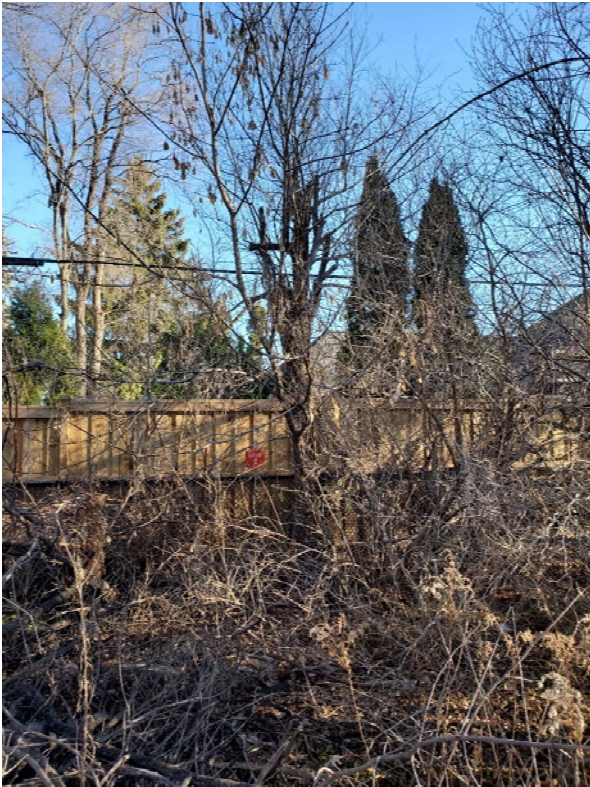
Image 5. Tree 7 (behind shrub)

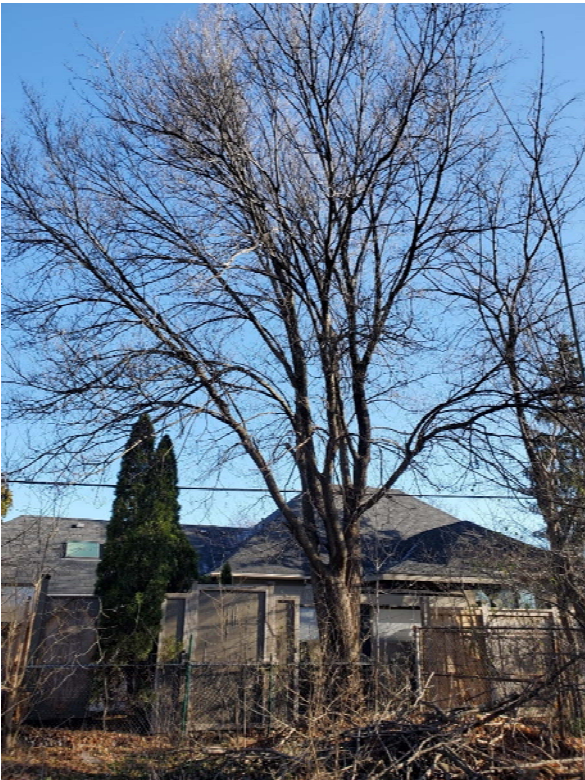
Image 6. Tree 8 (behind chain link fence)

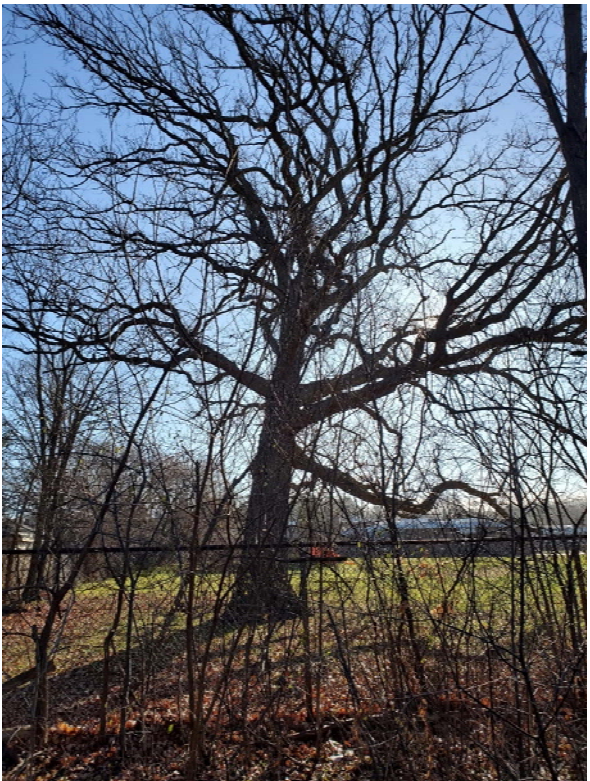
Image 7. Tree 9

9	Bur Oak	<i>Quercus macrocarpa</i>	~120	G	G	F	G	20	22	7.2	Leaning (L), epicormic branching (M), 5.5 meters from fence	Neighbouring	Retain
10	Silver Maple	<i>Acer saccharinum</i>	81	G	F	F	G		16	5.4	Epicormic branching (L)	Private	Remove

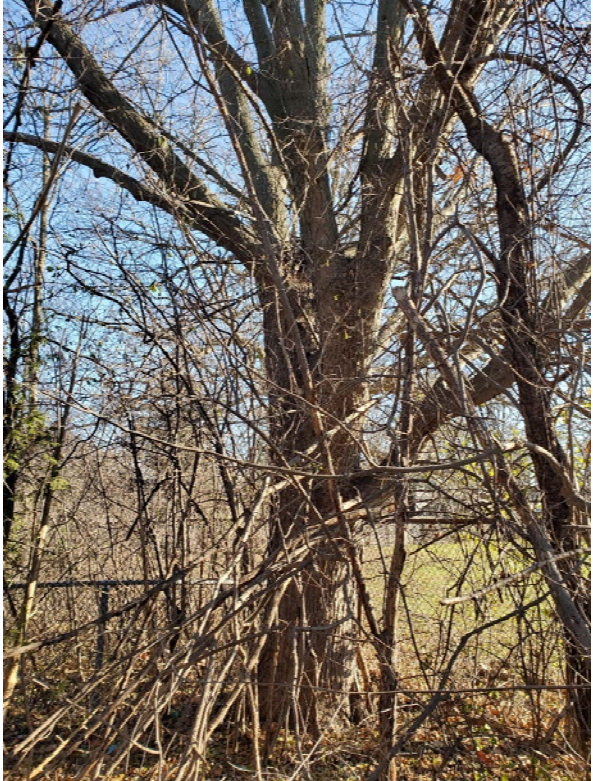
Image 8. Tree 10 (behind buckthorn)

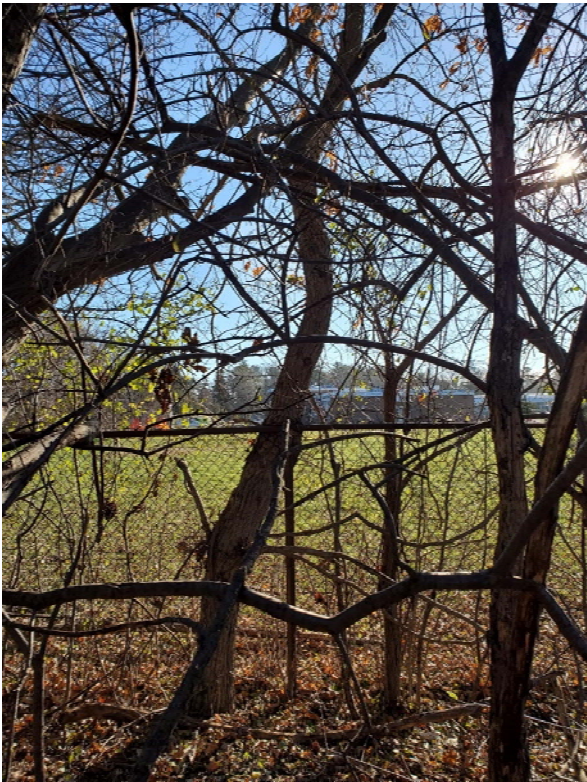
Image 9. Tree 11

11	Bur Oak	<i>Quercus macrocarpa</i>	~28	P	P	P	G		2	2.4	Remove, including fence, poor form (H), epicormic branching (H)	Private	Remove
12	Silver Maple	<i>Acer saccharinum</i>	~20, 35, 45, 30, 30	F	F	F	G		16	3.0	Co-dominance at base with 5 stems	Private	Remove
13	Silver Maple	<i>Acer saccharinum</i>	47.5	G	F	F/G	G		9	3.0	Poor form (L)	Private	Remove
14	Silver Maple	<i>Acer saccharinum</i>	32	G	FG	G	G		9	3.0		Private	Remove
15	Sugar Maple	<i>Acer saccharum</i>	~8, 10, 16	P/F	G	G	G		7	2.4	Co-dominance at base with 3 stems	Private	Remove
16	Silver Maple	<i>Acer saccharinum</i>	~8, 10, 15, 20, 20	F	G	G	G		12	2.4	Co-dominance at base with 5 stems	Private	Remove
17	Silver Maple	<i>Acer saccharinum</i>	~8, 15, 15, 15, 15	F	G	G	G		12	2.4	Co-dominance at base with 6 stems	Private	Remove
18	Apple species	<i>Malus sp.</i>	~12, 18, 10	G	G	F	G		8	2.4		Private	Remove
19	Apple species	<i>Malus sp.</i>	~26	G	G	F	G		7	2.4		Private	Remove

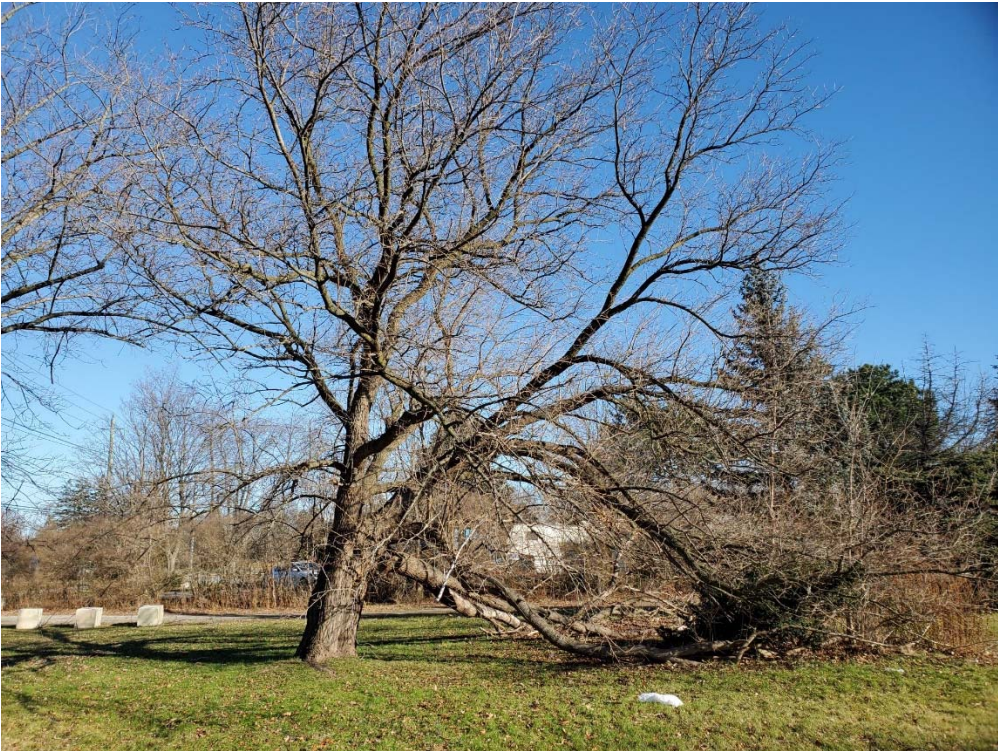
Image 19. Tree 23

21	Blue Spruce	<i>Picea pungens</i>	~25	G	G	G	G	40	4	2.4	Dead leader	Private	Remove
22	Blue Spruce	<i>Picea pungens</i>	~23	G	G	G	G		4	2.4		Private	Remove
23	White Mulberry	<i>Morus alba</i>	89	F	P/F	P	G	20	16	5.4	Exposed roots (H), 2 broken branches, epicormic branching (H)	Private	Remove
24	Silver Maple	<i>Acer saccharinum</i>	92	P/F	F	F	G		18	6.0	Pruning wounds (H), cankers (H), epicormic branching (M), to remove	Private	Remove
25	Honey Locust (shademaster)	<i>Gleditsia triacanthos inermis</i>	48.5	G	G	P/F	F		9	3.0	Asymmetrical crown (H), hybrid	City	Retain
26	Honey Locust (shademaster)	<i>Gleditsia triacanthos inermis</i>	54	G	P/F	P/F	F		10	3.6	Asymmetrical crown (H), epicormic branching (H), hybrid	City	Retain
27	American Beech	<i>Fagus grandifolia</i>	56	G	G	F	G		12	3.6		Private	Remove
28	White Birch	<i>Betula papyrifera</i>	28	G	G	P	G	40	6	2.4	Dead leader	Private	Remove
29	White Birch	<i>Betula papyrifera</i>	40.5	G	G	P	G	45	7	3.0	Dead leader	Private	Remove

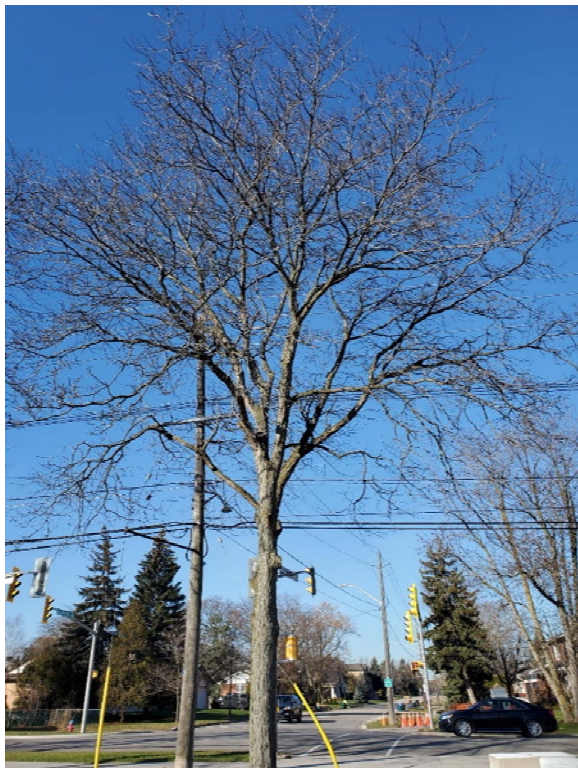
Image 25. Tree 30

30	Honey Locust (shademaster)	<i>Gleditsia triacanthos inermis</i>	48.5	G	G	P/F	F		14	3.0	Pruning wounds (M), epicormic branching (M)	City	Remove
31	Honey Locust (shademaster)	<i>Gleditsia triacanthos inermis</i>	53	G	G	P/F	F		15	3.6	Pruning wounds (M), epicormic branching (M)	City	Remove

The removal of Trees 30 & 31 (public trees) will be required to accommodate the proposed entrance into the subdivision. A permit to remove the public trees will be required from the Town.
