**Tree Inventory and Preservation Plan  
2172 Wyecroft Road  
Oakville, Ontario**

**O2 Planning and Design Inc.**

18 March 2025

KUNTZ FORESTRY CONSULTING INC. Project P4579

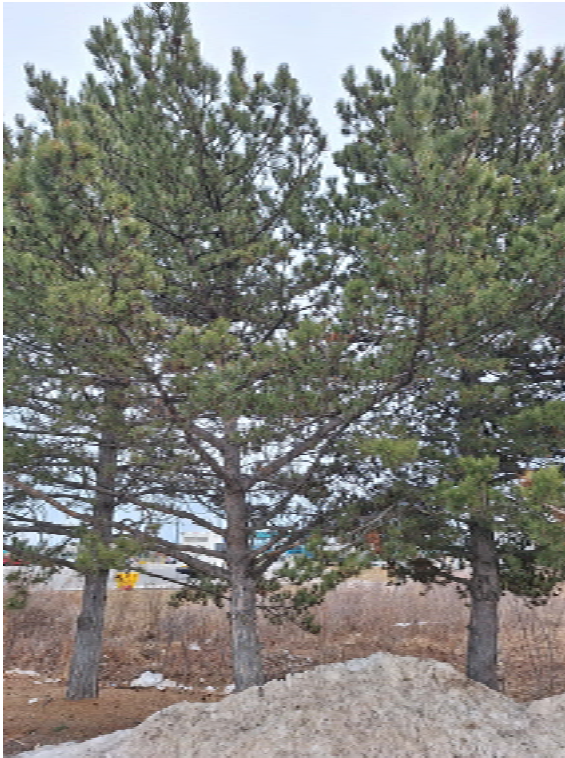
Image 1. Trees 301-303 (Right to left)

| Tree # | Common Name | Scientific Name | DBH | Multistem DBH | TI | CS | CV | CDB | DL | mTPZ | A. mTPZ | Oakville Tree # | Comments | Action | Owner | Comp. |
|---|---|---|---|---|---|---|---|---|---|---|---|---|---|---|---|---|
| 301 | Austrian Pine | <i>Pinus nigra</i> | 29 | | F | F | F | 10 | 4.5 | 2.4 | 3.7 | | Lean (M), epicormic branching (L), pruning wounds (L) | Preserve | Subject property | |
| 302 | Austrian Pine | <i>Pinus nigra</i> | 28 | | F | P-F | P-F | 30 | 4.5 | 2.4 | 2.4 | | Lean (L), crook (M), asymmetrical crown (L), epicormic branching (L) | Preserve | Subject property | |
| 303 | Austrian Pine | <i>Pinus nigra</i> | 33 | | G | F | F | 30 | 5.5 | 3.0 | 3.8 | | Epicormic branching (L), pruning wounds (L) | Preserve | Subject property | |

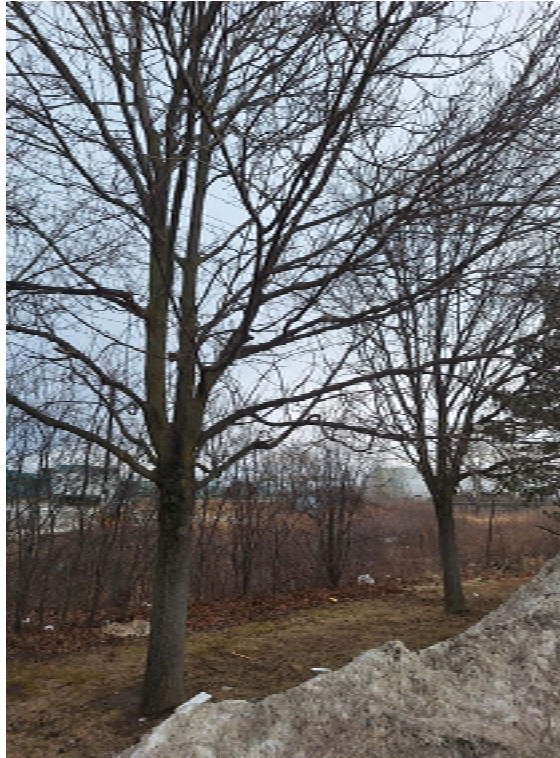
Image 2. Tree 304

| Tree # | Common Name | Scientific Name | DBH | Multistem DBH | TI | CS | CV | CDB | DL | mTPZ | A. mTPZ | Oakville Tree # | Comments | Action | Owner | Comp. |
|---|---|---|---|---|---|---|---|---|---|---|---|---|---|---|---|---|
| 304 | Norway Maple | <i>Acer platanoides</i> | 26.5 | | F-G | P-F | P-F | 30 | 4.5 | 2.4 | 4.0 | | Multiple branch attachments, asymmetrical crown (L), epicormic branching (L), broken branch (L) | Preserve | Subject property | |

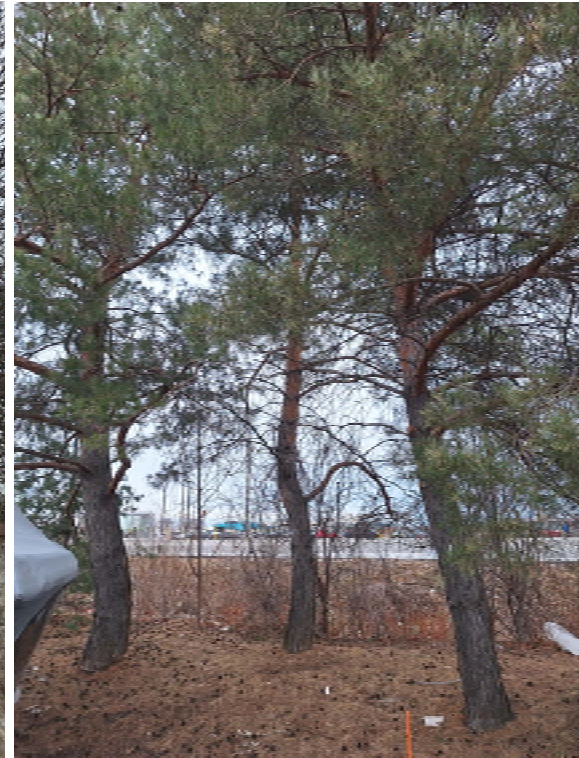
Image 3. Trees 306-308 (Right to left)

The removal of seven trees, including Trees 306-308 and 487-490, will be required to accommodate the proposed development. Trees 306 and 307 directly conflict with the proposed road. Minor encroachment into the minimum tree protection zone (mTPZ) of tree 308 will be required to accommodate the proposed road; although due to the tree's declining structural condition, we do not anticipate the tree can tolerate this level of injury. Significant encroachment into the mTPZ's of Trees 487-490 will be required to accommodate the proposed building and underground parking such that we do not anticipate these trees to tolerate this level of injury.

| Tree # | Common Name | Scientific Name | DBH | Multistem DBH | TI | CS | CV | CDB | DL | mTPZ | A. mTPZ | Oakville Tree # | Comments | Action | Owner | Comp. |
|---|---|---|---|---|---|---|---|---|---|---|---|---|---|---|---|---|
| 306 | Scots Pine | <i>Pinus sylvestris</i> | 28 | | P-F | F | F | 10 | 4.0 | 2.4 | | | Lean (L), crook (H), pruning wounds (L), poor form (L) | Remove | Subject property | 3 |
| 307 | Scots Pine | <i>Pinus sylvestris</i> | 29 | | F | F-G | F-G | 10 | 4.0 | 2.4 | | | Crook (L) | Remove | Subject property | 3 |
| 308 | Scots Pine | <i>Pinus sylvestris</i> | 39 | | F | F | F | 10 | 5.5 | 3.0 | | | Crook (M), sweep (L), broken branch (L), pruning wounds (L), asymmetrical crown (L) | Remove | Subject property | 4 |

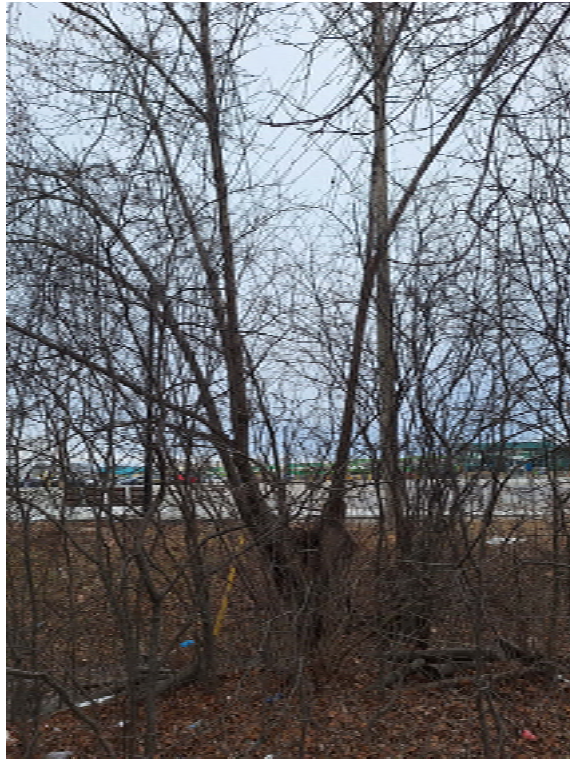
Image 4. Tree 309

| 309 | Silver Maple | <i>Acer saccharinum</i> | 39,<br>16.5 | 42.3 | P | P-F | P-F | 20 | 5.0 | 3.0 | 5.0 | | Union at 2m with cavity (H), pruning wounds (H), multiple branch attachment, poor branch unions, epicormic branching (M), poor form (M) | Preserve | Subject property | |

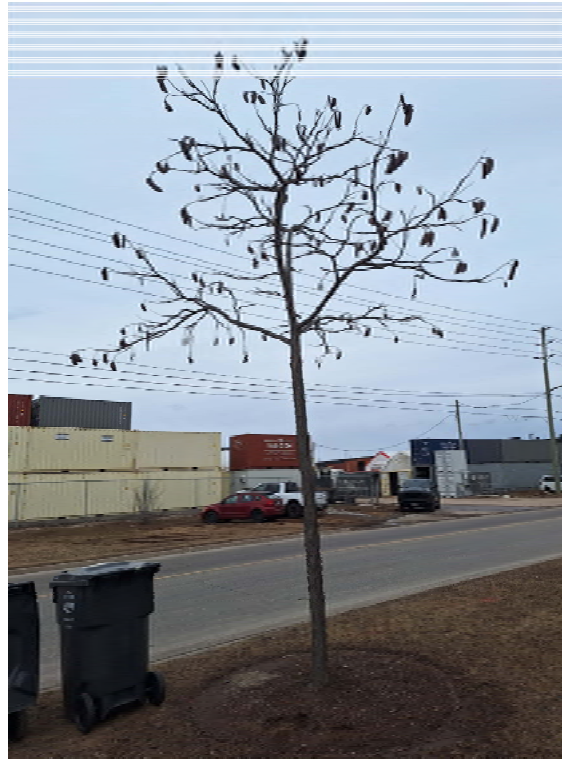
Image 5. Tree 482

| 482 | Kentucky Coffeetree | <i>Gymnocladus dioicus</i> | 11.5 | | G | G | G | | 2.5 | 2.4 | 2.5 | 466196 | | Preserve | Town | |

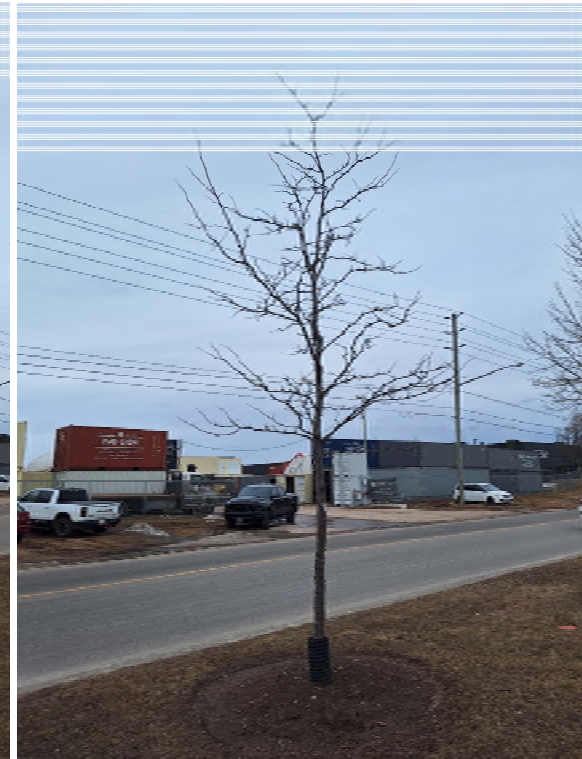
Image 6. Tree 483

| 483 | Honey Locust (shademaster) | <i>Gleditsia triacanthos inermis</i> | 7 | | G | G | G | | 2.0 | 1.8 | 2.8 | 592780 | | Preserve | Town | |

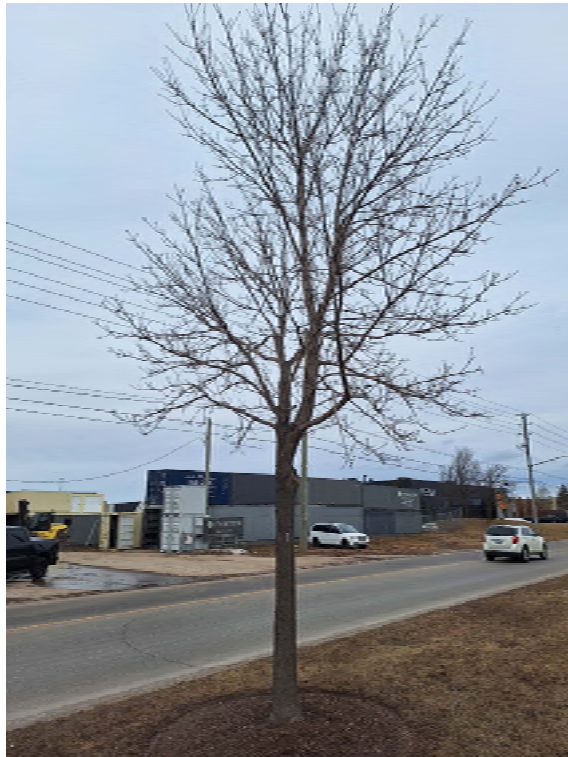
Image 7. Tree 484

| 484 | Norway Maple | <i>Acer platanoides</i> | 18.5 | | F | F-G | F | | 3.0 | 2.4 | 3.0 | 466194 | Epicormic branching (L), pruning wounds (M) with decay (L) | Preserve | Town | |

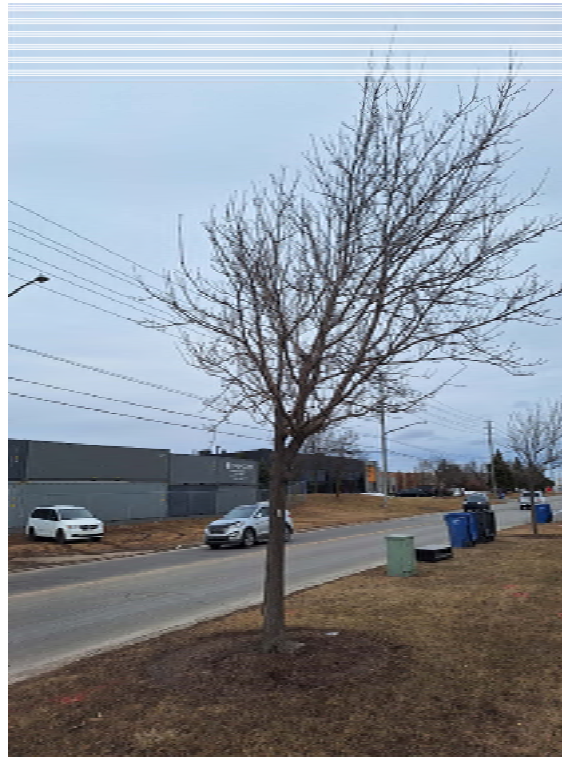
Image 8. Tree 485

| 485 | Norway Maple | <i>Acer platanoides</i> | 19 | | P-F | P-F | F | | 3.0 | 2.4 | 3.0 | 466193 | Asymmetrical crown (M), epicormic branching (M), stem wound (M) with decay (L), poor form (L), pruning wound (M) with decay (L) | Preserve | Town | |

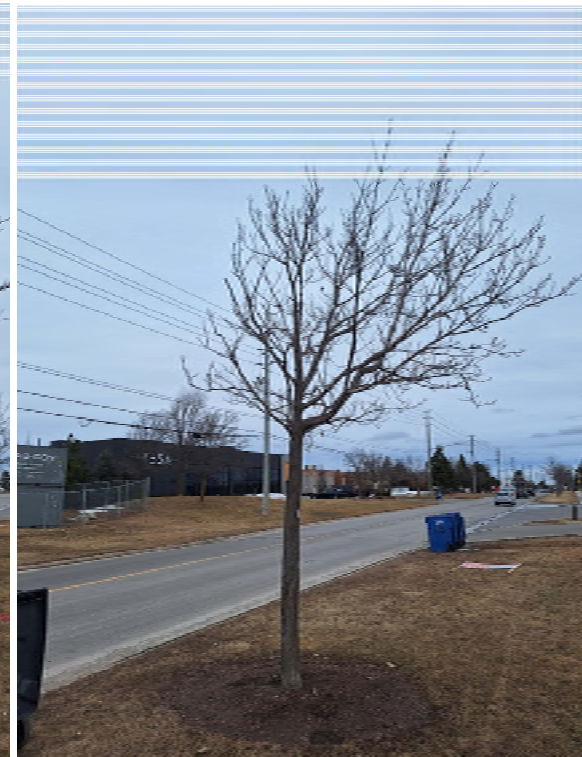
Image 9. Tree 486

| 486 | Norway Maple | <i>Acer platanoides</i> | 13 | | P-F | P-F | P-F | 30 | 3.0 | 2.4 | 3.0 | 466192 | Asymmetrical crown (M), seam (M) with decay (M), epicormic branching (L) | Preserve | Town | |

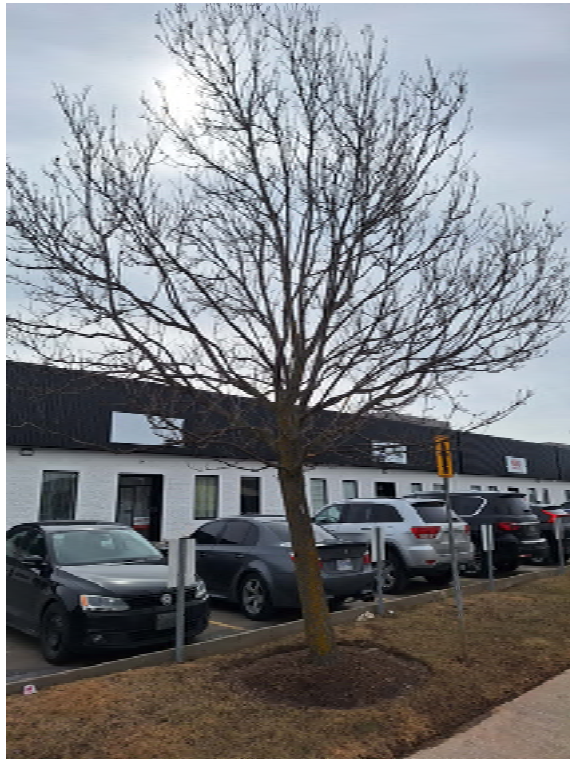
Image 10. Tree 487

| 487 | Norway Maple | <i>Acer platanoides</i> | 23.5 | | P-F | P-F | P-F | 30 | 3.5 | 2.4 | | | Lean (M), stem wound (L), with decay (L), poor branch unions | Remove | Subject property | 1 |

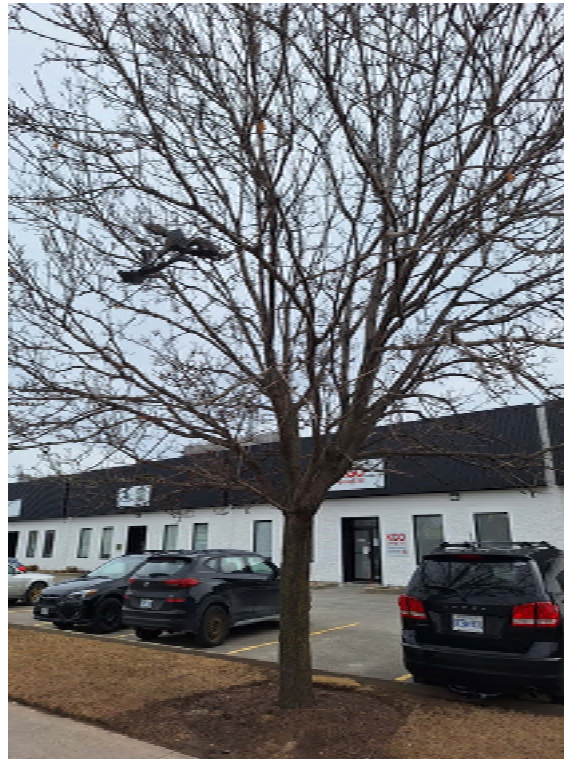
Image 11. Tree 488

| 488 | Norway Maple | <i>Acer platanoides</i> | 31 | | F | F | F | 20 | 4.5 | 3.0 | | | Multiple branch attachment with poor branch unions, epicormic branching (L) | Remove | Subject property | 3 |

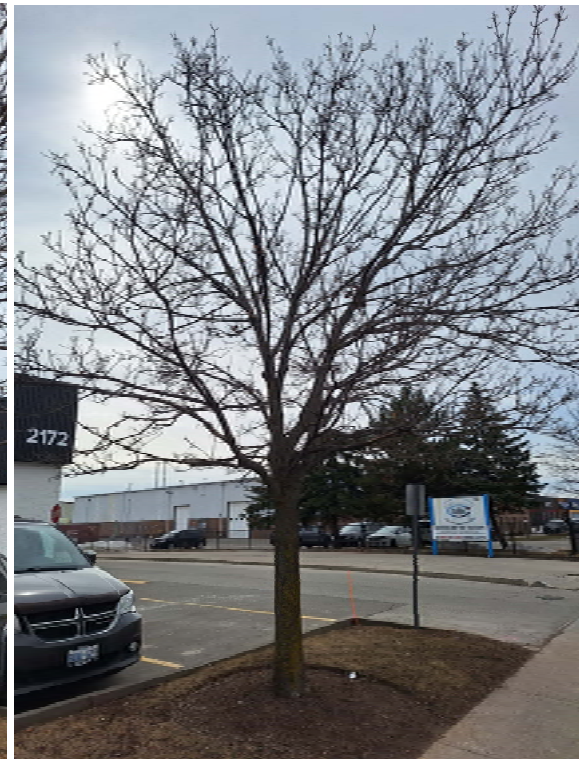
Image 12. Tree 489

| 489 | Norway Maple | <i>Acer platanoides</i> | 23 | | F | F | F | 20 | 3.5 | 2.4 | | | Growth deficit (L), multiple branch attachment with poor branch unions, epicormic branching (L) | Remove | Subject property | 2 |

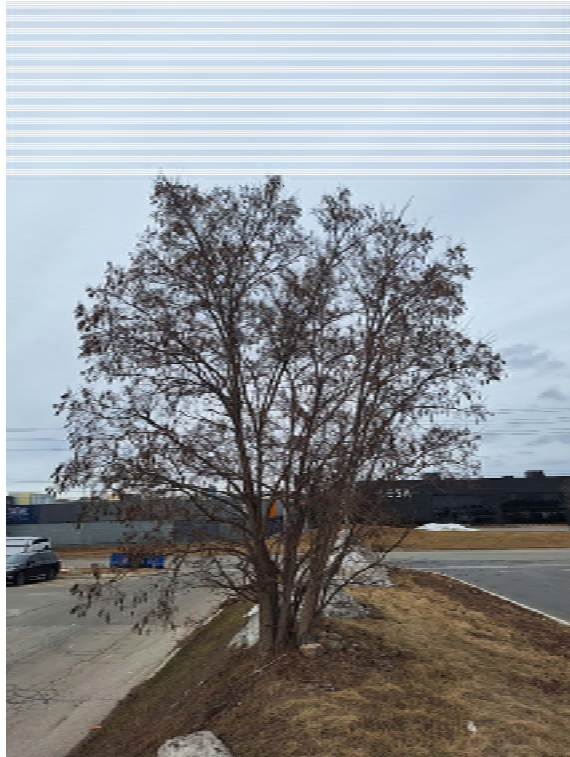
Image 13. Tree 490

| 490 | Black Locust | <i>Robinia pseudoacacia</i> | 15,<br>11.5,<br>11,<br>10 | 24.0 | F | F | F | | 3.0 | 2.4 | | Union and v-union at base, epicormic branching (M), stem wound (L) with decay (L), broken branches (L) | Remove | Neighbouring | 2 |

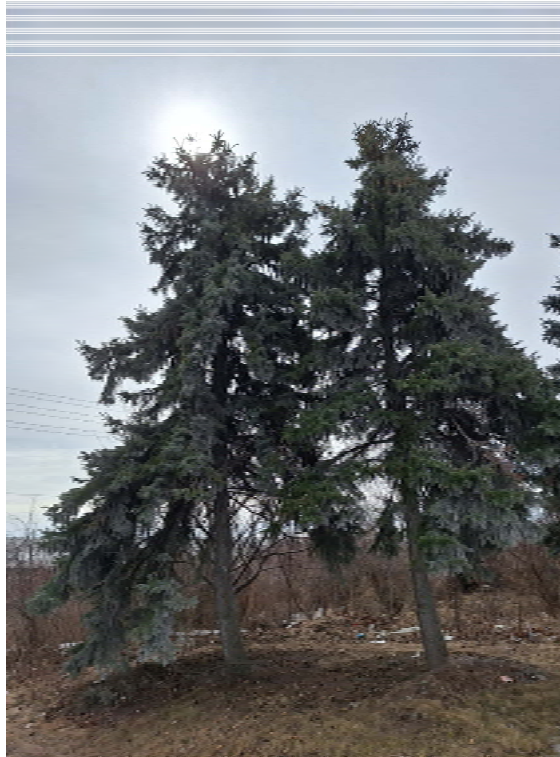
Image 14. Trees 491 and 492 (Right to left)

| 491 | Blue Spruce | <i>Picea pungens</i> | 21.5 | | F-G | F | F | 20 | 3.0 | 2.4 | 2.4 | Pruning wounds (M), buried root flare | Preserve | Neighbouring | |
| 492 | Blue Spruce | <i>Picea pungens</i> | 27.5 | | F | F | F | 20 | 3.0 | 2.4 | 4.9 | Sweep (M), pruning wounds (L) | Preserve | Neighbouring | |

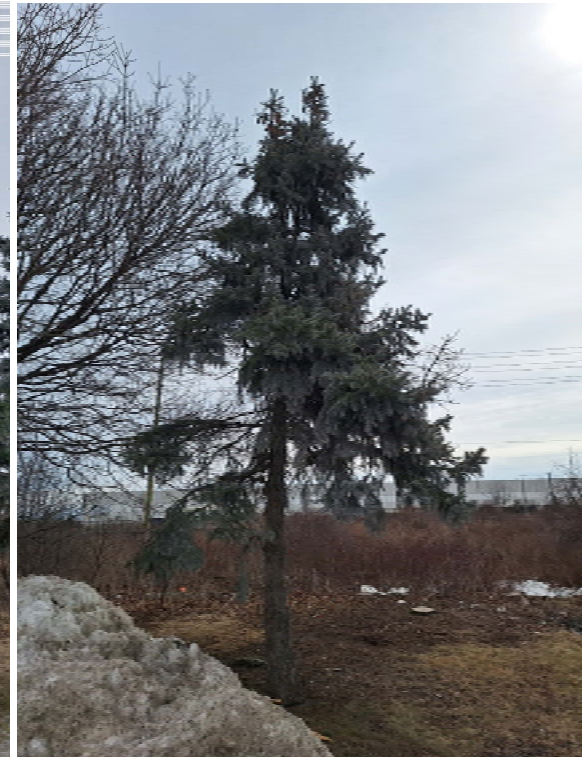
Image 15. Tree 493

| 493 | Blue Spruce | <i>Picea pungens</i> | 18.5 | | P-F | P-F | P-F | 40 | 2.5 | 2.4 | 2.0 | Sweep (M), pruning wounds (M), codominant crown | Preserve (Injure) | Neighbouring | |

Minor encroachment into the mTPZ's of Trees 493 and 498 will be required to accommodate the proposed walkway along the eastern boundary. Prior to construction, designated tree protection fencing must be installed as shown on Figure 1. Prior to the installation of the walkway, a trench must be excavated at the limit of the proposed walkway by hand or using Airspading technology under the supervision of a Certified Arborist. Any exposed roots must be pruned in accordance with Good Arboricultural Standards.

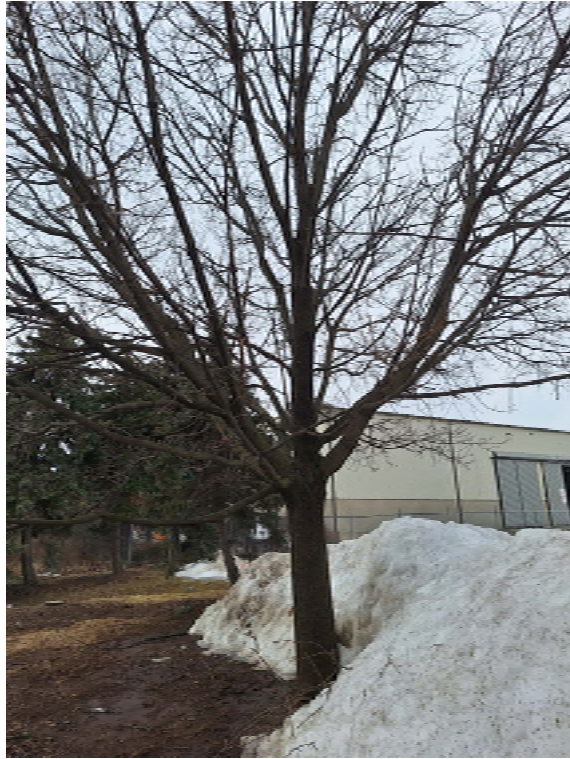
Image 16. Tree 494

| 494 | Norway Maple | <i>Acer platanoides</i> | 35.5 | | F | F | F | 30 | 6.5 | 3.0 | 3.8 | Multiple branch attachment with poor branch unions, epicormic branching (L), girdled roots (L) | Preserve | Neighbouring | |

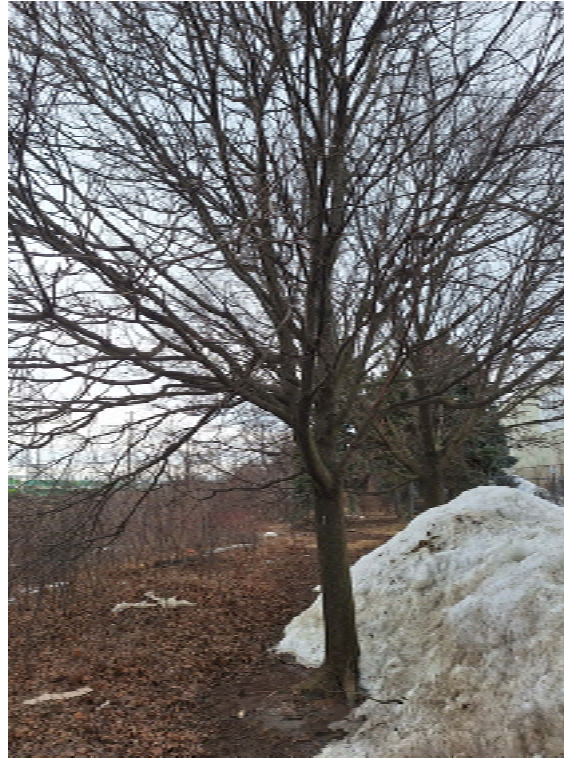
Image 17. Tree 495

| 495 | Norway Maple | <i>Acer platanoides</i> | 29.5 | | F-G | F | F | 30 | 5.5 | 2.4 | 6.5 | Poor branch union, epicormic branching (L), broken branch (L) | Preserve | Neighbouring | |

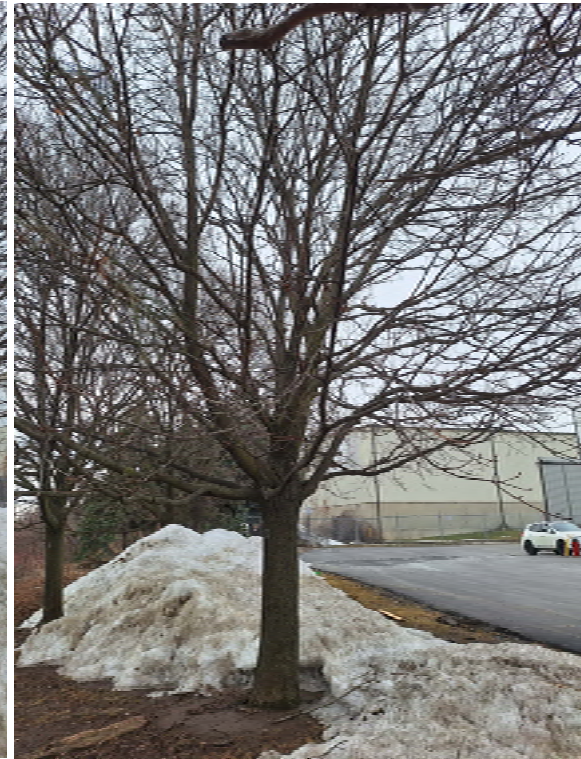
Image 18. Tree 496

| 496 | Norway Maple | <i>Acer platanoides</i> | 33 | | F | F | F | 30 | 5.5 | 3.0 | 4.0 | Multiple branch attachment, poor branch unions, exposed roots M(), with wounds (M), epicormic branching (L) | Preserve | Neighbouring | |

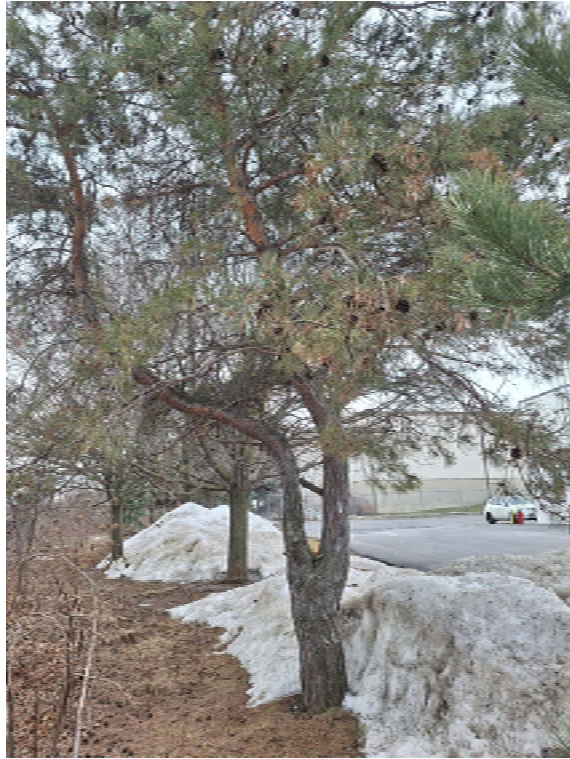
Image 19. Tree 497

| 497 | Scots Pine | <i>Pinus sylvestris</i> | 22,<br>18 | 28.4 | P-F | F | F | 20 | 4.5 | 2.4 | 4.3 | V-union at 1, crook (M), pruning wounds (M) | Preserve | Neighbouring | |

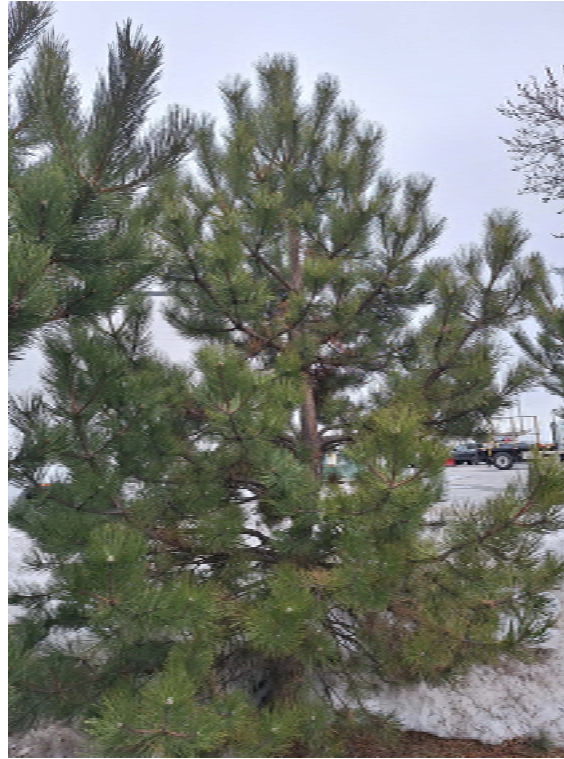
Image 20. Tree 498

| 498 | Austrian Pine | <i>Pinus nigra</i> | 12 | | F-G | G | G | | 2.0 | 2.4 | 2.1 | Crook (L) | Preserve (Injure) | Neighbouring | |

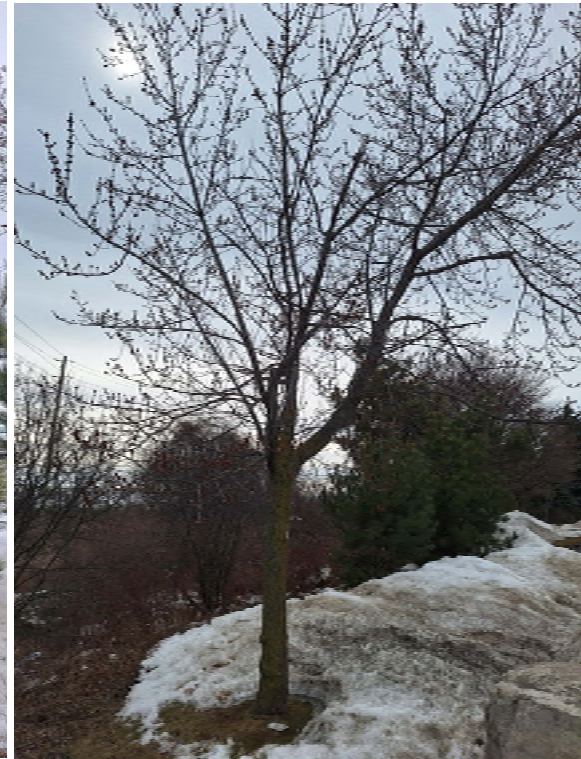
Image 21. Tree 499

| 499 | Silver Maple | <i>Acer saccharinum</i> | 23 | | F | F | F | 10 | 5.0 | 2.4 | 3.5 | Epicormic branching (M), asymmetrical crown (L), bowing (L), decay (L) in trunk | Preserve | Subject property | |

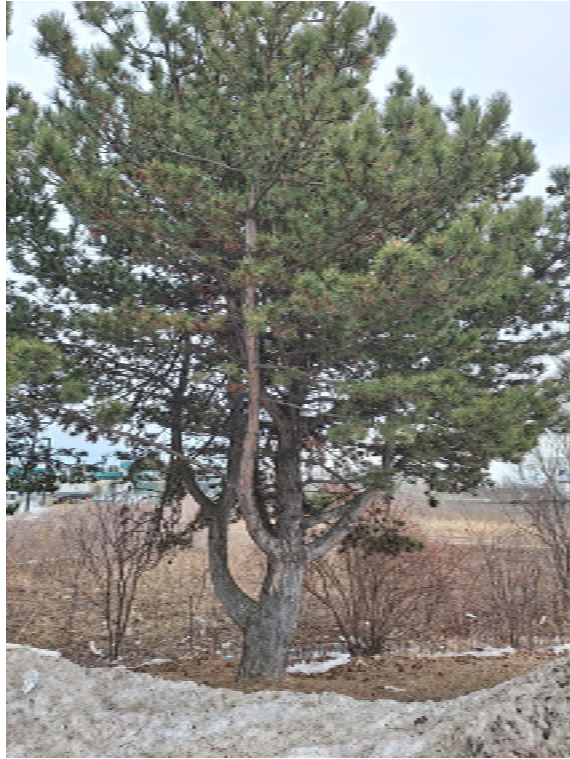
Image 22. Tree 500

| 500 | Austrian Pine | <i>Pinus nigra</i> | 30.5 | | F-G | F | F | 20 | 4.5 | 3.0 | 4.1 | | Lean (L), epicormic branching (L), poor form (L), pruning wounds (L) | Preserve | Subject property | |

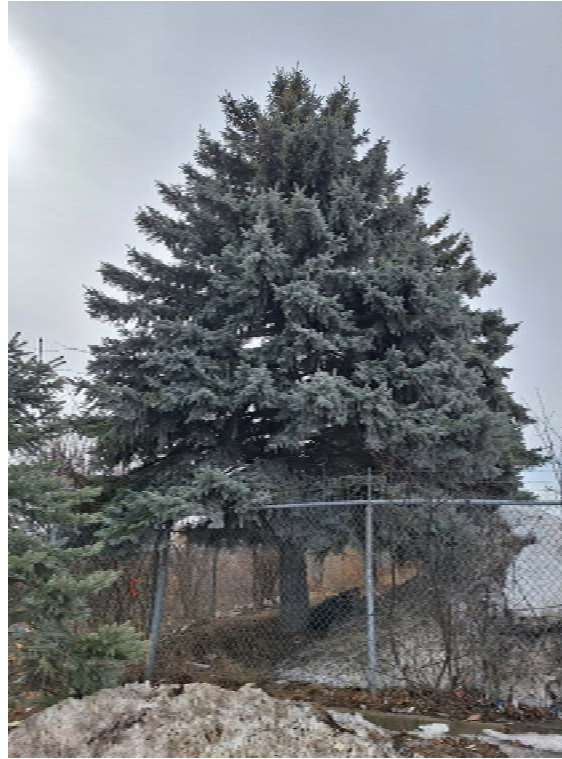
Image 23. Tree A

| A | Blue Spruce | <i>Picea pungens</i> | ~44 | | F | G | F | | 4.5 | 3.0 | 3.5 | | Sap ooze (M), lean (L) | Preserve | Neighbouring | |
