**Tree Inventory and Preservation Plan Report
3043 Sixth Line
Oakville, Ontario**

5 October 2022, revised 6 October 2023 and 17 February 2026

KUNTZ FORESTRY CONSULTING Inc. Project P4911 (P3475)

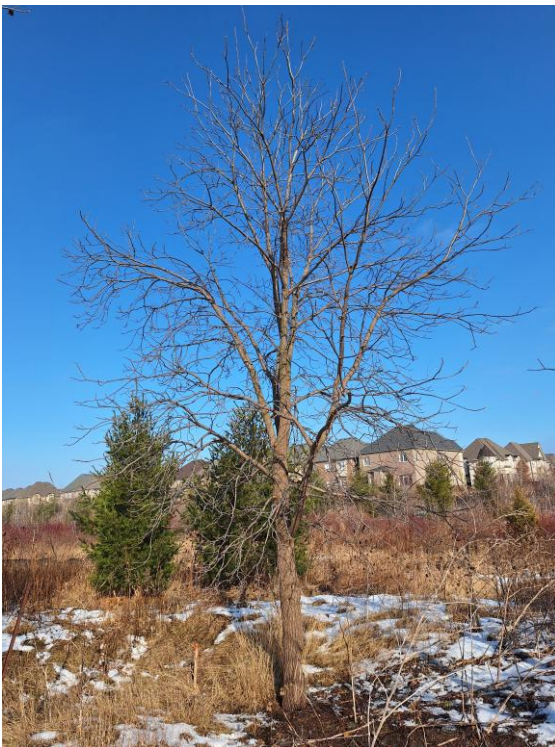
Image 3. Tree 5

The removal of 32 trees is required to accommodate the proposed development. Tree removals include Trees 1-5, 8-12, 15, 17, 18, 22, 24, 26, 31-41, 44-46, B, and C. The removal of Trees B and C is required to accommodate a new driveway. The remaining trees require removal due to conflict with the proposed underground parking. Tree 22 has a lean to north over the subject property and 80% crown-die-back. Its removal is recommended due to hazardous conditions. The removal of Tree 5 is recommended due to its poor condition and Tree 17 is dead.

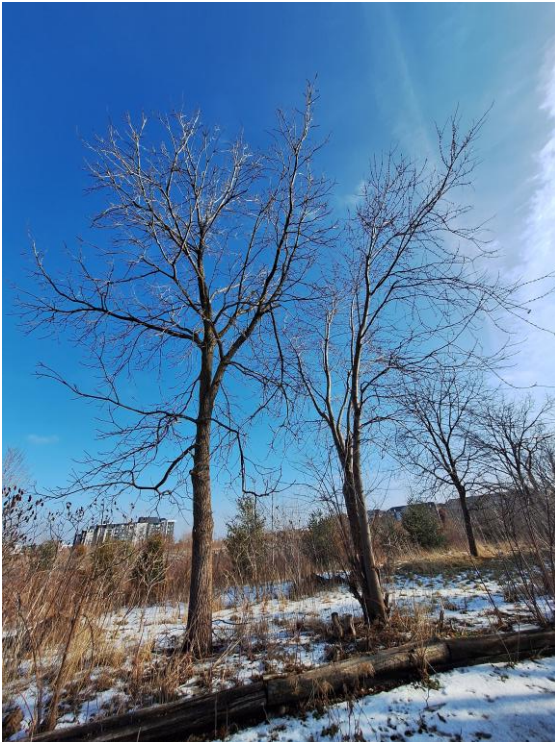
Image 7. Trees 11 (left) and 12

11	Black Walnut	<i>Juglans nigra</i>	32	G	G	G		3	3			Remove	Private	3
12	Silver Maple	<i>Acer saccharinum</i>	27, 18.5	P/F	P/F	F/G		3	1.8		Co-dominant at base, epicormic branching (H), lost leader (H)	Remove	Private	0
13	Green Ash	<i>Fraxinus pennsylvanica</i>	14	F	P	P	95	2.5	1.8	-	Almost dead	Had been Removed	Private	
14	Green Ash	<i>Fraxinus pennsylvanica</i>	10	P/F	F	P/F	40	2.5	1.8	-	Co-dominant at base, cracks (M), crown dieback (M)	Had been Removed	Private	
15	Black Walnut	<i>Juglans nigra</i>	37, 35.5, 26.5, 25.5, 23.5	F/G	F/G	F/G		4.5	3		Co-dominant at base (5 leaders)	Remove	Private	4
16	Staghorn Sumac	<i>Rhus typhina</i>	23	P	P	P	90	3	1.8	-	Leaning east (M), cracks (H), crown dieback (H), almost dead	Had been Removed	Private	
17	Silver Maple	<i>Acer saccharinum</i>	11.5, 10,8,6	-	-	-	100	-	1.8		Co-dominant at base, crown dieback (M)	Remove	Town (Park)	0
18	Black Walnut	<i>Juglans nigra</i>	36.5	F/G	F/G	F/G		4	3		Leaning west (L), pruning wounds (L), union at 3.5m	Remove	Town (Park)	4

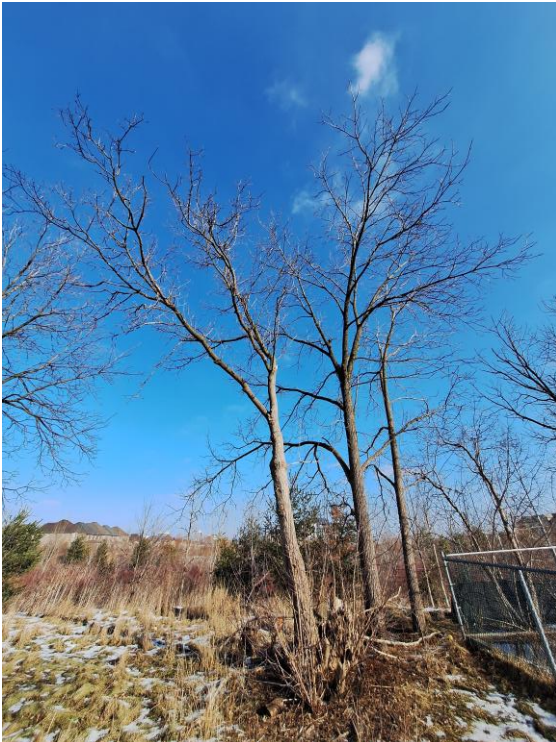
Image 11. Trees 21, 20, and 22 (from right)

19	Manitoba Maple	<i>Acer negundo</i>	13.5	F/P	F/P	P	70	5	1.8	-	Leaning north (M), lost leader (H), epicormic branching (M), crown dieback (H)	Had been Removed	Town (Park)	
20	Black Walnut	<i>Juglans nigra</i>	34	G	F	F/G		6	3	1.9	Union at 3m	Preserve	Town (Park)

21	Black Walnut	<i>Juglans nigra</i>	24.5	F/G	F	F/G		5	2.4	3.3	Asymmetrical crown (M), leaning east (L)	Preserve	Town (Park)	
22	Manitoba Maple	<i>Acer negundo</i>	35.5	P/F	F	P	80	4	3		Leaning north (M), co-dominant at base, lost leaders (H), crown dieback (H), epicormic branching (H), almost dead	Remove	Neighbor Private	0
23	Norway Spruce	<i>Picea abies</i>	35.5	F	G	F	-	3	2.4	-	Leaning east (L), exposed roots (L), dead branches (L), poor vigor (L)	Had been Removed	Private	
24	Norway Spruce	<i>Picea abies</i>	52	F	G	G		4.5	3.6		Leaning south (L), exposed roots (L)	Remove	Private	5
25	Norway Spruce	<i>Picea abies</i>	36	F/G	G	G		3	3	2.6	Leaning south (L)	Preserve	Shared Private	
26	Manitoba Maple	<i>Acer negundo</i>	12	F	F/G	F/G		2	2.4		Leaning north (L)	Remove	Private	0
27	Norway Spruce	<i>Picea abies</i>	19	G	G	G		2	2.4	2.4		Preserve	Shared Private	
28	Manitoba Maple	<i>Acer negundo</i>	13, 9.5	P/F	F	F/G		2	2.4	2.4	Co-dominant at base, leaning east (M)	Preserve	Shared Private

Trees 17 and 18 are located partially or fully on City parkland and Trees B and C are located within the town road right-of-way. Permission from the Town of Oakville is required prior to their removal. Tree 22 is a shared tree between the subject property and adjacent property at 3025 Sixth Line. Permission from the respective owner is required prior to its removal.

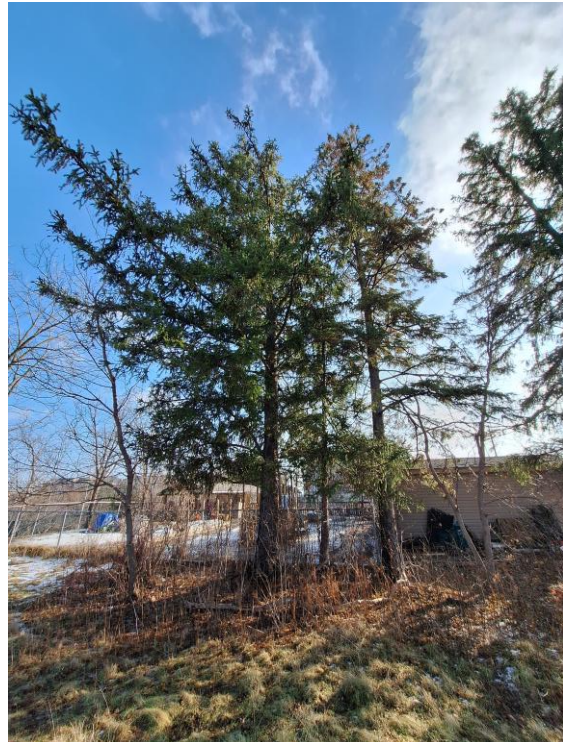
Image 12. Trees 26, 24, 27, 25, and 28
(from left)

Encroachment into the mTPZ of Tree 25, 27-30, 42, and 43 will be required to accommodate the proposed development. The construction of a new retaining wall at 1.5m from the property line, which will be at 1.3m from the base of the trees. As encroachment is moderate, the following mitigation measures must be implemented prior to construction to ensure the trees respond well to construction.

- Prior to the proposed development, tree preservation fence must be installed as indicated on Figure 1.
- Under the supervision of a Certified Arborist, air-spading technology should be used to excavate a trench at the excavation limits within the mTPZs of Tree 25, 27-30, 42, and 43.
- If it is determined that Trees 25, 27-30, 42, and 43 will not be destabilized from root pruning within the excavated trench, the exposed roots are to be pruned inside

- the trench by a Certified Arborist in accordance with Good Arboricultural Standards.
- If the excavation determines that excessive roots exist through that area such that their severance is predicted to cause the destabilization and/or decline of the trees, the trees may be identified for removal, at which point a permit from the Town of Oakville would be required.
 - The trench is to be back filled with clean topsoil.

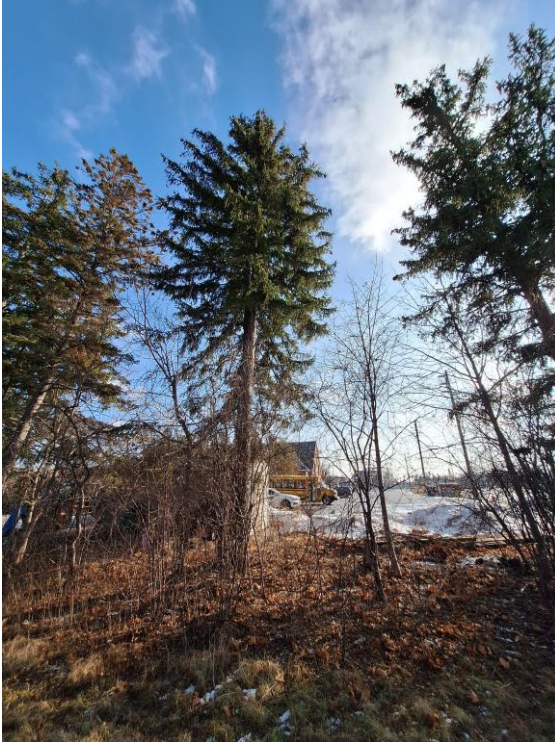
Image 13. Trees 29 (left) and 42

29	Norway Spruce	<i>Picea abies</i>	47	G	F	G		3	3	2.2	union at 6m	Preserve	Shared Private	
30	Norway Spruce	<i>Picea abies</i>	45.5	G	G	G		4	3	2.9		Preserve	Neighbor Private	
31	Black Walnut	<i>Juglans nigra</i>	14.5	F/G	F/G	F/G		2	2.4		Asymmetrical crown (L), poor vigor (L)	Remove	Private	0
32	Manitoba Maple	<i>Acer negundo</i>	14, 14, 13.5, 13.5	F	F	G		2.5	2.4		Co-dominant at base	Remove	Private	0
33	Eastern Red Cedar	<i>Juniperus virginiana</i>	14	F	F	G		1.5	2.4		Bowed (L), asymmetrical crown (L), trunk injury (L)	Remove	Private	0
34	Eastern Red Cedar	<i>Juniperus virginiana</i>	17.5	F	F	G		1.5	2.4		Bowed (L), union at 0.8m, asymmetrical crown (L)	Remove	Private	2
35	Eastern Red Cedar	<i>Juniperus virginiana</i>	13	G	F	G		1	2.4		Asymmetrical crown (L)	Remove	Private	0
36	Black Walnut	<i>Juglans nigra</i>	17.5	G	P	G		2	2.4		Lost leader (H)	Remove	Private	2
37	Eastern Red Cedar	<i>Juniperus virginiana</i>	27.5, 13, 11, 10	F	G	G		2.5	2.4		Co-dominant at base, pruning wounds (L)	Remove	Private	3

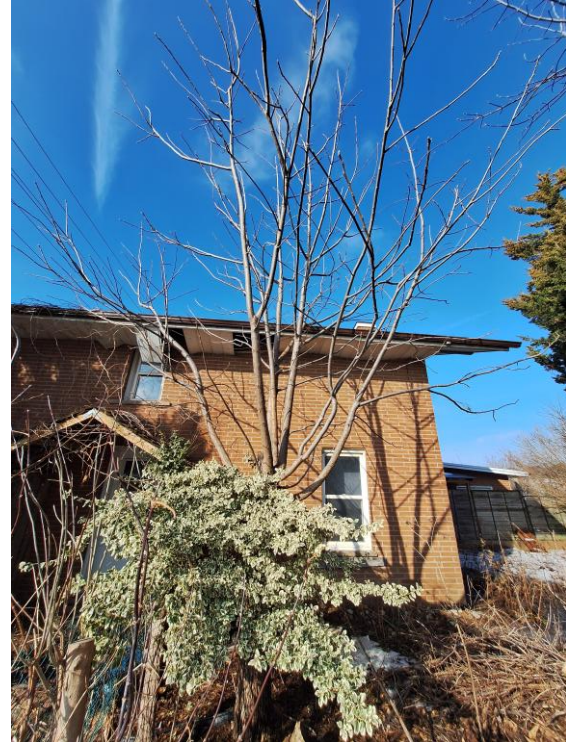
Image 18. Tree 46

45	Manitoba Maple	<i>Acer negundo</i>	10	F	G	G		1.5	2.4		Bow (M) to west	Remove	Private	0
46	Black Walnut	<i>Juglans nigra</i>	19.5	F	P/F	F		2	2.4		Topped at 1.8m, coppice growth (H)	Remove	Private	0
A	Hackberry	<i>Celtis occidentalis</i>	4.5	G	G	G		1	1.2	1.2		Preserve	Town (ROW)	
B	Honey Locust (shademaster)	<i>Gledistia tricanthos 'inermis'</i>	5.5	G	G	G		1.5	1.2			Remove	Town (ROW)	valuation
C	Ginkgo	<i>Ginkgo biloba</i>	4	G	G	G		1	1.2			Remove	Town (ROW)	valuation
D	Hackberry	<i>Celtis occidentalis</i>	5	G	G	G		1	1.2	1.2		Preserve	Town (ROW)	
E	Ginkgo	<i>Ginkgo biloba</i>	4	G	G	G		1	1.2	1.2		Preserve	Town (ROW)	
F	Hackberry	<i>Celtis occidentalis</i>	3.5	G	G	G		1	1.2	1.2		Preserve	Town (ROW)	
													TOTAL	41

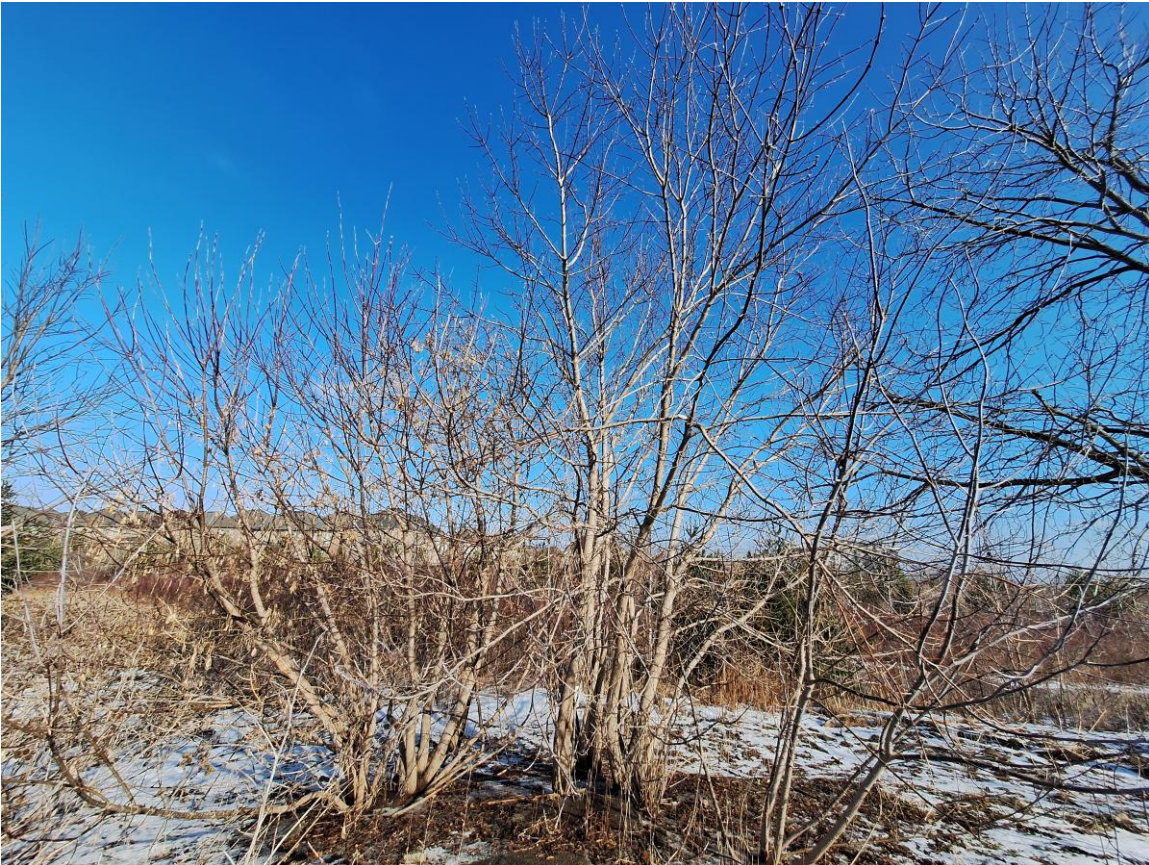
Image 19. Trees 38-41 (from left)

38	Manitoba Maple	<i>Acer negundo</i>	11, 8.5, 8, <7	F	G	G		2.5	2.4		Union at base with 11 stems	Remove	Private	0
39	Manitoba Maple	<i>Acer negundo</i>	12	F/G	G	G		1.5	2.4		Sweep (L)	Remove	Private	0
40	Manitoba Maple	<i>Acer negundo</i>	11, 10.5, 7	F	G	G		2.5	2.4		Union at base, bow (L)	Remove	Private	0
41	Manitoba Maple	<i>Acer negundo</i>	12, 11, 8.5	F	G	G		3	2.4		Union at base, bow (L)	Remove	Private	0
42	Norway Maple	<i>Acer platanoides</i>	11.5	G	G	G		1.5	2.4	1.5		Preserve	Shared Private	
43	Norway Maple	<i>Acer platanoides</i>	13	G	G	G		1.5	2.4	2.2		Preserve	Shared Private	
44	Black Walnut	<i>Juglans nigra</i>	13	F/G	G	G		1.5	2.4		Co-dominance at 1.6m	Remove	Private	0
