Tree Inventory and Preservation Plan Report 42 Lakeshore Road West Oakville, Ontario

4 May 2023, revised 28 July 2023 and 14 August 2023

KUNTZ FORESTRY CONSULTING INC Project P3684

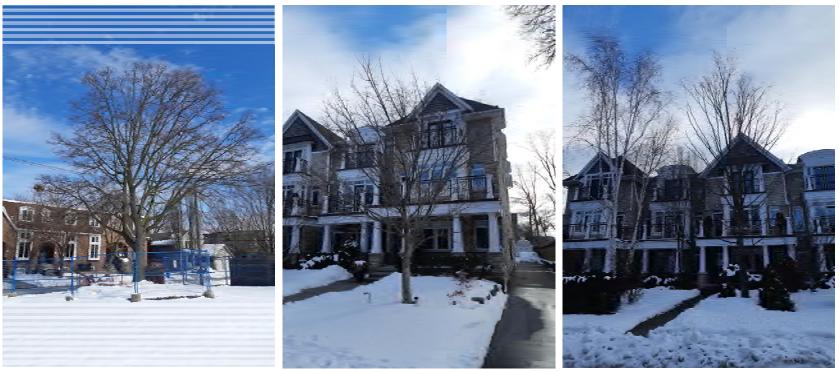
Image 13. Tree 75

Encroachment into a portion of the minimum tree protection zones (mTPZ's) of Trees 75, H, I, and K is required to accommodate excavation for the proposed storm sewer extension along Chisholm Street. If the following mitigation measures are employed, longterm adverse effects are not anticipated for these trees:

- Prior to the commencement of the proposed works, vertical tree protection fencing should be installed at the locations indicated on Figure 1.
- Air-spading or hydro-vac technology should be used, under the supervision of a Certified Arborist, to excavate a trench on the northeast side of the tree protection fencing within the mTPZ's of Trees 75, H, I, and K.
- The roots of Trees 75, H, I, and K are to be pruned inside the trenches by a Certified Arborist in accordance with Good Arboricultural Standards.
- The trenches are to be backfilled with clean topsoil.
