Cultural Heritage Assessment (2017) and Update (2020)

Cultural Heritage Report

For A Municipal Class EA For Lakeshore Road West, From Mississaga Street to Dorval Drive, Town of Oakville, Ontario

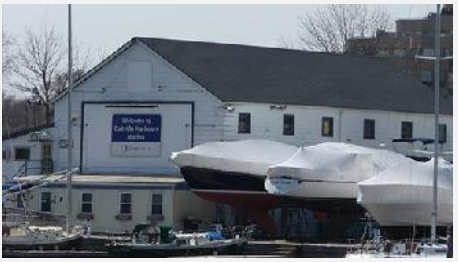
Identification of Heritage Resources						
Identification	HP 2					
Lot and Concession	Plan M11, Lot 91					
Property Name	Bronte Marina Building					
Street Address	2508 Lakeshore Road West					
Recognition	Designated: By-Law 2014-124					
Community	Bronte					
Municipality	Oakville					
Regional	Halton					
Construction Date	1943					
Building/Landscape Type	Mid 20th Century ship-building shed					
Cultural Heritage Value	High					
Heritage Impact of Development	Low					
Photograph Description	Clad in white shingles

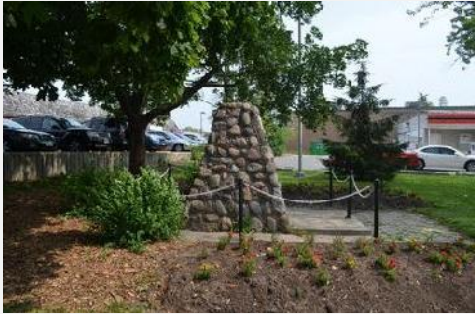
Identification of Heritage Resources			
Identification	HP 5

Lot and Concession	Plan M11, Lot 91		
Property Name	Bronte Cenotaph		
Street Address	2457 Lakeshore Road West		
Recognition	Listed		
Community	Bronte		
Municipality	Oakville		
Regional Municipality	Halton		
Construction Date	1956		
Building/Landscape Type	Cenotaph		
Cultural Heritage Value	High		
Heritage Impact of Development	Low		
Photograph Description	Stone Cenotaph		
Evaluation of Cultural Heritage Value		Ontario Regulation 9/06	
Criteria	No	Detailed Criteria	Description
Design or Physical Value	1	Is a rare, unique, representative or early example of a style, type, expression, material or construction method.	
	2	Displays a high degree of craftsmanship or artistic value.	
	3	Displays a high degree of technical or scientific achievement.

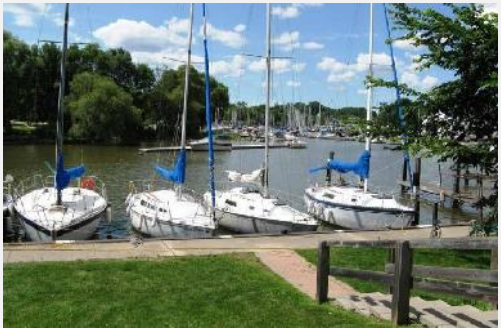
Identification of Heritage Resources							
Identification	HP 1						
Lot and Concession							
Property Name	Bronte Harbour						
Street Address	3014 Lakeshore Road West						
Recognition	Listed						
Community	Bronte						
Municipality	Oakville						
Regional	Halton						
Construction Date	early 19th Century						
Building/Landscape Type	Harbour						
Cultural Heritage Value	High						
Heritage Impact of Development	Low						
Photograph Description	Harbour with sailboats

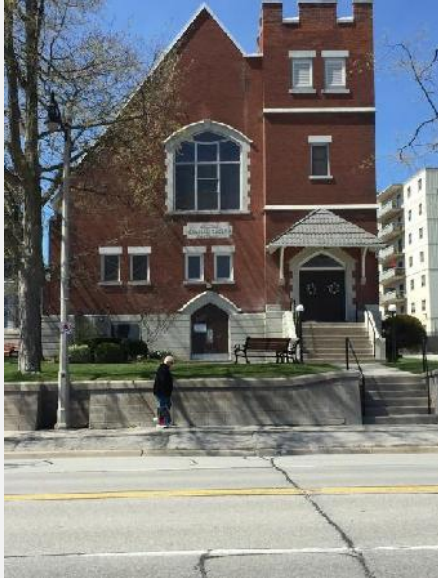
Identification of Heritage Resources			
Identification Number	HP 4

Lot and Concession Number	Plan M10 Lot 65		
Property Name	Walton Memorial United Church		
Street Address	2489 Lakeshore Road West		
Recognition	Designated: By-Law 1993-053		
Community	Bronte		
Municipality	Oakville		
Regional Municipality	Halton		
Construction Date	1914		
Building/Landscape Type	Church		
Cultural Heritage Value	High		
Heritage Impact of Development	Medium		
Photograph Description	Front view of red-brick Gothic church		
Evaluation of Cultural Heritage Value		Ontario Regulation 9/06	
Criteria	No.	Detailed Criteria	Description
Design or Physical Value	1	Is a rare, unique, representative or early example of a style, type, expression, material or construction method.	Gothic style that represents ornamental styles of the Victorian era. Good example of church architecture from the turn of the century.
	2	Displays a high degree of craftsmanship or artistic value.

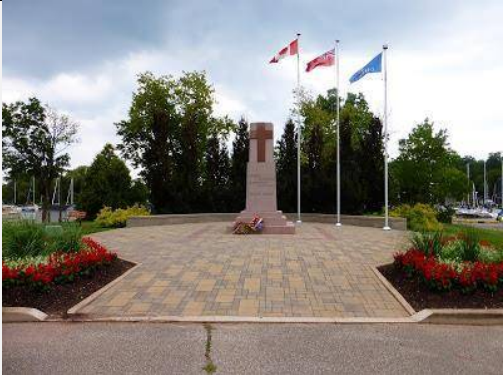
Identification of Heritage Resources			
Identification Number	HP 3

Lot and Concession Number			
Property Name	Chris Vokes Memorial Park		
Street Address	2500 Lakeshore Road West		
Recognition	Listed		
Community	Bronte		
Municipality	Oakville		
Regional Municipality	Halton		
Construction Date			
Building/Landscape Type	Cenotaph and Park		
Cultural Heritage Value	High		
Heritage Impact of Development	Low		
Photograph Description	The Cenotaph at the front of the park		
Evaluation of Cultural Heritage Value		Ontario Regulation 9/06	
Criteria	No.	Detailed Criteria	Description
Design or Physical Value	1	Is a rare, unique, representative or early example of a style, type, expression, material or construction method.	
	2	Displays a high degree of craftsmanship or artistic value.	
	3	Displays a high degree of technical or scientific achievement.

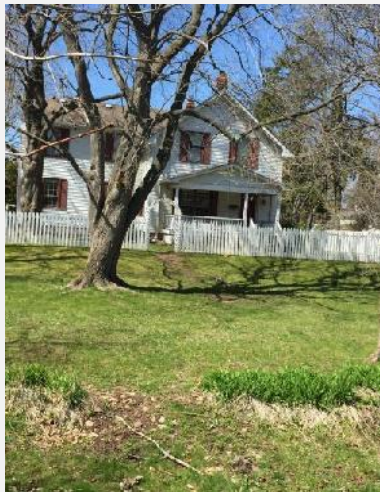
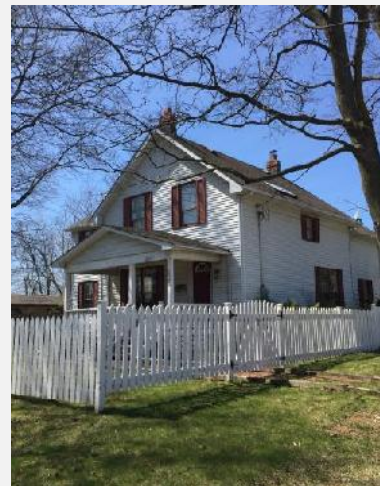
Identification of Heritage Resources			
Identification Number	HP 6	Regional Municipality	Halton
Lot and Concession Number		Construction Date	Early 20th century
Property Name		Building/Landscape Type	Farmhouse
Street Address	2003 Lakeshore Road West	Cultural Heritage Value	High
Recognition	Listed	Heritage Impact of Development	Low
Community	Bronte	Photograph Description	White sided early 20th century farmhouse with picket fence
Municipality	Oakville

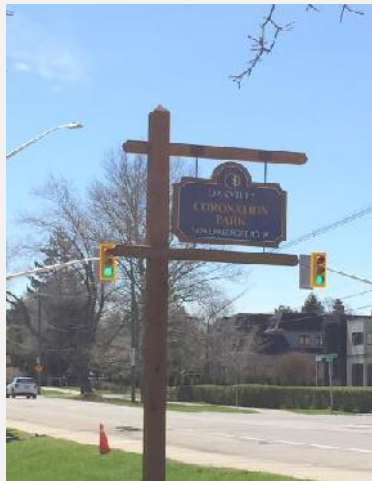
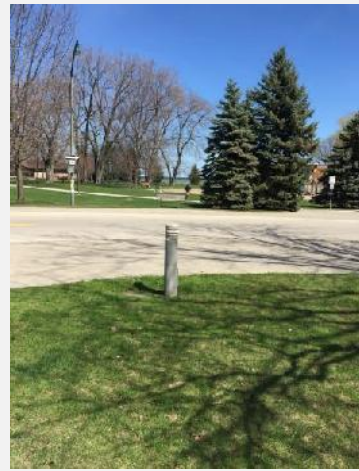
Identification of Heritage Resources			
Identification Number	HP 7	Regional Municipality	Halton
Lot and Concession Number		Construction Date	
Property Name	Coronation Park	Building/Landscape Type	Park
Street Address	1426 Lakeshore Road West	Cultural Heritage Value	High
Recognition	Listed	Heritage Impact of Development	Low
Community	Bronte	Photograph Description	Entrance to Coronation Park
Municipality	Oakville

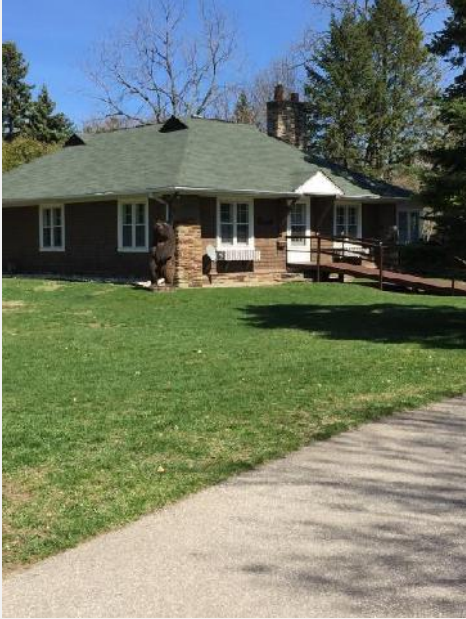
Identification of Heritage Resources			
Identification Number	HP 8

Lot and Concession Number			
Property Name			
Street Address	1110 Lakeshore Road West		
Recognition	Listed		
Community	Bronte		
Municipality	Oakville		
Regional Municipality	Halton		
Construction Date			
Building/Landscape Type			
Cultural Heritage Value			
Heritage Impact of Development			
Photograph Description			
Evaluation of Cultural Heritage Value		Ontario Regulation 9/06	
Criteria	No.	Detailed Criteria	Description
Design or Physical Value	1	Is a rare, unique, representative or early example of a style, type, expression, material or construction method.	Representative of farm workers' cottages.
	2	Displays a high degree of craftsmanship or artistic value.	
	3	Displays a high degree of technical or scientific achievement.

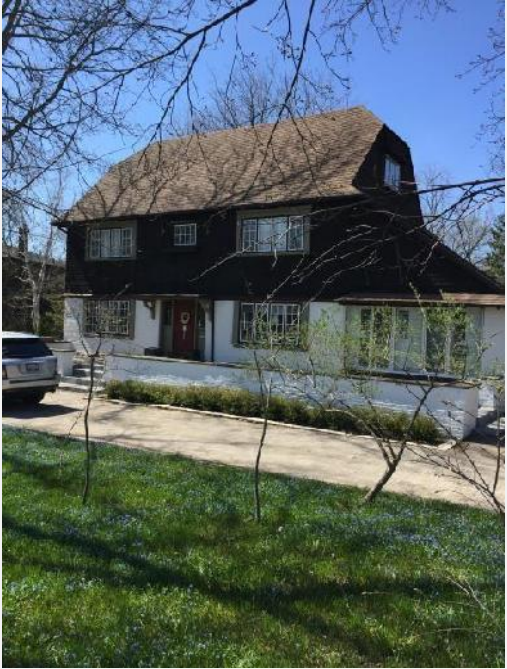
Identification of Heritage Resources			
Identification Number	HP 9

Lot and Concession Number	Pt Lot 20, Con 3 SDS		
Property Name	The Acacias		
Street Address	573 Lakeshore Drive West		
Recognition	Designated: By-Law 2015-044		
Community	Bronte		
Municipality	Oakville		
Regional Municipality	Halton		
Construction Date	1911		
Building/Landscape Type	House		
Cultural Heritage Value	High		
Heritage Impact of Development	Low		
Photograph Description	2-1/2 storey house with Arts and Crafts inspired details.		
Evaluation of Cultural Heritage Value		Ontario Regulation 9/06	
Criteria	No.	Detailed Criteria	Description
Design or Physical Value	1	Is a rare, unique, representative or early example of a style, type, expression, material or construction method.	Representative of an Arts and Crafts home from the early 20th century.
	2	Displays a high degree of craftsmanship or artistic value.	
	3	Displays a high degree of technical or scientific achievement.

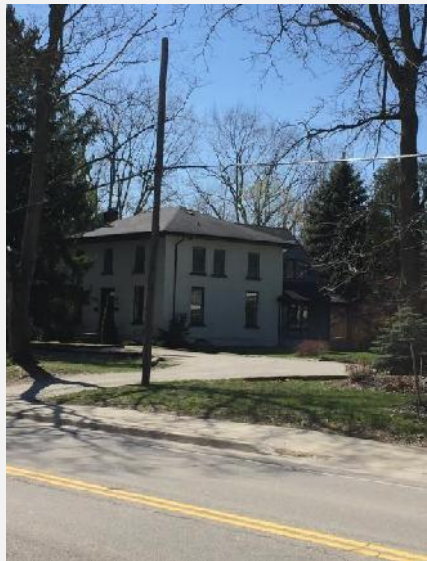
Identification of Heritage Resources			
Identification Number	HP 10

Lot and Concession Number	Plan M341 Lot 15		
Property Name	Old McCraney House		
Street Address	549 Lakeshore Drive West		
Recognition	Designated: By-Law 1984-083		
Community	Bronte		
Municipality	Oakville		
Regional Municipality	Halton		
Construction Date	circa 1860		
Building/Landscape Type	House		
Cultural Heritage Value	High		
Heritage Impact of Development	Low		
Photograph Description	grey 2 storey house		
Evaluation of Cultural Heritage Value		Ontario Regulation 9/06	
Criteria	No.	Detailed Criteria	Description
Design or Physical Value	1	Is a rare, unique, representative or early example of a style, type, expression, material or construction method.	
	2	Displays a high degree of craftsmanship or artistic value.	
	3	Displays a high degree of technical or scientific achievement.

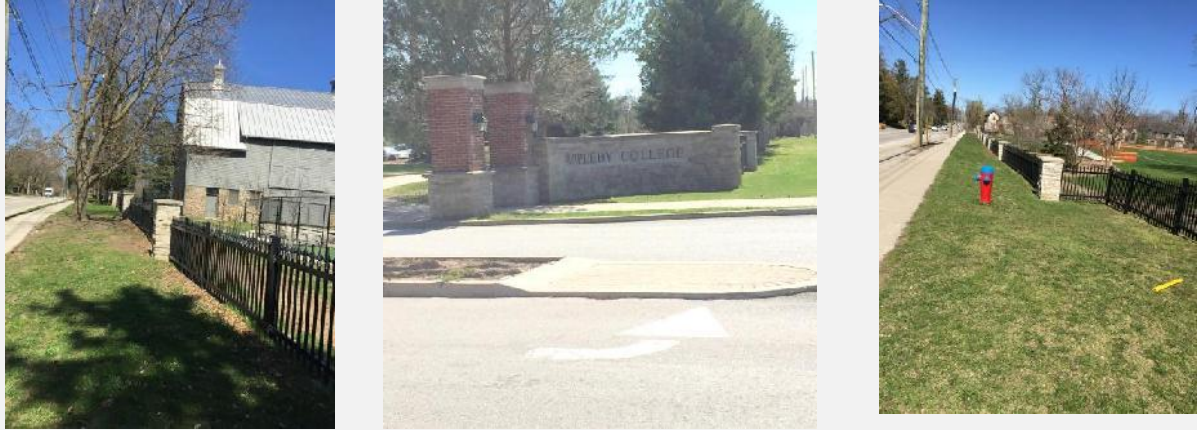
Identification of Heritage Resources			
Identification Number	HP 11	Regional Municipality	Halton
Lot and Concession Number		Construction Date	Early 20th century
Property Name	Appleby College	Building/Landscape Type	Historic institution as a cultural heritage landscape
Street Address	540 Lakeshore Drive W	Cultural Heritage Value	
Recognition (Designated or Listed)	Listed	Heritage Impact of Development	High impact on wrought iron and stone fences and gateway
Community	Bronte	Photograph Description	Photos show proximity of fences and gates to roadway.
Municipality	Oakville

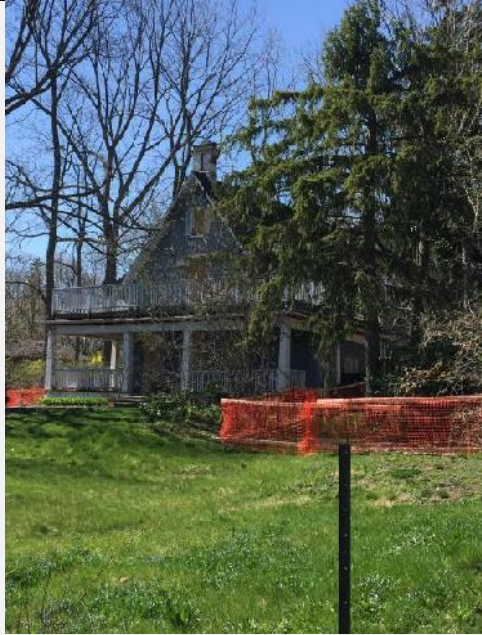
Identification of Heritage Resources			
Identification Number	HP 12

Lot and Concession Number	Part Lot 18, Plan 390		
Property Name	Captain G.E. Morden House		
Street Address	491 Lakeshore Drive W		
Recognition	Listed		
Community	Bronte		
Municipality	Oakville		
Regional Municipality	Halton		
Construction Date	1858		
Building/Landscape Type	House		
Cultural Heritage Value	Medium		
Heritage Impact of Development	Low		
Photograph Description	House surrounded by hoarding		
Evaluation of Cultural Heritage Value		Ontario Regulation 9/06	
Criteria	No.	Detailed Criteria	Description
Design or Physical Value	1	Is a rare, unique, representative or early example of a style, type, expression, material or construction method.	Representative of Gothic-style, rectangular 2-1/2 storey masonry structure.
	2	Displays a high degree of craftsmanship or artistic value.	
	3	Displays a high degree of technical or scientific achievement.

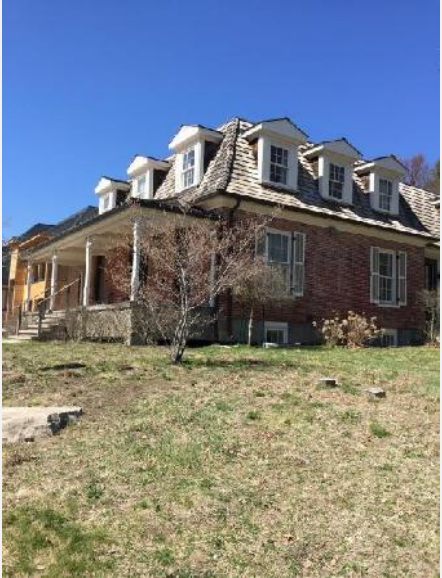
Identification of Heritage Resources			
Identification Number	HP 17

Lot and Concession Number	Con 3 SDS Pt Lot 19		
Property Name	Retreat/Clifton/Rosedale Villa		
Street Address	105 Paliser Court		
Recognition	Designated: By-Law 1987-302		
Community	Bronte		
Municipality	Oakville		
Regional Municipality	Halton		
Construction Date	1853		
Building/Landscape Type	Regency style cottage		
Cultural Heritage Value	High		
Heritage Impact of Development	Low		
Photograph Description	Regency style cottage with mansard roof		
Evaluation of Cultural Heritage Value		Ontario Regulation 9/06	
Criteria	No.	Detailed Criteria	Description
Design or Physical Value	1	Is a rare, unique, representative or early example of a style, type, expression, material or construction method.	A representative regency style cottage with open verandah with decorative posts and doorway flanked by two sidelights.
	2	Displays a high degree of craftsmanship or artistic value.

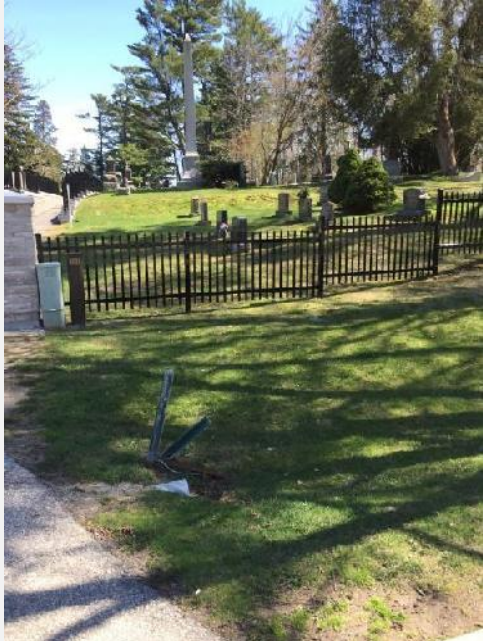
Identification of Heritage Resources							
Identification Number	HP 16						
Lot and Concession Number	Pt Lot 17, Con 4						
Property Name	St. Jude's Cemetery						
Street Address	258 Lakeshore Drive W						
Recognition	Designated: By-Law 2009-075						
Community	Bronte						
Municipality	Oakville						
Regional Municipality	Halton						
Construction Date	1853						
Building/Landscape Type	Cemetery						
Cultural Heritage Value	High						
Heritage Impact of Development	Low						
Photograph Description	Entrance to cemetery with stone posts and wrought-iron fence

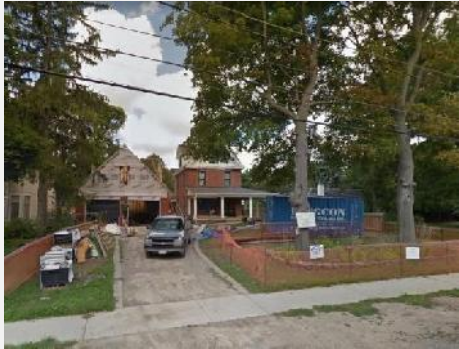
Identification of Heritage Resources			
Identification Number	HP 15

Lot and Concession Number			
Property Name			
Street Address	335 Lakeshore Drive W		
Recognition	Listed		
Community	Bronte		
Municipality	Oakville		
Regional Municipality	Halton		
Construction Date	late 19th-century		
Building/Landscape Type	House		
Cultural Heritage Value	Medium		
Heritage Impact of Development	Low		
Photograph Description	House and garage undergoing renovations.		
Evaluation of Cultural Heritage Value		Ontario Regulation 9/06	
Criteria	No.	Detailed Criteria	Description
Design or Physical Value	1	Is a rare, unique, representative or early example of a style, type, expression, material or construction method.	Representative of a 19th-century red brick Victorian home.
	2	Displays a high degree of craftsmanship or artistic value.	
	3	Displays a high degree of technical or scientific achievement.

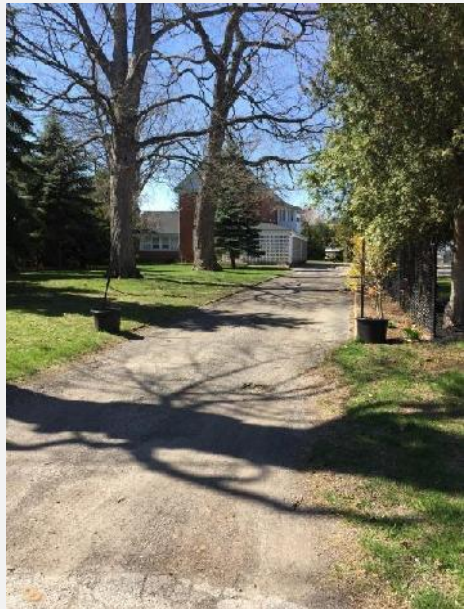
Identification of Heritage Resources							
Identification Number	HP 14						
Lot and Concession Number							
Property Name							
Street Address	369 Lakeshore Drive W						
Recognition	Listed						
Community	Bronte						
Municipality	Oakville						
Regional Municipality	Halton						
Construction Date	1890						
Building/Landscape Type	House						
Cultural Heritage Value	Medium						
Heritage Impact of Development	Low, set back long driveway.						
Photograph Description	Red brick Victorian house

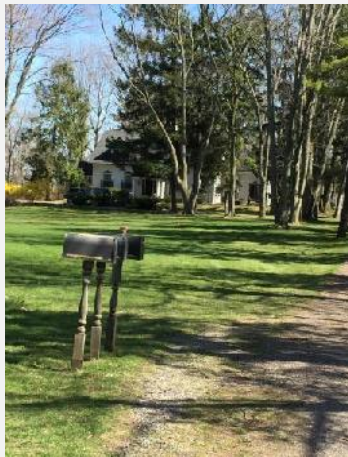
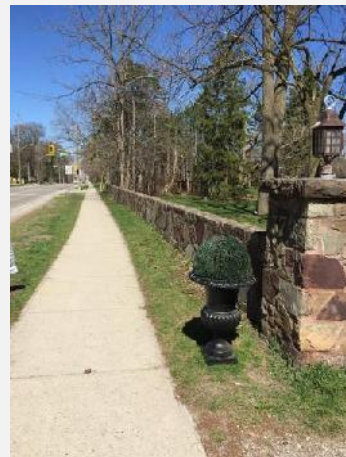
Identification of Heritage Resources			
Identification Number	HP 13	Regional Municipality	Halton
Lot and Concession Number		Construction Date	Late 19th-century
Property Name		Building/Landscape Type	House
Street Address	372 Lakeshore Drive W	Cultural Heritage Value	High
Recognition (Designated or Listed)	Listed	Heritage Impact of Development	High impact on stone wall and gates.
Community	Bronte	Photograph Description	House set back from road with stone wall and gateway near road.
Municipality	Oakville

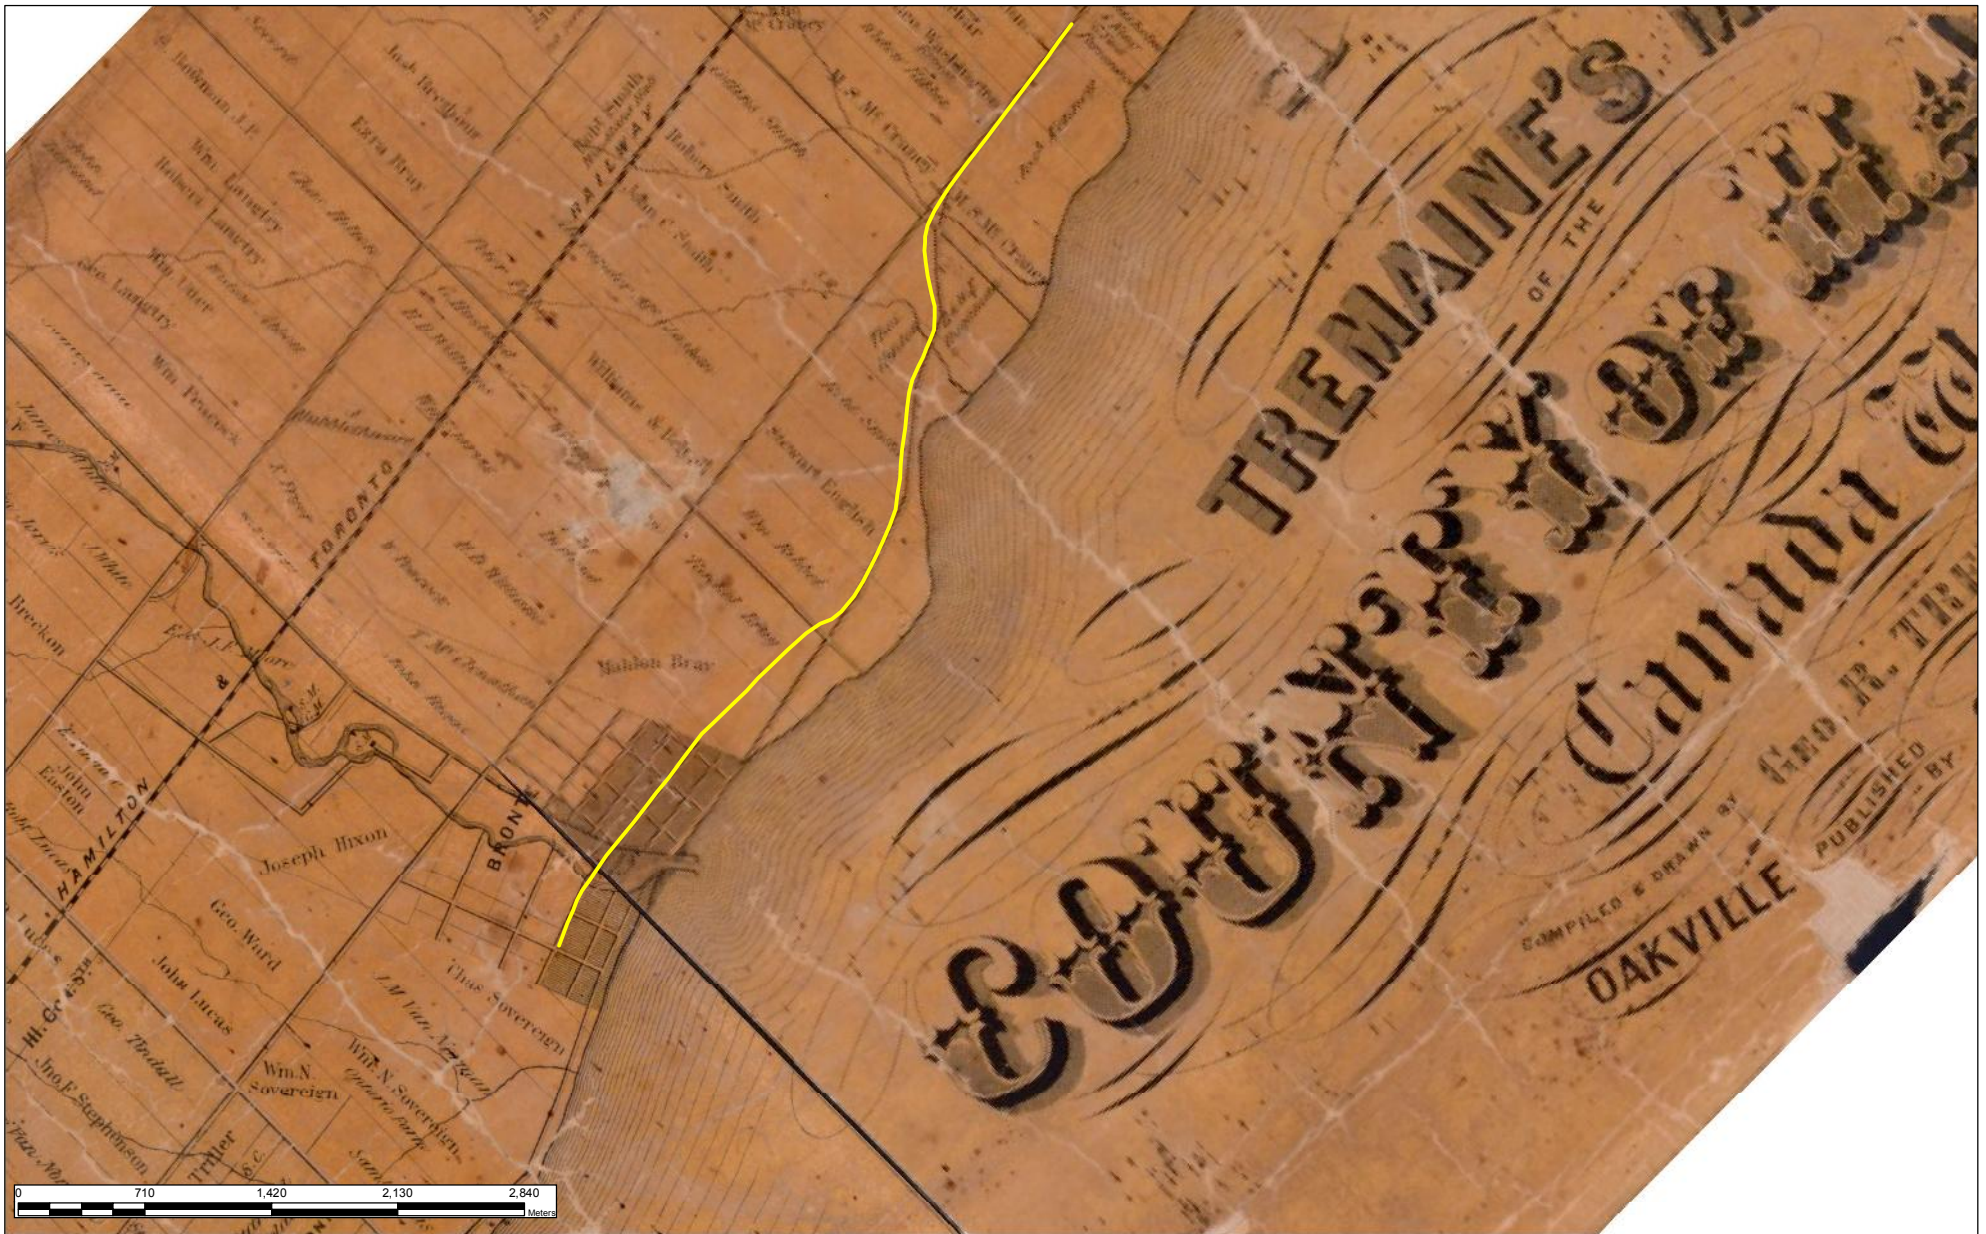
PROJECT N°: TPB166147 **FIGURE: 4b**
 DATE: February, 2017

NOTES:
 LOCATION OF FEATURES ARE APPROXIMATE
 This drawing should be read in conjunction with the Wood PLC Environment & Infrastructure Report No. TB165009
 Conditions encountered in the field may be different from the interpreted information presented on this figure.
 SOURCE: Basemao (Google Earth)
 1858 Tremaine's Map

In the *Plan of the Second Township* (1806) (Figure 4a), the study corridor was not yet a roadway. The southwestern-most section of the corridor crossed Bronte Creek, and then ran eastward through what was then called the "Plains" (the present-day Village of Bronte). As the study area continued east-northeast, the corridor would have traversed portions of private land, although, as noted in the Table above, there were no historic features illustrated within or directly adjacent to the study corridor at this time. Creeks and tributaries that are illustrated on later historical mapping are also not shown (see Figures 4b and 5, Appendix A). As the study corridor passed through lots 17 to 20

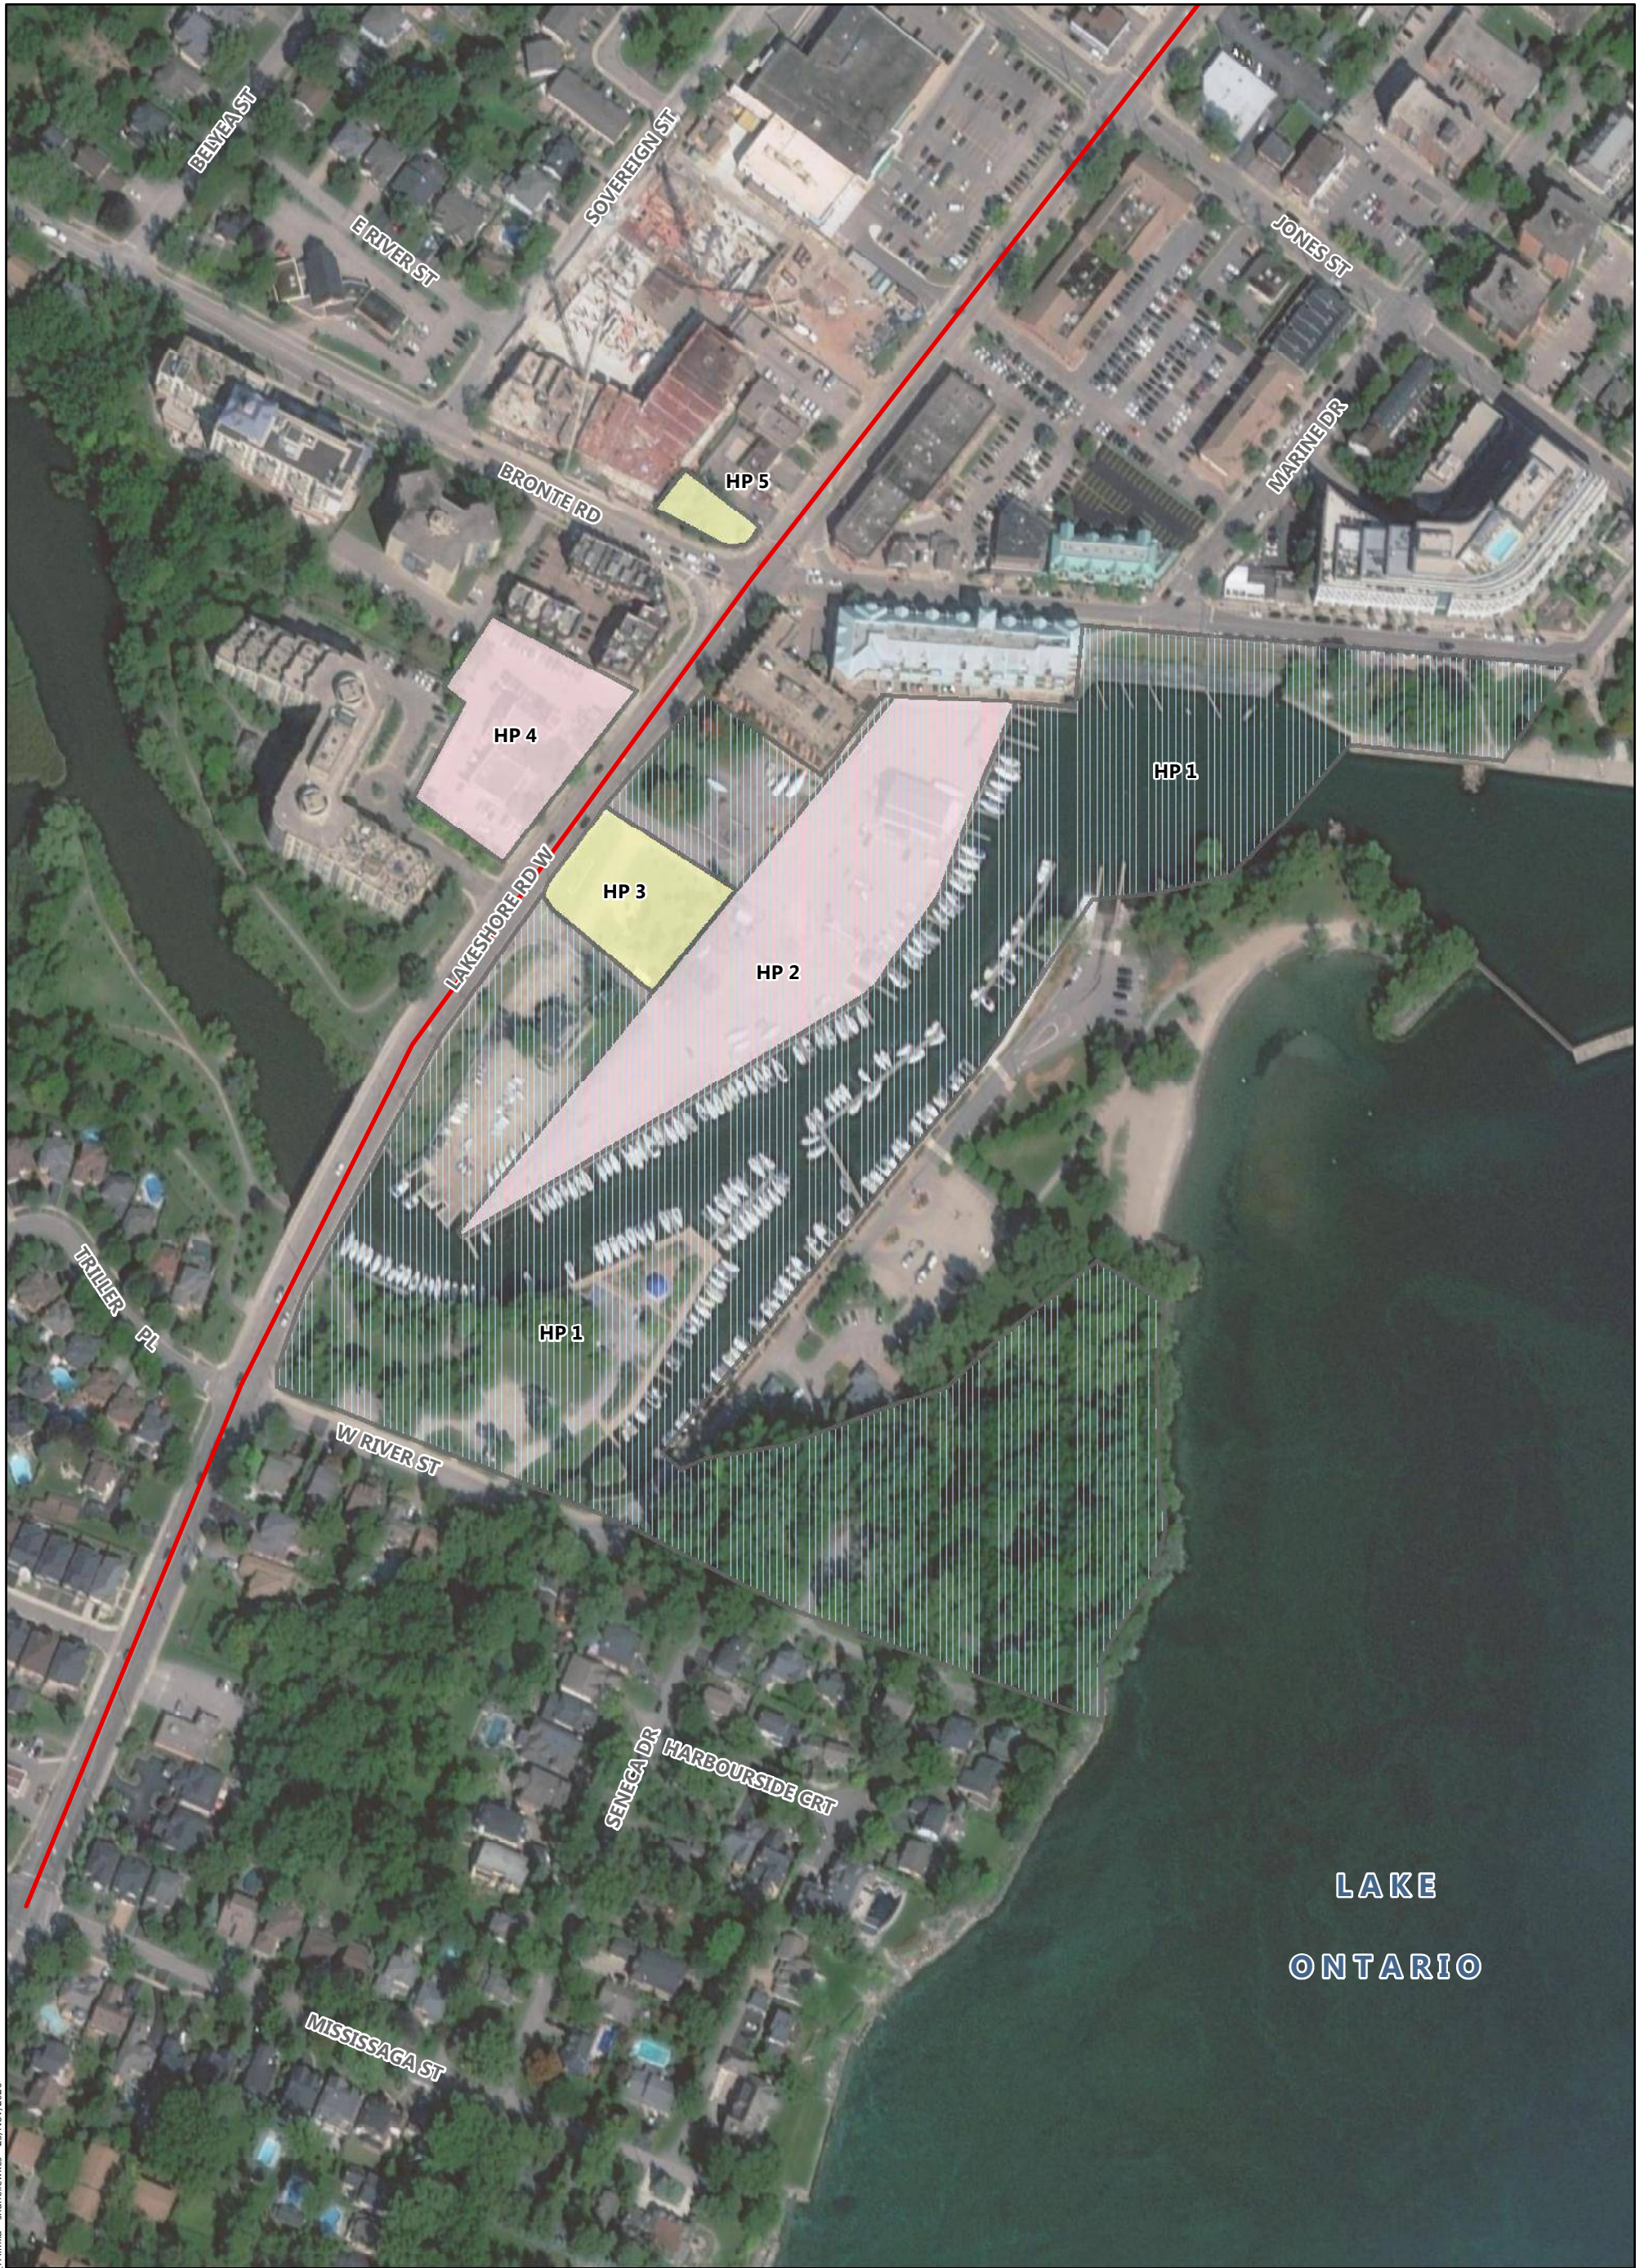
<p>LEGEND</p> <ul style="list-style-type: none"> — Proposed Alignment Designated Under Part IV of the Ontario Heritage Act Listed on the City of Oakville Heritage Register Intention to Designate under Part IV of the Ontario Heritage Act 	<p>KEY MAP</p>	<p>NOTES:</p> <p>Datum: NAD83 Projection: UTM Zone 17N</p>	<div style="display: flex; justify-content: space-between; align-items: center;"> </div> <p style="text-align: center;">CULTURAL HERITAGE EVALUATION REPORT FOR LAKESHORE ROAD WEST</p> <p style="text-align: center;">Location of Built Heritage Resources & Cultural Heritage Landscapes</p>
		<p>PROJECT N°: TPB166147</p> <p>SCALE: 1:2,450</p>
