Fluvial Geomorphology Report

**Fluvial Geomorphology Review and Preliminary Channel Design
Fourteen Mile Creek & McCraney Creek
Lakeshore Road West Improvements
Class Environmental Assessment
Town of Oakville**

DRAFT April 4, 2017 / 2nd DRAFT May 19, 2017 / FINAL March 19, 2018

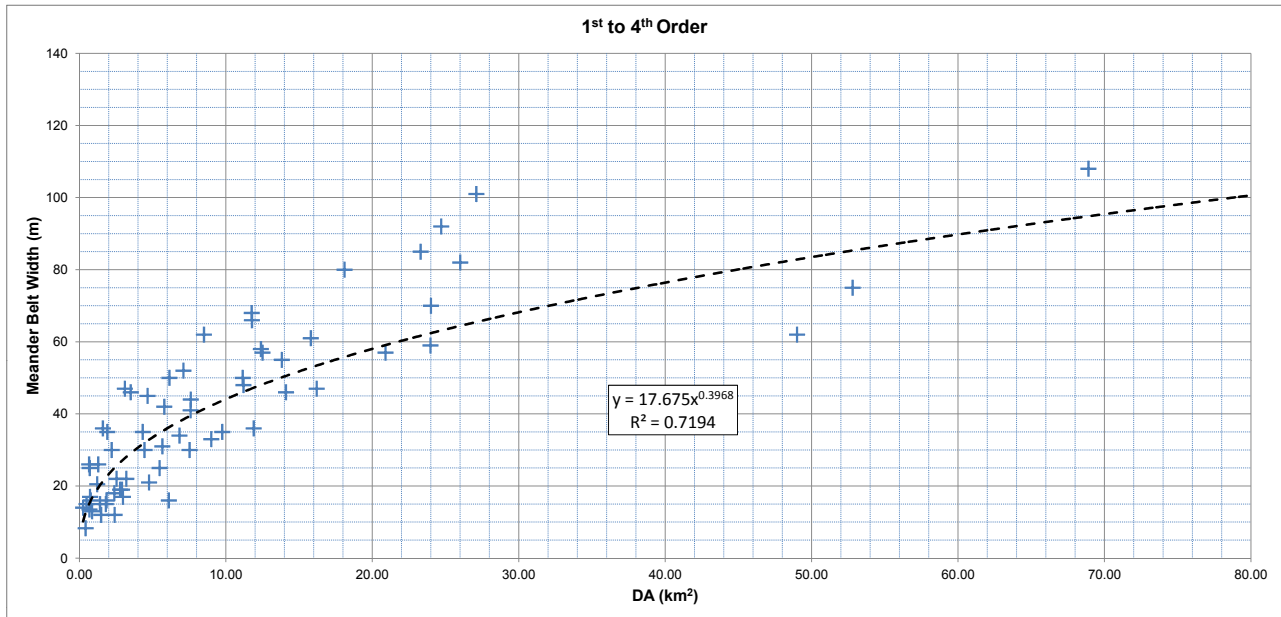
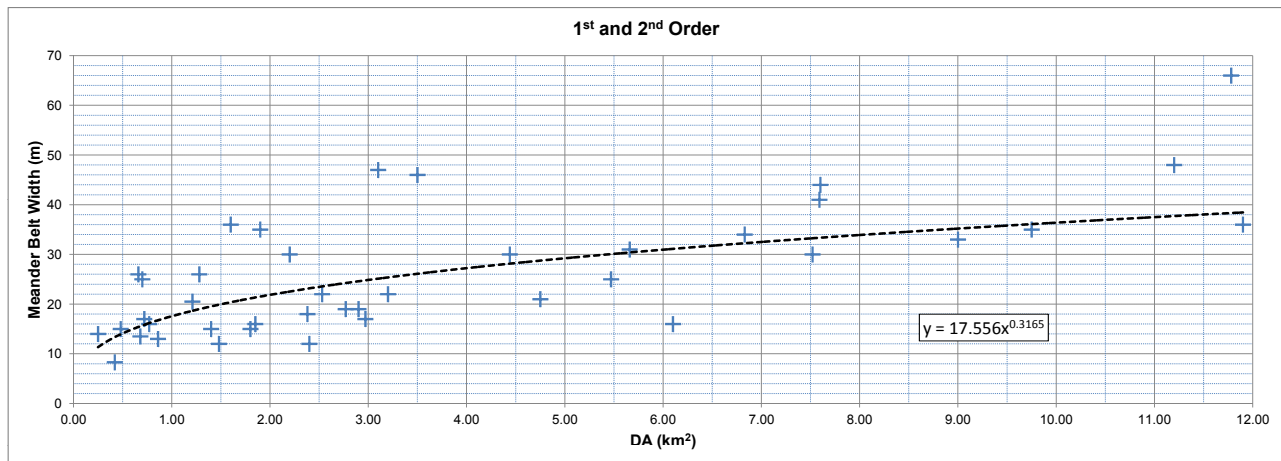
Regional Regression Curves for Meander Belt Width - Southern Ontario Data

DA (km ²)	meander belt width (m)
Fourteen Mile Creek @ Lakeshore Road	25.8	64.2

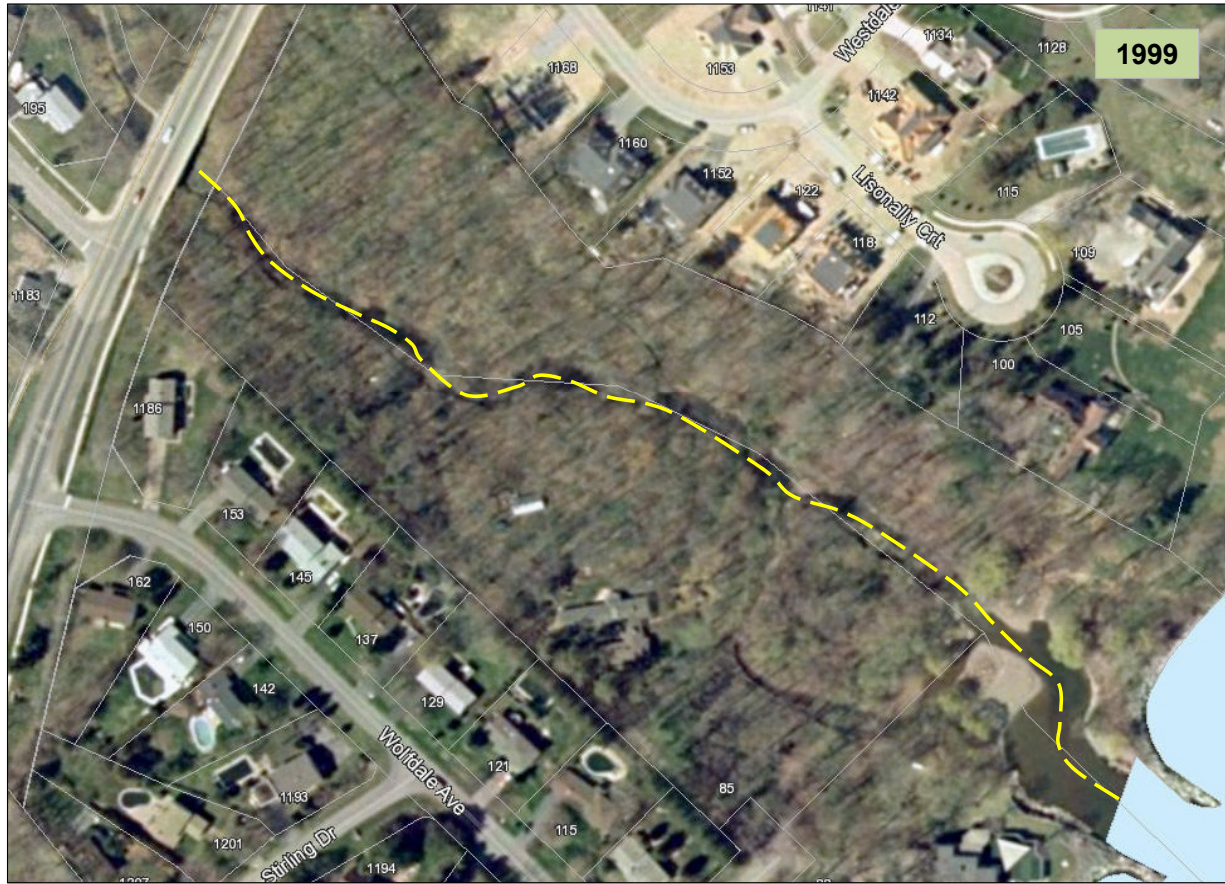
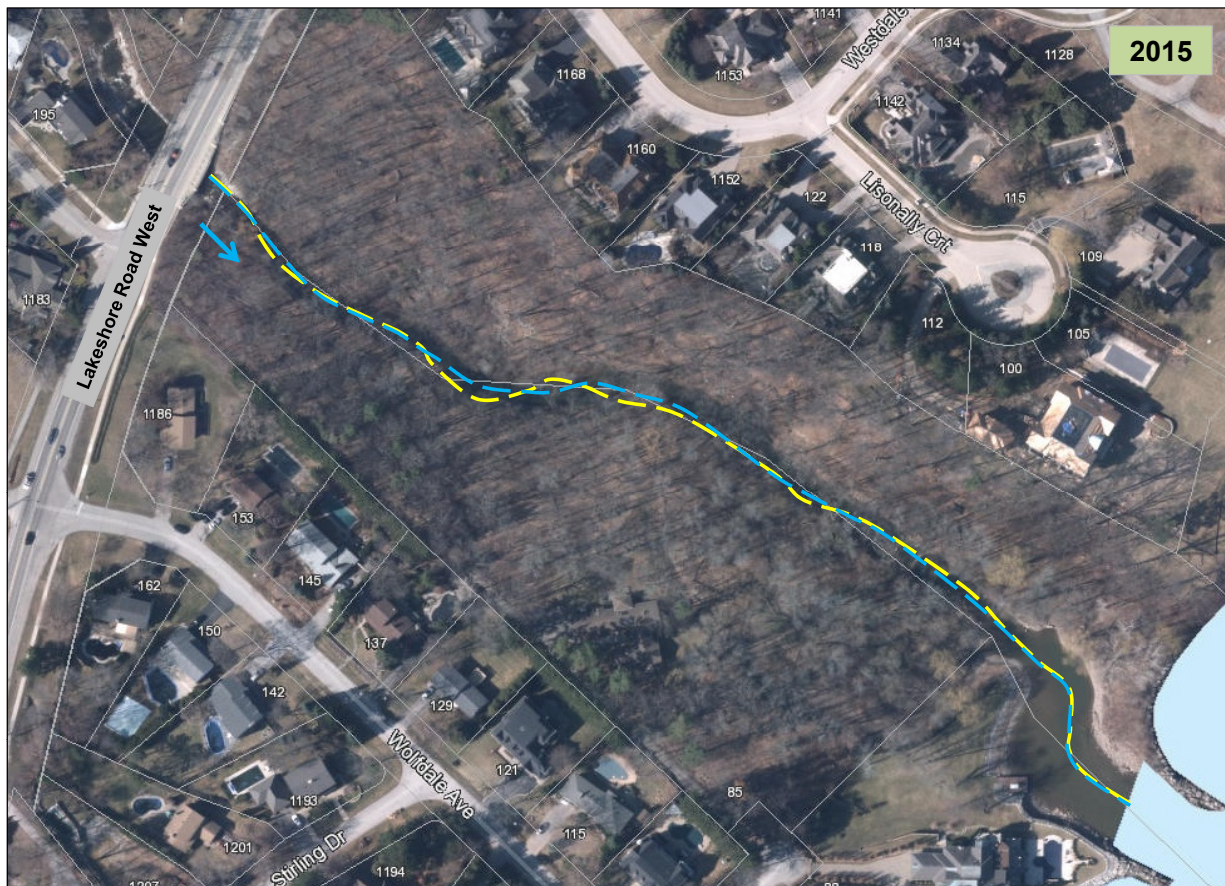
Fourteen Mile Creek - Planform Comparison Lakeshore Road West Improvements Class Environmental Assessment

The comparison shows essentially identical planform patterns at both intervals. As a result, there is no evidence of expansive amplitude or expansive meander belt development. Likewise there is no evidence of reach or meander based up or down valley translation of aggressive erosion patterns. Based on this summary there is a lack of opportunity, and no explicit need, to make recommendations for meander pattern related requirements for crossing sizing.

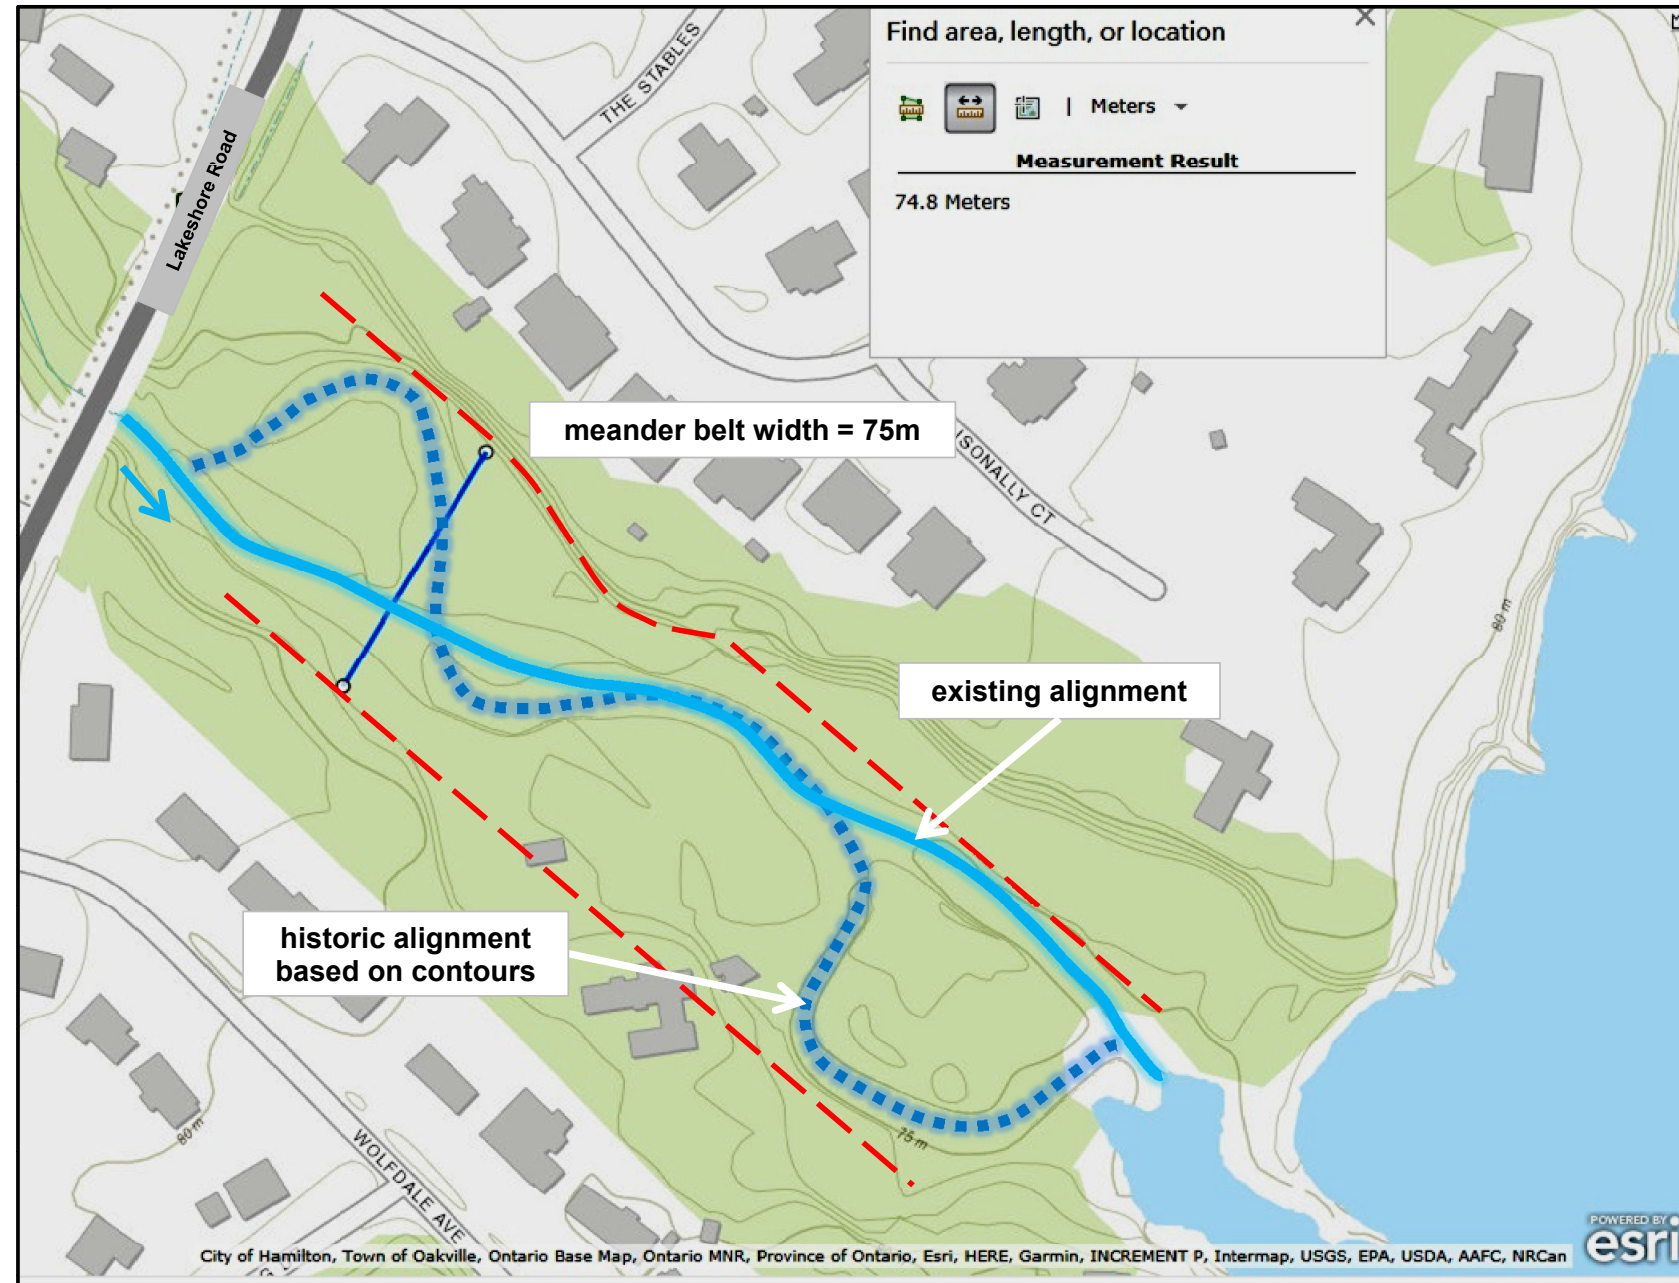
Fourteen Mile Creek - Meander Belt Width Lakeshore Road West Improvements Class Environmental Assessment

The recommended meander belt limits for delineation of Fourteen Mile Creek related Redside Dace habitat are 75m, with 25m measured westerly and 50m measured easterly from the creek centreline along Lakeshore Road. The existing crossing opening width for Fourteen Mile Creek is considered acceptable and the minimum crossing opening width recommended for McCraney Creek is 13.5m which encompass bankfull width of 6.5m with 3.5m overbanks on both sides. Larger crossing opening width would also be suitable, with overbank width adjusted accordingly. Opening sizing is conditional on implementation of scour protection to feasible levels.

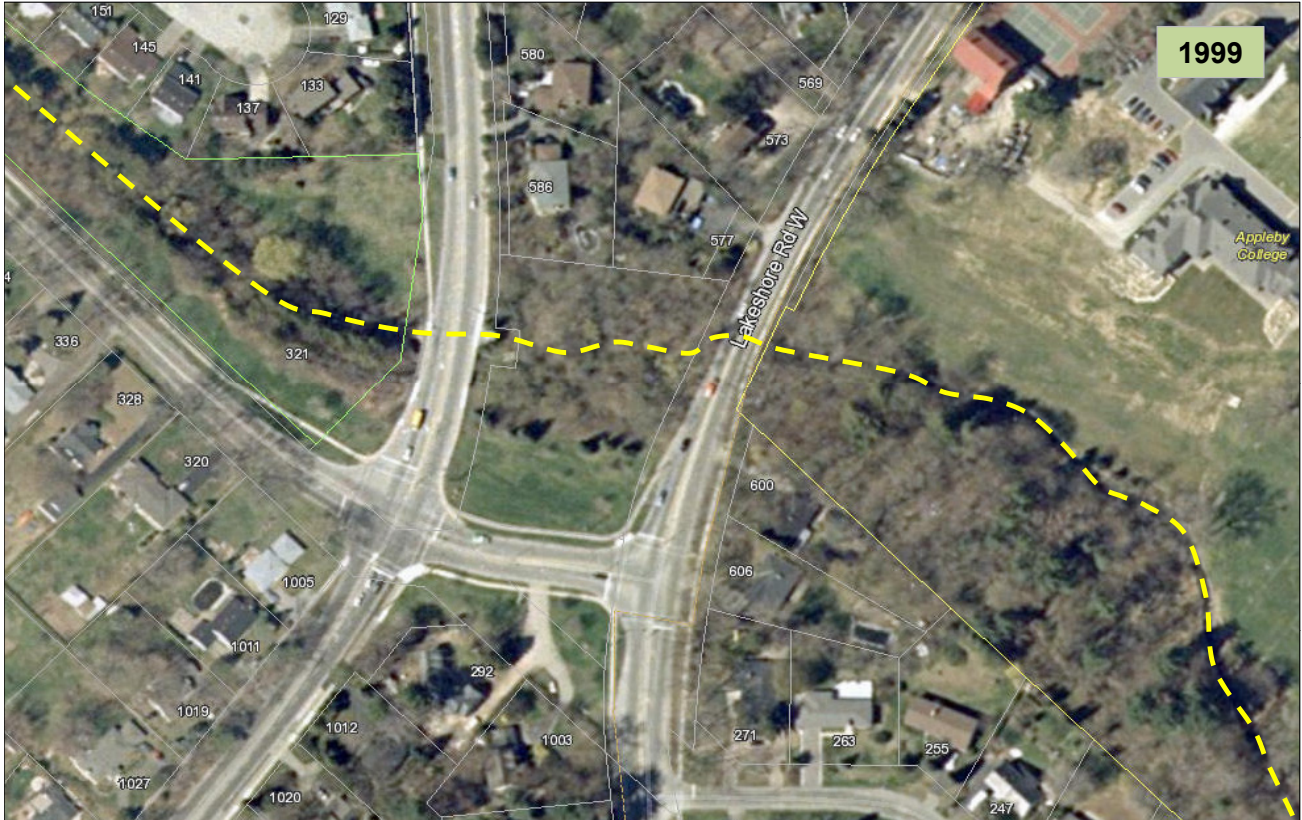
McCraney Creek - Planform Comparison
Lakeshore Road West Improvements Class Environmental Assessment

The comparison shows essentially identical planform patterns at both intervals with possible reflection of some down valley movement in the eroding bend leading directly into the crossing. There is no evidence of widespread expansive amplitude or expansive meander belt development. Based on this summary there is a lack of opportunity, and no explicit need, to make recommendations for meander pattern related requirements for crossing sizing. Addressing the erosion site upstream of the crossing will involve in-situ adjustment of the channel that will likely result in some adjustment of the planform leading to the crossing.

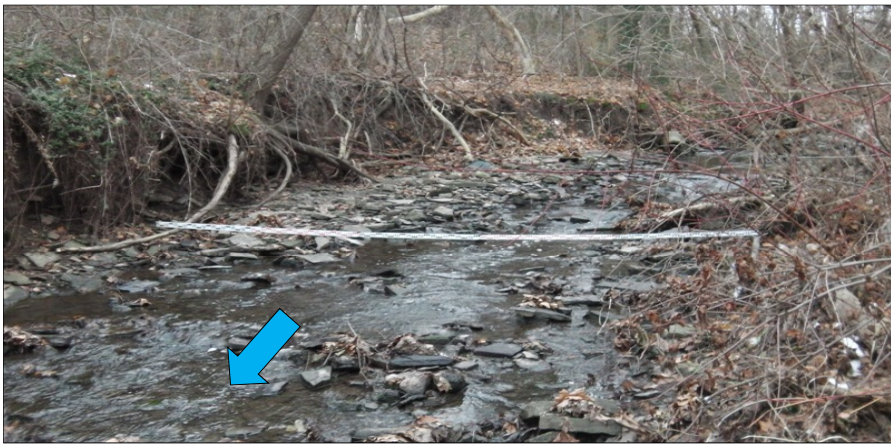
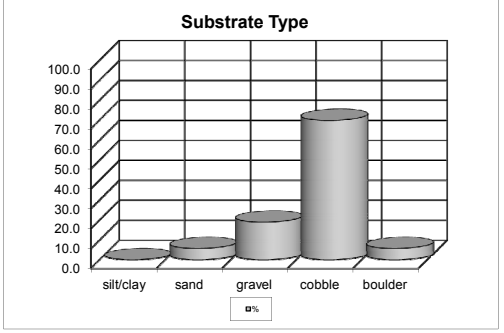
Project: McCraney Creek Preliminary Channel Design
Lakeshore Road Crossing
Existing Conditions Active Channel - Section 1 upstream

Morphology Type	Hydraulic Geometry
cascade	A (m ²) 2.66
step	R (m) 0.40
riffle	TW (m) 6.40
run	WP (m) 6.70
glide	max d (m) 0.57
pool	mean d (m) 0.42
thalweg out of phase	E _s (Limerinos) (m) [+]
	E _s (Strickler) (m) [+]

Erosion Thresholds		Bank Data u/s L		u/s R	
τ _{calc} (kg m ⁻²)	6.35	H _b (m)		Bf _d (m)	
τ _{calc} (N m ⁻²)	62.23	RDp (m)		H _r /Bf _d	
τ D _{crit} (gr-co) (mm)	64.16	RDp/H _b		RDn (%)	
D ₅₀ V _c (vcs +) (m s ⁻¹)	1.66	BA (°)		BFP (%)	
D ₈₄ V _c (vcs +) (m s ⁻¹)	2.11

Flow regime conditions for the proposed channel design are based on field survey of existing active flow or bankfull conditions. Field survey was done at two representative locations, upstream and downstream of the existing crossing, to determine a target bankfull flow.

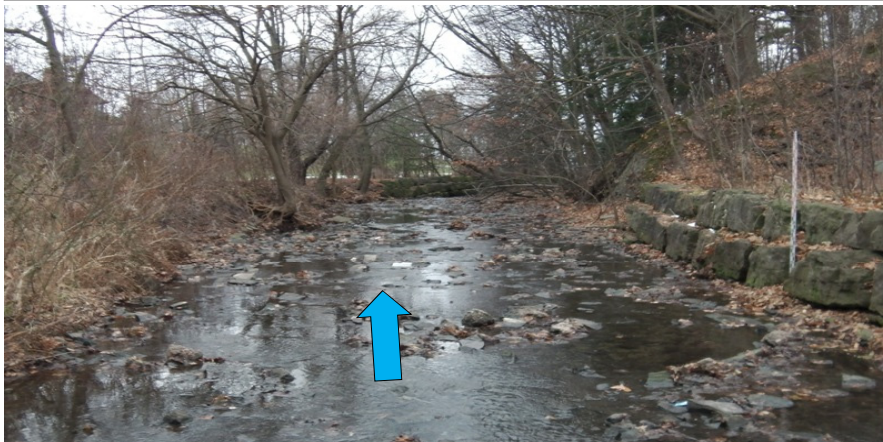
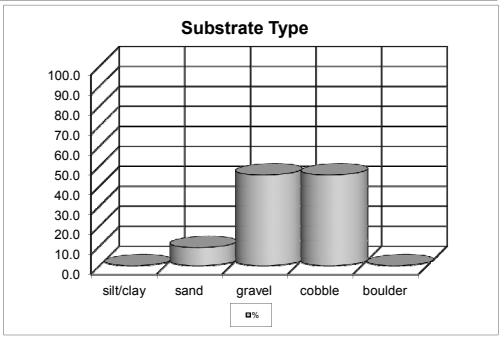
Project: McCraney Creek Preliminary Channel Design
Lakeshore Road Crossing
Existing Conditions Active Channel - Section 2 downstream

Morphology Type	Hydraulic Geometry
cascade	A (m ²) 3.04
step	R (m) 0.39
riffle	TW (m) 7.40
run	WP (m) 7.71
glide	max d (m) 0.53
pool	mean d (m) 0.41
thalweg out of phase	E _s (Limerinos) (m) [+]
	E _s (Strickler) (m) [+]

Erosion Thresholds				Bank Data u/s L		Bank Data u/s R	
τ _{calc} (kg m ⁻²)	5.12			H _b (m)			
τ _{calc} (N m ⁻²)	50.18			B _f _d (m)			
τ _{crit} (gr-co) (mm)	51.74	Strickler	Limerinos	RD _p (m)			
D ₅₀ V _c (vcs +) (m s ⁻¹)	0.98	1.15		H _b /B _f _d			
D ₈₄ V _c (vcs +) (m s ⁻¹)	1.90	2.22		RD _p /H _b			
				RD _n (%)			
				BA (°)			
				BFP (%)

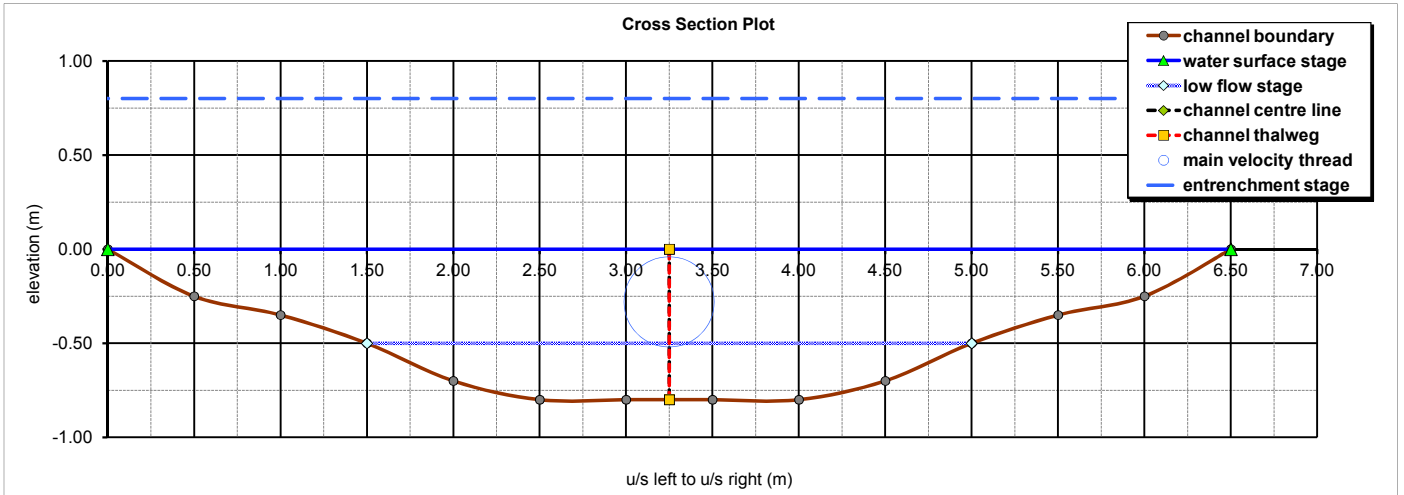
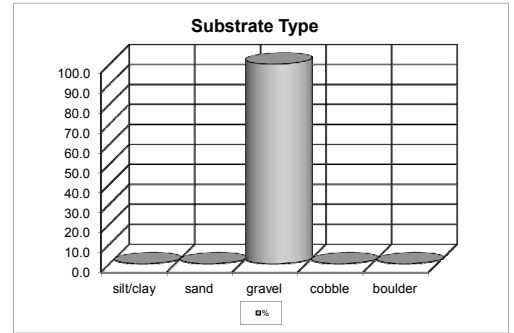
Project: McCraney Creek Preliminary Channel Design
Lakeshore Road Crossing
Proposed Pool Section

Morphology Type	Hydraulic Geometry
cascade	A (m ²) 3.40
step	R (m) 0.50
riffle	TW (m) 6.50
run	WP (m) 6.78
glide	max d (m) 0.80
pool	mean d (m) 0.52
thalweg out of phase	E _s (Limerinos) (m) [+]
Hydraulic Roughness	E _s (Strickler) (m) [+]
rr R/D ₈₄ 11.15	Hydraulic Ratios
ff V mean/V* 7.74	ER max d 3.85
ff D ₈₄ 8.90	r _c / TW
ff mean 8.32	TW / L _f 1.86
SMOOTH BED	TW/max d 8.1
	TW/mean d 12.4

Flow Regime		Strickler method		Limerinos method	
Q (cms)	3.686	Ω (watts m ⁻¹)	216.74	Ω (watts m ⁻¹)	
V (m s ⁻¹)	1.08	ω _a (watts m ⁻²)	31.97	ω _a (watts m ⁻²)	
n	0.045	ω _s /TW (watts m ⁻¹)	4.92	ω _s /TW (watts m ⁻¹)	
Fr	0.48	Re*	56.6	Re*	
D _c rectangular (m)	0.32	Re	476994	Re	
D _c trapezoidal (m)	0.53	turbulence	HIGH	turbulence	
D _c triangular (m)	0.79				
D _c parabolic (m)	0.48				
D _c mean (m)	0.53				
flow type	SUBCRITICAL

Based on the results of opening width recommendations and the surveys of existing bankfull conditions, proposed design cross-section models were produced for riffle and pool features that mimic the existing channel type at channel forming flow. The sections were designed at the average bankfull width noted in erosion limits discussion. Detailed results are appended showing the proposed bankfull channel forming geometry. Channel forming slope used in section models was adjusted to match the combination of proposed planform requirements and hydraulic analysis. Riffle slope was modeled at

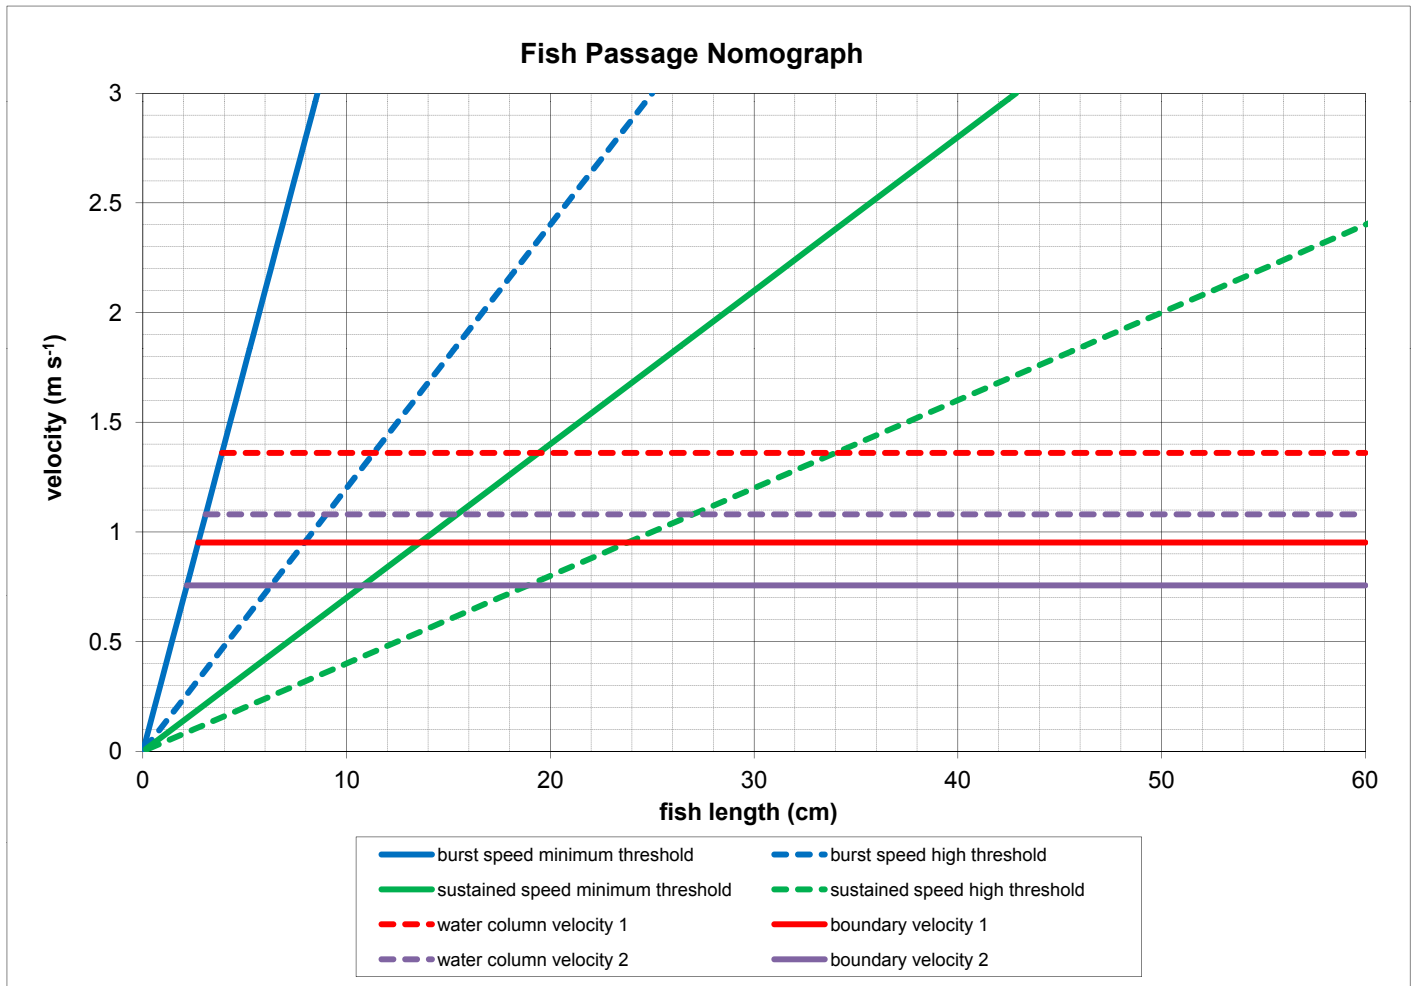
FSH-PASS v.2.2 Fish Passage Channel Velocity Analysis Model

Fish Length Data					
		sustained speed high threshold	sustained speed minimum threshold	burst speed high threshold	burst speed minimum threshold
1	fish length L_f (cm) at V	34.0	19.4	11.3	3.9
	fish length L_f (cm) at V_b	23.8	13.6	7.9	2.7
2	fish length L_f (cm) at V	27.0	15.4	9.0	3.1
	fish length L_f (cm) at V_b	18.9	10.8	6.3	2.2

Fish passage confirmation was undertaken using a velocity nomograph to assess the size of fish capable of moving upstream against specific nose velocities. Bankfull event velocities under proposed design riffle and pool cross-section conditions were used to check the preliminary design. Detailed results are appended. The results show that fish as small as approximately 2-3cm long range can use burst speed to move up the channel boundary and fish as small as 3-4cm range can use burst speed to move suspended through the water column. Burst speed distances are theoretically 90m or more before velocity shelter is required. Based on the proposed length of the crossing and the intervening shelter from bedform sequencing in the realignment, there are no constraints foreseen to the size range of typical fish that will pass the design during high flows. These results are conservative because they represent the peak of freshet or infrequent storm events when fish are more likely to only be active during the rise or upon the recession of flows to levels less than bankfull
