### TECHNICAL MEMORANDUM NH#1 - REACH 14W-14A AQUATIC HABITAT

Job No.: 14.09222.001 Date: March 28, 2012 Author: Mark Cece, B.Sc. – Ecology Department Manager/Senior Fisheries Biologist

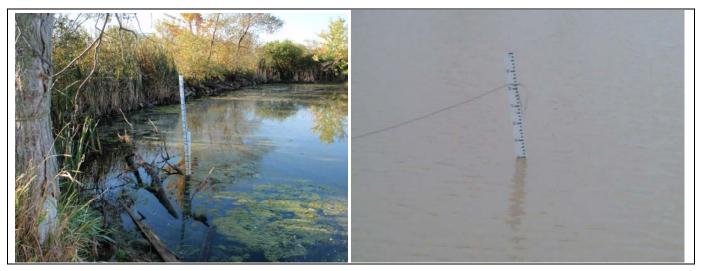
Plate 1: Staff Gauge, October 6, 2011

As discussed the pond receives input from tributaries 14W-13 and 14W-14 at the north end and through surface flows from the relatively small catchment area from the adjacent table lands draining the pond. As a result, water levels can fluctuate by more than a meter during periods of heavy rains. The following pictures show the staff gauge installed at the south end of the pond at the deepest part of the pond. The photo on the left (Plate 1) was taken on (October 6, 2011 when Environment Canada recorded 0 mm of rainfall during the 24 hours prior, (26.5 mm of rain – 7 days prior). The photo on the right (Plate 2) shows the staff gauge on October 20, 2011 with when Environment Canada recorded approximately 60 mm of rainfall during the 24 hours prior (63.5 mm of rain – 7 days prior). The observation suggest that the pond is heavily influenced by the surface water contributions and that once the pond is no longer hydraulically connected to the downstream watercourse, there are no other inputs that assist in maintaining water levels. Instead the water level is decreased through evaporation.

Plate 2: Staff Gauge, October 20, 2011

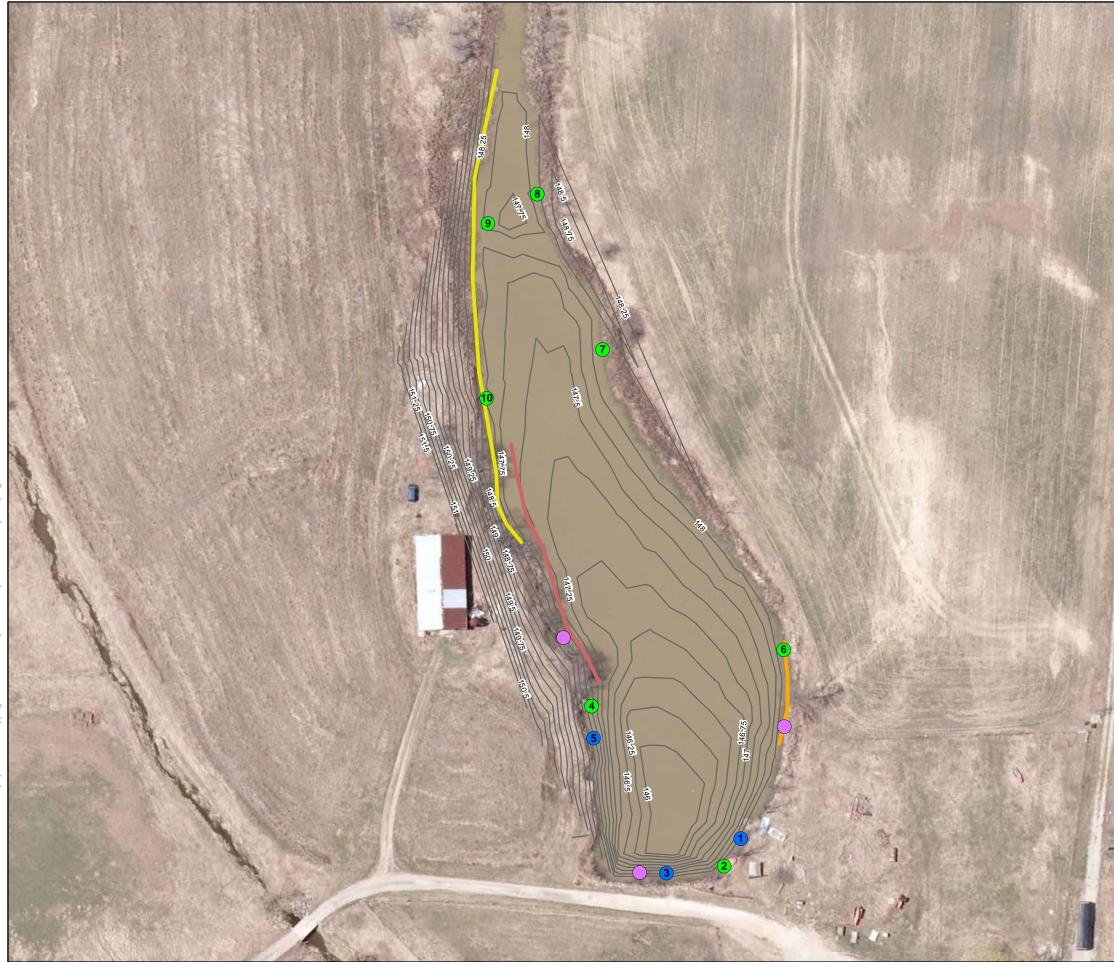
Bathymetric Survey / Approximate Fish Community Sampling Locations

The bathymetry of the pond is illustrated in Figure 1. The pond is generally shallowest at the northwest end of the pond, with depth increasing fairly uniformly toward the southeast end of the pond. The slope of the pond bottom varies, with some areas having a greater slope than other areas. The most prominent slope occurs along the southeastern end of the pond, parallel to the laneway.

As a result the fish community of the farm pond has been surveyed on the following occasions and the approximate locations identified on Figure 1:

- 2002 MMM Group Minnow Trap (approx. 24 hr set) to obtain background data for site;
- 2002 NRSI Backpack Electroshocking along the shoreline in support of NOCSS;
- 2009 MMM Group Minnow Trap (approx. 24 hr set) in support of the EIR;
- 2009 MMM Group Backpack Electroshocking along the shoreline in support of the EIR
- 2011 MMM Group Minnow Trap to supplement existing data at request of HC
- 2011 MMM Group Pot Trap to supplement existing data at request of HC
