**PHASE ONE ENVIRONMENTAL SITE ASSESSMENT  
UPDATE**

**1020, 1024, 1028, 1032 AND 1042 SIXTH LINE  
OAKVILLE, ONTARIO**

**S2S  
Environmental Inc.**

**JANUARY 24, 2023**

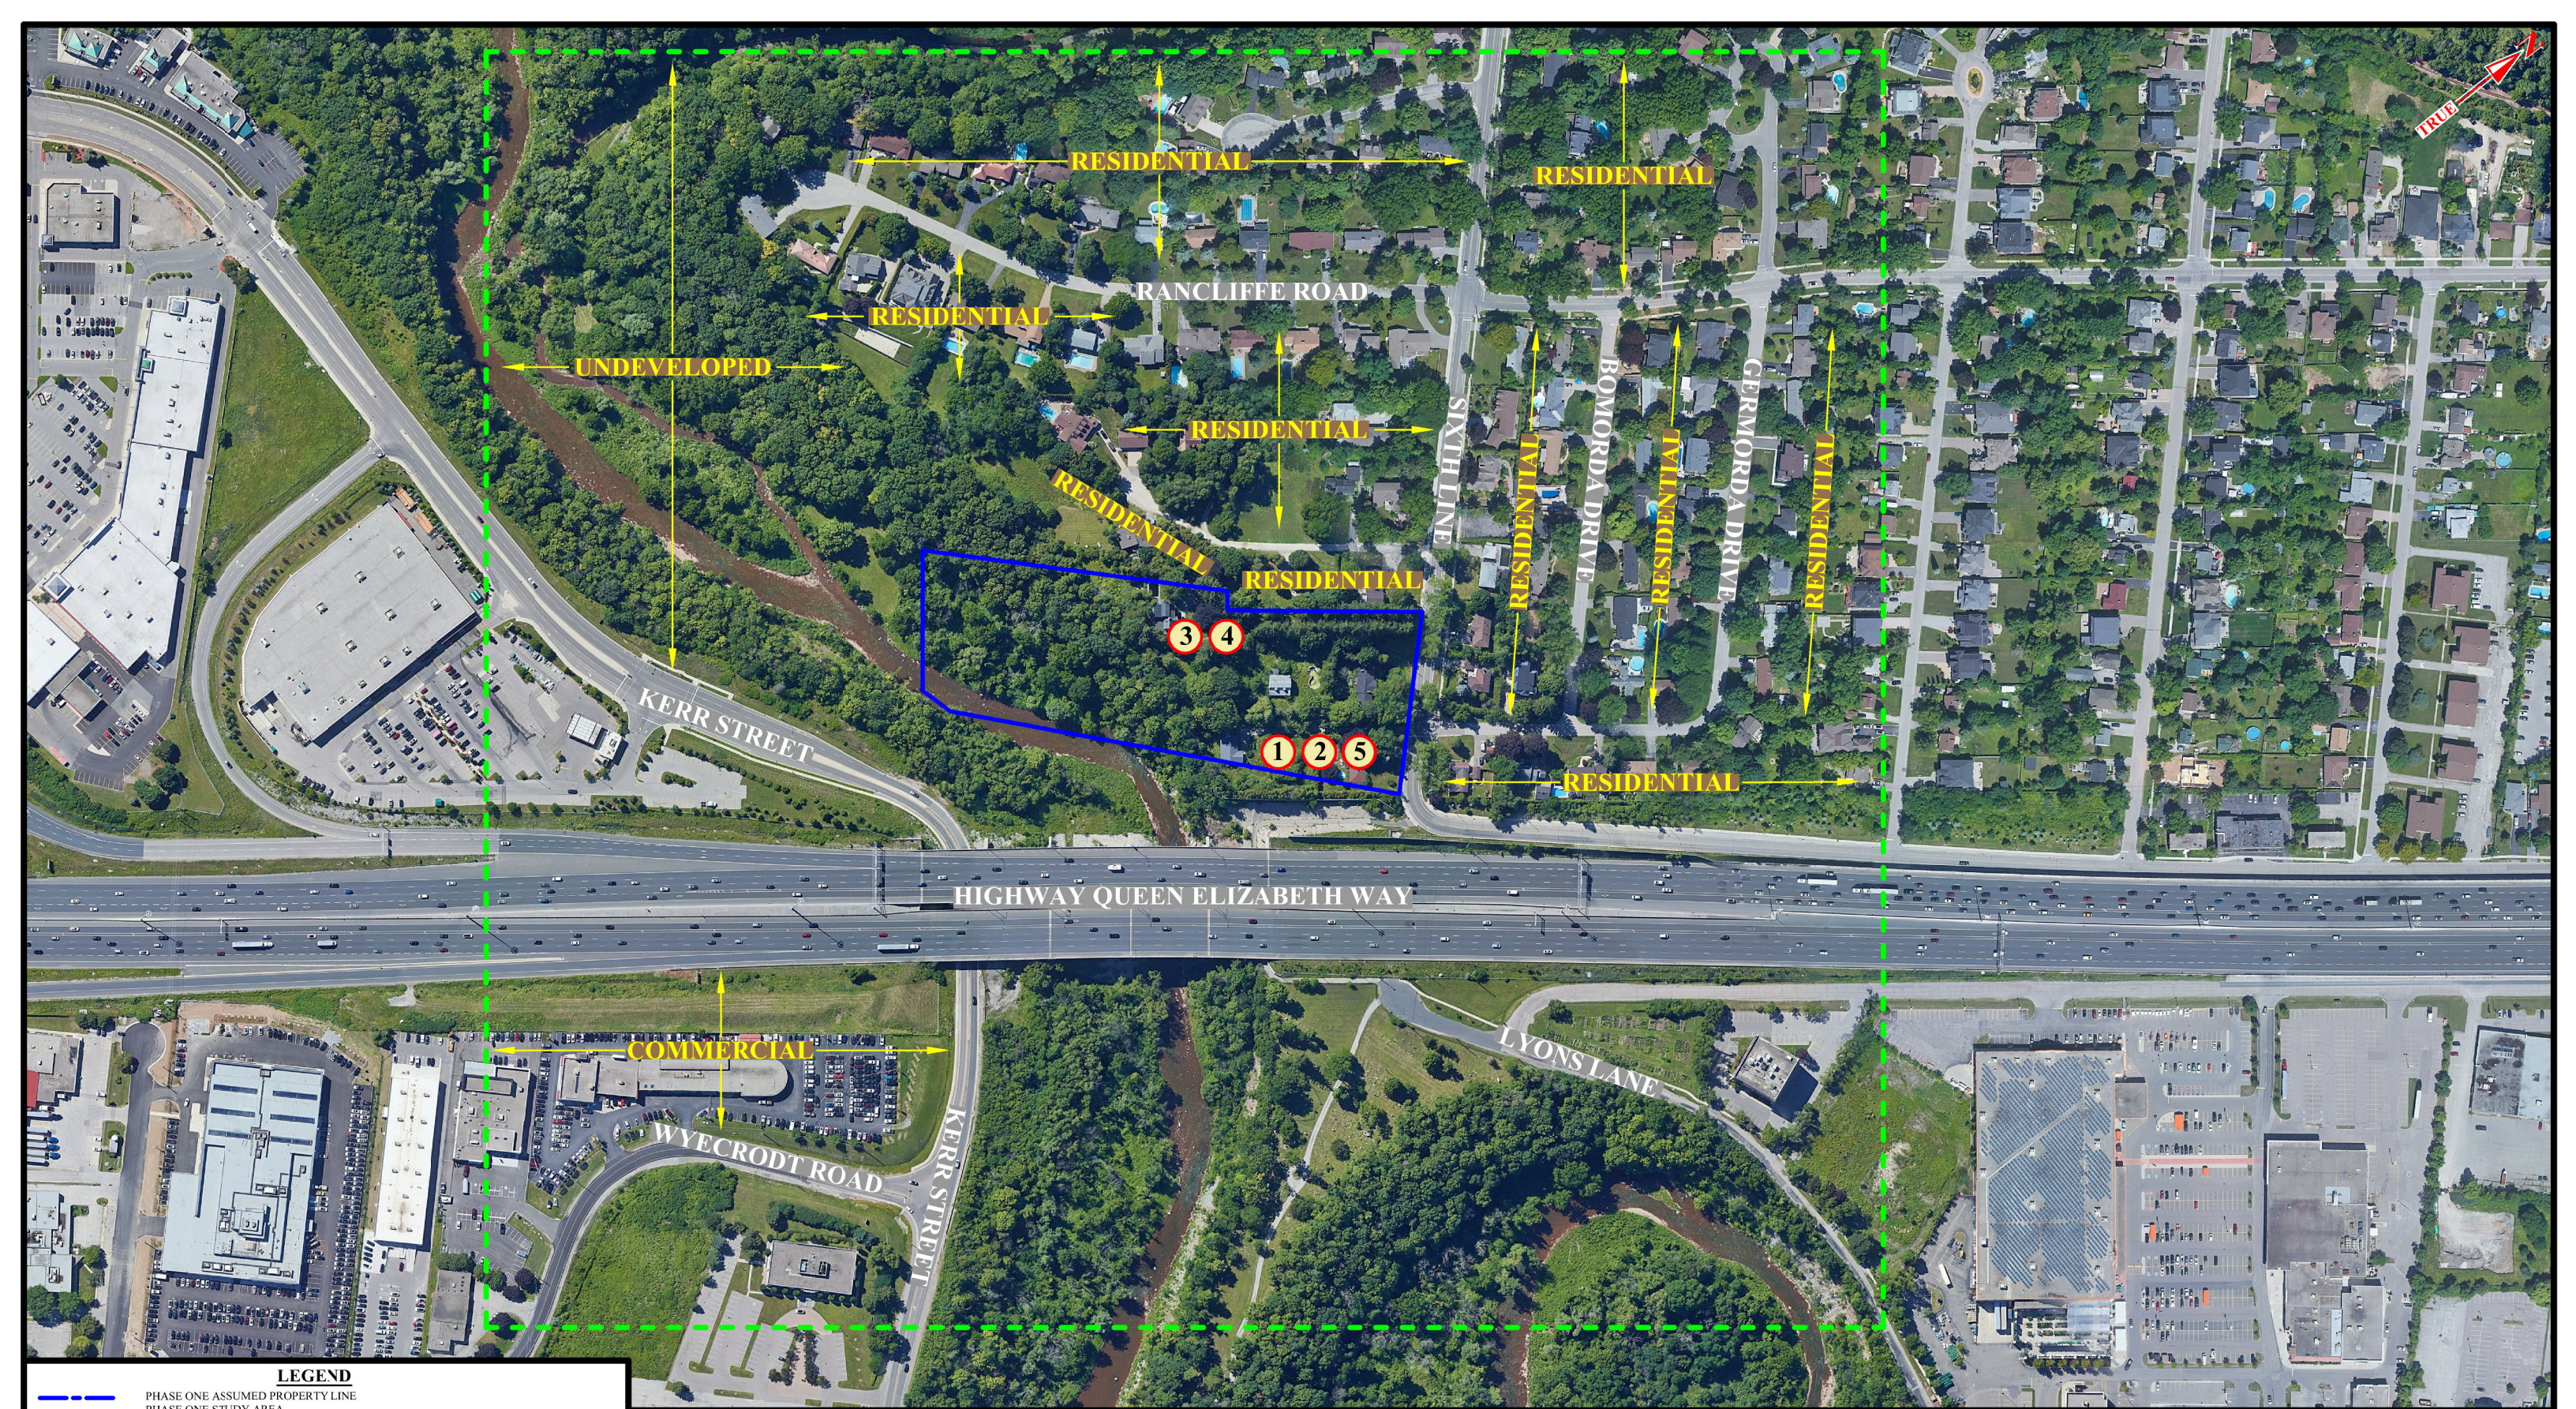
<b>S2S Environmental Inc.</b>		SCALE: 
PROJECT NO: <b>10906</b>	SITE LOCATION: <b>1020, 1024, 1028, 1032 AND 1042 SIXTH LINE OAKVILLE, ONTARIO</b>	DRAWING NO: <b>2</b>

- LEGEND**
- PHASE ONE ASSUMED PROPERTY LINE
  - PHASE ONE STUDY AREA
  - POTENTIALLY CONTAMINATING ACTIVITY (PCA)
    - 1. East portion of Phase One Property  
#30 - Imporporation of Fill Material of Unknown Quality
    - 2. East portion of Phase One Property  
#40 - Pesticides (including Herbicides, Fungicides and Anti-Fouling Agents) Manufacturing, Processing, Bulk Storage and Large-Scale Applications
    - 3. Central North portion of Phase One Property  
#30 - Imporporation of Fill Material of Unknown Quality
    - 4. Central North portion of Phase One Property  
#28 - Gasoline and Associated Products Storage in Fixed Tanks
    - 5. East portion of Phase One Property  
(Applicator of road salt along Sixth Line and on the Phase One Property)

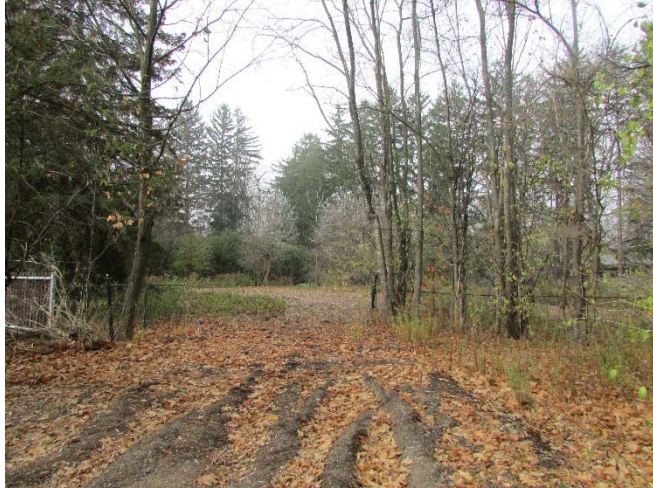
**Photo 9: View of the central portion of the Phase One Property, in the vicinity of the historical building structures.**

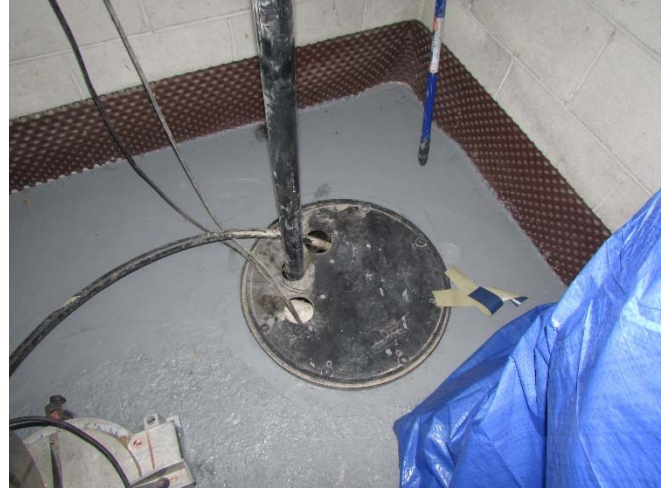
**Photo 10: View of a sump pit in the basement of Building C at the time of the site reconnaissance.**

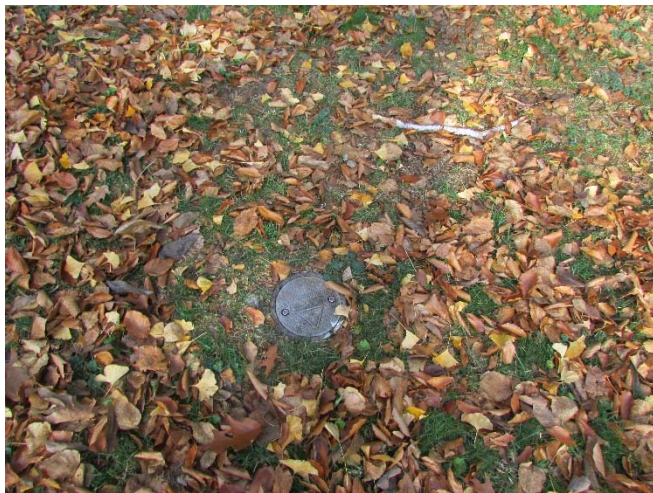
**Photo 11: View of a typical groundwater monitoring well (previously installed by others) observed in the vicinity of Building C at the time of the site reconnaissance.**

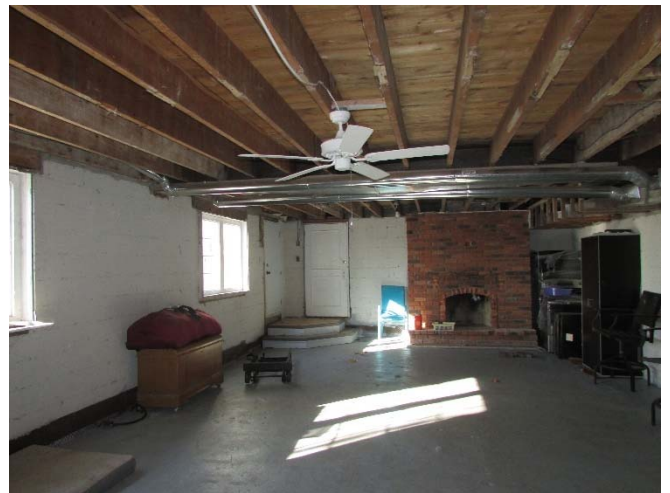
**Photo 12: View of a portion of the basement of Building A at the time of the site reconnaissance.**

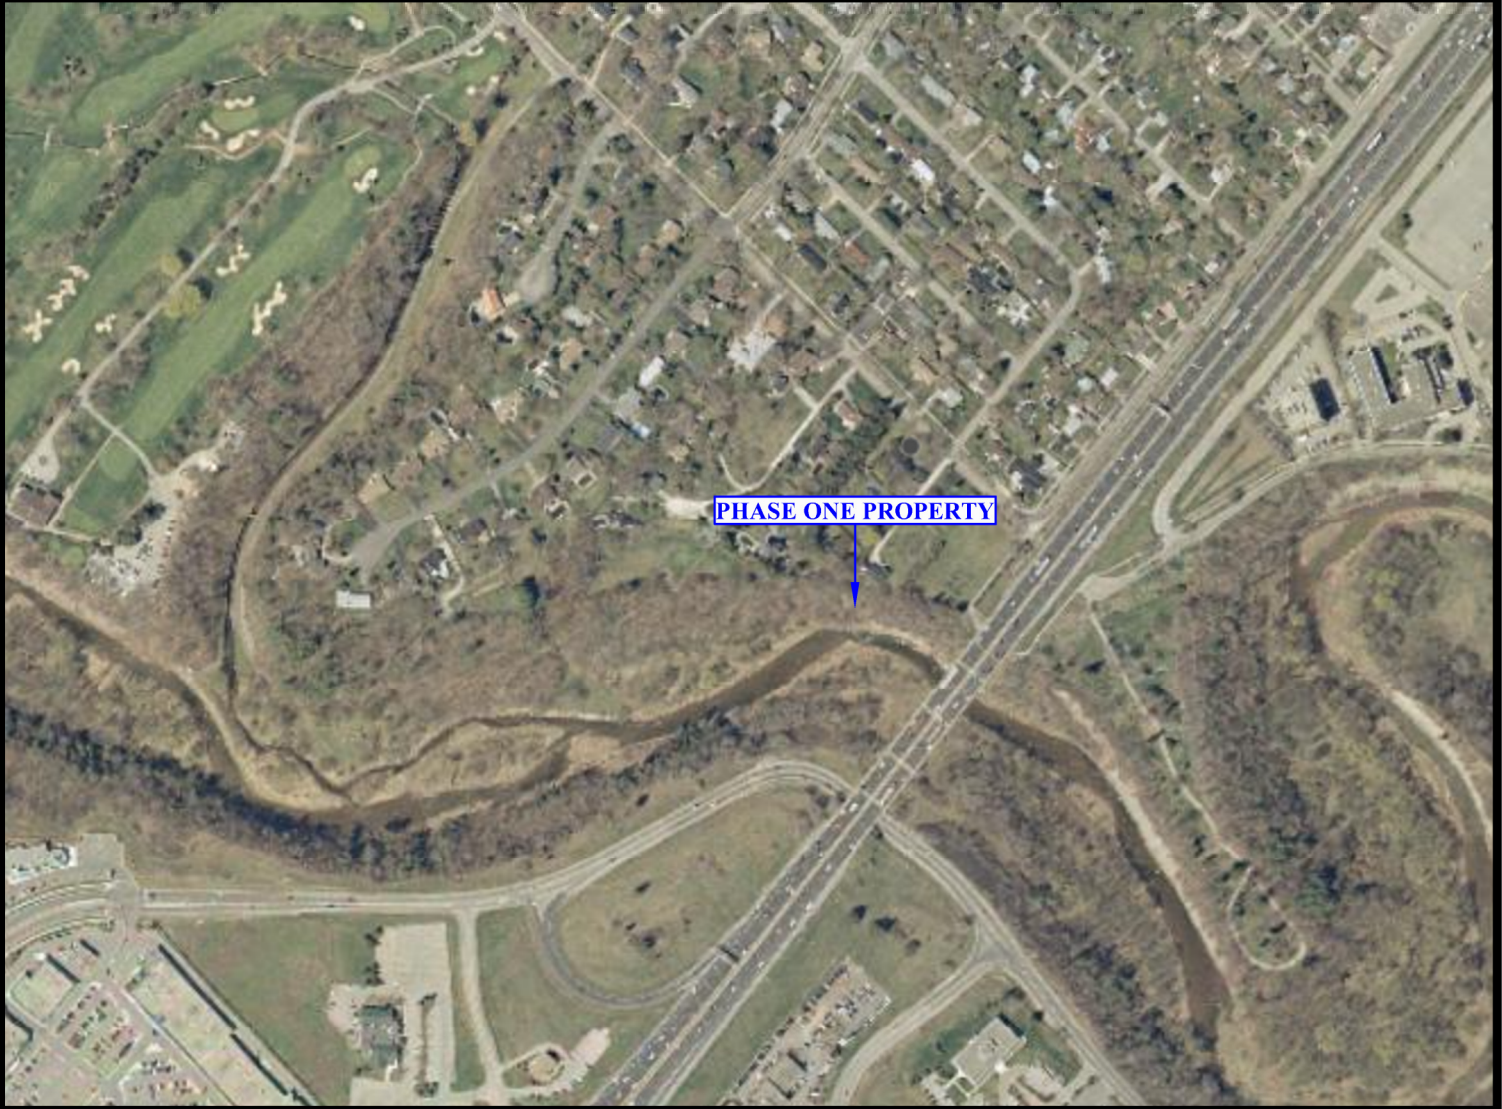
**AERIAL PHOTO SHOWING SUBJECT  
PROPERTY - 1999**

1999	Phase One Property, North, East, South, Southwest, Northwest	The Phase One Property and immediate adjacent/neighbouring properties on all sides of the Phase One Property appeared to be similar to that observed in the 2008 aerial photograph.
1988	Phase One Property, North, East, South, Southwest, Northwest	The Phase One Property and immediate adjacent/neighbouring properties on all sides of the Phase One Property appeared to be similar to that observed in the 1999 aerial photograph.
1979	Phase One Property, North, East, South, Southwest, Northwest	The Phase One Property and immediate adjacent/neighbouring properties on all sides of the Phase One Property appeared to be similar to that observed in the 1988 aerial photograph.
1965	Phase One Property	The Phase One Property appeared to be developed with inferred residential buildings, and an inferred orchard on the south portion of the Phase One Property.

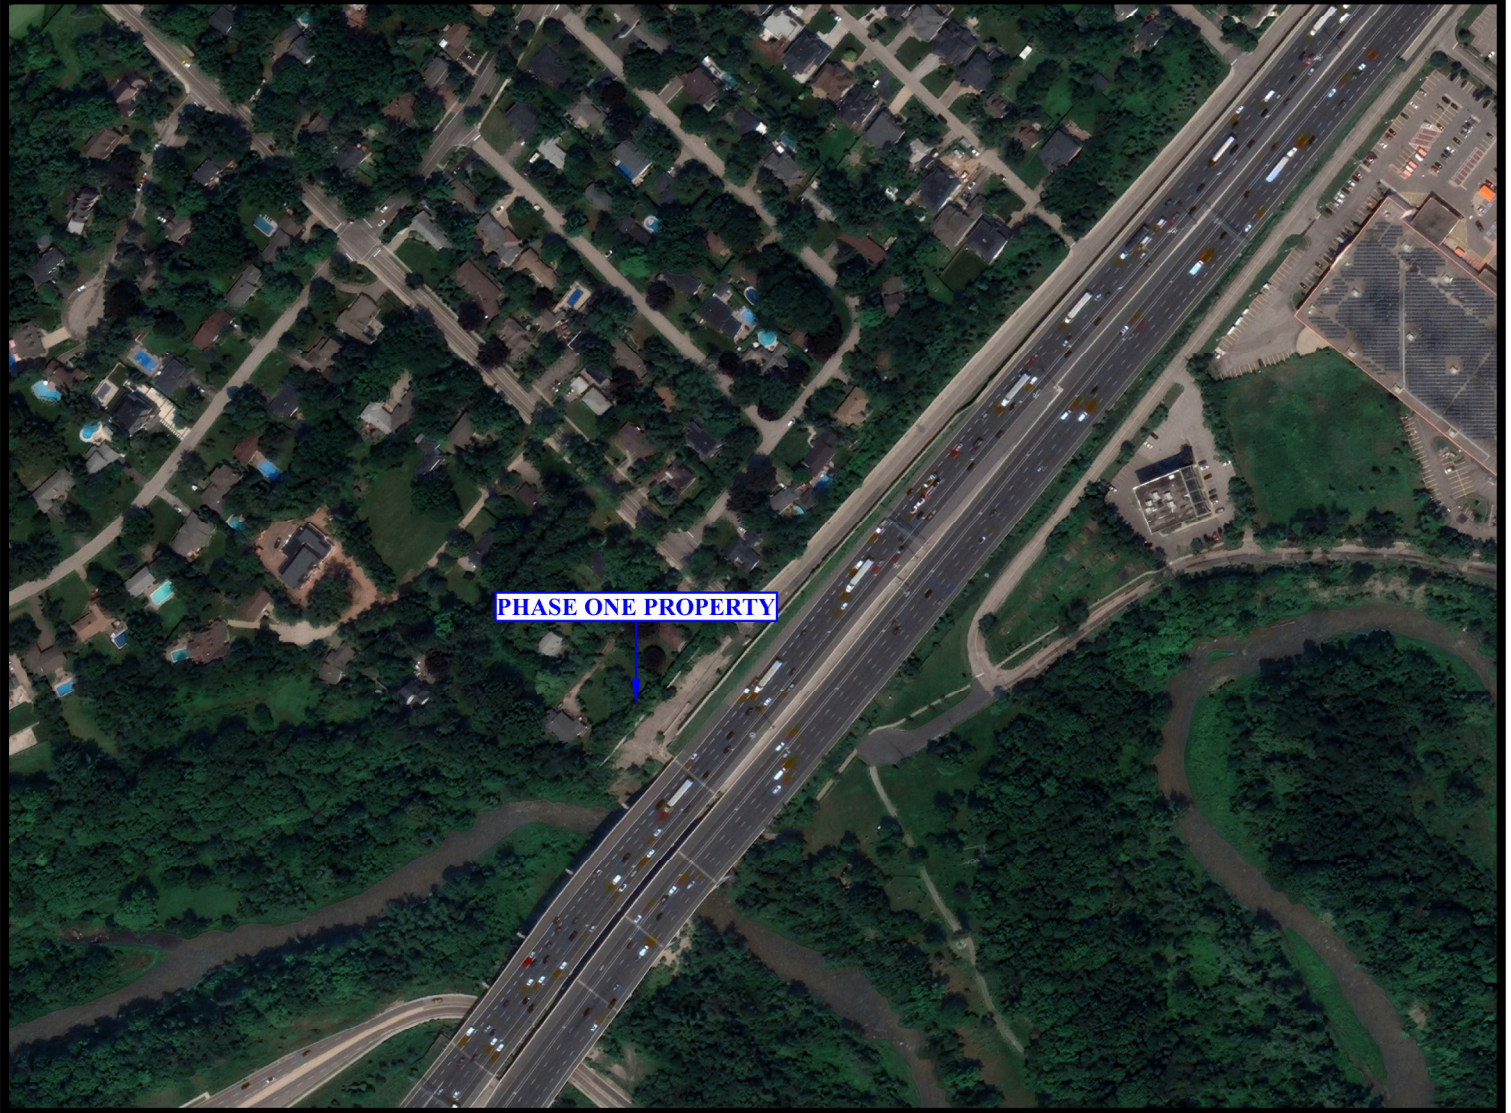
**AERIAL PHOTO SHOWING SUBJECT  
PROPERTY - 2021**

Year of Photograph	Findings for Phase One Property and Adjacent/Neighbouring Properties	
2021	Phase One Property:	The Phase One Property appeared to be developed with buildings of similar size and configuration as the current Subject Buildings. It should be noted that two historical structures were observed on the central portion of the Phase One Property.
	North, East, Northwest	The adjacent/neighbouring properties located to the north, east (across Sixth Line) and northwest of the Phase One Property appeared to be developed with inferred residential buildings, consistent with S2S's observations at the time of the site reconnaissance.
	South:	The adjacent property located to south of the Phase One Property appeared to be developed with the QEW, consistent with S2S's observations at the time of the site reconnaissance.
