# ENVIRONMENTAL IMPLEMENTATION REPORT / FUNCTIONAL SERVICING STUDY - MAIN REPORT (6TH SUBMISSION)

September 2020

14 Mile Creek West and the Lazy Pat Farm Property  
(3269 Dundas Street West), North Oakville West

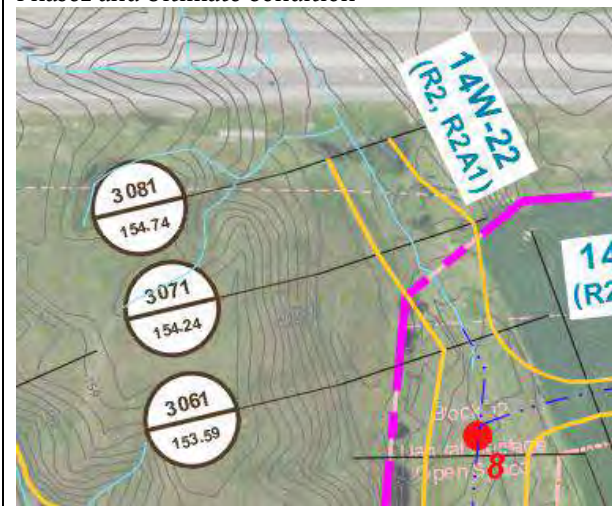
Existing/Proposed RS	Existing	Phase 2	Ultimate	228/3061	154.32	153.60	153.59	(n/a)/3071		154.32	154.24	3081/3081	154.76	154.75	154.75
Existing/Proposed RS	Existing	Phase 2	Ultimate														
228/3061	154.32	153.60	153.59														
(n/a)/3071		154.32	154.24														
3081/3081	154.76	154.75	154.75														
b) 14W-22, River 2, Reach R2A1, River Station 3061 – The predicted flood elevation at the south Transitway boundary is higher under Phase 2 and Ultimate Conditions then Existing Conditions. This increase must be eliminated unless written permission is obtained from the Province.	<p>Phase2 and Ultimate Condition</p>

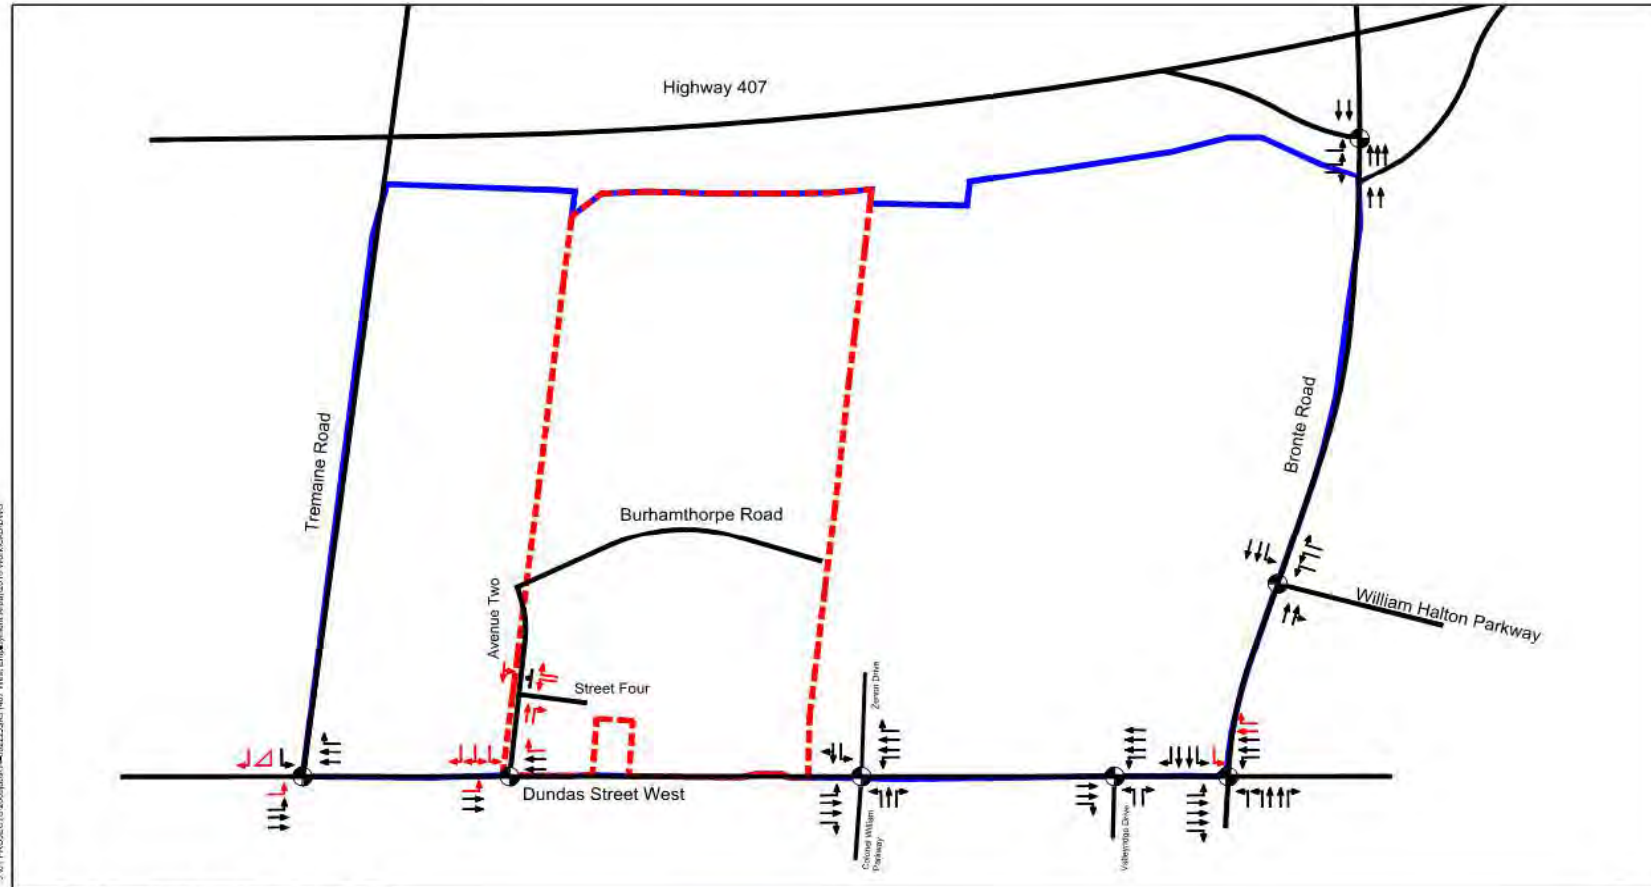
Region of Halton	WSP Response
<p>Lane Configuration Diagrams: Confirm that all lane configuration diagrams and Synchro reports are consistent with one another and update them accordingly (example: Figure 5-1 vs. synchro sheets);</p>	<p>Based on a review of the lane configuration figures and Synchro sheets, the following minor discrepancies were identified:</p> <ul style="list-style-type: none"><li>- The northbound movement at the intersection of William Halton Parkway at Bronte Road was coded as two-through lanes in Synchro rather than one through and one shared through/right-turn lane. However, as the northbound right-turn volumes were coded into the Synchro model, the results would not change should the model be re-run as the right-turning volumes were considered in the analysis. Should the model be updated, only the arrow diagram on the Synchro result sheets would be updated, which is not deemed to be necessary.</li><li>- The eastbound approach lane configuration of two through lanes and one shared through/right-turn lane was not illustrated at the intersection of Dundas Street and Valleyridge Drive in Figure 5-1. However, the configuration was properly coded in the Synchro model.</li></ul> <p>An updated version of Figure 5-1 showing the eastbound approach configuration at the intersection of Dundas Street and Valleyridge Drive is provided below:</p>

- Signalized Intersection
- Stop-Controlled Intersection
- Recommended Lane Configuration
- 407 West Area Employment Lands
- Subject Property

Note: All Channelized right-turn lanes are recommended to be implemented along with an additional receiving lane that would taper out.

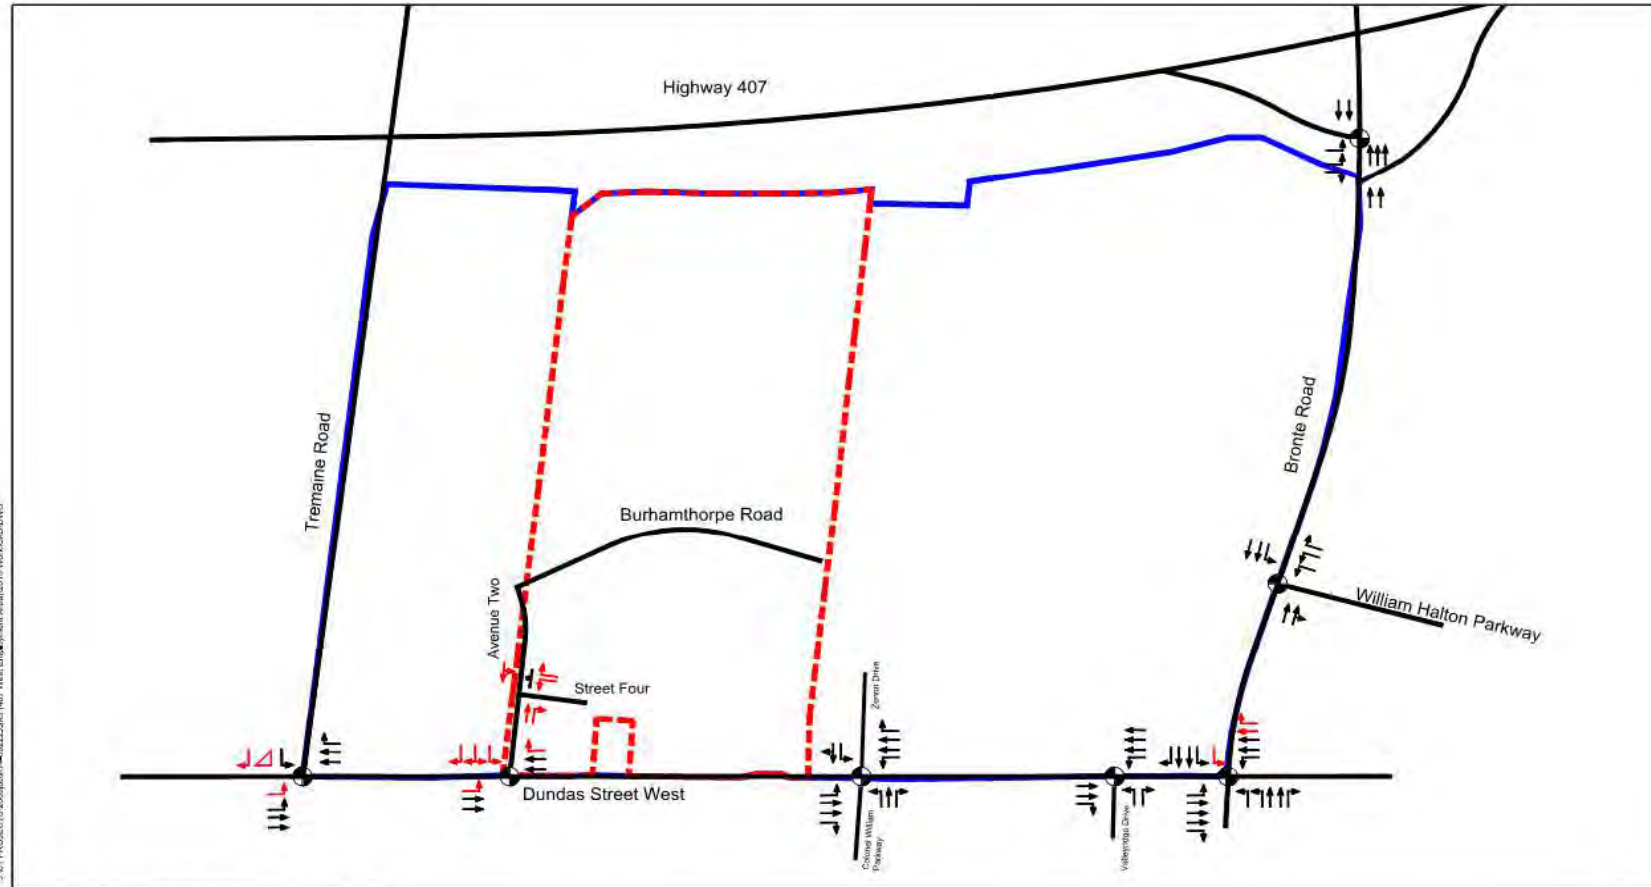
Region of Halton	WSP Response
<p>Lane Configuration Diagrams: Confirm that all lane configuration diagrams and Synchro reports are consistent with one another and update them accordingly (example: Figure 5-1 vs. synchro sheets);</p>	<p>Based on a review of the lane configuration figures and Synchro sheets, the following minor discrepancies were identified:</p> <ul style="list-style-type: none"><li>- The northbound movement at the intersection of William Halton Parkway at Bronte Road was coded as two-through lanes in Synchro rather than one through and one shared through/right-turn lane. However, as the northbound right-turn volumes were coded into the Synchro model, the results would not change should the model be re-run as the right-turning volumes were considered in the analysis. Should the model be updated, only the arrow diagram on the Synchro result sheets would be updated, which is not deemed to be necessary.</li><li>- The eastbound approach lane configuration of two through lanes and one shared through/right-turn lane was not illustrated at the intersection of Dundas Street and Valleyridge Drive in Figure 5-1. However, the configuration was properly coded in the Synchro model.</li></ul> <p>An updated version of Figure 5-1 showing the eastbound approach configuration at the intersection of Dundas Street and Valleyridge Drive is provided below:</p>

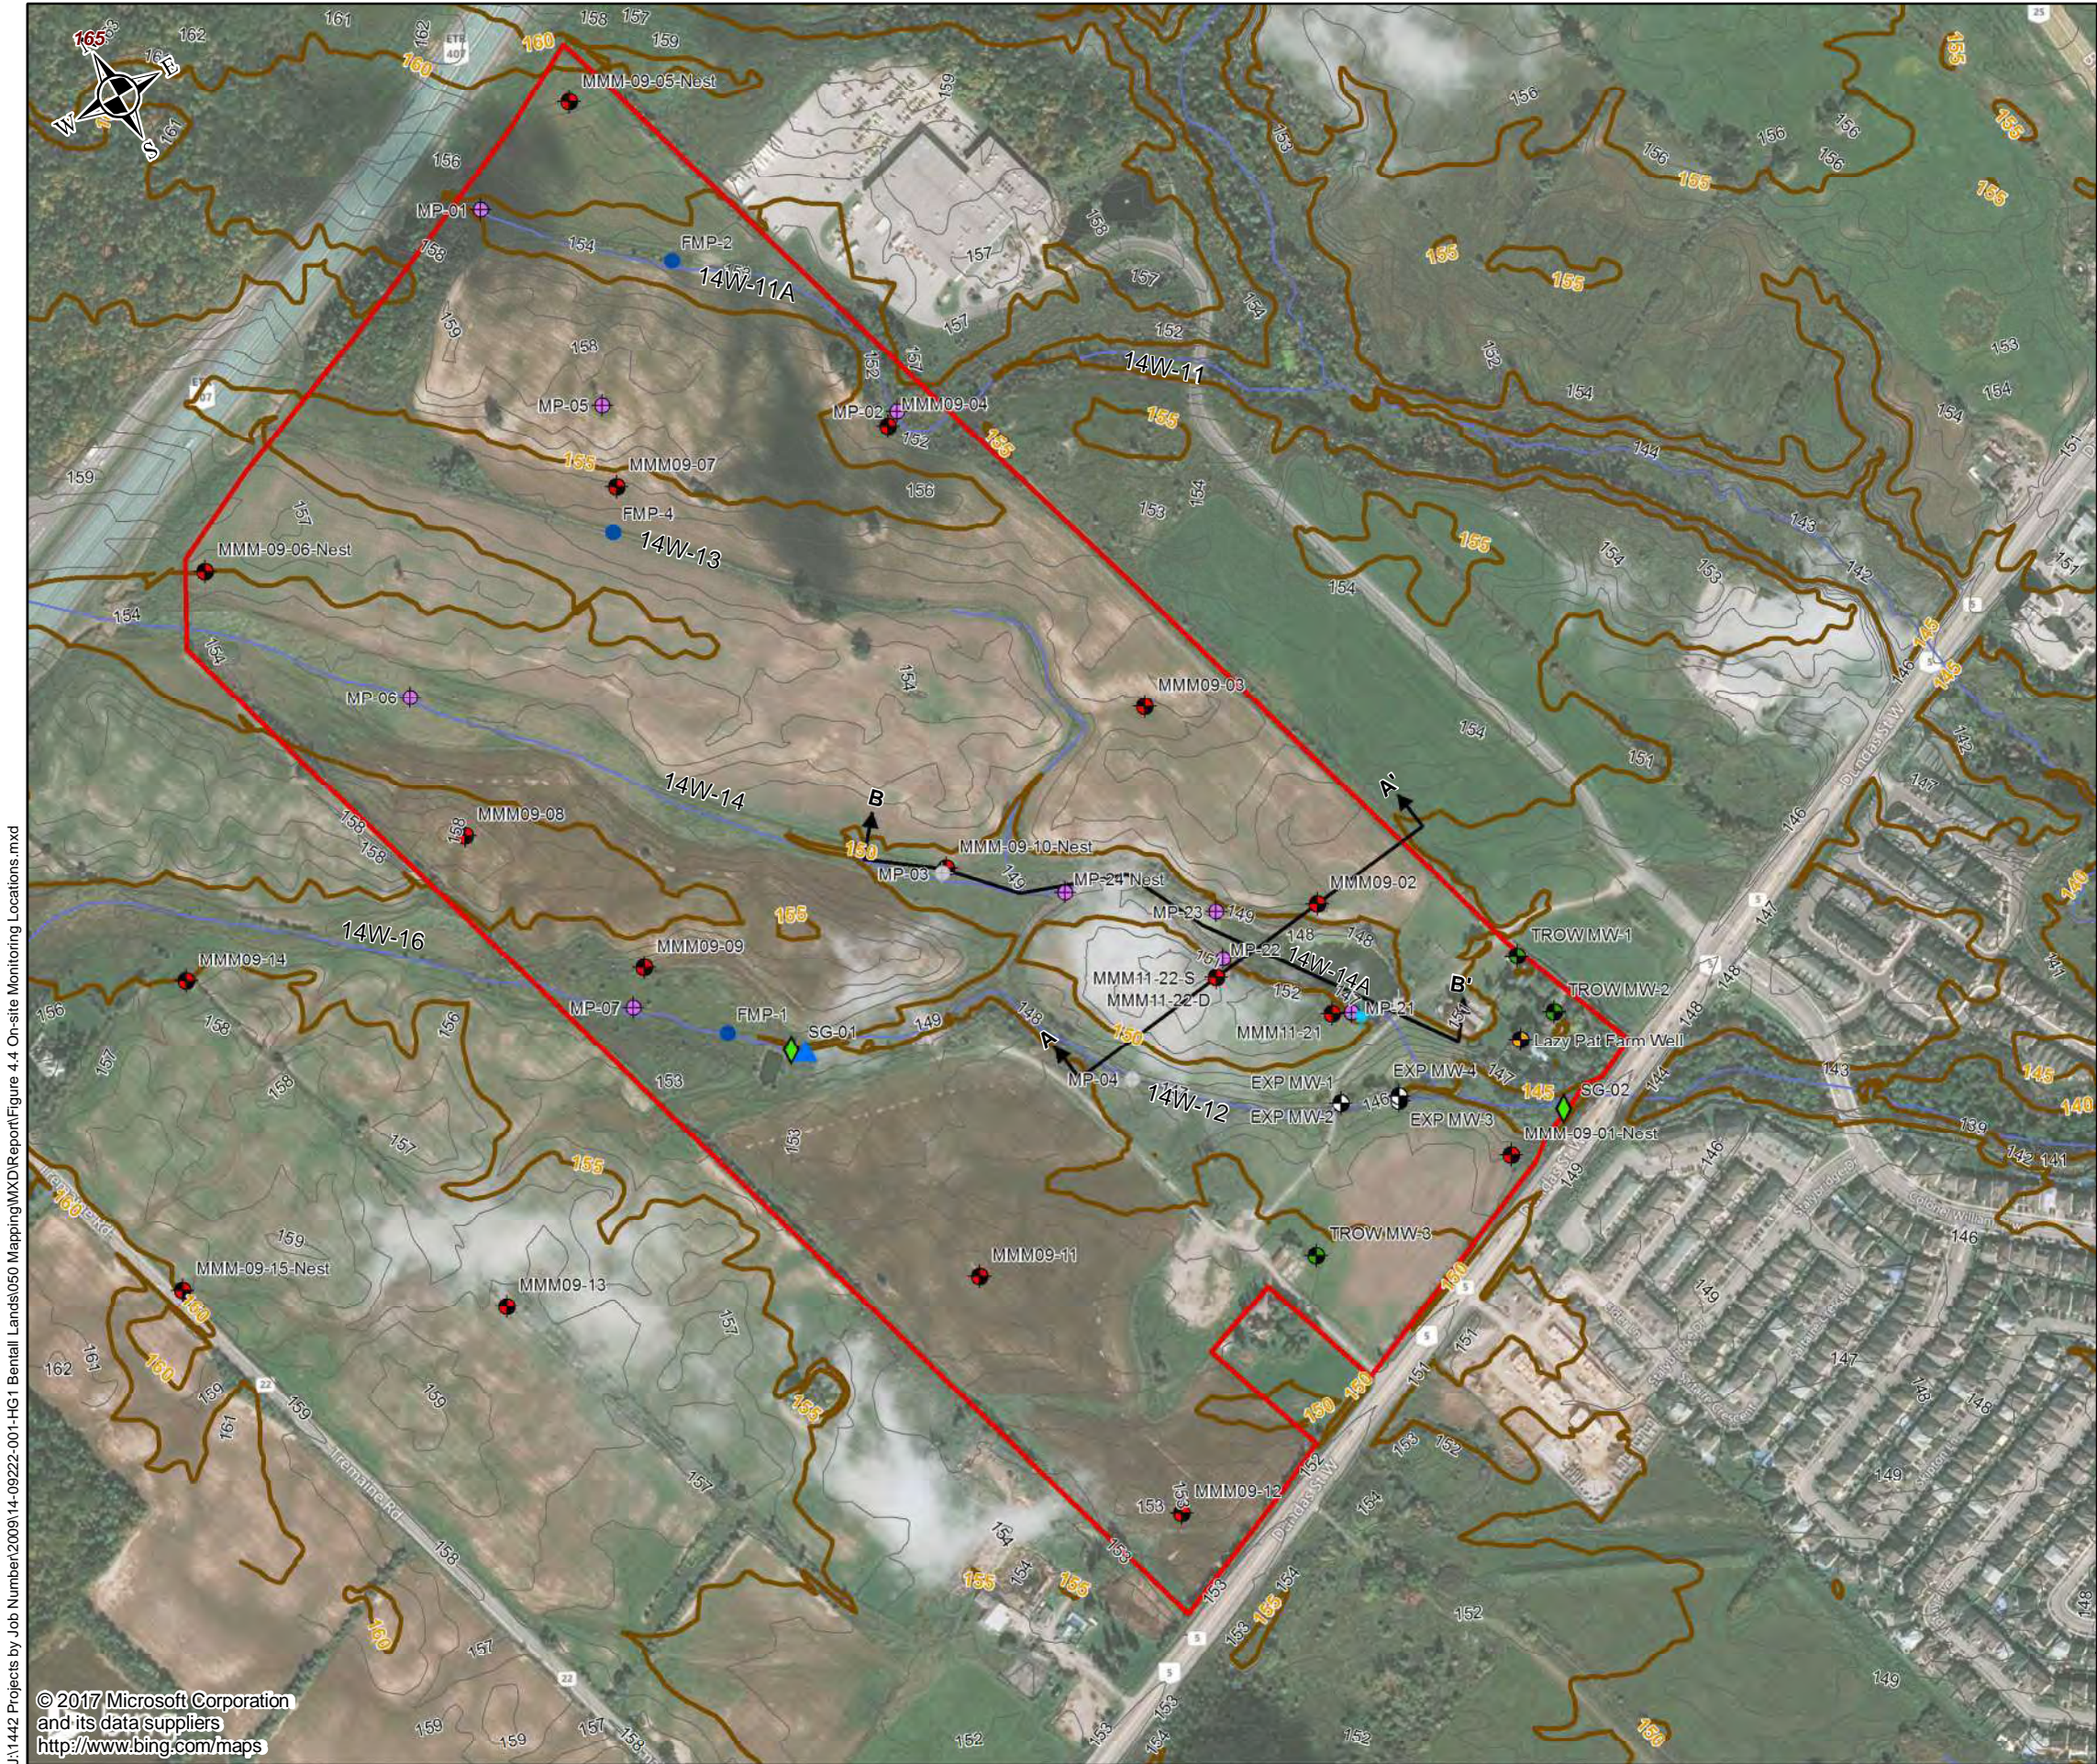
Client	Prepared By
Date	Project No.
May 2020	09M-00013-01
Scale as Shown	<b>Figure: 4.4</b>
© Queen's Printer for Ontario

## On-site Monitoring Locations
